# **Phase Two Environmental Site Assessment**

**5150 Ninth Line**

**Mississauga, Ontario**

**DS Project No: 18-748-100**

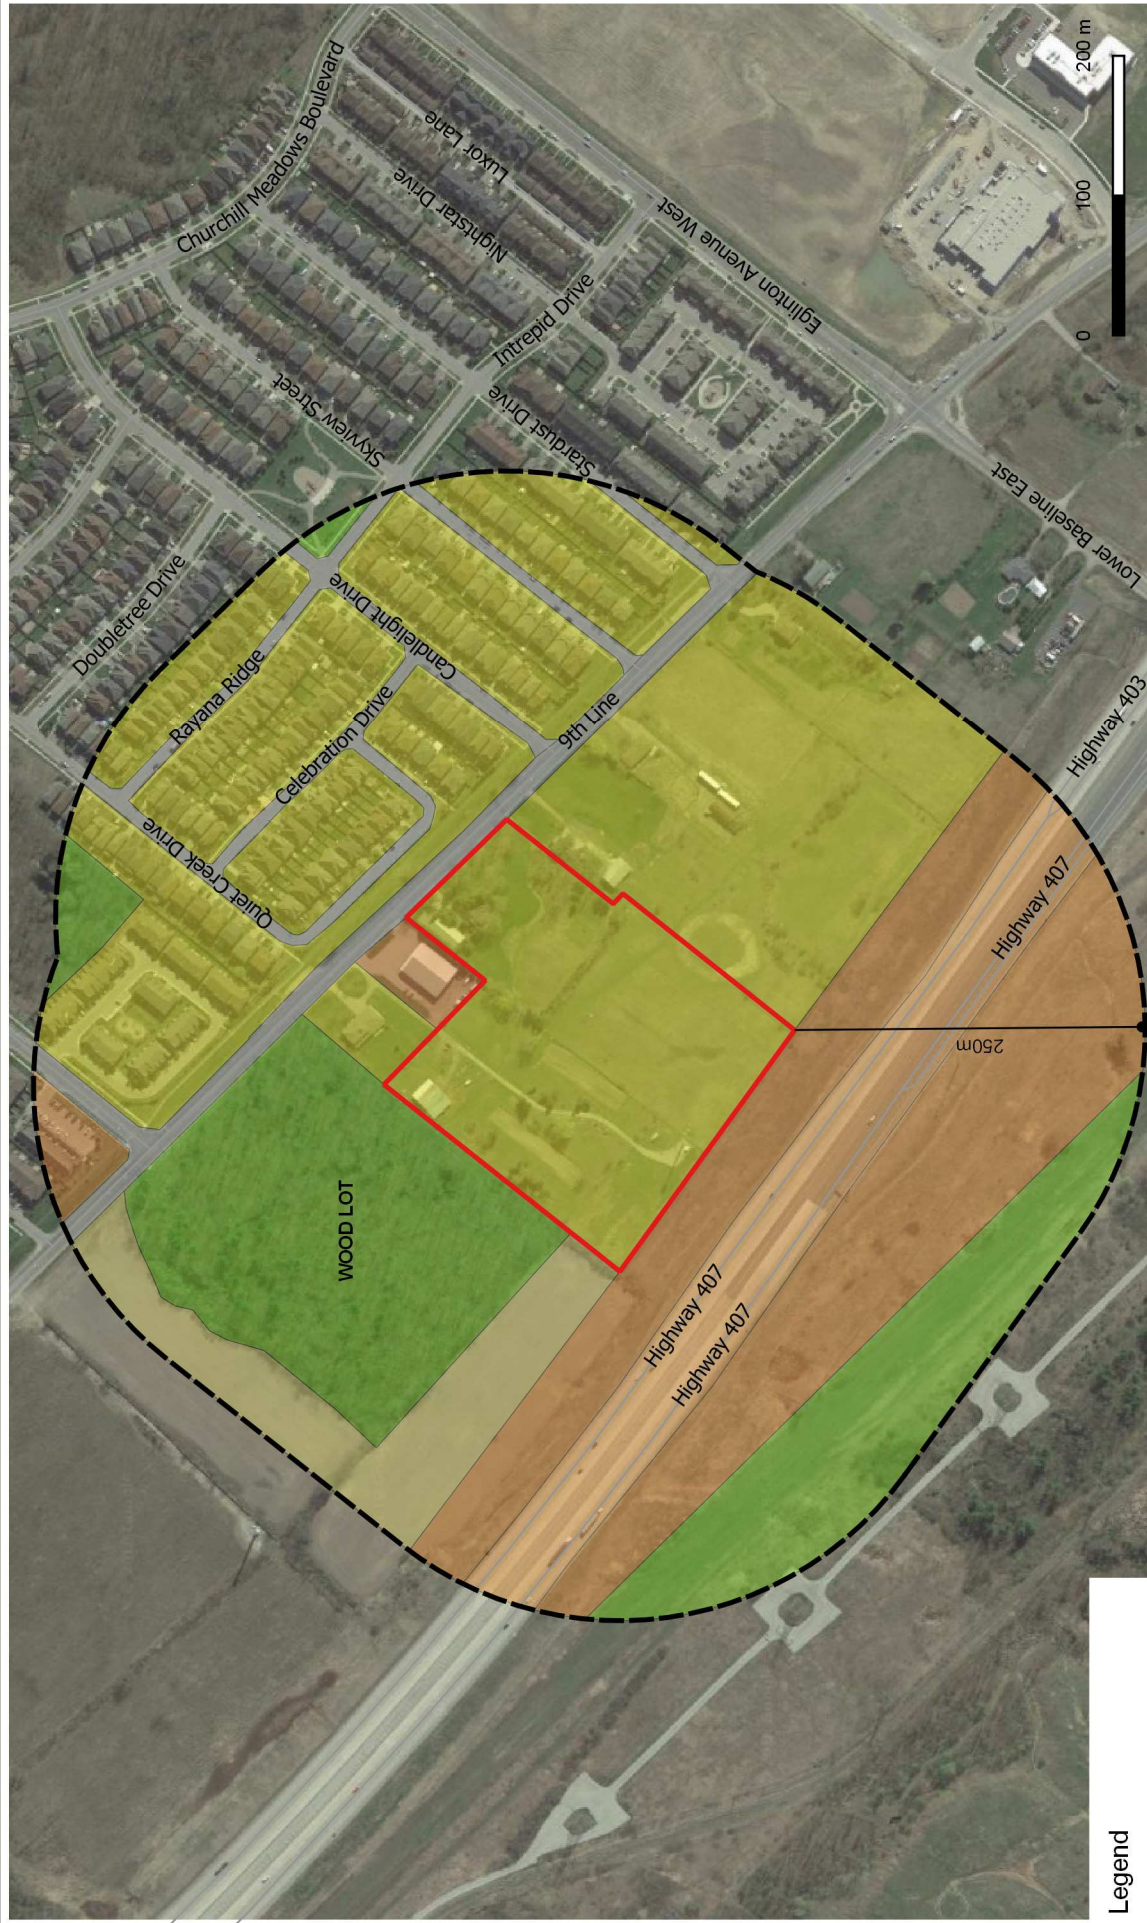
PCA Item	PCA Description (Per Table 2, Schedule D of O.Reg. 153/04)	Description
1	PCA-28: Gasoline and associated products storage in fixed tanks	One (1) AST
2	PCA-30: Importation of Fill Material of Unknown Quantity.	Fill Material was observed in previous geotechnical investigations
3	PCA-40: Pesticides (including Herbicides, Fungicides, and Anti-Fouling Agents) Manufacturing, Processing, Bulk Storage and Large Scale Applications.	Historical use of the Phase One Property for agricultural use.
4	PCA - N/S: Operation of cell tower	Shallow PHC impacts in soil identified during previous Phase II assessment in the vicinity of the cell tower
5	PCA - N/S: Orchard	Inferred use of pesticides on historical orchard.
6	PCA-58: Waste Disposal and Waste Management, including thermal treatment, landfilling and transfer of waste, other than use of biosols as soil conditioners.	Generation of pathological and photoprocessing waste

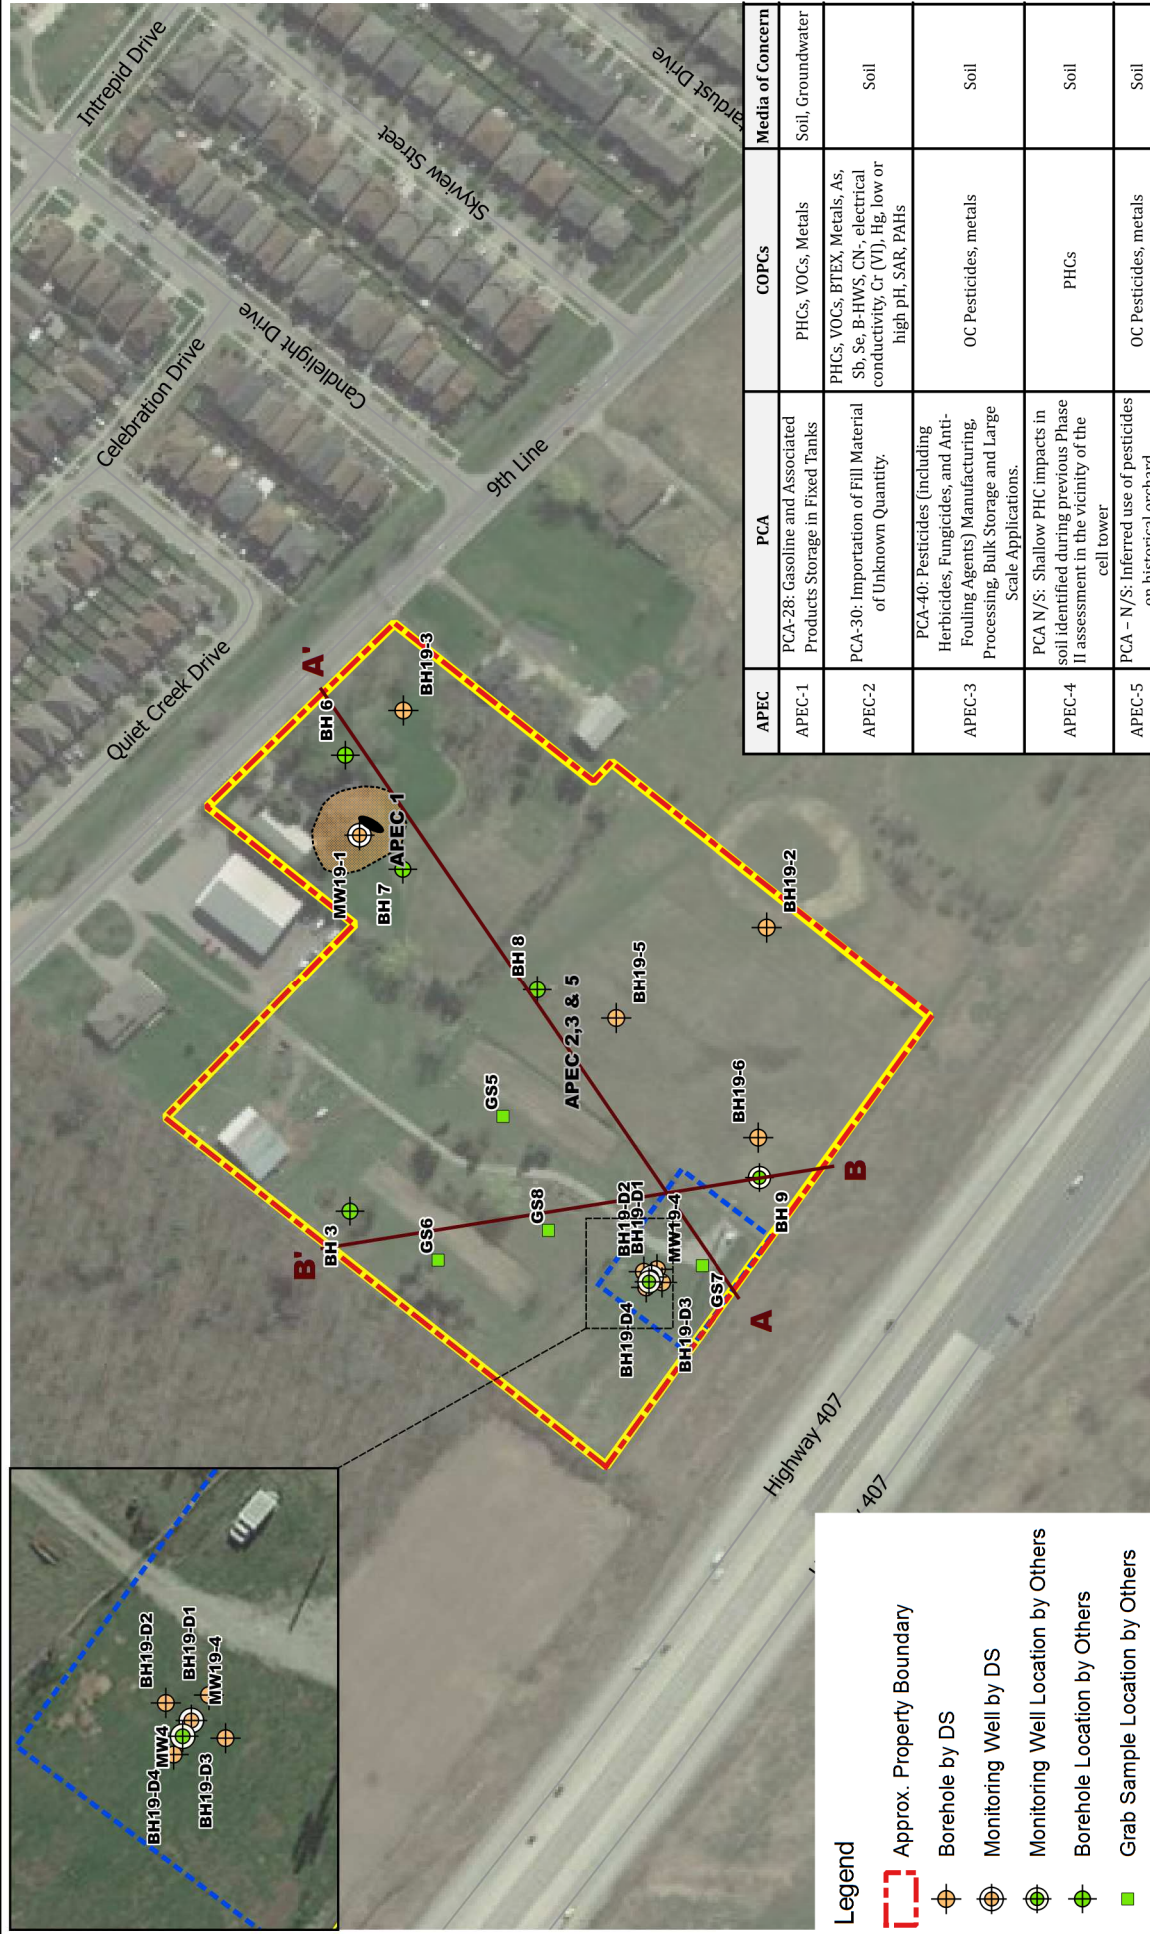
Figure No.: **5**

- Approx. Property Boundary
- Borehole by DS
- Monitoring Well by DS
- Monitoring Well Location by Others
- Borehole Location by Others
- Grab Sample Location by Others
- APEC 1
- APEC 4
- APEC 2, 3 & 5
- Cross Section
- AST

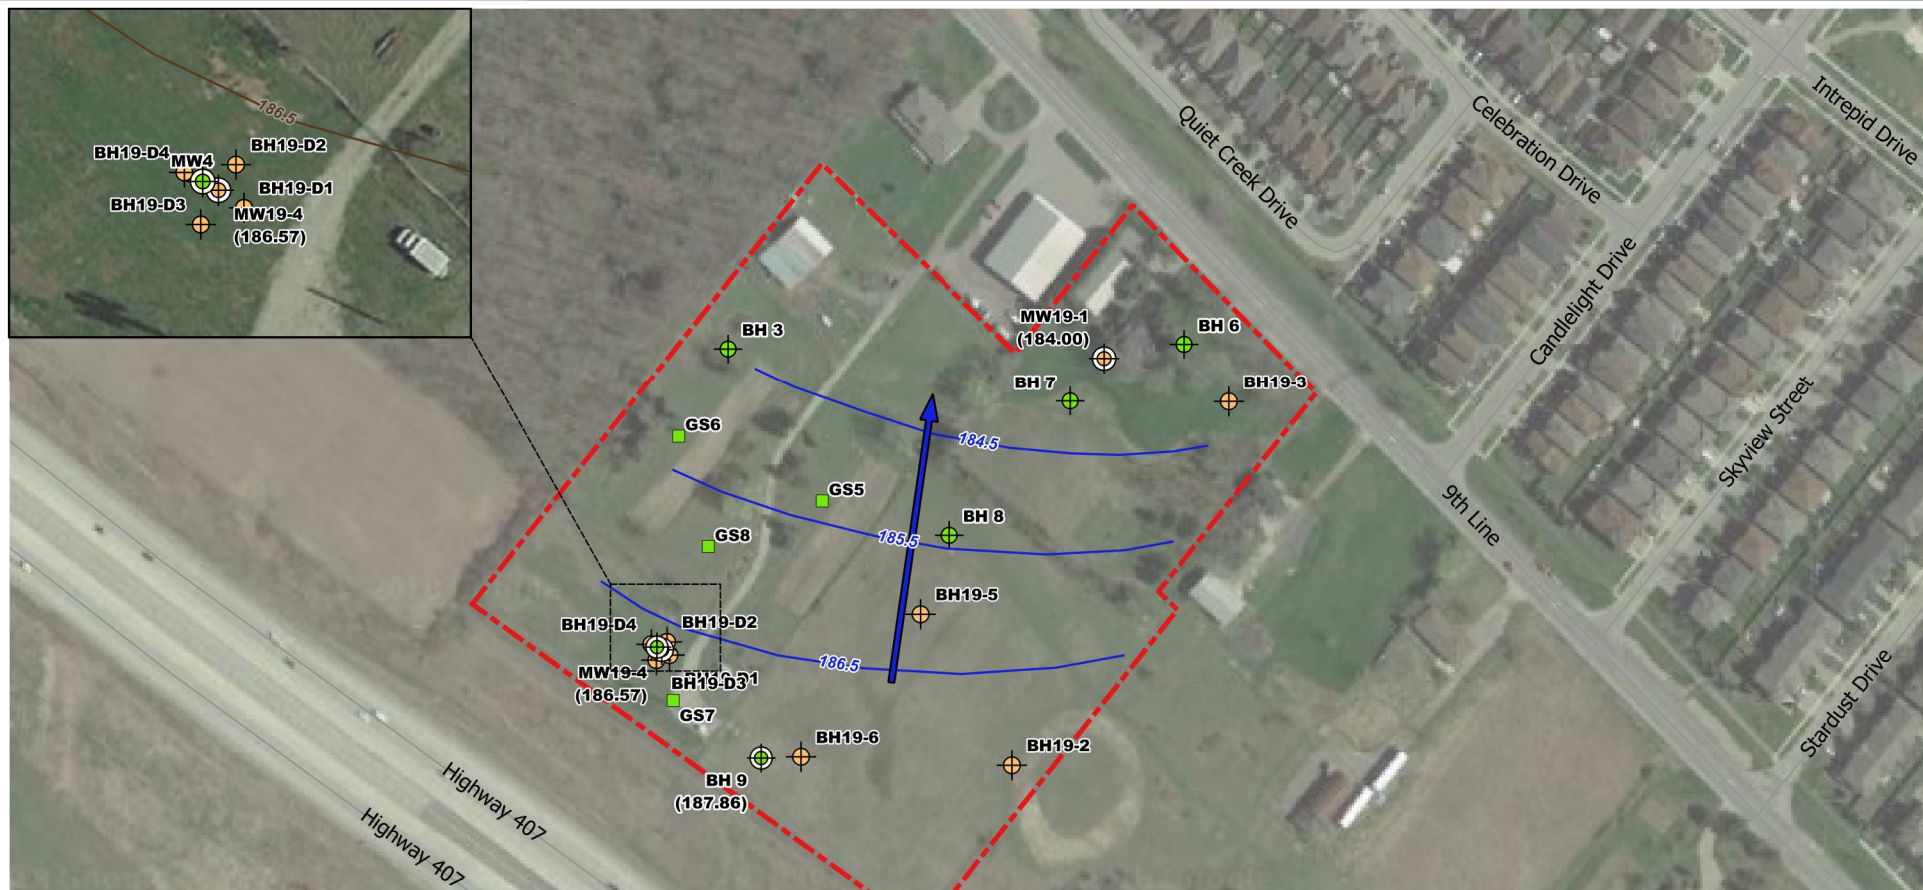
- Approx. Property Boundary
- ⊕ Borehole by DS
- ⊗ Monitoring Well by DS
- ⊕ Monitoring Well Location by Others
- ⊗ Borehole Location by Others
- Grab Sample Location by Others
- Groundwater Elevation Contour
- ➔ Interpreted Groundwater Flow Direction

The groundwater elevation was calculated by subtracting the depth to groundwater from the surface elevation determined by the surface elevation survey conducted as part of this investigation. A summary of the groundwater elevations calculated is presented in Table 1. Generally, the groundwater elevation was found to range from 184 to 187.8 masl in the aquifer investigated.

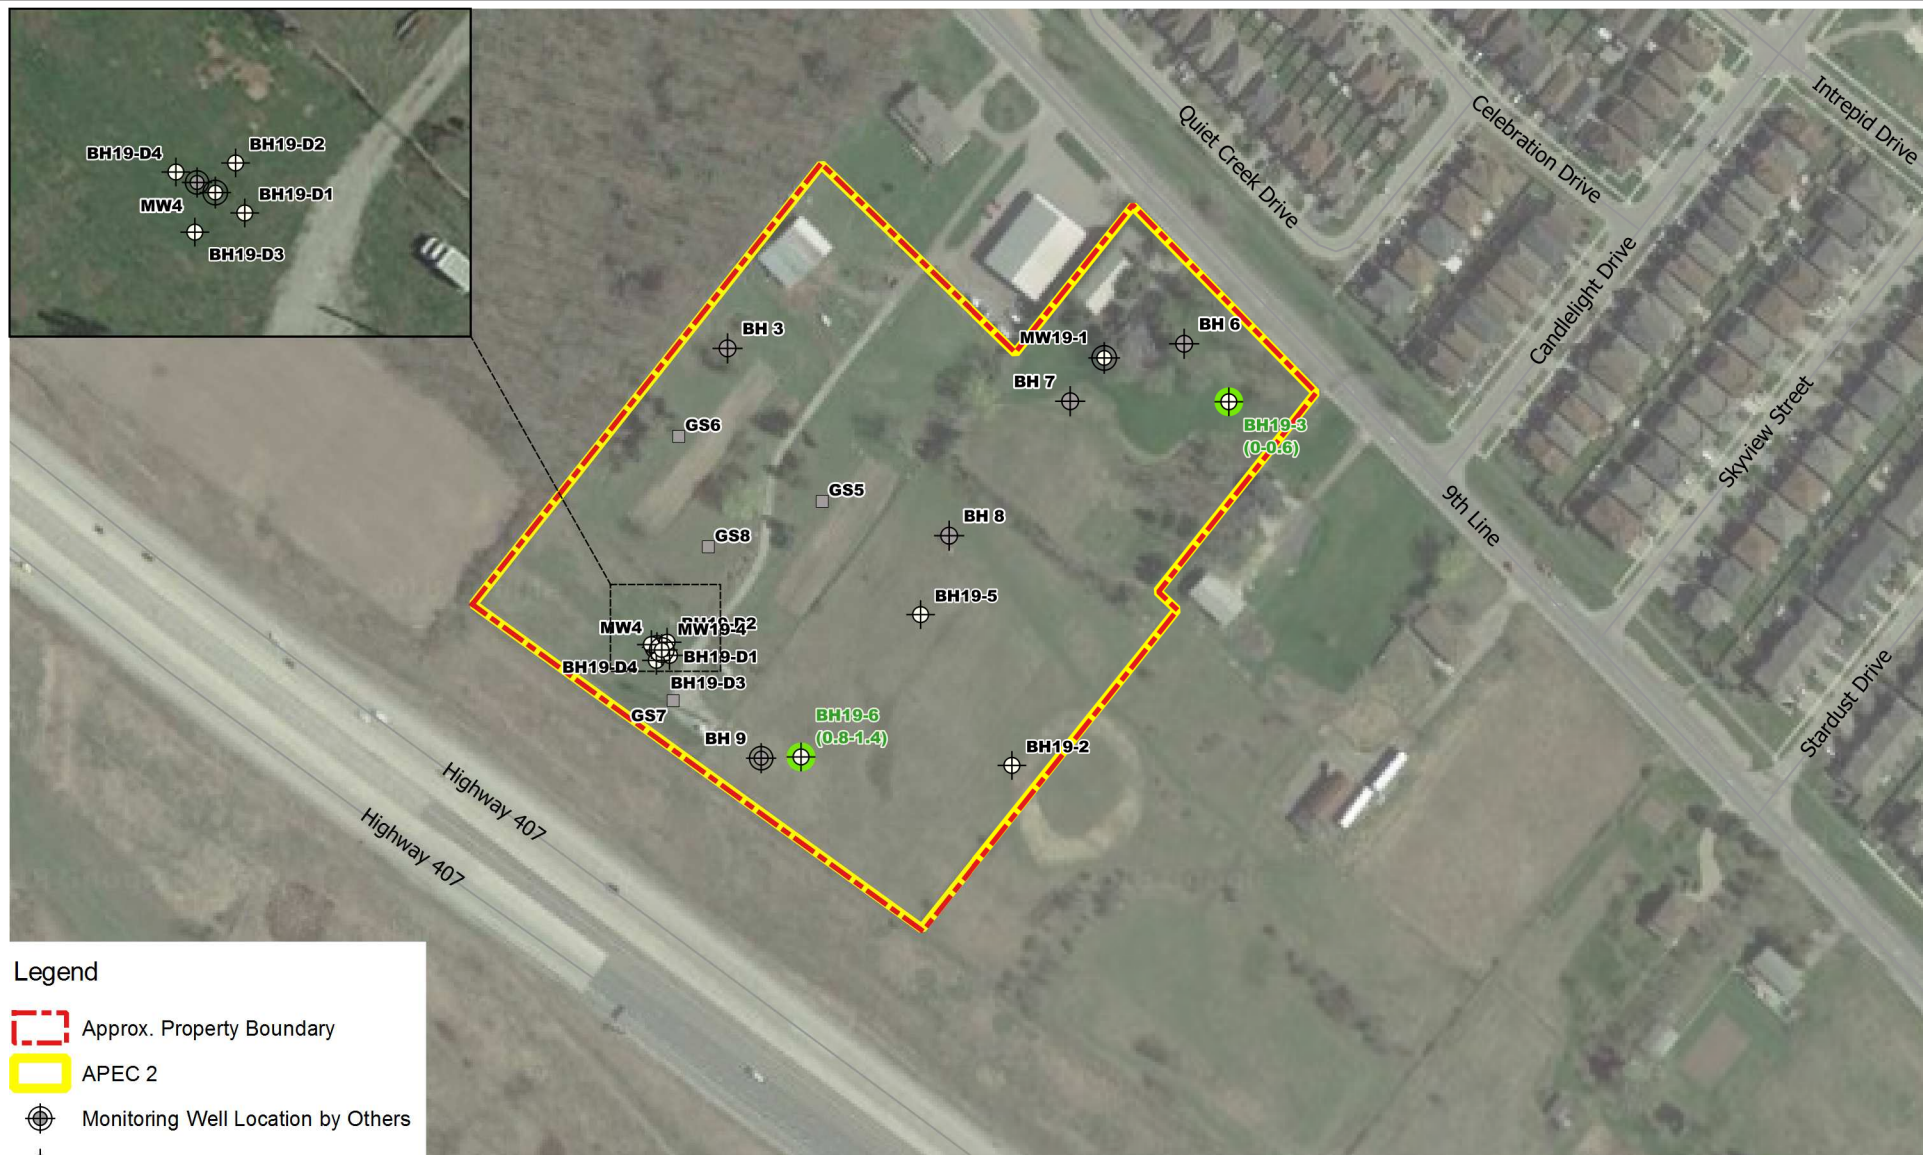
Size: 8.5 x 11	Approved By: R.F	Drawn By: S.Y	Date: February 2019
Rev: 0	Scale: As Shown	Project No.: 18-748-100	Figure No.: <b>6C</b>
Image/Map Source: Google Satellite Image

- Approx. Property Boundary
- APEC 2
- ⊗ Monitoring Well Location by Others
- ⊕ Borehole Location by Others
- Grab Sample Location by Others
- ⊕ Borehole by DS
- ⊗ Monitoring Well by DS
- Met T2 RPI Standards
- (0-1.2) Sample Depth (mbgs)

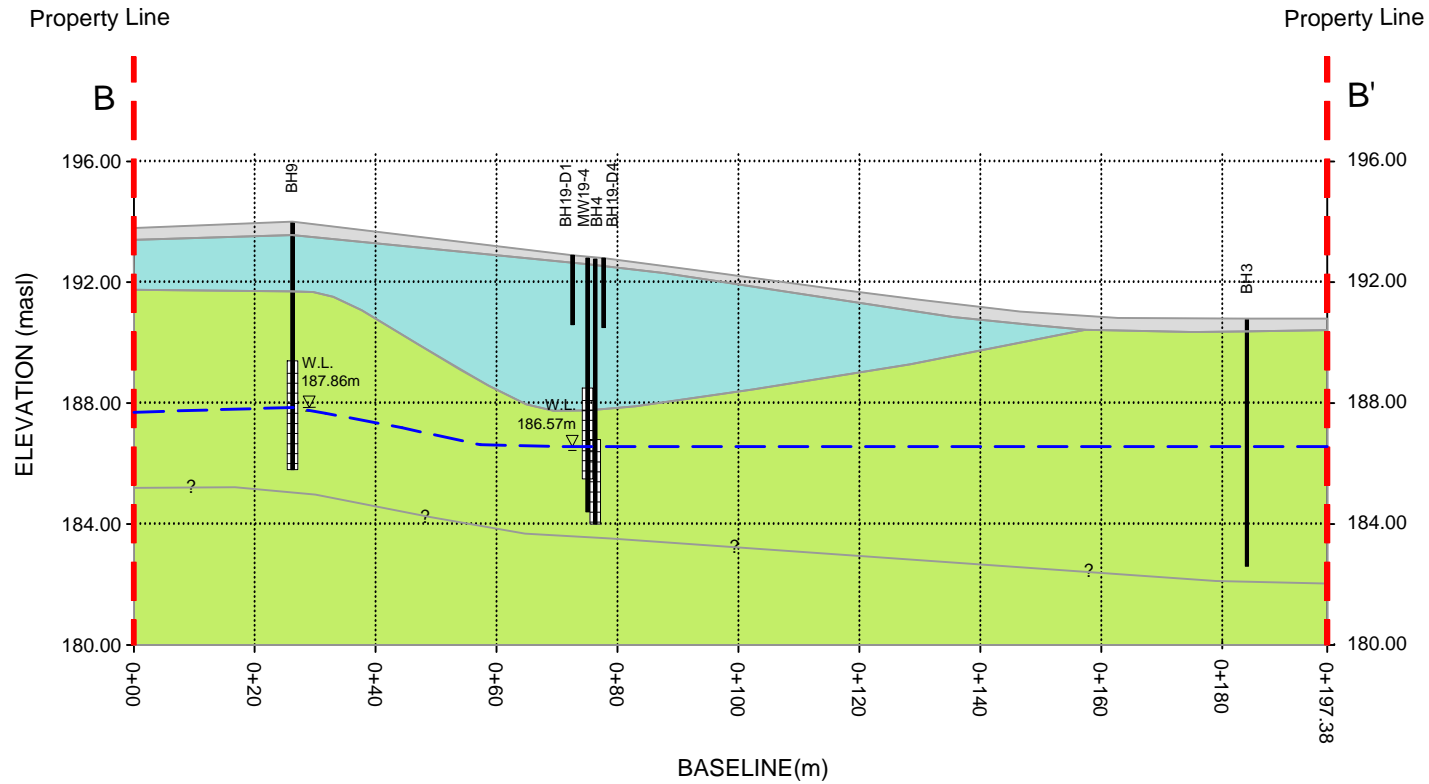
Size: 8.5 x 11	Approved By: R.F	Drawn By: S.Y	Date: February 2019
Rev.	Scale: As Shown	Project No: 18-748-100	Figure No. 8B

Topsoil
  Sandy Silt Till/Sandy Silt
  Clayey Silt Till/Silty Clay Till

Horizontal Scale: 1:1250  
 Vertical Scale: 1:250
