Arborist Report for 1381 Lakeshore Road East

Mississauga, Ontario

The following is an arborist report for the property at 1381 Lakeshore Road East Drive, in Mississauga Ontario. The purpose of this report was to ascertain the potential impacts of the proposed construction of a new development on the trees on the site and on adjacent properties.

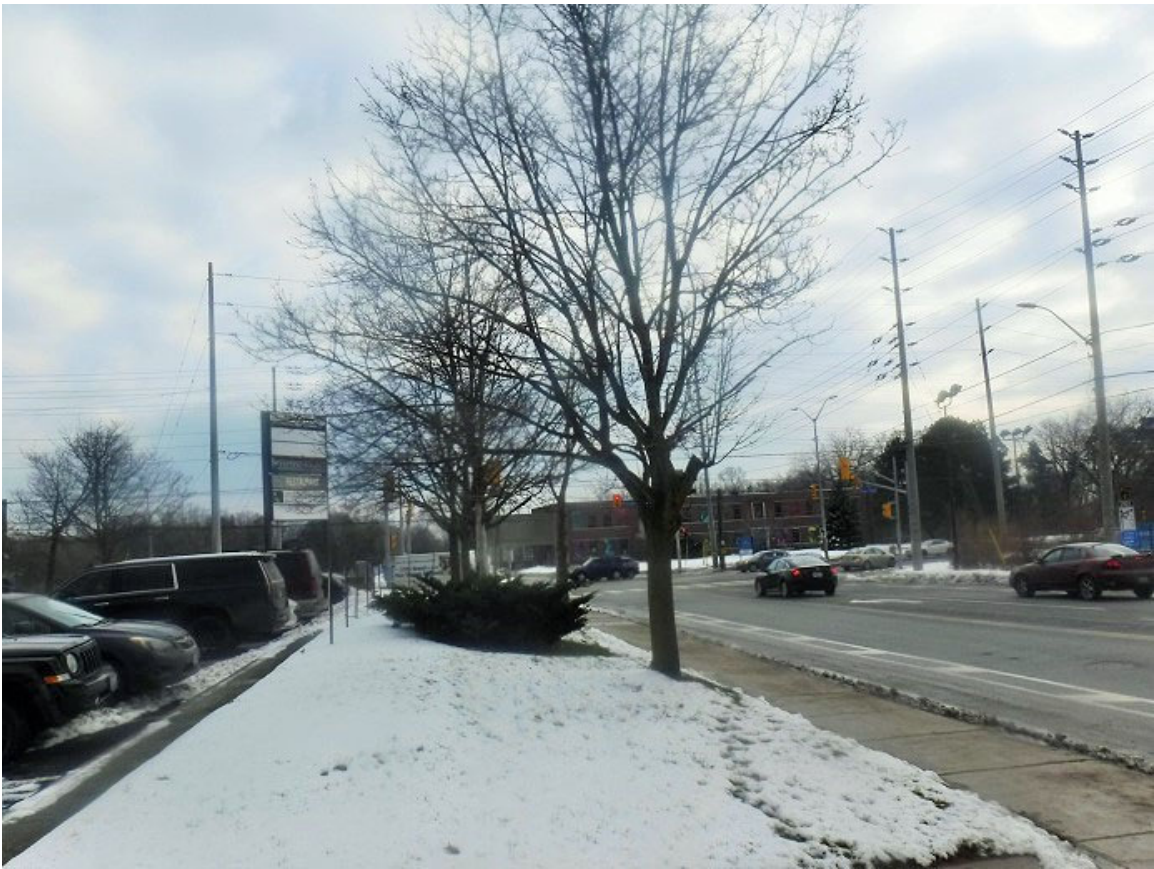
Image #1: Existing Trees along Dixie road frontage.

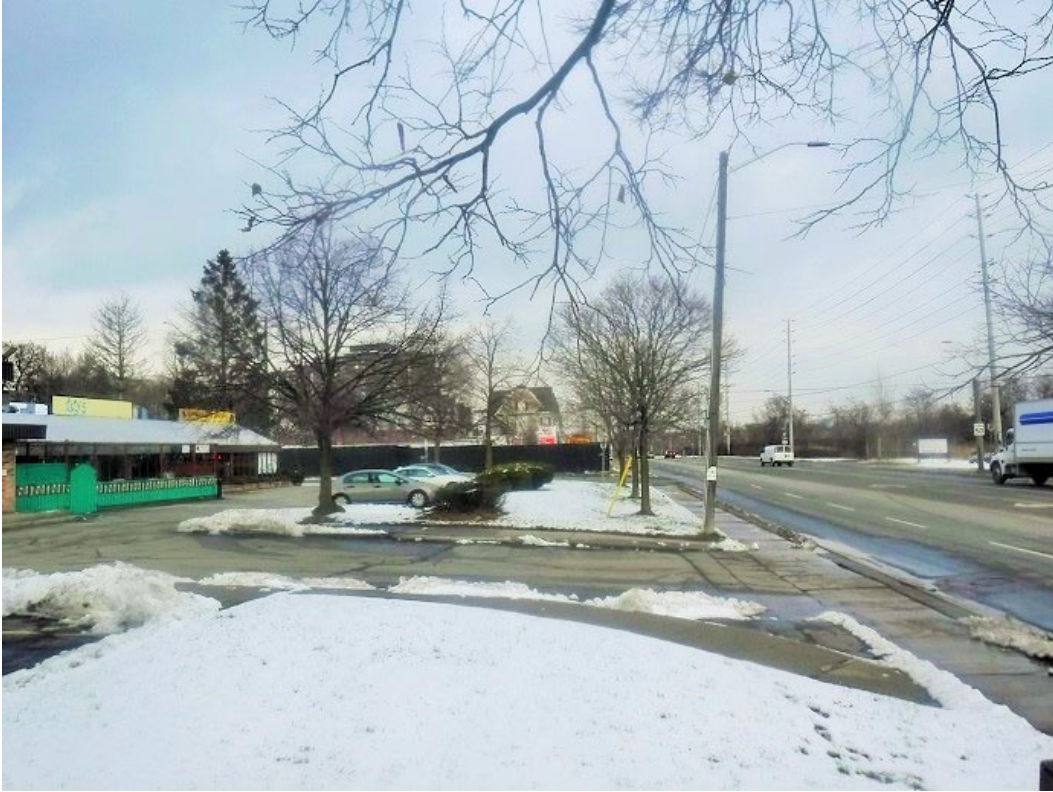
Image #2: Existing Trees along Lakeshore Road frontage.

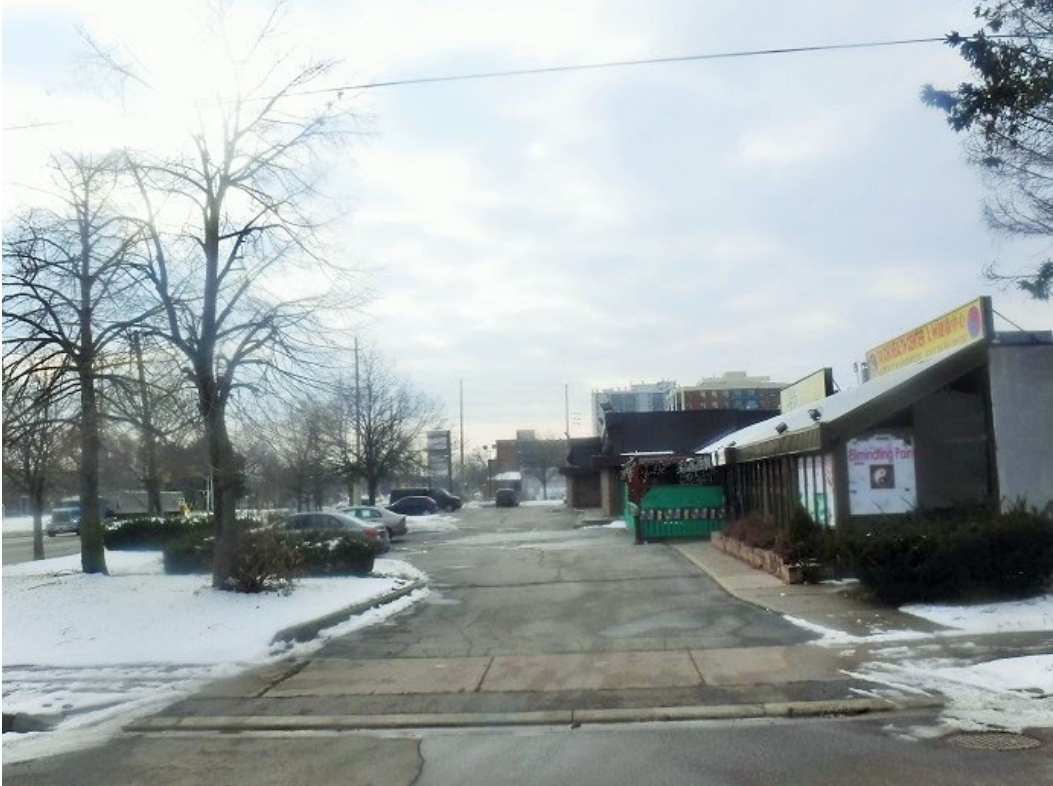
Image #3: Existing Trees #15 & 16 at Lakeshore and Cherribell intersection

#15	Linden	32	55	Private	To be Removed ; <i>conflict with proposed development</i>
#16	Linden	32	60	Private	To be Removed ; <i>conflict with proposed development</i>

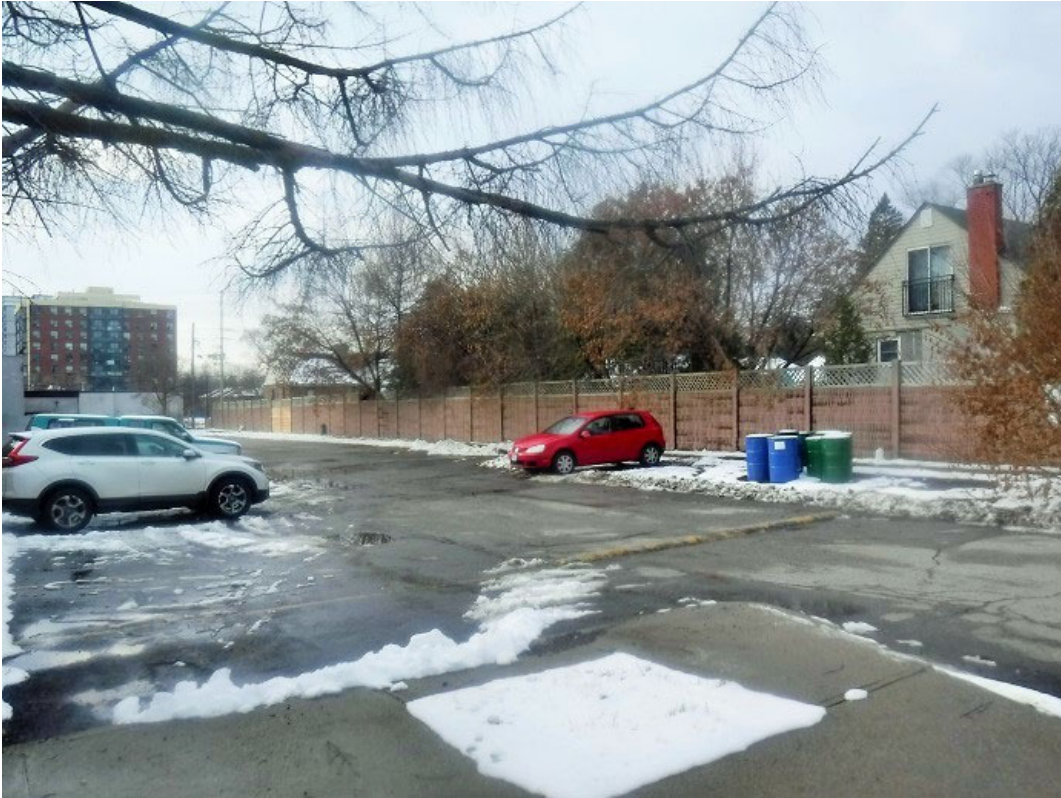
Image #4: Existing Neighbouring trees to remain at rear of property.

No Neighbouring trees will require removal or injury. Several Neighbouring trees are to be retained and the existing fence is to act as protection during the demolition and construction work on the site. Refer to tree locations on the plan developed by *MSLA Landscape Architects*..

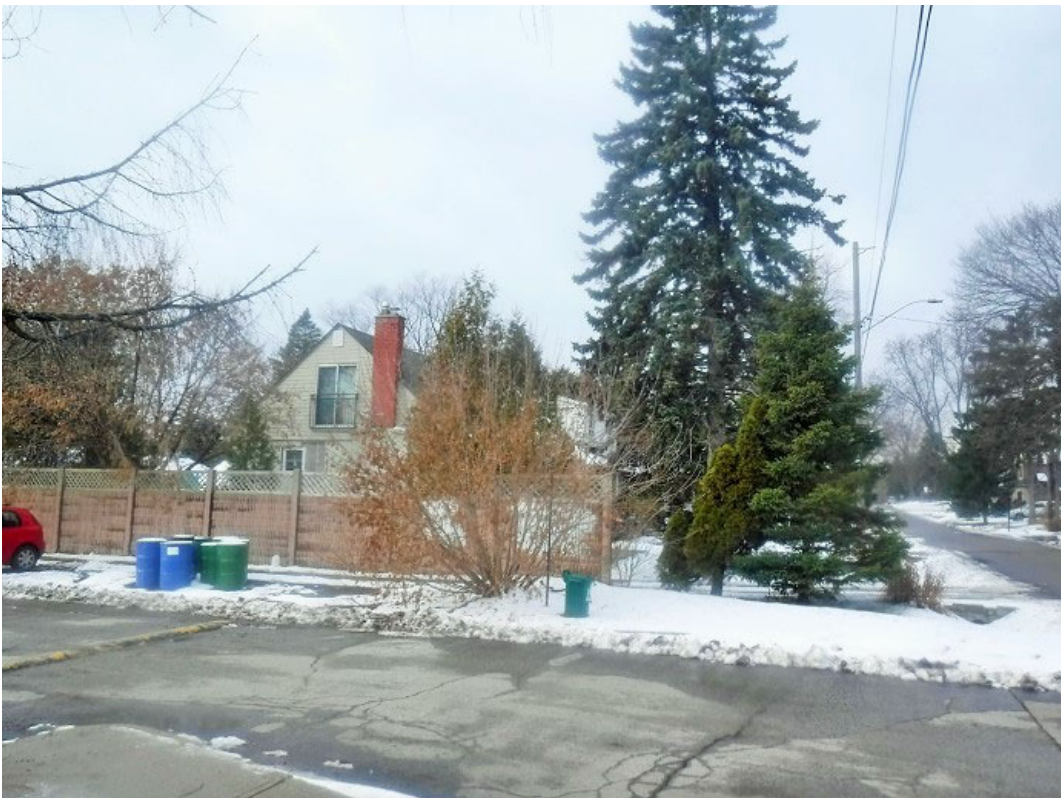
Image #5: Existing Trees #1 & 20 along Cheribell Road.
