## **Phase One and Limited Phase Two Environmental Site Assessment**

**Living Arts Drive Extension, Rathburn Road West  
to Centre View Drive, Mississauga, Ontario**

**GeoPro Project No.: 17-1798E**

**Report Date: November 20, 2017**

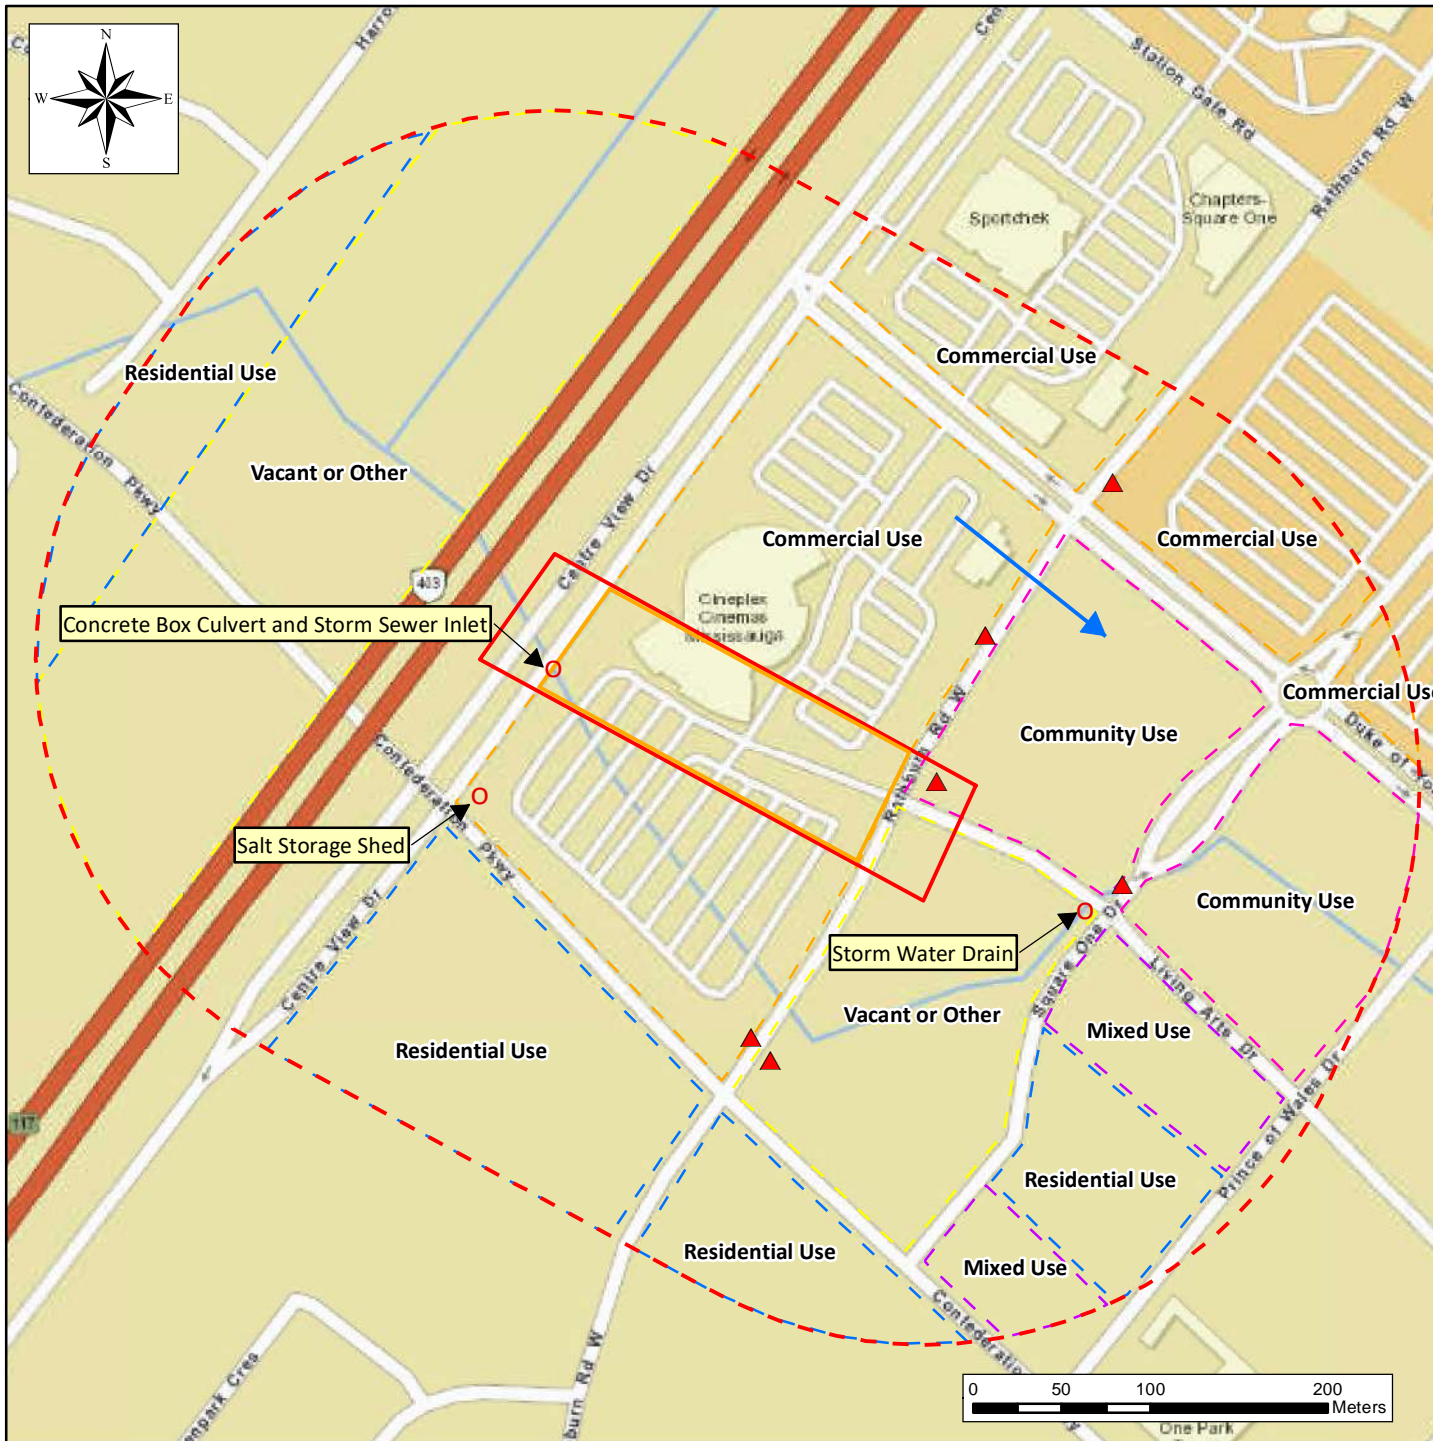
Title: Project Area and Surrounding Land Use  
and Observed Features

No other potential or actual contamination was identified during the site reconnaissance. The features observed during the site reconnaissance are shown on Drawing No. 2.

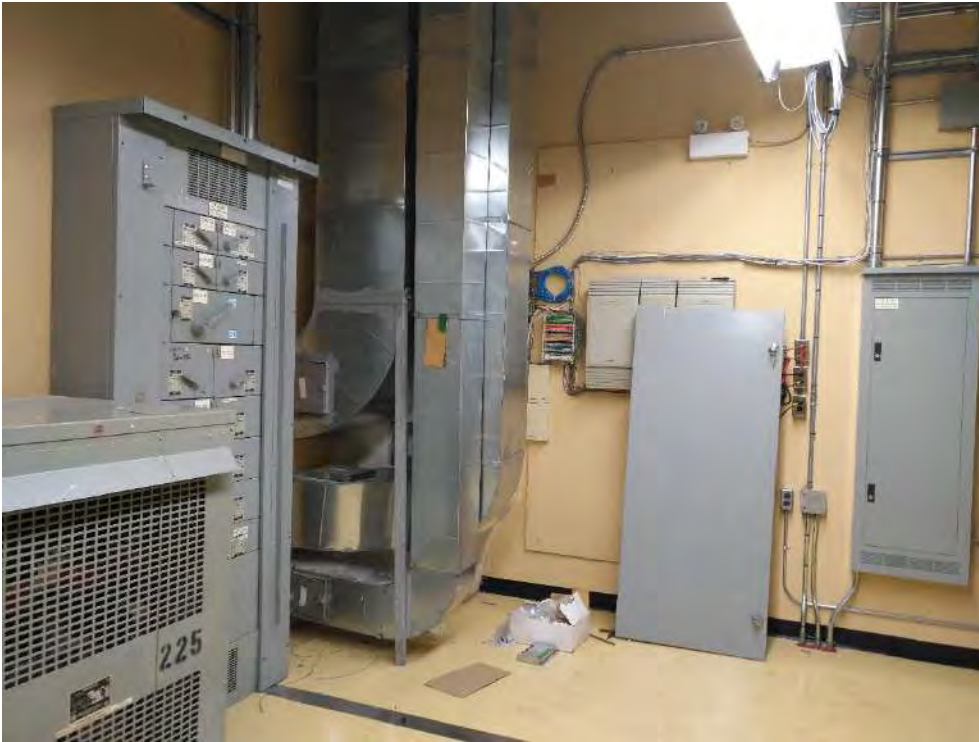
Photo 3 - View of the electrical room within the Cineplex Cinema Building

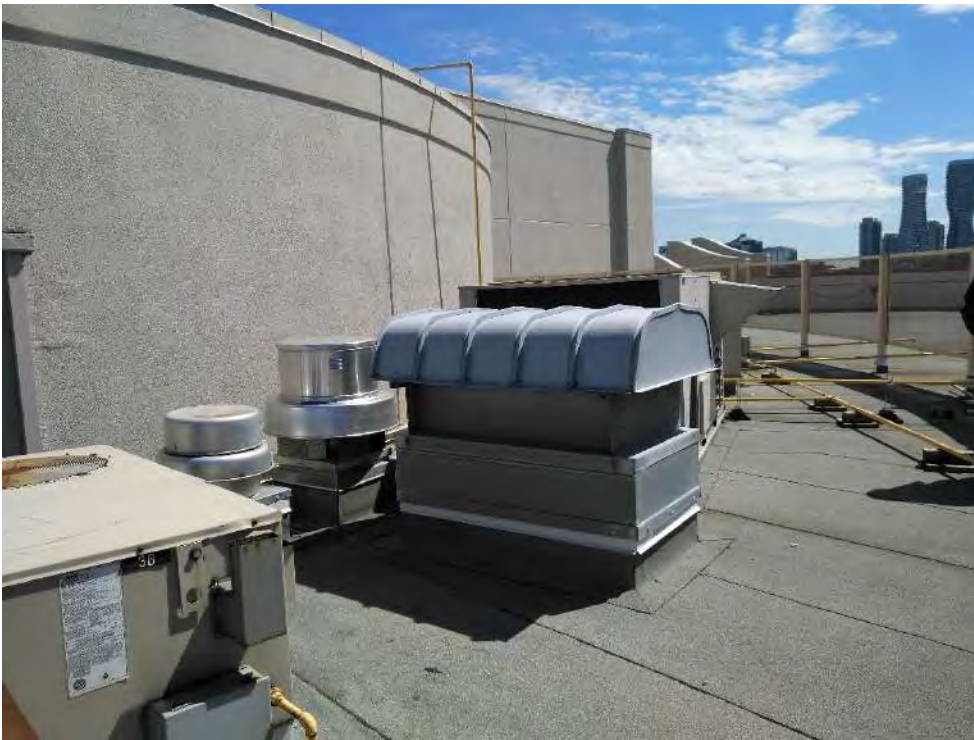
The Cineplex Cinema building was heated with rooftop natural gas-fired forced air heating units and cooled using central air conditioners on the roof of the Cinema building.

Photo 4 - View of the rooftop HVAC units (looking southeast)

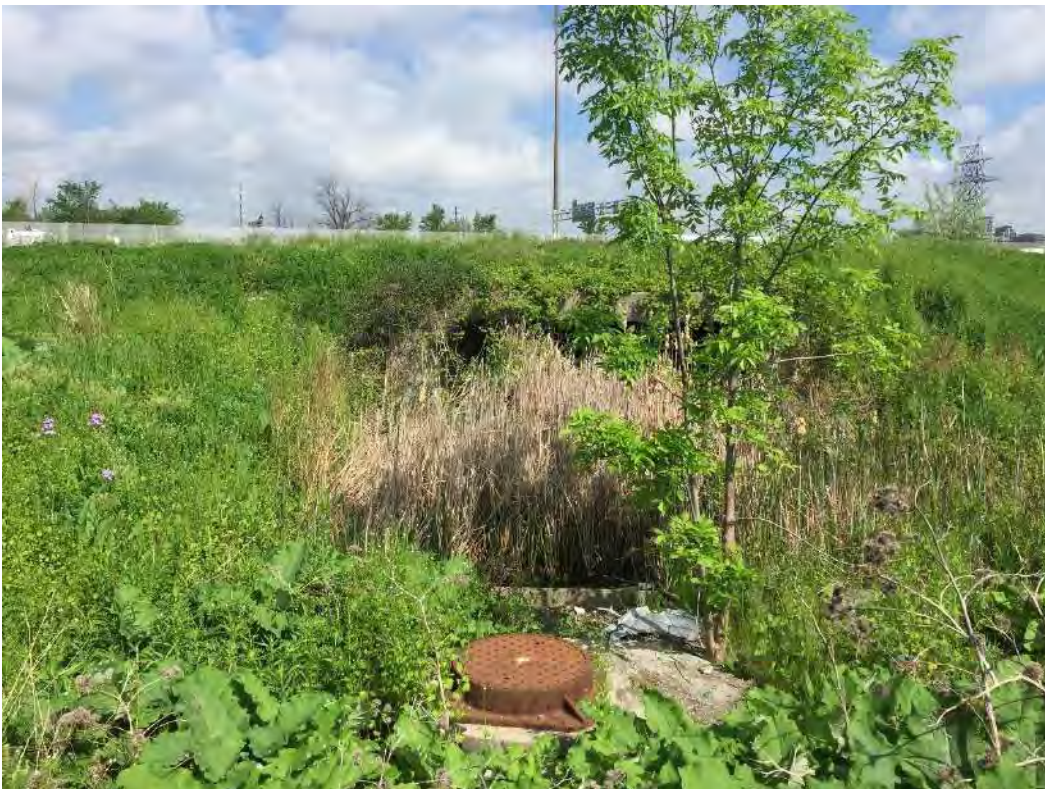
No watercourses, ditches or standing water were observed within the Project Area during the site reconnaissance. However, water was noted flowing out of a concrete box culvert and into a storm sewer drain located in the north part of the Project Area.

Photo 6 - View of a culvert outlet and a storm drain inlet into a storm sewer located in the northwest portion of the Site

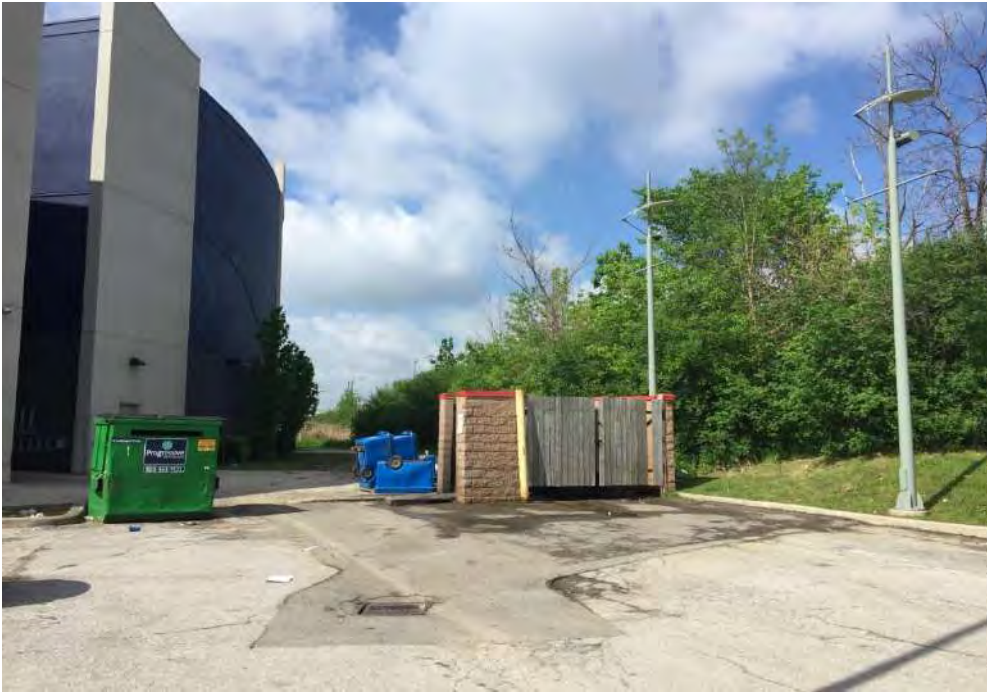
Photo 7 - View of the back of Cineplex Cinema building (looking southwest). Enclosed storage area, and garbage bins/containers were noted.

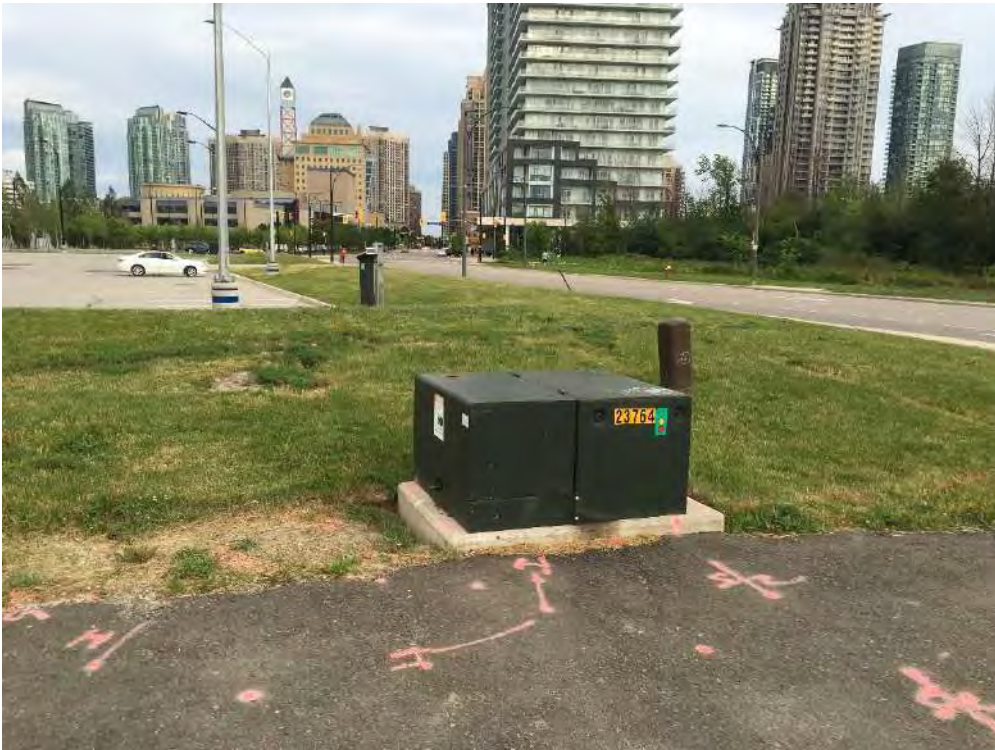
- A salt storage shed was noted in the parking lot area located at the west corner of the Cineplex Cinema property at 309 Rathburn Road West.
- Transformers mounted on concrete pads were noted at the following locations.
  - Both sides of Rathburn Road West on the northeast side of the intersection of Rathburn Road West and Confederation Parkway
  - East of the intersection of Rathburn Road West and Living Arts Drive (within the Project Area)
  - North of the intersection of Living Arts Drive and Square One Drive
  - Near the southern property boundary in the northeastern portion of the property at 309 Rathburn Road West

Photo 8 - View of a transformer located on Site at the corner of intersection of Rathburn Road West and Living Arts Drive (looking southeast)

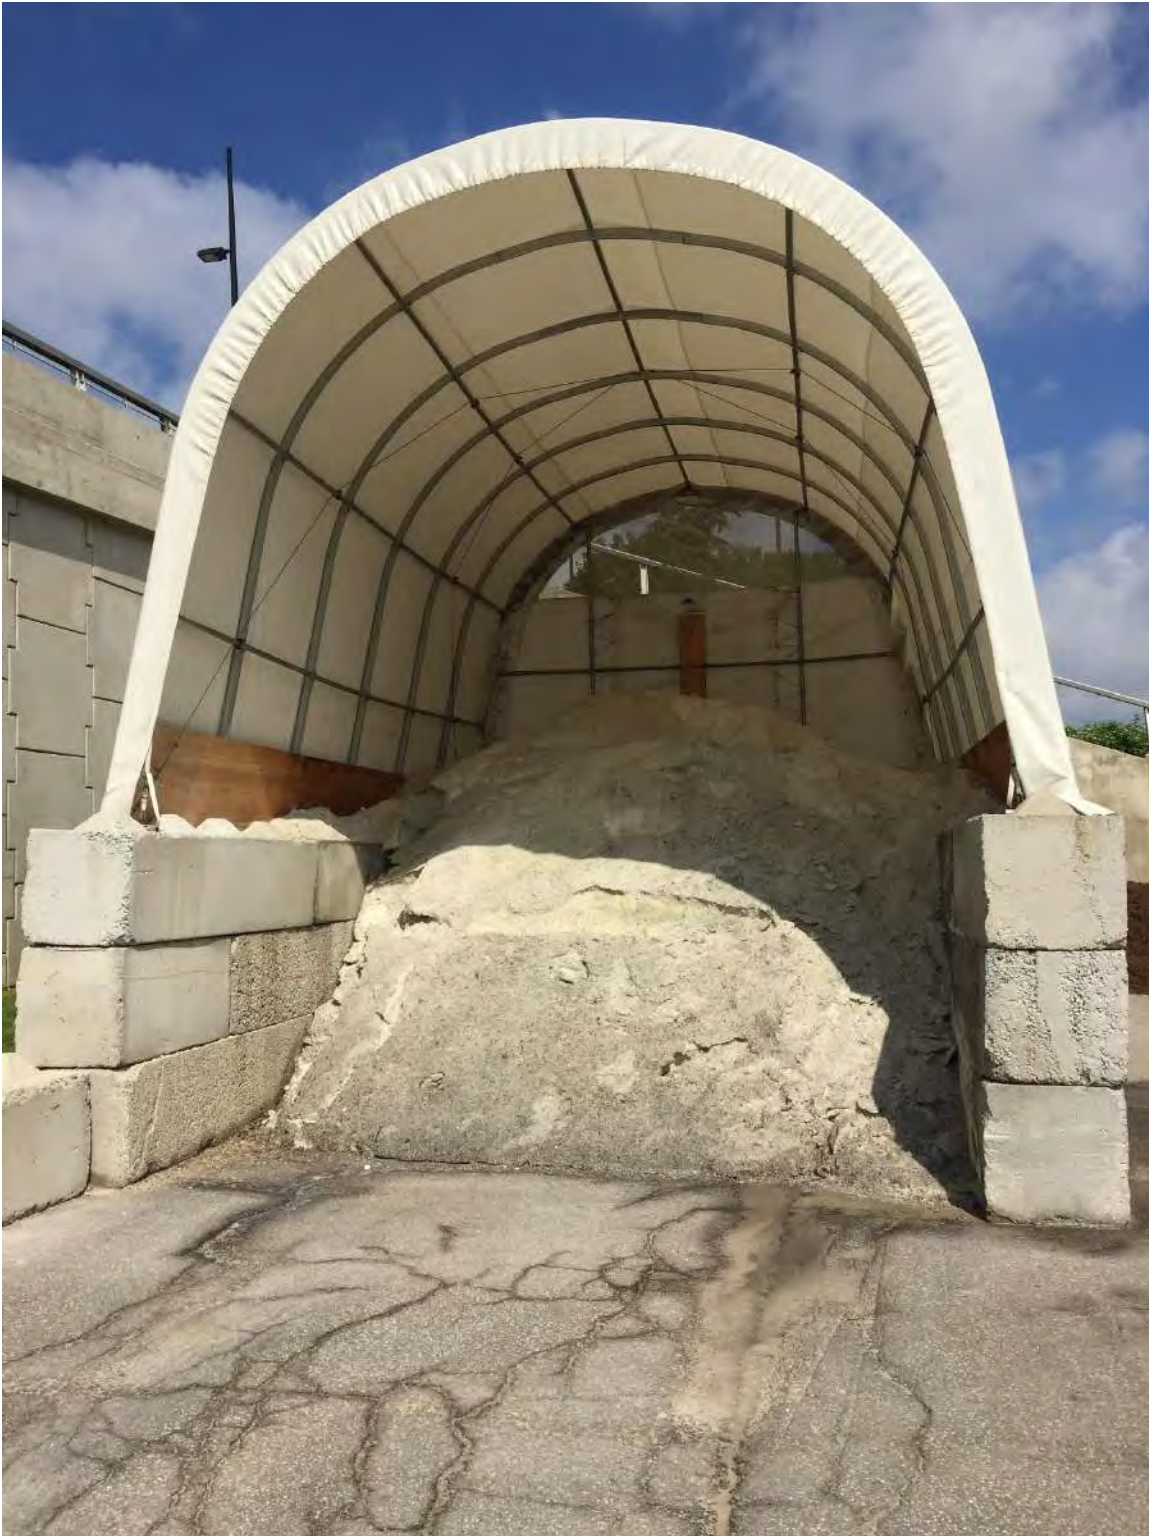
Photo 9 - View of a salt storage shed at the west corner of the property at 309 Rathburn Road West (looking northwest).

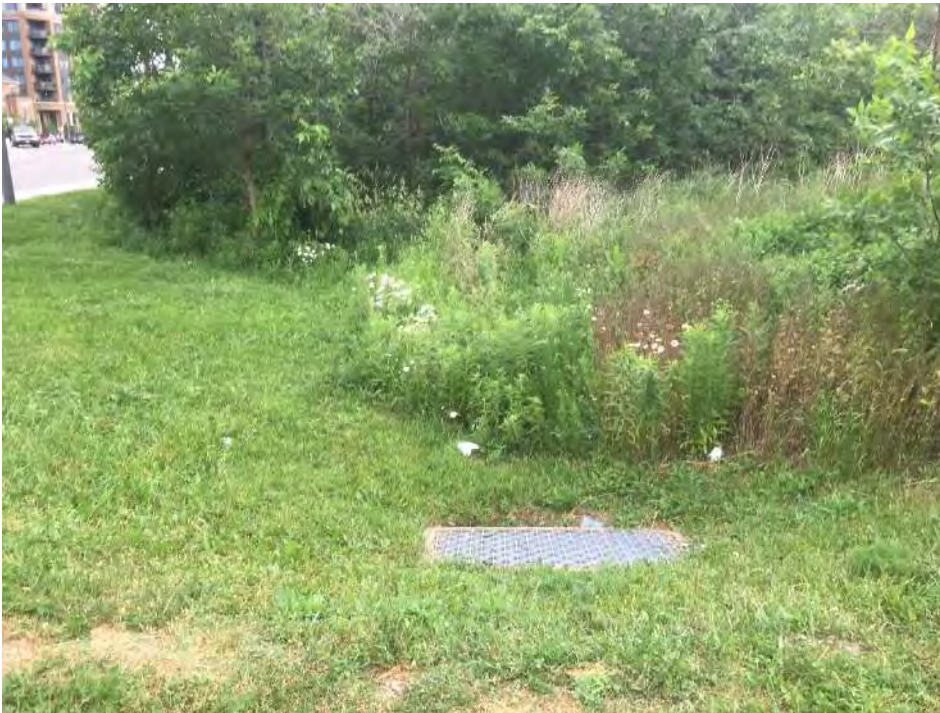
drain located southeast side of Centre View Drive and in the northwest part of the Project Area. A dry ditch, likely the previous creek channel, was noted in the vacant wooded area on the northwest side of Square One Drive. In addition, a storm water drain was observed at the east corner of the wooded land.

Photo 13 - View of the inlet to the storm sewer for surface water/runoff from the vacant/wooded area at 4220 Living Arts Drive. The inlet is located at the west corner of intersection of Living Arts Drive and Square One Drive
