Appendix J **GEOTECHNICAL REPORT**

Geotechnical Investigation

Living Arts Drive Extension

Mississauga, Ontario

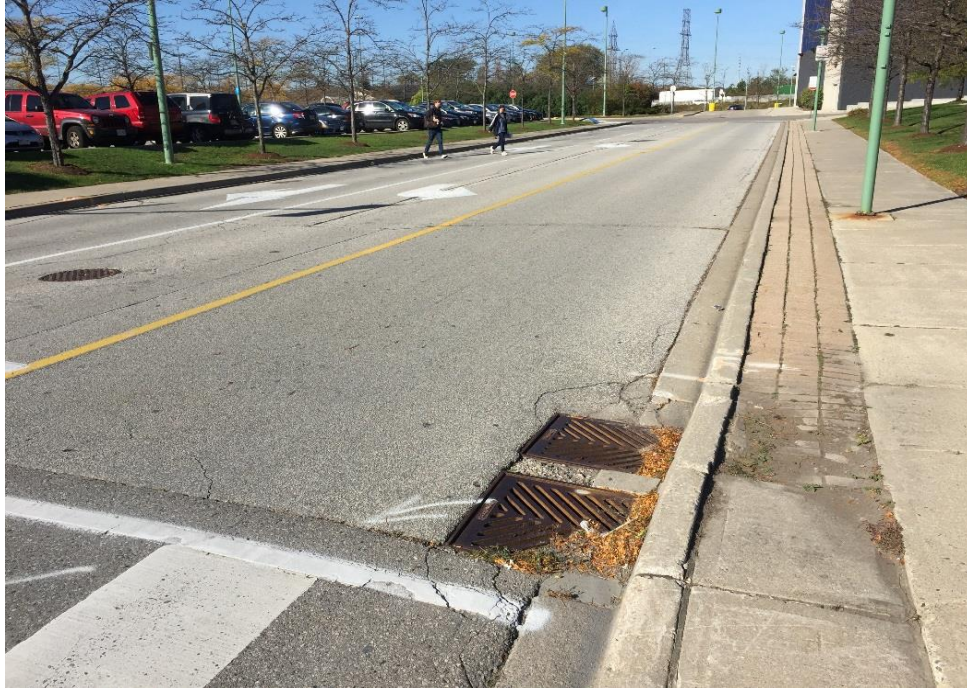
Photograph 1 – Existing Access Road/future Extension of Living Arts Drive, westbound lane, at the intersection of Rathburn Road West, looking west, showing moderate construction joint cracking, moderate longitudinal and transverse cracking. Catch basin was in fair condition with slight alligator and random cracking around it.

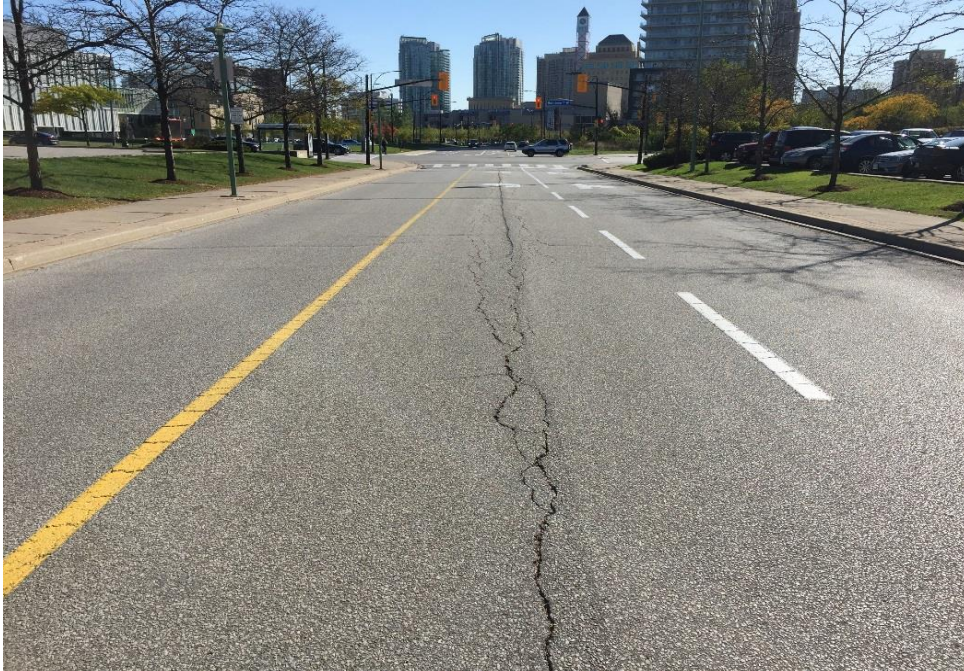
Photograph 3 – Existing Access Road/future Extension of Living Arts Drive, eastbound lane, about 50 m west of Rathburn Road West, looking east, showing moderate longitudinal cracking associated with slight to moderate alligator cracking and slight to moderate transverse cracking.

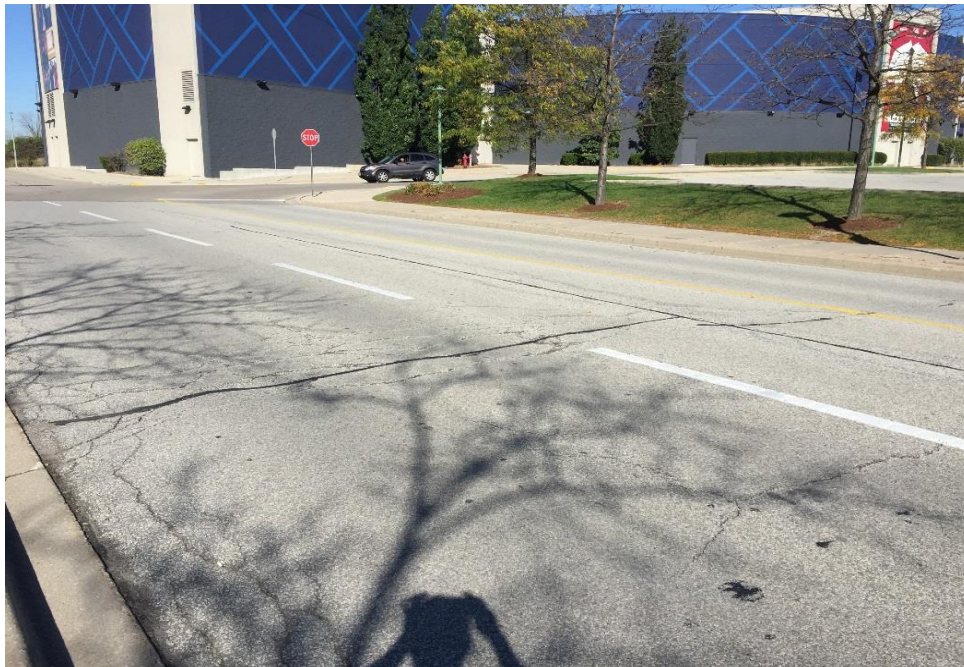
Photograph 4 – Existing Access Road/future Extension of Living Arts Drive, eastbound lane, about 45 m west of Rathburn Road West, looking west, showing moderate edge cracking associated with alligator cracking, slight to moderate longitudinal and transverse cracking (partially sealed).

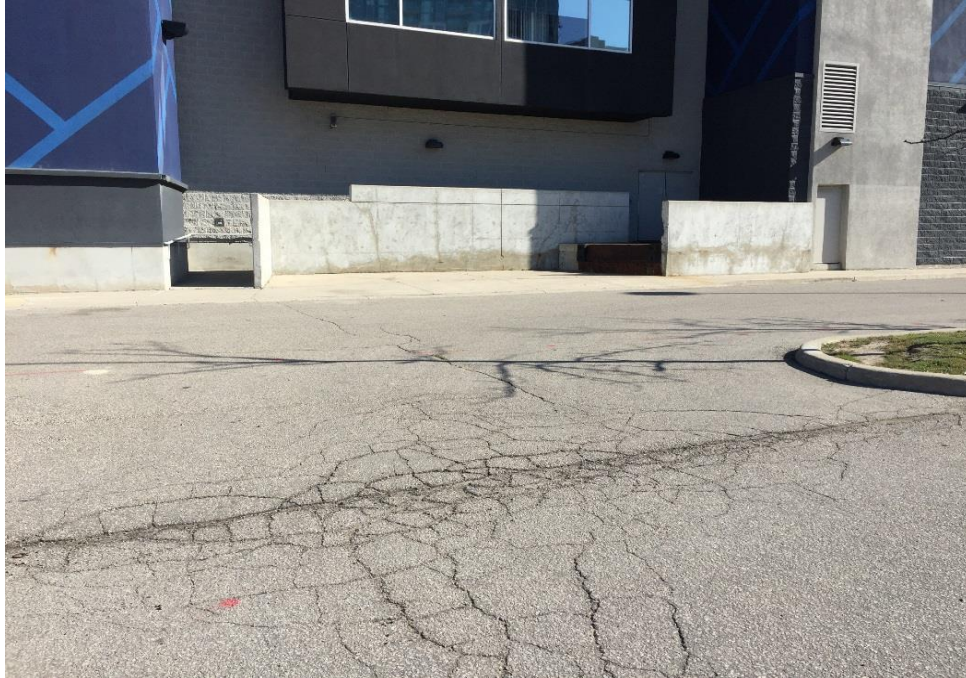
Photograph 5 – Existing Access Road/future Extension of Living Arts Drive, south of the theater, about 140 m west of Rathburn Road West, looking north, showing moderate longitudinal and transverse cracking associated with slight to moderate alligator cracking and.

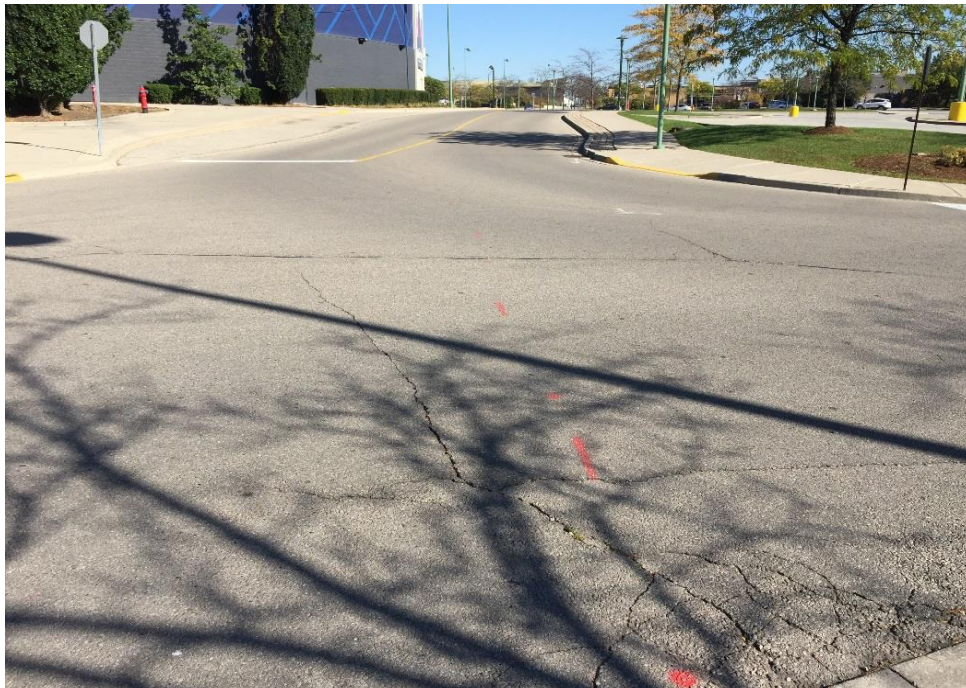
Photograph 6 – Existing Access Road/future Extension of Living Arts Drive, about 160 m west of Rathburn Road West, looking east, showing moderate longitudinal and transverse cracking associated with alligator cracking.

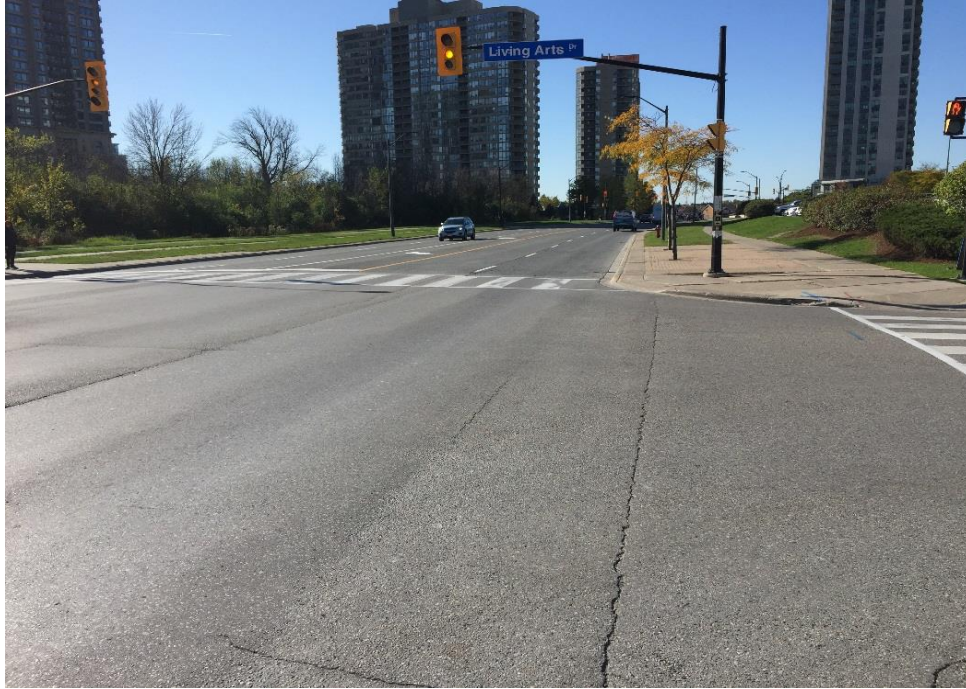
The existing pavement on Rathburn Road West at the intersection of Living Arts Drive was observed to be in fair condition. The most significant distresses are slight to moderate longitudinal and transverse cracking.

Photograph 7 – Rathbun Road West, at the intersection of Living Arts Drive, looking south, showing slight to moderate longitudinal and transverse cracking.

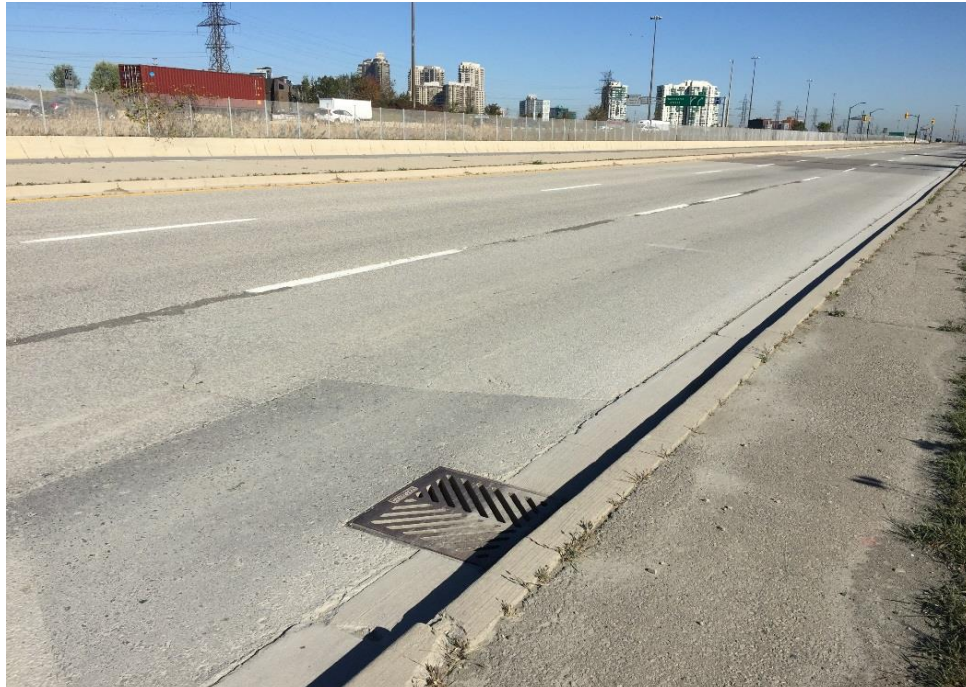
The existing pavement on Centre View Drive at the proposed intersection of Living Arts Drive Extension was observed to be in fair condition. The most significant distresses are slight to moderate longitudinal and transverse cracking and slight cut patching.

Photograph 8 – Centre View Drive, eastbound lane, at the proposed intersection with Living Arts Drive, showing slight edge cracking, slight longitudinal and transverse cracking (partially sealed) and slight cut patching. Catch basin was in fair condition.
