**REPORT ON  
PRELIMINARY GEOTECHNICAL AND PAVEMENT INVESTIGATION  
CREDITVIEW ROAD CLASS EA STUDY  
FROM BANCROFT DRIVE TO OLD CREDITVIEW ROAD  
MISSISSAUGA, ONTARIO**

Project: 1824-560  
Draft on April 1, 2014  
Final on May 14, 2015  
Revised Final on Nov. 4, 2015

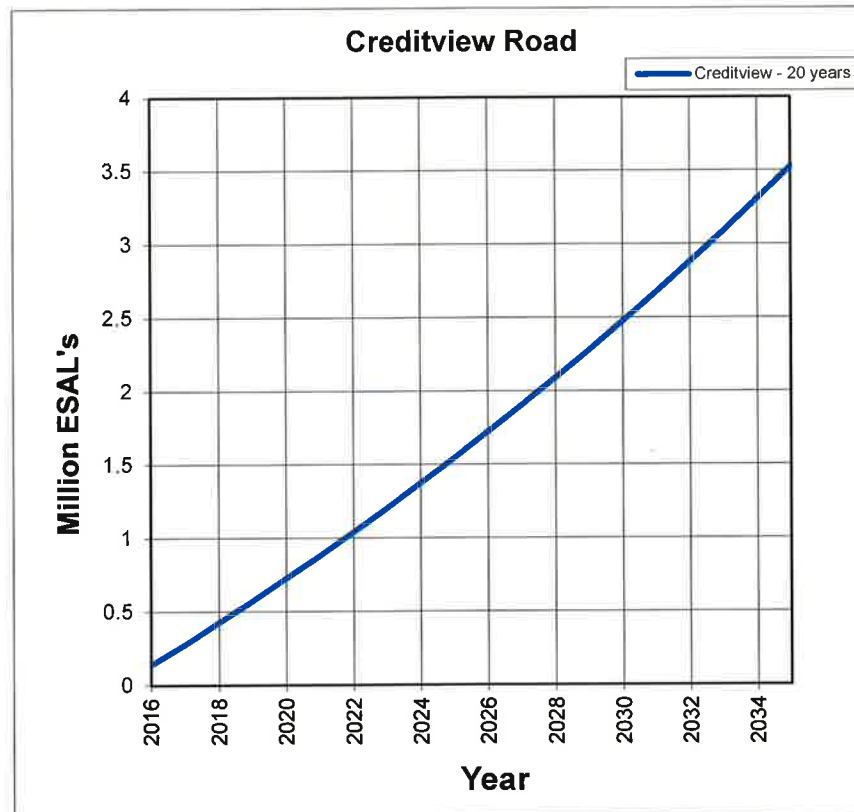
**Figure 1 Cumulative ESAL for Creditview Road (Within the Project Limits)**

**Figure 1** illustrates the cumulative ESAL for four-lane calculations, along Creditview Road within the project limits, for over a 20-year design period.

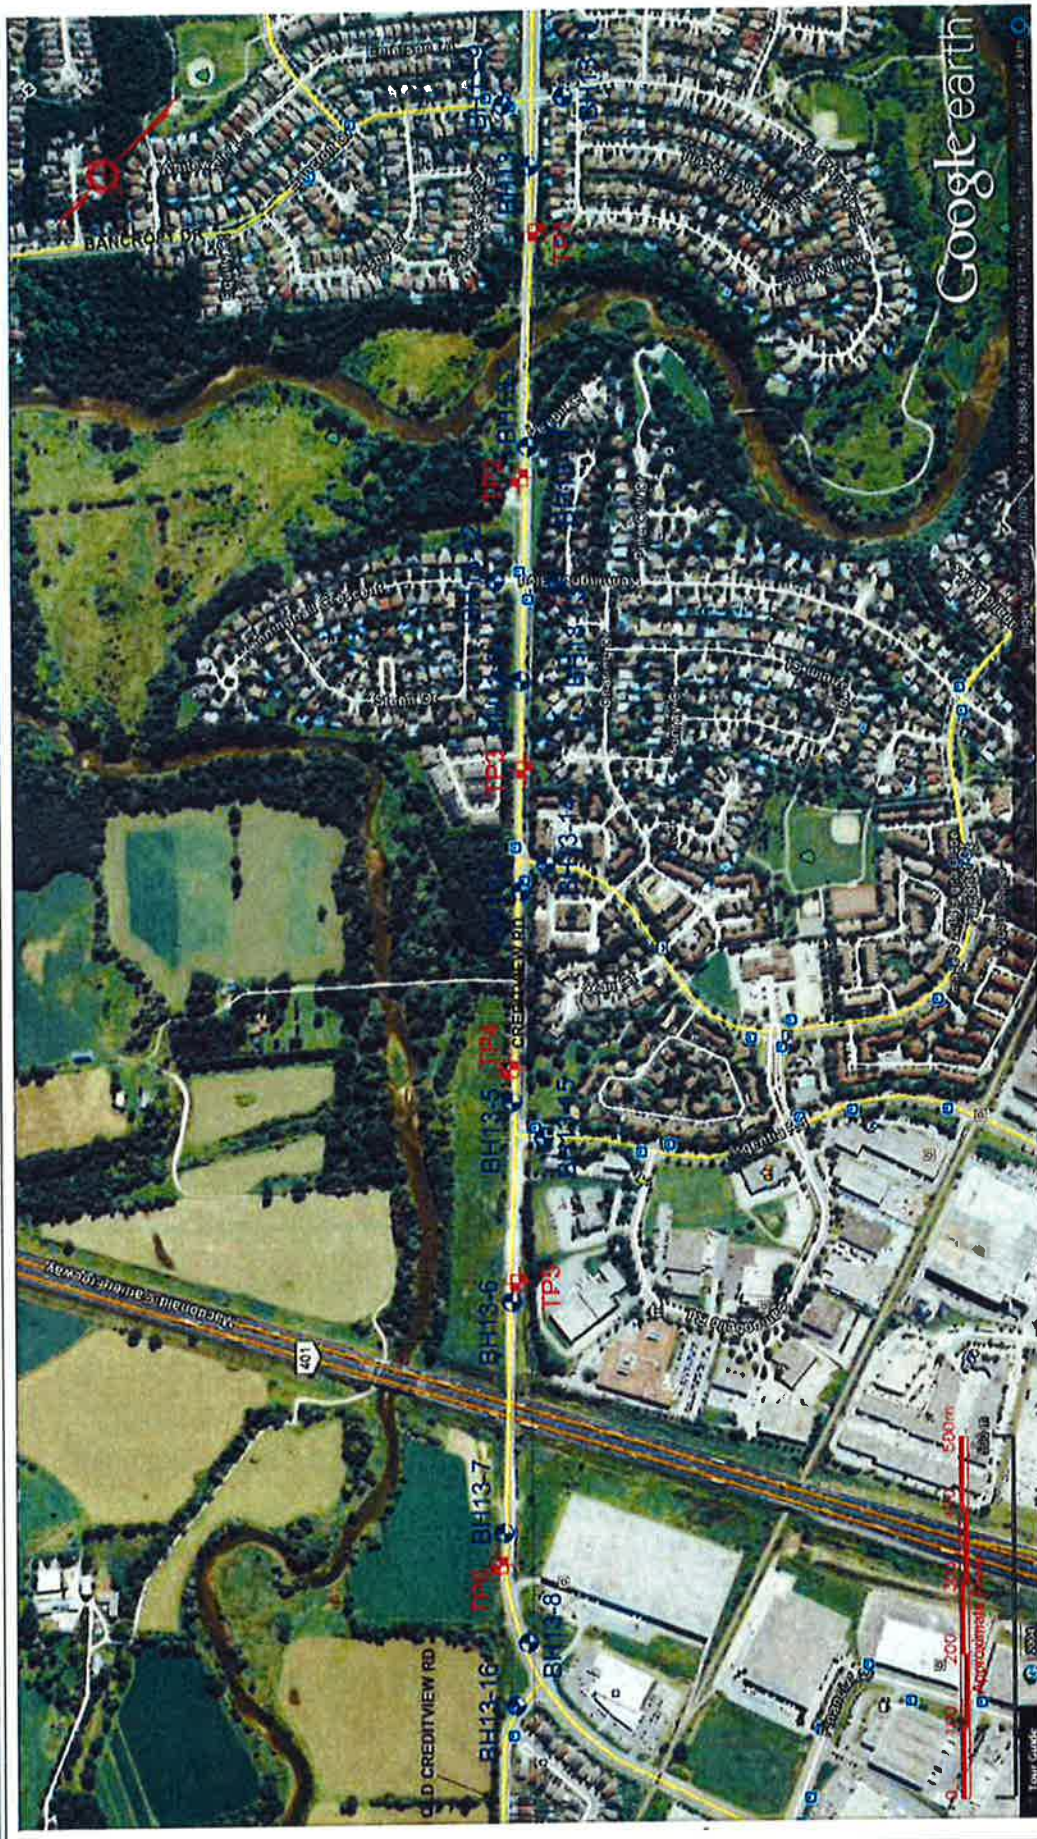
- Approximate Boreholes Location
- Approximate Taps Location

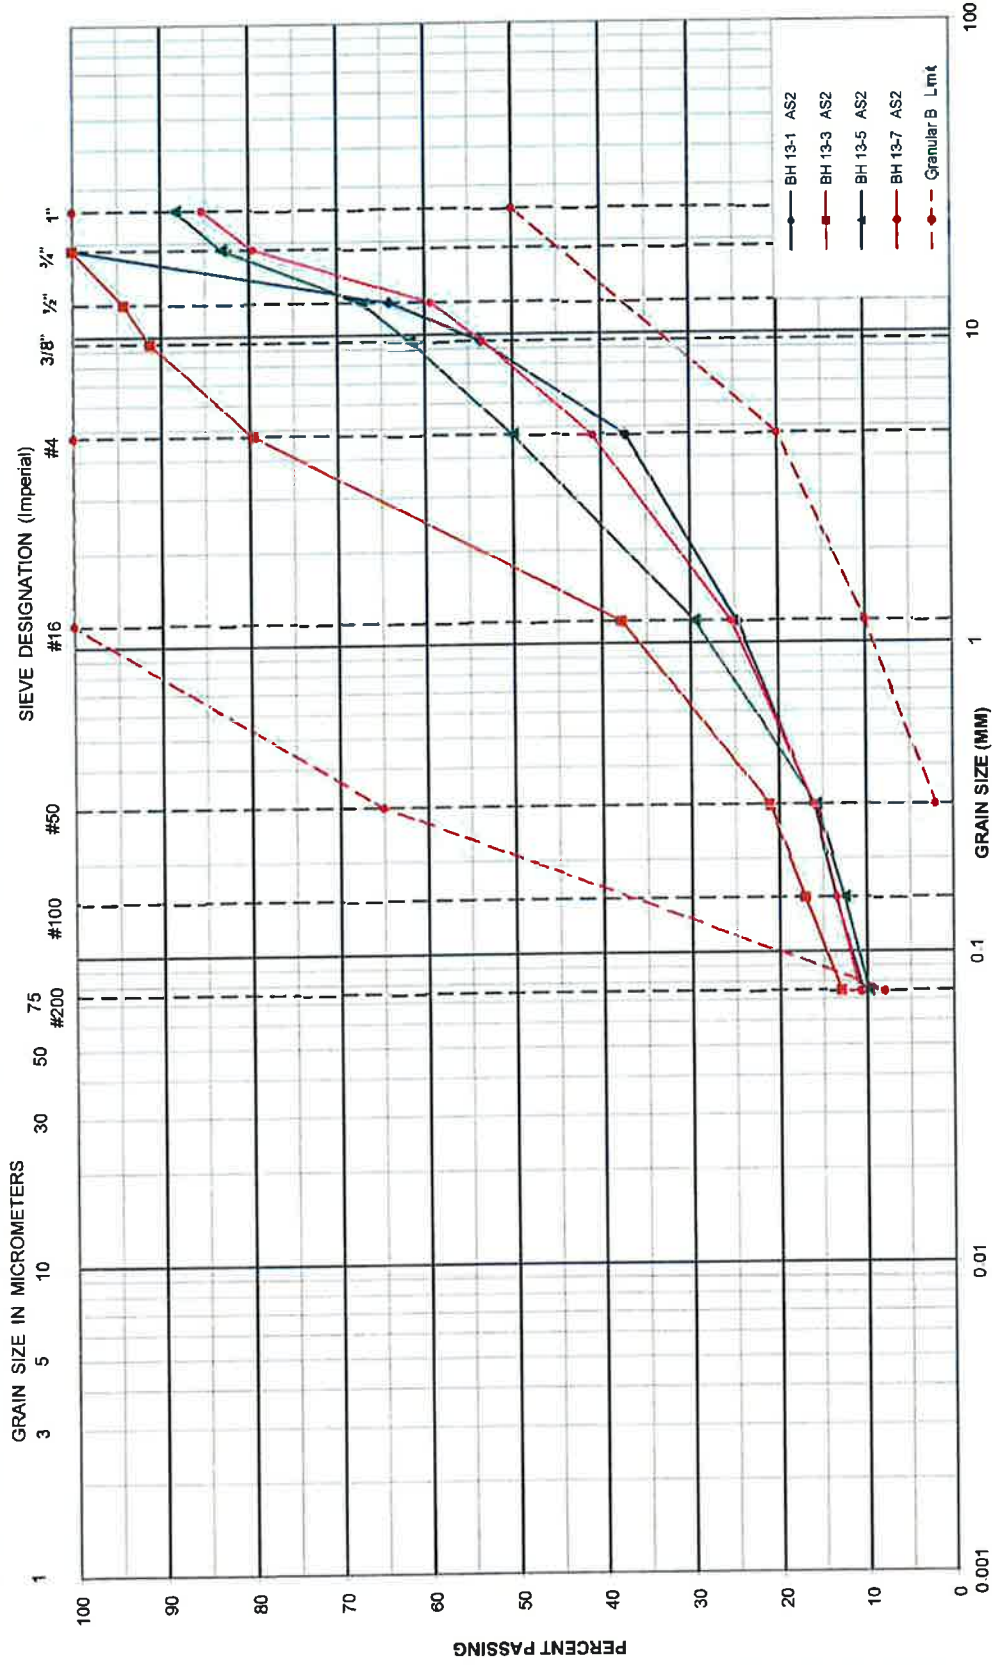
Figure No:	20
Project No.	1824-560
Date :	March 14, 2014

## GRAIN SIZE DISTRIBUTION

As well as visual examination in the laboratory, all of the soil samples were tested for moisture content. Sieve analyses of eight (8) pavement granular fill samples were conducted and the results are presented on **Drawings 18 and 19**. Grain size analyses of three (3) subgrade soil samples were conducted and the results are presented on **Drawing 20**.

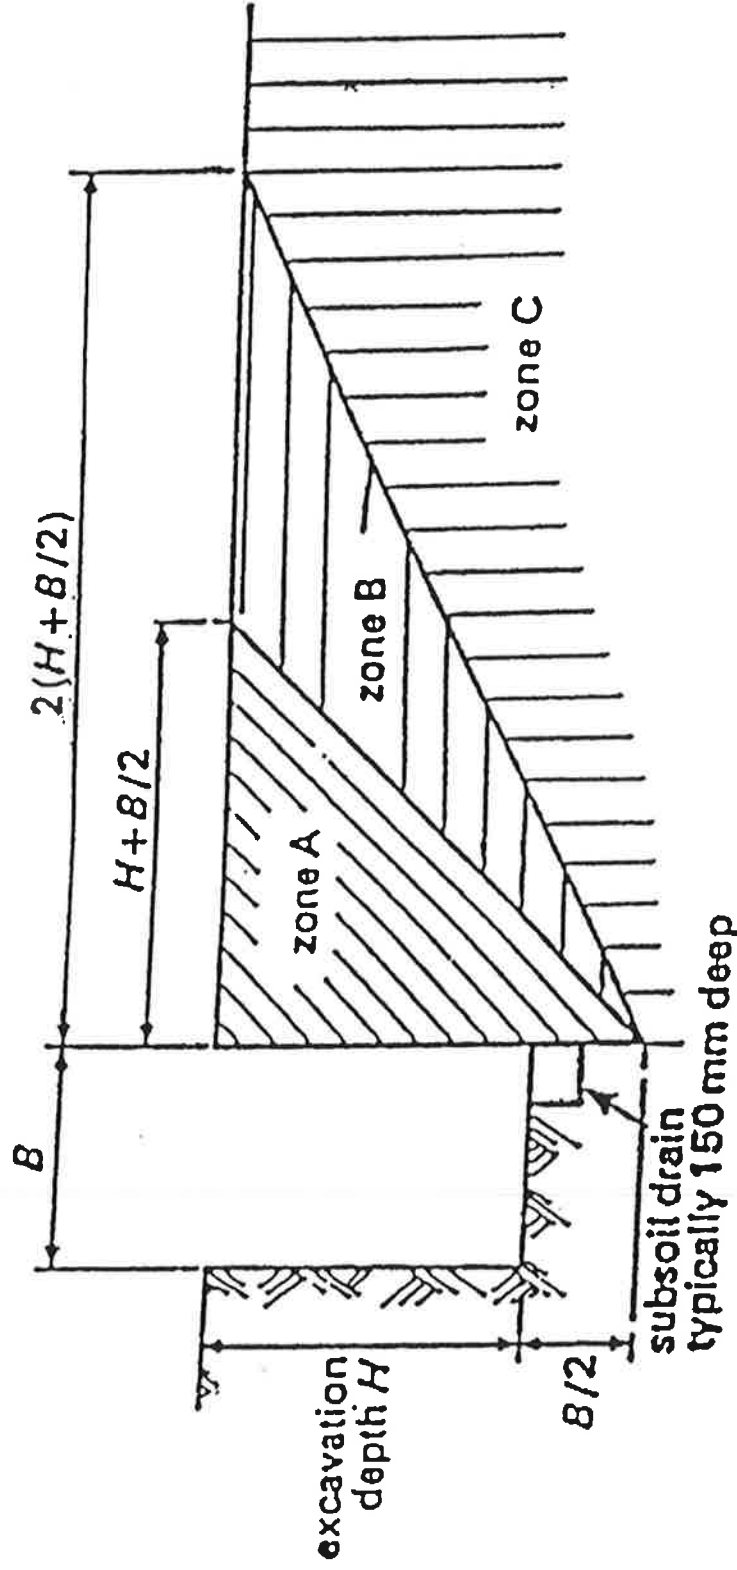
Client:	AECOM		Project no:	1824-560	Drawing no:	21
Drawn:	TJ	Approved:	AS	Risk Zone		
Date:	Feb., 2014	Scale:	N.T.S	Preliminary Geo. Investigation- Creditview Road Mississauga, ON.		
Original Size:	Letter	Rev:	N/A

**RISK ZONES** (after Howe et al., 1980): Zone A is zone of long term risk, Zone B is zone of intermediate risk, Zone C is zone of no risk

Reference to **Drawing No. 21** indicates zones in which some degree of movement of the ground can be anticipated as a consequence of trench excavation and the position of the existing buried services should be located with regard to this. In this respect, it should also be noted that less ground movements will be experienced outside the excavation if the sides of the excavation are properly

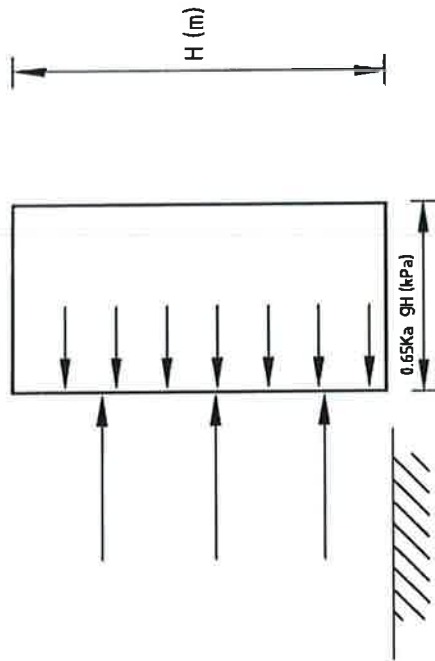
$g$  = unit weight of soil =  $21.0 \text{ kN/m}^3$

$g'$  = submerged unit weight of soil (i.e. below ground water level) =  $11.2 \text{ kN/m}^3$

1. Check system for partial excavation condition.
2. If the free water level is above the base of the excavation, the hydrostatic pressure must be added to the above pressure distribution.
3. If surcharge loadings are present near the excavation, these must be included in the lateral pressure calculation.

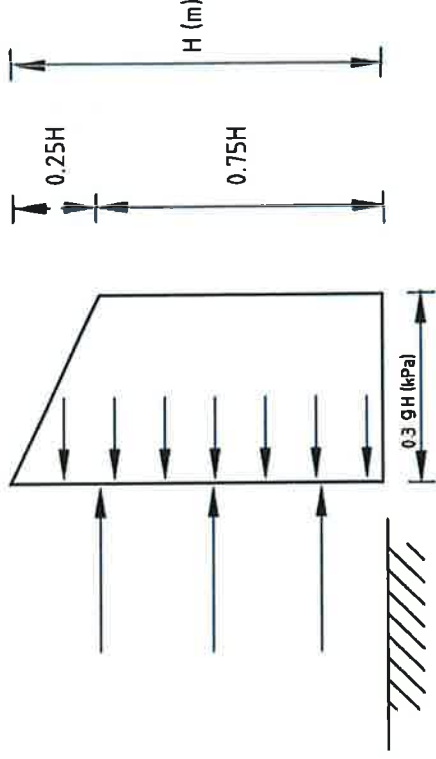
$g$  = unit weight of soil =  $21.5 \text{ kN/m}^3$

$g'$  = submerged unit weight of soil (i.e. below ground water level) =  $11.7 \text{ kN/m}^3$
