Square One Drive Extension Municipal Class Environmental Assessment Environmental Study Report

Limited Phase One Environmental Site Assessment

Square One Drive Extension Rathburn Road West to Confederation Parkway Mississauga, Ontario

GeoPro Project No.: 15-1151-02 Report Date: May 29, 2017

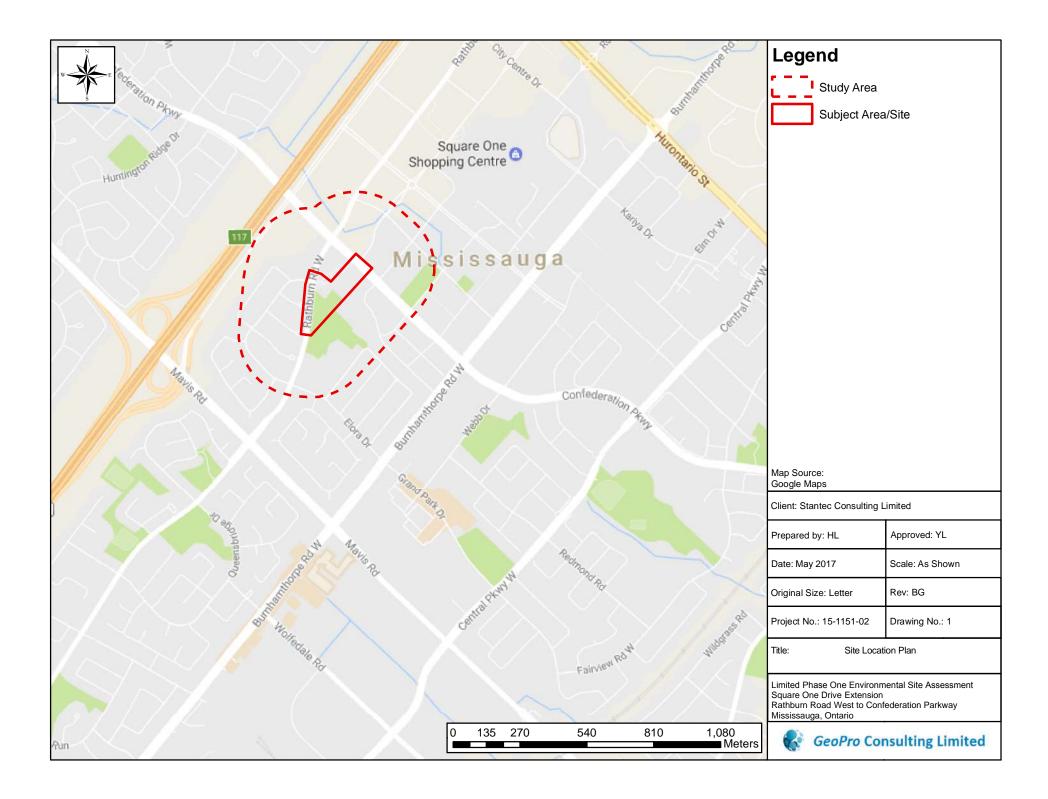
GeoPro Consulting Limited ("GeoPro") was retained by Stantec Consulting Limited ("Stantec") on behalf of the City of Mississauga ("the City") (collectively named as the "Client") to conduct a Limited Phase One Environmental Site Assessment (Phase One ESA) for the proposed extension of Square One Drive from Rathburn Road West to Confederation Parkway, in the City of Mississauga, Ontario ("Subject Area" or "Site"). The Site Location Plan is provided in Drawing No.1.

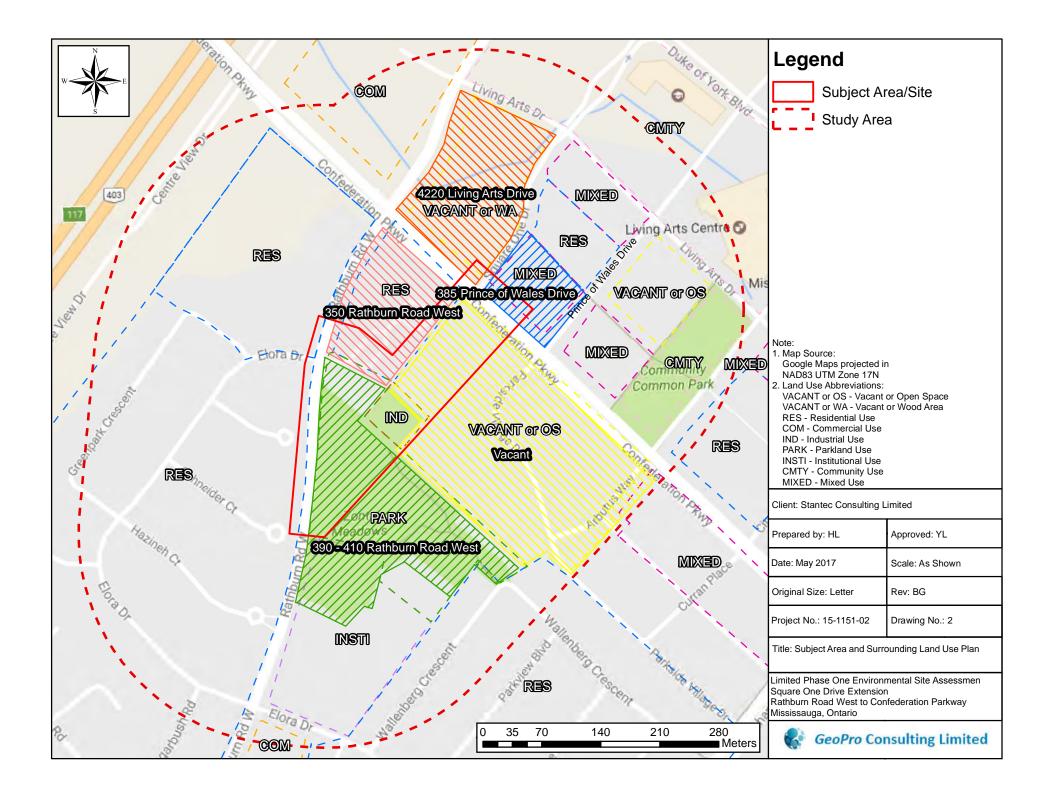
The Site and Surrounding Land Uses are shown on Drawing No. 2. At the time of the site visit, the observations of the Subject Area were divided into four portions.

- The north portion of the Subject Area consists a parking garage entrance, a parking lot, a storage building, a tennis court and green spaces for the high-rise residential buildings at 330 to 350 Rathburn Road West.
- The south portion consists of the parklands of Zonta Meadows Park with several pad mounted transformer boxes, a substation building, a parking lot, and tennis courts.
- The east portion consists of a vacant land, and a section of Confederation Parkway.
- The west portion consists of Rathburn Road West roadway.

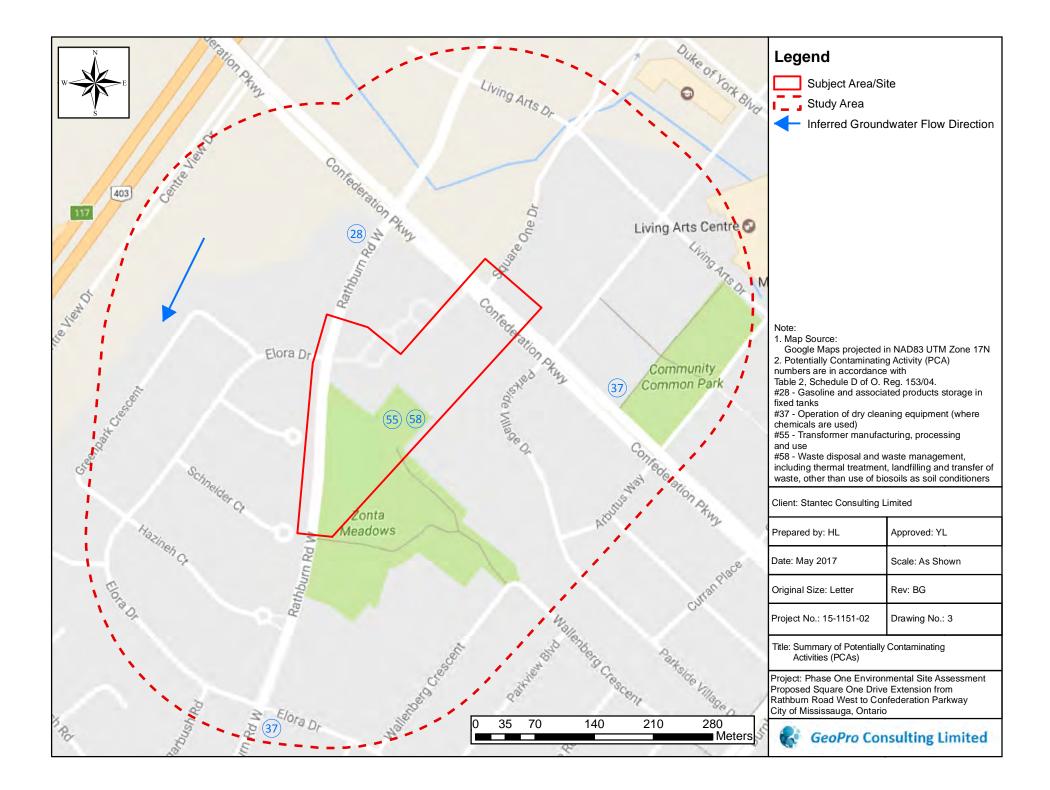
Based on the information obtained, PCAs have been identified on the Project Area and in the Study Area, and are summarized in the following table and shown on Drawing No. 3.

Location, Distance and Direction from the Site	Operations or Activity Identified (Source)	PCA Number	PCA Contributing to Environmental Concern					
Project Area								
Enersource facility property at 390 Rathburn Road West	Presence of three (3) transformer boxes (as per site visit)	PCA #55: Transformer Manufacturing, Processing and Use	Yes. Considering the location, the activities associated with the operation of transformers and generation of wastes may contribute to environmental concern on the Subject Area					
On site – 0 m	waste generator of acid solutions containing heavy metals (as per ERIS report)	PCA #58: Waste Disposal and Waste Management, including thermal treatment, landfilling and transfer of waste, other than use of biosoils as soil conditioners						
	Study Area							
592 Rathburn Road West; Off-site, about 230 m south 388 Price of Wales Drive; off-site, about 100 m east of the Subject Area	Operation of Dry Cleaner shop (namely Kleenlook Cleaners) as per site visit Operation of Dry Cleaner shop (Quality Care Cleaners) as per site visit	PCA #37: Operation of dry cleaning equipment (where chemicals are used) PCA #37: Operation of dry cleaning equipment (where chemicals are used)	No. Based on the location of the shops, no ventilation pipes were noted, and these dry cleaning shops should be drop-off depots. It is unlikely that the operation of a drop-off depot would contribute to an environmental concern to a site.

335 Rathburn Road West; off-site, about 100 m north/northwest of the Subject Area	Record of furnace oil spill (as per ERIS report), indicating the presence of storage tank	PCA# 28: Gasoline and Associated Products Storage in Fixed Tanks	No. The original property has been re-developed with a high-rise residential building. It is unlikely that the former storage tank would contribute to an environmental concern

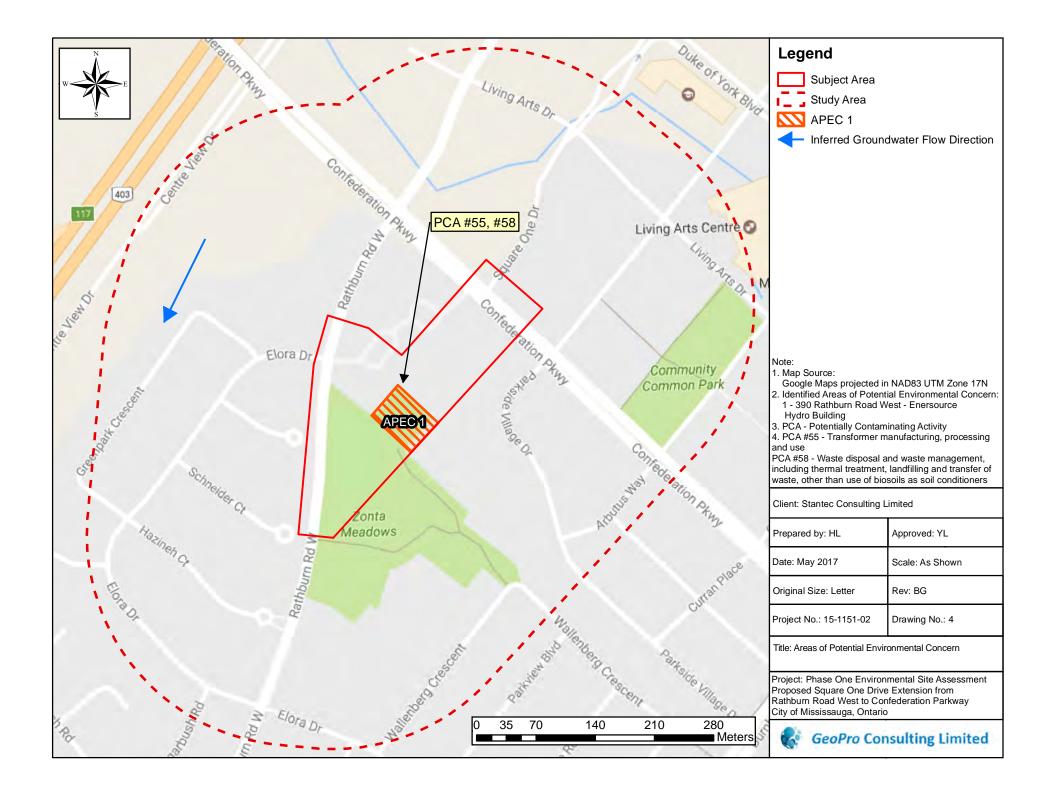
Based on the Phase One ESA completed by GeoPro, PCAs were identified on the Project Area and on the Study Area. Further analysis of the PCAs indicated that an APEC would be considered to be present in the Project Area, which are summarized in the following table and shown on Drawing No. 4.

APEC No.	Location	PCA No.	Location of PCA	СОРС	Media Potentially Impacted
1	1 390 Rathburn Road West	#55	On-Site	Metals, PHCs, PAHs, PCBs	Soil and/or Groundwater
		#58	On-site	Metals	Soil and/or Groundwater

- Should road extension project involve the property acquisitions, a site specific Phase One and/or Phase Two ESAs would be required to be conducted for the transferred areas, which however may depend on the City's requirements related to the land conveyance to the City.
- A further environmental investigation should be conducted in the form of a full Phase One and/or Two ESA at 390 Rathburn Road West.
- Soil and/or groundwater may be impacted by de-icing salt materials in the area on and adjacent to the roadways. Therefore, excess soils generated during the construction on and near Rathburn Road West and Confederation Parkway should be tested to confirm the soil quality for re-use and/or off-site disposal purposes.
