HERITAGE IMPACT STUDY

*1661 BLYTHE RD.
MISSISSAUGA, ON*

SM Strickland
DA Mateljan
Design + Architecture

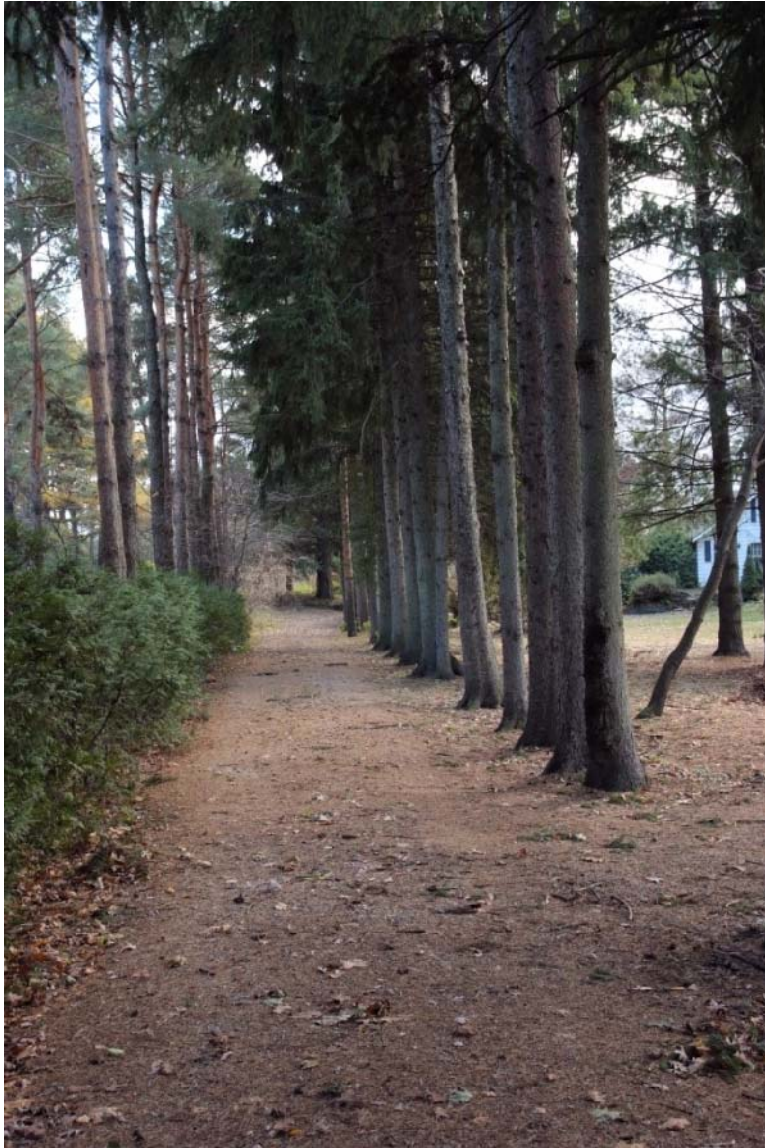
ALLEE OF TREES LOOKING SOUTH

The driveway access to this home is via the allee of trees along the east side of the property. This and the evergreen

plantings along the edges of the property appear to have been in place prior to the construction of this house but may have been embellished to support it. (see also analysis of air photos in section 2). Because of this they should be considered built features of the property as opposed to natural features. They are of some very limited interest. Many of the individual trees are not very healthy as evidenced by the significant variation in their trunk size, canopy size and vigor. The trees along the property line are significantly smaller and less healthy than those to the west. There are numerous examples where trees have been removed and not replaced, so the intended continuity has been compromised.

Allees of trees are classical elements in landscape architecture to define an entry to a place; typically a grand house or public building or space. In this case, the effect is weak both because of the irregular nature of the planting and because the allee leads to the side garage of the building, and eventually to the bank of the river. There is no strong terminus to the allee and no appreciable sense of arrival at its end.

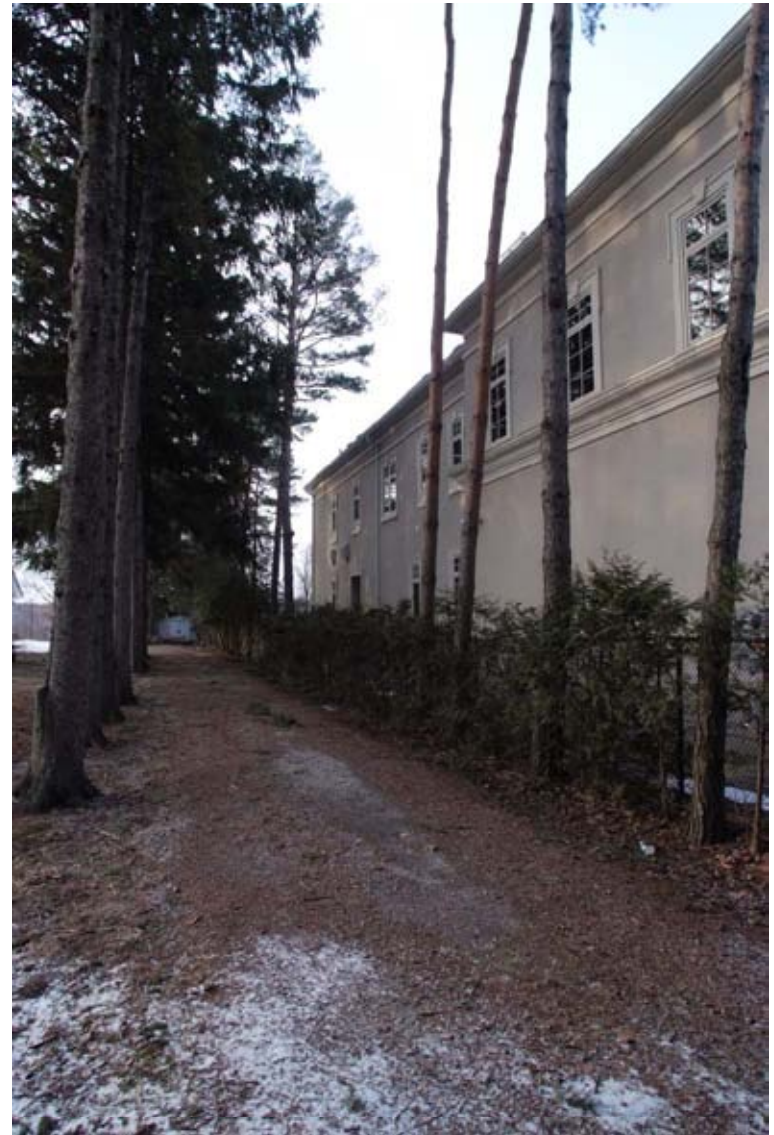
**ALLEE OF TREES – SHOWING SPARSE AND UNHEALTHY
PLANTING ALONG PROPERTY LINE**

there is a secondary planting row that forms an allee that leads from Blythe Rd. to the rear of the site. The trees are generally untended with much die-back and present an unattractive, overgrown aspect.

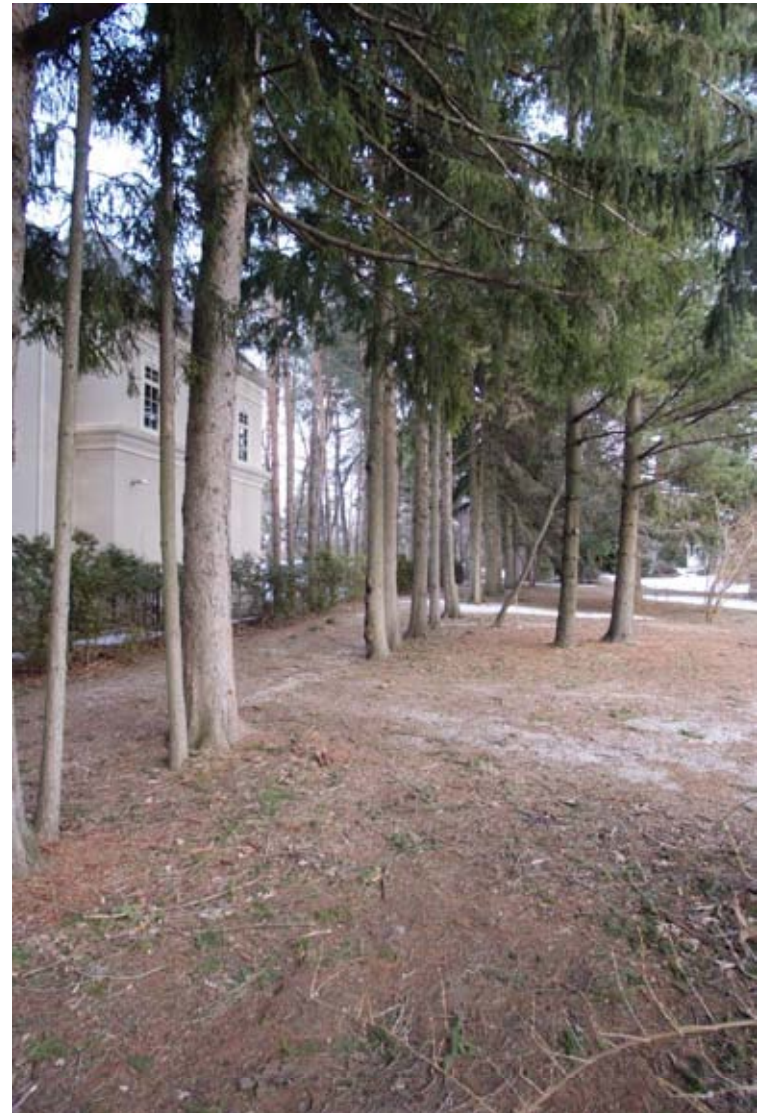
ALLEE OF TREES – SHOWING GAPS AND VARIATIONS IN SPECIMEN SIZE

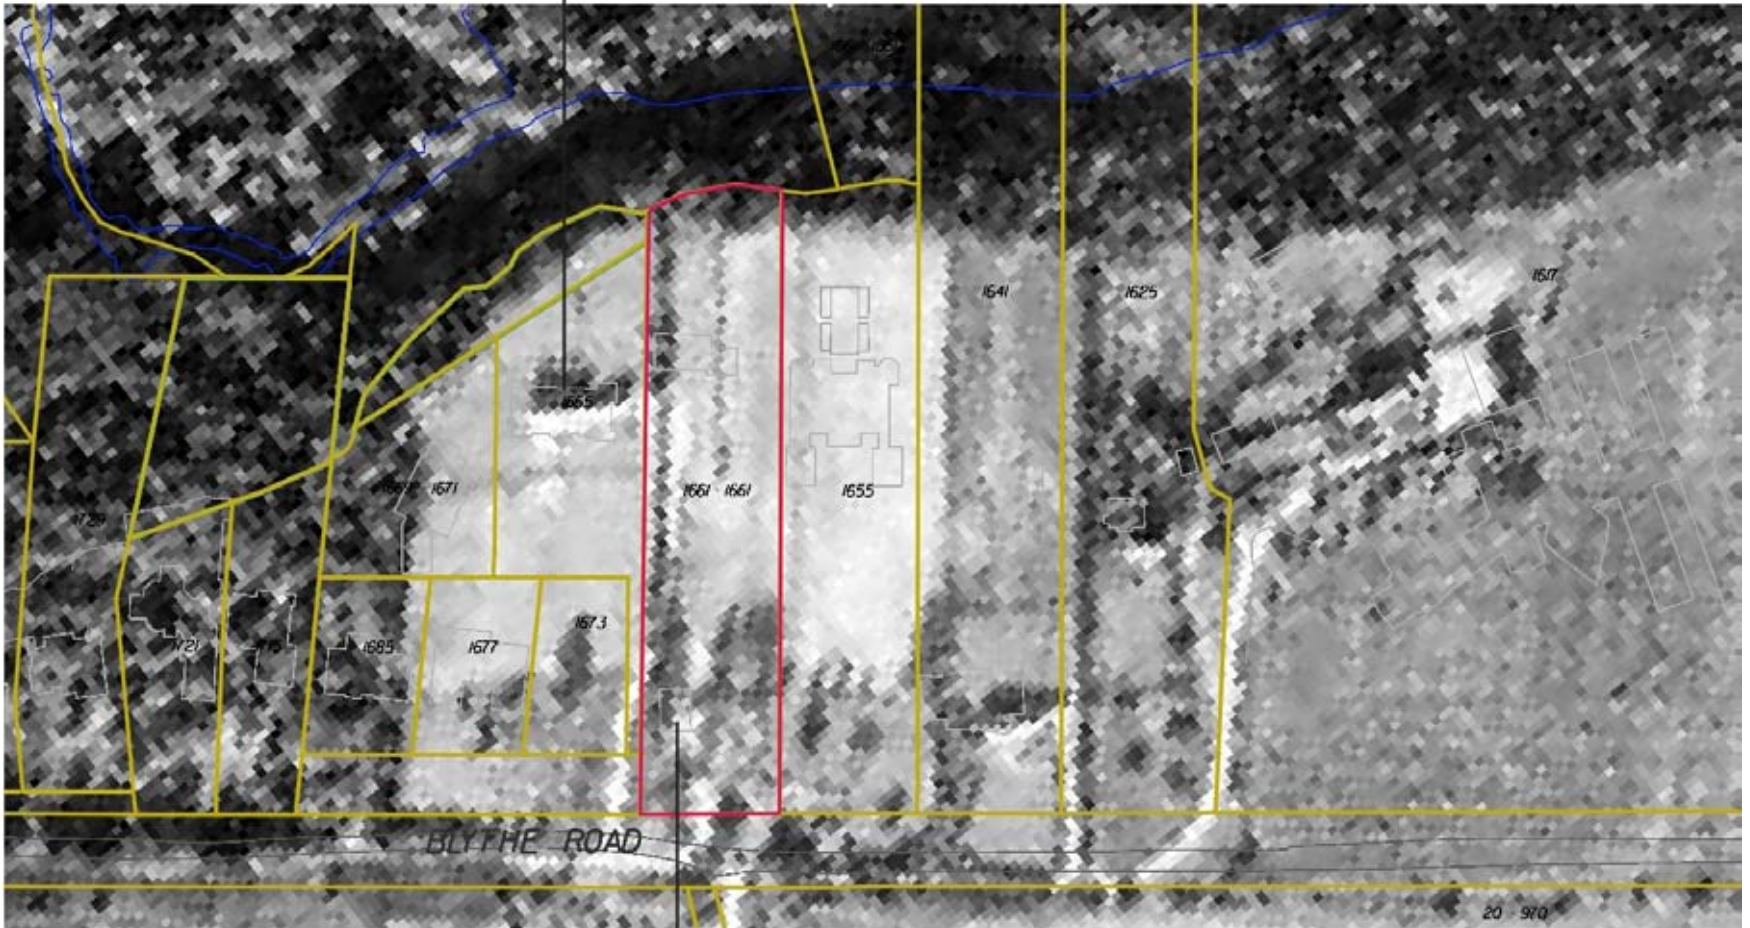
PRESUMED BARN

HOUSE

BLYTHE ROAD

Air photos are available from 1944 and in this year and in 1954 they show the one-storey house in place and also show a large building behind it that by its size and relationship to the house can be assumed to be a barn. A narrow, winding path or driveway connects them. This small farm would have taken up our subject site and the lands to the west up until the present end of Blythe Rd. – the area presently occupied by 8 houses. Backing continuously onto the Credit River, it would have been a spectacularly beautiful piece of property.

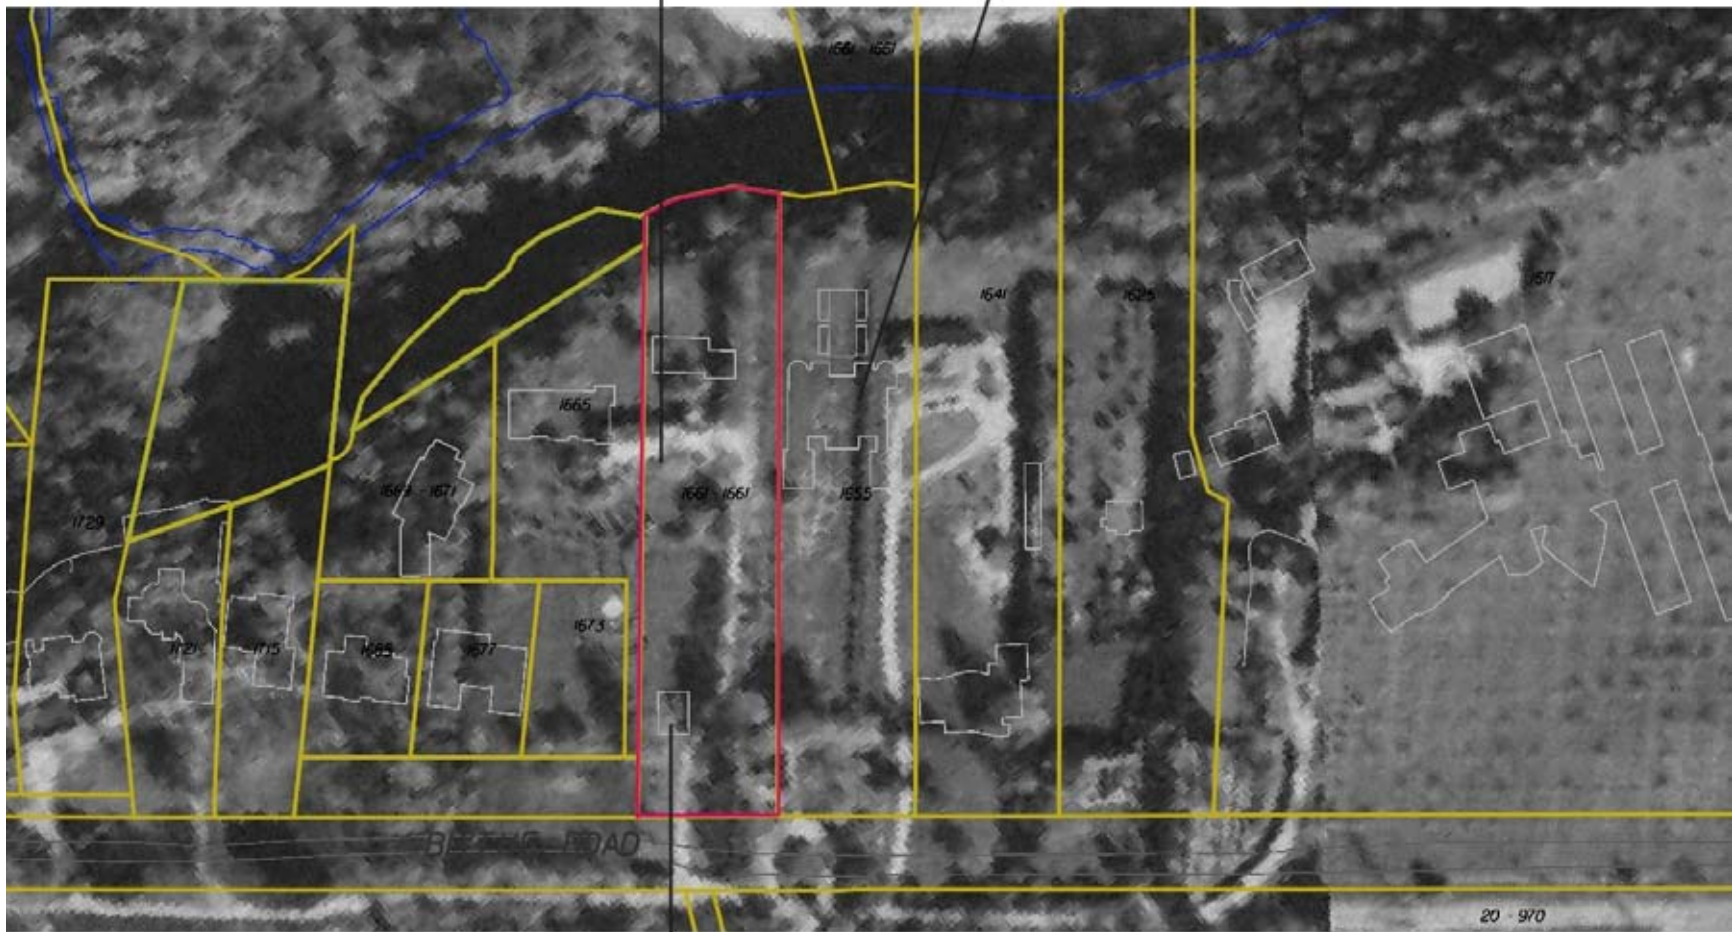
PRESUMED BARN

BEGINNING OF TREE ALLEE

HOUSE

The next available air photo from 1963 is unclear but appears to show the new 2-storey home and changes to the rural driveway and path leading to the rear of the site. This would correspond to the known 1963 building permit issuance in the City of Mississauga records. The next available air photo is from 1966 and is much more clear. This shows the 2-storey house clearly in place and the driveway in its present configuration. This allows us to conclusively date the modern development of the site to the period between 1963 and 1966.

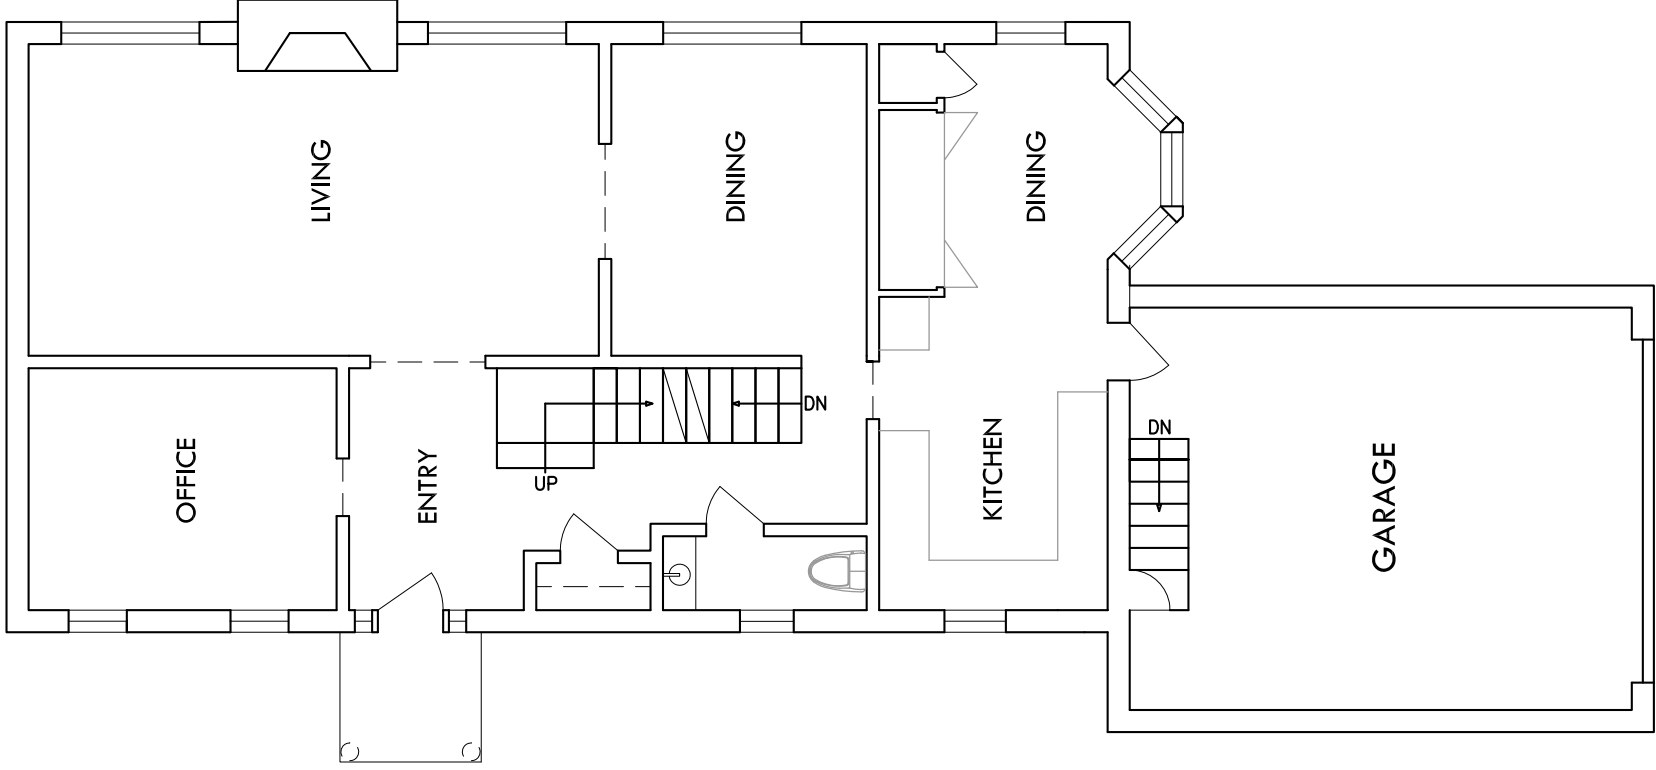
1661 BLYTHE RD
2-STORY HOUSE
EXISTING PLANS
1:100

MAIN FLOOR

The larger home is solid brick construction, approx. 2600 square feet on two levels with attached garage, partially finished basement and simple gabled roof. The main floor includes a kitchen with breakfast area, laundry room, living and dining room, powder room and small office/den. The second floor includes four bedroom including master bedroom. There is one bathroom shared by three bedrooms. The master bedroom has an ensuite bath and walk-in closet. There are wood-burning fireplaces on the main floor in the family room and on the second floor in the master bedroom. Windows throughout are wood double-hung with metal storm panels. The massing, character, materials and architectural design of the home are highly suggestive of early 1960's construction.

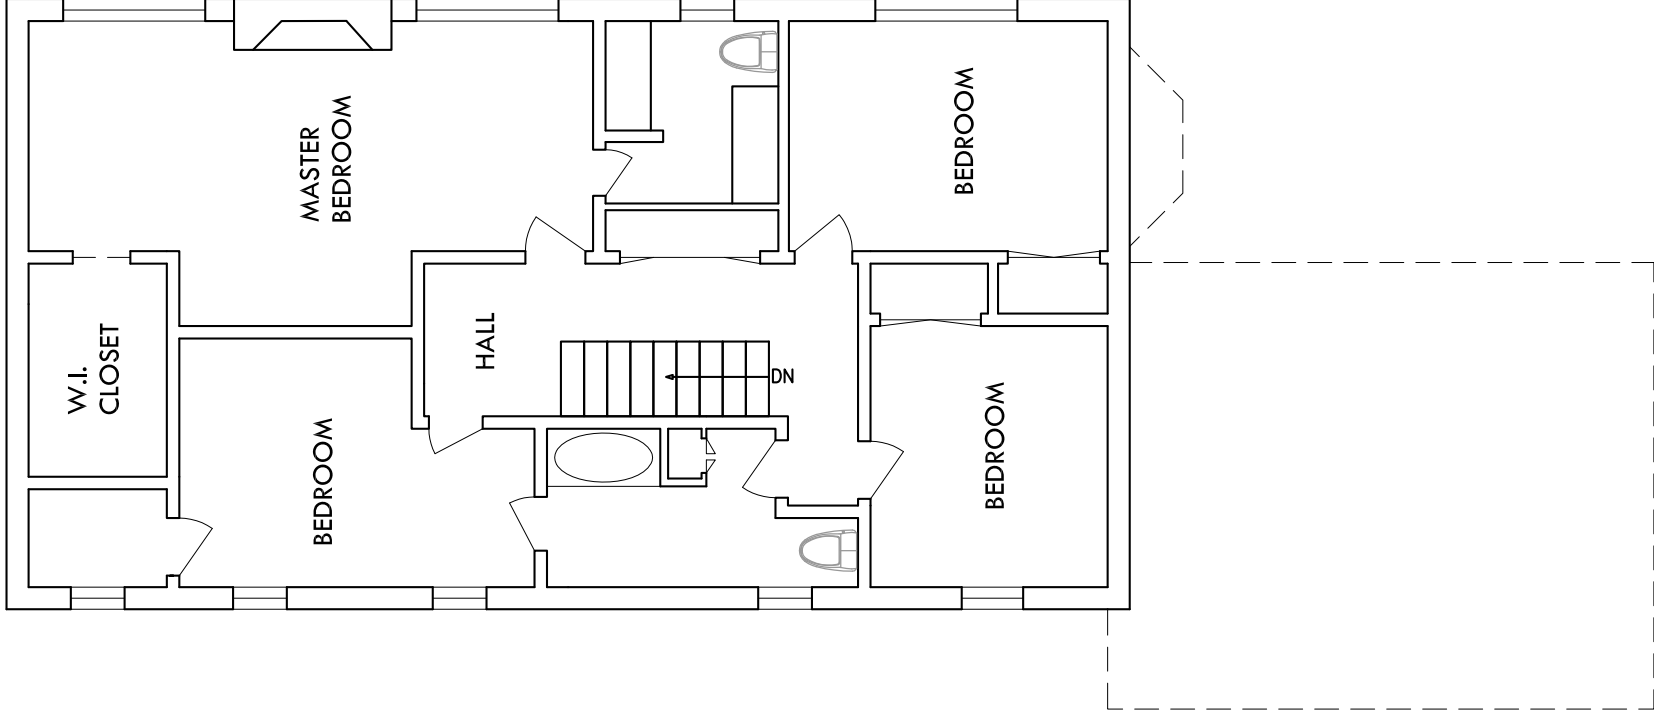
1661 BLYTHE RD
2-STORY HOUSE
EXISTING PLANS
1:100

SECOND FLOOR

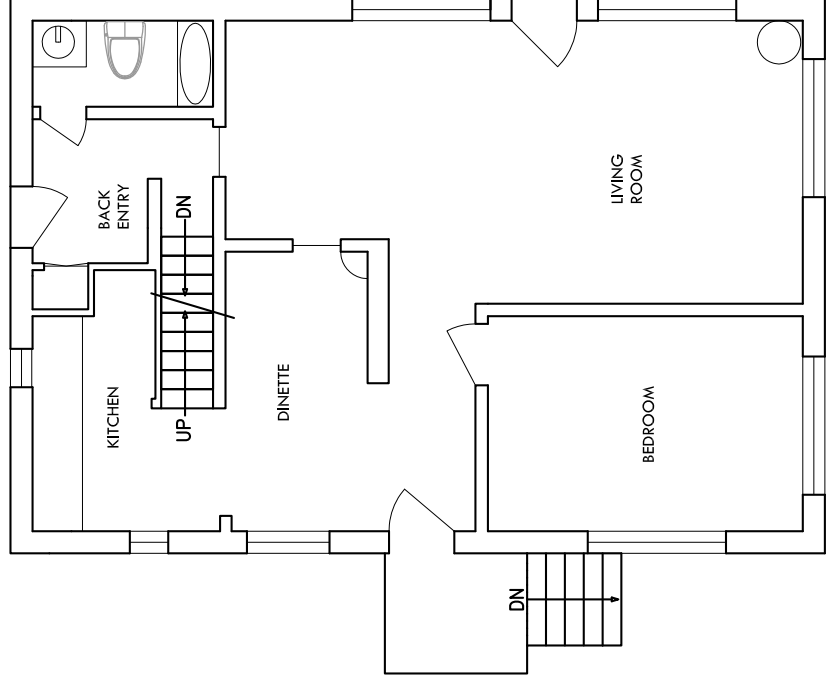
1661 BLYTHE RD
1-STOREY HOUSE
EXISTING PLANS
1:100

MAIN FLOOR

The main floor consists of a kitchen, living room, bathroom and bedroom. The second floor consists of two small bedrooms. First and second floor are connected by a narrow staircase. There is a full concrete block basement (partially finished). The blocks are slightly imperfect and more porous than modern concrete blocks suggestive of

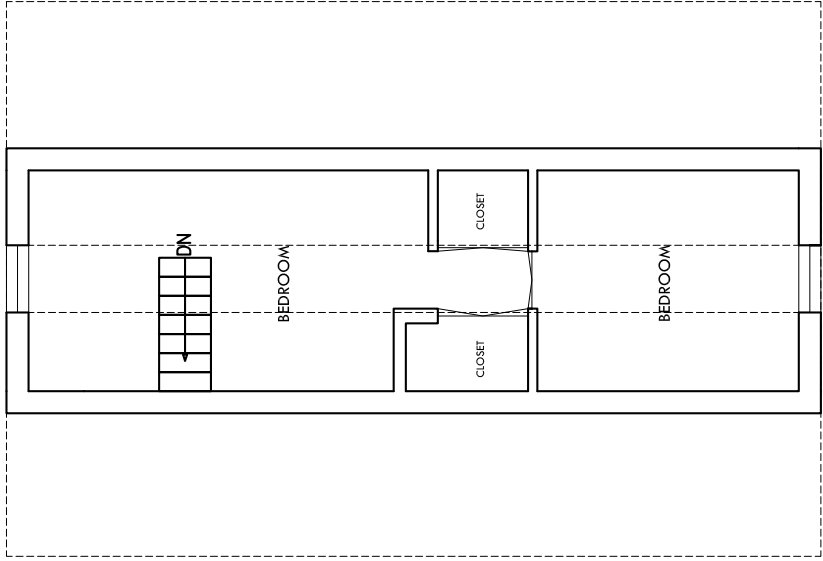
1661 BLYTHE RD
1-STOREY HOUSE
EXISTING PLANS
1:100

LOFT

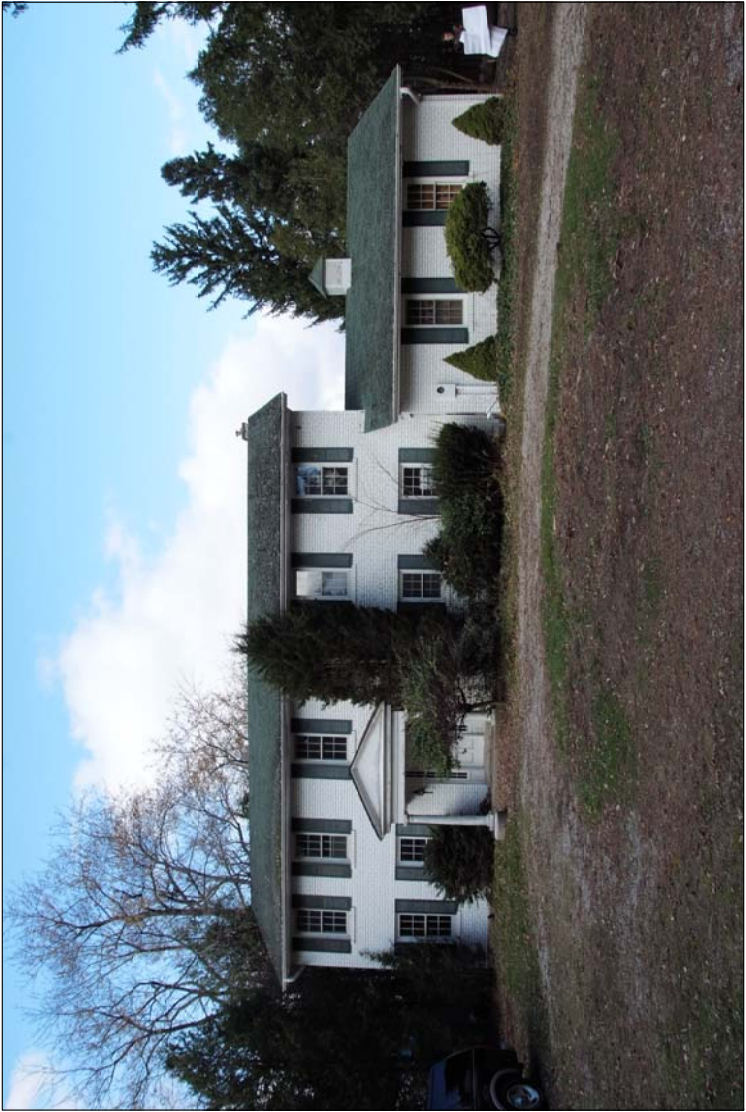
2-STORY HOME – FRONT ELEVATION

The exterior of the home is white glazed brick with asphalt shingles and green false shutter panels. Soffits are painted plywood. There is a faux-classical pedimented canopy at the front door with wooden columns. The level of detail and architectural merit of the exterior is minimal. The roof is in very bad condition. There has also clearly been little maintenance done of late and the overall condition of the exterior is fair to poor.

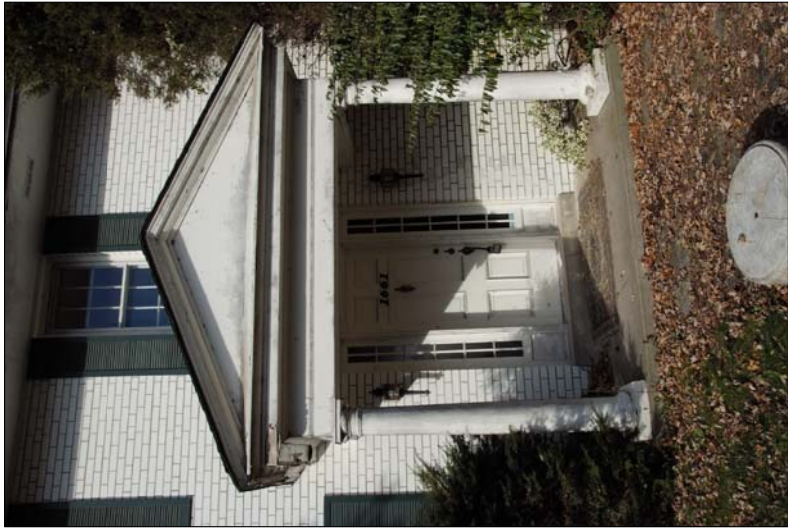
2-STORY HOME – FRONT PORTICO

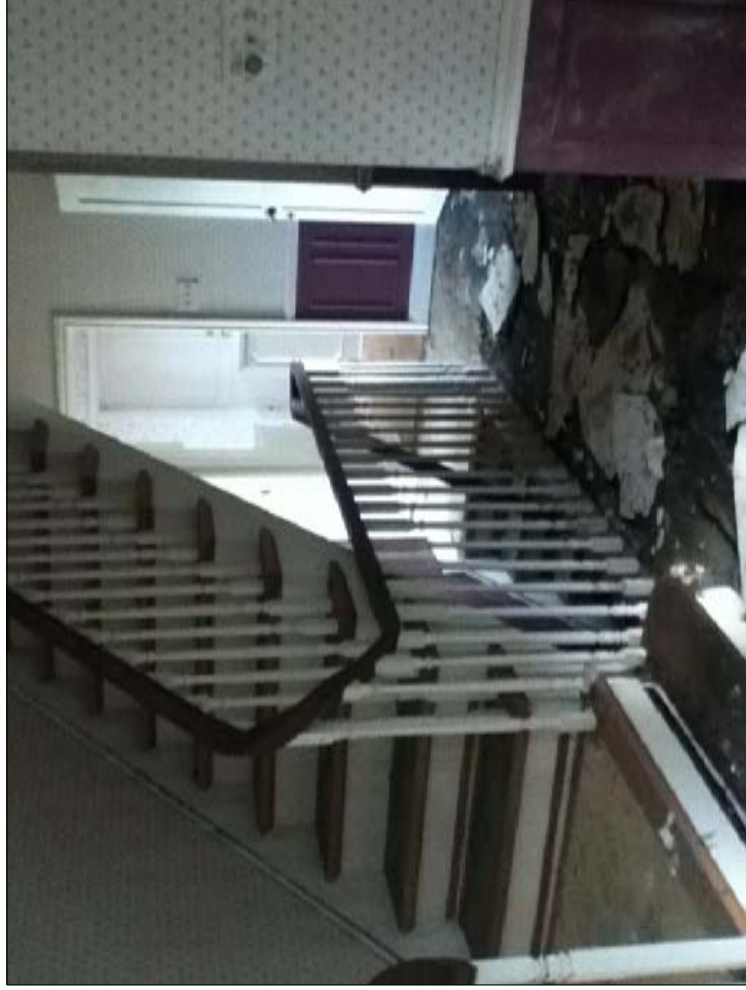
2-STOREY HOME - HALL - NOTE DAMAGE FROM WATER LEAKAGE

The house does not appear to have been lived in for several years. The overall condition of the interior is good except for one area on the main floor near the powder room where it appears that pipes have frozen in the ceiling and then

burst, causing extensive localized damage to the ceiling, walls and floor finishes. The resultant flooding also destroyed most of the basement finishing. There is also obvious mold contamination in the house that is probably related to this incident.

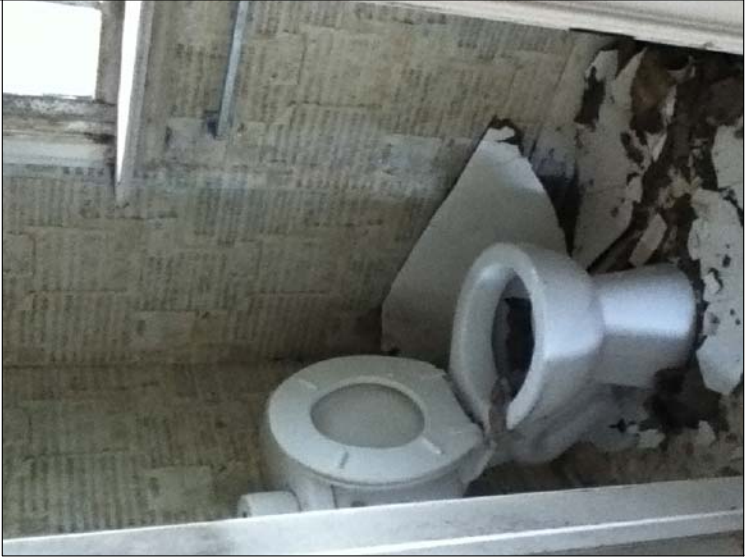
2-STORY HOME - POWDER ROOM - NOTE WATER DAMAGE

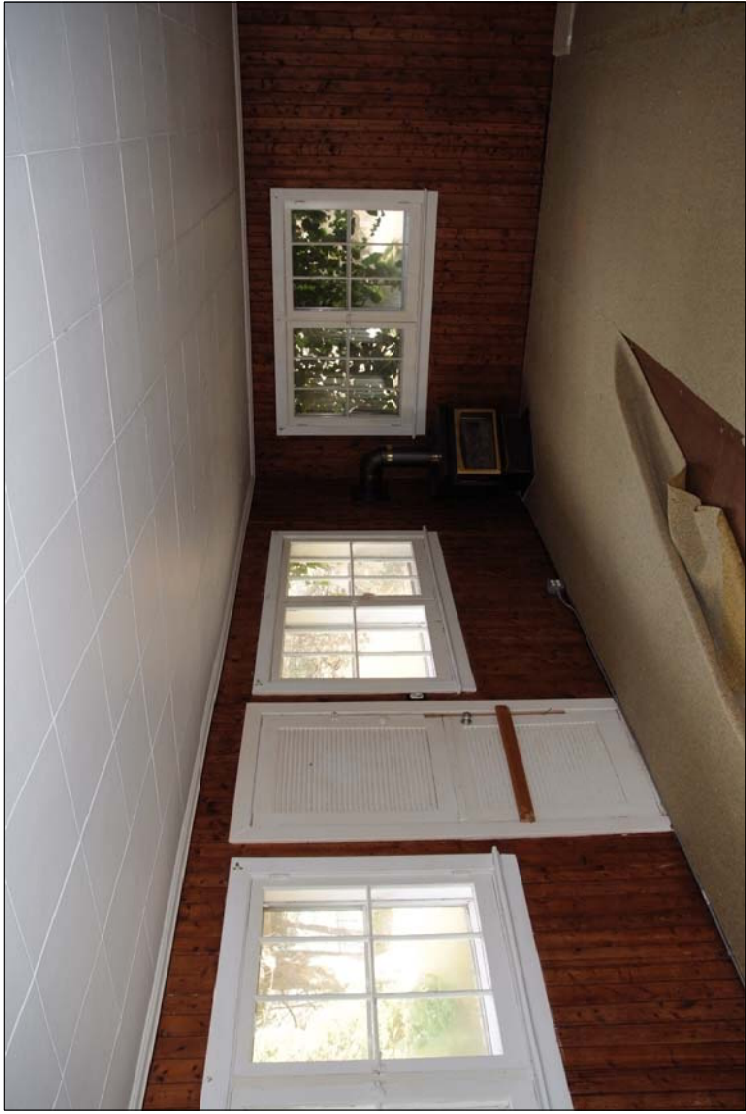
1-STORY HOME – LIVING ROOM SHOWING WINDOWS

early 20th century manufacture. The exterior cladding is aluminum horizontal siding. This is obviously a replacement material. The original siding material is probably still in place below the metal cladding. The house sits surrounded by a kind of berm or plinth – as though the basement was partially excavated and the removed material piled against the building. The berm is retained by a dry-laid rubble wall that almost certainly is made from locally gathered stones and from those taken from the basement excavation. The overall condition of the building is good and it appears to have been inhabited recently. The building is heavily overgrown by coniferous plantings and ivy growing on the building walls. A significant character-defining element of this building are over-sized paired 6-paned casement windows in the principle rooms of the building. The impact of these windows is somewhat lost because of the heavy overgrowth and because of metal storm windows that have been fitted on the exterior, but these windows are important both for their visual character and because they are significant in helping to date the construction of the building. Casement windows were a popular in the 1920's and '30's – Frank Lloyd Wright's Prairie Style houses used them exclusively, for example – and while this building

exhibits none of the attributes of that style the choice of these windows is significant and likely rooted in what would have been the fashion of the day.

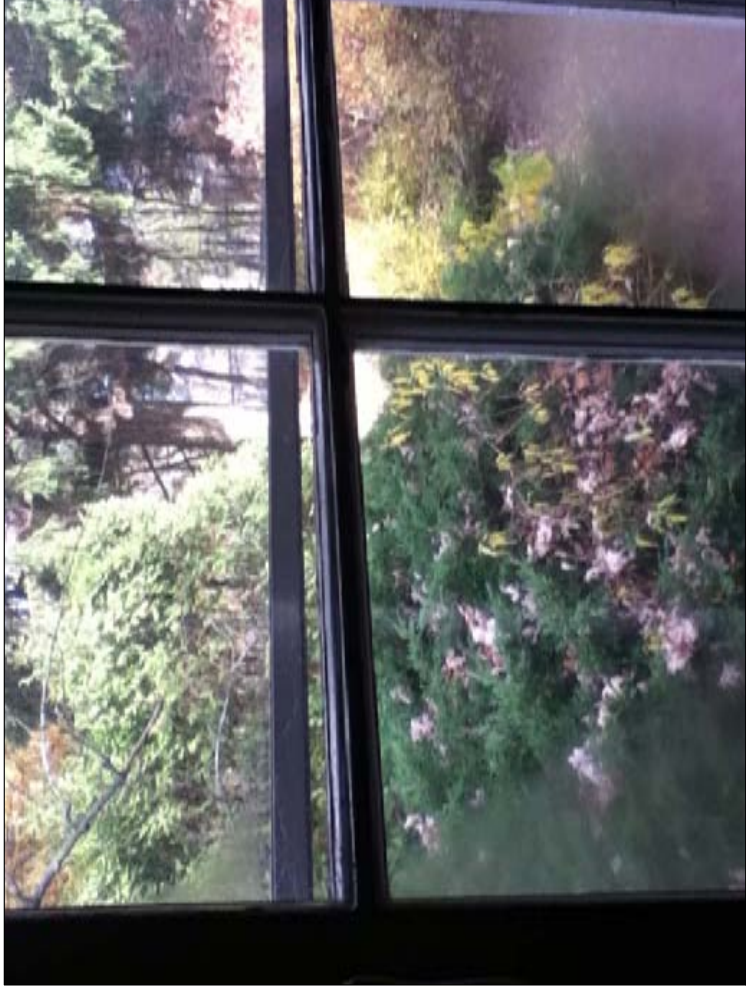
1-STOREY HOME – TYPICAL WINDOW MUNTIN DETAIL
