HERITAGE ADVISORY COMMITTEE

THE CORPORATION OF THE CITY OF MISSISSAUGA

TUESDAY, MARCH 10, 2015 – 9:30 A.M.

1. Approval of Minutes of Previous Meeting held on February 10, 2015
2. Proposed Heritage Designation and Alteration, Scruton House, 307 Queen Street South (Ward 11)

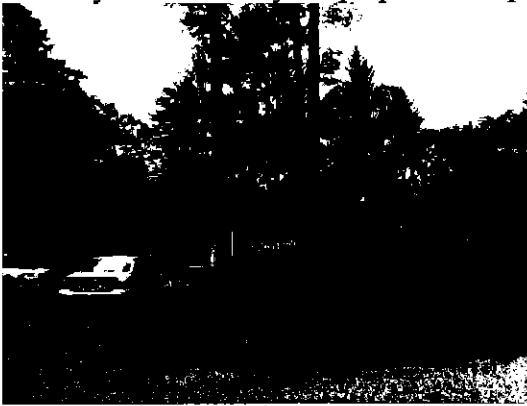
Photo #1

Figure #1: These 2 photos show the front and back yard of the property at 169 Donnelly Drive as they appeared during the tree inventory conducted on September 9, 2014.
