Heritage Advisory Committee

2015/11/17

- 5.3. Museums and Heritage Planning Strategic Plan Update - Marcus Letourneau, Letourneau Heritage Consulting
6. MATTERS TO BE CONSIDERED
 - 6.1. Proposed Heritage Designation Amendment, Timothy Street House 41 Mill Street (Ward 11) – *(Page 11)*

- 6.2. Request to Demolish a Heritage Listed Property 1190 Mona Rd (Ward 1) – *(Page 25)*
 - 6.3. Request to Demolish a Heritage Listed Property: 906 Whittier Cres (Ward 2) – *(Page 83)*

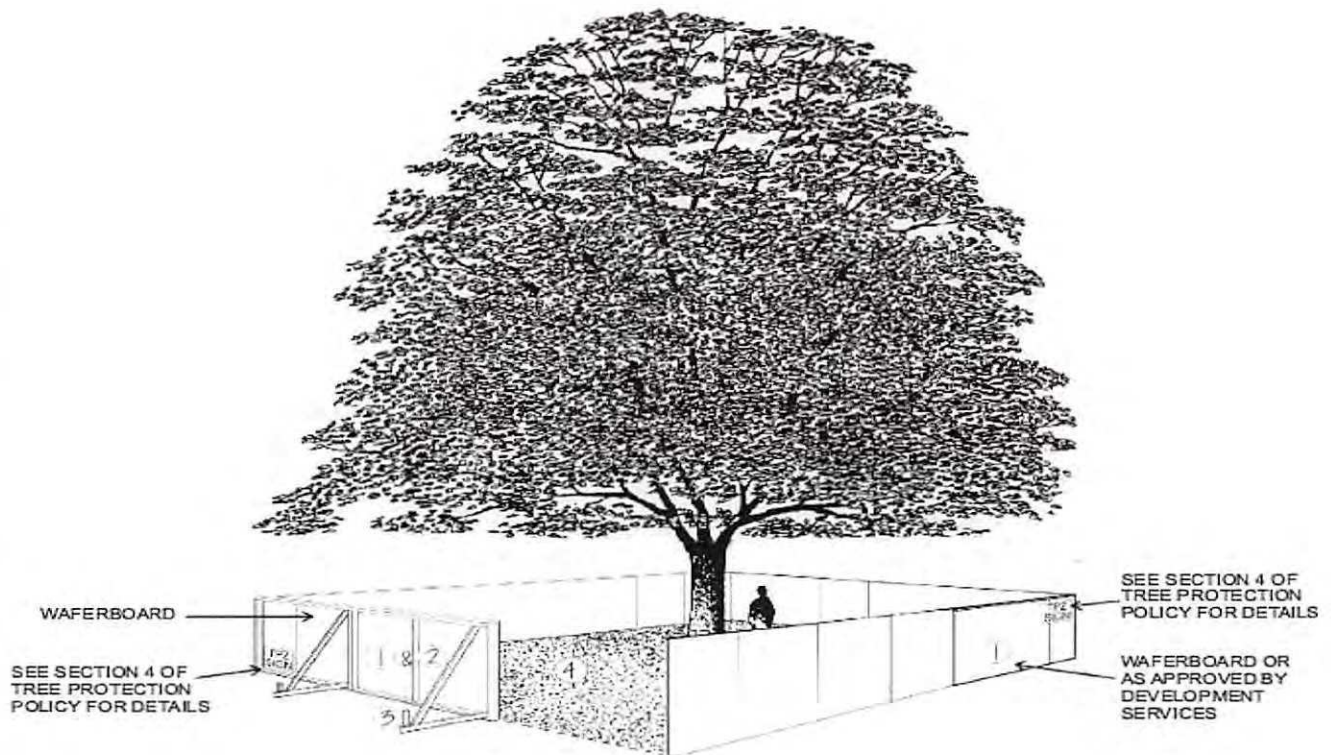
Tree Protection Procedure EN-TRE-001-001

- ① Tree protection barriers must be 1.2m (4ft.) high, waferboard hoarding or an equivalent approved by Development Services.
- ② Where earthworks material is to be temporarily located near a tree protection barrier, plywood must be used to ensure no material enters the Tree Protection Zone.
- ③ All supports and bracing should be outside the Tree Protection Zone. All such supports should minimize damaging roots outside the Tree Protection Barrier.
- ④ No construction activity, grade changes, surface treatment, or excavations of any kind is permitted within the Tree Protection Zone.

Tree Protection Zones	
Trunk Diameter (DBH)	Minimum Protection Distances Required
Less than 10cm	1.8m
11-40cm	2.4m
41-50cm	3.0m
51-60cm	3.6m
61-70cm	4.2m
71-80cm	4.8m
81-90cm	5.4m
91-100+cm	6.0m

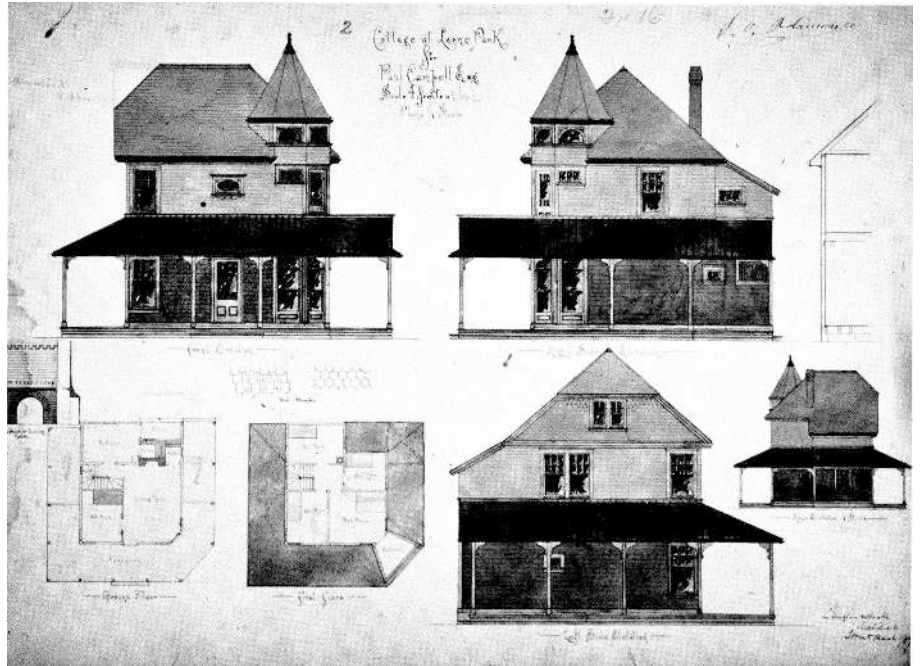
Architectural drawing of Argyle Cottage by Edmund Burke.
A Village within a City, The Story of Lorne Park Estates.

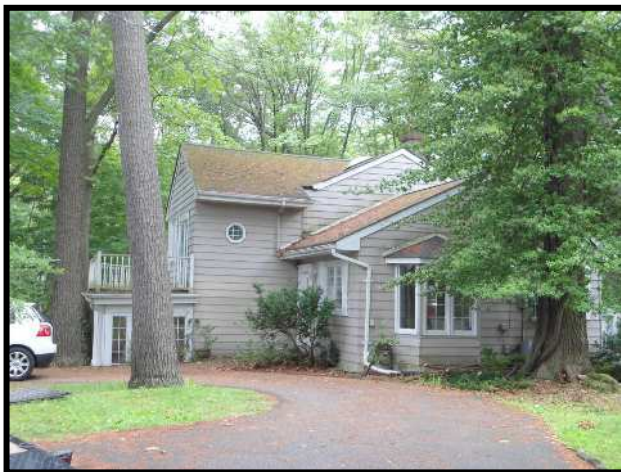
View of existing driveway

footprint and will be irreversibly damaged during the removal of the existing structure. The proposed driveway is to be maintained in terms of the access to the street and the circular configuration. The driveway will be modified at the front of the proposed attached garage to facilitate access to the garage. This is being done to mitigate the impact on the mature trees in the middle of the circular driveway.

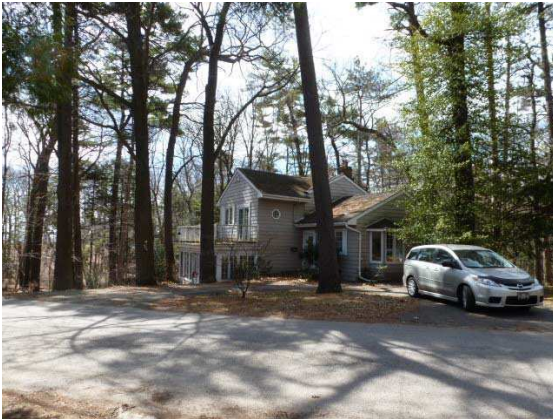
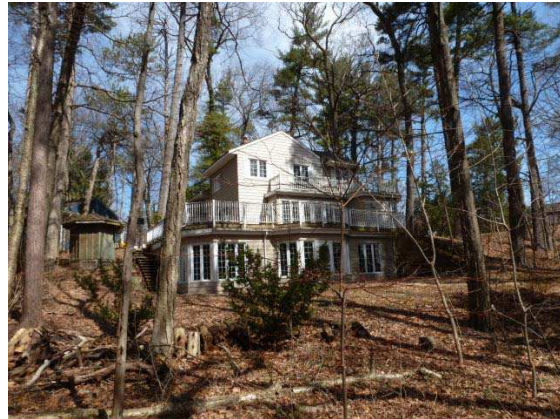
Figure #1: These 2 photos show the front and back yard of the property at 906 Whittier Crescent as they appeared during the tree inventory conducted on April 16, 2015.

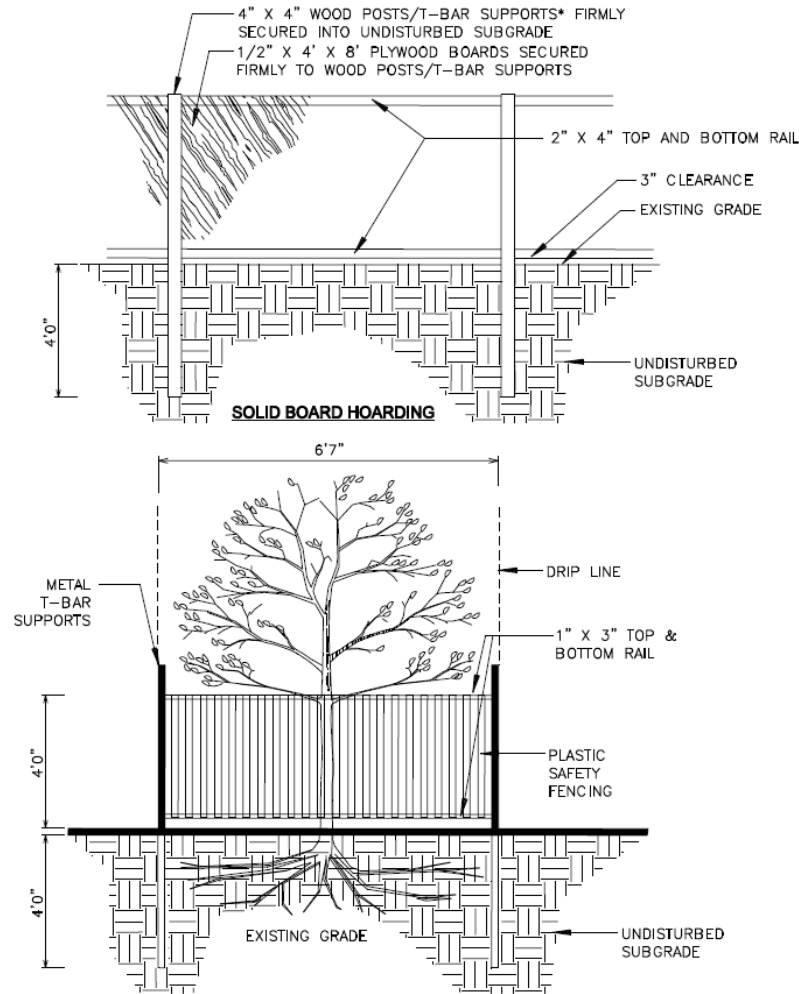
The diagram below provides the City of Mississauga's standards for Tree Protection Zone (T.P.Z) hoarding.

1. HOARDING DETAILS TO BE DETERMINED FOLLOWING INITIAL SITE INSPECTION.
 2. HOARDING TO BE APPROVED BY DEVELOPMENT AND DESIGN.
 3. HOARDING MUST BE SUPPLIED, INSTALLED AND MAINTAINED BY THE APPLICANT THROUGHOUT ALL PHASES OF CONSTRUCTION, UNTIL APPROVAL TO REMOVE HOARDING IS OBTAINED FROM DEVELOPMENT AND DESIGN.
 4. DO NOT ALLOW WATER TO COLLECT AND POND BEHIND OR WITHIN HOARDING.
- * T-BAR SUPPORTS FOR SOLID HOARDING WILL ONLY BE ALLOWED WITH PRE APPROVAL FROM DEVELOPMENT AND DESIGN.

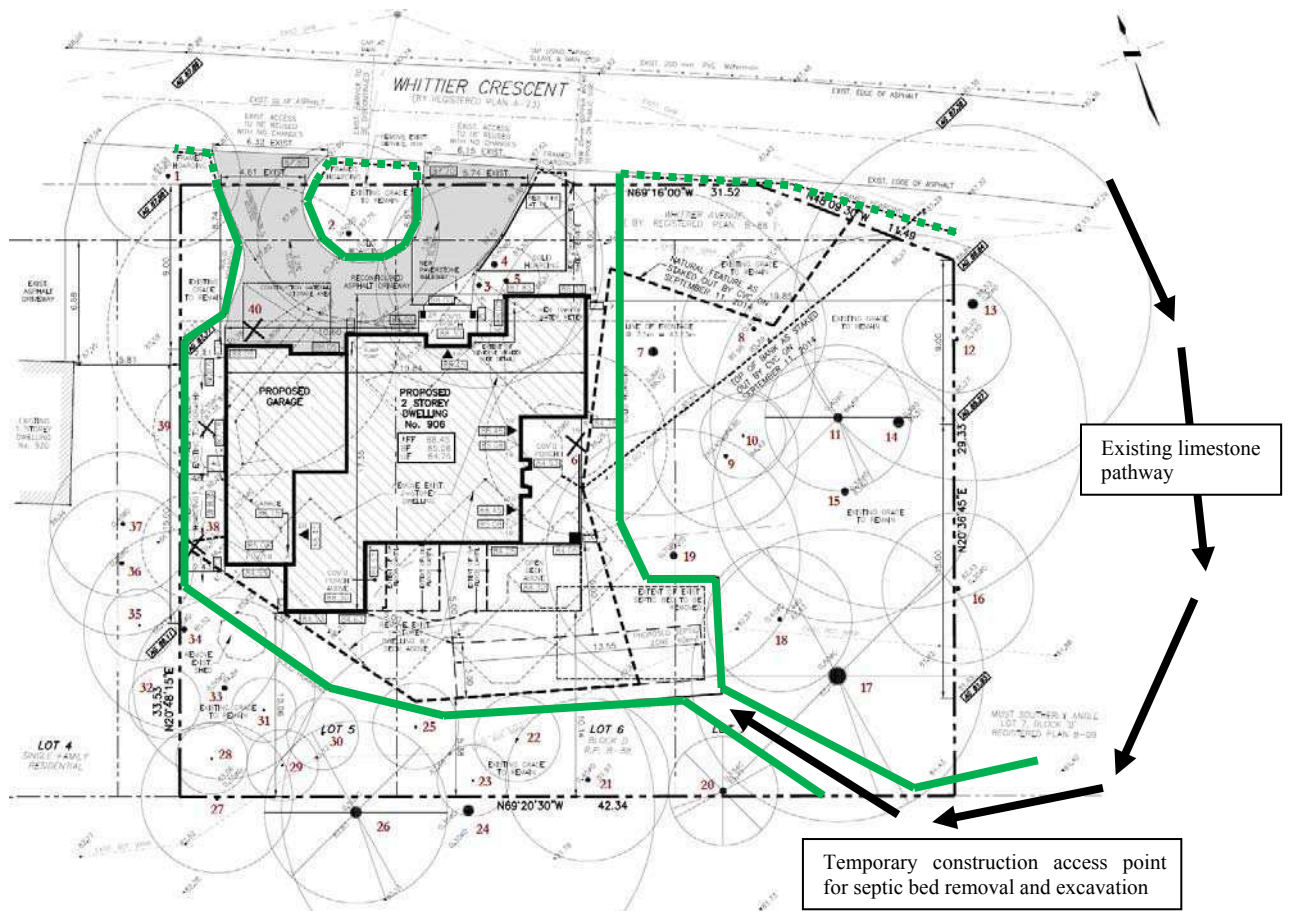
Note: The proposed Tree Protection Zone (TPZ) hoarding is shown as green lines and is not to scale on this drawing.

1. A temporary construction access point will be required for removal of the existing septic bed and excavation for the new septic bed. This access point shall be located between Trees #17 and 20 and the access point shall be mulched according to the □Horizontal Mulching□specifications on Page 14 of this report.
2. Access to the lower property shall be confined to the existing gravel/limestone path located along the eastern property line as indicated by the black arrows.

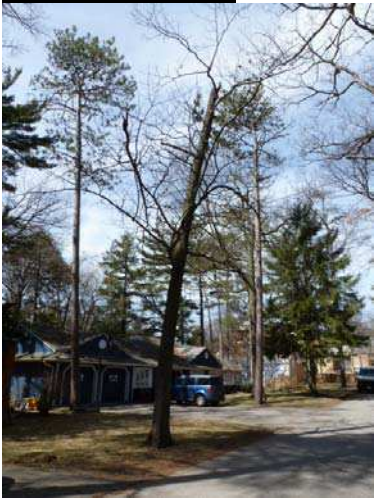
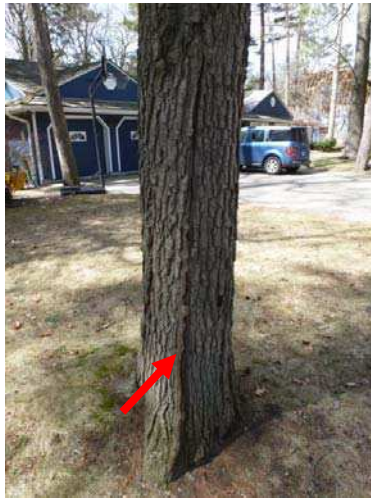
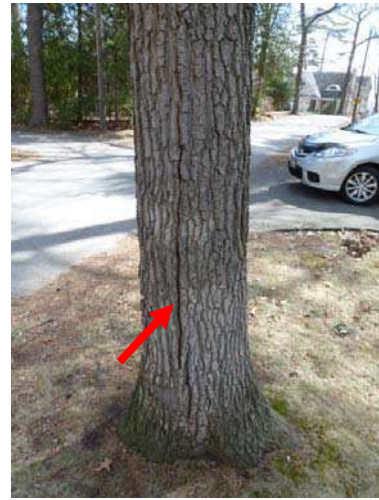
Appendix C: Site Photos □ hazard trees to be removed

Photo #3 (Tree #1)

Photo #4 (Tree #1)

Photo #5 (Tree #1)

Appendix C contains selected photos of three (3) hazard trees recommended for removal from this site due to their poor structural condition and increased level of risk. □

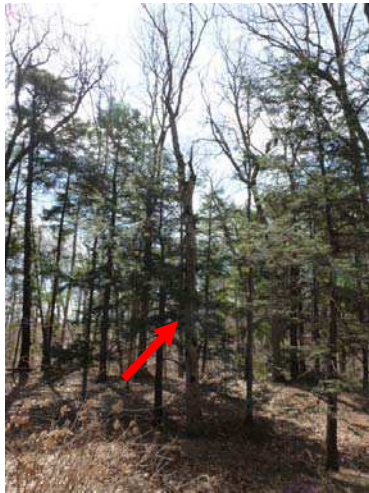
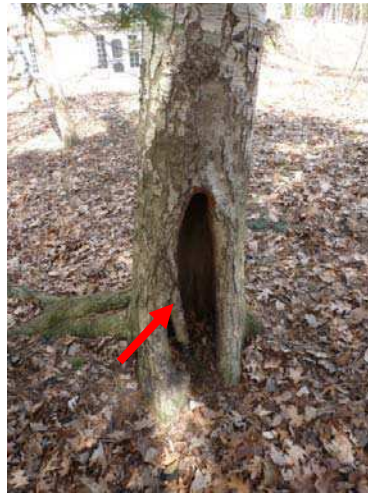
Photo #6 (Tree #21)

Photo #7 (Tree #21)

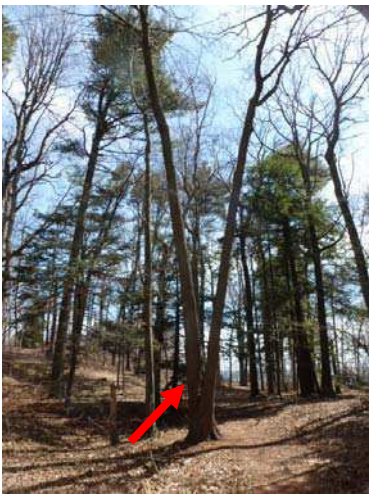
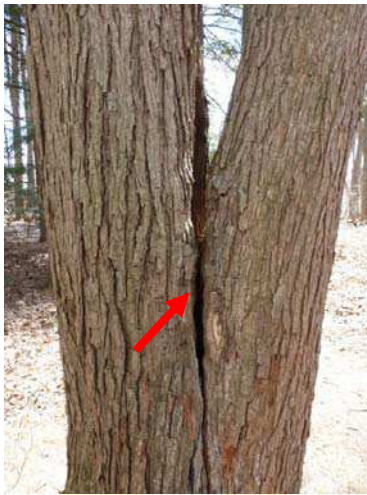
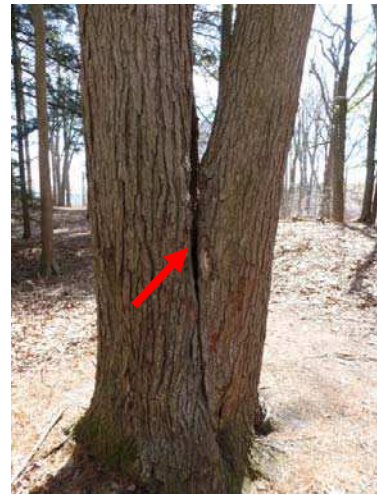
Photo #8 (Tree #24)

Photo #9 (Tree #24)

Photo #10 (Tree #24)

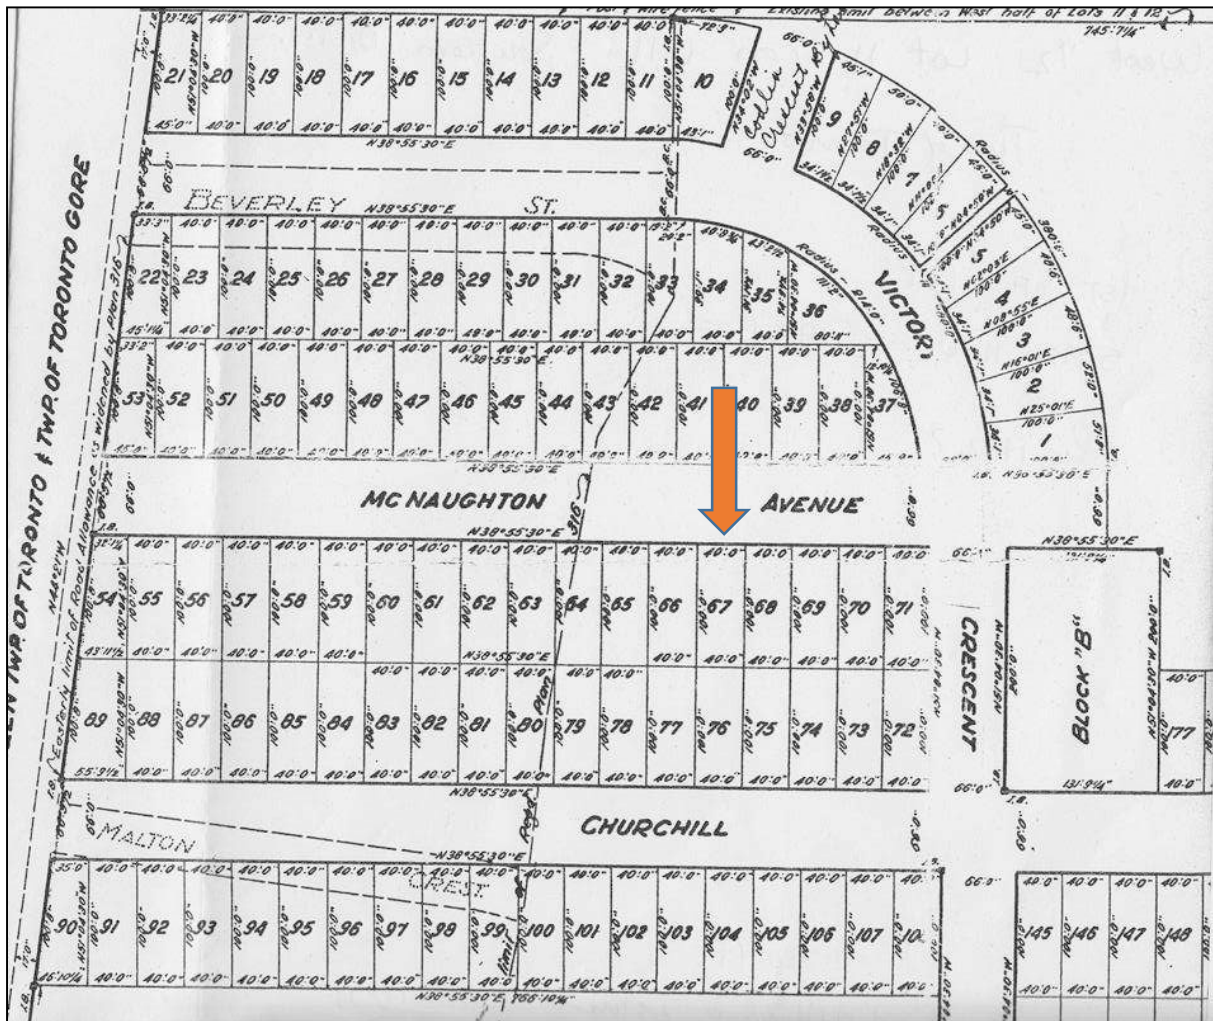
Section of 1951 Plan 436 for Victory Village, indicating Lot 67 on McNaughton Avenue. Note the indication of the earlier Plan 316.

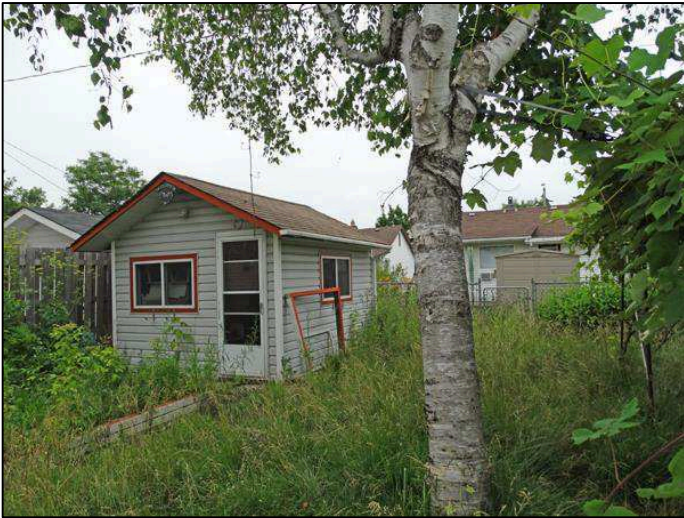
Above: Shed in rear yard

The rear yard is sufficient for a vegetable garden, which was an important consideration when the house was erected. It contains a vintage garden shed. The front yard is grassed.

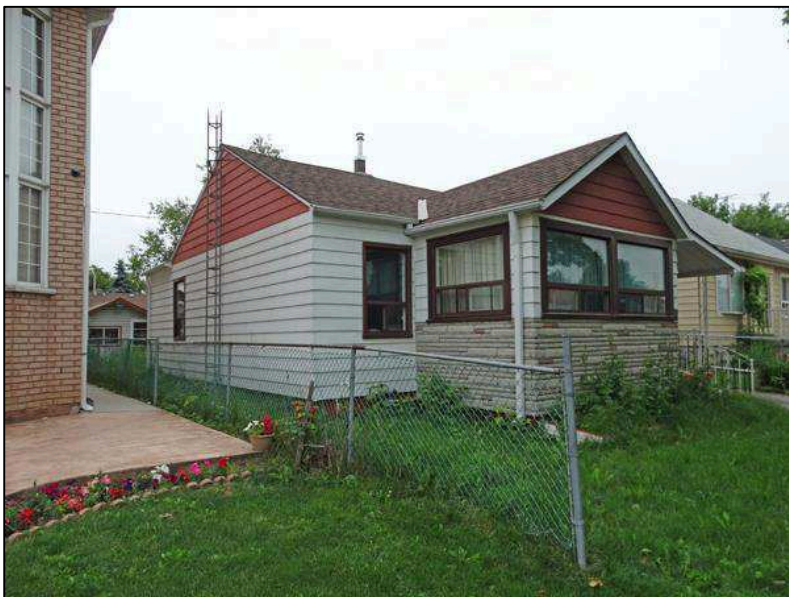
Below: East and north (front) facades

The exterior cladding is replacement vinyl siding with a front section of angel stone brick veneer. The window sashes have been replaced.

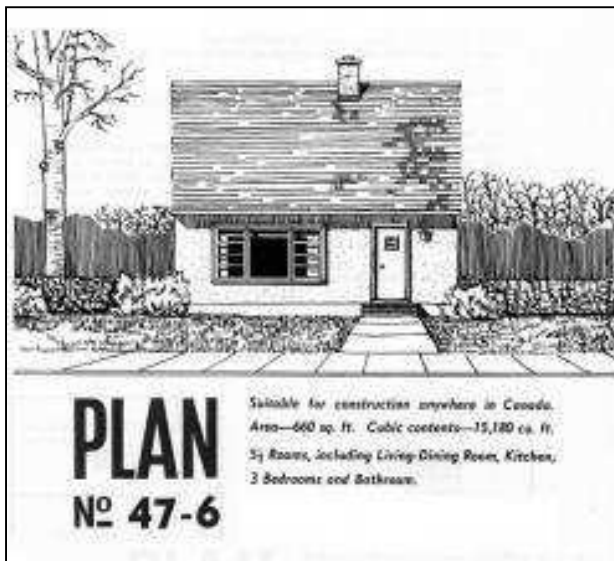
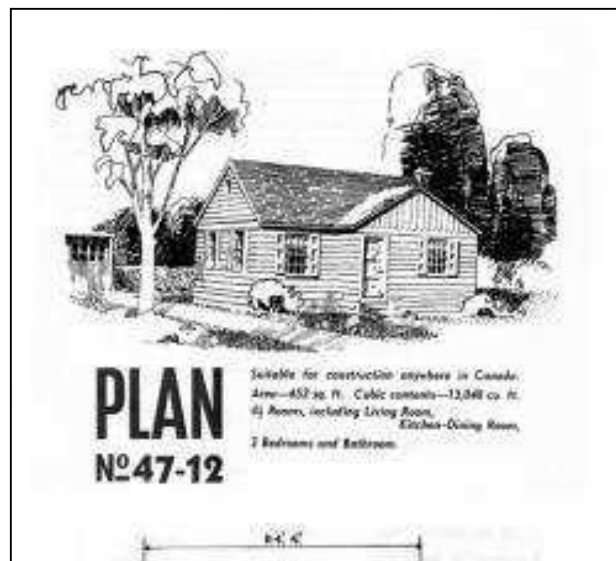
Wartime Housing Ltd. erected economical, frame, sometimes prefabricated, single and one and a half storey rental houses. The designs, floor plans, and materials were standardized. When

built, these dwellings were considered by many to be “state of the art” and included window blinds and a large coal or wood burning stove for heating the entire house. They did not have basements. Central Mortgage and Housing Corporation continued this practice and published numbered building plans with limited options (examples shown previous page) that came with low rate mortgages for veterans. The priority was affordable housing.

The dwelling at 3056 McNaughton is a single storey with a medium pitched gable roof and a rectangular plan. It has the standard four room plan (kitchen, sitting/dining room, two bedrooms with a closet) plus a bathroom. The enclosed, gable roofed, front entryway is either a later addition and/or a modification of the original front extension (with window openings, sashes, door, and stairway changes). A basement has been added. An enclosed entranceway at the south end of the west facade and a low height section at the rear, accommodate the entrance and basement.

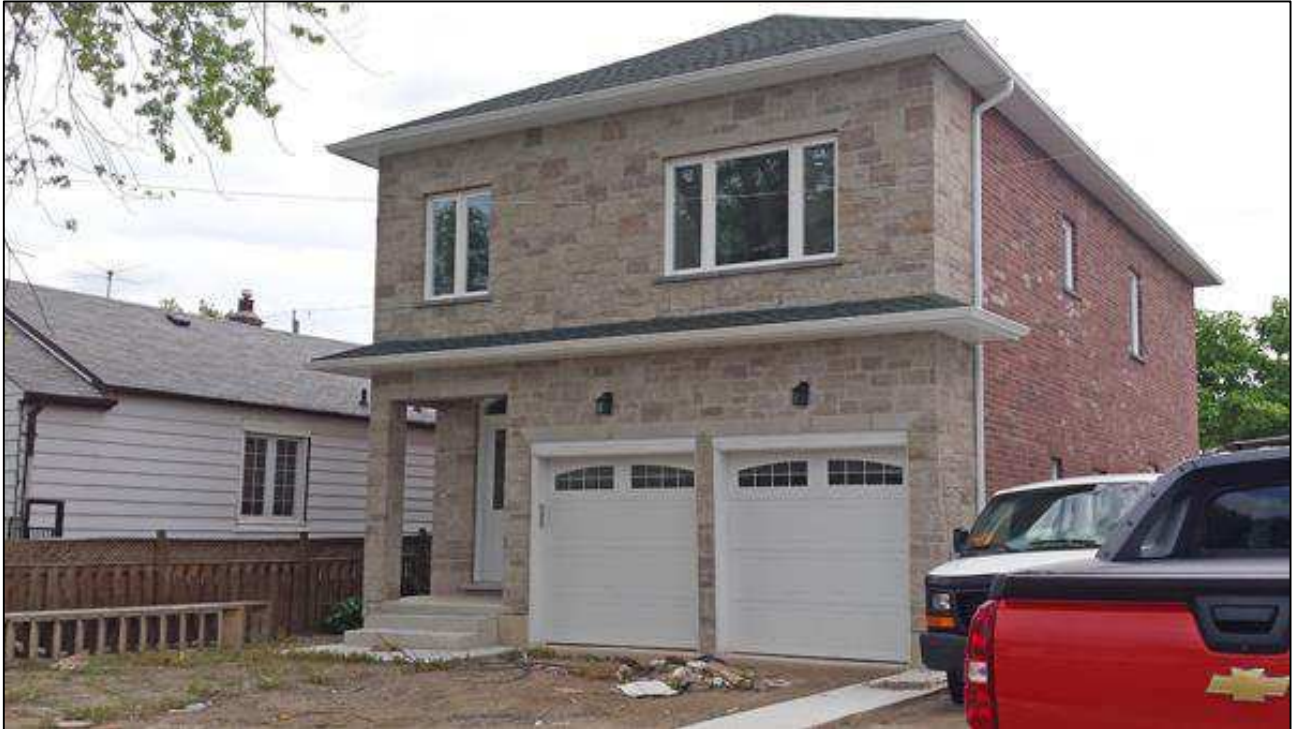
This infill dwelling at 3094 Churchill Avenue (shown nearing completion) is proposed for 3056 McNaughton with location of garage reversed. This design is depicted in the conceptual streetscape on previous page.
