Heritage Impact Statement

1392 Stavebank Road
Mississauga ON L5G 2V3

June 20, 2013

Report prepared by David W. Small

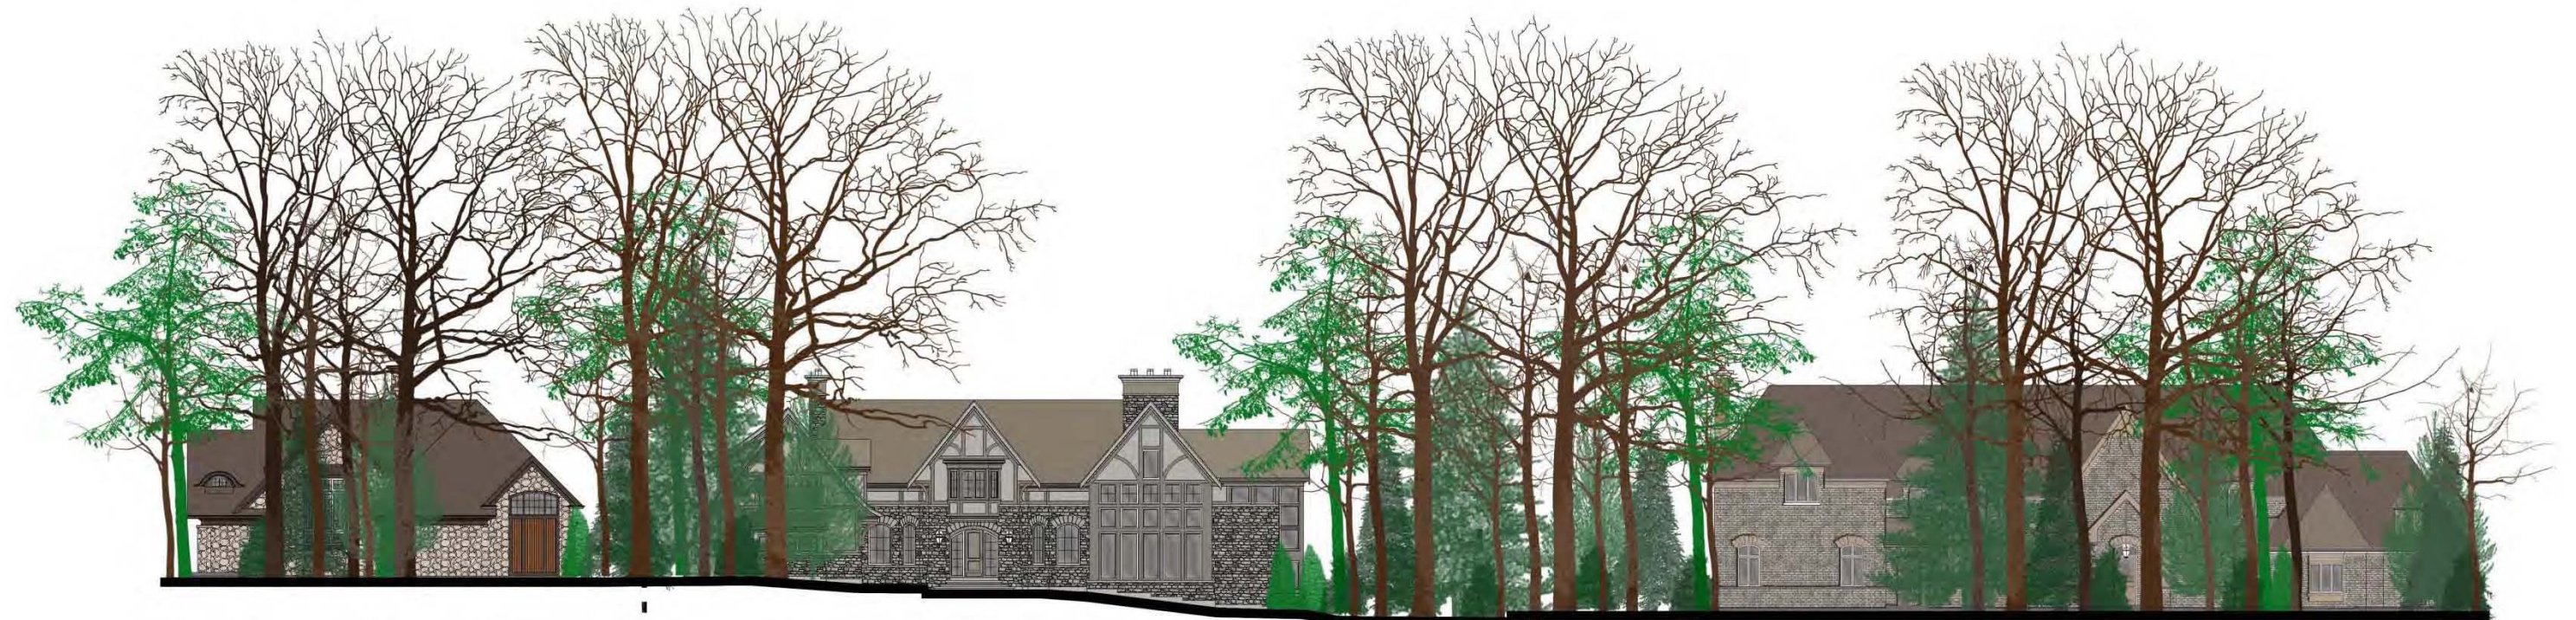
Proposed Elevations:

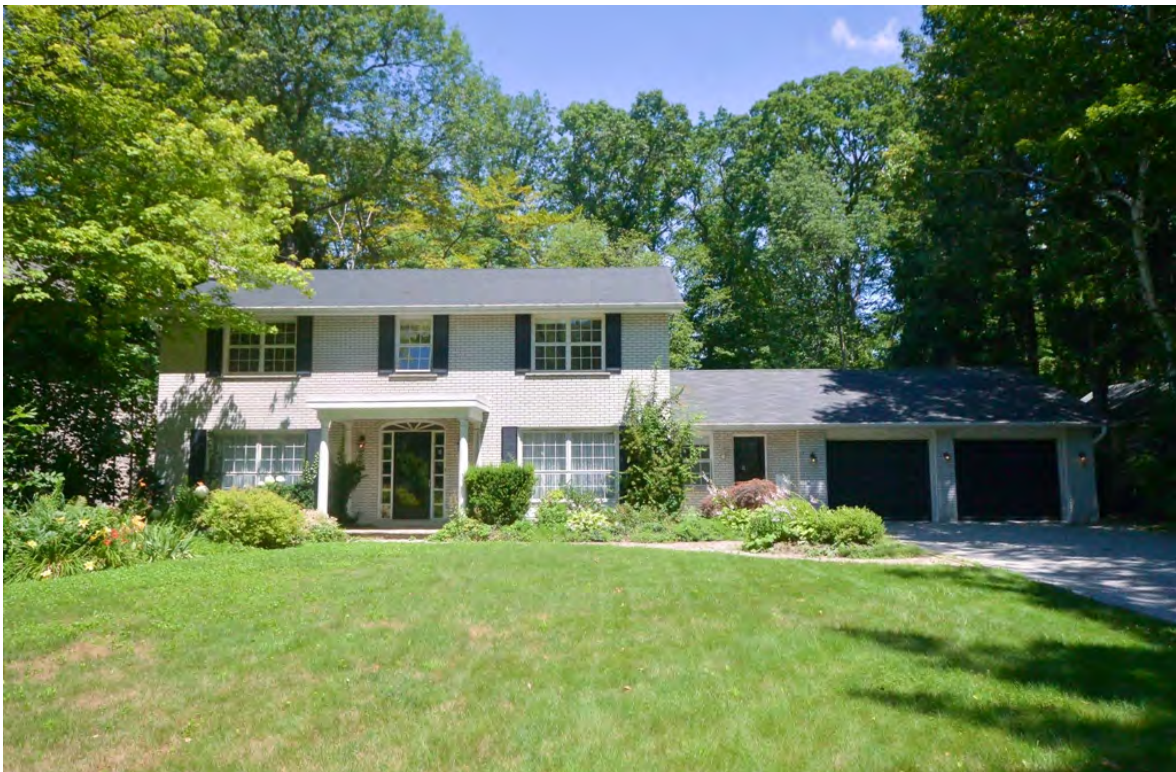
Fig. 19 Front facade (west elevation) of house and garage wing

The symmetrical front facade is centred on the front entrance, which references a commonly found Neoclassical entrance consisting of a six-panelled door, sidelights and fanlight. It does not have the delicacy true Neoclassical entrances exhibit. Four of the windows in the front facade are double the size of windows in Neoclassical houses. The metal shutters are decorative – much too narrow to cover the windows as was needed in the nineteenth century. The light grey brick cladding, popular in the mid-twentieth century, was not available in the nineteenth century.

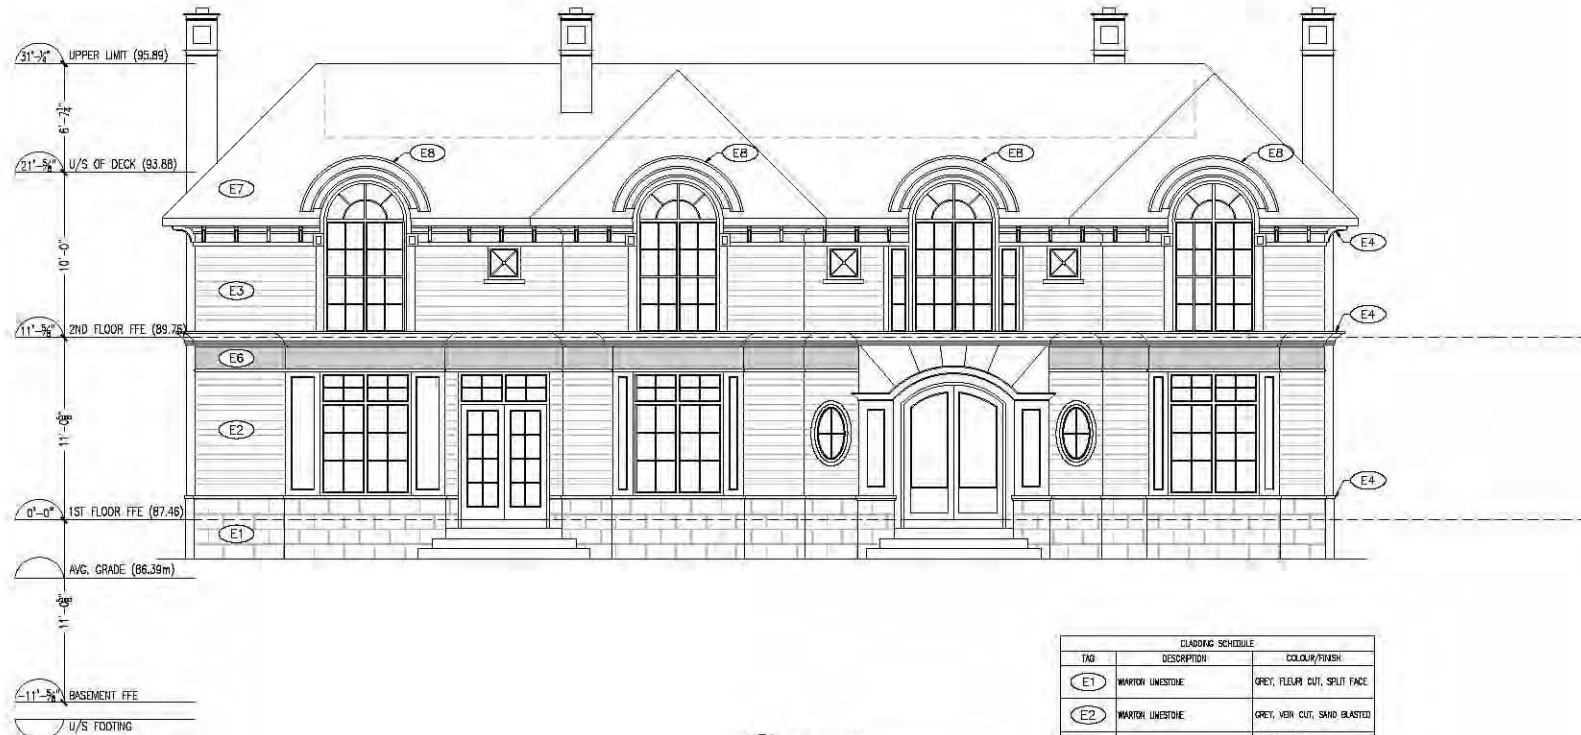
1 WEST ELEVATION
 SCALE: 3/16" = 1'-0"

TAG	DESCRIPTION	COLOR/FINISH
E1	MARTON Limestone	GREY, FLEUR CUT, SPLIT FACE
E2	MARTON Limestone	GREY, VEH CUT, SAND BLASTED
E3	MARTON Limestone	GREY, VEH CUT, SMOOTH/FACED
E4	MULLINGS	COLOR AND FINISH TBD
E5	STUCCO	COLOR TBD, TEXTURED FINISH
E6	STUCCO	COLOR TBD, SMOOTH FINISH
E7	ASPHALT SHINGLES	BLACK DEEP SHADOW
E8	STANDING SEAM METAL ROOF	BLACK

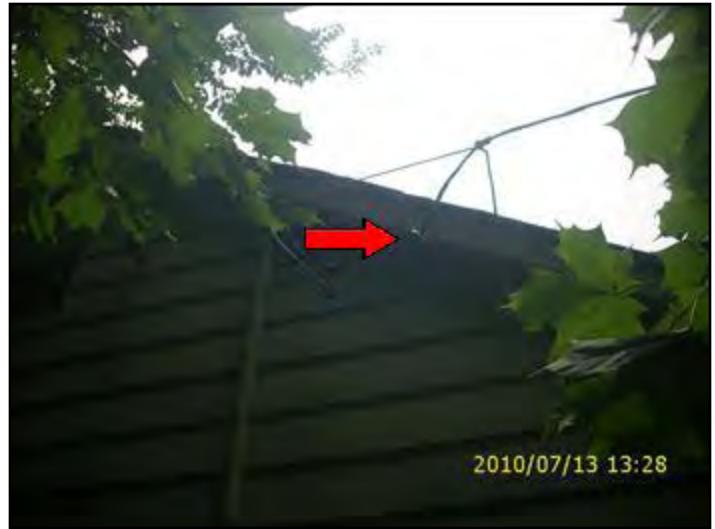
16. Anchor loose

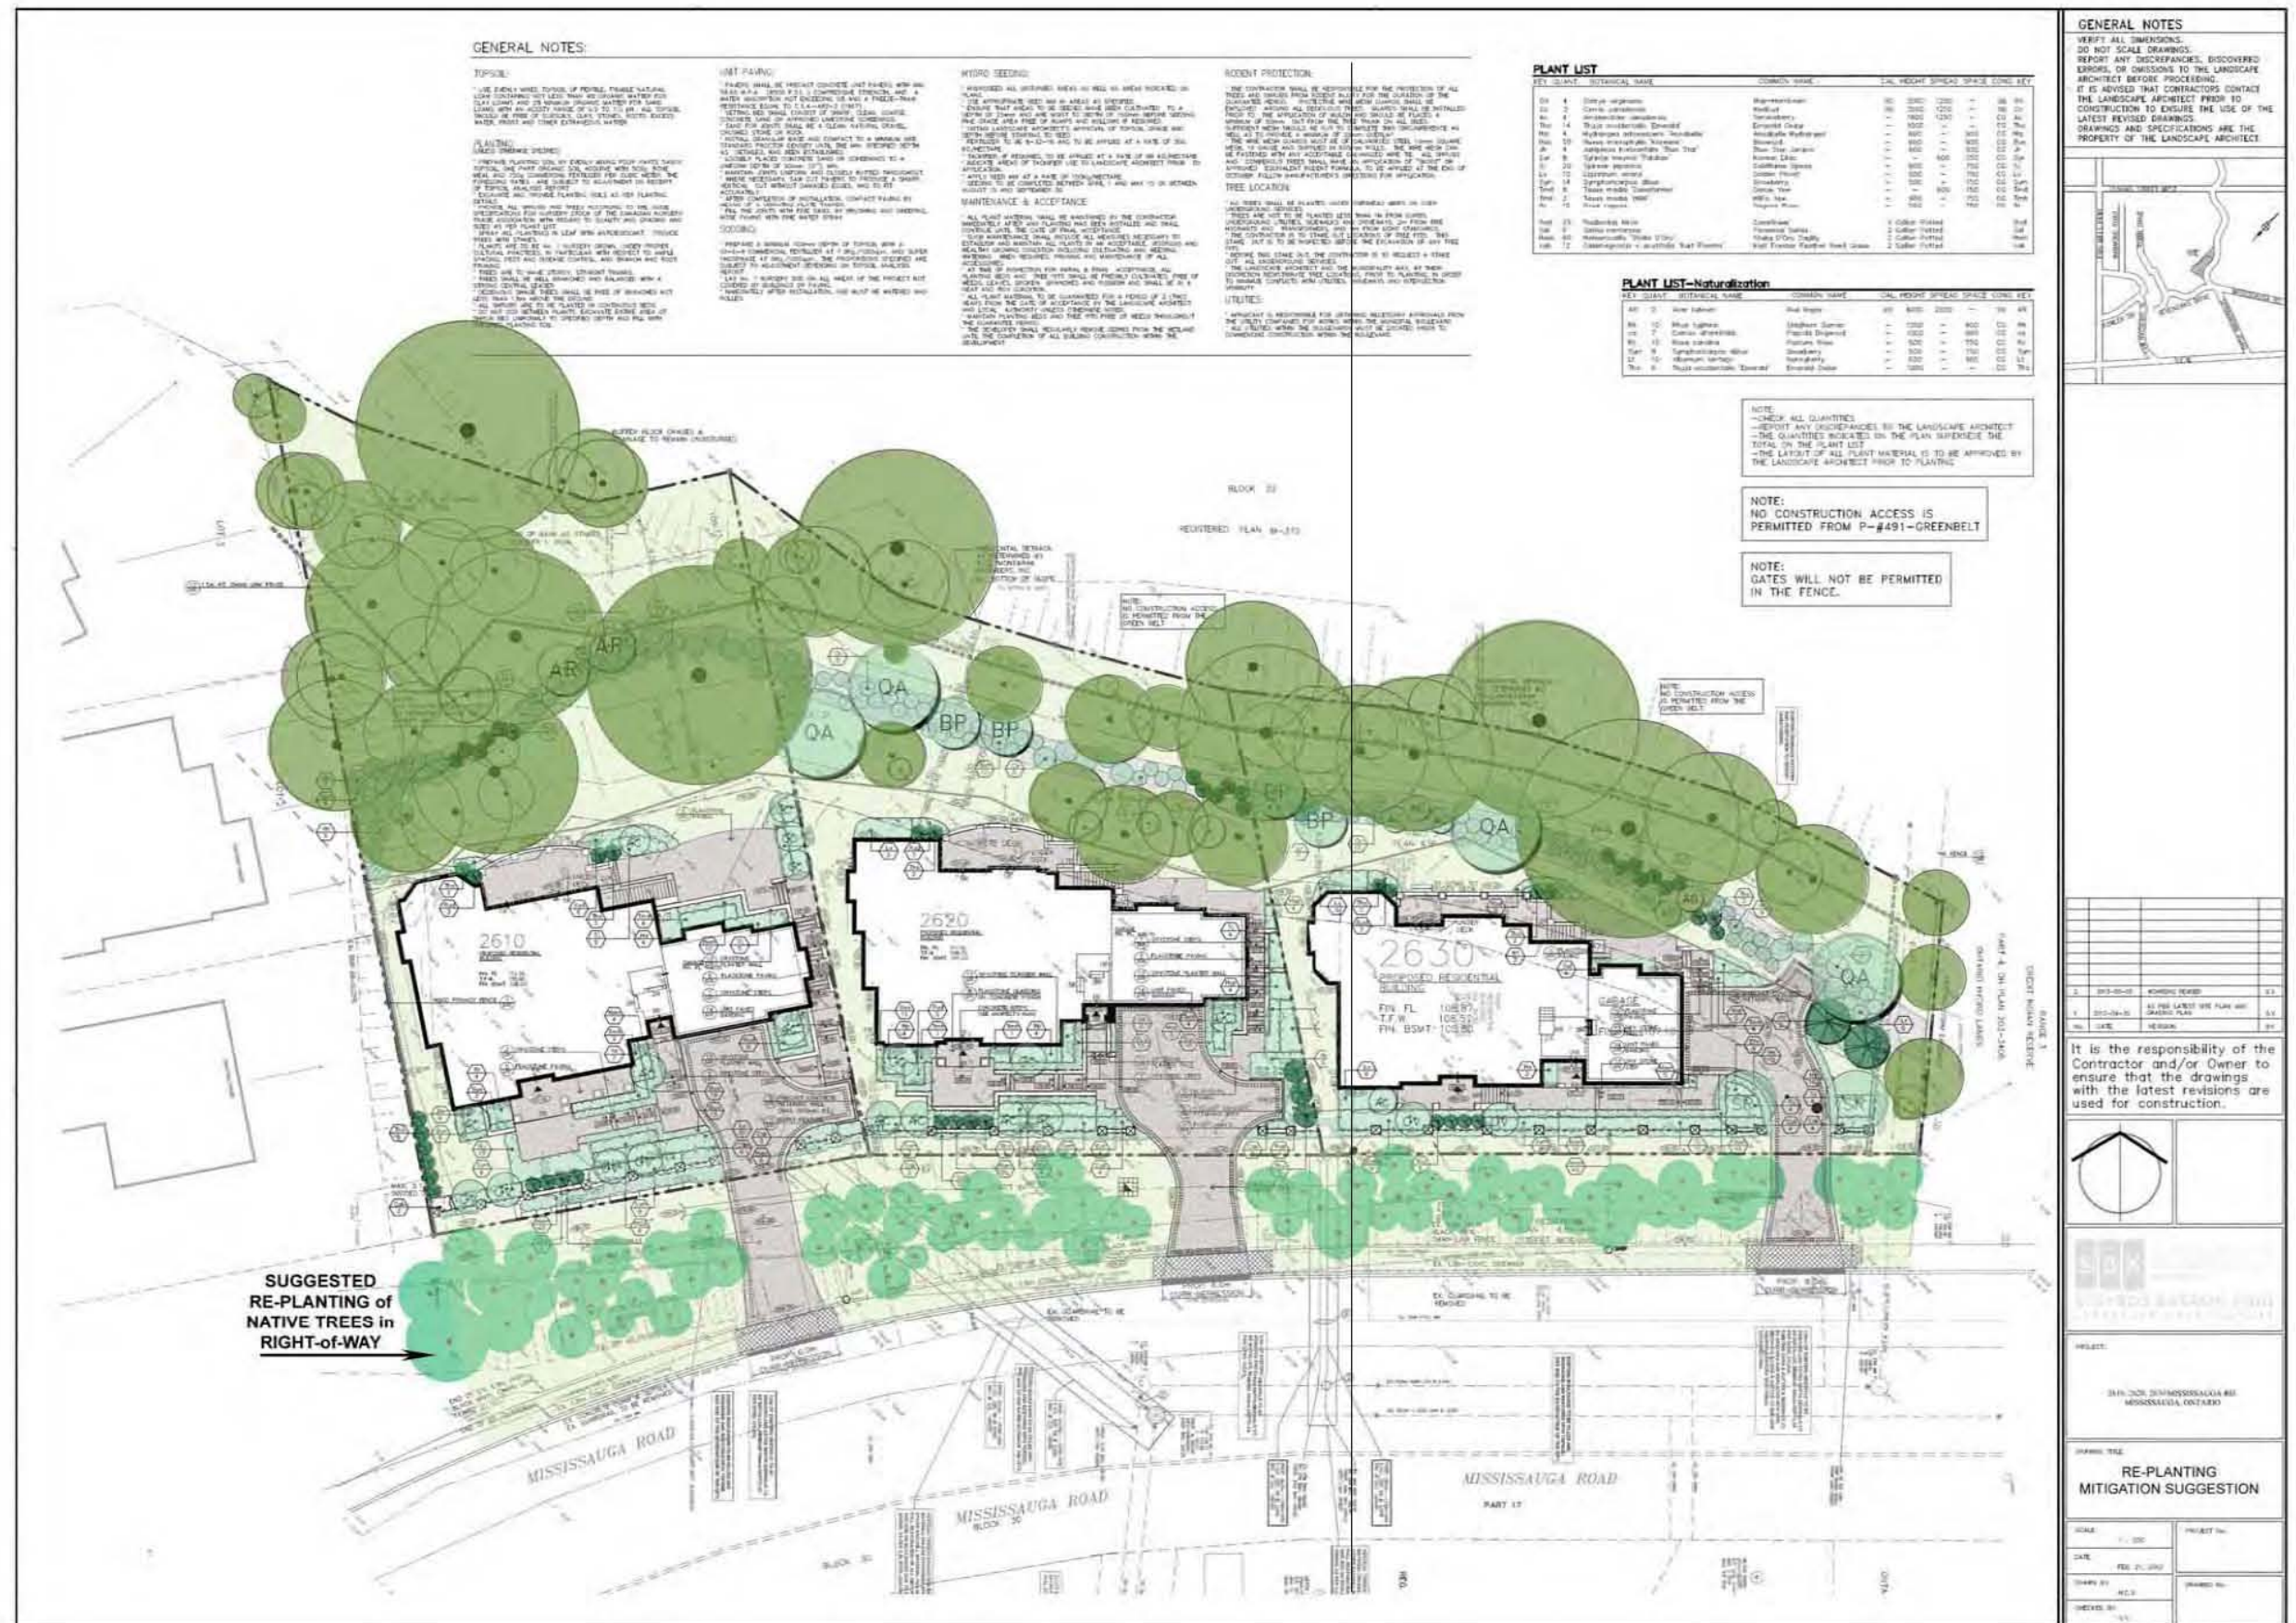
Figure 33

suggested woodlot re-planting in Mississauga Road right-of-way

To mitigate the change in view and loss of woodlot trees, a native tree re-planting scheme in the Mississauga Road right-of-way is suggested (Figure 33 - Streetscape Plan). The view, in the longer term, would be consistent with much of the Mississauga Road streetscape in this area of the cultural landscape (see Figures 22 and 26). The Landscape Plan (Figure 34) responds to this recommendation/mitigating measure.
