Phase I Environmental Site Assessment
5155 Mississauga Rd., Mississauga, ON

Project 15*4249 BRUCE A. BROWN ASSOCIATES LIMITED
Consultants in the Environmental & Applied Earth Sciences

PHASE I ENVIRONMENTAL SITE ASSESSMENT – 5155 MISSISSAUGA ROAD, MISSISSAUGA

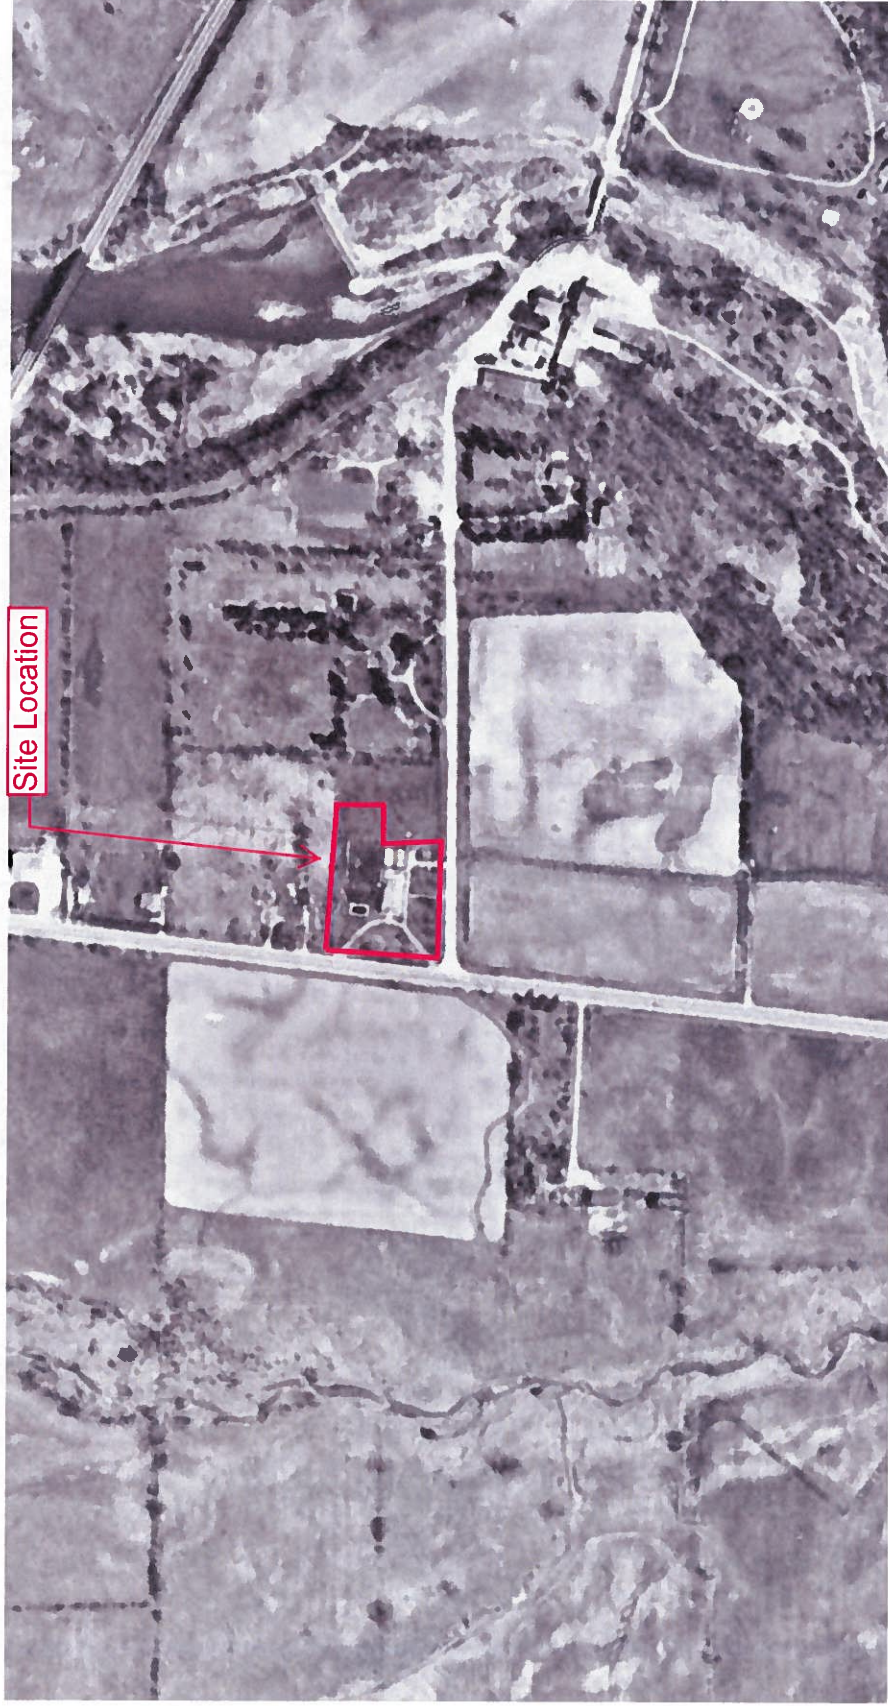
Historical Air Photo: 1966

No changes were noted in the 1966 photo except for the addition of two small residences immediately to the north of Barber House. The dam and Barbertown bridge remained in place. In a 1980 photograph the only difference from previous is the dam has been breached in the centre and the Credit River flows in a middle channel. The Barbertown bridge is still in place.

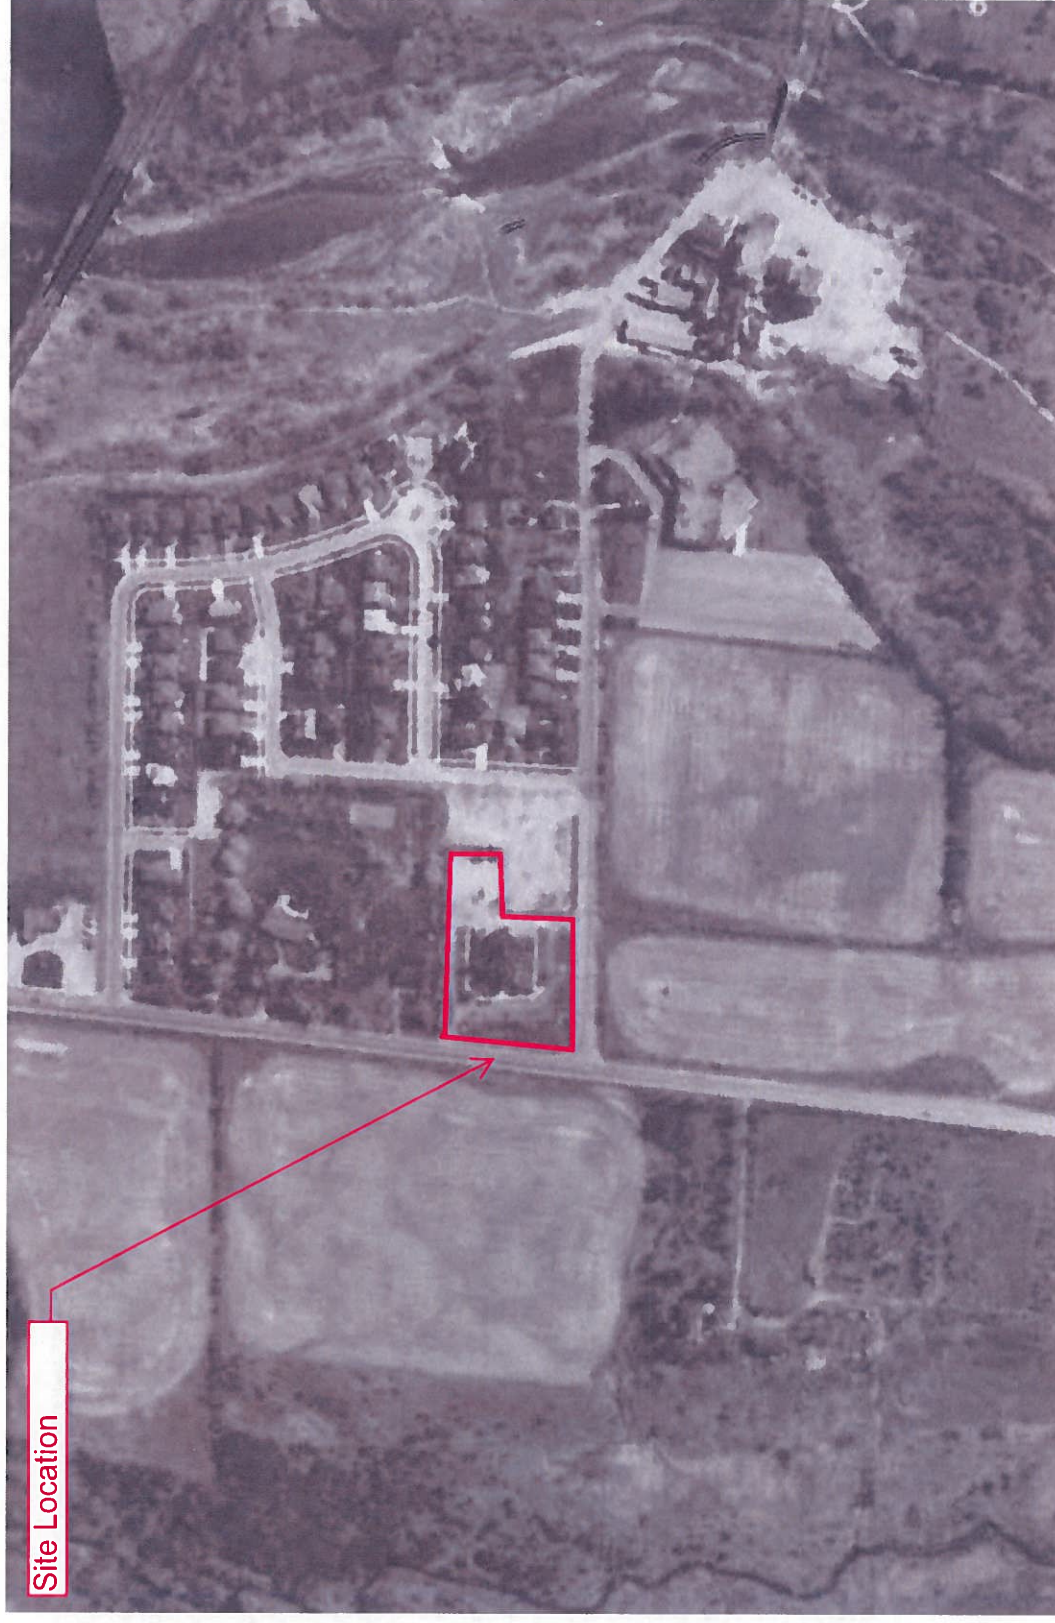
Historical Air Photo: 1985

A 1985 photograph shows the former Robert Barber property redeveloped with single family homes on Amana Place and Melody Drive. What is now the rear parking lot was graded flat and is free of vegetation as well as lands to the west and south of it. There is still no redevelopment to the south across Mississauga Road.

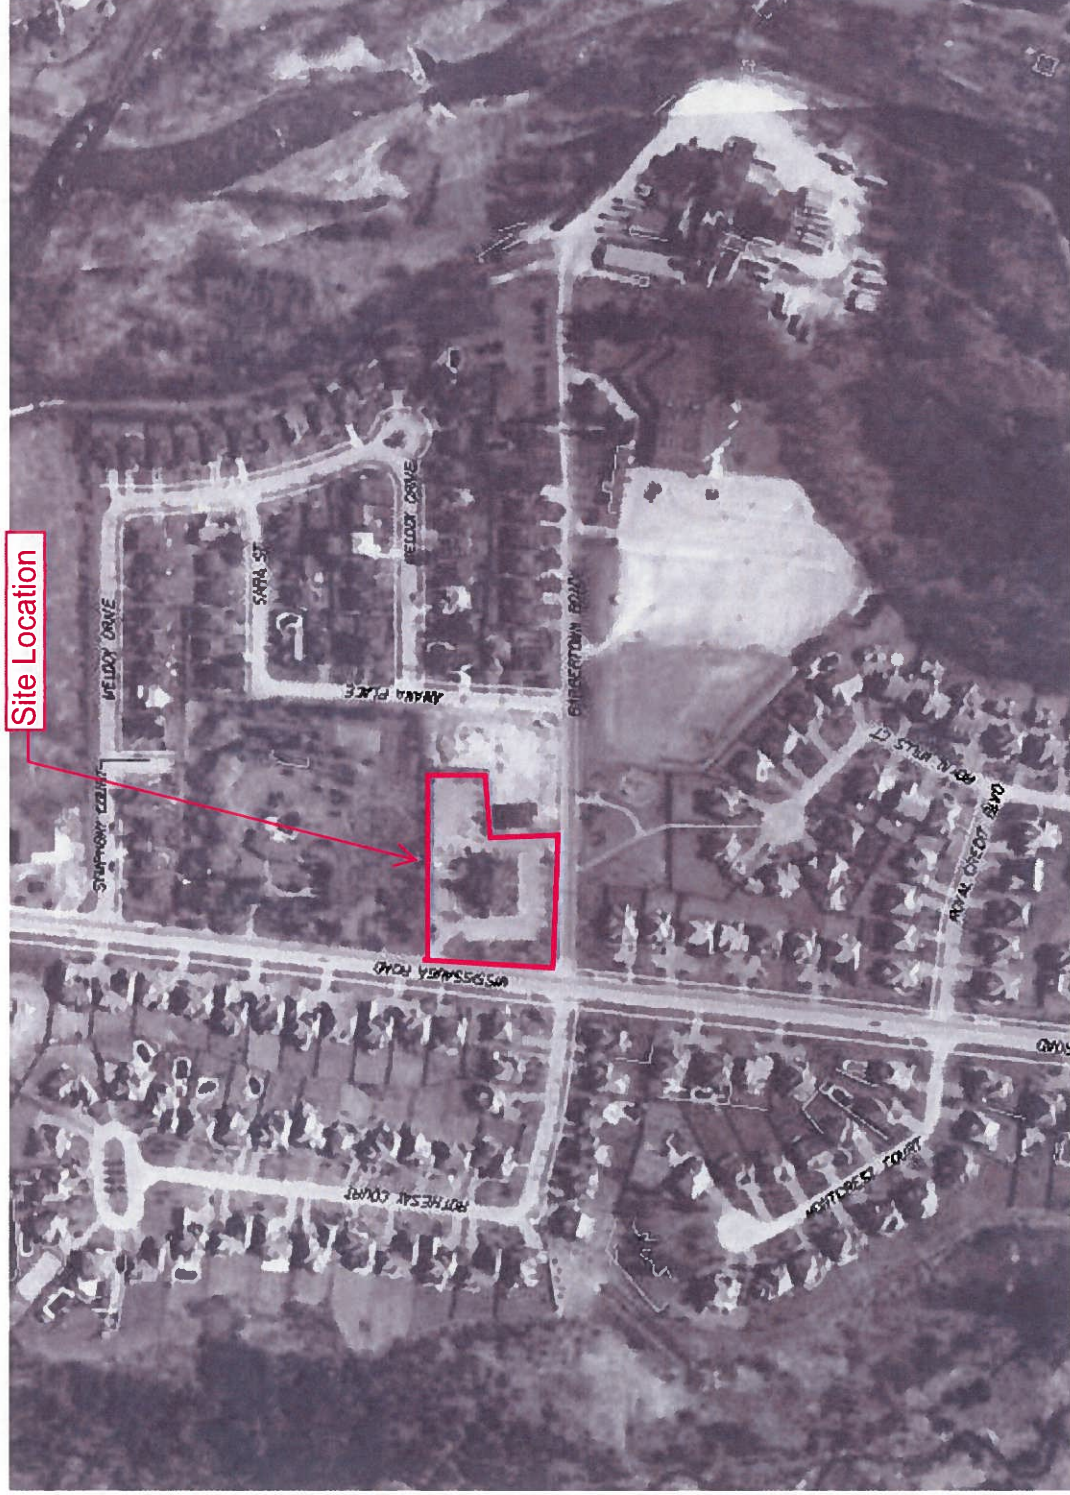
Historical Air Photo: 1995

A 1995 photograph shows one single family house constructed to the immediate east on Barbertown and the balance of lands east to Amana still vacant. Residential subdivisions are built out to the south and across Mississauga Road. The parking area for the community church has been graded out. A graveled parking lot and the original church building have been constructed. There is considerable expansion of the mill building complex and many bulk carrier trailers parked surrounding the site.

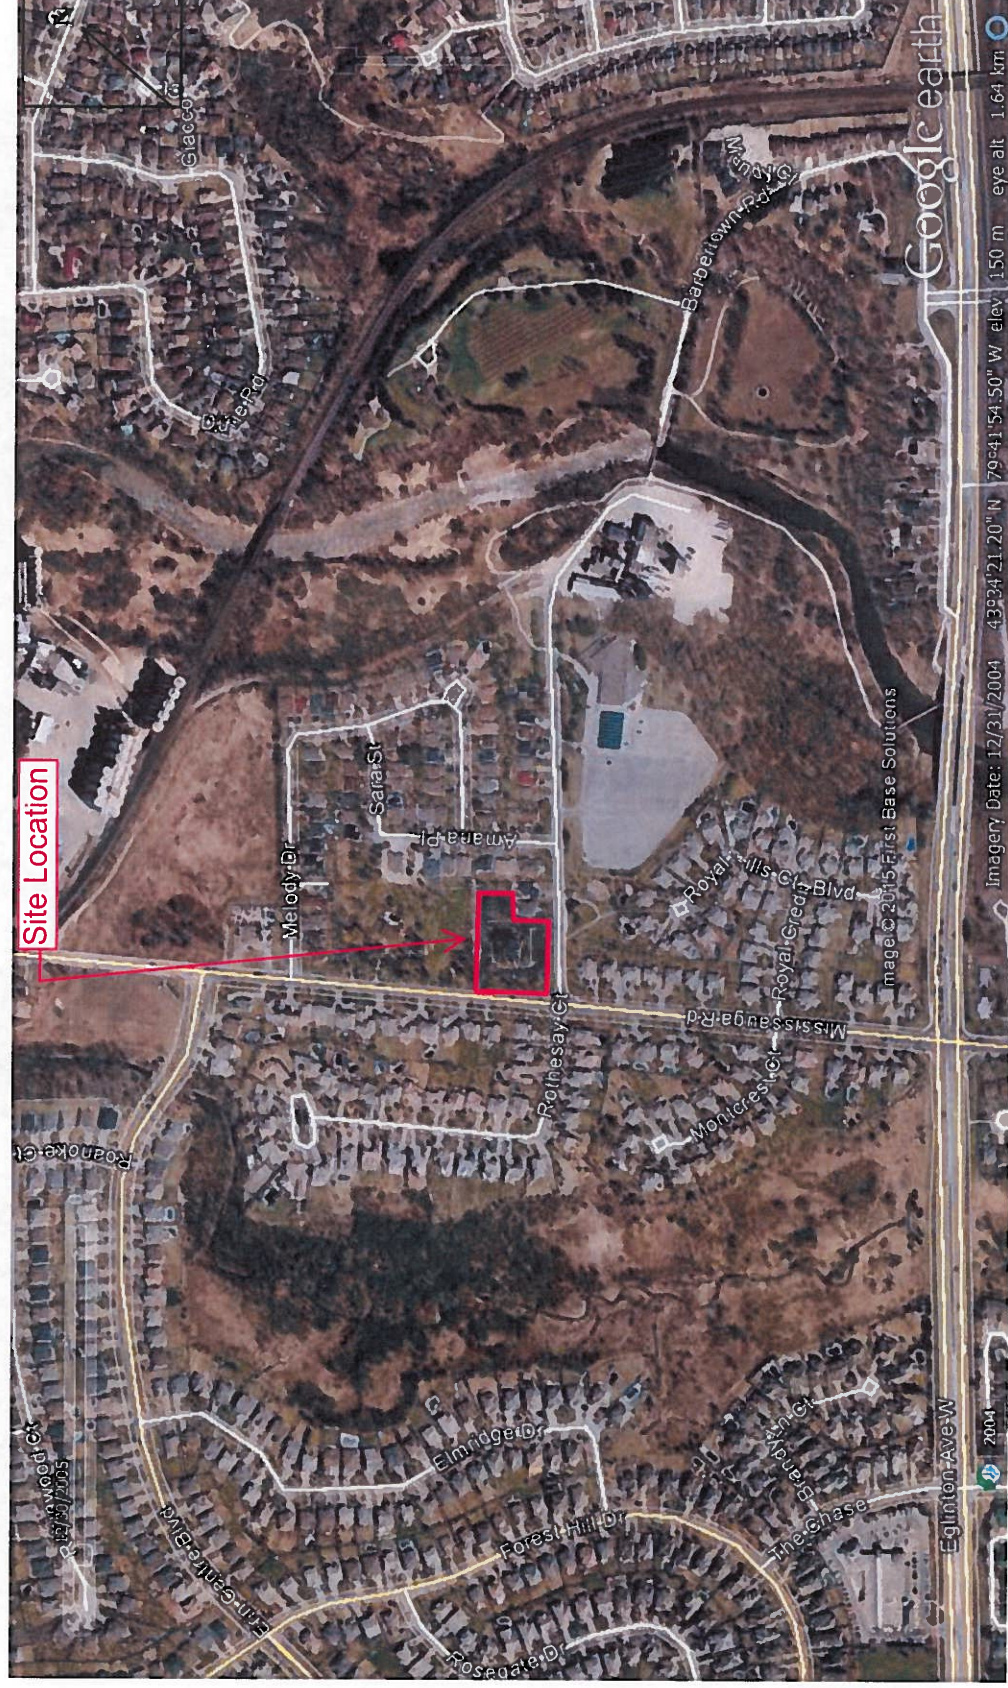
Historical Air Photo: 2004

By December 2004, the remaining residences have been infilled and the community church to the southeast have been expanded and the north addition to the restaurant completed. By 2010 there is improved paved parking surrounding the restaurant and some landscaping features on the north side. No changes are noted in the May 2015 image.

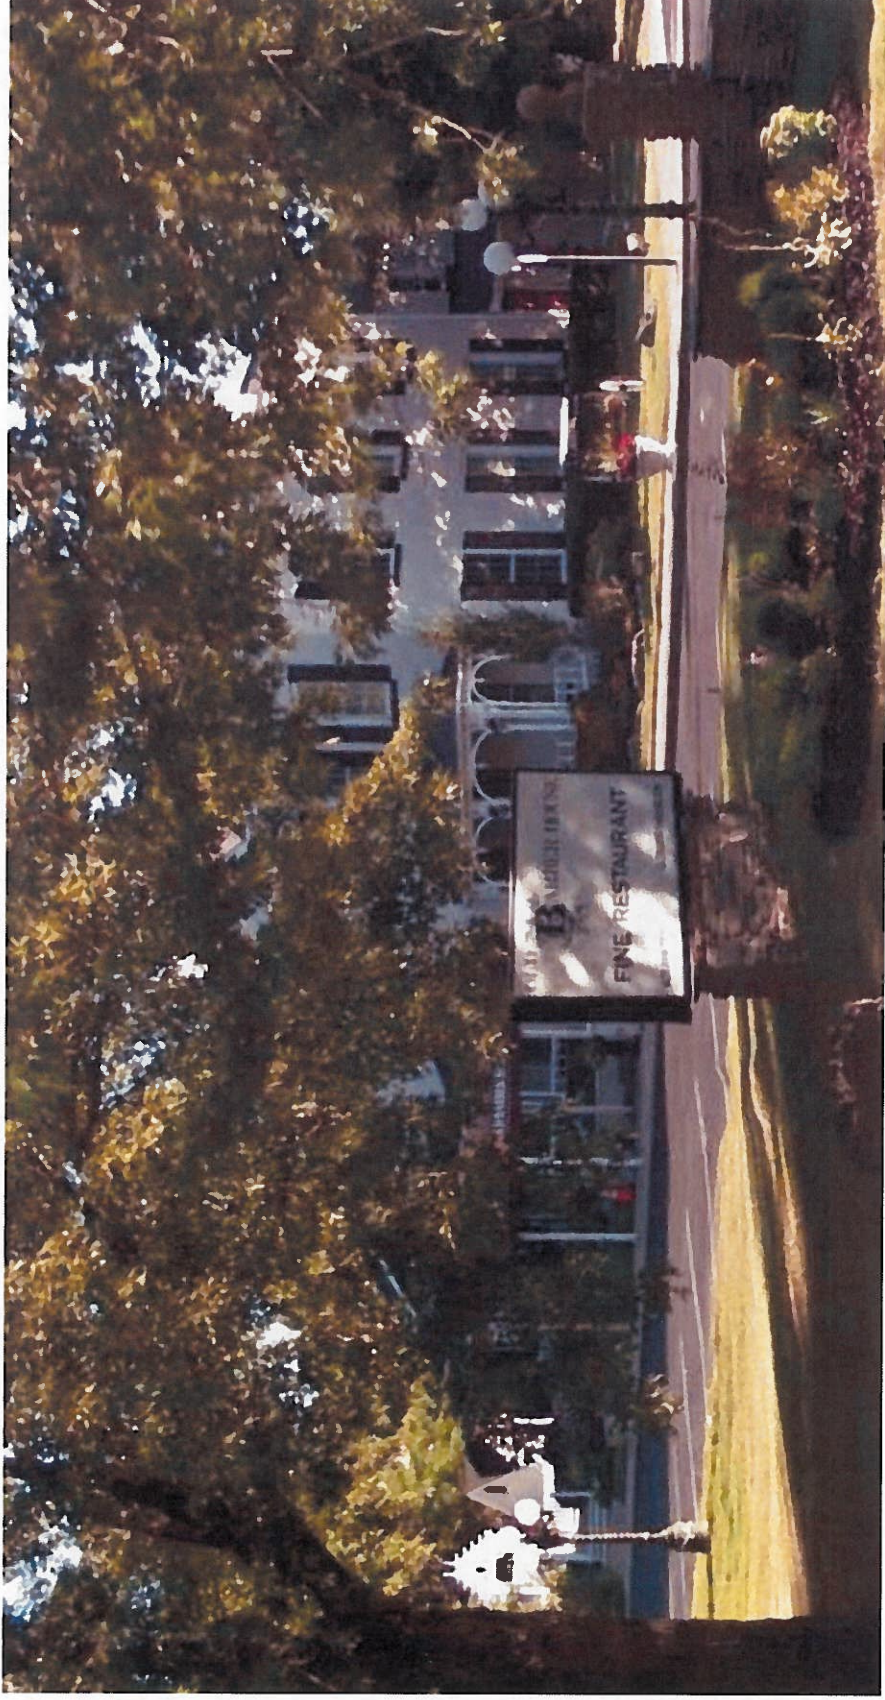
View to Northeast - View of Front and South Elevations

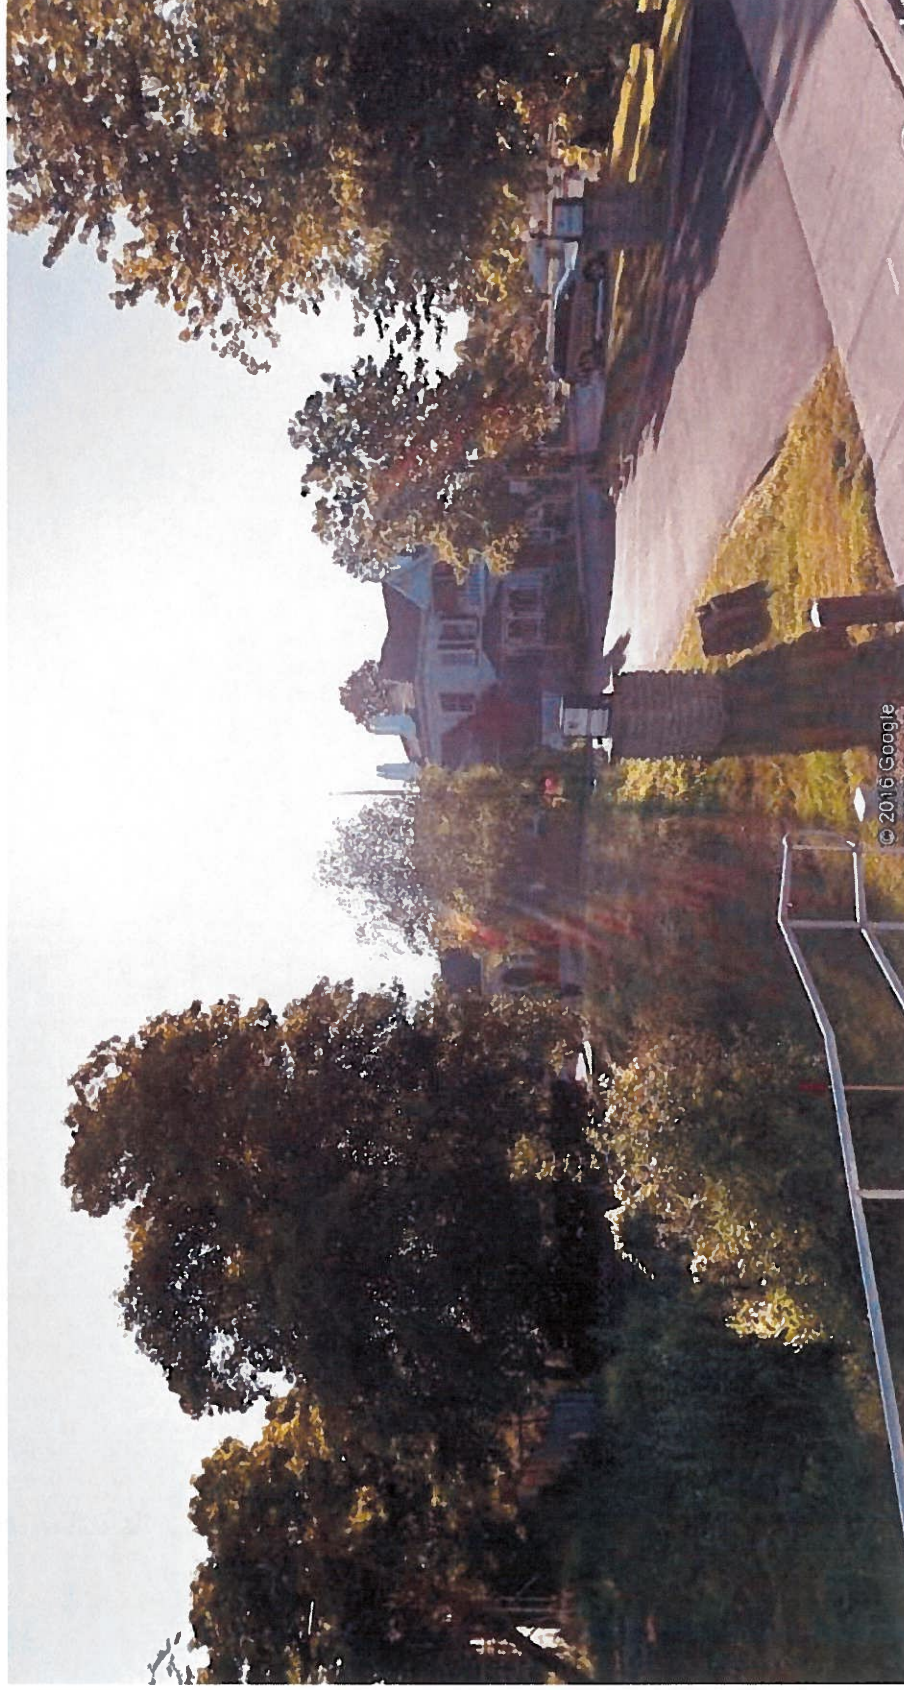
View to Southeast - View of Front and North Elevations
