**PHASE ONE ENVIRONMENTAL
SITE ASSESSMENT**

**INDUSTRIAL PROPERTY
80 THOMAS STREET
MISSISSAUGA, ONTARIO**

October 2016
Reference No. 16-0031.04

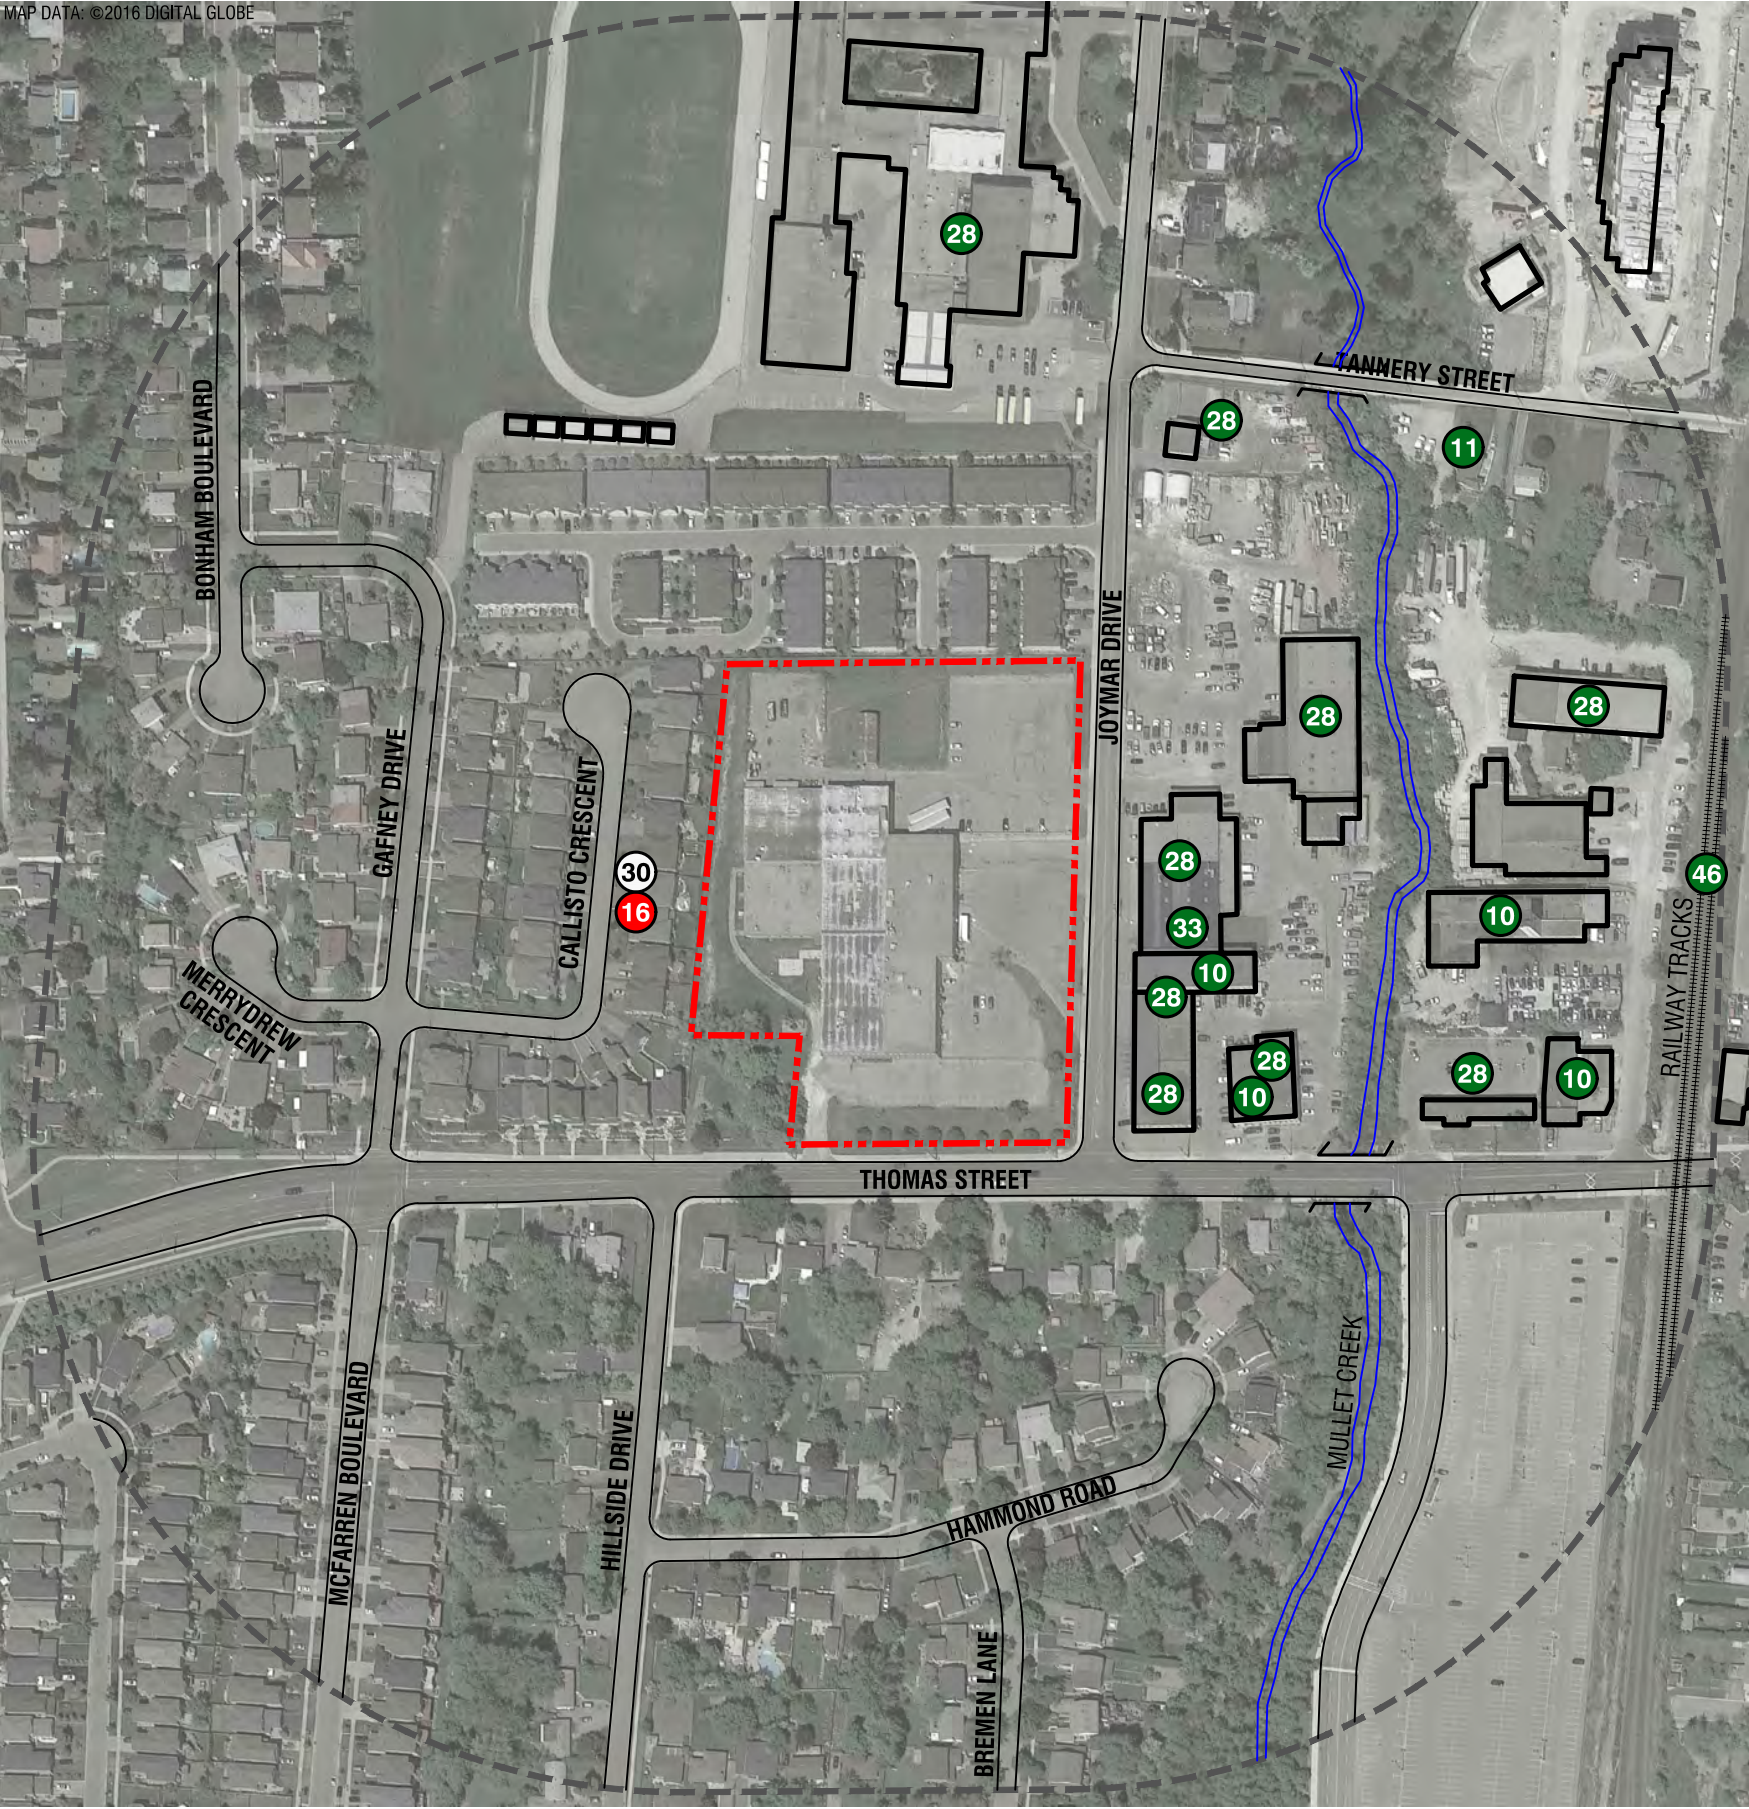
- POTENTIALLY CONTAMINATING ACTIVITIES (PCAs)**
- 10 - COMMERCIAL AUTOBODY SHOP
 - 11 - COMMERCIAL TRUCKING AND CONTAINER TERMINALS
 - 28 - GASOLINE AND ASSOCIATED PRODUCTS STORAGE IN FIXED TANKS
 - 30 - IMPORTATION OF FILL MATERIAL OF UNKNOWN QUALITY
 - 33 - METAL TREATMENT, COATING, PLATING AND FINISHING
 - 39 - PAINTS MANUFACTURING, PROCESSING AND BULK STORAGE
 - 46 - RAIL YARDS, TRACKS AND SPURS
 - 51 - SOLVENT MANUFACTURING, PROCESSING AND BULK STORAGE
 - 55 - TRANSFORMER MANUFACTURING, PROCESSING AND USE
 - 57 - VEHICLES AND ASSOCIATED PARTS MANUFACTURING

Based on the PCAs identified from current and historical activities at and west of the Phase One Property, and the APECs they represent, Watters Environmental recommends that a Phase Two ESA be completed that is compliant with the requirements of O. Reg 153/04 (as amended), after taking into account the relevant information available from the previous Phase II ESAs.

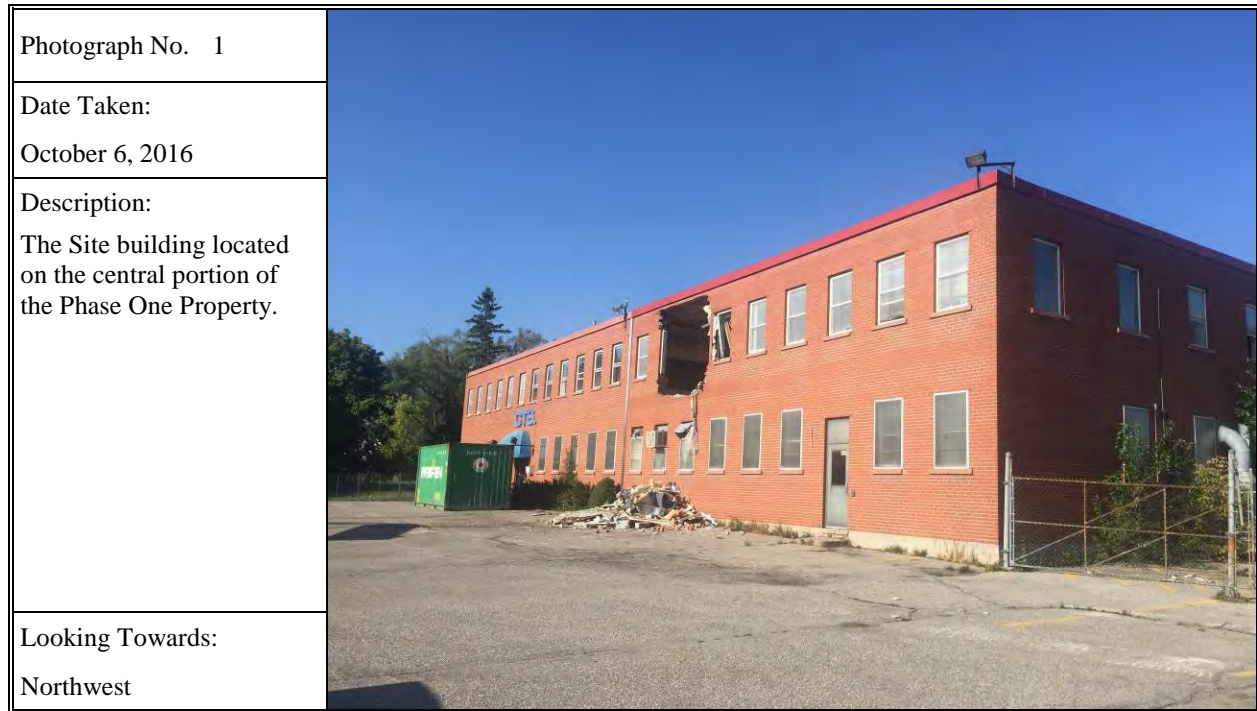
The Phase One Property contains a single two-storey slab-on-grade industrial building (the “Site building”; see Photograph 1) and one single-storey slab-on-grade shed (the “Main Shed”; see Photograph 2), both located on the northern portion of the Phase One Property. There are also three small sheds attached to the Site building, on the southeastern (“Southeast Shed”; see Photograph 3), southwestern (“Southwest Shed”; see Photograph 4), and northwestern portions (“Northwest Shed”; see Photograph 5) of the Site building. The Southeast Shed, with an unknown previous use, was observed to be vacant with an exhaust pipe extending outwards from the side of the shed. The Northwest Shed, with an unknown previous use, was locked at the time of the Site visit and thus was inaccessible. The Southwest Shed was noted to have previously been a Vacuum Pump room, which was primarily vacant at the time of the Site reconnaissance.

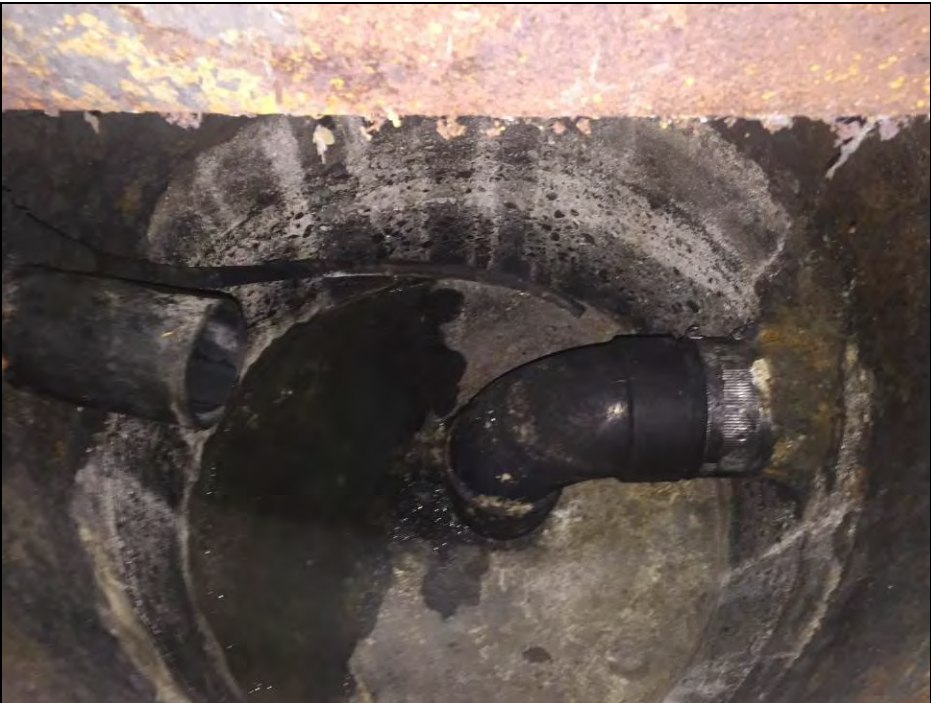
Photograph No. 11

Date Taken: October 6, 2016	
Description: The sump located in the northeastern portion of the Site building, observed to contain a small amount of oily water.	
Looking Towards: N/A
