Phase I Environmental Site Assessment  
5155 Mississauga Rd., Mississauga, ON

Project 15\*4249 BRUCE A. BROWN ASSOCIATES LIMITED  
Consultants in the Environmental & Applied Earth Sciences

Re: Phase I Environmental Site Assessment Update  
5155 Mississauga Road, Mississauga, ON

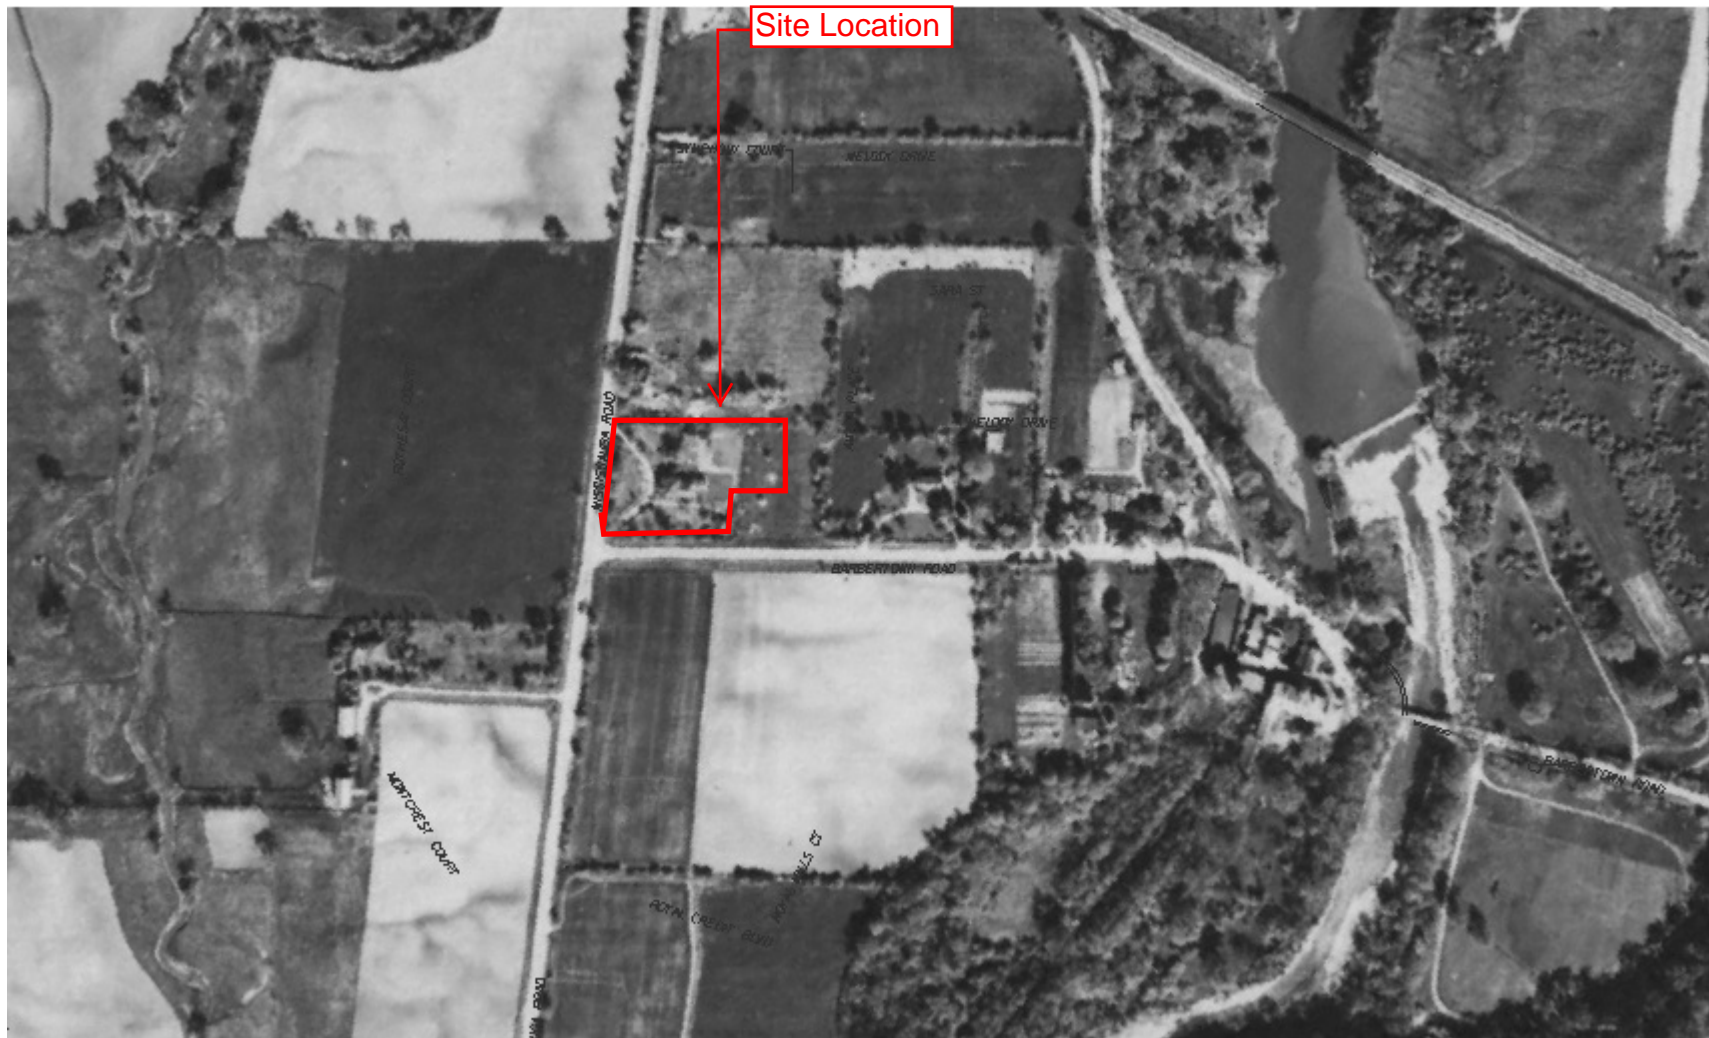
Historical Air Photo: 1954

The earliest available photograph from 1954 shows the Barber House with a small addition on the north side, surrounded by agricultural fields on three sides and another vintage house (the Robert Barber House) to the east. The rail line to the flour mill was in place and Barbertown Road crossed the Credit River east of the mill. A dam was located about 200m upstream from the mill and a mill race with standing water extended towards the mill site. The CP rail river crossing is noted in the upper left side of the photograph.

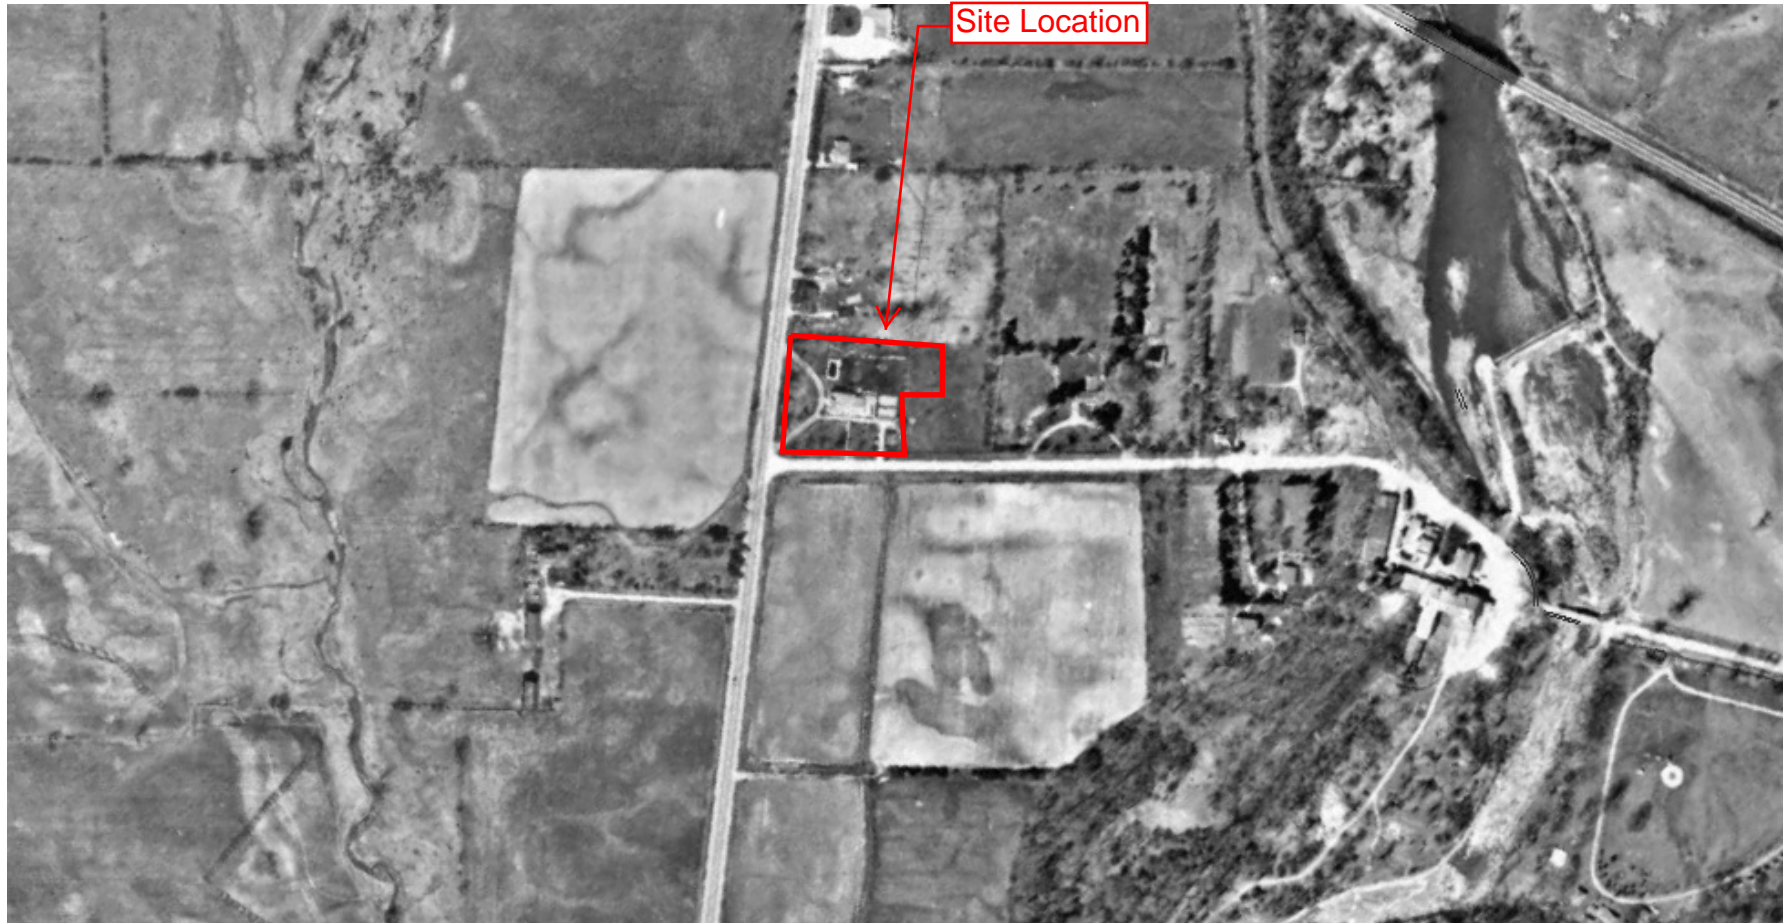
Historical Air Photo: 1966

No changes were noted in the 1966 photo, except for the addition of two small detached residences immediately to the north of Barber House. The dam and Barbertown bridge remained in place. In a 1980 photograph, the only difference from previous images is the dam has been breached in the centre and the Credit River flows in a middle channel. The Barbertown bridge is still in place.

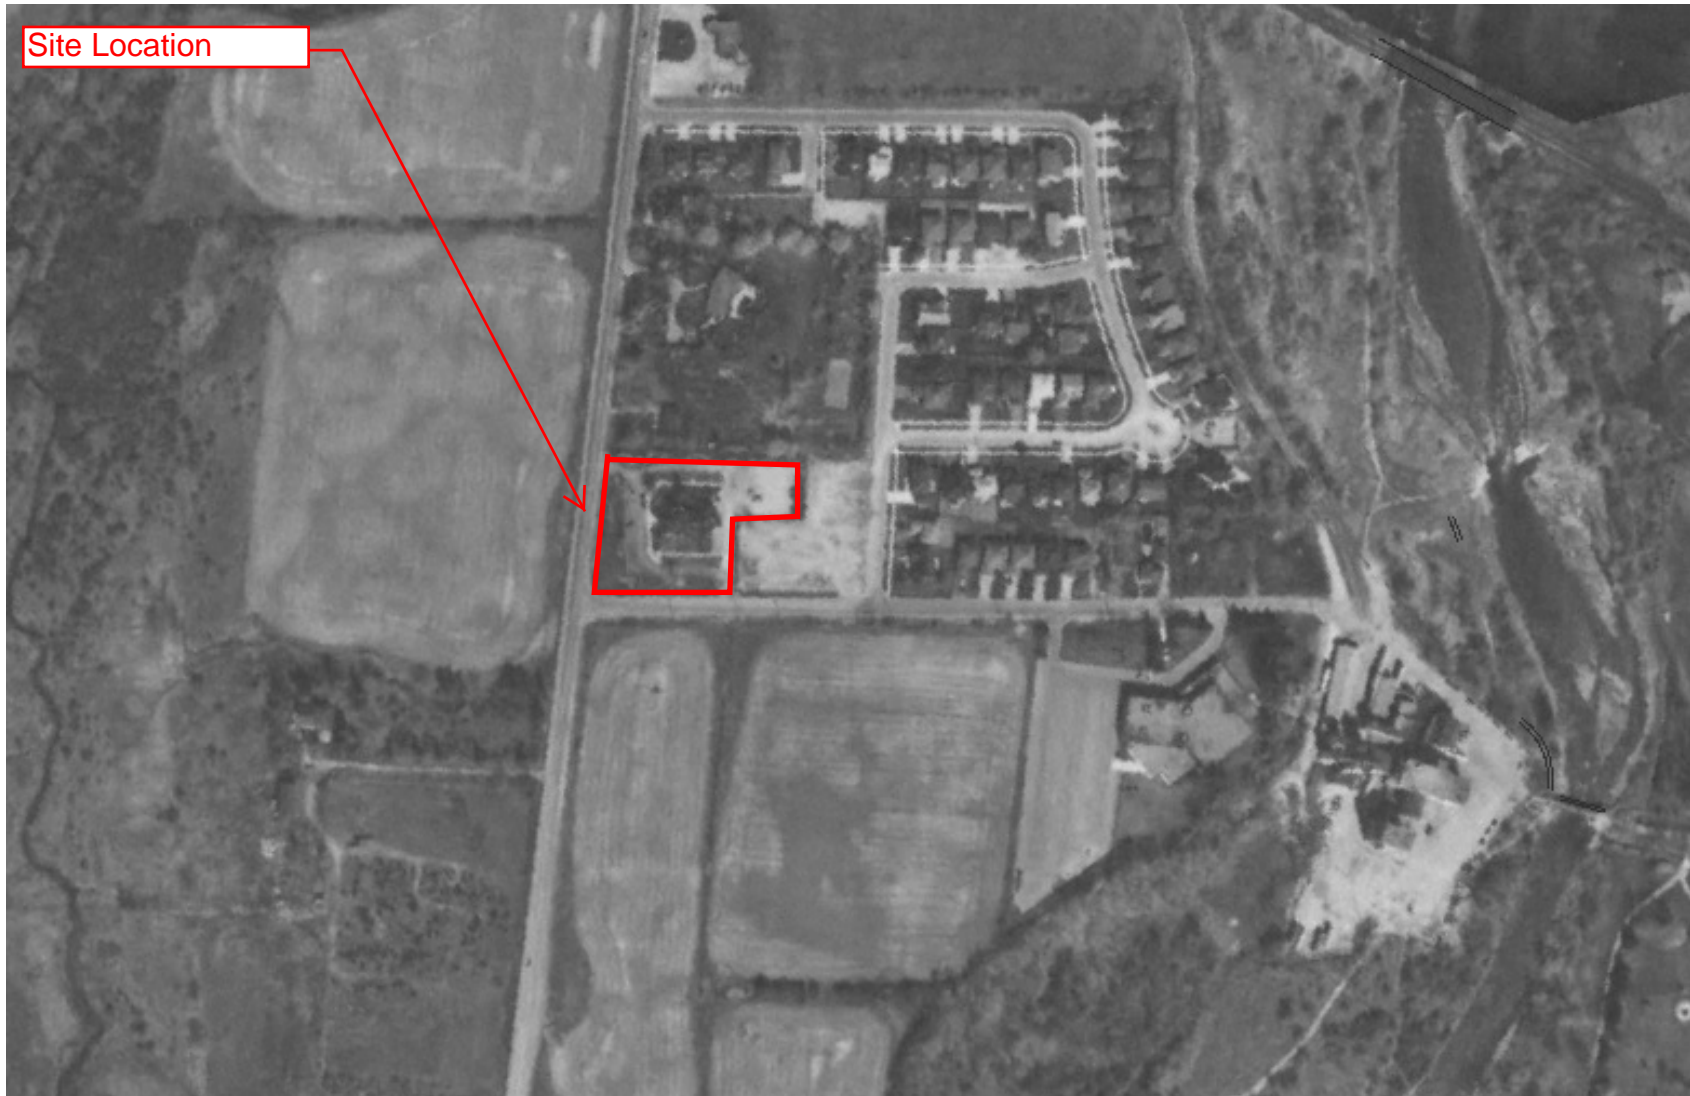
Historical Air Photo: 1985

A 1985 photograph shows the former Robert Barber property redeveloped with single family homes on Amana Place and Melody Drive. What is now the rear parking lot was graded flat and is free of vegetation as well as lands to the west and south of it. There is still no redevelopment to the south across Mississauga Road.

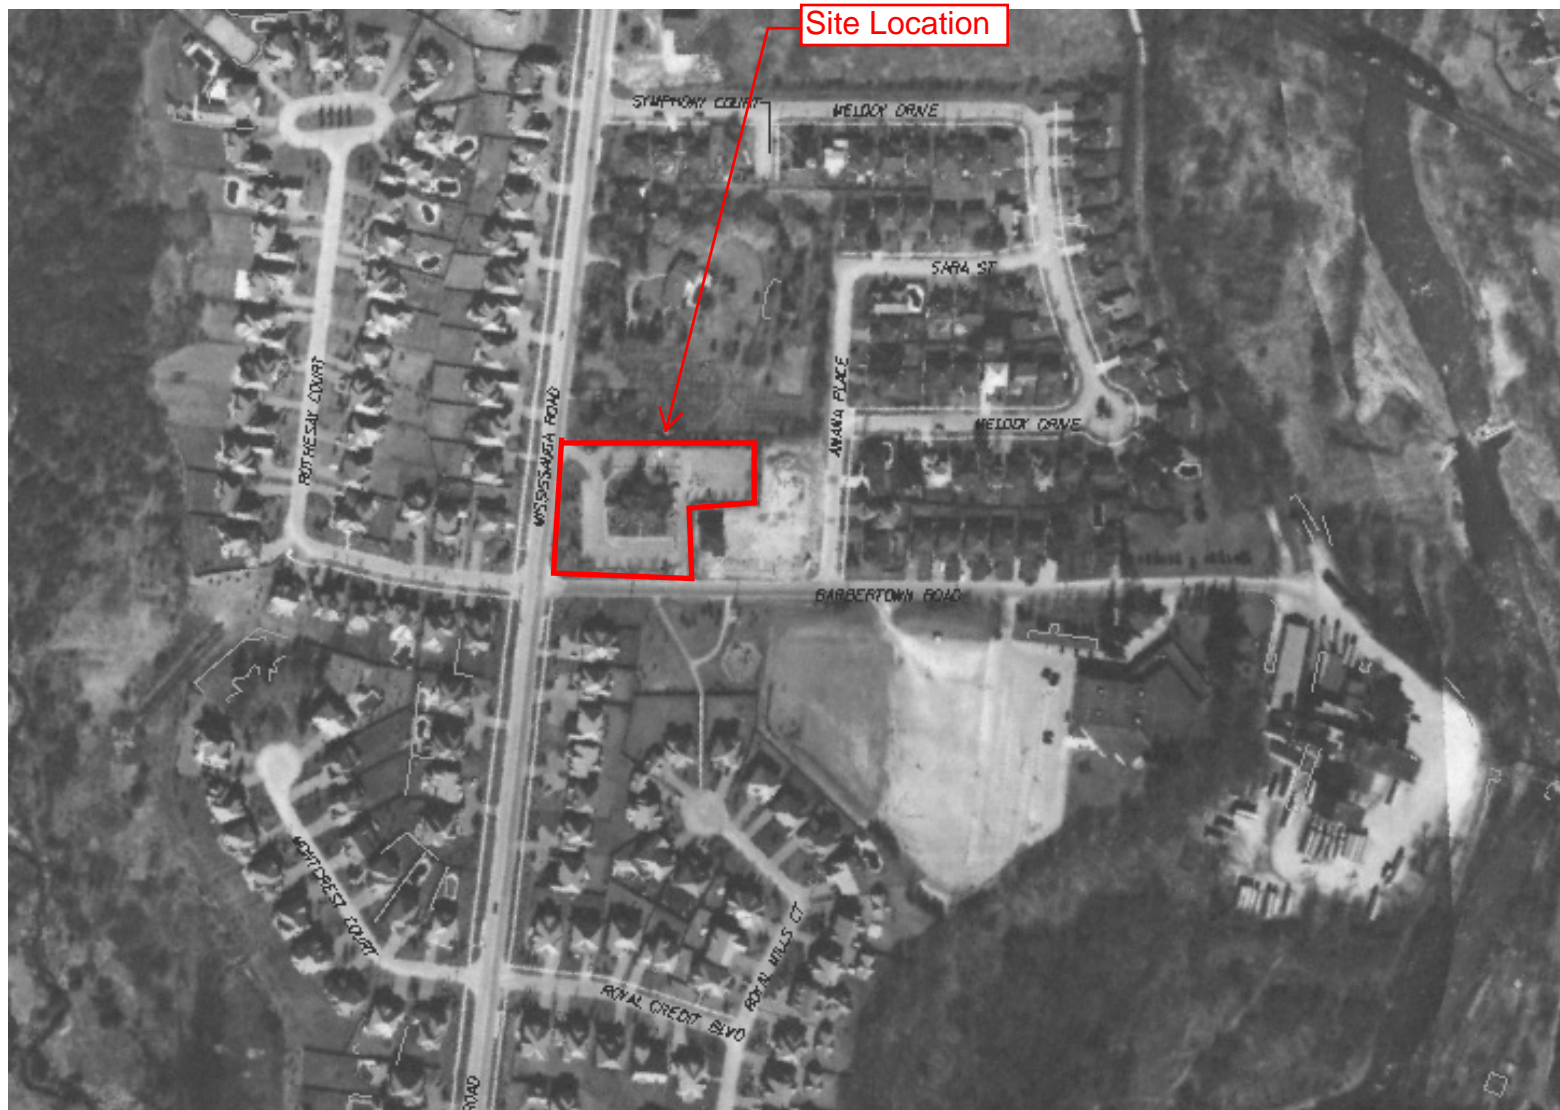
Historical Air Photo: 1995

A 1995 photograph shows one single family house constructed to the immediate east on Barbertown Road and the balance of lands east to Amana still vacant. Residential subdivisions with single family homes are built out to the south and across Mississauga Road. The parking area for the community church has been graded out. A

graveled parking lot and the original church building have been constructed. There is considerable expansion of the mill building complex and many bulk carrier trailers are parked surrounding the site.

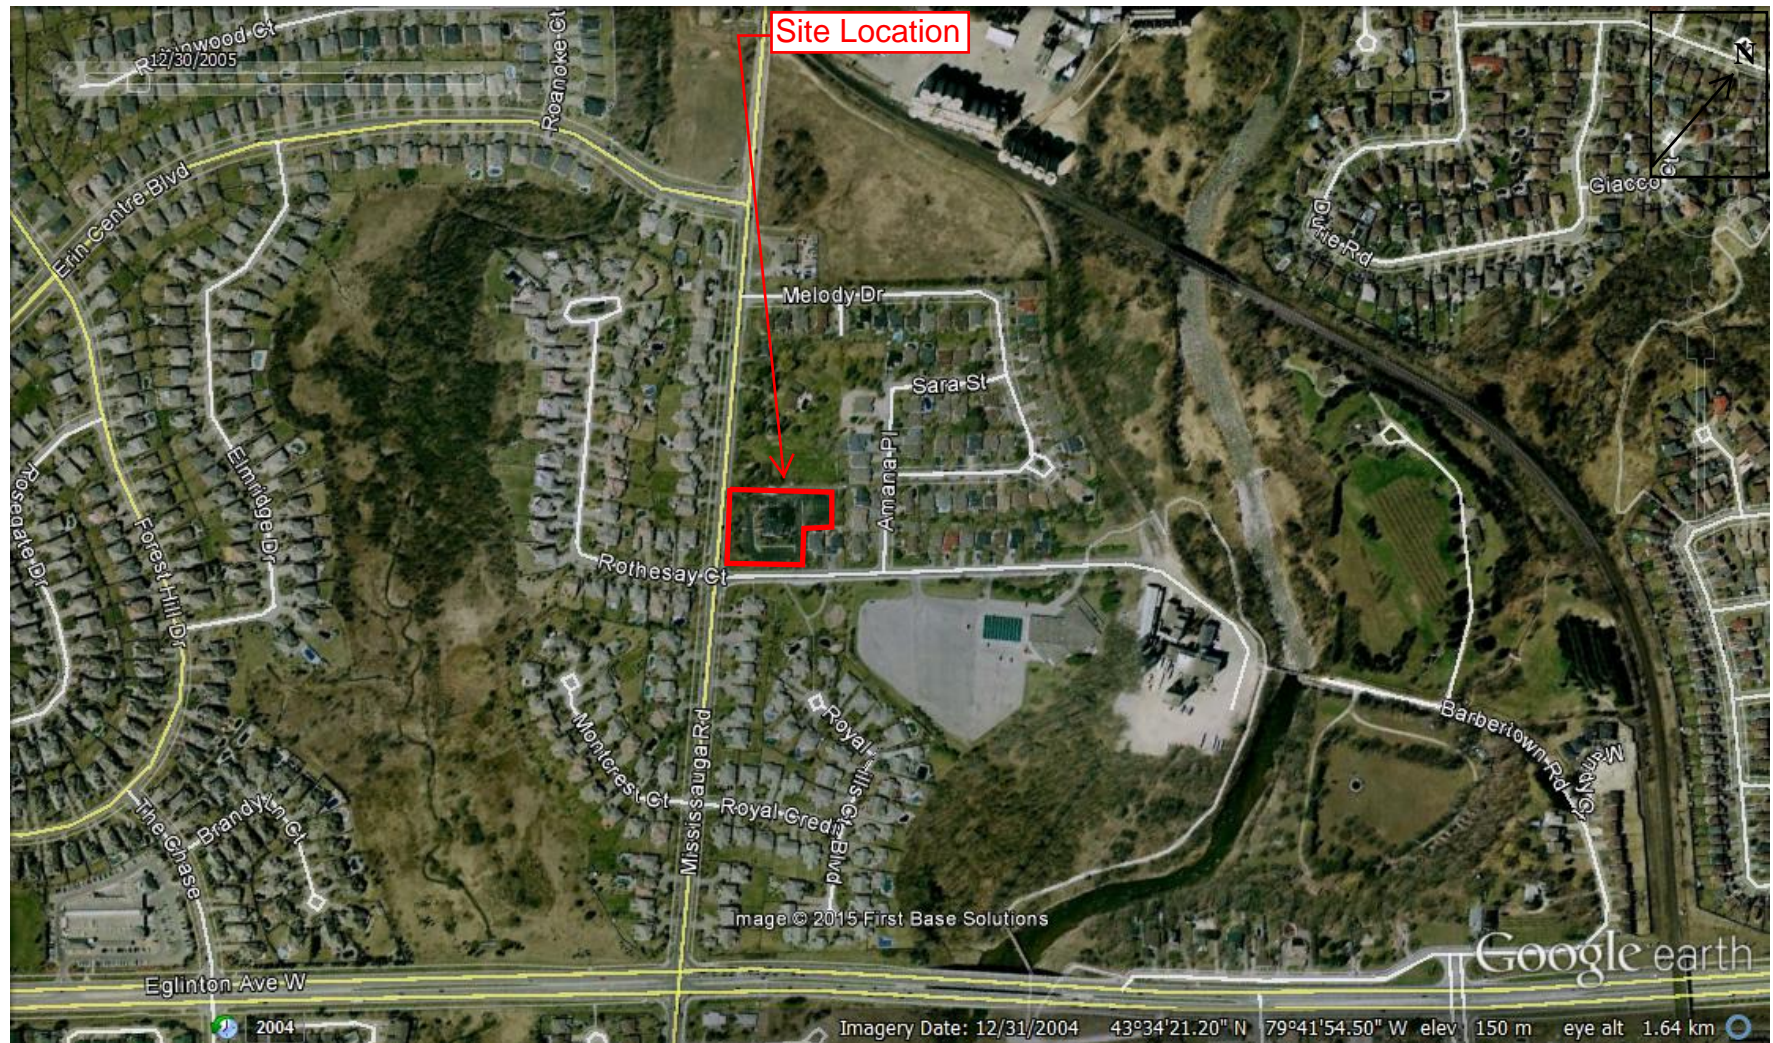
Historical Air Photo: 2004

By December 2004, the remaining surrounding detached residences have been infilled. The community church to the southeast has been expanded and the north addition to the restaurant completed. By 2010, there is improved paved parking surrounding the restaurant and some landscaping features on the north side. No changes are noted in the May 2015 image.

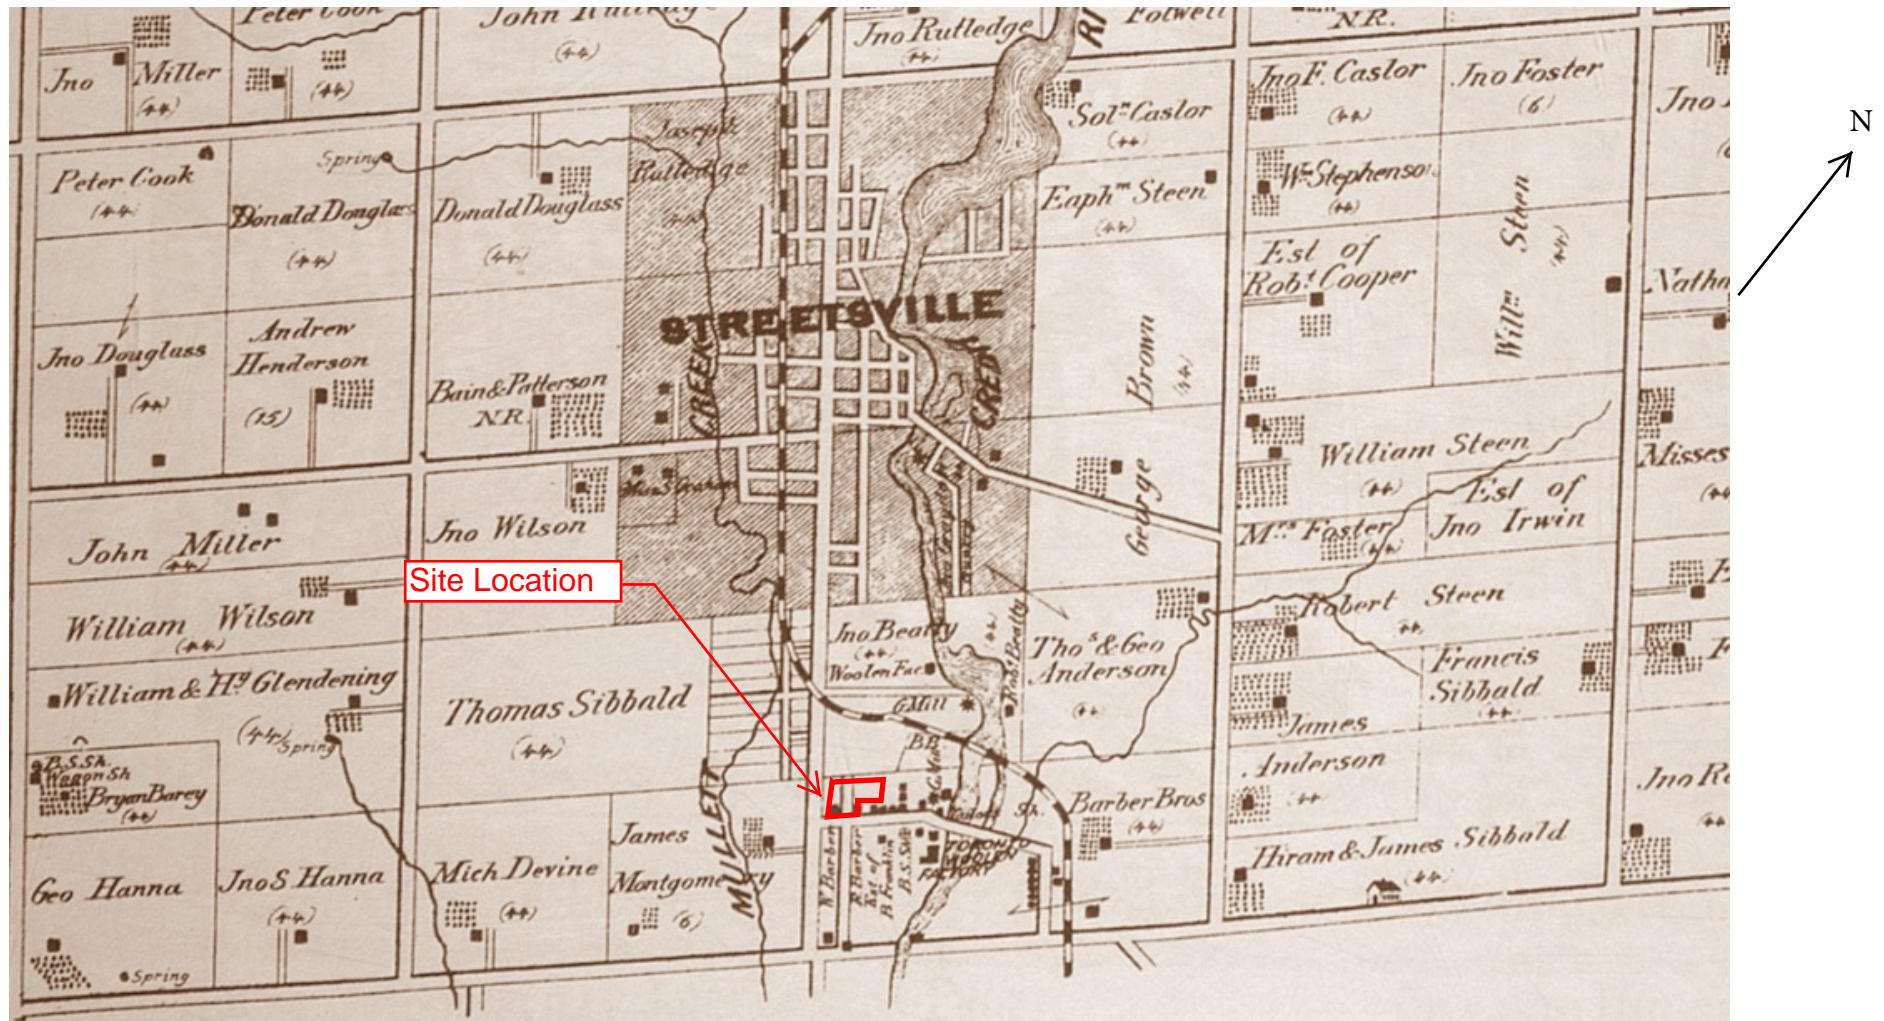
County of Peel: North Toronto Township - 1877

In addition to Pleistocene geological mapping, mapping records consulted during this evaluation were the 1877 Peel County Atlas Map, and the City of Mississauga Natural Areas Survey map. Mapping from 1877, found in **Appendix E**, shows the phase one lands as being rural and agricultural as part of a larger farm holding. The lands were generally cleared and planted by the early 1800s. The Natural Areas map indicates the Phase One property lies in between two natural areas. The site is itself is located in a built area.

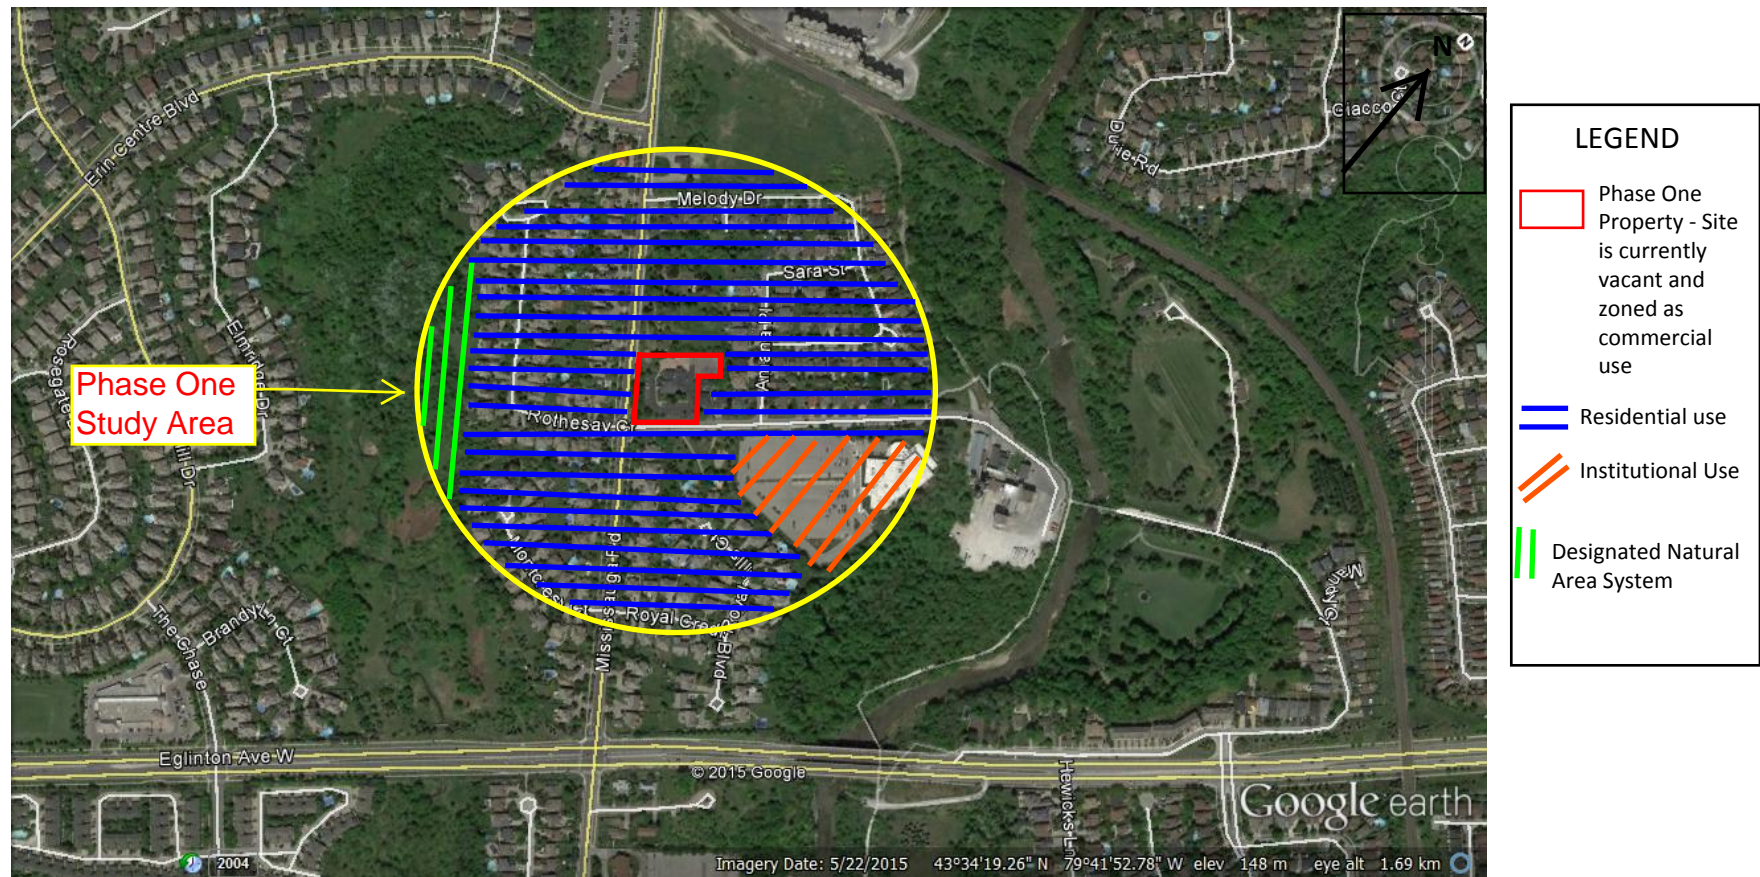
Figure 1: Phase One Conceptual Site Model

No potentially contaminating activities were identified within the phase one study area and no areas of potential environmental concern were identified on the phase one property. Adjacent uses are low density residential. An institutional use is noted to the southeast, where a church is located beyond the study area. There is no heavy industry or other potentially contaminating activities located within the phase one study area.
