**PHASE ONE ENVIRONMENTAL SITE ASSESSMENT  
RESIDENTIAL PROPERTIES  
2476 AND 2482 CONFEDERATION PARKWAY  
MISSISSAUGA, ONTARIO  
L5B 1R9**

# Phase One Environmental Site Assessment

Project No.: TPB188171  
February 2020

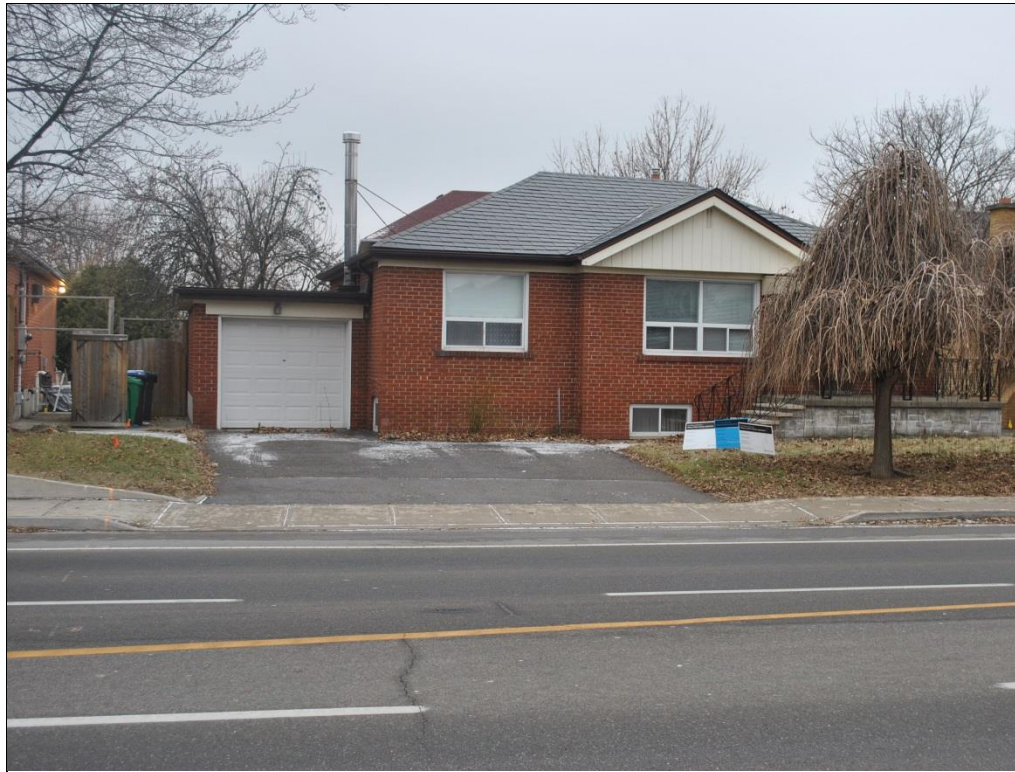
**Photo 1:**

A view of the residential dwelling with attached garage at 2476 Confederation Parkway.

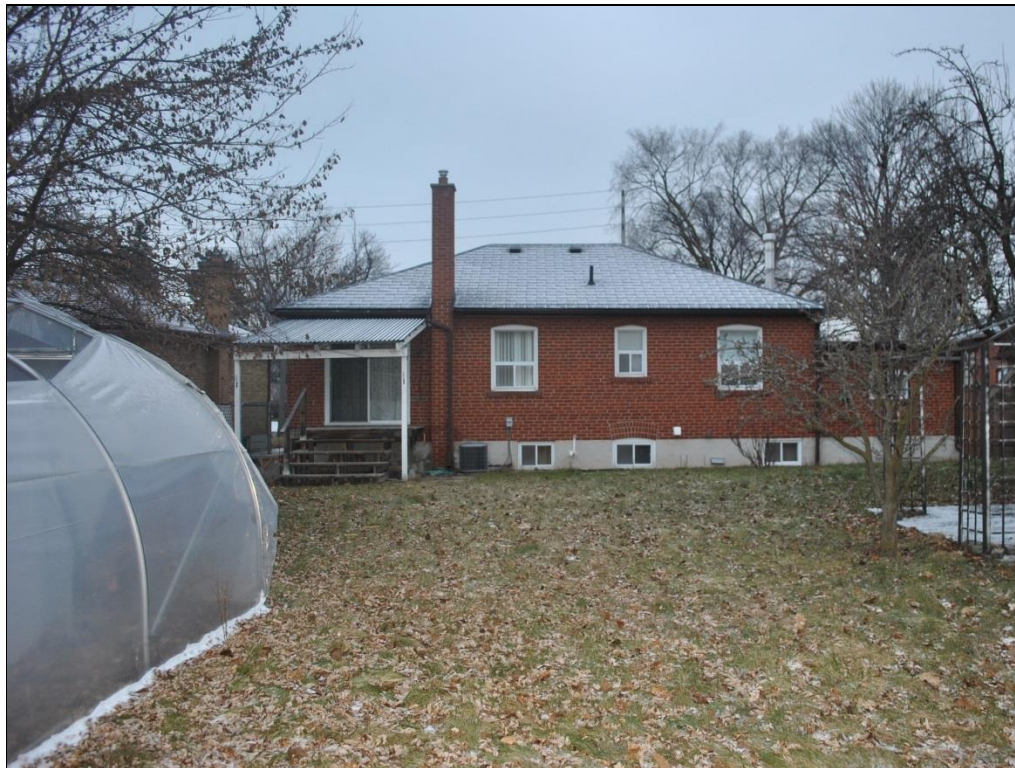
**Photo 2:**

A view of the rear side of the residential dwelling at 2476 Confederation Parkway from the southern end of the Phase One Property.

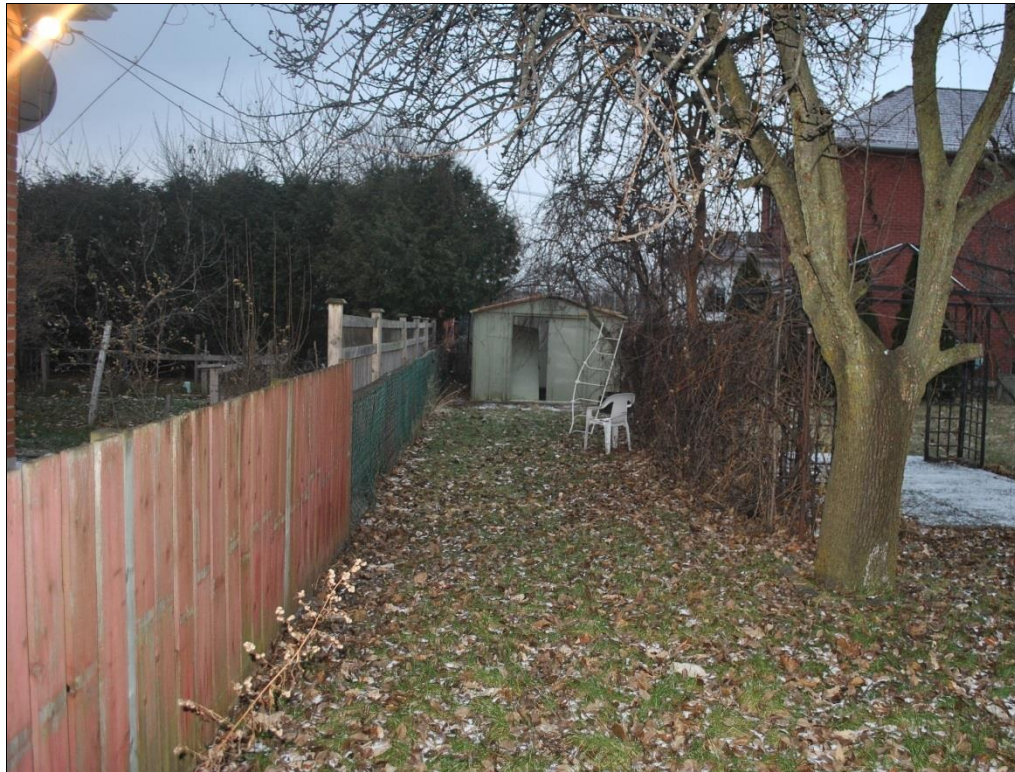
**Photo 3:**

A view of the southeastern boundary of the Phase One Property; in the background is shown a metal shed and on the right side of the photo a gazebo structure mounted on a concrete slab.

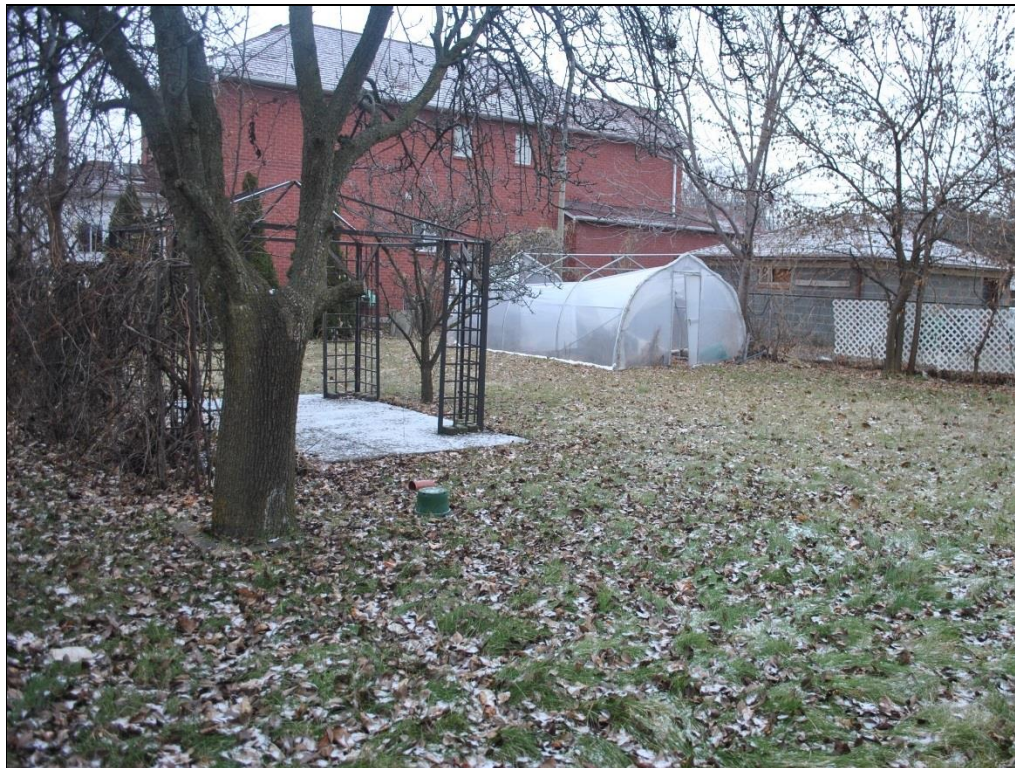
**Photo 4:**

A view of the backyard at 2476 Confederation Parkway. A greenhouse is shown on the center of the photo.

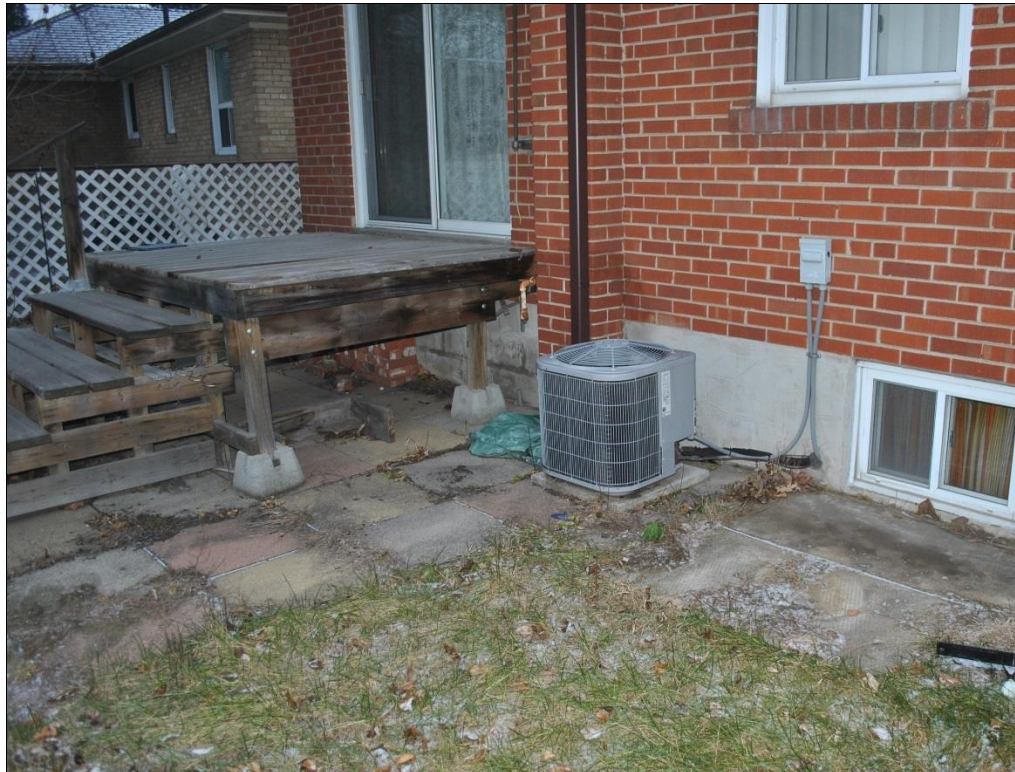
**Photo 5:**

A view of the western corner of the residential dwelling at 2476 Confederation Parkway. Animal feces were observed below the wooden deck.

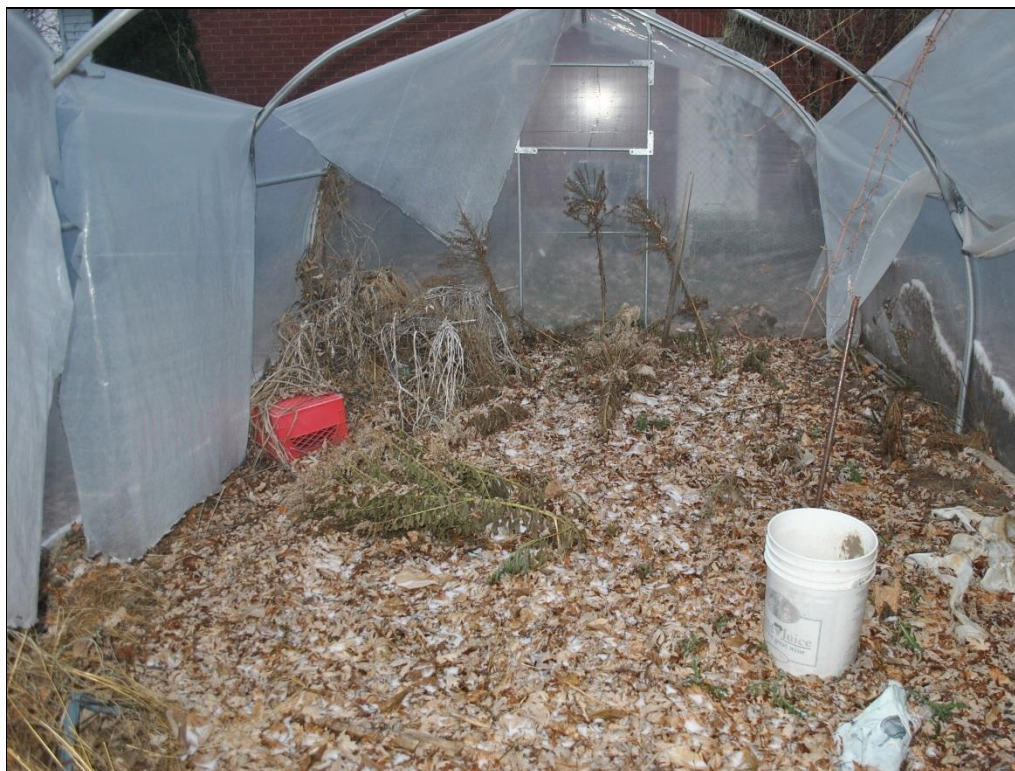
**Photo 6:**

A view of the interior of the greenhouse shown on photo 4.

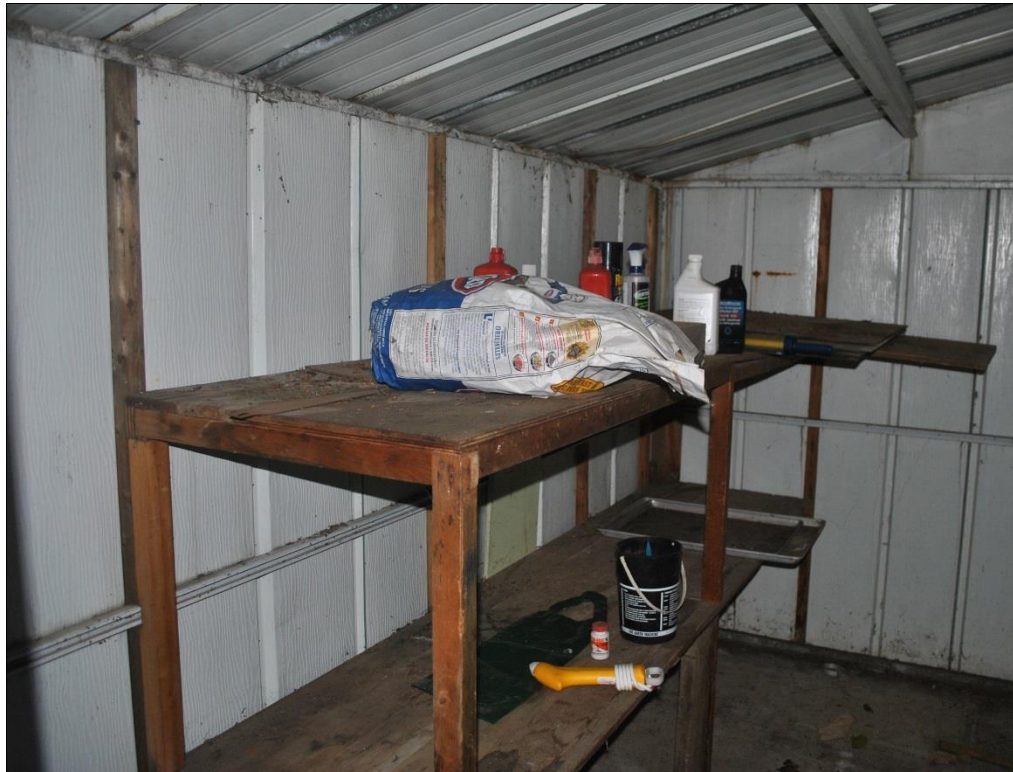
**Photo 7:**

A view of the interior of the shed shown on photo 3. Animal feces were observed on the ground. Domestic quantities of charcoal, pesticides and motor oil were observed on the shelf.

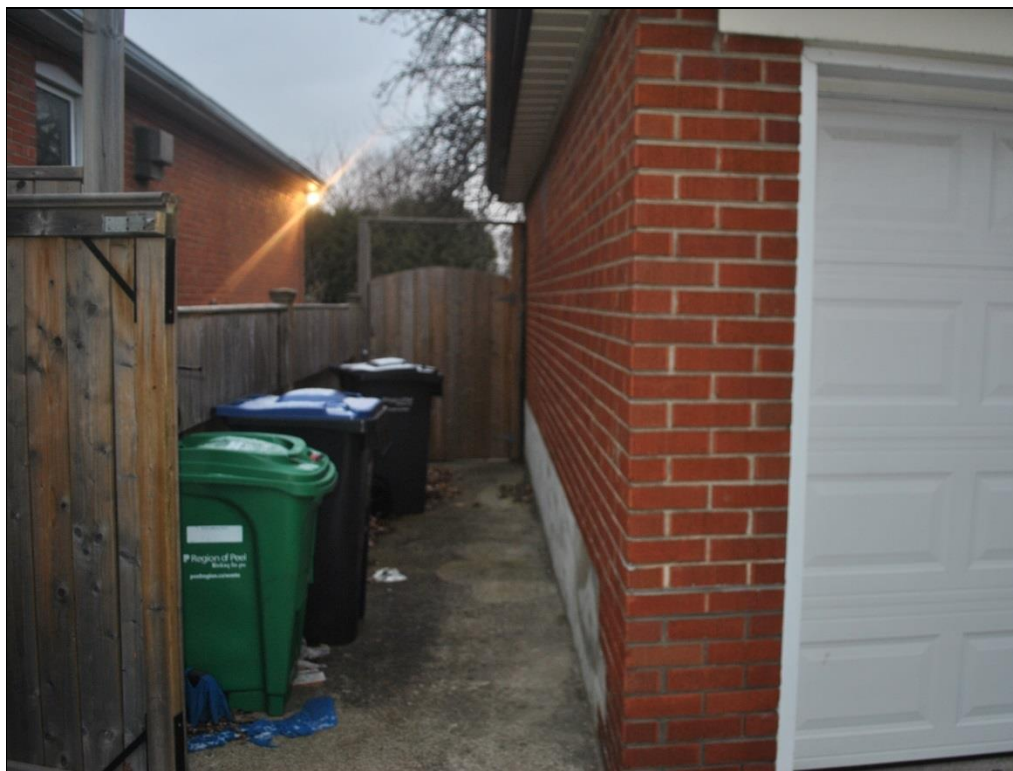
**Photo 8:**

A view of the southeastern end of the Phase One Property, with storage of garbage bin at 2476 Confederation Parkway

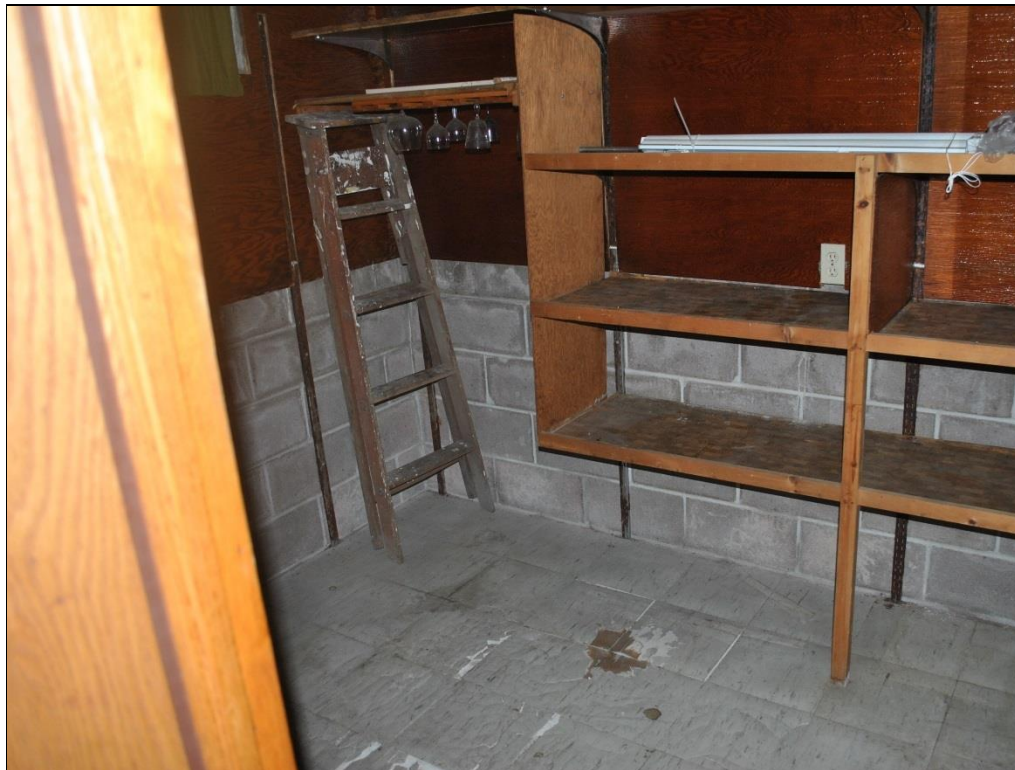
**Photo 12:**

Wood was advised by the site representative that an asbestos survey has not been conducted at the Phase One Property, and that ACMs are not known to be present at the Phase One Property. Based on the date of construction of the Phase One Property buildings (i.e., approximately 1966), ACMs may be present at the Phase One Property as the use of friable ACMs was not discontinued until the early 1990s and the use of non-friable ACMs continues to this date. Suspect ACMs observed as part of the Phase One ESA, included drywall which generally appeared in good condition in the basement of the buildings at

2476 and at 2482 Confederation Parkway; vinyl floor tiles were also observed in the basement of the building at 2476 Confederation Parkway.

A view of one of the rooms in the basement of the residential dwelling at 2476 Confederation Parkway. Vinyl tiles are shown in the floor, some of which were broken.

- A Designated Substances Survey (DSS) is required if future repair, renovation or demolition activities are planned which could affect the pipe insulation, vinyl floor tiles, ceiling tiles and stucco walls and roof. A DSS is required to fulfil the Owner’s requirements under Section 30 of the Ontario Occupational Health and Safety Act, (the OHSA), Revised Statutes of Ontario 1990, (as amended). The building owner must provide the DSS report to all contractors working on the Property. Subsequently, all contractors must furnish the DSS report to their subcontractors.

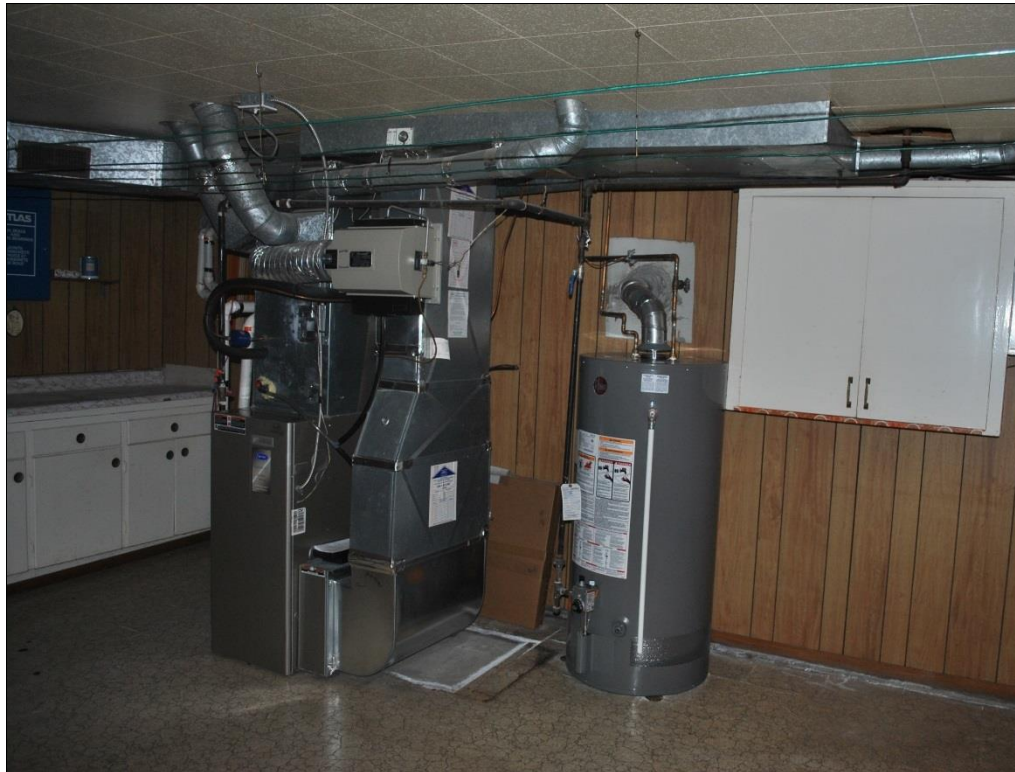
**Photo 13:**

A view of the natural gas furnace and hot water tank in the basement of the residential dwelling at 2476 Confederation Parkway. Vinyl tiles are shown in the floor.

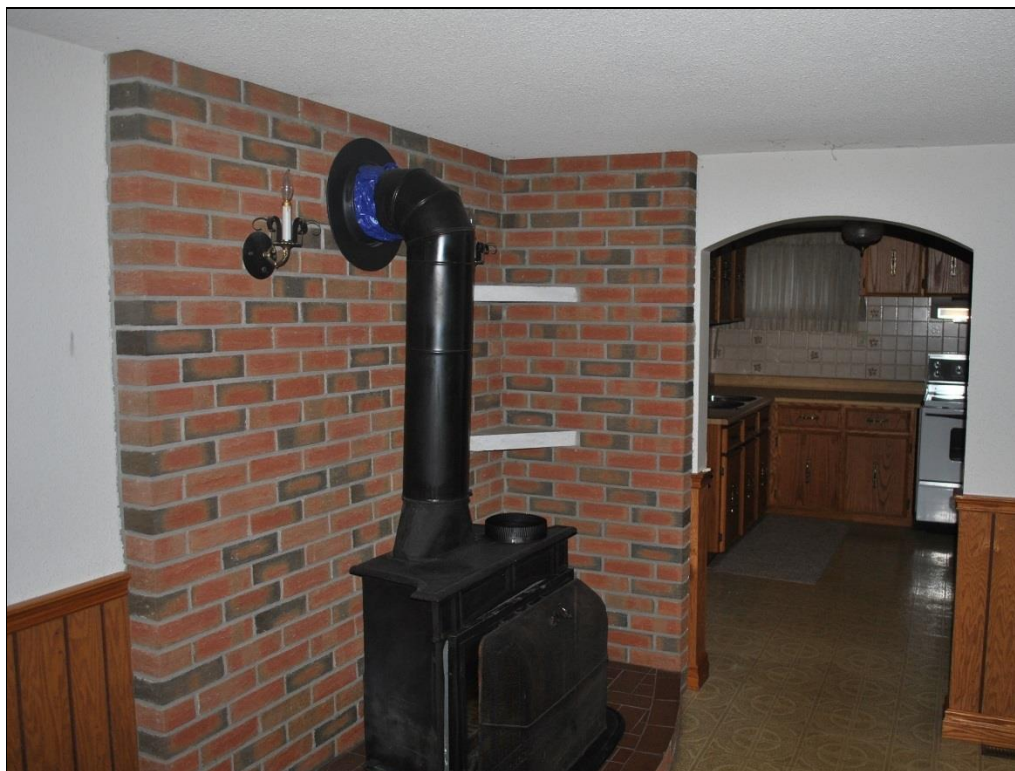
**Photo 14:**

View of kitchen and wood burning stove in basement of the residential dwelling at 2476 Confederation Parkway.

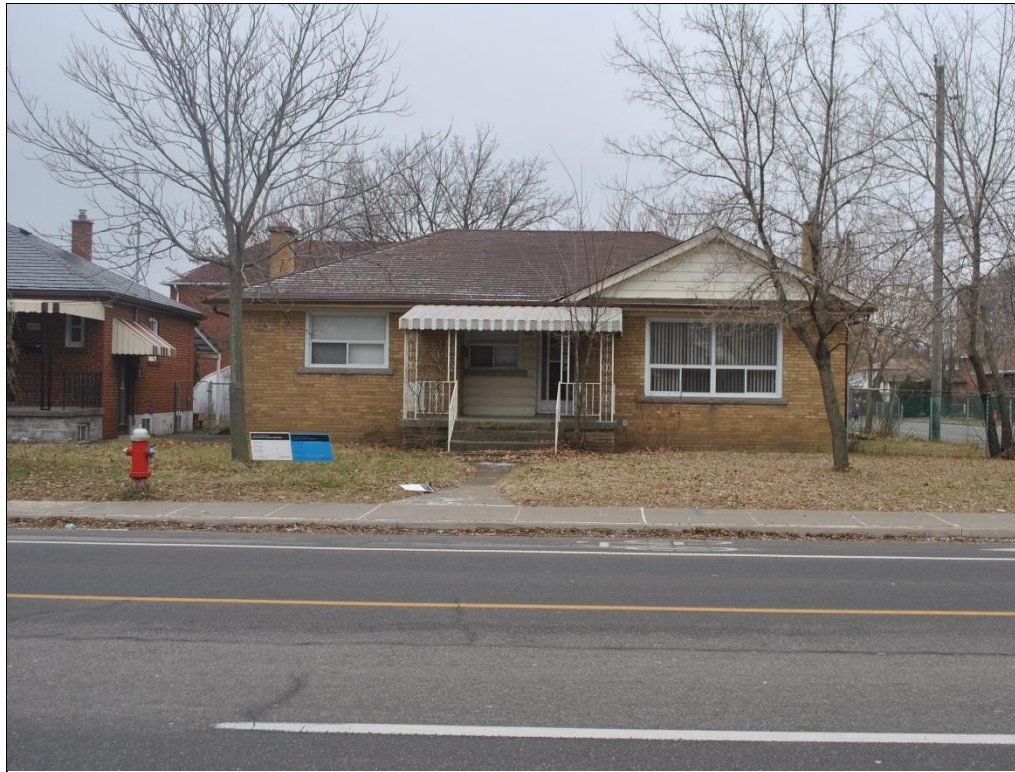
**Photo 15:**

A view of the front façade of the residential dwelling located at 2482 Confederation Parkway. Inferred hydroelectric overhead cable is shown at the northern corner of the dwelling.

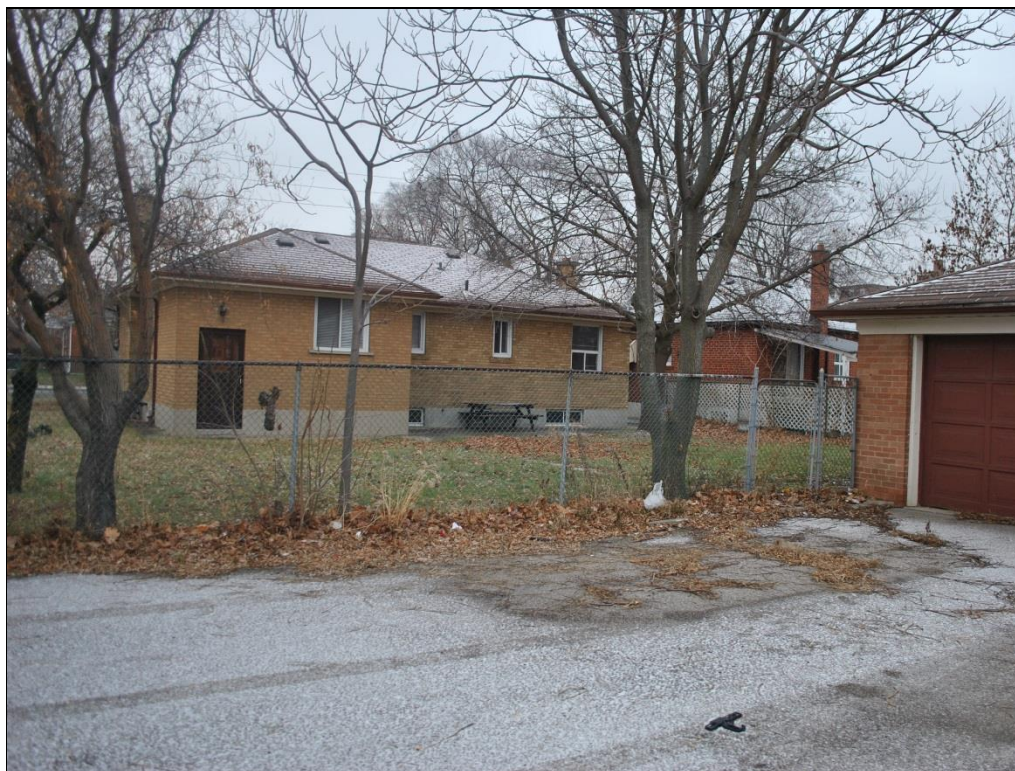
**Photo 16:**

A view of the southwestern façade and backyard of the residential dwelling located at 2482 Confederation Parkway. On the right end of the photo is shown the detached garage of the parcel.

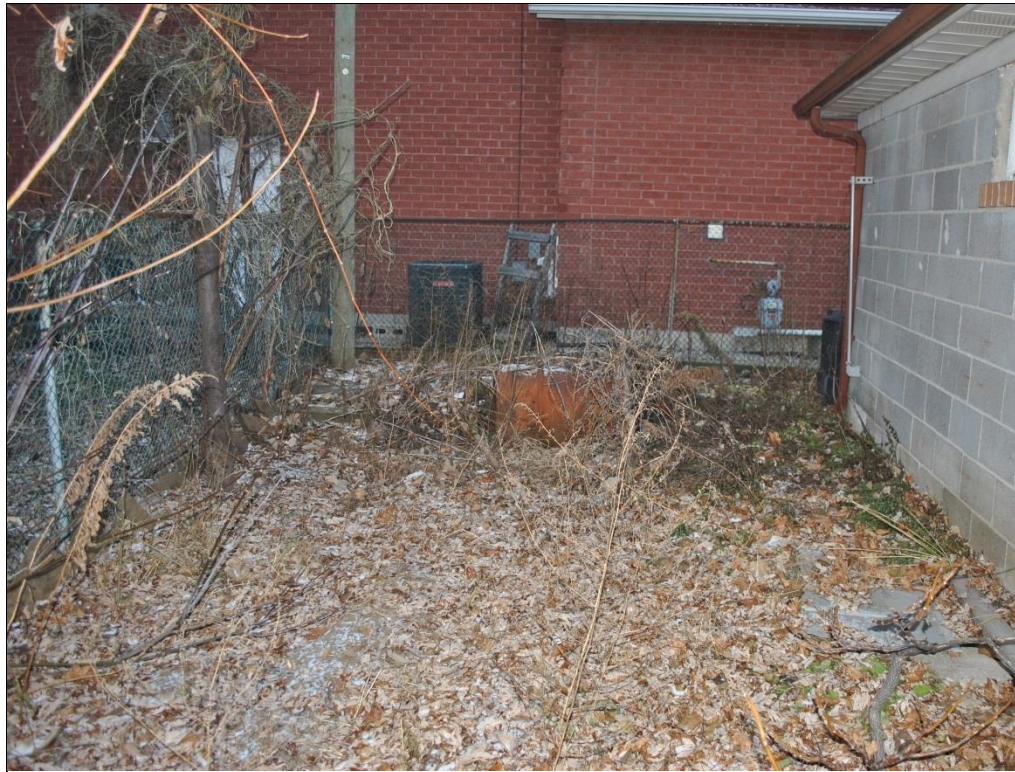
**Photo 17:**

During the site reconnaissance Wood did not observe any amounts of debris, with the exception of a metal drum likely containing ashes, a plastic tank for compost, wood and metal sheet observed along the western external wall of the garage located at 2482 Confederation Parkway; and an abandoned garden green house, which cover was partially shredded poly tarp, at 2476 Confederation Parkway.

A view of the southern end of 2482 Confederation Parkway. A rusty drum containing ashes is shown in the center of the photo.

- The debris identified at the Phase One Property should be removed and disposed as per the applicable regulations;
- Based on the date of construction of the building (i.e., approximately 1966), friable Asbestos Containing Materials (ACMs) may be present in drywall compounds, floor tiles and/or behind walls and ceilings. A comprehensive asbestos survey is recommended in order to comply with Ontario Regulation 278/05 and Ontario Regulation 279/05. An asbestos management plan will be required for any confirmed friable ACM which is not abated or has not been tested to be deemed non asbestos;

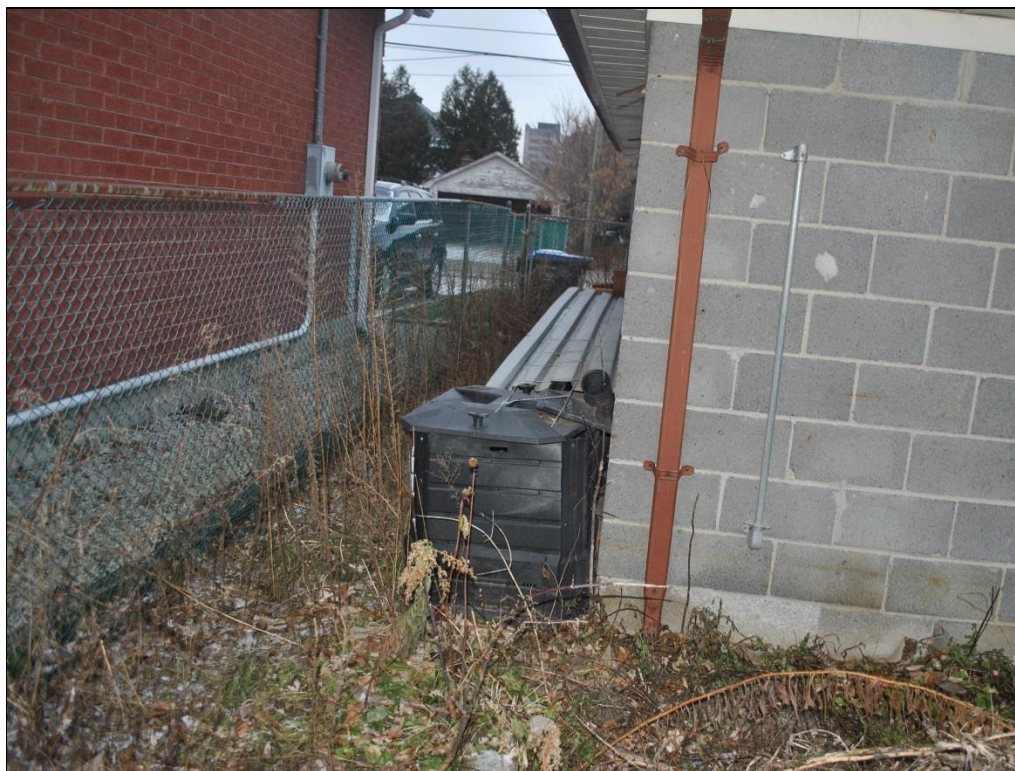
**Photo 18:**

2482 Confederation Parkway included a backyard consisting of a landscaped area and inferred garden. Some miscellaneous materials, including a metal drum likely containing ashes, a plastic tank for compost, wood and metal sheet were observed along the western external wall of the garage.

Miscellaneous materials, including a plastic tank for compost, metal and wooden sheet are shown along the western exterior wall of the detached garage at 2482 Confederation Parkway

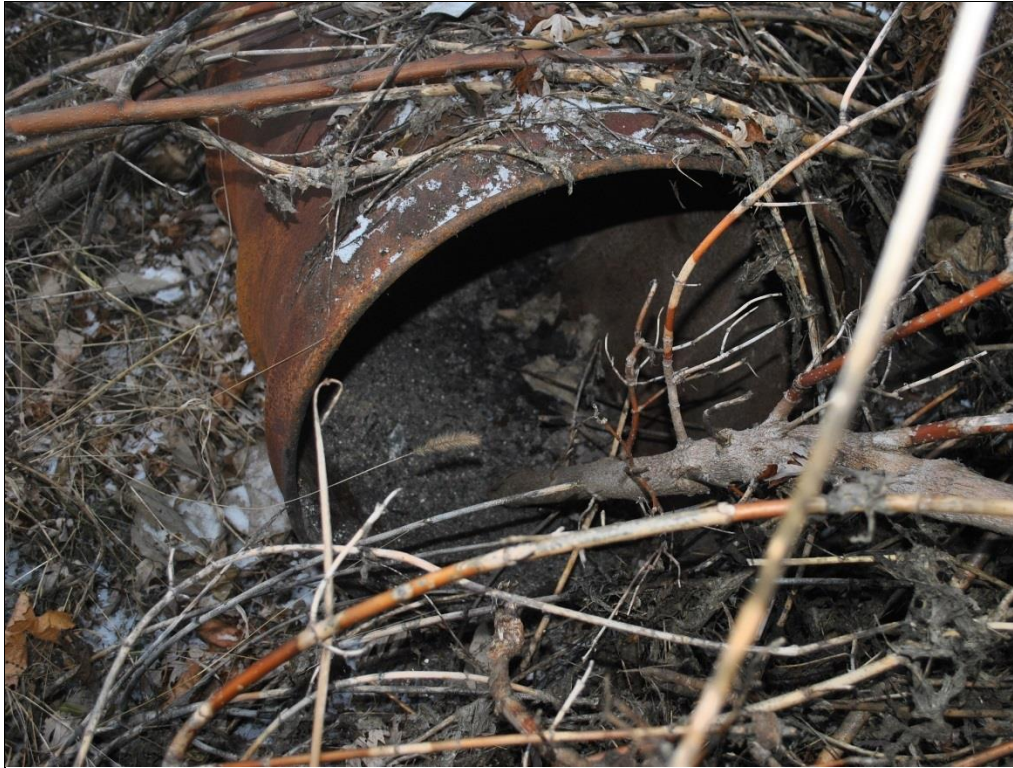
**Photo 19:**

A close caption of the drum with ashes shown on photo 17

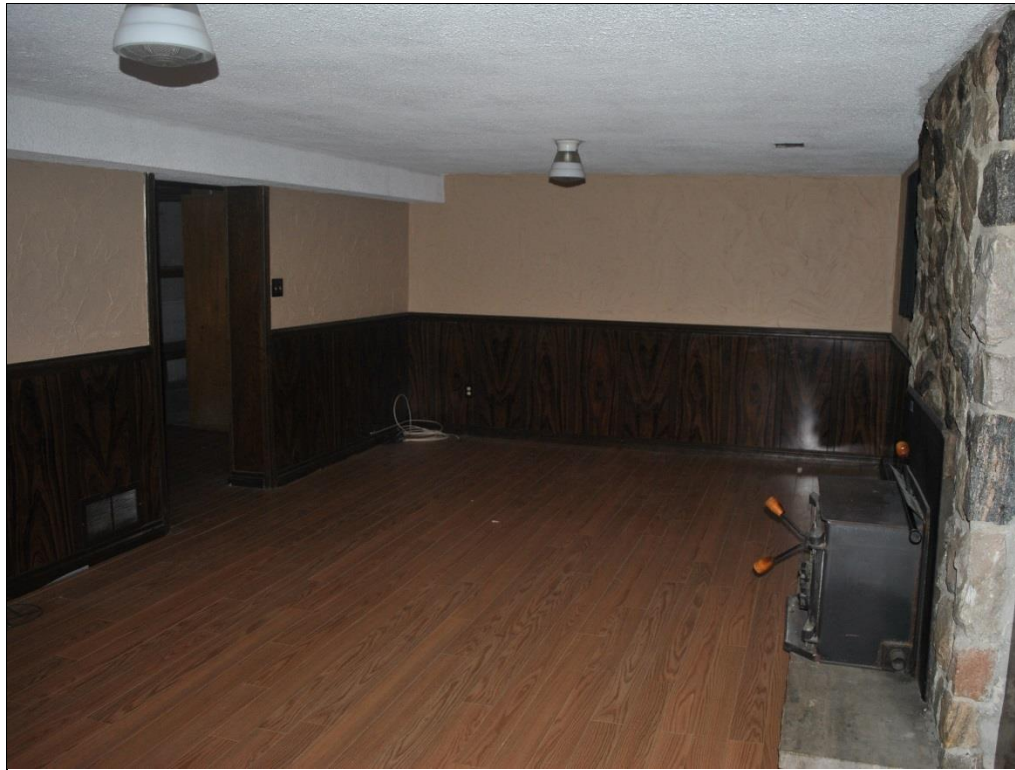
**Photo 25:**

A view of a room in the basement of the residential dwelling at 2482 Confederation Parkway. On the right side of the photo is shown a stove

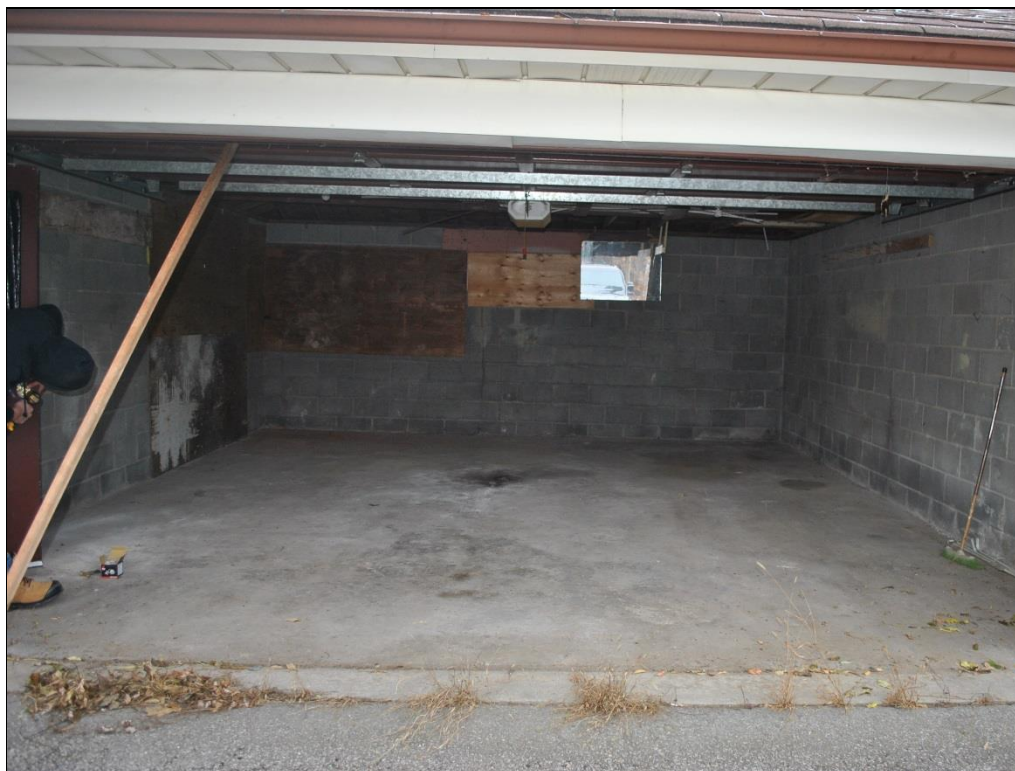
**Photo 26:**

A view of the interior of the detached garage at 2482 Confederation Parkway.
