PHASE ONE ENVIRONMENTAL SITE ASSESSMENT
958 - 960 EAST AVENUE,
MISSISSAUGA, ONTARIO
THE REGION OF PEEL

PROJECT NO.: 181-11306-00
DATE: OCTOBER 2018

Subject: Phase One Environmental Site Assessment

958 – 960 East Avenue, Mississauga, Ontario

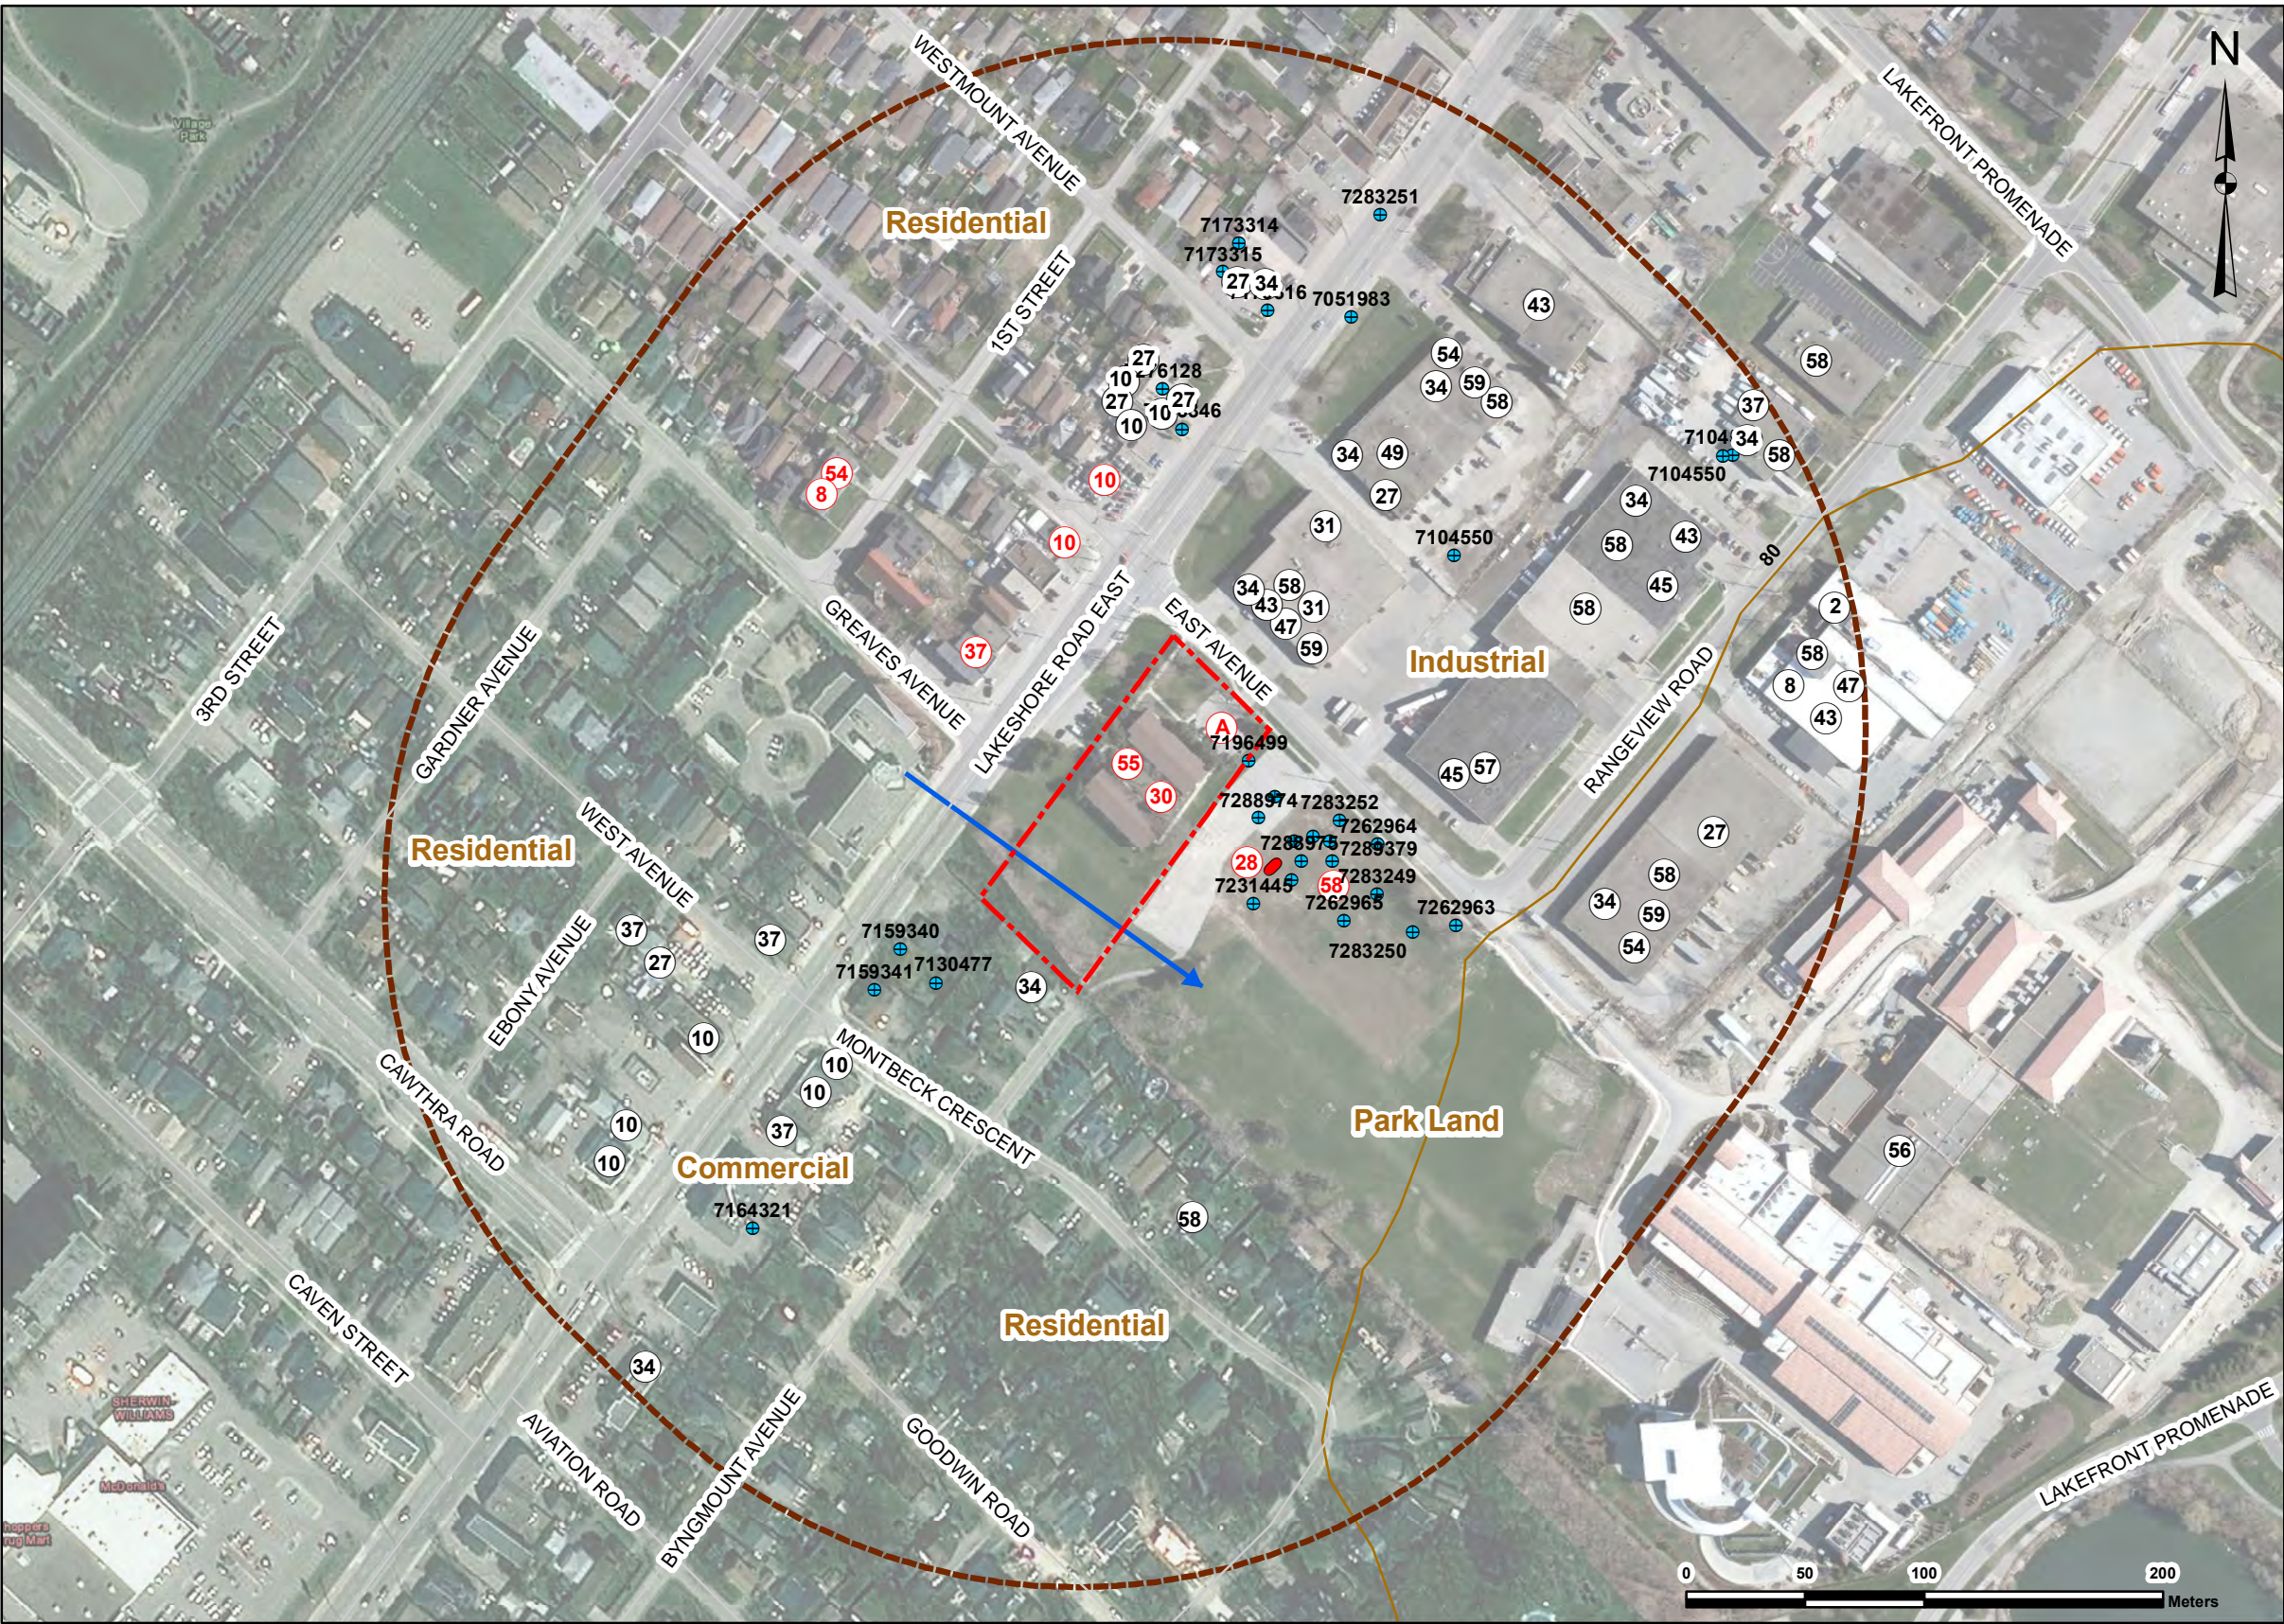
POTENTIALLY CONTAMINATING ACTIVITIES (PCAs)

- ⑳ PCA27 - Garages and Maintenance and Repair of Railcars, Marine Vehicles and Aviation Vehicles
- ㉔ PCA28 - Gasoline and Associated Products Storage in Fixed Tanks

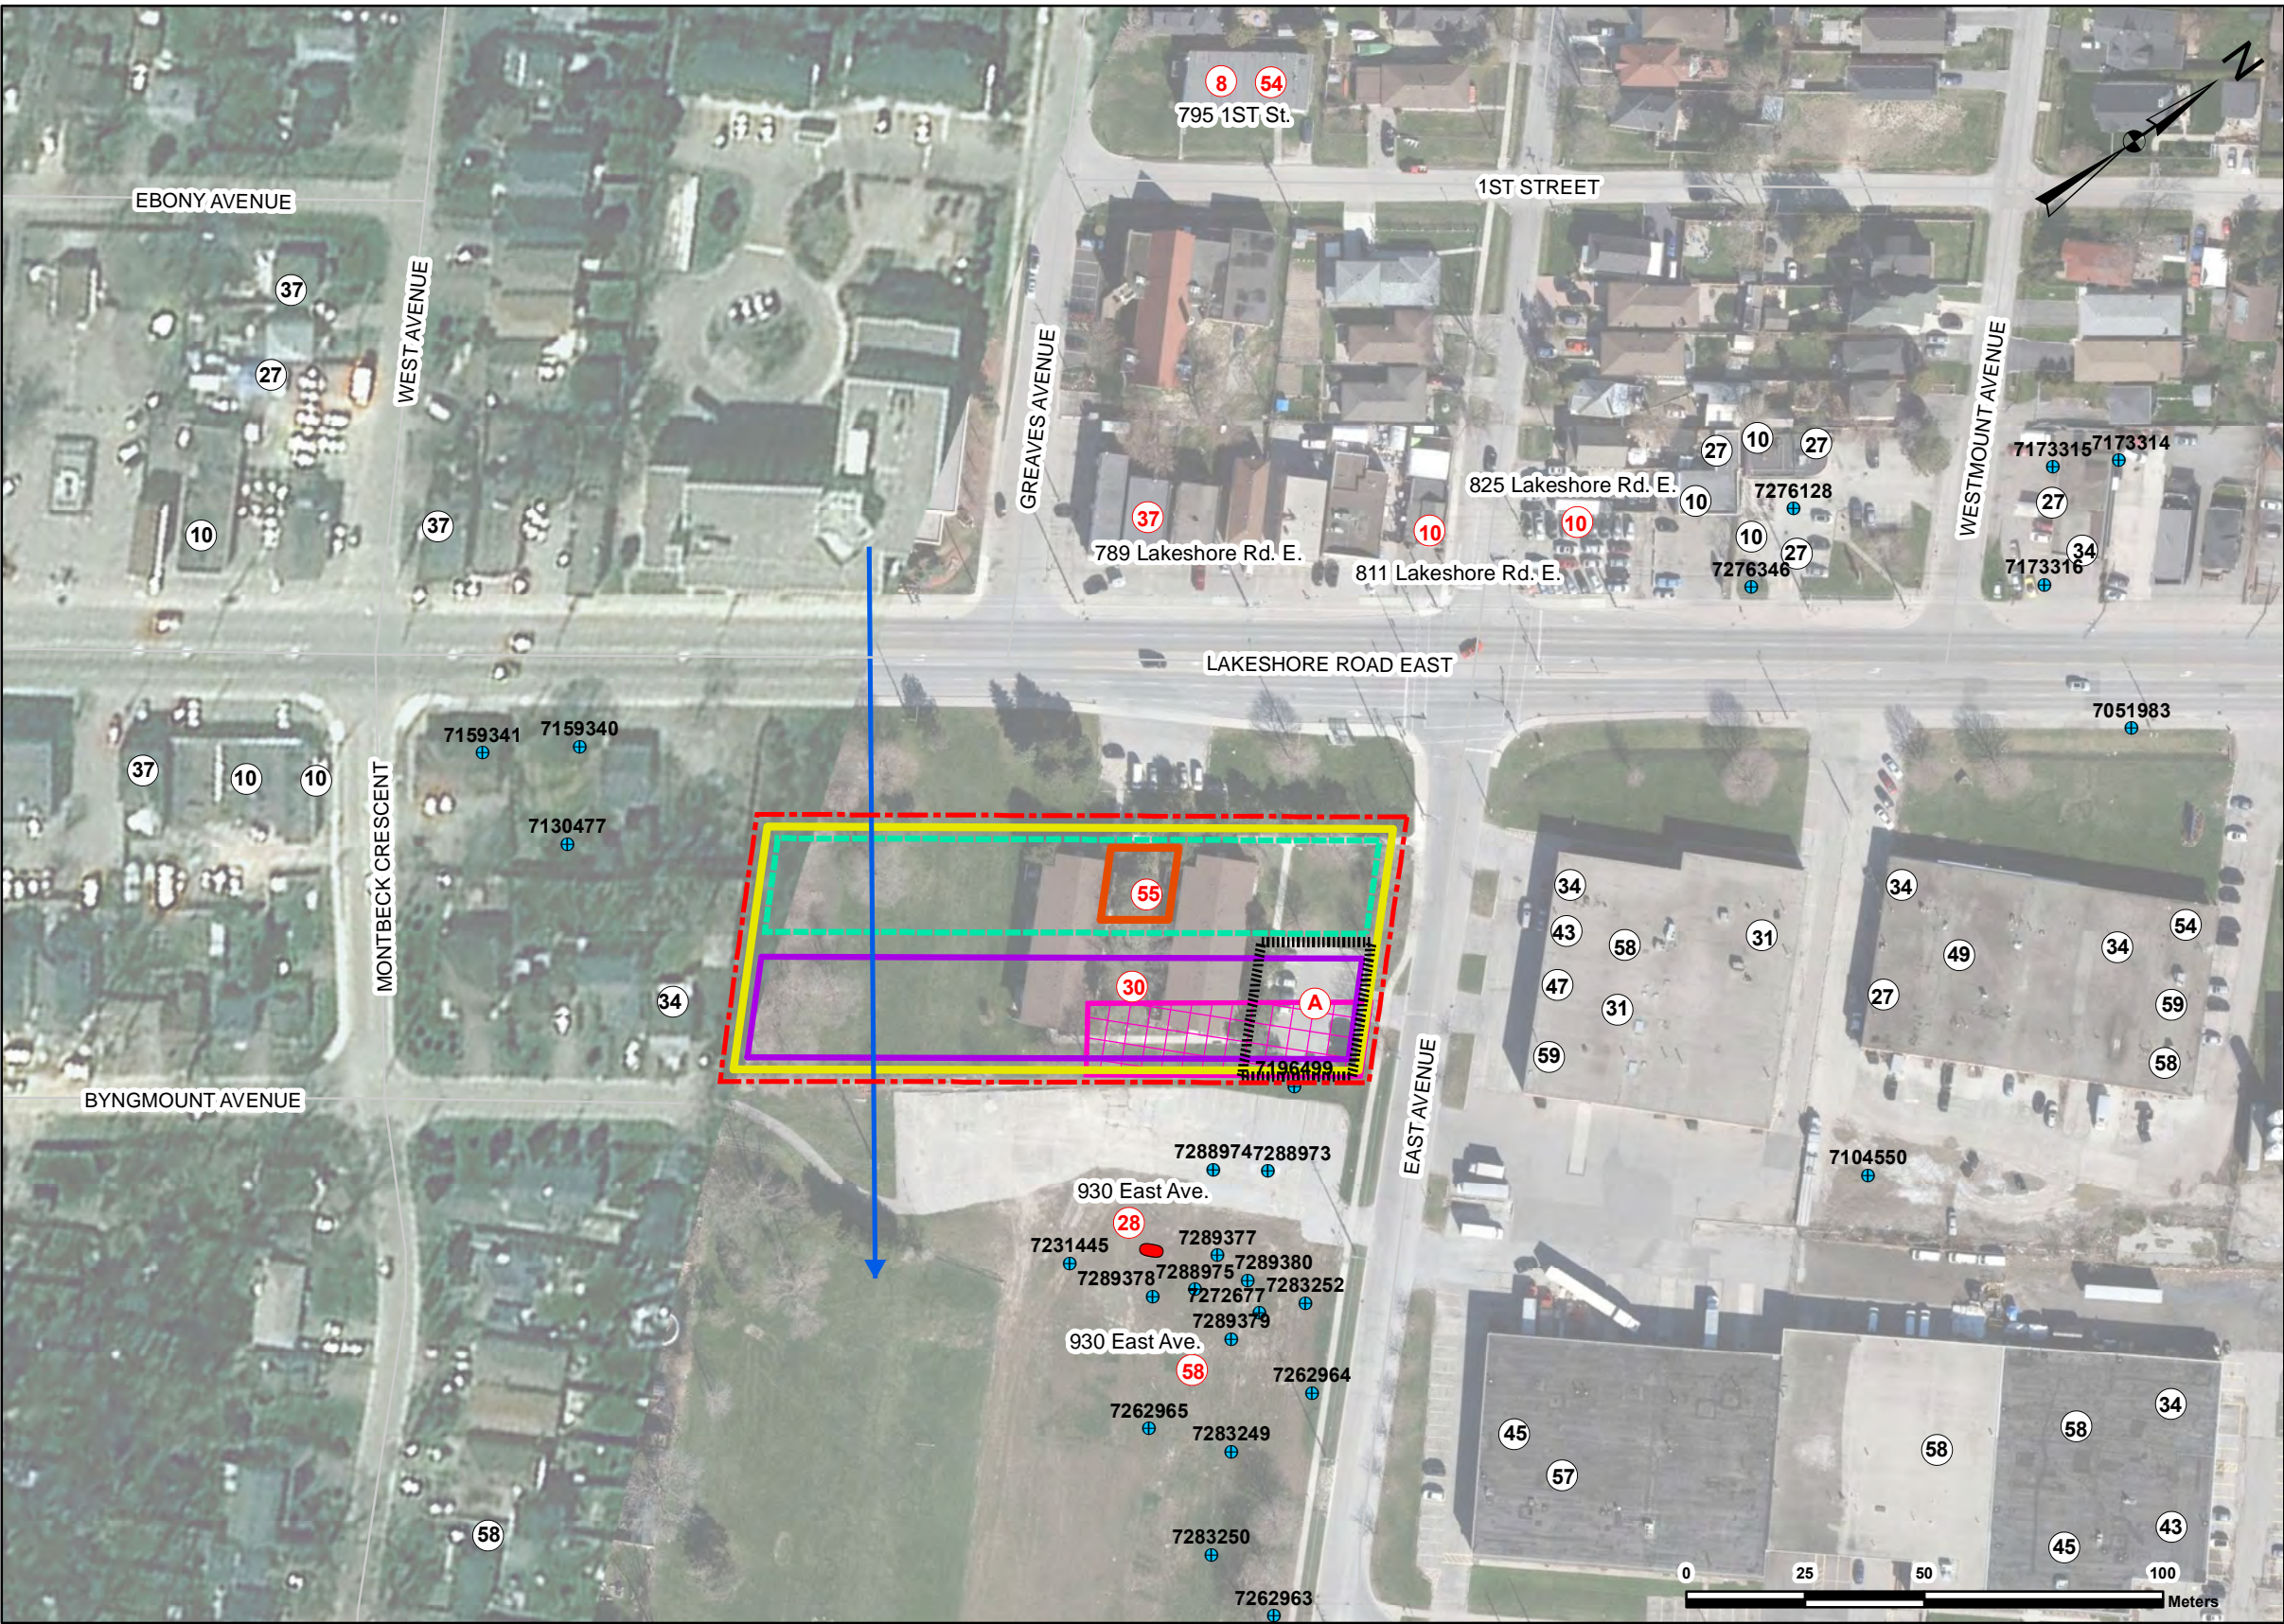
POTENTIALLY CONTAMINATING ACTIVITIES (PCAs)

- ⑩ PCA10 - Commercial Autobody Shops
- ②⑦ PCA27 - Garages and Maintenance and Repair of Railcars, Marine Vehicles and Aviation Vehicles
- ②⑧ PCA28 - Gasoline and Associated Products Storage in Fixed Tanks

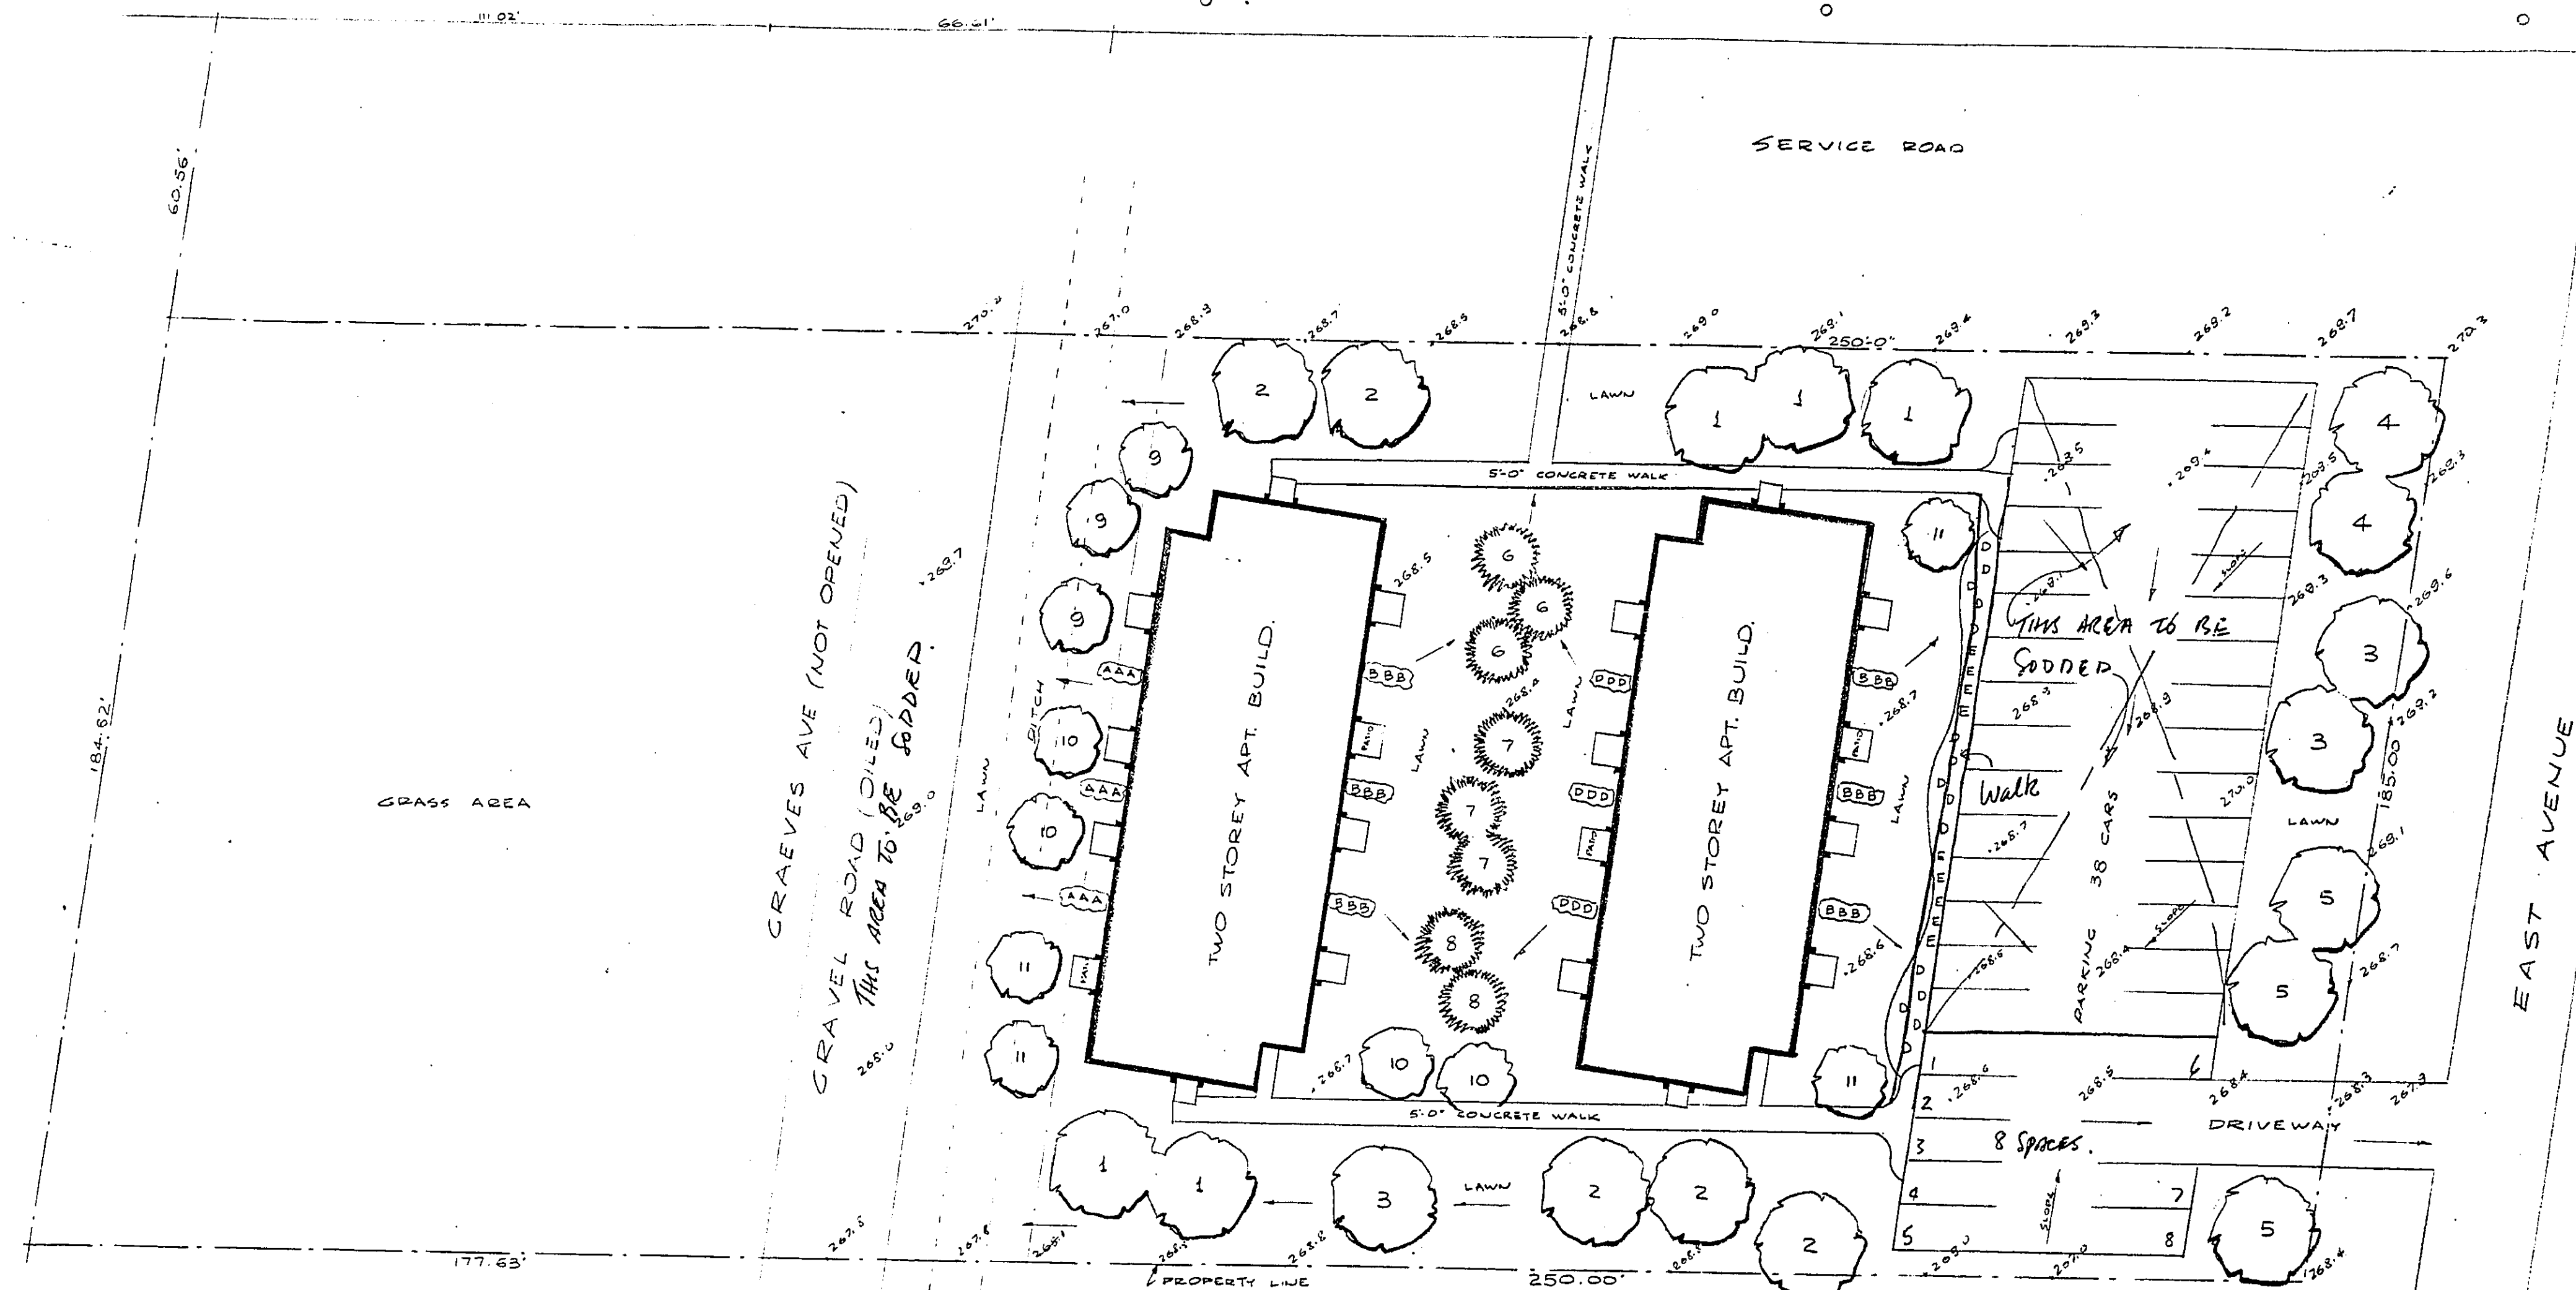
SITE PLAN SCALE 1"=20"
LOTS 9 AND 10 CONCESSION 3 S.D.S.
TOWNSHIP OF TORONTO

THE SITE SHALL BE GRADED SO AS TO DIRECT SURFACE WATER AWAY FROM BUILDINGS. THE FINISHED GRADE SURFACE SHALL SLOPE AWAY FROM THE FOUNDATIONS NOT LESS THAN 3" IN 10'-0" NOR MORE THAN 7" IN 10'-0" FOR A MINIMUM DISTANCE OF 10'-0"

ALL PATIOS SHALL BE 24"X24" PRECAST CONCRETE SLABS LAID OVER 4" SAND BED.

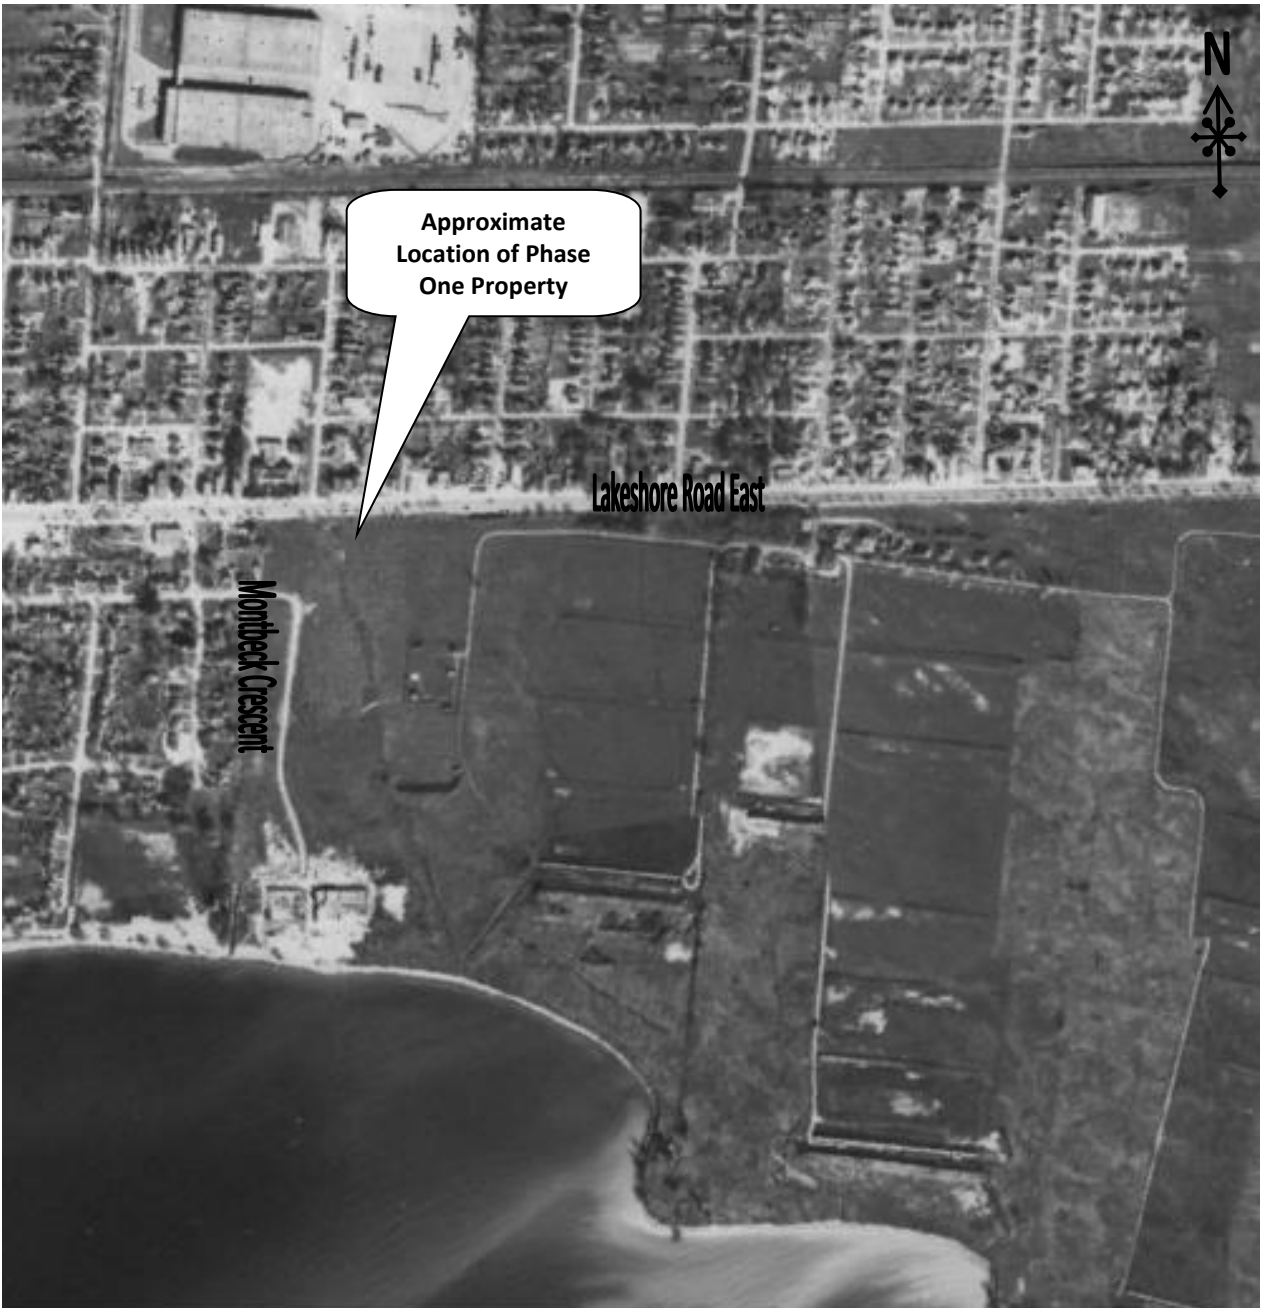
AERIAL PHOTOGRAPH: 1954

Scale: ~1:6,900	PHASE ONE ENVIRONMENTAL SITE ASSESSMENT 930 EAST AVENUE MISSISSAUGA, ONTARIO	Prepared By: KM
Date: September 2018		Reviewed By: KM
Project: 1481-11306-00	Prepared For: Region of Peel	Drawing No. E-1

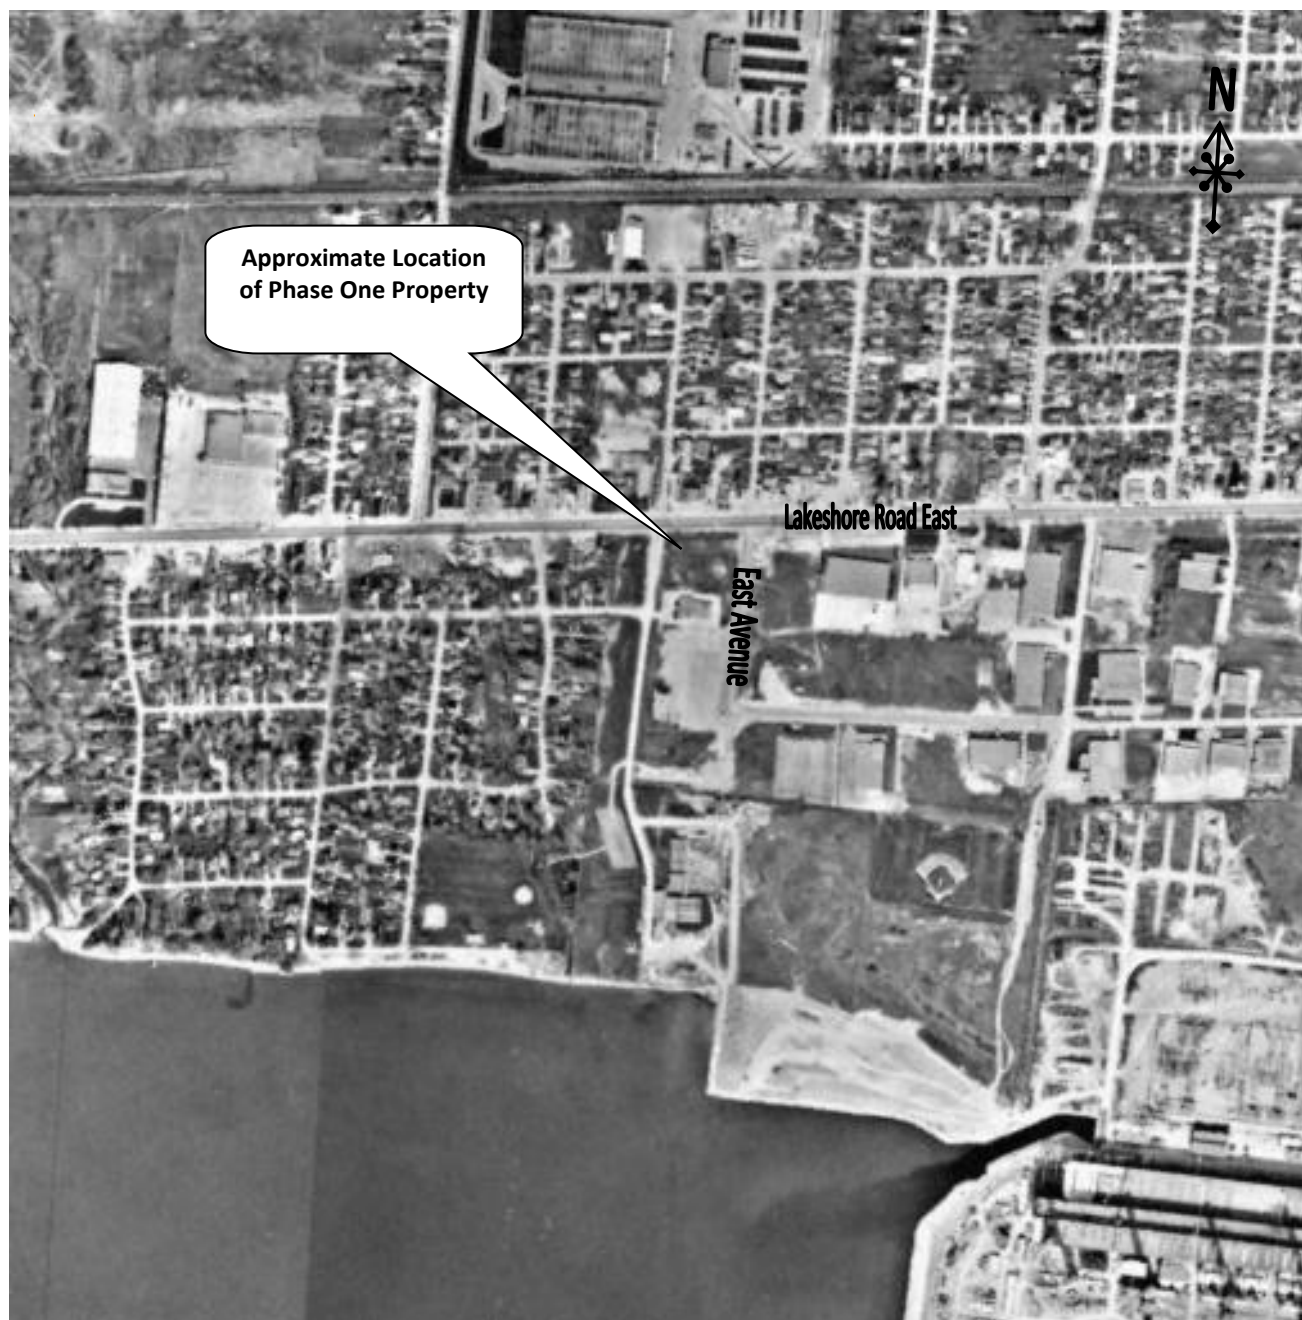
AERIAL PHOTOGRAPH: 1977

Scale: ~1:4,500	PHASE ONE ENVIRONMENTAL SITE ASSESSMENT 930 EAST AVENUE MISSISSAUGA, ONTARIO	Prepared By: KM
Date: September 2018		Reviewed By: MB
Project: 181-11306-00	Prepared For: Region of Peel	Drawing No. E-3

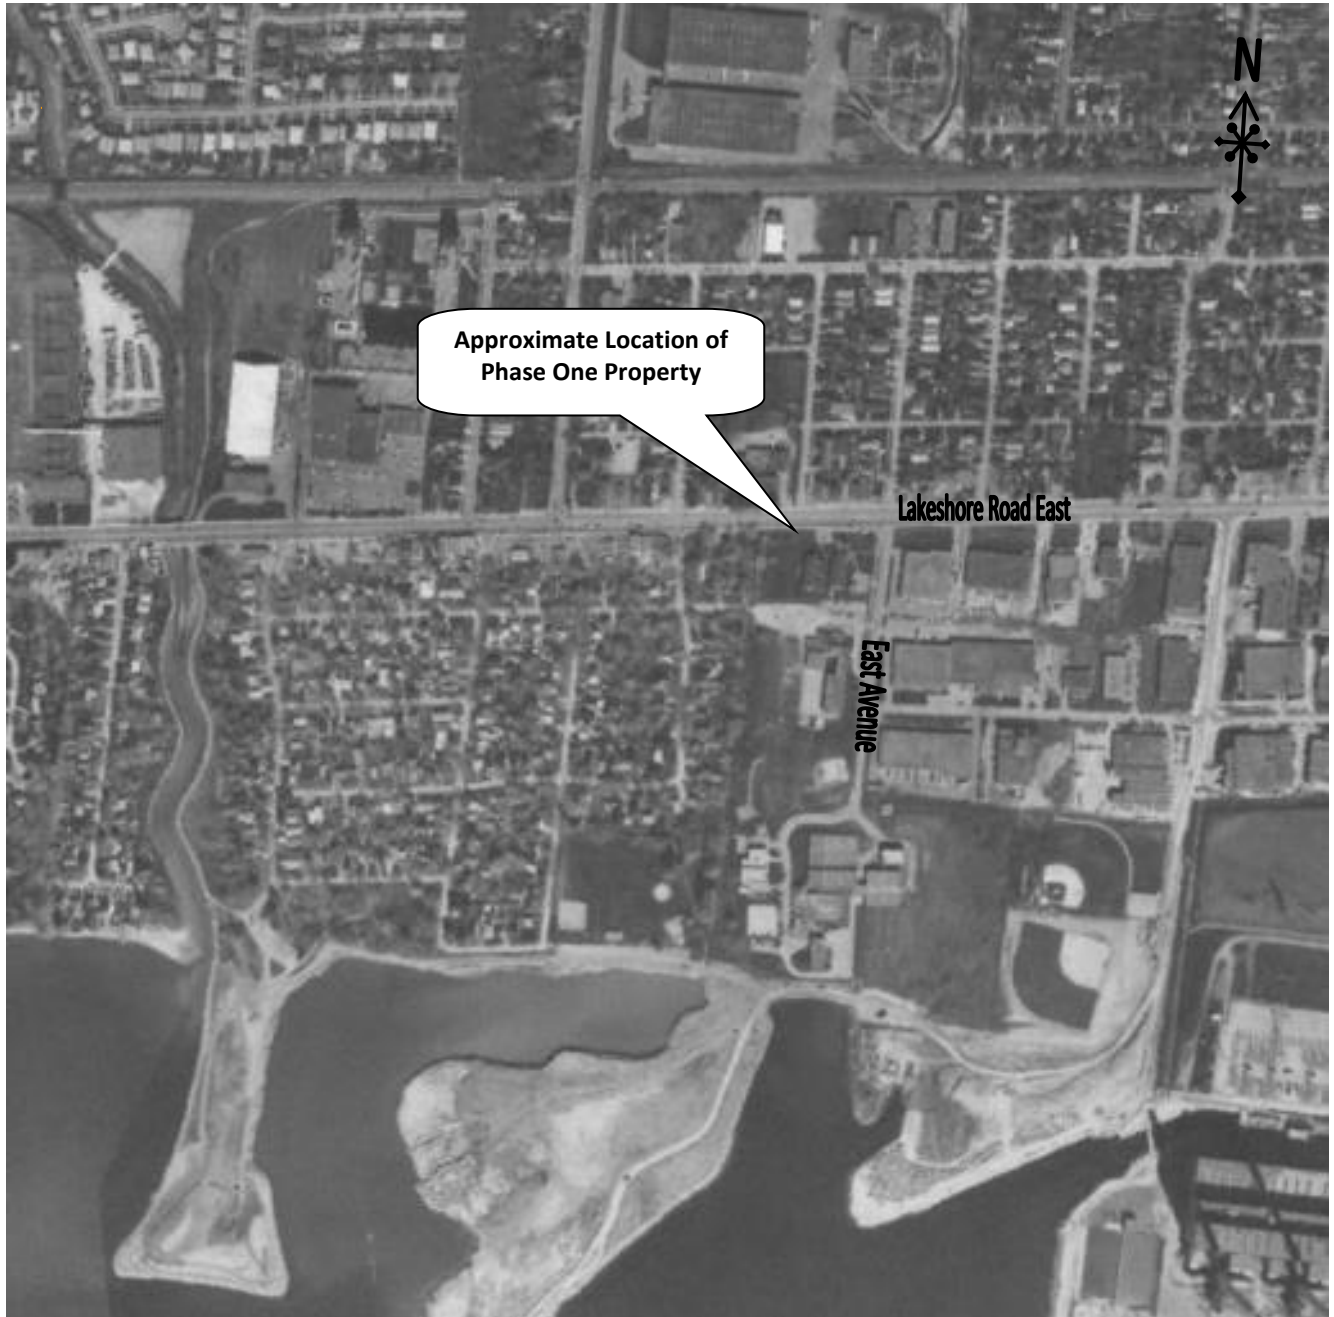
AERIAL PHOTOGRAPH: 1988

Scale: ~1:7,500	PHASE ONE ENVIRONMENTAL SITE ASSESSMENT 930 EAST AVENUE MISSISSAUGA, ONTARIO	Prepared By: KM
Date: September 2018		Reviewed By: MB
Project: 181-11306-00	Prepared For: Region of Peel	Drawing No. E-4

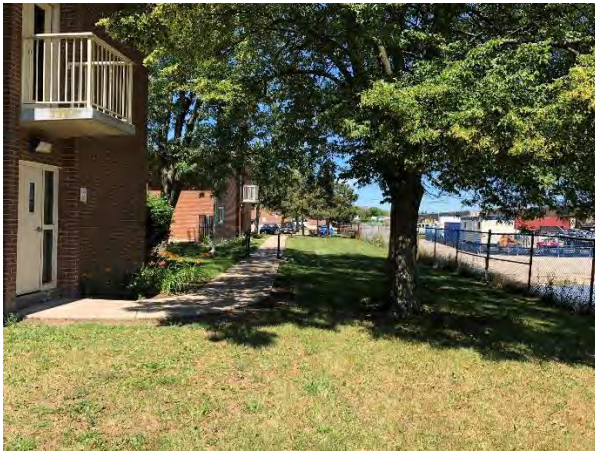
- Uneven grading was observed throughout the Phase One Property during the site reconnaissance, it is assumed that fill material was historically imported on to the Site.

1. View of Phase One Property, taken from the southwest corner of the property facing southeast.

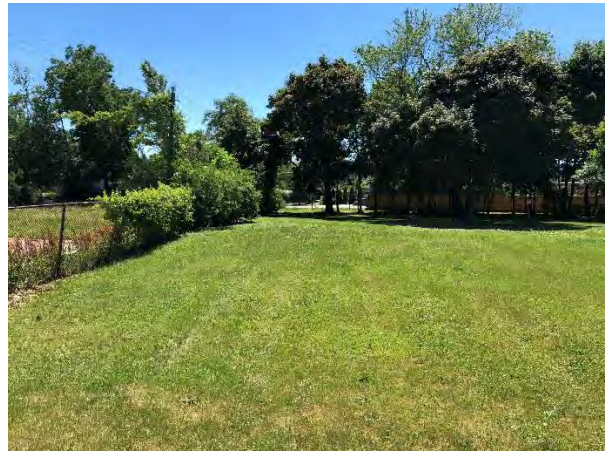
2. View of the Phase One Property, taken from the southwest corner of the property facing southwest.

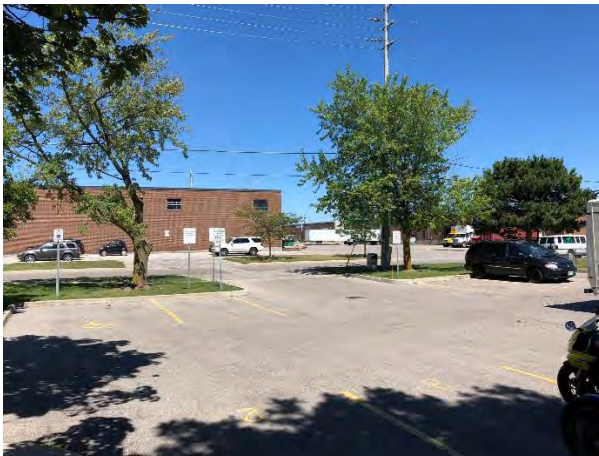
- A transformer was also observed on the Phase One Property during the site reconnaissance.
- In addition, two (2) vehicle parking lots are located on the Site, as a result it is assumed that de-icing activities occurred on the Phase One Property.

3. View of a parking area on the Phase One Property, facing southeast.

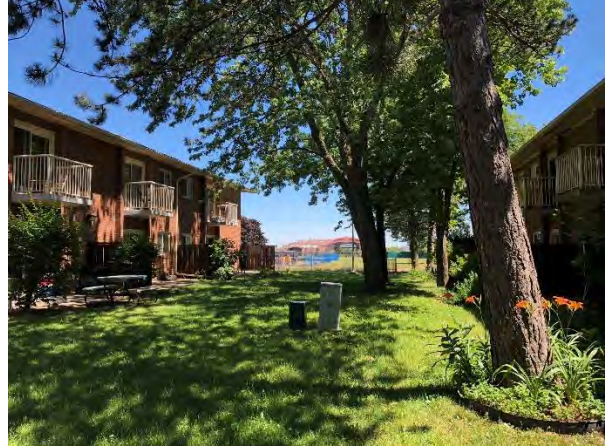
4. View of the residential building on the Phase One Property, taken from the middle of the site, facing north.

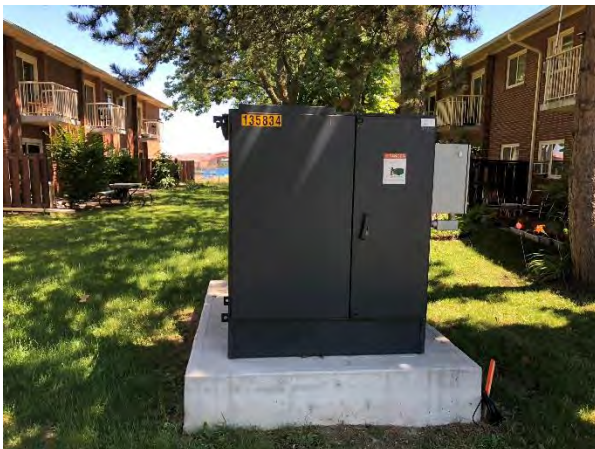
5. View of the transformer located in the middle of the Phase One Property.

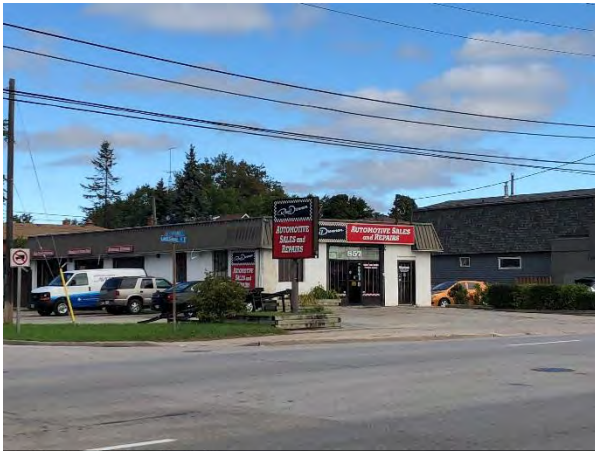
7. View of the east neighboring commercial property.

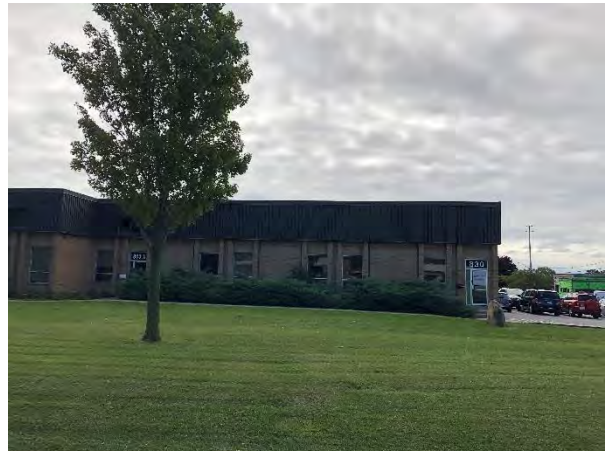
8. View of east neighboring industrial operations.

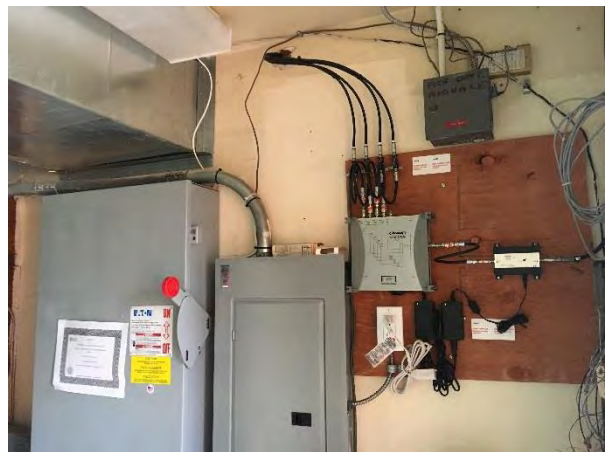
12. View of electrical panel at 958 East Avenue.

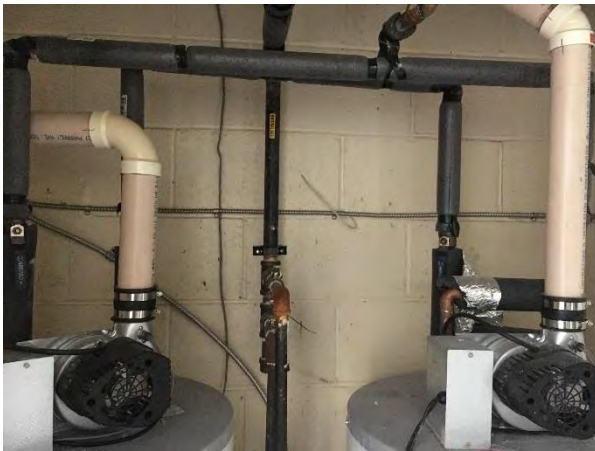
15. View of hot water piping at 960 East Avenue.

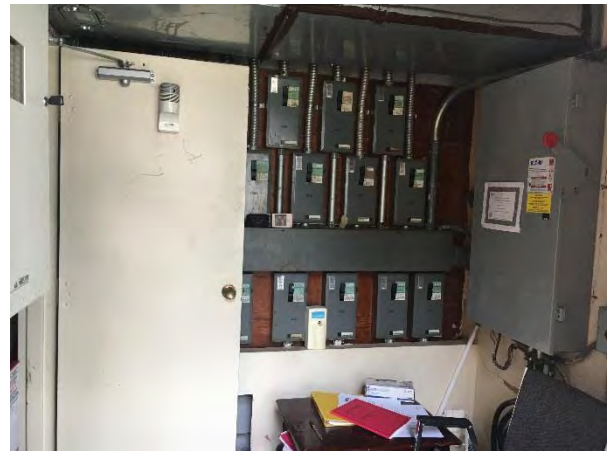
16. View of electrical panel at 960 East Avenue.
