GUIDING SOLUTIONS IN THE
NATURAL ENVIRONMENT

6620 Rothschild Trail

Scoped Environmental Impact Study

Block 21 Vintages Select, City of Mississauga
Part of Lot 21 and 22, Registered Plan 43M-1710

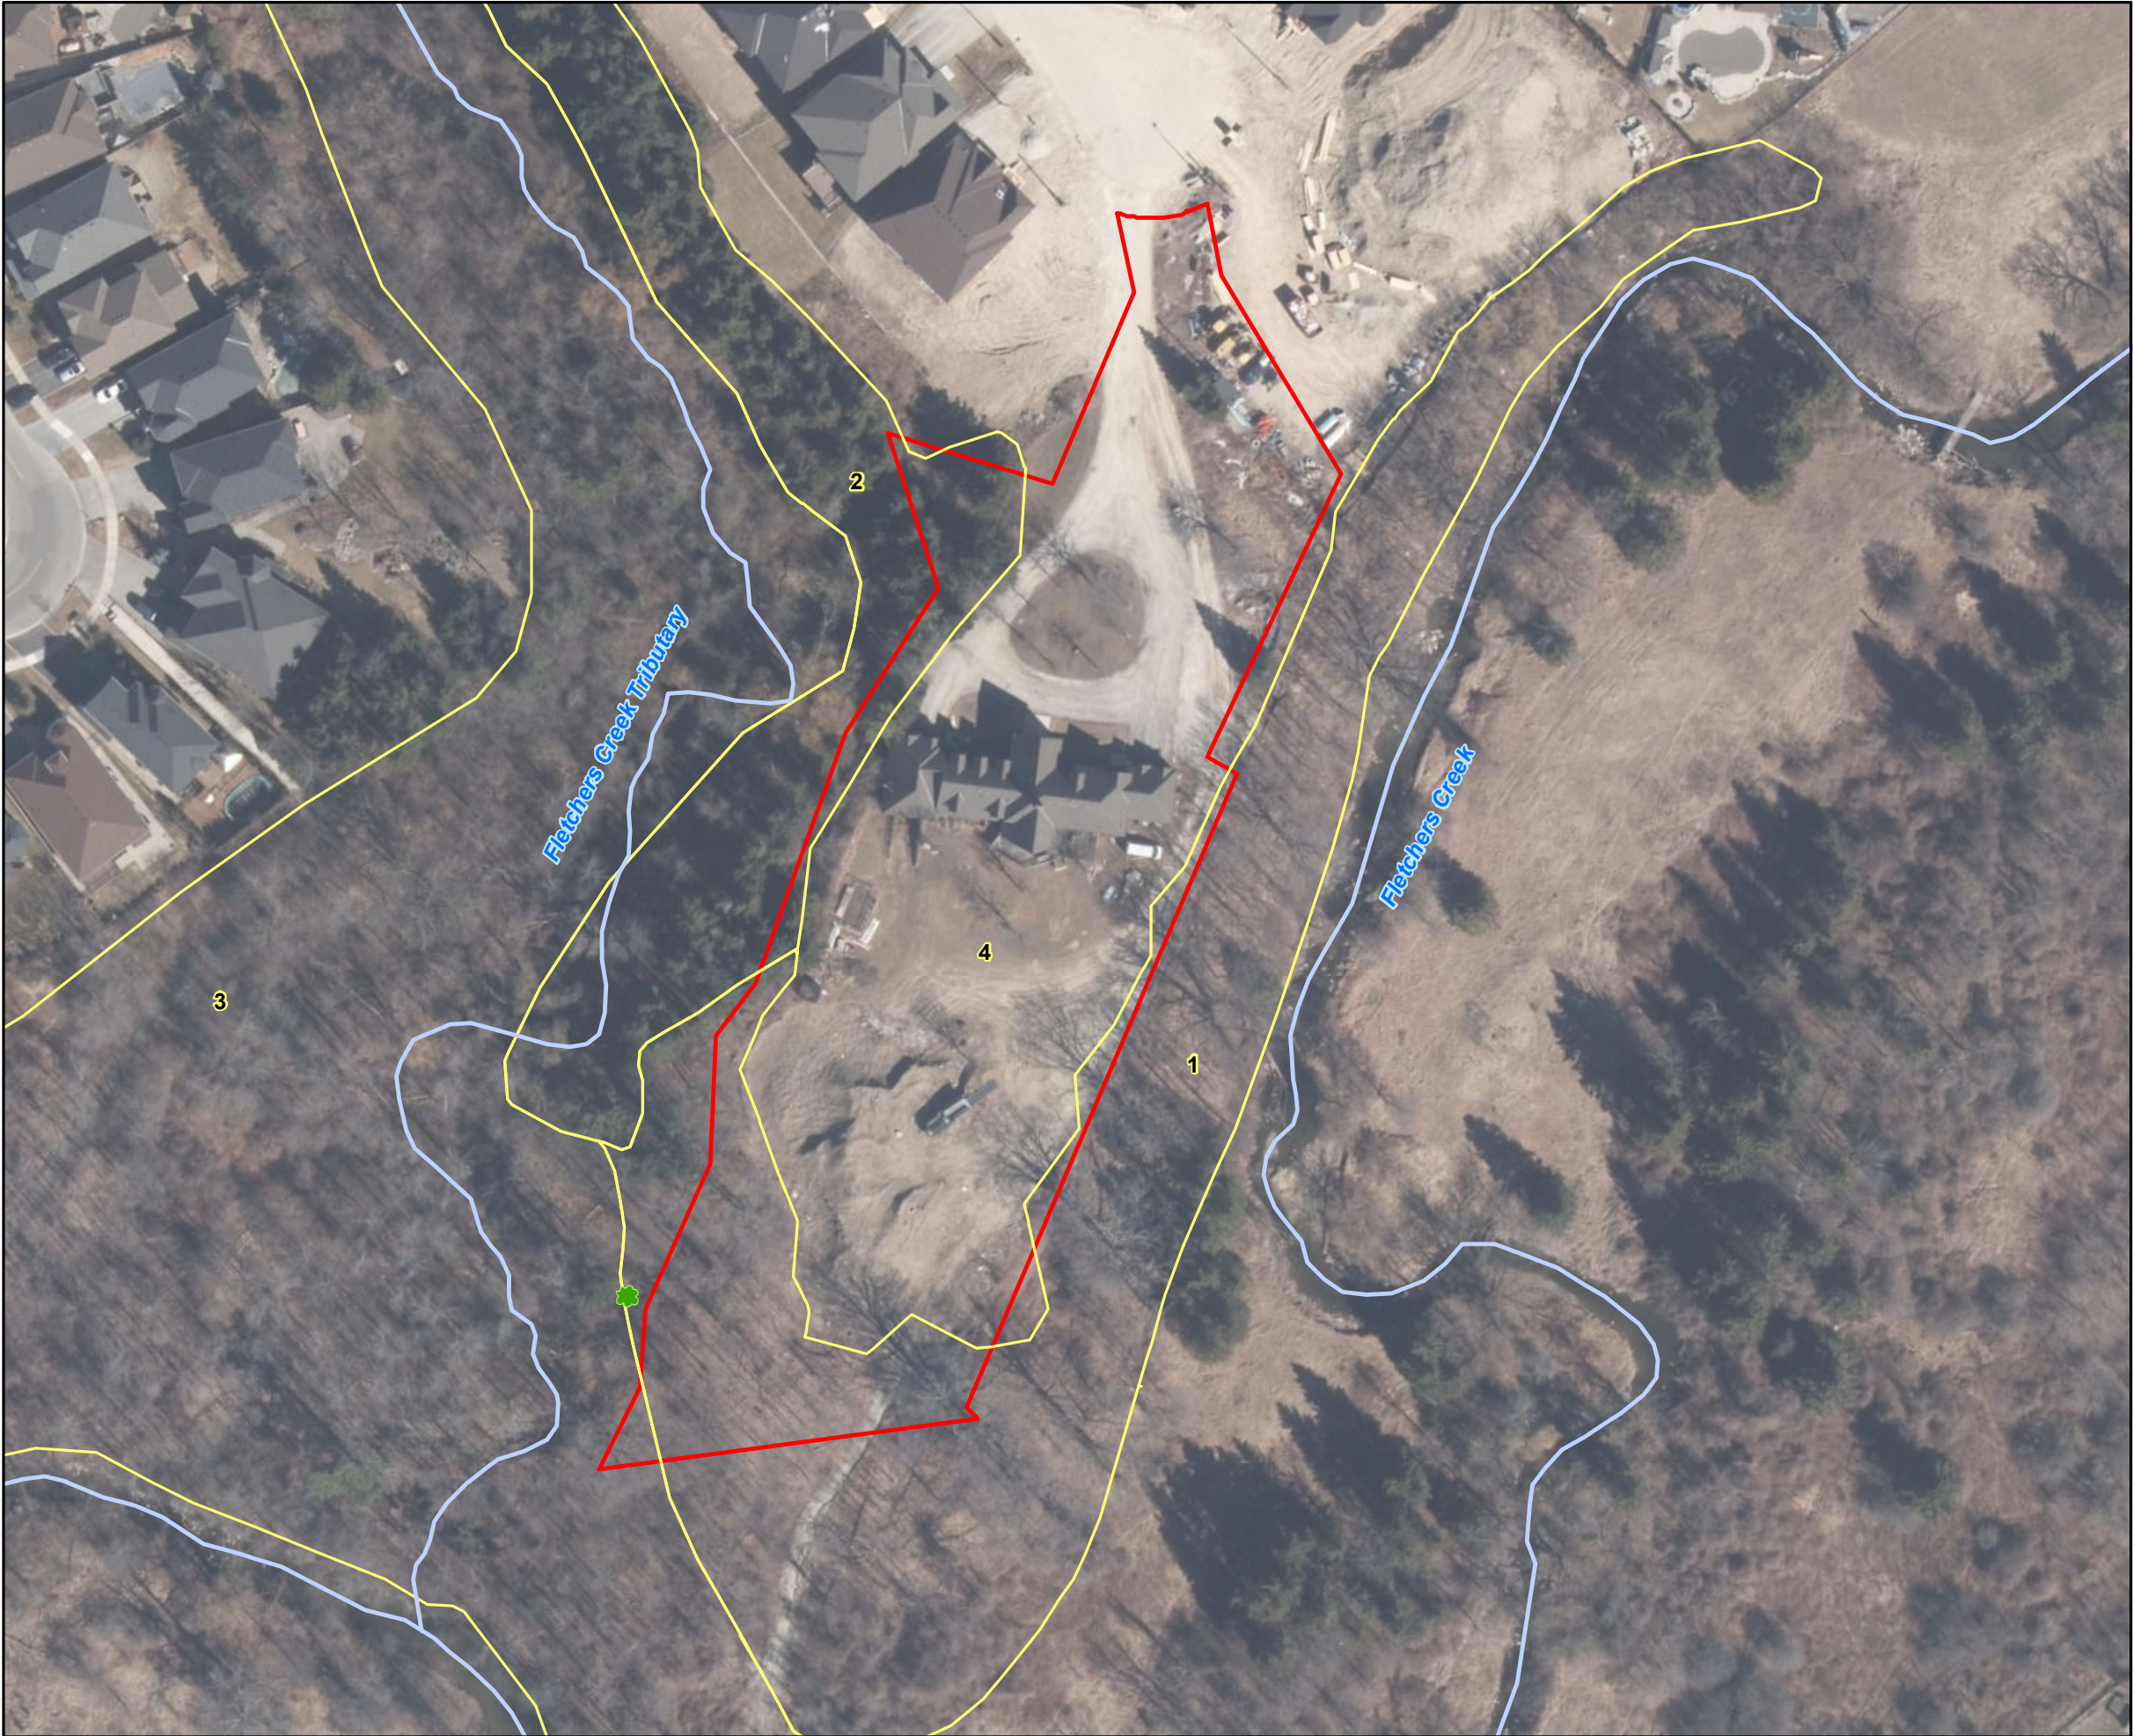
Figure 2B

Existing Conditions
Terrestrial

ELC communities identified on and adjacent to the subject property are illustrated on **Figure 2b**. The following is a description of each community.

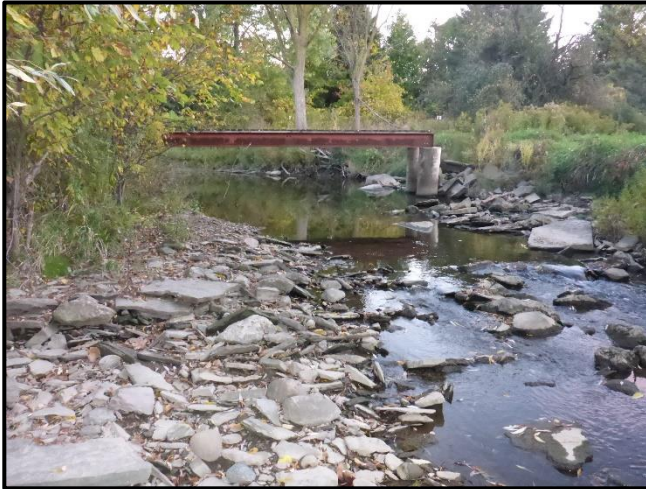
Reach FC-1

Photo 1 (Photo Location 1)
Downstream view of outflanked pedestrian crossing.

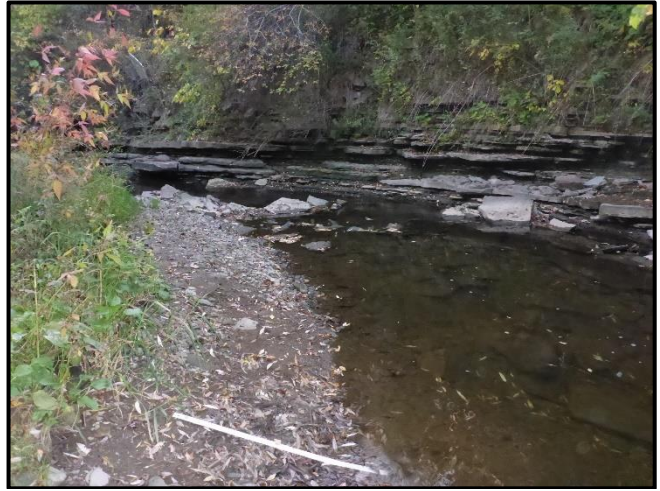
Reach FC-1

Photo 2 (Photo Location 2)
Downstream view of point bar formation (left bank) and valley wall contact upstream of subject property (right bank).

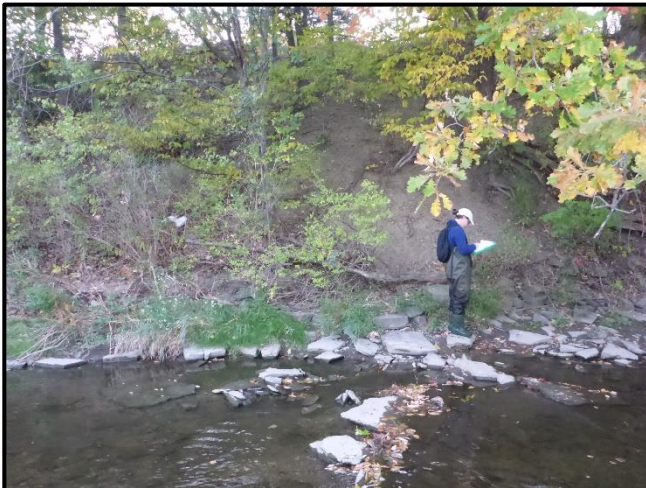
Reach FC-1

Photo 3 (Photo Location 3)
North-facing view of valley slope conditions at subject property.

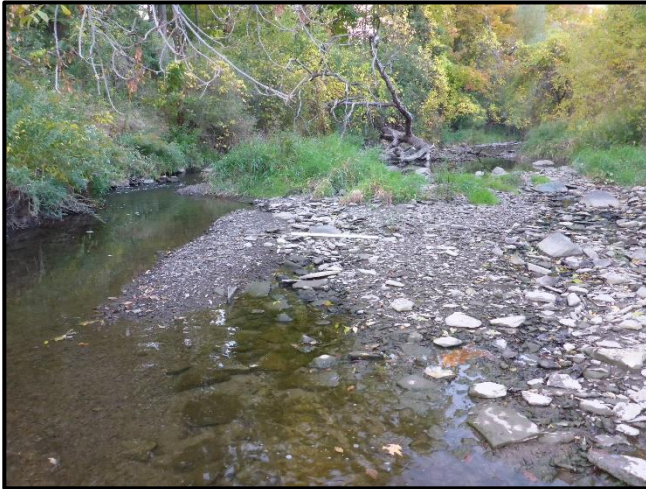
Reach FC-1

Photo 5 (Photo Location 5)
Upstream view of lateral bar formation.

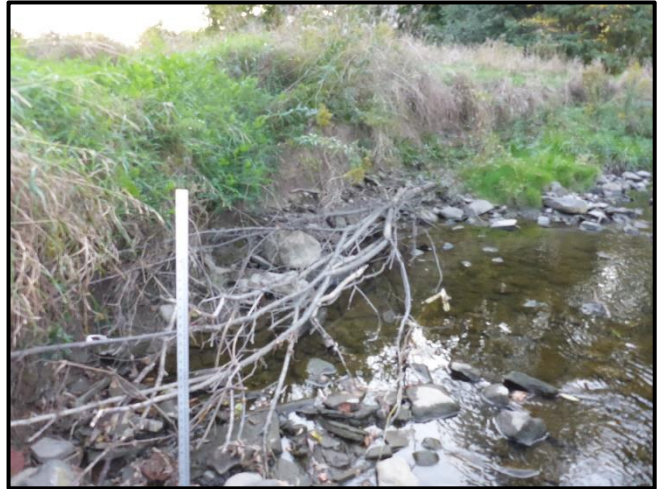
Reach FC-1

Photo 6 (Photo Location 5)
Downstream view of bank erosion and undercutting along outer meander bend.

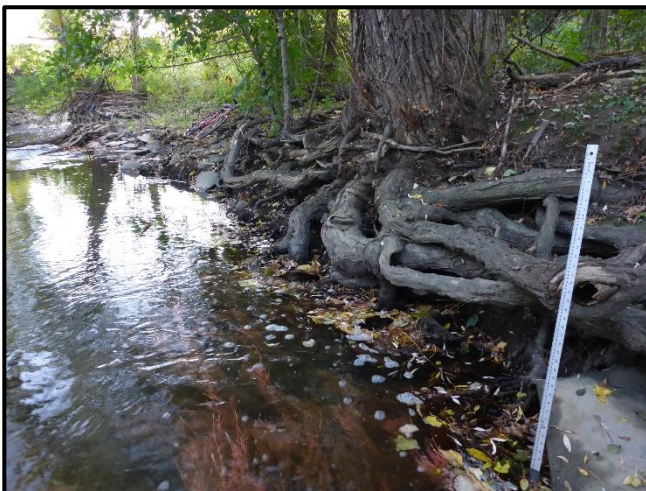
Reach FC-1

Photo 7 (Photo Location 6)
Evidence of basal scour (elevated tree roots) along outer bank.

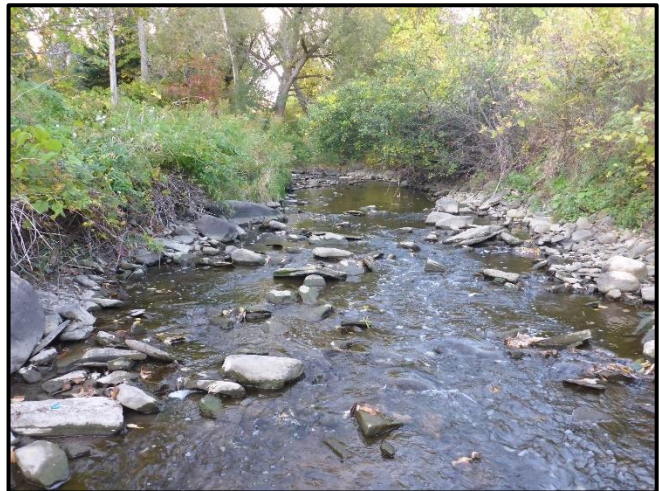
Reach FC-1

Photo 8 (Photo Location 7)
Upstream view of general conditions along riffle section. Note: evidence of basal scour observed along bank (photo left).

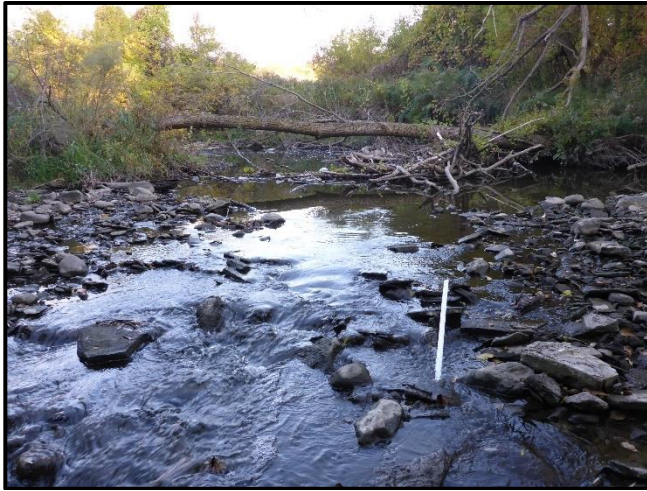
Reach FC-1

Photo 9 (Photo Location 8)
Upstream view of general conditions. Note: wood debris within channel

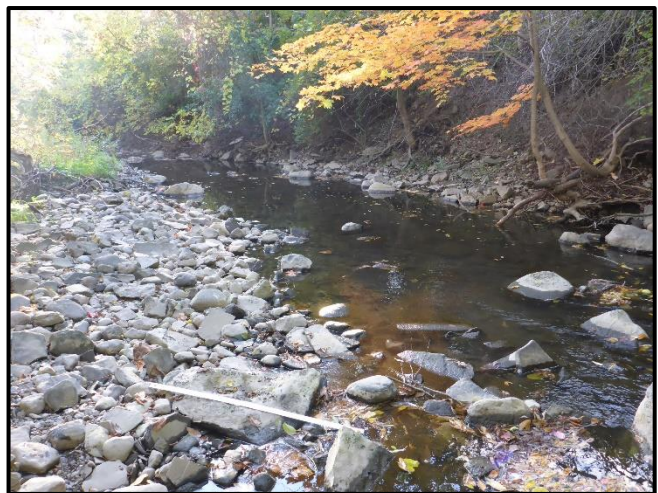
Reach FC-2

Photo 12 (Photo Location 10)
Downstream view of lateral bar formation (left bank) and valley wall contact (right bank).

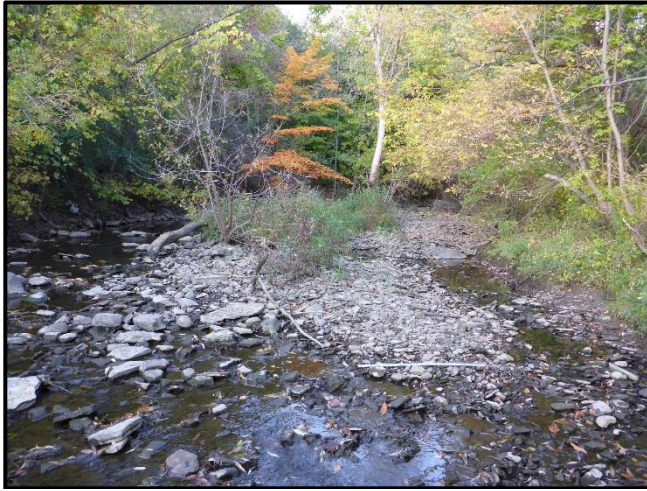
Reach FC-2

Photo 13 (Photo Location 11)
Upstream view of lateral bar with chute formation
(photo right).

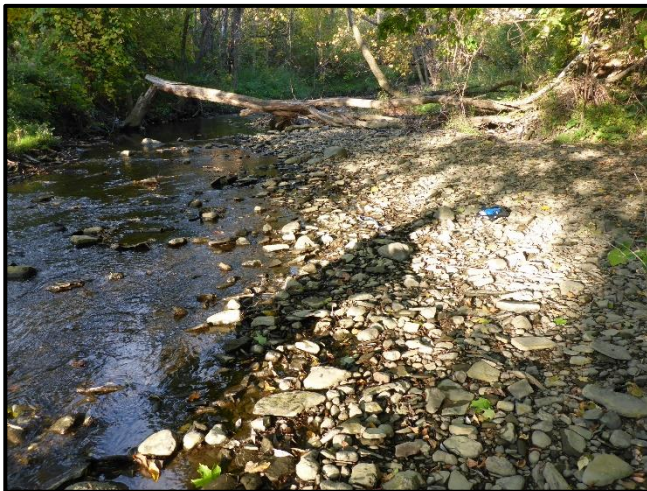
Reach FC-2

Photo 15 (Photo Location 13)
Upstream view of lateral bar formation.

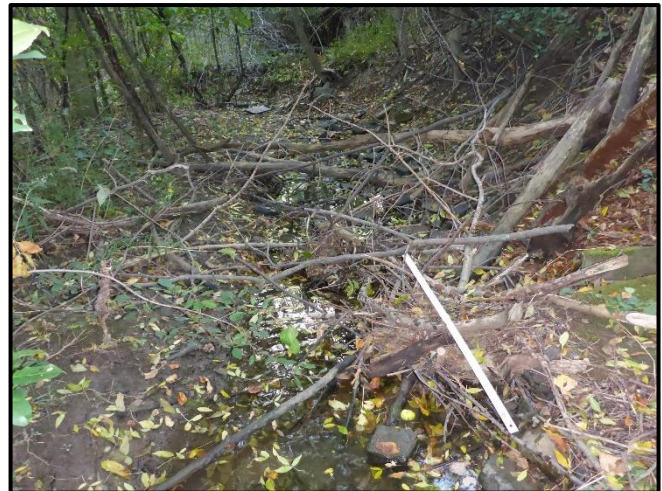
Reach FCT-1

**Photo 20 (Photo Location 17)
Upstream view of tributary conditions adjacent to
subject property. Note: channel is intermittently
defined; presence of instream wood debris.**
