## **Phase Two Environmental Site Assessment**

6302 and 6314 Ninth Line (Parcels E and F) Mississauga, Ontario

Derry Britannia Developments Limited 7880 Keele Street Vaughan, Ontario L4K 4G7

**DS Project No:** 18-692-100

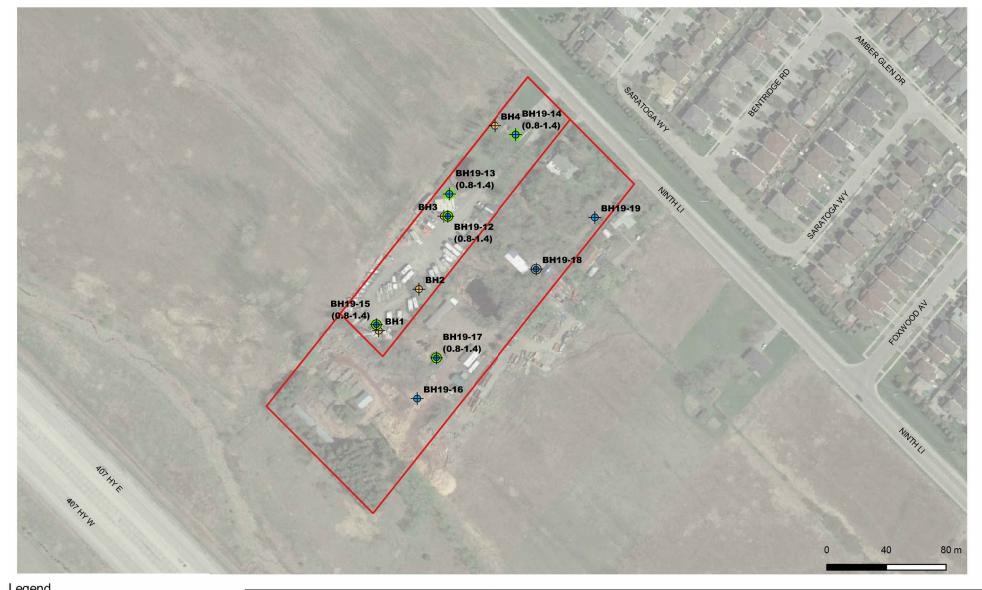
Size: 8.5 x 11	Approved By:	R.F	Drawn By:	S.Y	Date:	June 2019
Rev:	Scale:	As Shown	Project No.:	18-692-100	Figure No.:	6D
0	Image/Man Source	. Google Satellite Im	nae

#### SUMMARY OF VOCs IN SOIL

A total of five (5) samples were submitted for analysis of VOCs. The results of the analyses are tabulated in Table 7 and presented on Figure 6D. The results of the chemical analyses conducted indicated that all samples analyzed met the applicable Site Condition Standards.

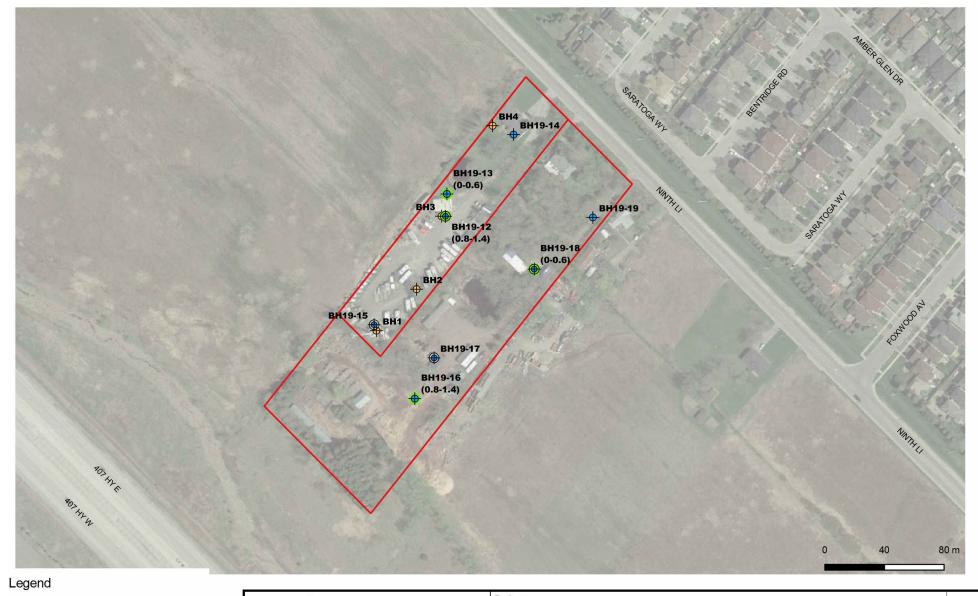
Size	e: 5 x 11	Approved By:	R.F	Drawn By:	S.Y	Date:	June	2019
Rev	v:	Scale:	As Shown	Project No.:	18-692-100	Figure No.:	6E	
	0	Image/Map Source	: Google Satellite Ima	ge

SUMMARY	OF	PAHS	IIN 3	SOIL

A total of five (5) samples, including one (1) field duplicate for QA/QC purposes were submitted for analysis of PAHs. The results of the analyses are tabulated in Table 8 and presented on Figure 6E. The results of the chemical analyses conducted indicated that all samples analyzed met the applicable Site Condition Standards.

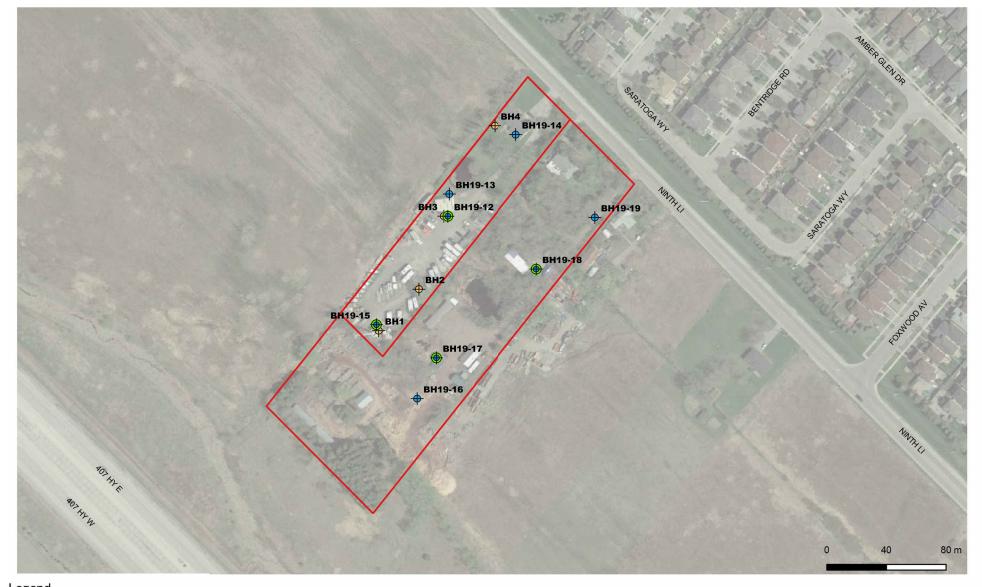
Size: 8.5 x 11	Approved By:	R.F	Drawn By:	S.Y	Date:	June 2019
Rev:	Scale:	As Shown	Project No.:	18-692-100	Figure No.:	7B
0	Image/Map Source	: Gooale Satellite Ima	ае		•

#### SUMMARY OF PHCs IN GROUNDWATER

10 and presented on Figure 7B. The results of the chemical analyses conducted indicated that all samples analyzed met the applicable Site Condition Standards.
