**PHASE ONE
ENVIRONMENTAL SITE ASSESSMENT
200 SOUTH SERVICE ROAD AND 201 RADLEY ROAD
MISSISSAUGA, ONTARIO**

Prepared for: Dream Maker Inc.
c/o Glen Schnarr & Associates Inc.
700-10 Kingsbridge Garden Circle
Mississauga, ON L5R 3K6

File No 1-17-0877-41
December 21, 2017
©**Terraprobe Inc.**

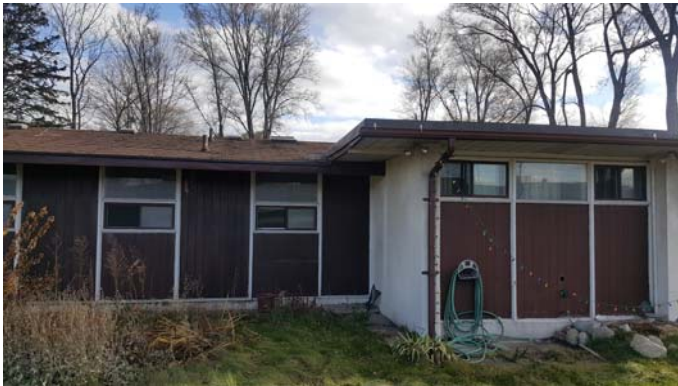
Photograph 1

Location: 200 South Service Road
Viewing: South
Description: Single storey bungalow located at 200 South Service Road.

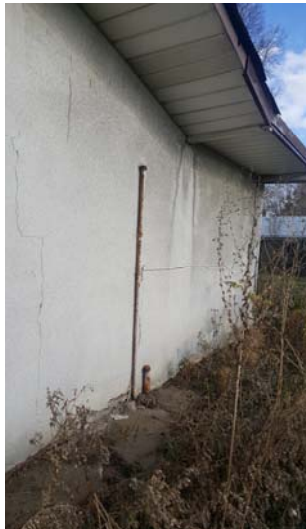
Photograph 2

A fill pipe and a vent pipe were observed on the western exterior wall of the residential building at 200 South Service Road. The pipes may be connected to an underground storage tank suspected to be located

to the west of the building. No other underground storage tanks or evidence of historical underground storage tanks was observed during the site inspection.

Location: 200 South Service Road
Viewing: Southeast
Description: Fill pipe and vent pipe observed on the west wall of the building located at 200 South Service Road.

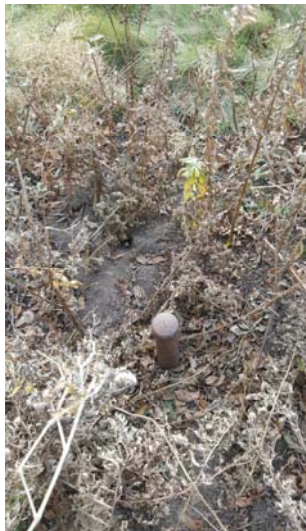
Photograph 3

Location of PCA	PCA	Potential APEC (yes/no)	Justification
Northwestern portion of the Phase One Property	#28 – Gasoline and Associated Products Storage in Fixed Tanks	Yes	Potential presence of an underground storage tank located to the west of the residential building located at 200 South Service Road.
155 North Service Rd. 95 m west	#28 – Gasoline and Associated Products Storage in Fixed Tanks	No	Trans-gradient PCA separated by a major highway (QEW). Ground water impacts, if present, would be unlikely to cause contamination on the Property. The QP's assessment is that this PCA will not cause an APEC on the Property.
240 South Service Rd. 110 m northeast	#28 – Gasoline and Associated Products Storage in Fixed Tanks	No	Trans-gradient PCA. Ground water impacts, if present, would be unlikely to cause contamination on the Property due to the distance from the Phase One Property. The QP's assessment is that this PCA will not cause an APEC on the Property.

Location: 200 South Service Road
Viewing: West
Description: Suspected underground storage tank located to the west of the building on site.

Based upon the review and evaluation of information gathered from the Phase One ESA, an Area of Potential Environmental Concern (APEC) has been identified on the Phase One Property arising from the current and historical PCA found at the Property which may have resulted in adverse impact to the environmental condition of the Property. A Phase Two ESA is required to investigate the APEC.

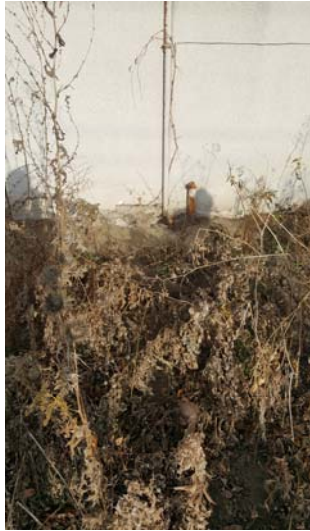
Photograph 4

Location: 200 South Service Road
Viewing: East
Description: The pipes seems to be connected to an underground storage tank/structure buried to the west of the building.

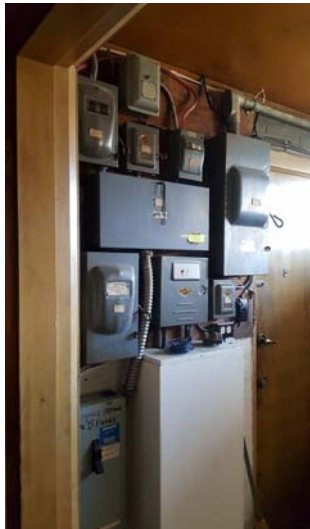
Photograph 5

Location: 200 South Service Road
Viewing: Northwest
Description: Electrical panel observed near the entrance of the building.

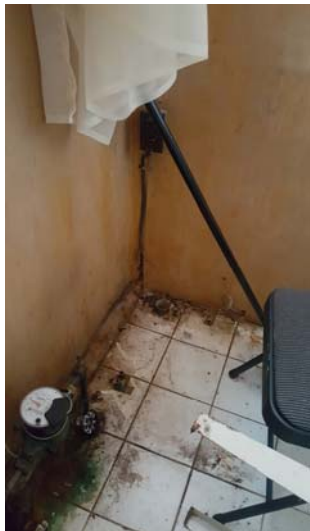
Photograph 6

Location: 200 South Service Road
Viewing: North
Description: Water meter observed near the electrical panel room.

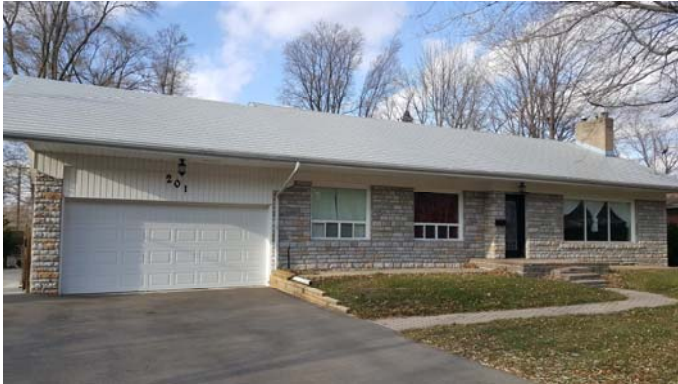
Photograph 7

Location: 201 Radley Road
Viewing: North
Description: Single storey brick building with a basement.

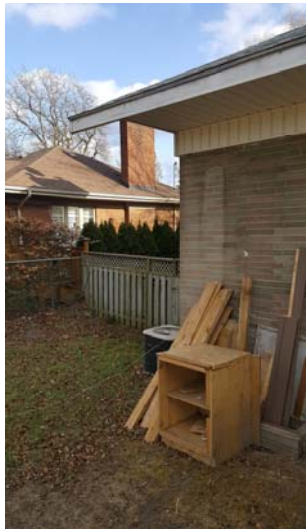
Photograph 8

Location: 201 Radley Road
Viewing: East
Description: Exterior AC unit was observed in the backyard.

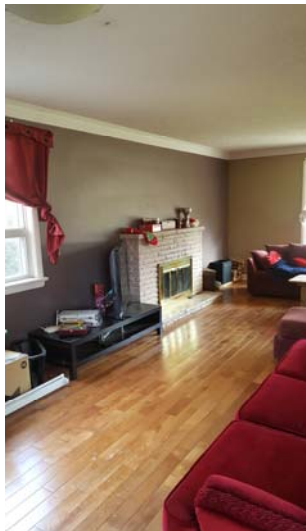
Photograph 9

Location: 201 Radley Road
Viewing: Northeast
Description: Typical interior structure. The ceiling and walls are either drywall or plastered. Floor is made of wooden panels.

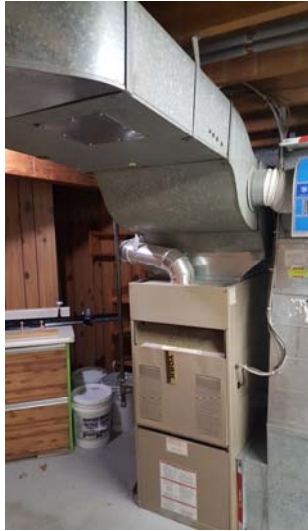
Photograph 10

The residential building on the southern portion of the Property (201 Radley Road) has a basement. The basement at the building is refurbished and contains a room for a water boiler, gas-fired furnace and an electrical room. The building structures consisted of concrete poured slabs and concrete blocks foundation walls.

Location: 201 Radley Road
Viewing: Basement
Description: Gas-fired furnace and water boiler are observed in the utility room located in the basement.

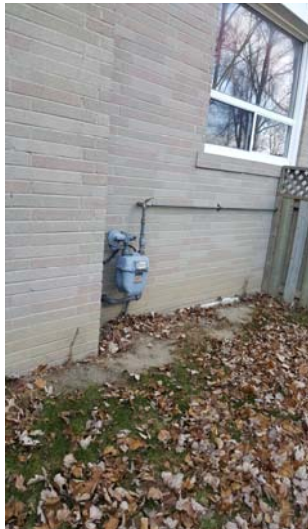
Photograph 11

Location: 201 Radley Road
Viewing: West
Description: Gas utilities located at east side of the building.

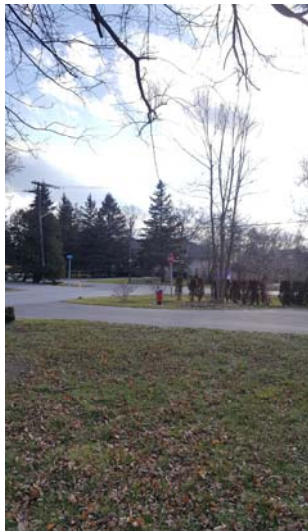
Photograph 12

Location: 201 Radley Road
Viewing: Southwest
Description: Fire hydrants were observed along the property boundary.

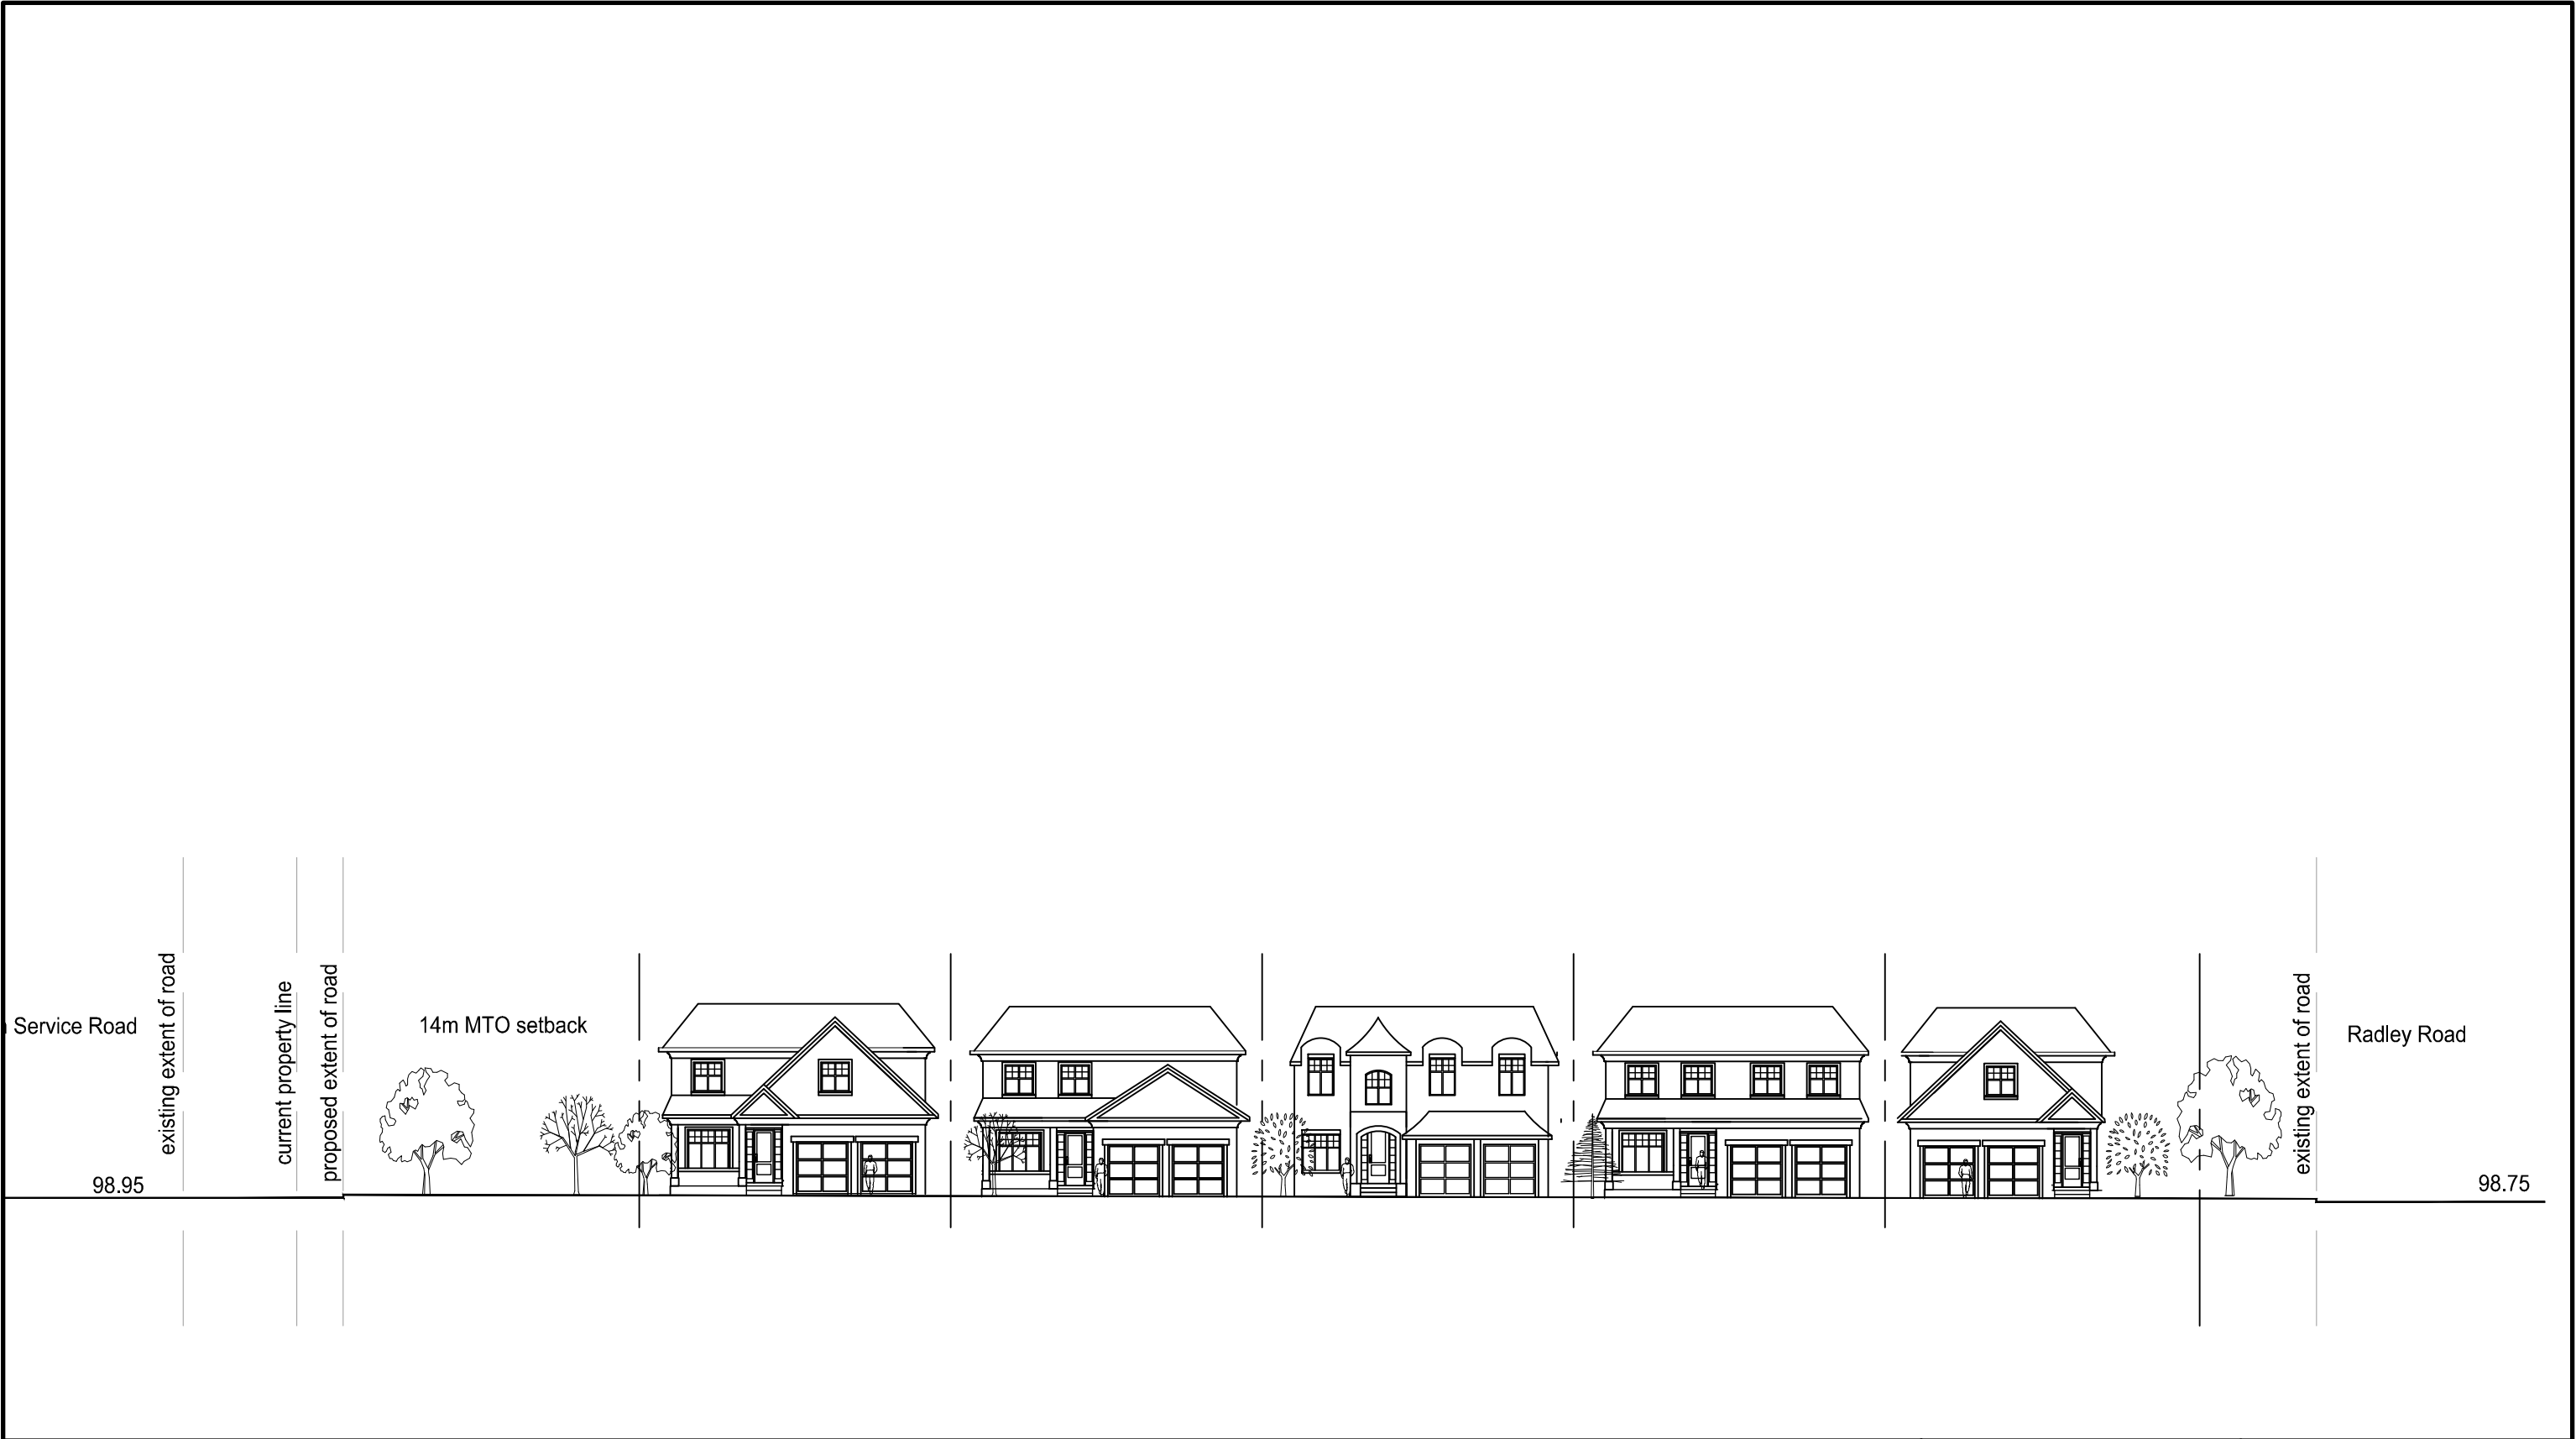
<div>MC.A</div> <div>MARA CERVINI, ARCHITECT</div> <div>18115 MOUNTAINVIEW RD.</div> <div>CALEDON EAST, ON L7K 2G4</div> <div>416-574-1086</div> <div>maracerviniarch.com</div> <div>www.maracerviniarch.com</div>	PROJECT NAME: 200-250 S Service Road Mississauga, ON	DRAWING NAME: Concept Street Elevation 5 Single Family Homes	DRAWING NUMBER: <div>02</div>
	PROJECT NUMBER: 17-08	SCALE: 1:300

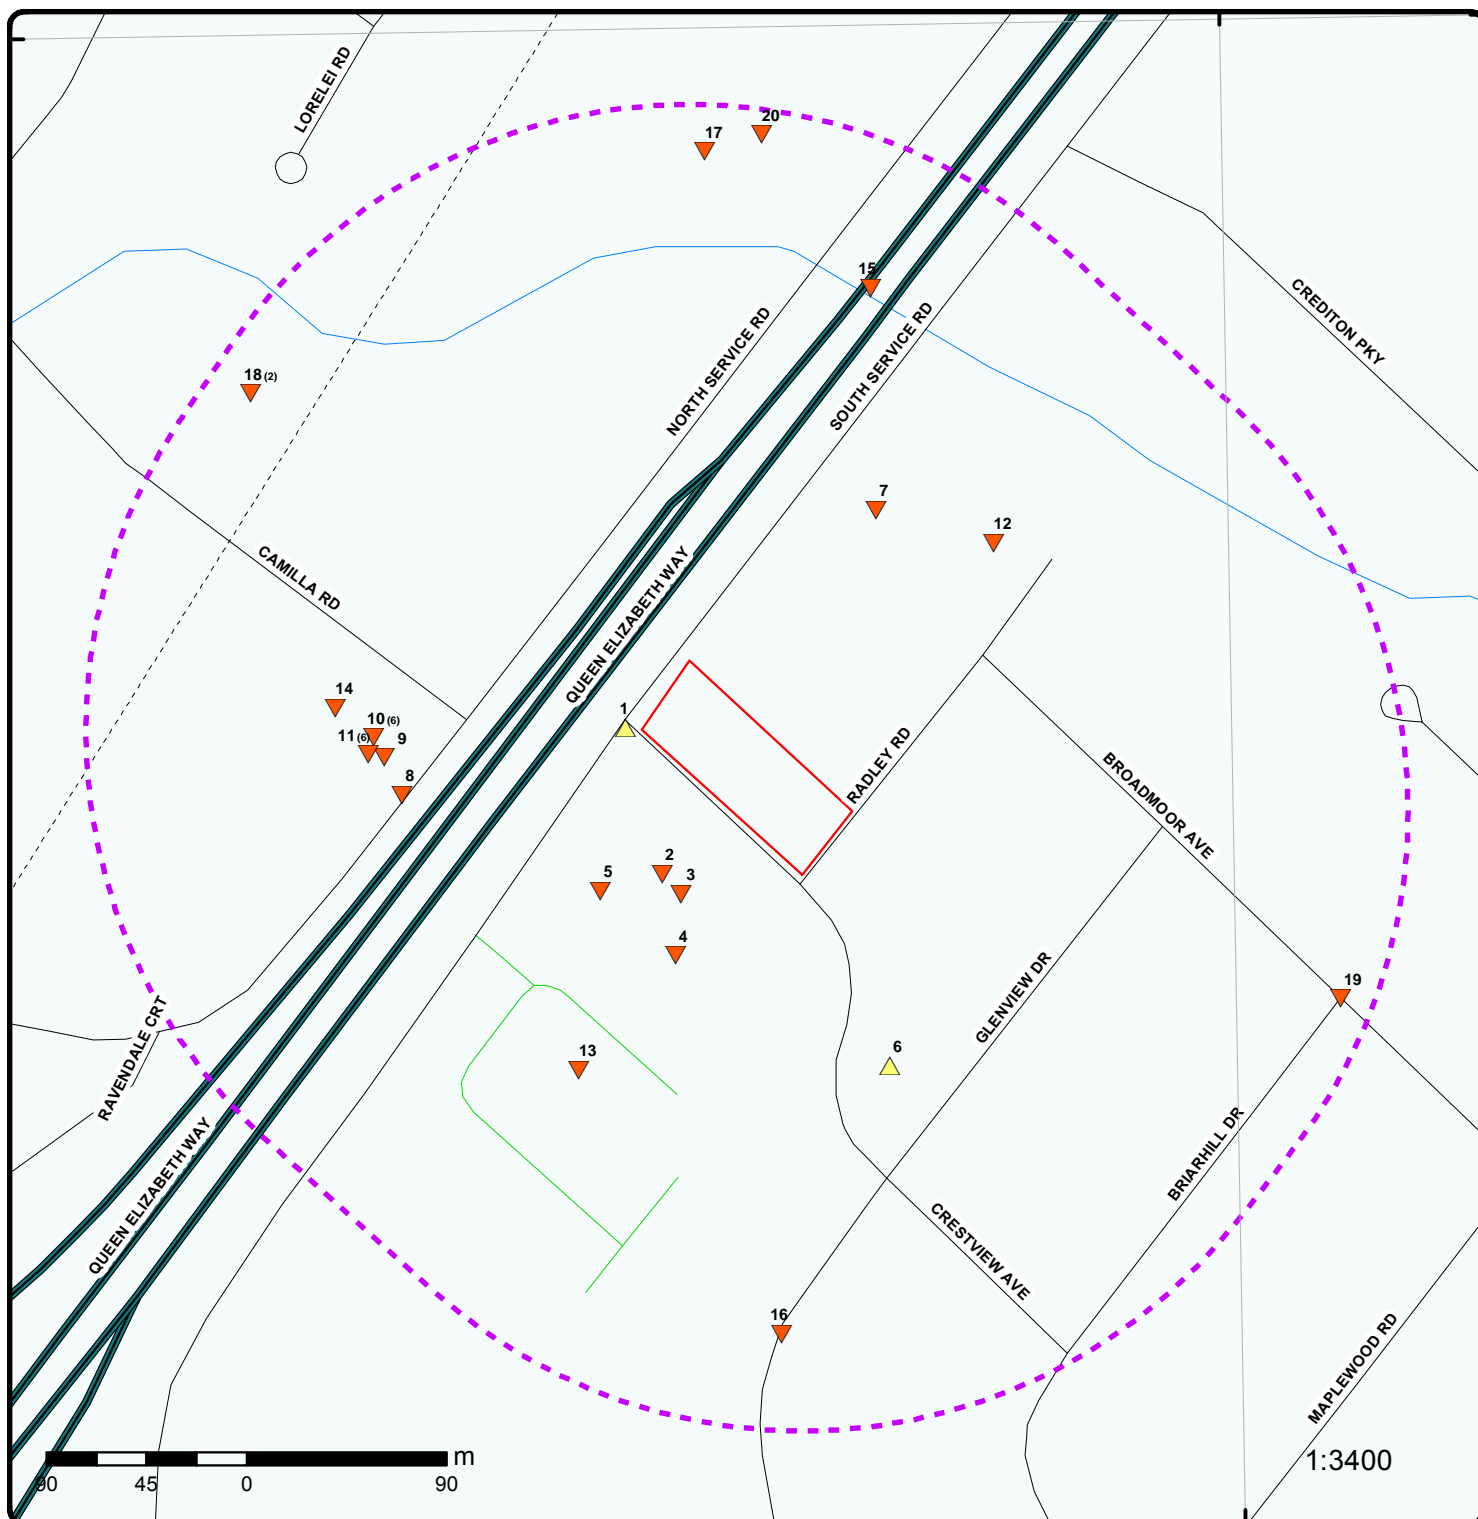
Map : 0.25 Kilometer Radius

<u>Site</u>	<u>Address</u>	<u>Distance (m)</u>	<u>Map Key</u>
	MISSISSAUGA ON	64.9	<u>4</u>
	Mississauga ON	66.2	<u>5</u>
	ON	111.6	<u>8</u>
	Mississauga ON	116.4	<u>9</u>
	MISSISSAUGA ON	138.0	<u>14</u>

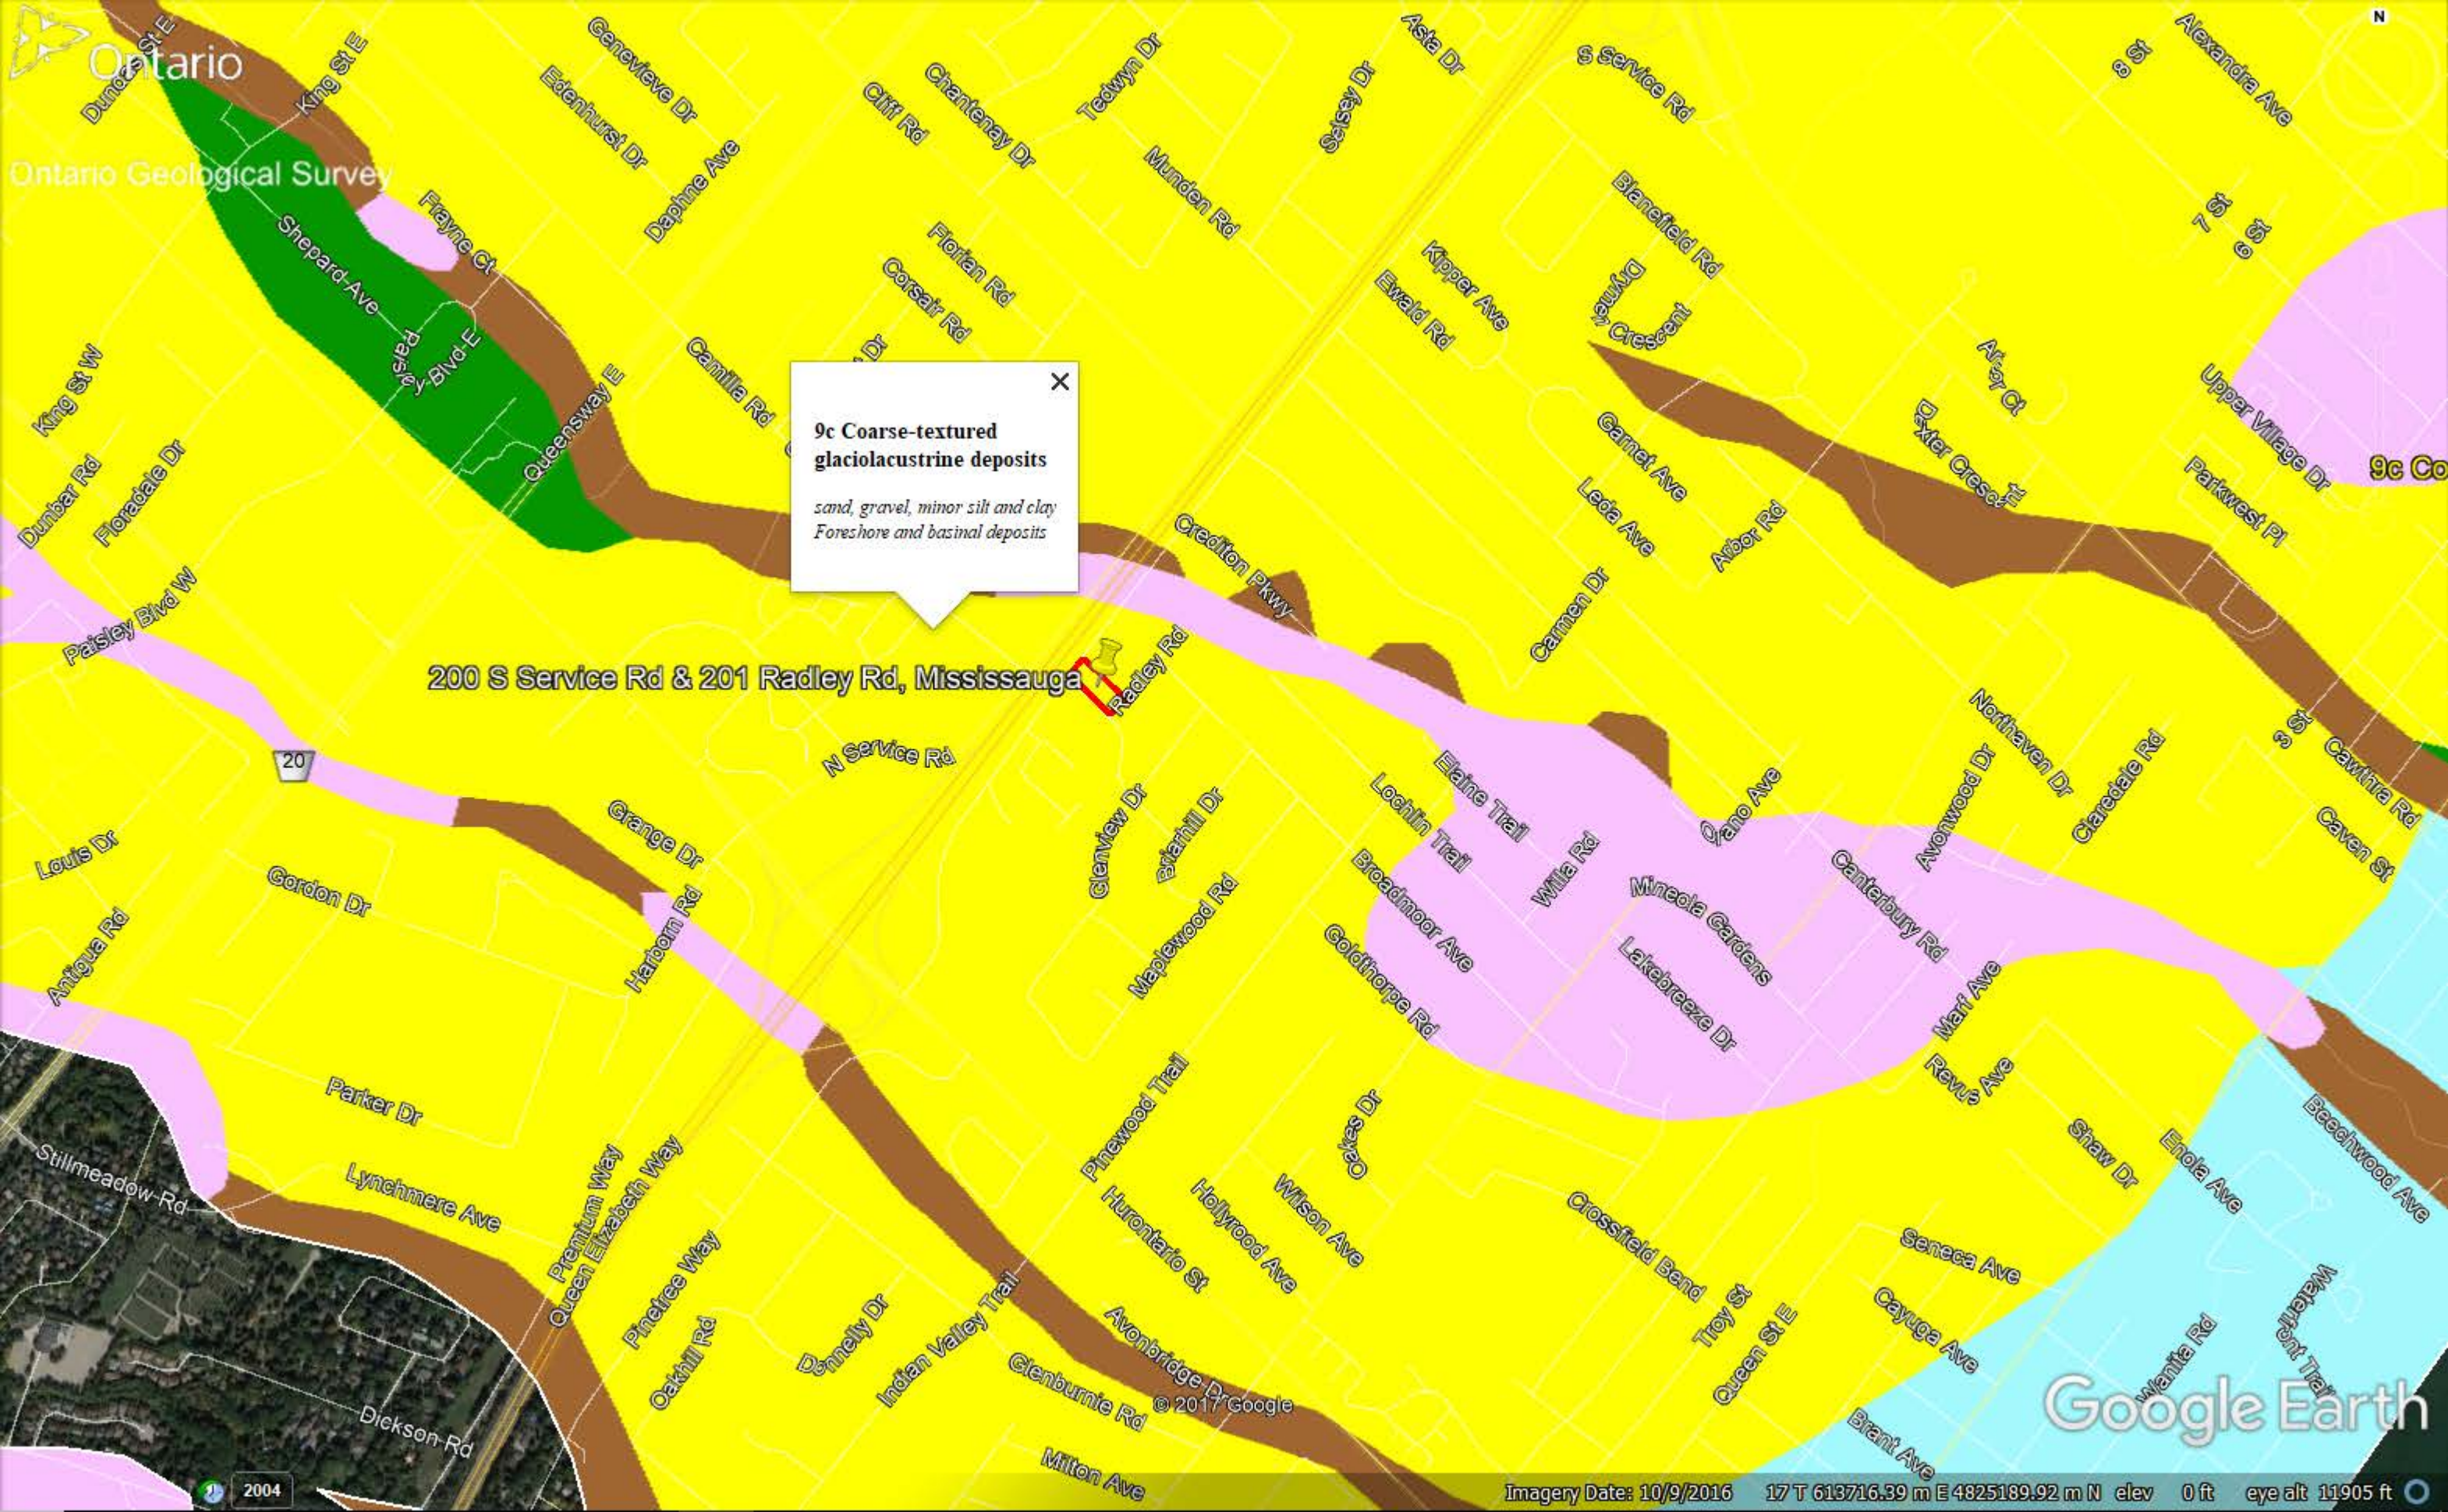
**9c Coarse-textured
glaciolacustrine deposits**
*sand, gravel, minor silt and clay
Foreshore and basinal deposits*

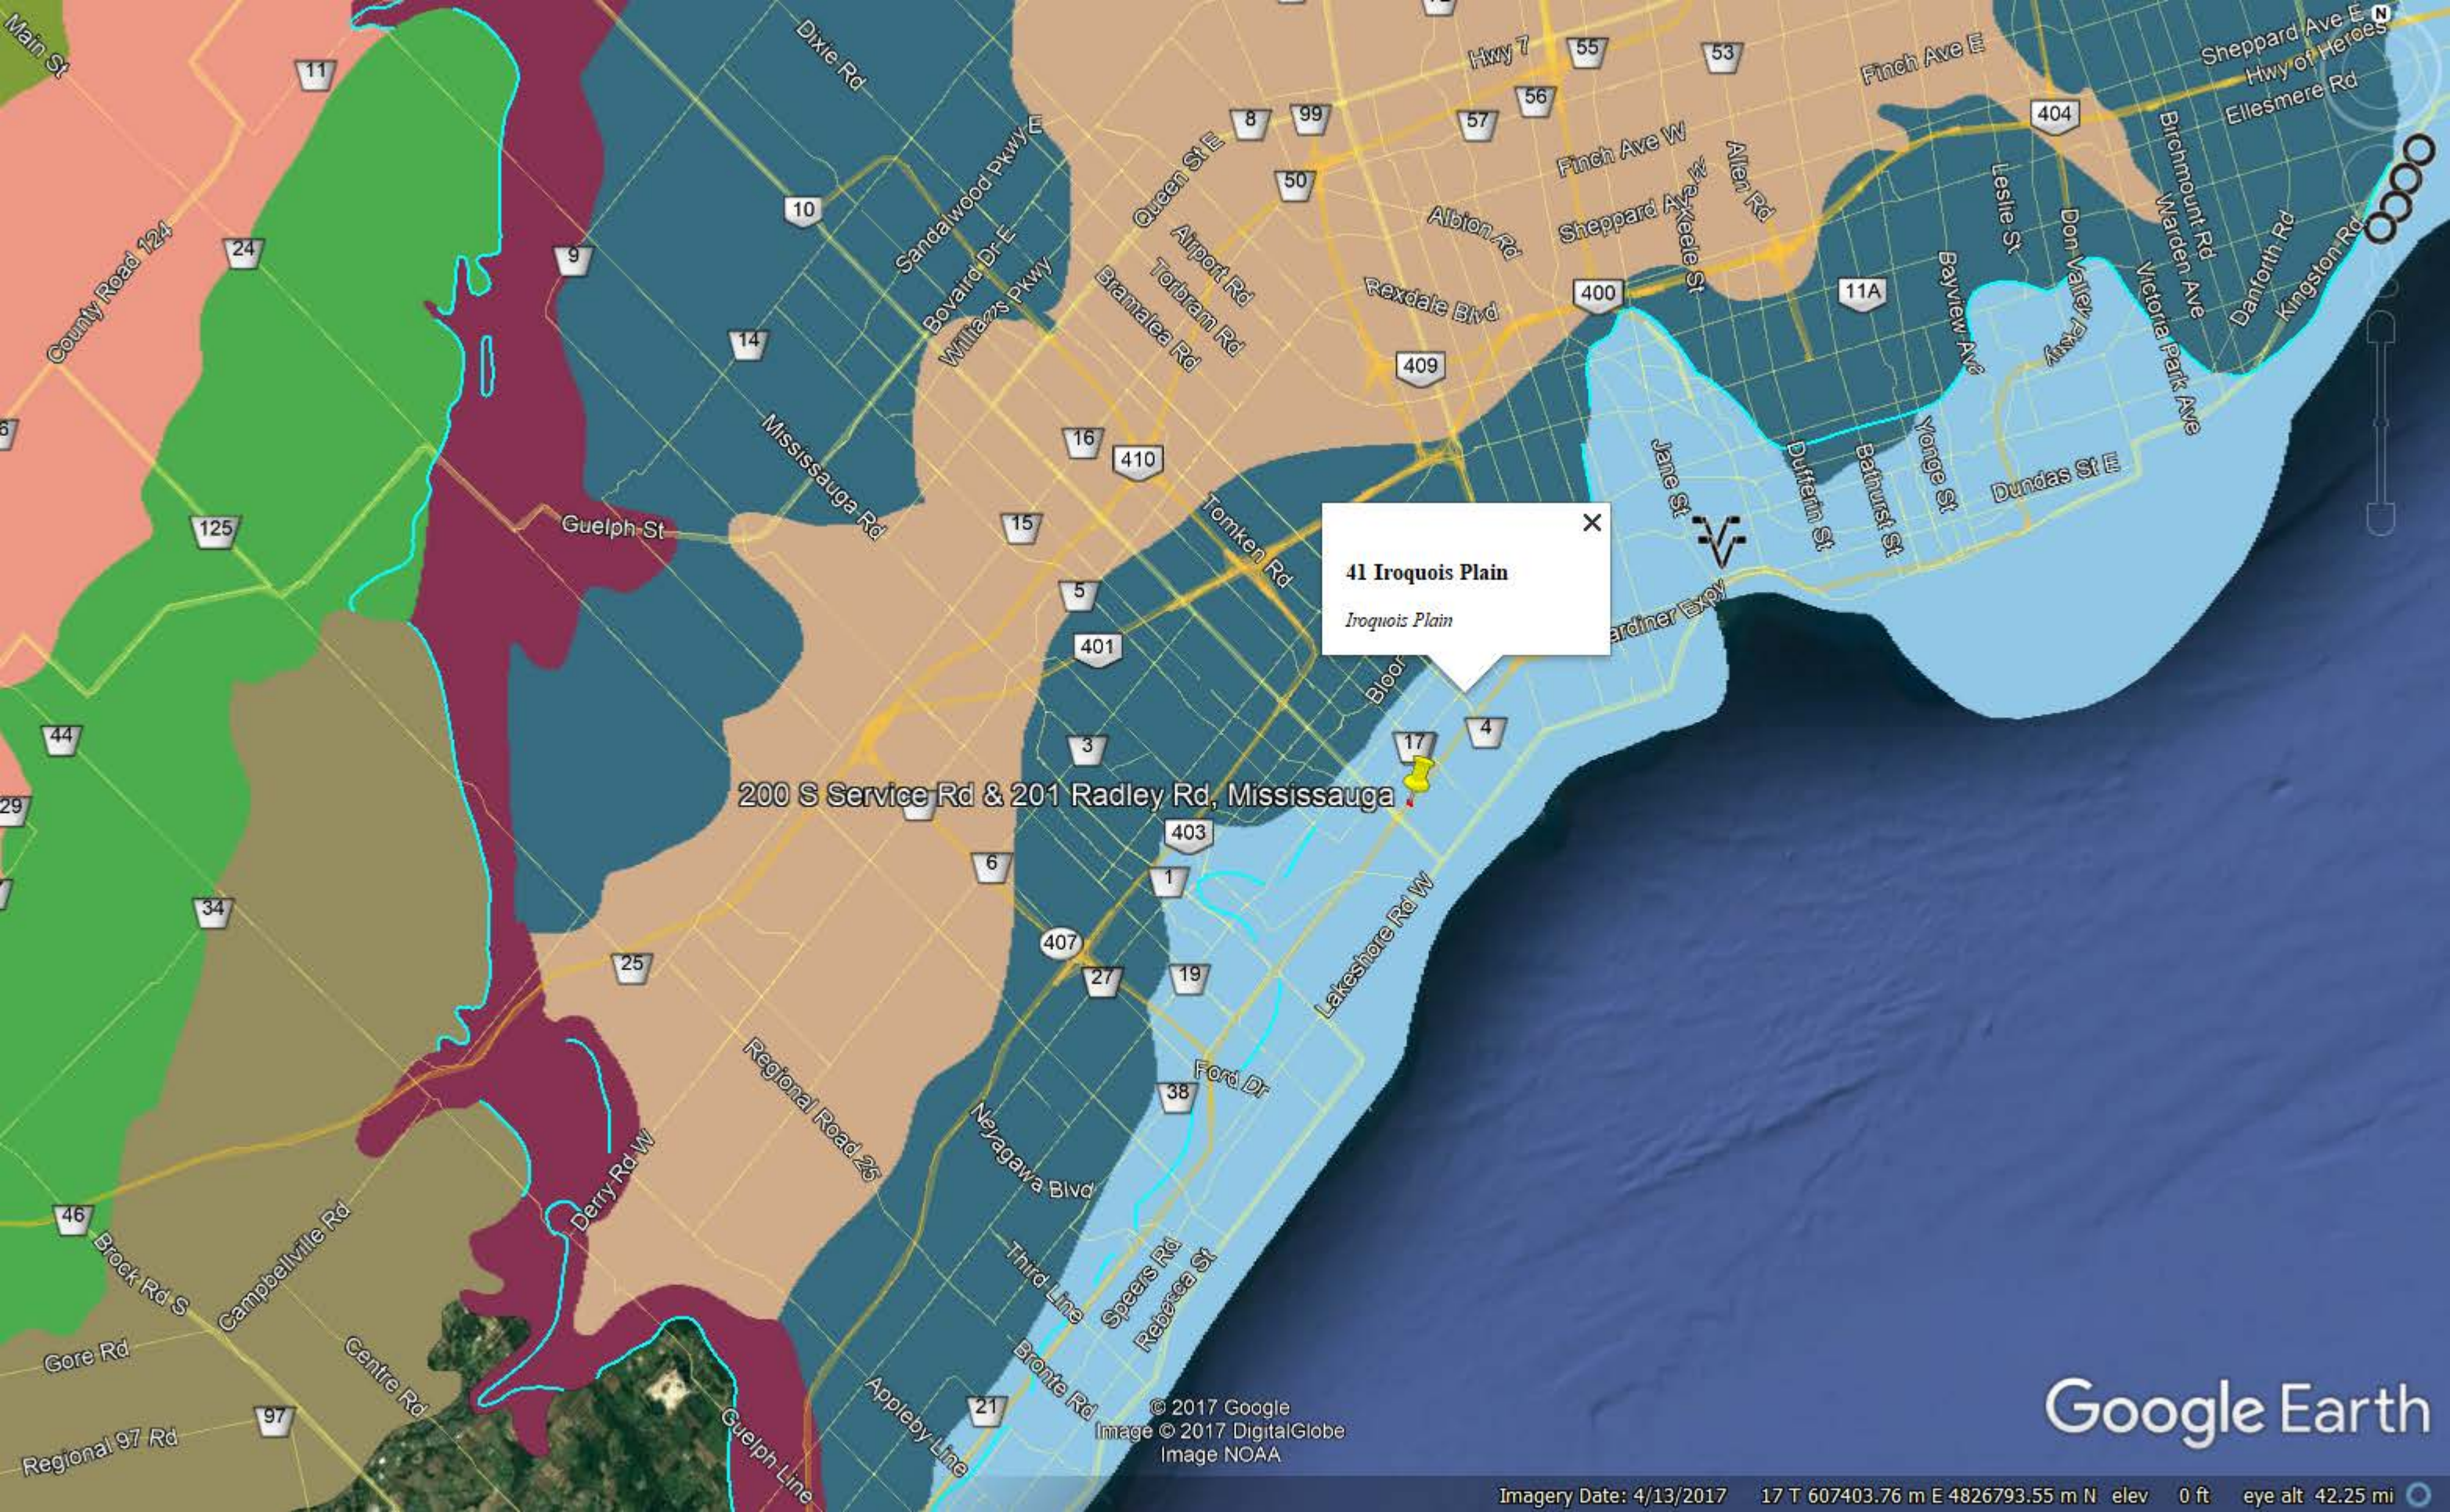
41 Iroquois Plain
Iroquois Plain
