Phase 1 Environment Site Assessment Update  
2103, 2107, 2113, 2119 Primate Road,  
1351 & 1357 Wealthy Place and  
2116 & 2122 Dixie Road, Mississauga

**PHASE ONE ENVIRONMENTAL SITE ASSESSMENT - PRIMATE ROAD, WEALTHY PLACE, DIXIE ROAD, CITY OF MISSISSAUGA**

Bruce A. Brown Associates Limited completed a Phase I Environmental Site Assessment Update on the eight lot assembly of single-family properties on Wealthy Place, Primate Road and Dixie Road, City of Mississauga. The purpose of this investigation was (1) to conduct an assessment to determine whether there are any adverse environmental conditions which may require mitigation to meet current regulatory requirements, (2) to determine whether any environmental condition exists which may adversely impact the real value of the property, (3) to determine whether any designated substances or conditions exist which would require special care or management for the protection of personnel and disposal of materials during the demolition process, and (4) to provide base environmental information with reliance to a purchaser or developer, and/or a future mortgage lender, and to the City of Mississauga in the plans-approvals process.

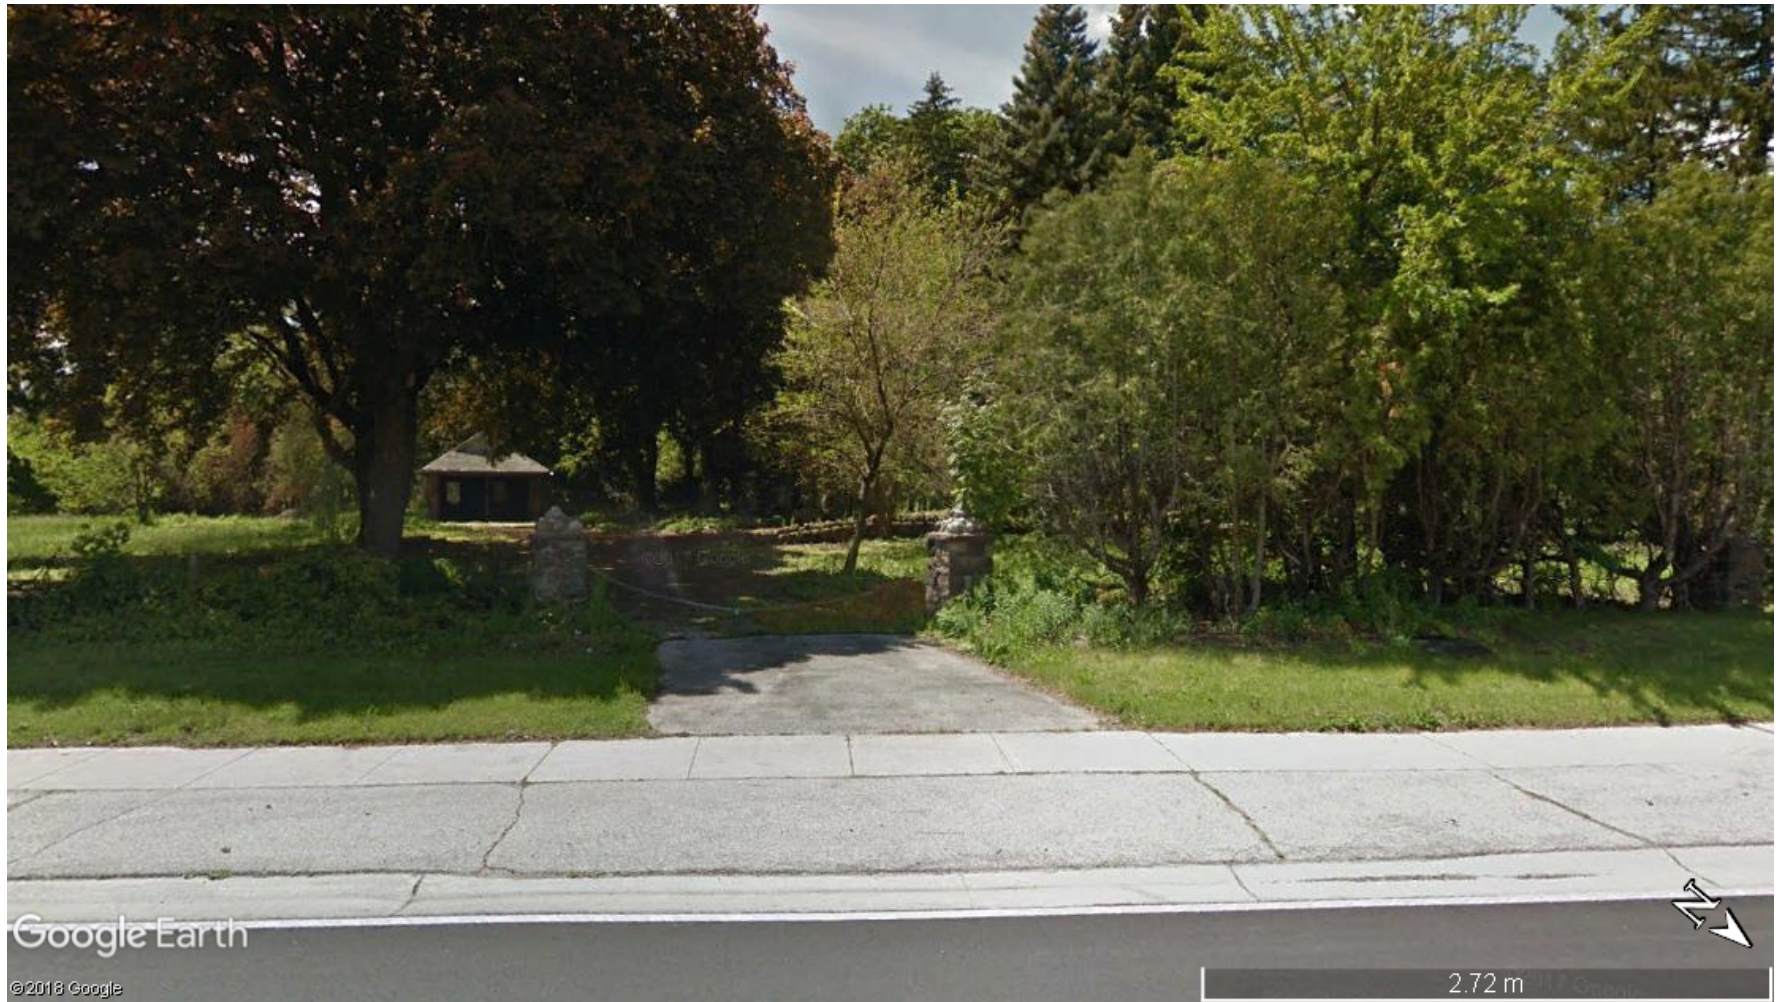
View to West - 2116 Dixie Road, Showing Residence has been Demolished (Google June 2017)

No changes are noted on the Phase One lands in air photo images available online from Google Earth for years, 2003, 2004, 2005, 2007, 2009, 2012, 2013, 2014, 2015, or 2016. The residence and garage at 2116 Dixie remained present in all images and were noted as demolished by June 2017 in streetscape coverage by Google.
