PHASE ONE ENVIRONMENTAL SITE ASSESSMENT **6710 HURONTARIO STREET** MISSISSAUGA, ONTARIO

SIRATI & PARTNERS CONSULTANTS LIMITED

Project: SP18-347-20-01 March 27, 2019

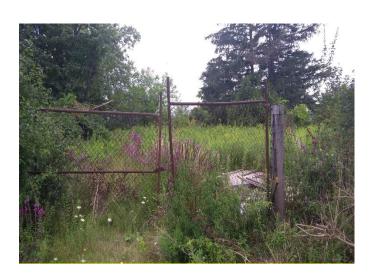
Photograph 1

| Location: | 6710 Hurontario Street | | | |
|---|---|--|--|--|
| Description: | View of the entrance to the Property from Hurontario Street. | | | |

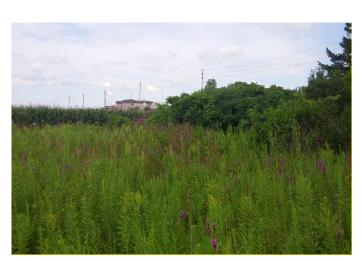
Photograph 2

| Location: | Phase I Property | | |
|---|---|--|--|
| Description: | View of the west portion of the Property, looking towards the east. | | |

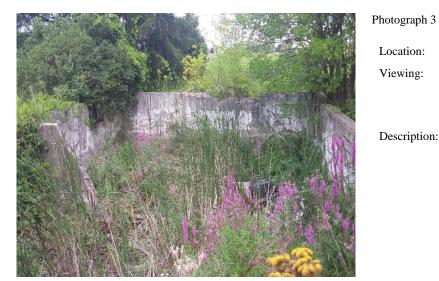
| Location: | East portion of the Property |
|---|---|
| Description: | View of the former residential building with one (1) level of basement. The building was not backfilled, and concrete foundation and some debris were observed on the east portion of the Property. |

Based on the findings of the Phase One ESA, SIRATI recommends a Phase Two ESA to confirm the soil quality at the Property.

The Property historically has been used for agricultural and residential purposes. During the site inspection, it was noted that the former residential building had one (1) level of basement that was not backfilled after the demolition.

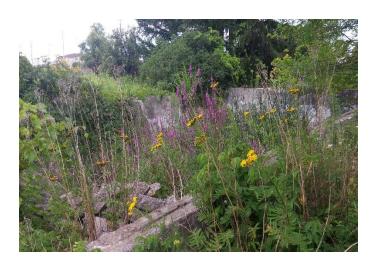
Photograph 4

| Location: | East portion of the Property |
|---|---|
| Description: | View of the concrete foundation of the former residential building. |

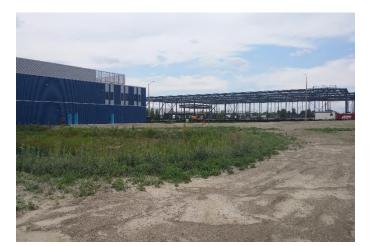
Photograph 5

| Location: | West portion of the Property |
| Viewing: | West |
| Description: | View of west portion of the Property. |
