Phase One Environmental Site Assessment

Sandalwood Square Shopping Centre, Mississauga, Ontario

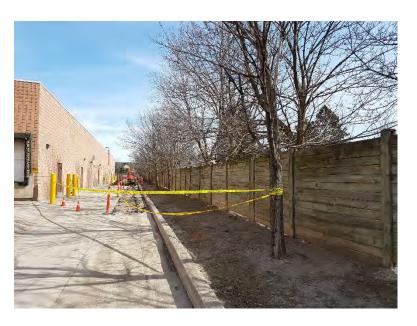
Photo 2 – View of the eastern property boundary and taped off area for excavation of new electrical lines.

- Buried hydro, natural gas and telecommunication wires are present on the Site. A utilities plan was not provided to Golder as part of this investigation. A trench to replace electrical lines which were damaged as a result of the on-Site fire had been excavated in the parking area along the southeast portion of the Site at the time of the Site visit. The trench was reported to be temporary, and the work area was taped off;

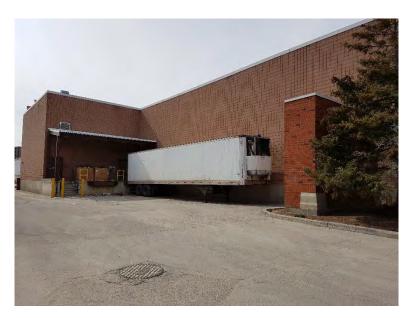
Photo 4 – View of loading dock area and vicinity of former UST to the east of Unit 701 70 Bristol Road East, occupied by Valu Village.

- The approximately 1,360 litre out-of-use UST, associated piping and underlying concrete slab located at 70 Bristol Road East were removed on January 13, 2011. The UST was reported to be in good condition upon removal;
- Approximately 11.5 tonnes of petroleum hydrocarbon ("PHC")-impacted soil was removed from Site for off-Site disposal. The excavation was reported to be approximately 3.7m by 4.6 m, and 2.1 m in depth. Confirmation floor and wall soil samples were screened in the field for evidence of contamination;
- S2S Environmental Inc. reported that no groundwater was encountered during the investigation;
- The excavation was backfilled with previously excavated (non-impacted) soil and imported granular "A" material on January 13 and 14, 2011;

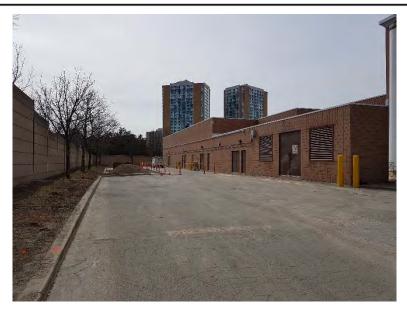
Photo 5 – Exterior view of the eastern side of 50-70 Bristol Road East including the door to the locked hydro vault.

Topic	Observations	Source
Potentially Contaminating Activity	A locked hydro vault (Alectra Utilities) was observed in the eastern side of 50-70 Bristol Road East. The hydro vault was not accessible at the time of the Site visit; however it is assumed that an oil-filled transformer is present within the vault. The operation of an oil-filled transformer at the Site is considered a potentially contaminating activity. The former presence and use of a diesel oil UST at the Site is considered a potentially contaminating activity.	Site observations, Previous Reports
Unidentified Substances	None identified.	Site observations

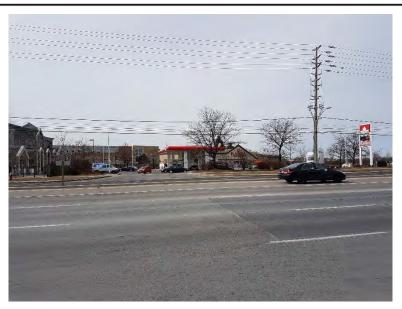
Photo 7 – View of the Petro Canada gas station located approximately 40 m southwest of the Site at 20 Bristol Road West.

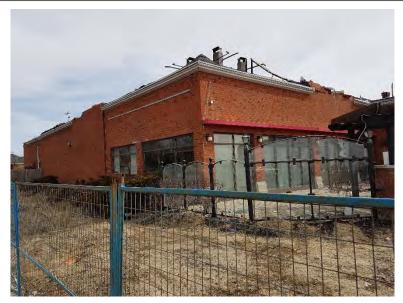
Photo 9 - View of 30 Bristol Road East, which was inaccessible due to a recent fire.

Caller reports fire in restaurant. Involves front entrance area which appears to be for storage/ freezer. Likely not gas related but this has not been confirmed. Fire affected other three units in building. Mostly water damage. Roof tops exposed to fire. The unit housing CIBC bank was not heavily impacted. Three units had gas capped at manifold and CIBC had the gas shut off. All four received a warning tag. No injuries, the 4 units were evacuated and media, CP 24, was on site.
