Heritage Advisory Committee

2016/10/11

1. *That the property at 1216 Mississauga Road, which is listed on the City's Heritage Register, is not worthy of heritage designation, and consequently, that the owner's request to demolish proceed through the applicable process.*
 2. *That prior to demolition, the owner provide measured drawings of the structure currently on the property as described in the corporate report.*
 3. *That the owner provides a demolition documentation report with information as described in the corporate report.*
- 7.2. Request to Demolish a Heritage Listed Property: 243 Oakhill Road (Ward 1)
Corporate Report dated September 15, 2016 from the Commissioner of Community Services.

That the property at 243 Oakhill Road, which is listed on the City's Heritage Register, is not worthy of heritage designation, and consequently, that the owner's request to demolish proceed through the applicable process.

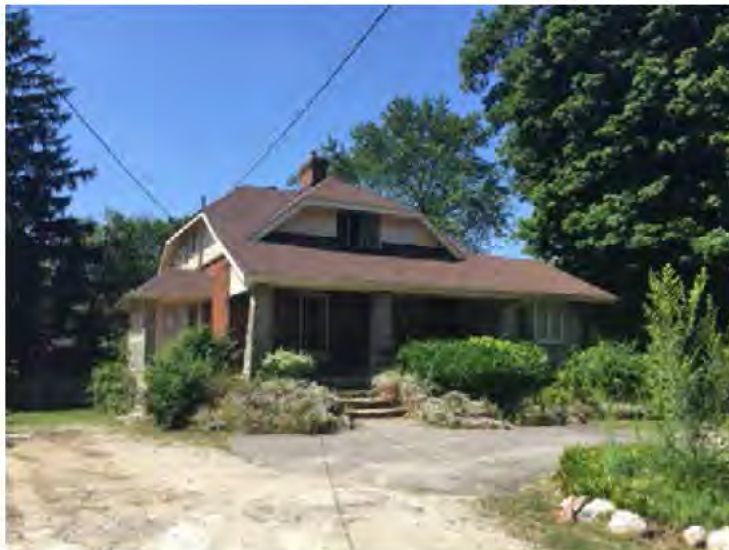
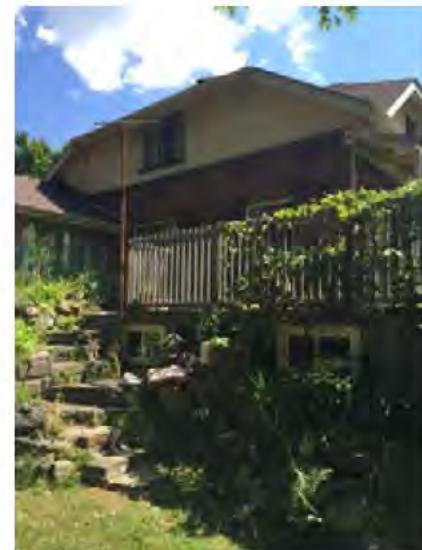
Left: View of the house at 1216 Mississauga Road from the front yard looking west. Right: View from the backyard (west corner) looking east.

The house has a compact square plan and the roof has a cross-gable with four clipped gables. There is a deep porch across the front façade. The roofline extends over the front porch and is supported by rugged stone pillars with a tapered profile. Some modifications to the original house were noted at the site visit and confirmed later with archival research. The porch has been extended beyond the corner of the house on the north side and has been enclosed to create a small sunroom off the main living room. A covered side entrance was added on the east side.

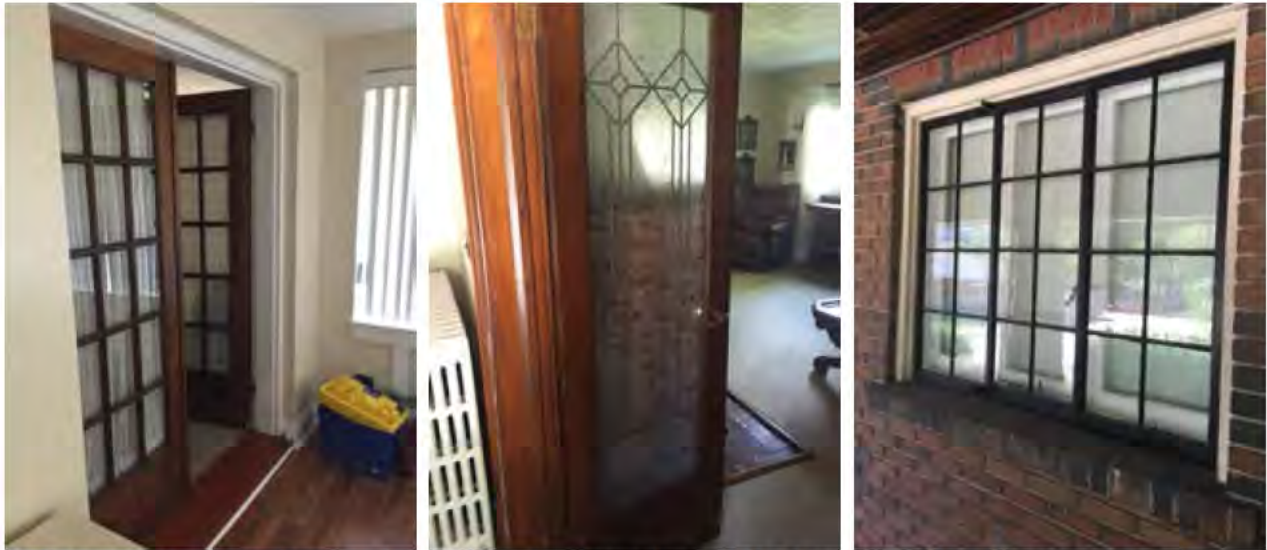
Left to right: Interior doors and one of the front windows of the house at 1216 Mississauga Road.

The foundation is concrete block with a decorative bevelled margin, typically referred to as a 'panel' style block. The walls are clad with red brick with stucco in the front gable. The brick has a rough textured surface and is pre-dominantly red brick with an even colour, but there are random patches of darker brick, referred to as 'clinker' brick because the bricks are over-fired and therefore burnt and blackened on the surface. There are also some units that have patches of bright red glaze applied to the surface for decorative effect, in the lintels above the door and windows on the main façade, and in a few other random locations.

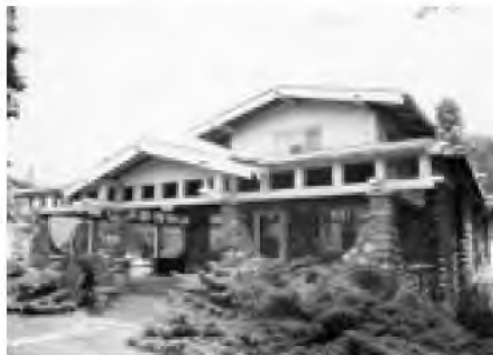
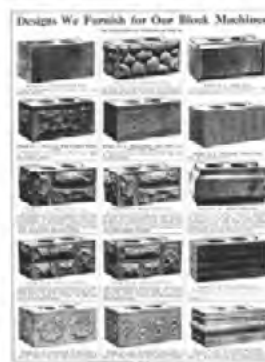
Left: A Designated Craftsman Bungalow c. 1925 by a David Stevenson a local builder and entrepreneur (Bolder Villa in Clarkson). Right: 1917 Sears Catalogue displaying concrete block machine face plates, top right example showing a Panel Front.

While not entirely successful, the cladding materials reflect the Arts & Crafts inspired taste for hand-crafted rustic materials that is associated with the Craftsman Bungalow. These features were quickly standardized and mass-produced in North America to satisfy the large demand for relatively inexpensive and easily constructed middle-class housing. Designs for modest houses very similar to the subject property appeared in architectural and popular magazines in the 1920's and 1930's and entire kit houses could be ordered by catalogue from Sears and shipped to a building site to be easily assembled without

the need of specialized trades.⁴⁹ The concrete blocks for the foundation could be made on site with a simple block-making machine like those distributed by the Ideal Block Company in London, Ontario.

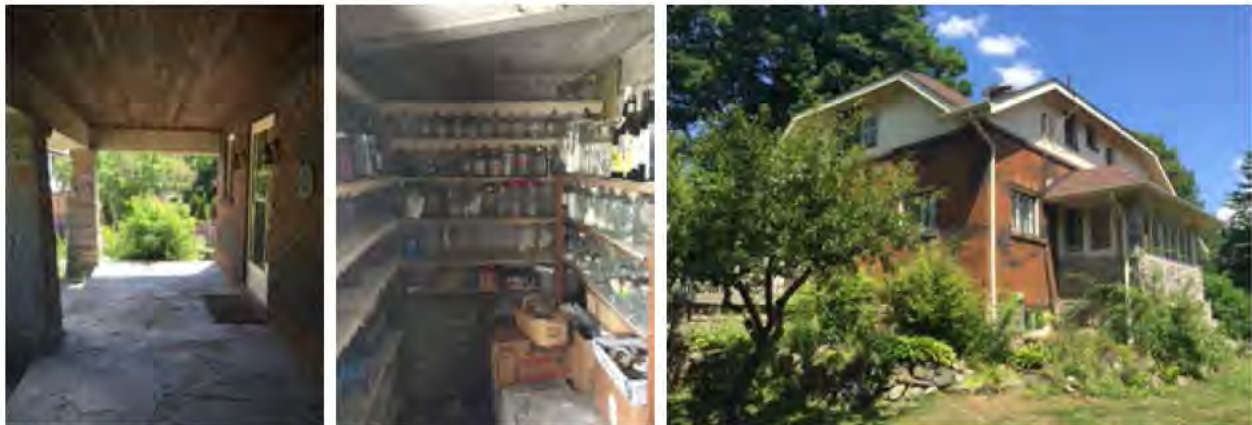
There is a side entrance on the east elevation that contains a small room opening into the kitchen. Again, the stone is closely matched, but investigation of the foundation indicated that this was added to the main block after it was constructed. It has a rubble stone foundation instead of concrete block, and the original exterior wall of the house is visible in the cold room located in the basement below it.

There is a garage on the basement level that is attached to the southwest corner of the house. Again the original exterior wall of the house was visible in this area, indicating the garage was added later, sometime before 1952 when it appears on the Fire Insurance map.

Left to right: Front veranda, cold room and view of the house from the south (eastern) corner of the property.

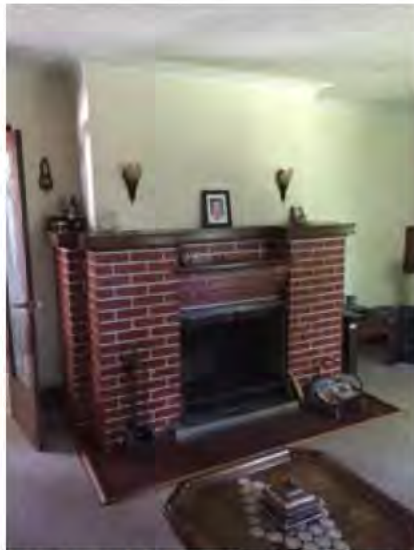
Left to right: Fireplace in the living room, kitchen and one of the upstairs bedrooms.

The interior contains features that are associated with the Craftsman Bungalow style, such as the simple wood baseboards and trim used throughout and the brick fireplace with a plain wood mantle in the living room. (The fireplace bricks have been painted, so their original appearance could not be determined). In the front hallway, there is a built-in seat at the base of the stairs. This feature recalls, on a very limited scale, the elaborate wood panelling and built-in furnishings and fixtures associated with Arts and Crafts interiors. The walls and ceilings in the front hall and the stairwell have a heavily textured plaster finish. The brass light fixture in the front hall appears to be original and has a very simple cylindrical form. The interest in simplicity and the display of the traditional handcrafted building arts (ie; carpentry, brick-laying, plastering, metalwork) reflects the Arts & Crafts ideology that filtered down into the Craftsman Bungalow on a very modest and simplified scale.

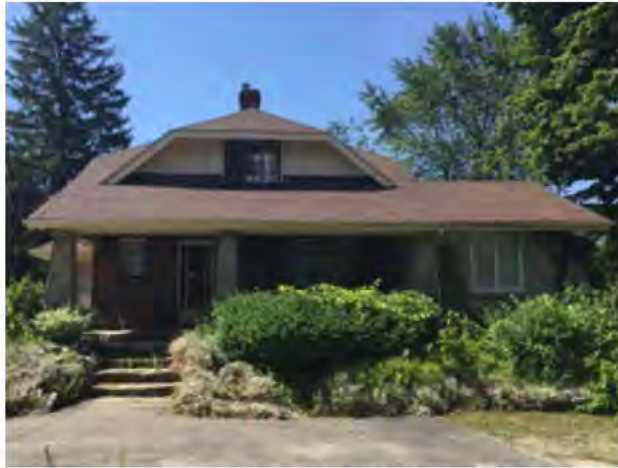
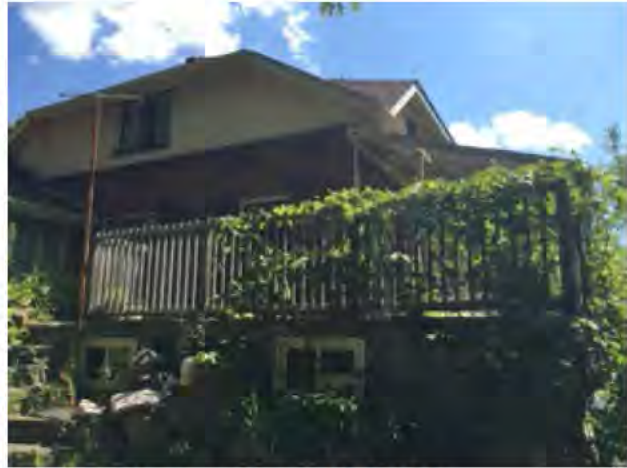
The existing house at 1216 Mississauga Road, which the Wrights owned from 1937-1973.

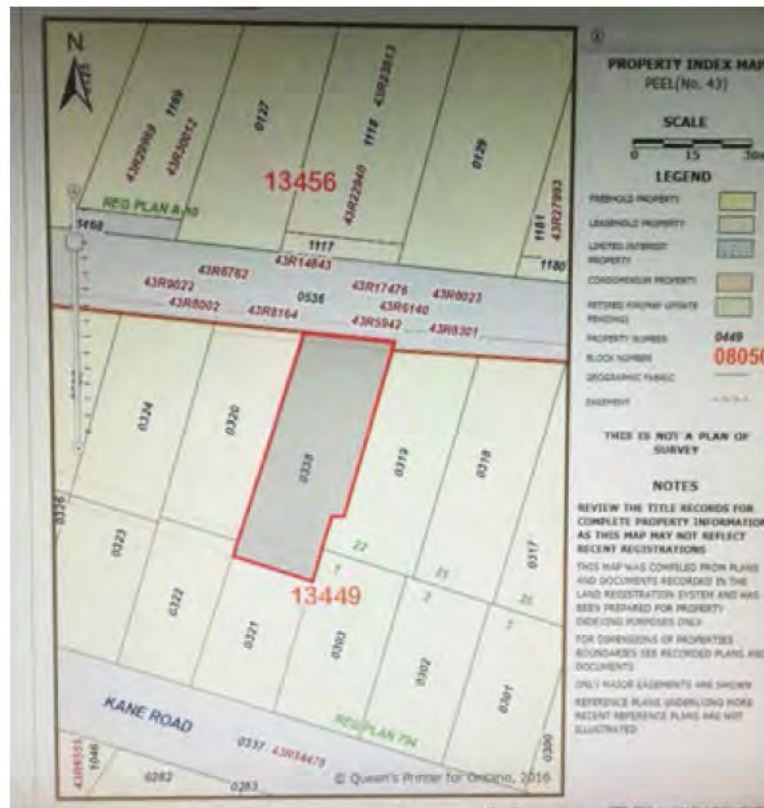
Property Index Map - Part of Lot 8, Range One, CIR, Toronto as in RP 43R8164 Parts 2,3,4,8,9,10

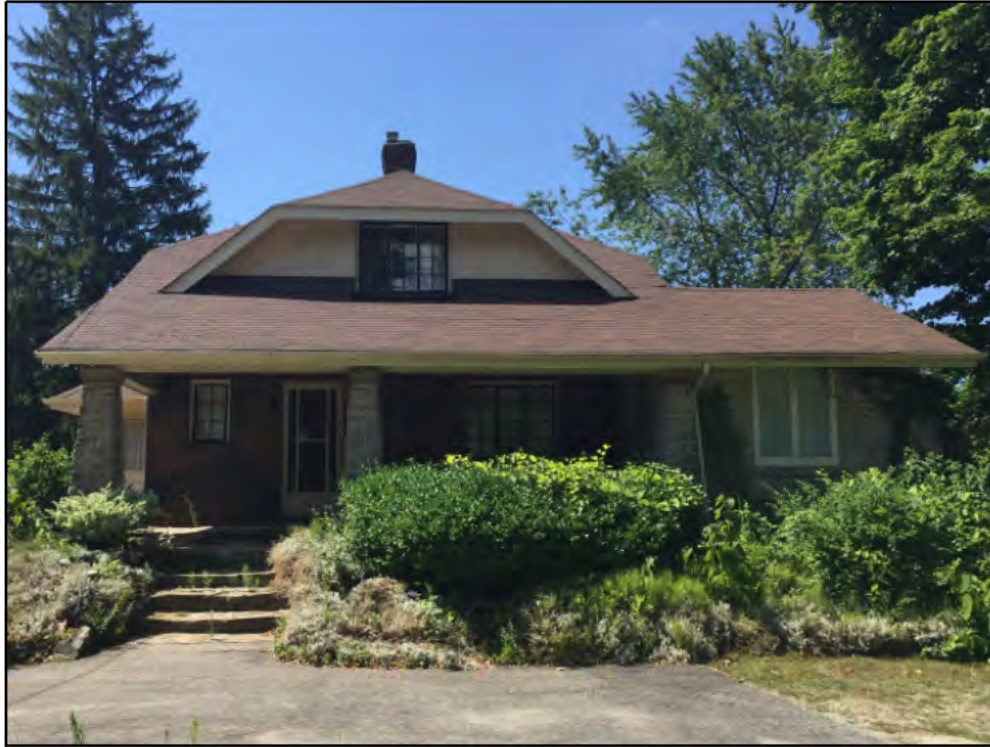
Plate 1: View of front of house looking south from driveway

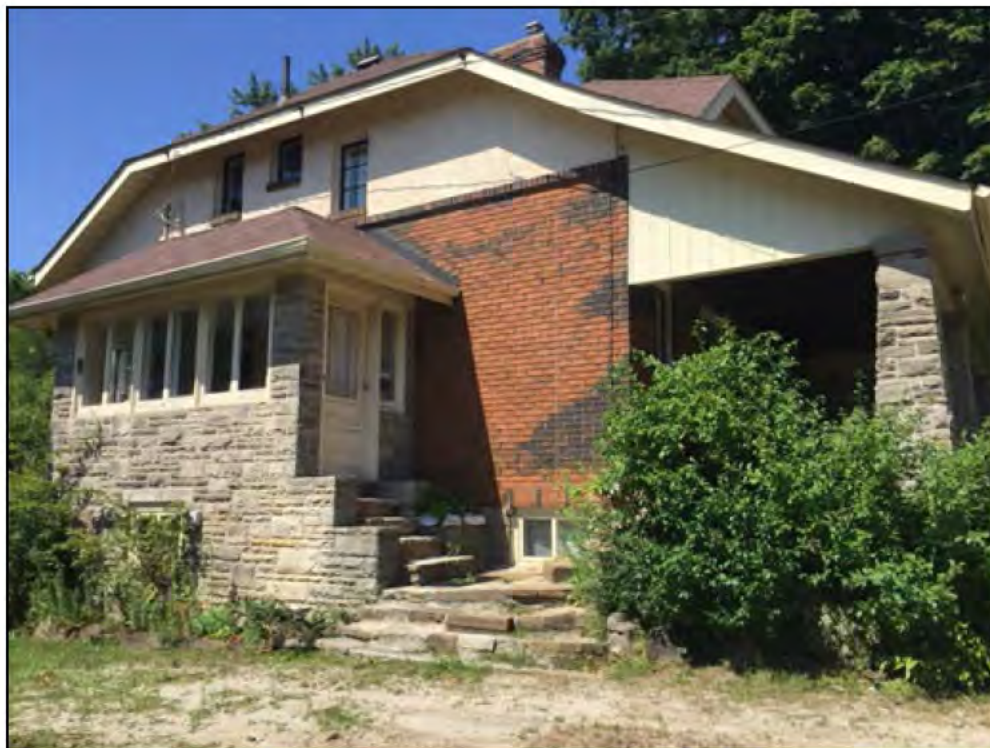
Plate 2: View of side of house looking southwest from driveway. The side entry was not part of the original bungalow. The stone was carefully matched but the windows are wood framed and single paned and are grouped like a strip window.

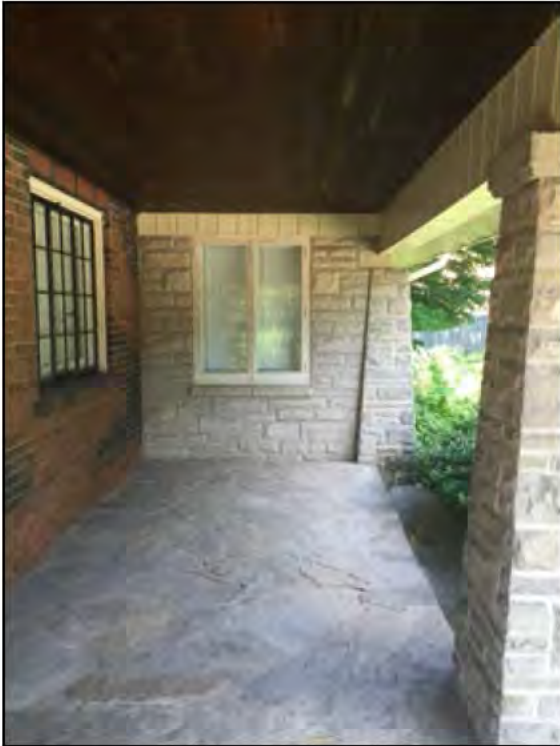
Plate 3: View of verandah looking west. The sunroom juts out so that the porch is enclosed at the west end. This room was not part of the original bungalow. The stone work was carefully matched but the windows are wood frame casements with single panes.

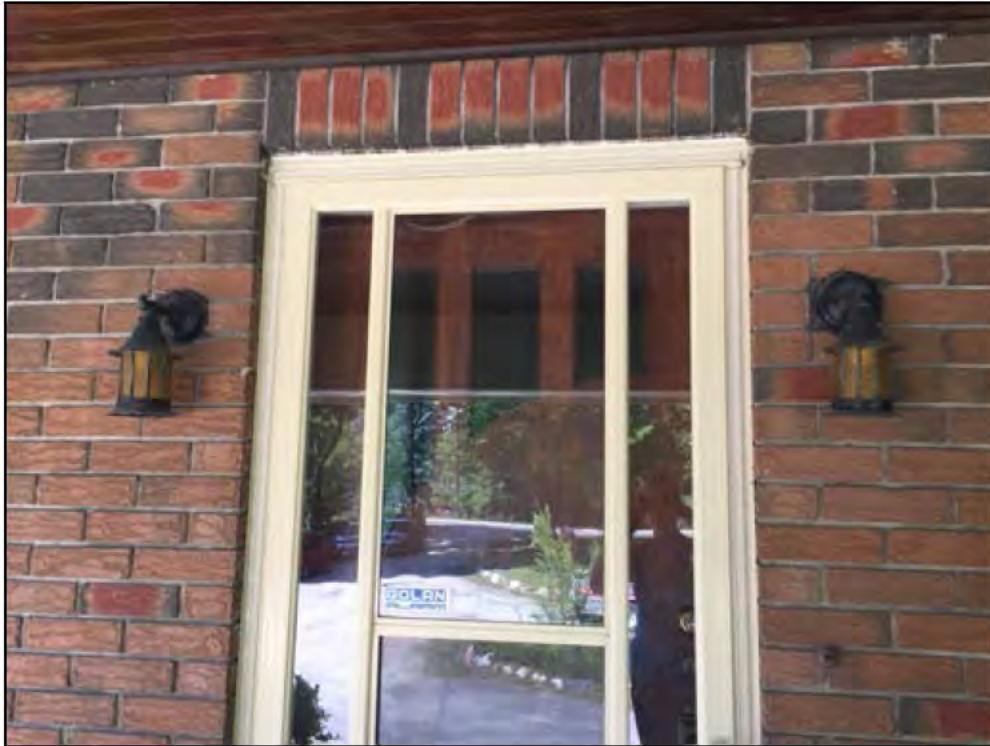
Plate 5: Front door detail. A specialty brick is used for the caldding of the original bungalow. It has a textured surface and varied colouring.

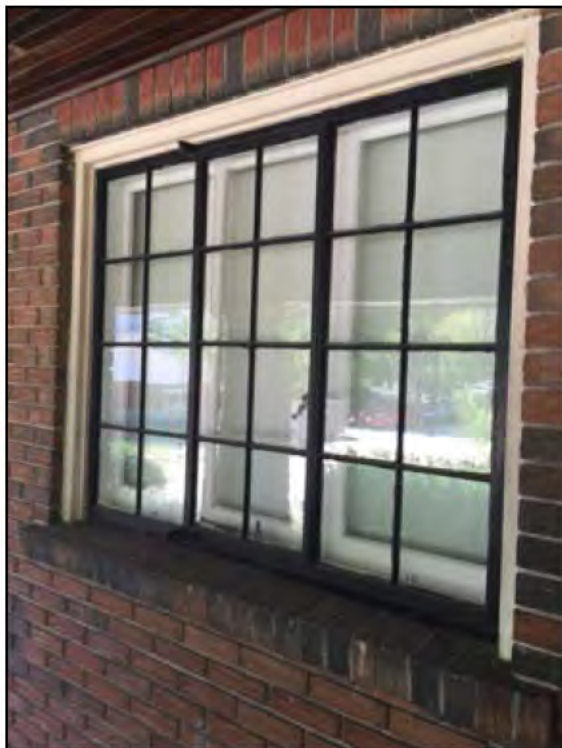
Plate 6: Front window detail. The original bungalow has metal casement windows.

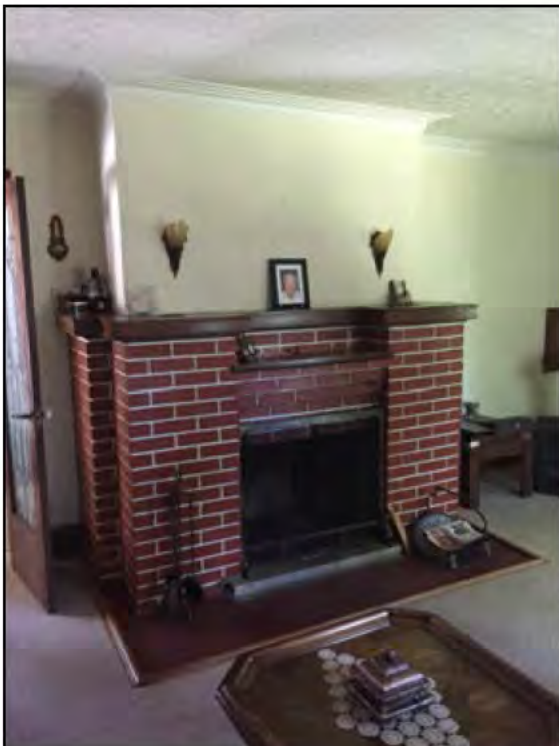
Plate 8: Fireplace in living room. The brick has been painted.

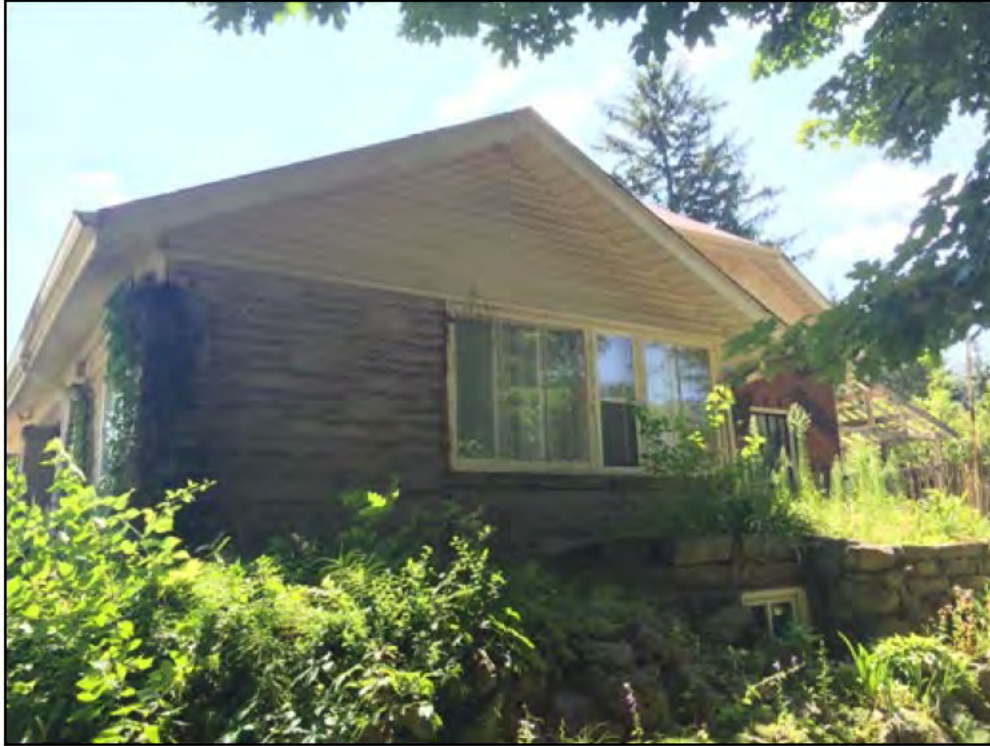
Plate 41: West face of house, additional room (looking southeast from west edge of property). The sunroom was added to the original bungalow.

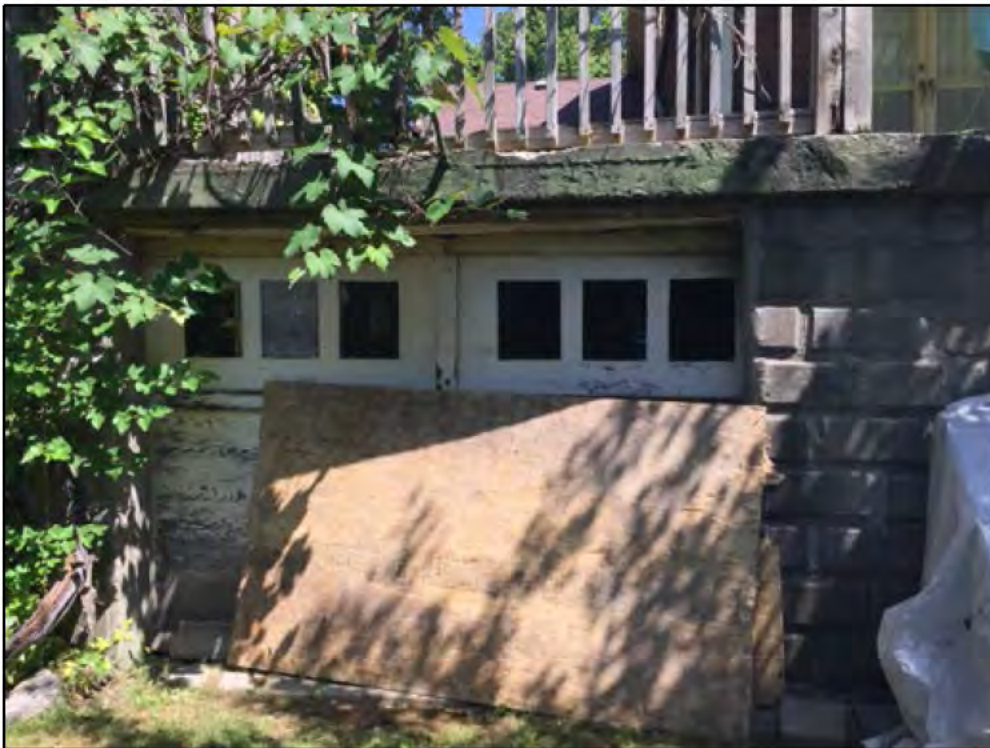
Plate 46: Outside of
garage doors. The
garage was added to
the original
bungalow.

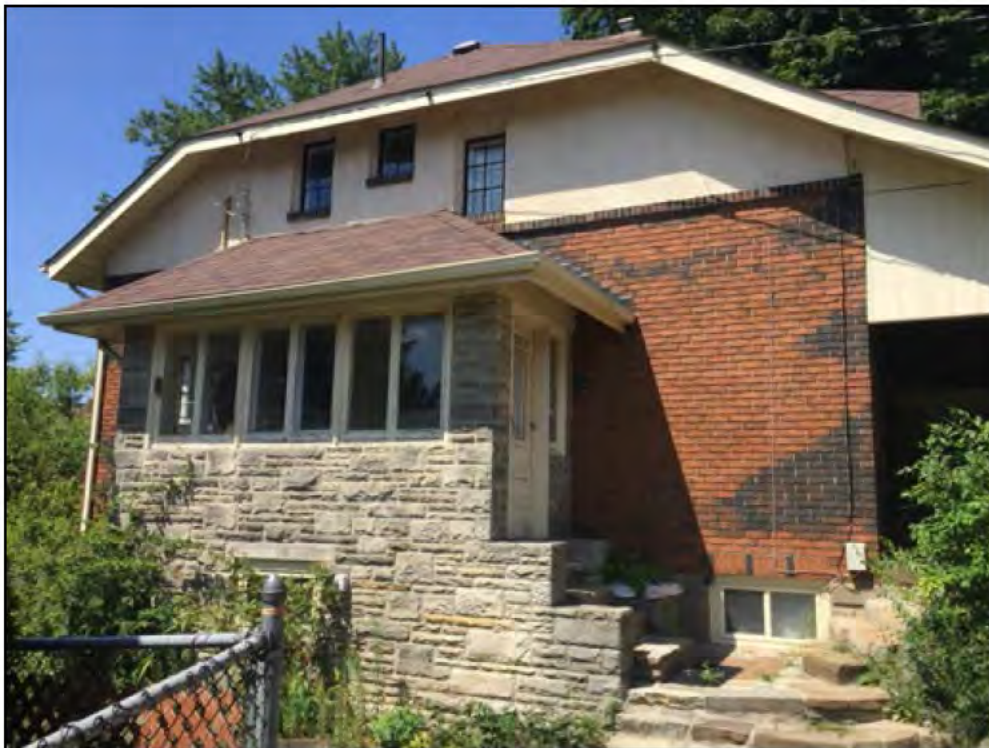
Plate 48: East face of building (viewed from east edge of property) The side entry was added to the original bungalow.

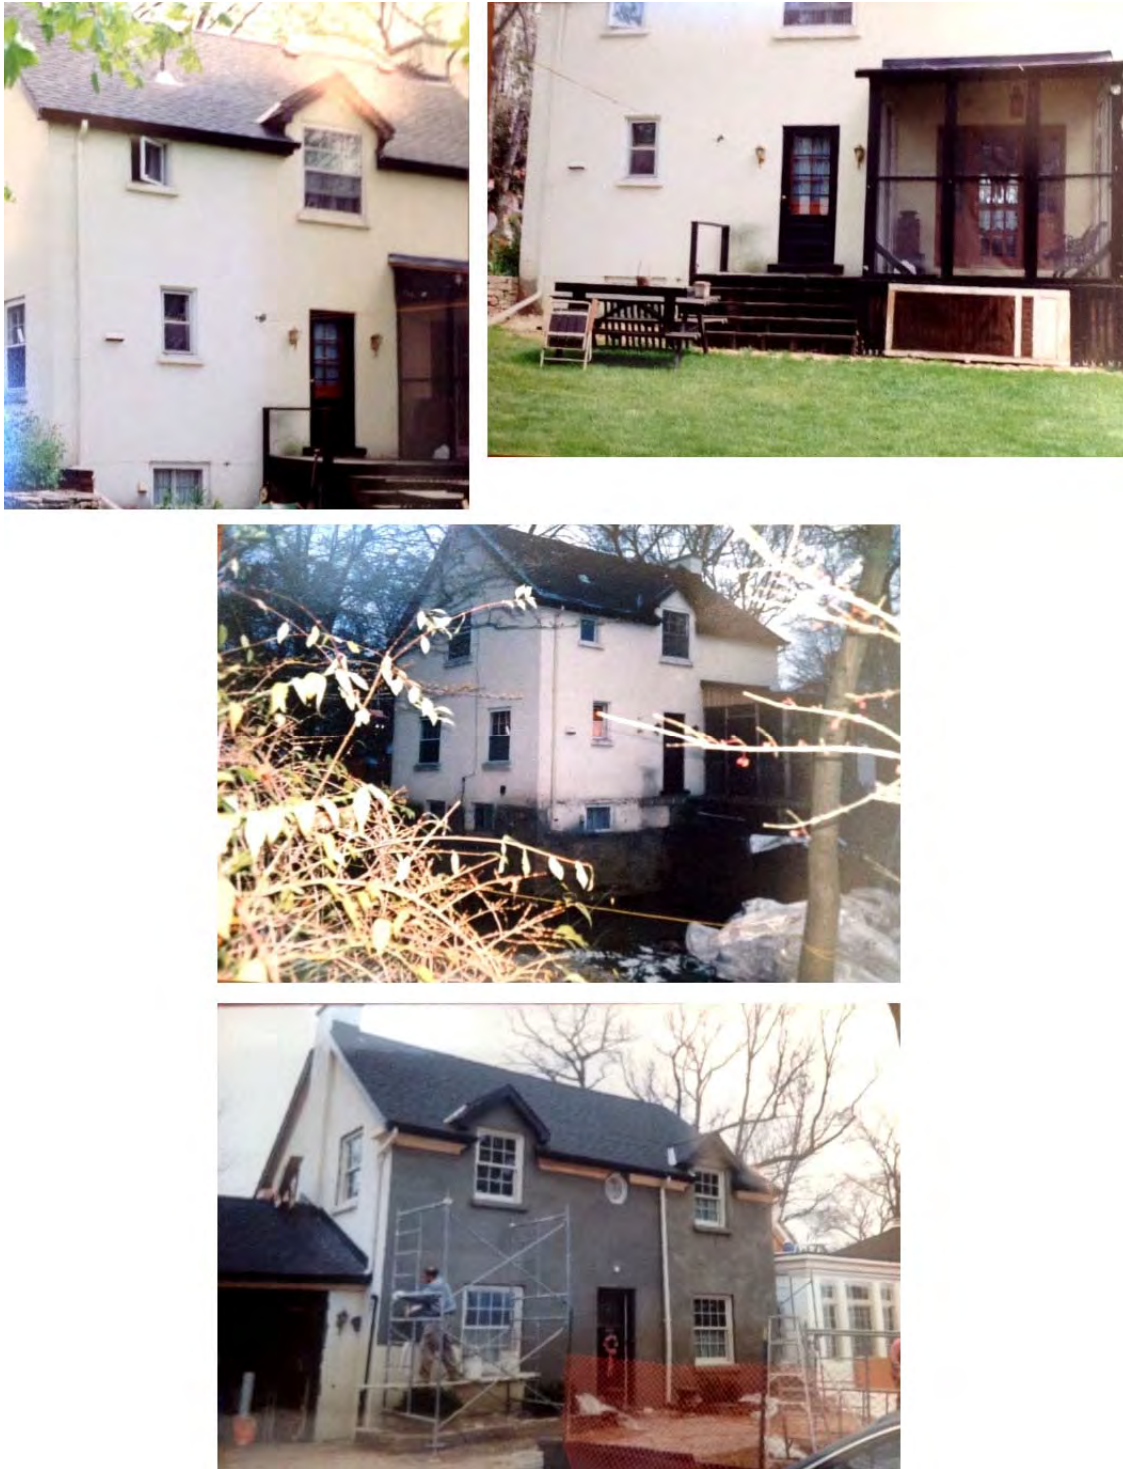
Figure 13: Photos taken by the current owners in 1995, just prior to and during the construction of the addition. (top). Shows the original rear façade, deck and screened porch, an added wood storm door. (middle) Shows the original east façade with its two exposed basement windows, when excavations for the new foundation were underway. (bottom) Shows the new wood trim added to the eaves, and stucco work in progress and the front façade of the unfinished addition.

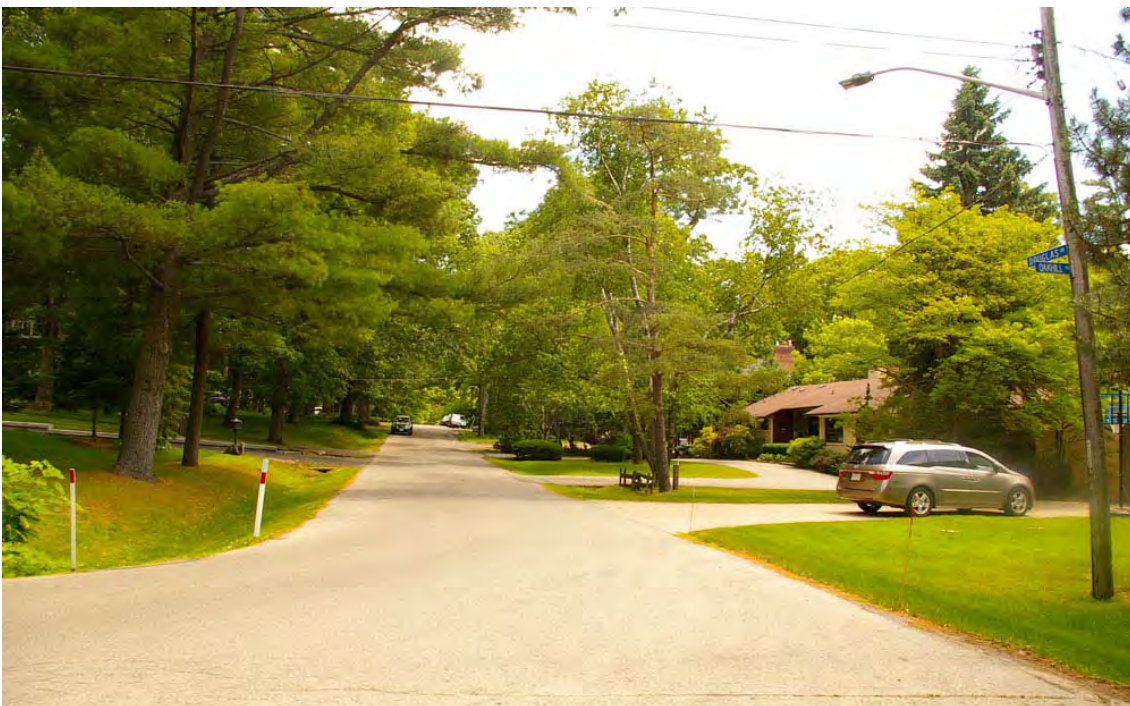
Photo 4: Douglas Drive looking south-east from the corner of Oakhill. The original ditch and culvert method of drainage still exists on the east side of the roadway, which was part of the original plan of subdivision. (G 2-7-2016)

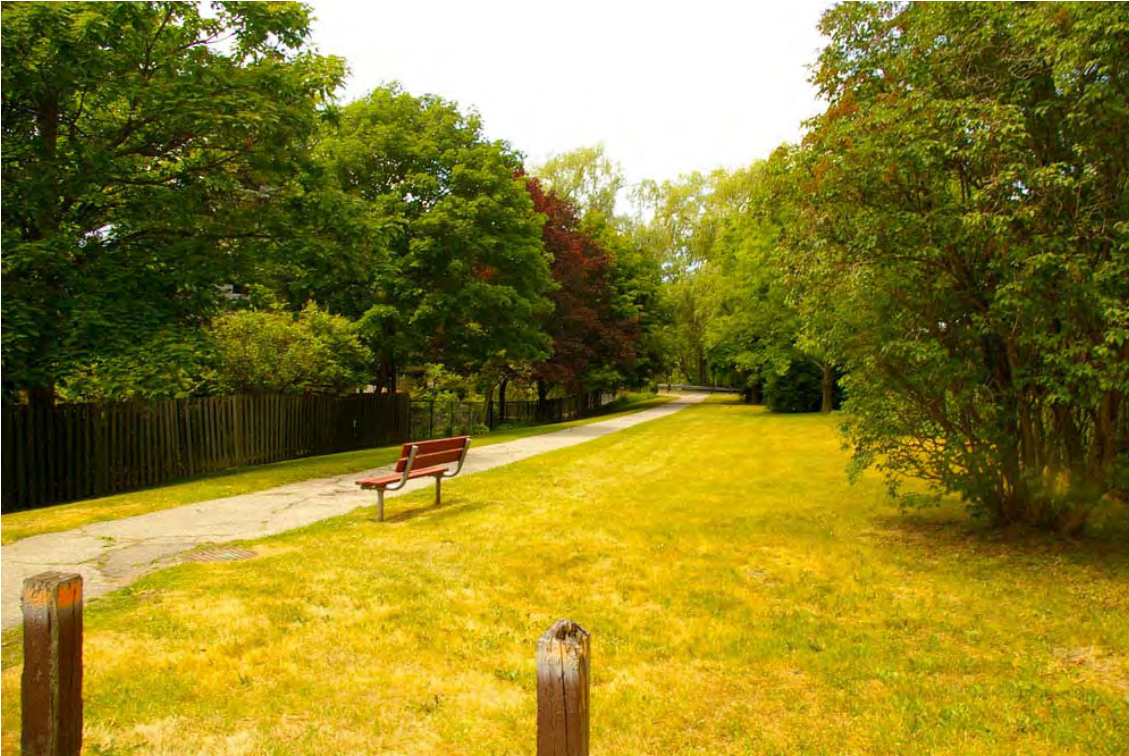
Photo 5: View of Kenollie Park looking north-west from the south end of Oakhill towards Pinetree Way. This parkette was built on a road allowance for the extension of Douglas Drive. (G 2-7-2016)

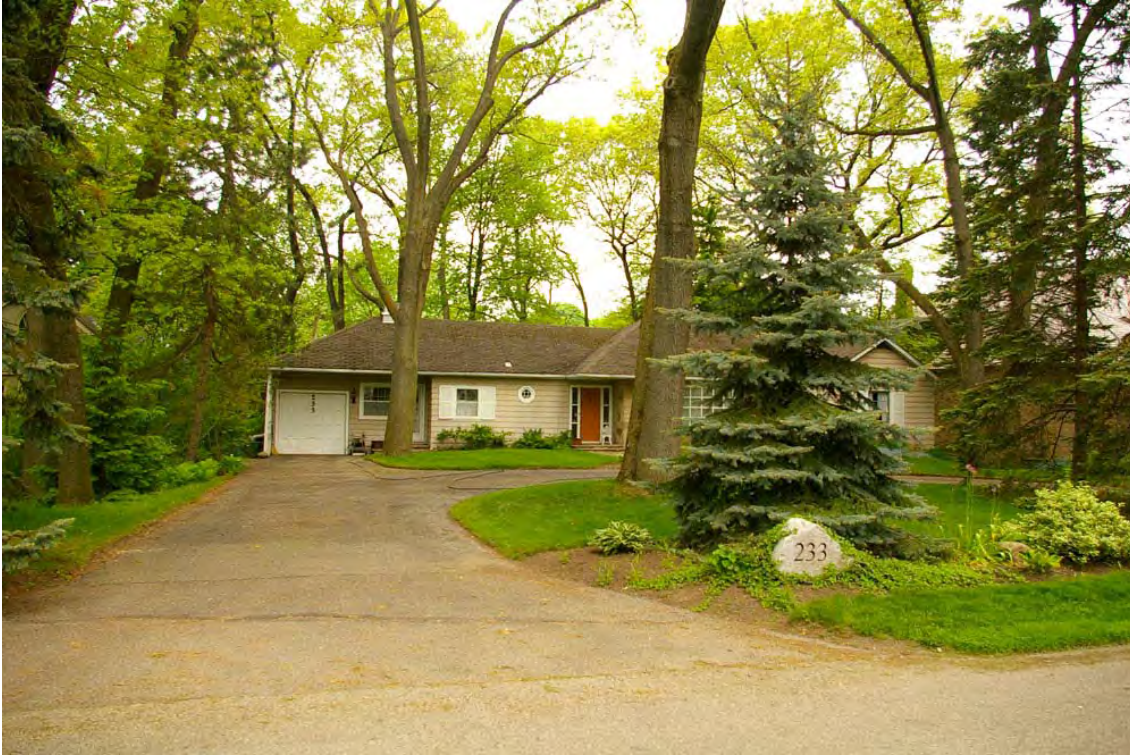
Photo 7: #233 (east side of #243) Original *Ranch* style dwelling probably built in early 1950s; frame with clapboard (or simulated) siding; hipped roof; built-in single car garage; an octagonal window similar to #243. Landscaping: informal; aged asphalt driveway with a walkway extension to the front entrance; grass cover with a few some shrubbery and perennials. (G 26-6-2016)

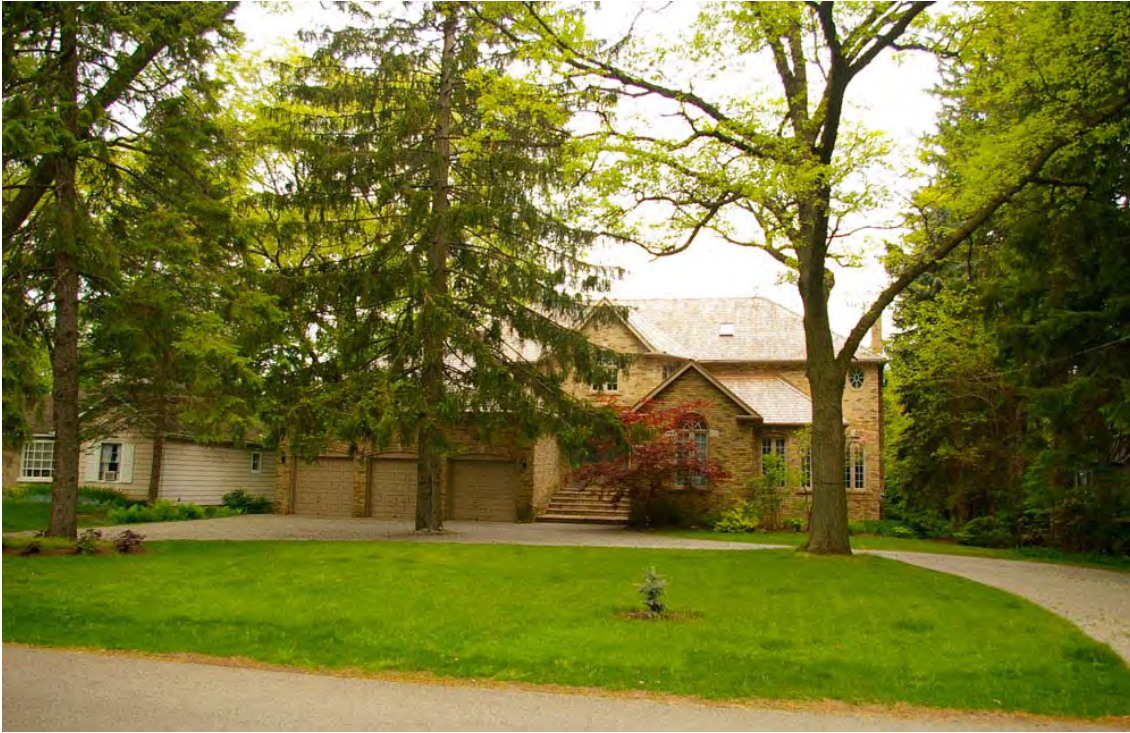
Photo 8: #223 First known replacement residence (2 stories) built in 1988; stone veneer cladding; hipped roof with gable features; dominant three-car garage. Landscaping: integrated driveway and walkway constructed of concrete pavers; mature deciduous tree and two tall conifers, which now partially obscure the front façade. (G 26-6-2016)

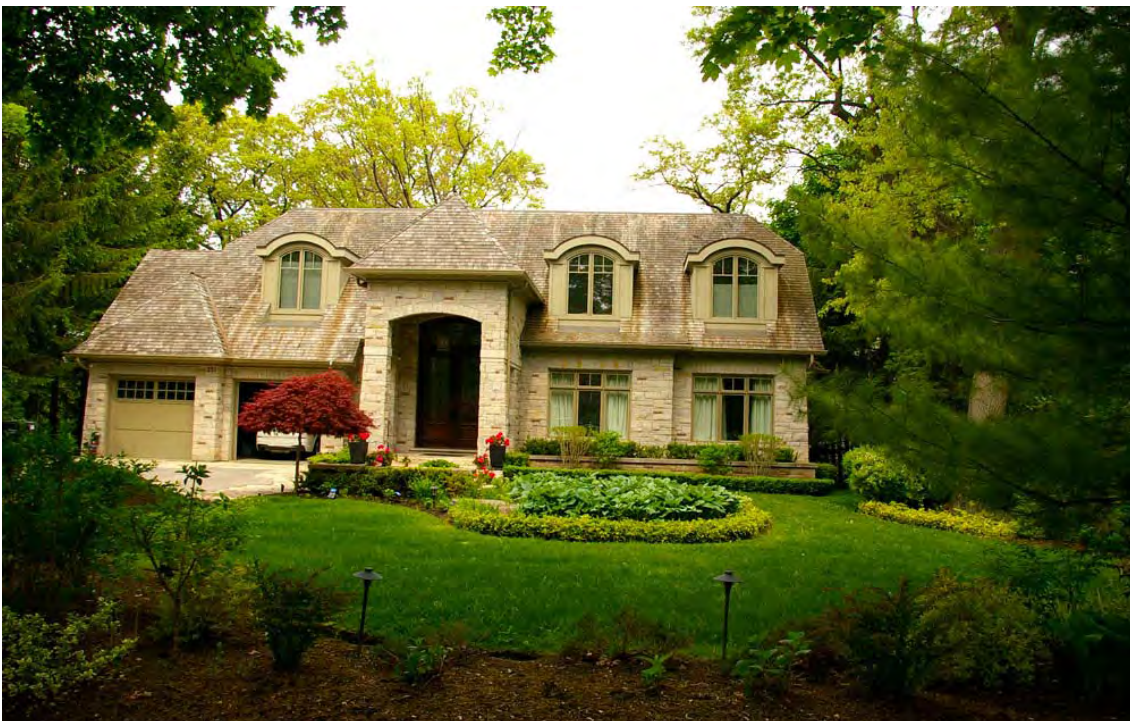
Photo 9: #251 (west of #243) 1½ storey replacement residence built in 2006 by the prospective owner of #243; stone veneer cladding; steep-pitched truncated hipped roof with three dormers; overstated tall entrance portico. Landscaping: attractive design of grass cover and curvilinear plant and shrub beds. (G 26-6-2016)

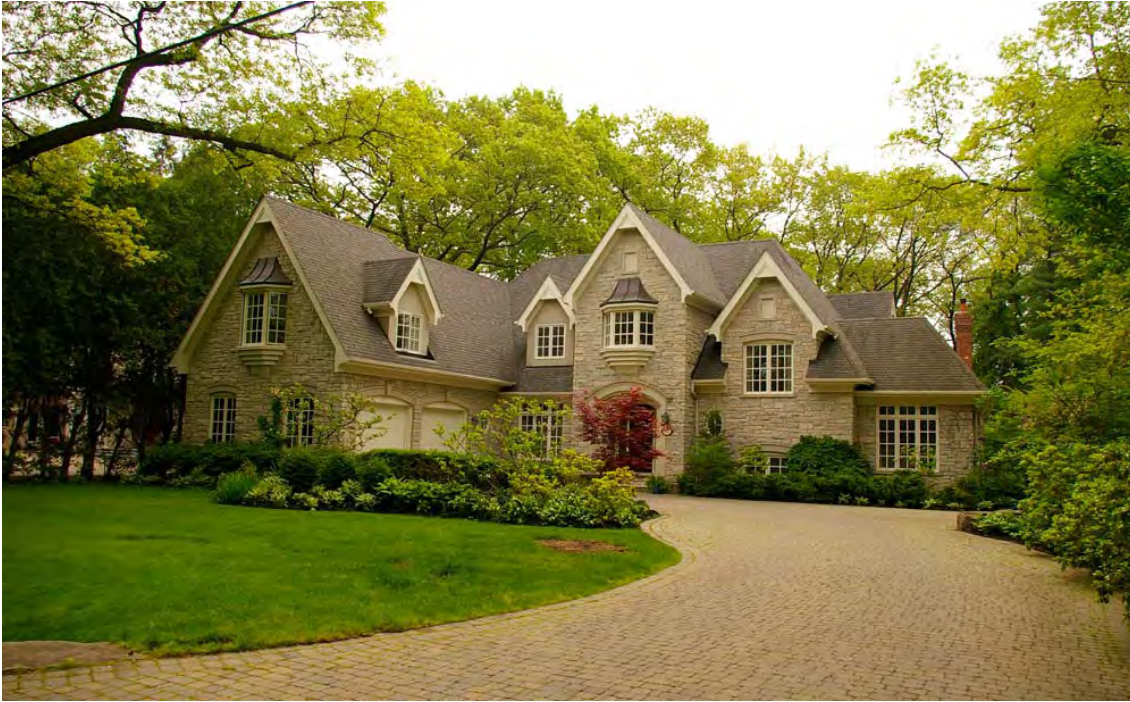
Photo 10: #242 Large 1½ to 2-storey residence built in 1997 on an original deep lot (directly opposite #243); stone veneer cladding; steep-pitched hipped roof with gables and dormers; perpendicular, side-facing garage. Landscaping: Integrated curvilinear driveway and walkway of concrete pavers; grass cover with shrub and plant beds (trees close to the road but not visible in photo). (G 26-6-2016)

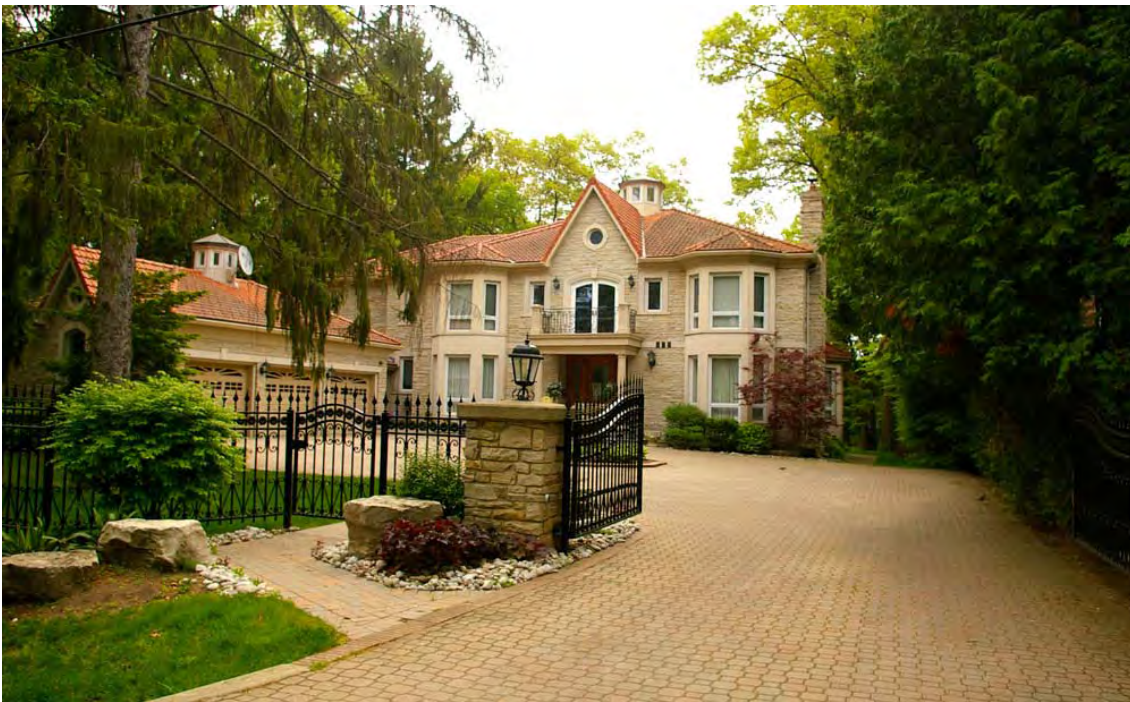
Photo 11: #234 An early large two-storey residence built in 1990 (also on an original deep lot); stone veneer cladding; hipped roof (main house) and side-gabled roof over the perpendicular three-car garage, all roofed with clay tile. Formal landscaping: grass cover, shrubbery and mature trees; and hard surfacing of concrete pavers, enhanced by iron fencing with gates for driveway and walkway. (G 26-6-2016)

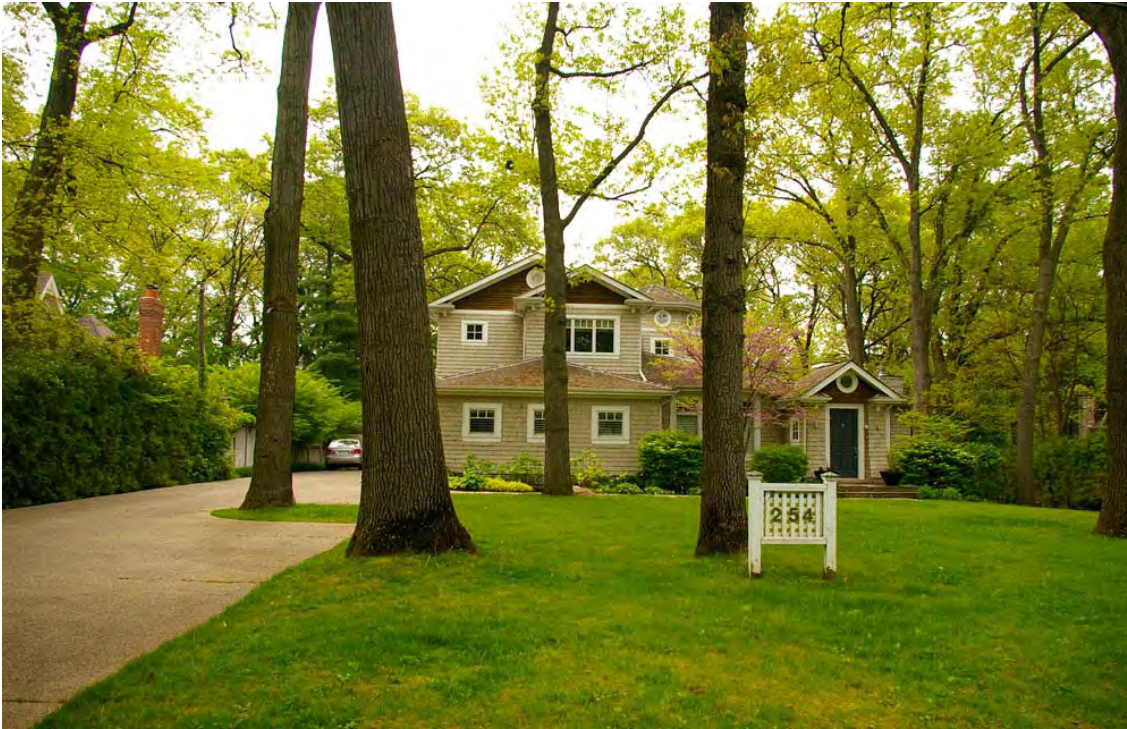
Photo 12: #254 Large 2-storey replacement residence built in 2005 on an original deep lot (depth of house is much greater than its width which reduces its visual impact from the street); cladding: clapboard or simulated. Informal landscaping: asphalt driveway cut around a mature deciduous tree; grass cover with shrub and plant beds close to the house. (G 26-6-2016)

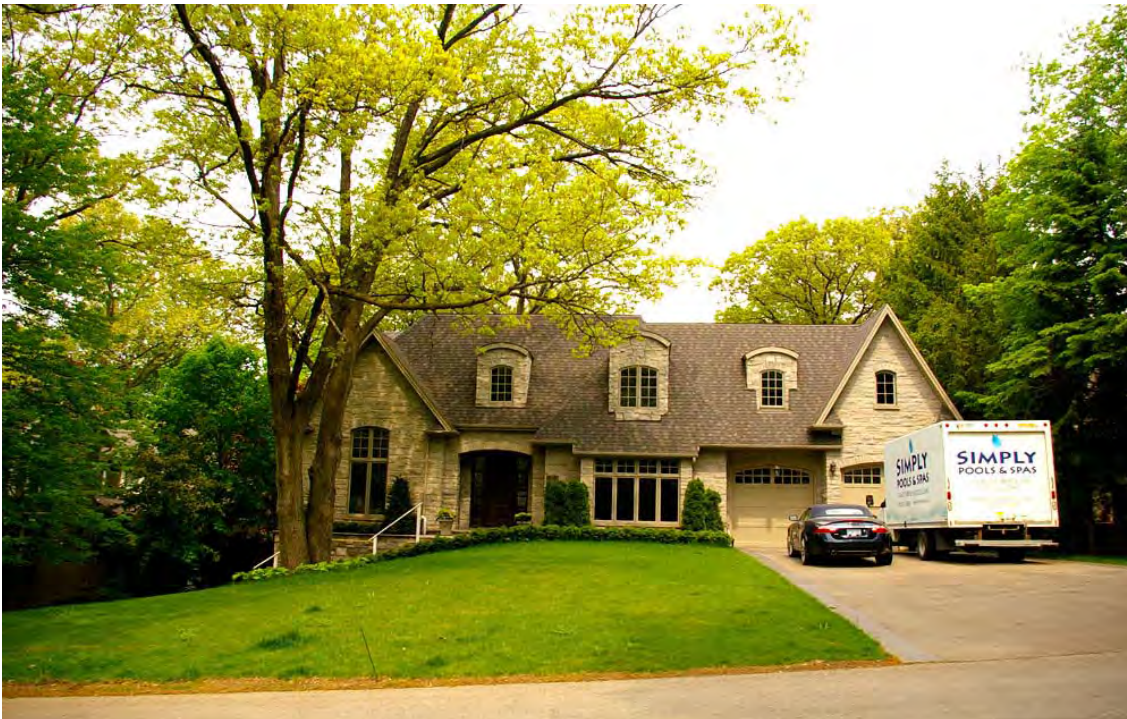
Photo 13: #261 1½ storey replacement residence built in 2009; stone veneer cladding; steep-pitched hipped roof with three dormers and end gables. Landscaping: concrete-bordered asphalt driveway; grass cover with shrub and plant beds close to the house. (G 26-5-2016)

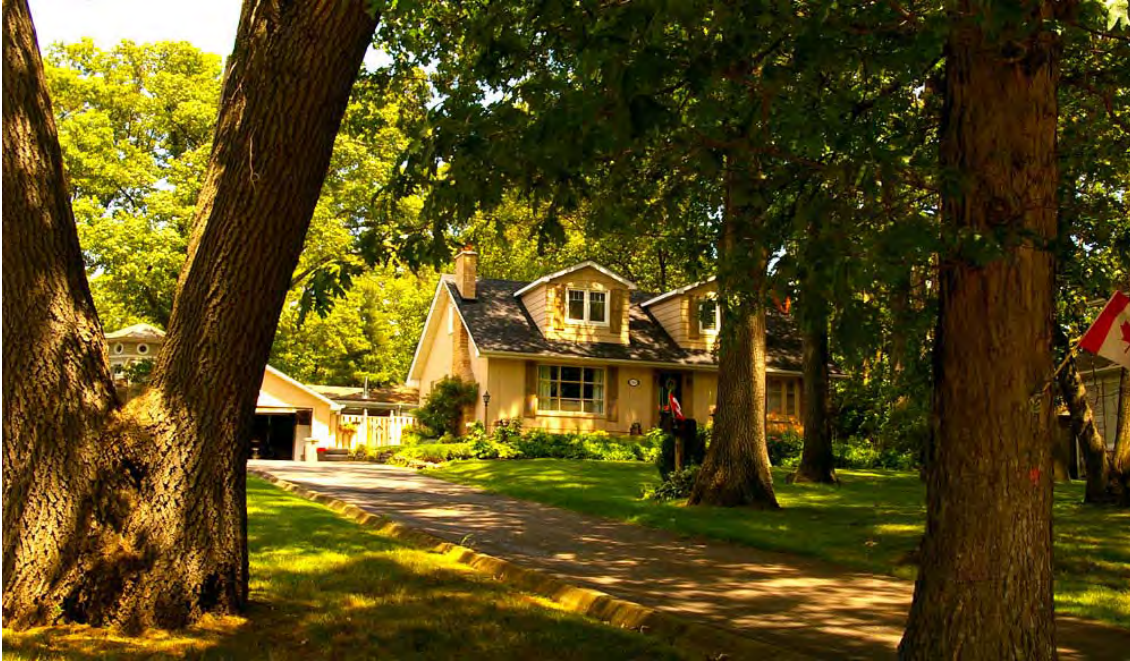
Photo 14: 1561 Douglas Drive: second lot (#2 in the original plan of subdivision) south of Oakhill Original *Colonial Revival* 1½ storey dwelling probably built in the late 1940s; shown on the 1952 Fire Insurance Plan as concrete block construction with a detached frame garage; alterations include the enlarged dormer windows (1964) and picture windows. Informal landscaping: asphalt driveway; grass cover with shrub and plant beds around the house perimeter; at least 8 mature deciduous trees in the front yard. (G 2-7-2016)

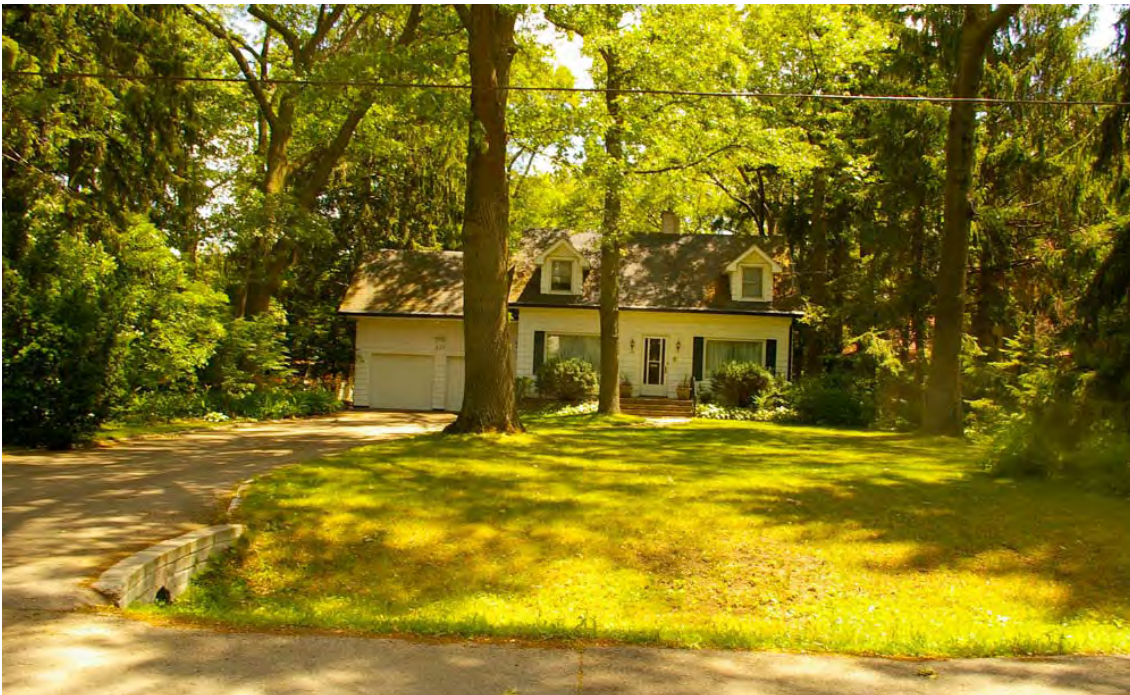
Photo 15: 222 Oakhill Drive An original 1½ storey *Georgian/ Colonial Revival* style dwelling probably built in the late 1940s; shown on the 1952 Fire Insurance Plan as concrete block construction; two original dormers entirely within the roof structure; enlarged picture windows; attached original two-car garage for single car).

Informal landscaping: asphalt driveway; grass cover with shrub and plant beds around the house perimeter; note the original ditch and stone culvert drainage system. (G 2-7-2016)
