Heritage Advisory Committee

2016/10/11

1. *That the property at 1216 Mississauga Road, which is listed on the City's Heritage Register, is not worthy of heritage designation, and consequently, that the owner's request to demolish proceed through the applicable process.*
 2. *That prior to demolition, the owner provide measured drawings of the structure currently on the property as described in the corporate report.*
 3. *That the owner provides a demolition documentation report with information as described in the corporate report.*
- 7.2. Request to Demolish a Heritage Listed Property: 243 Oakhill Road (Ward 1)
Corporate Report dated September 15, 2016 from the Commissioner of Community Services.

That the property at 243 Oakhill Road, which is listed on the City's Heritage Register, is not worthy of heritage designation, and consequently, that the owner's request to demolish proceed through the applicable process.

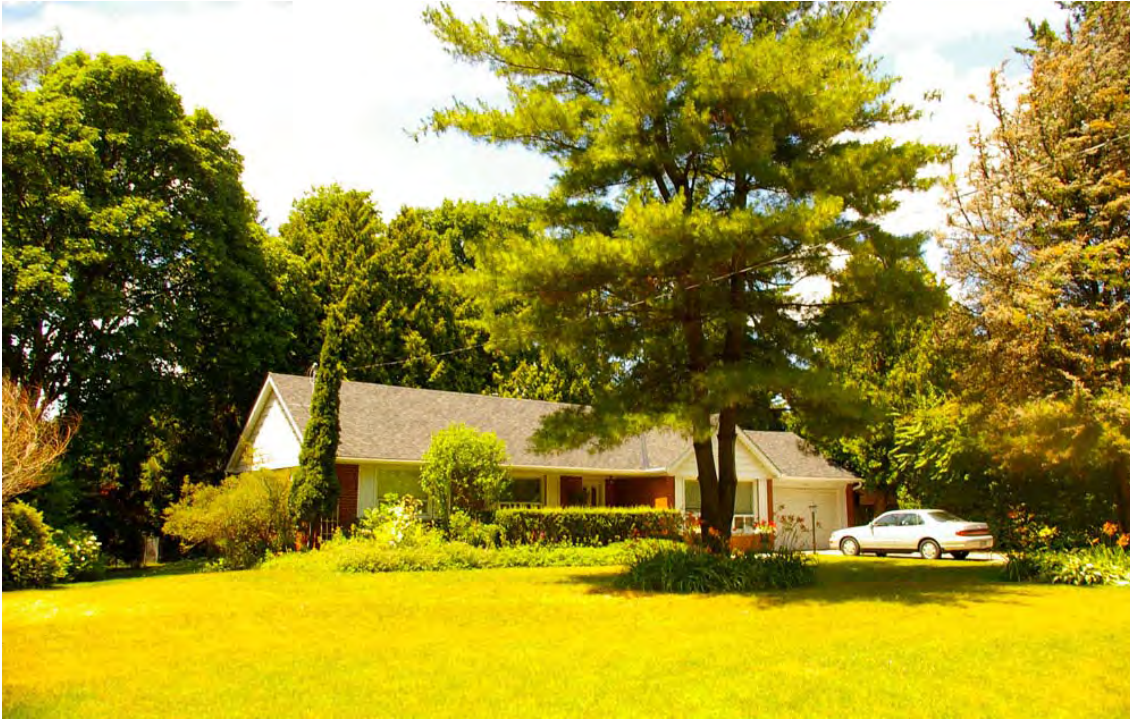
Photo 16: 205 Oakhill (outside the original plan of subdivision on the curved extension) An original *Ranch* style dwelling, not shown on the 1952 Fire Insurance Plan; attached single-car garage. Informal landscaping: asphalt driveway; grass cover with some plant/ shrub beds and mostly coniferous trees. (G 2-7-2016)

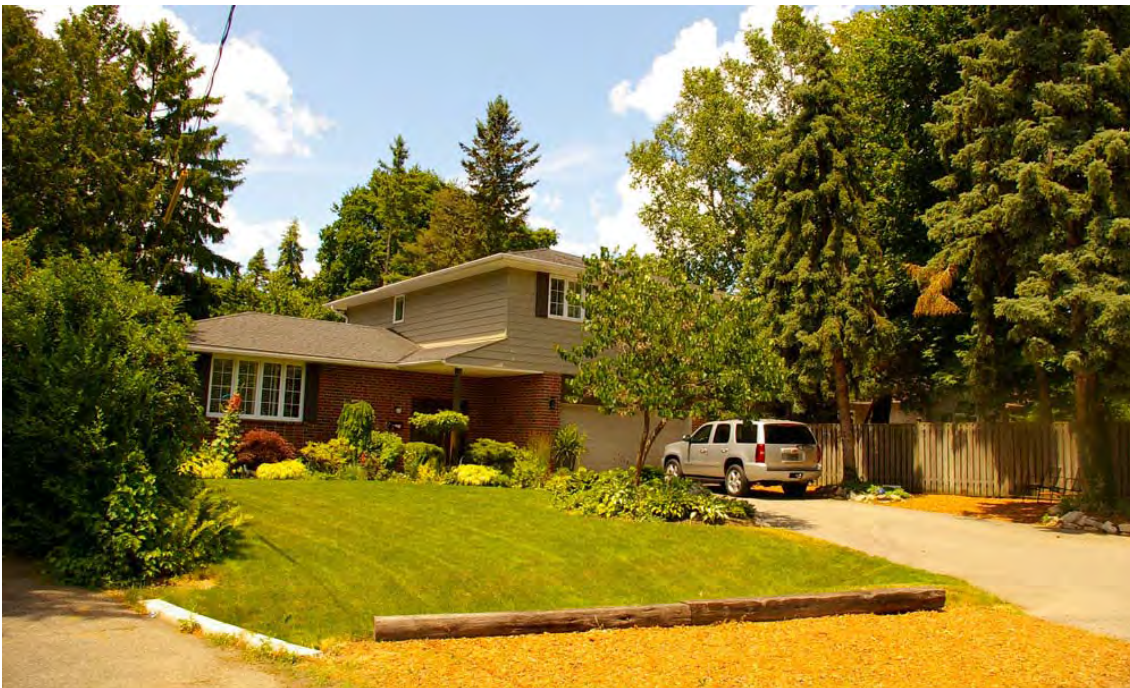
Photo 17: 197 Oakhill (adjacent to #205). An original *Split-level* style dwelling probably built in the late 1950s or early 1960s; brick and clapboard (or simulated) cladding; built-in double garage. Informal landscaping: asphalt driveway; grass cover with some plant/ shrub beds. (G 2-7-2016)

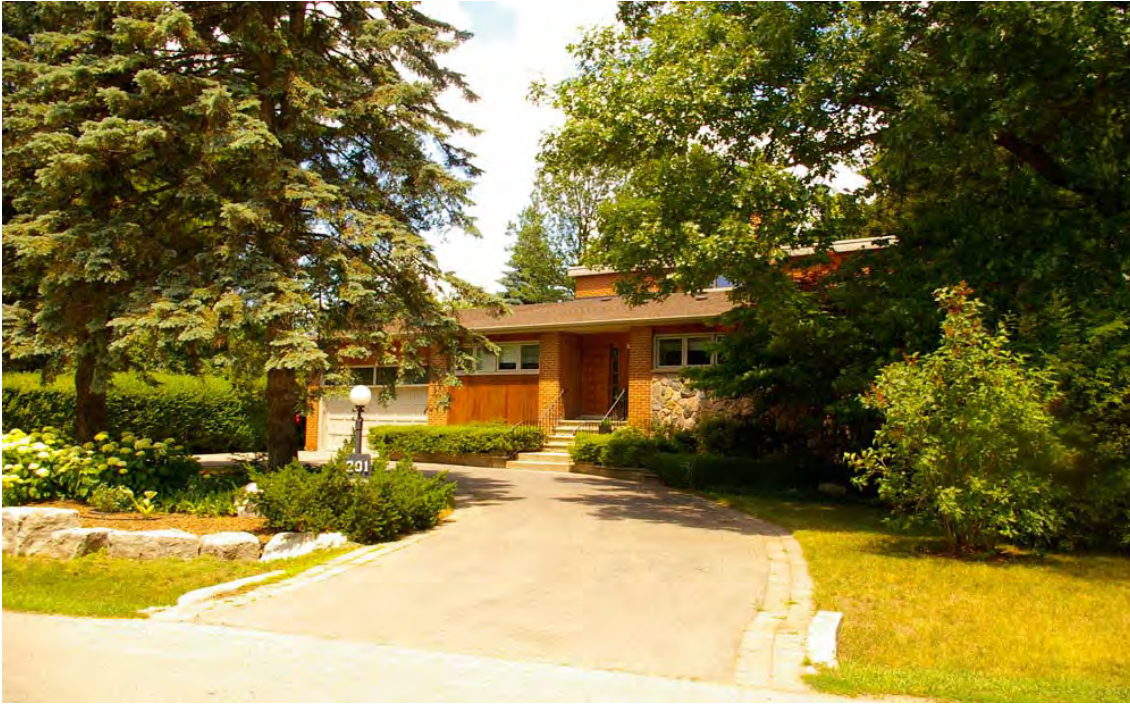
Photo 18: 201 Gill Avenue (adjacent to house above) An original *Shed* style residence most likely architect-designed and built in the 1960s; cladding of brick with natural wood and stone accents. More formal landscaping: circular asphalt driveway bordered with concrete pavers; integral plant/ shrub beds. (G 2-7-2016)

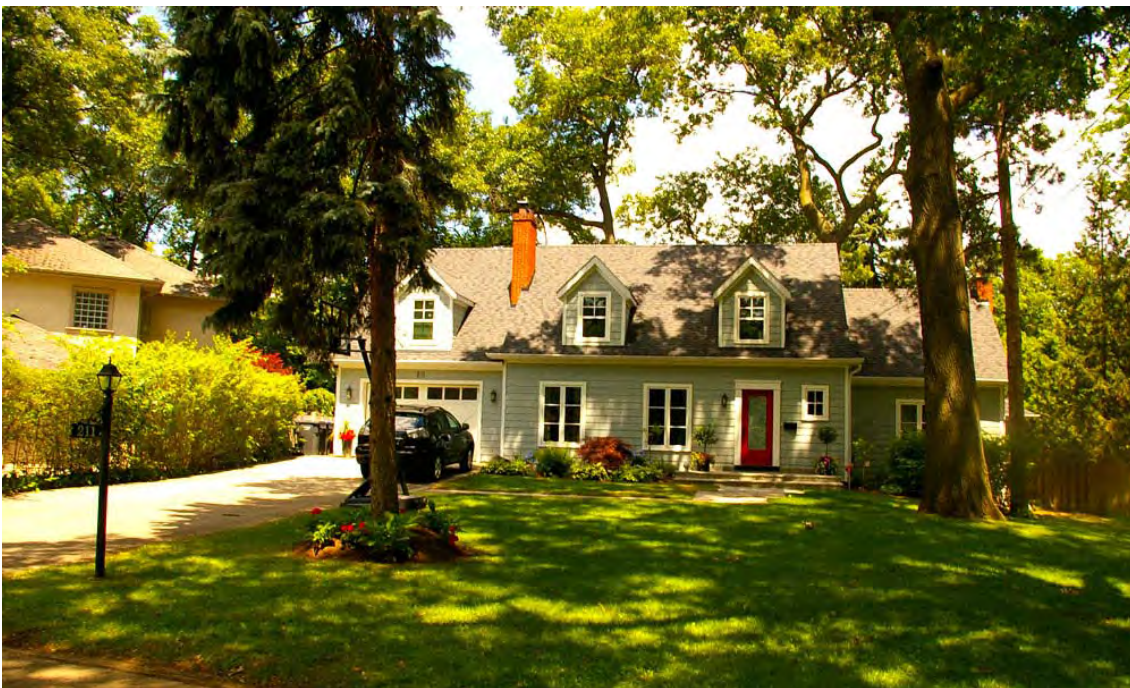
Photo 19: 211 Donnelly Drive An original *Georgian/Colonial Revival* style 1½ storey dwelling, which is not shown as existing on the July 1952 Fire Insurance Plan; asymmetrical façade with a classically-inspired door surround; assumed to be frame construction with clapboard (or simulated) siding; two original dormers; side addition (circa 1980s); attached single-car garage (may be original but with a half storey added with a new roof and dormer in 2005). Informal landscaping: asphalt driveway; grass cover with shrub and plant beds around the house perimeter and tree. (G 2-7-2016)

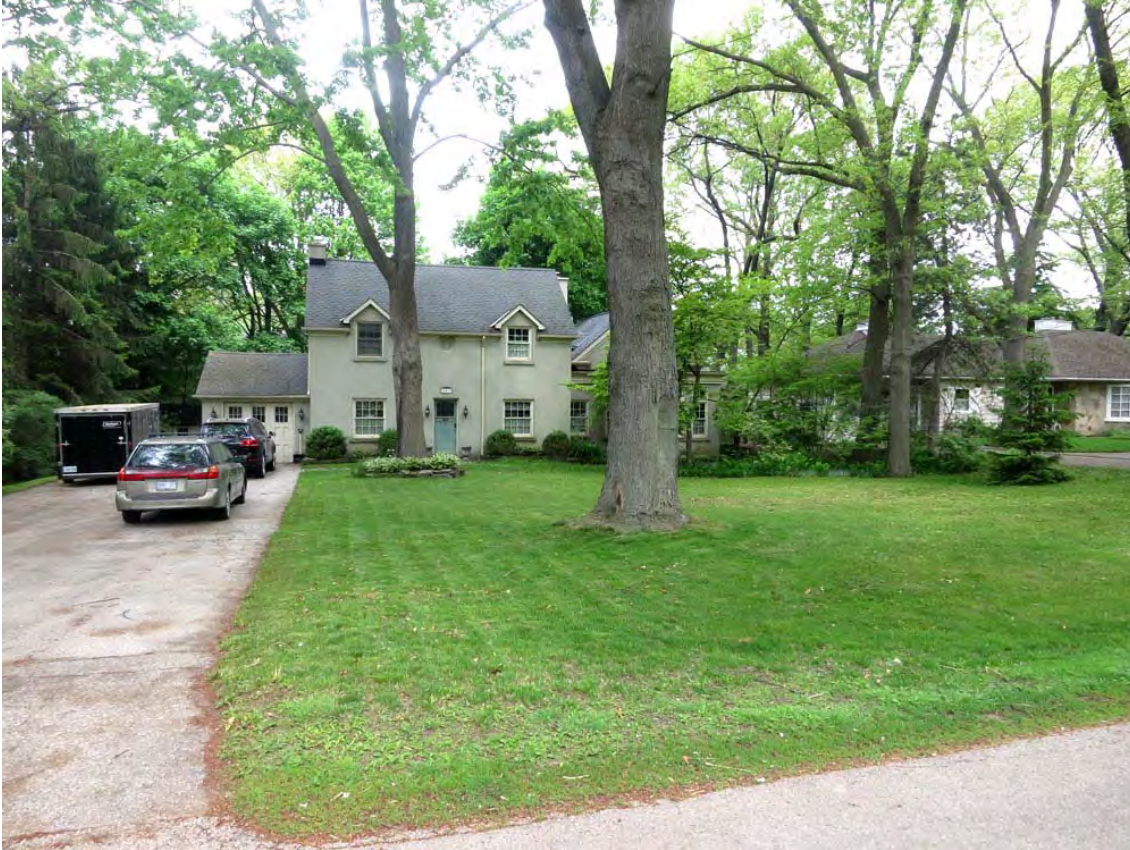
Photo 20: View of the subject property looking north from Oakhill Road, with the original bungalow at #233 partially visible to the right. Shows the mature Silver Maple tree directly in front of the house identified on the Site, Grading and Servicing Plan as #165 (to be removed due to construction encroachment) and in the foreground, another Silver Maple located on the City property, which is to be preserved (#164). (H-25-6-2016)

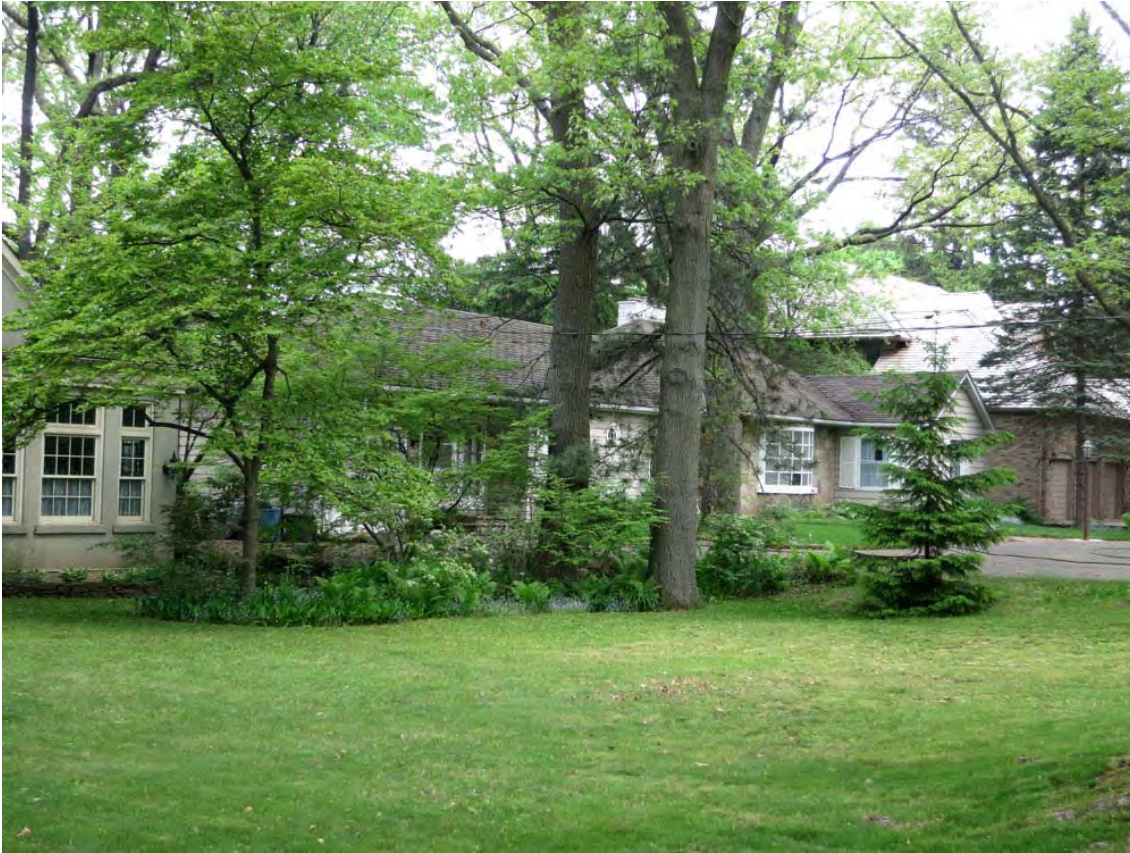
Photo 21: Cluster of trees on the east side of the front yard looking north, with the adjacent original one-storey dwelling partially visible behind the trees and the replacement residence beyond at #223. Shows three trees on the subject property, as numbered on the Site, Grading and Servicing Plan: a semi-mature Magnolia on the left (#159) and two Red Oaks: #161 in the foreground and #160 behind and to the left. All three are to be removed due to construction encroachment. Tree beyond is on the adjacent property.

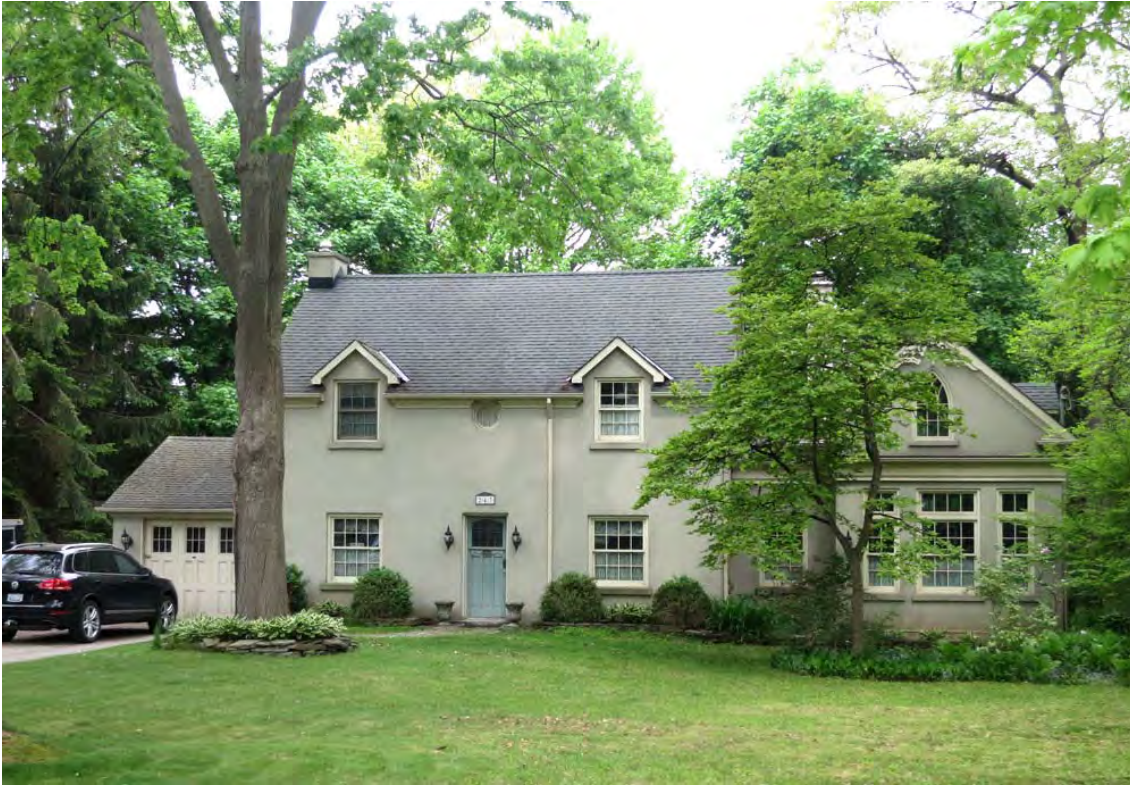
Photo 24: Front façade of the original 1947 dwelling, attached garage and 1995 addition. (H-25-6-2016)

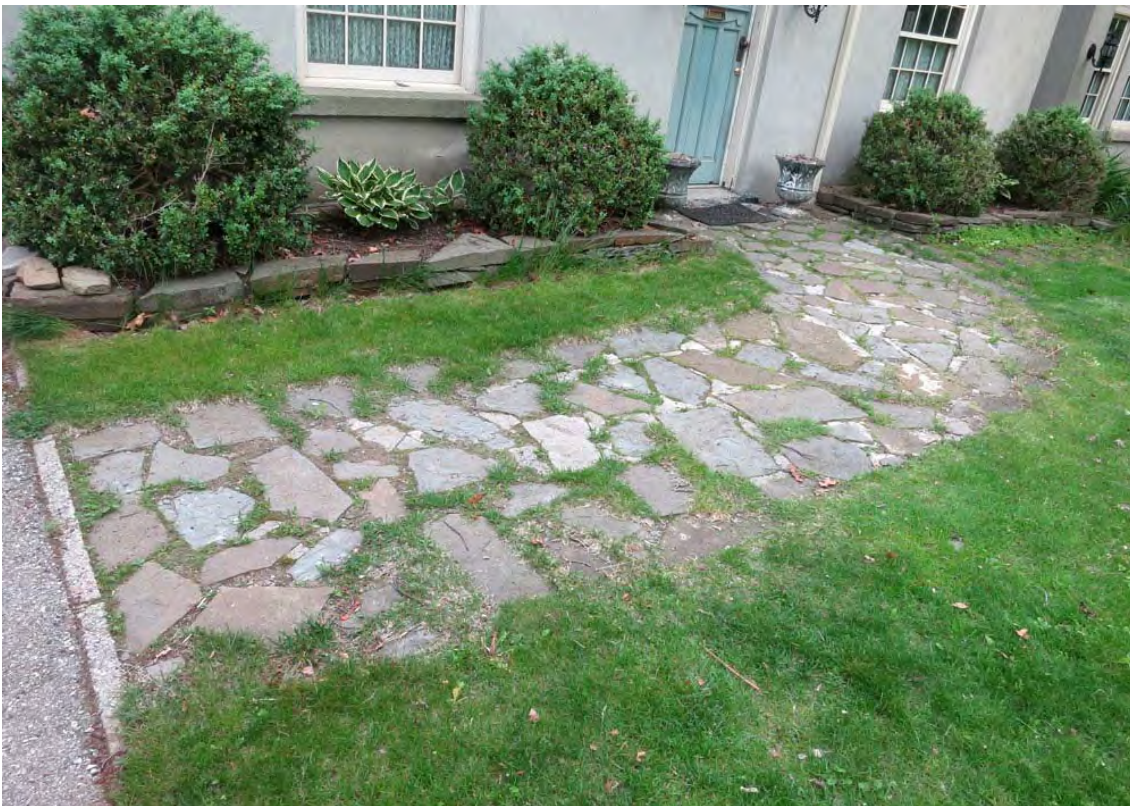
Photo 26: The original window opening and concrete sill to the left of the front doorway, showing one of the 8-over-8 thermopane sash replacement windows, replicating the original pane configuration. (H-25-6-2016)

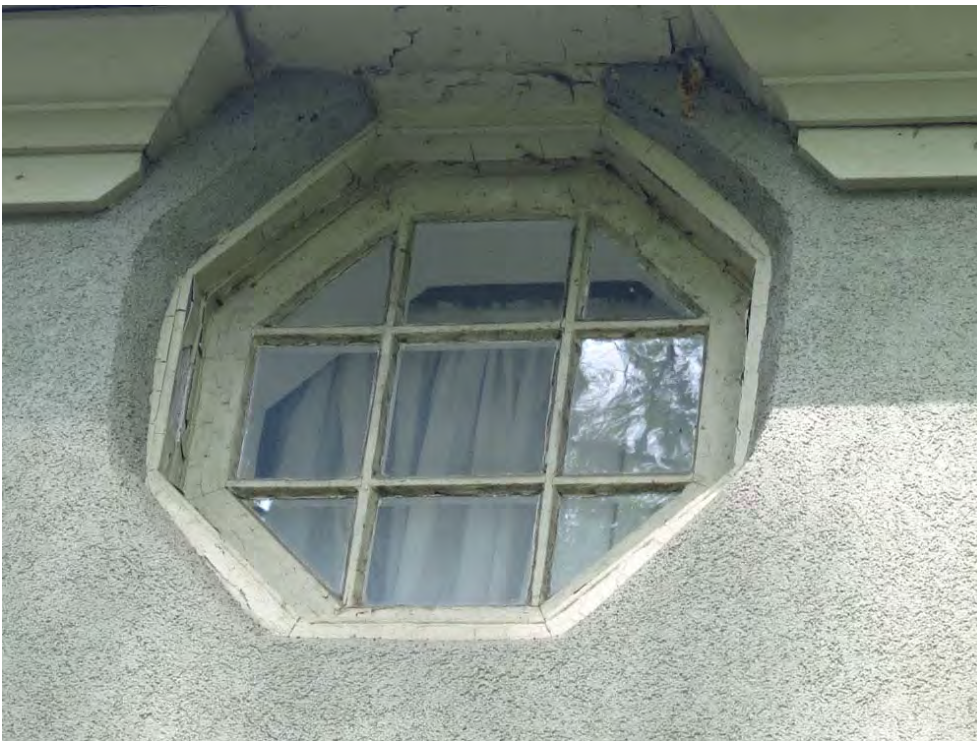
Photo 27: Small original octagonal window above the front doorway: wood window set into a wood frame with four criss-crossed narrow muntin bars dividing the window into 9 panes; also shows the detailing of the eaves mouldings added in 1995. (H-25-6-2016)

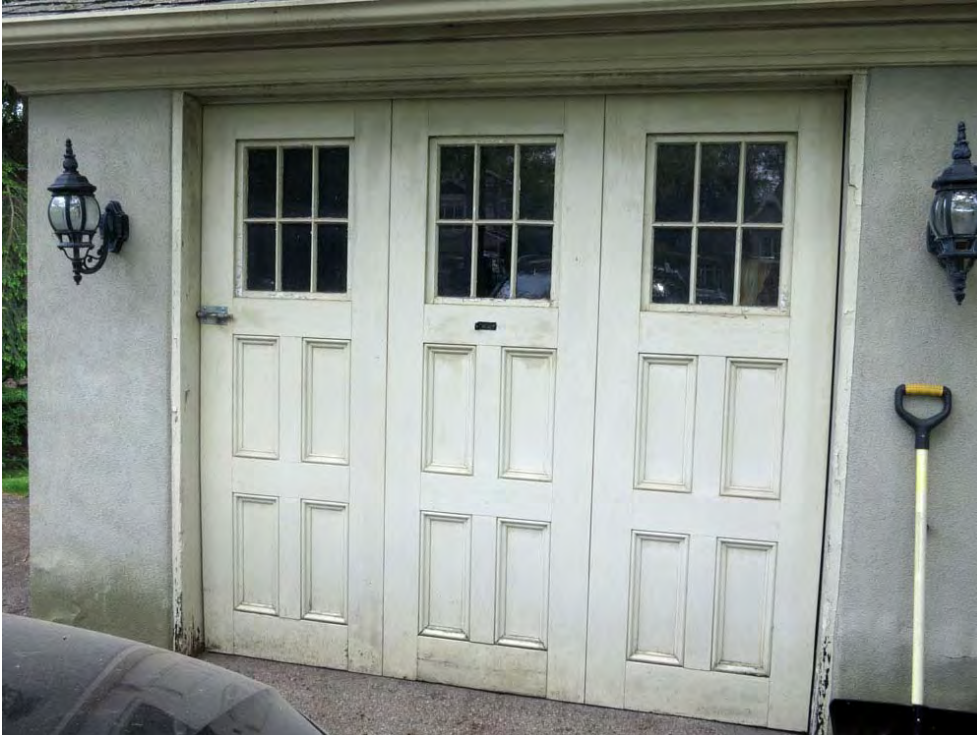
Photo 28: Original wood-framed garage door opening, with the original wood door as reclad in 1995 with three panelled sections and three acquired vintage windows. Also shows the moulding trim added to the roof eaves around the same time. (H-25-6-2016)

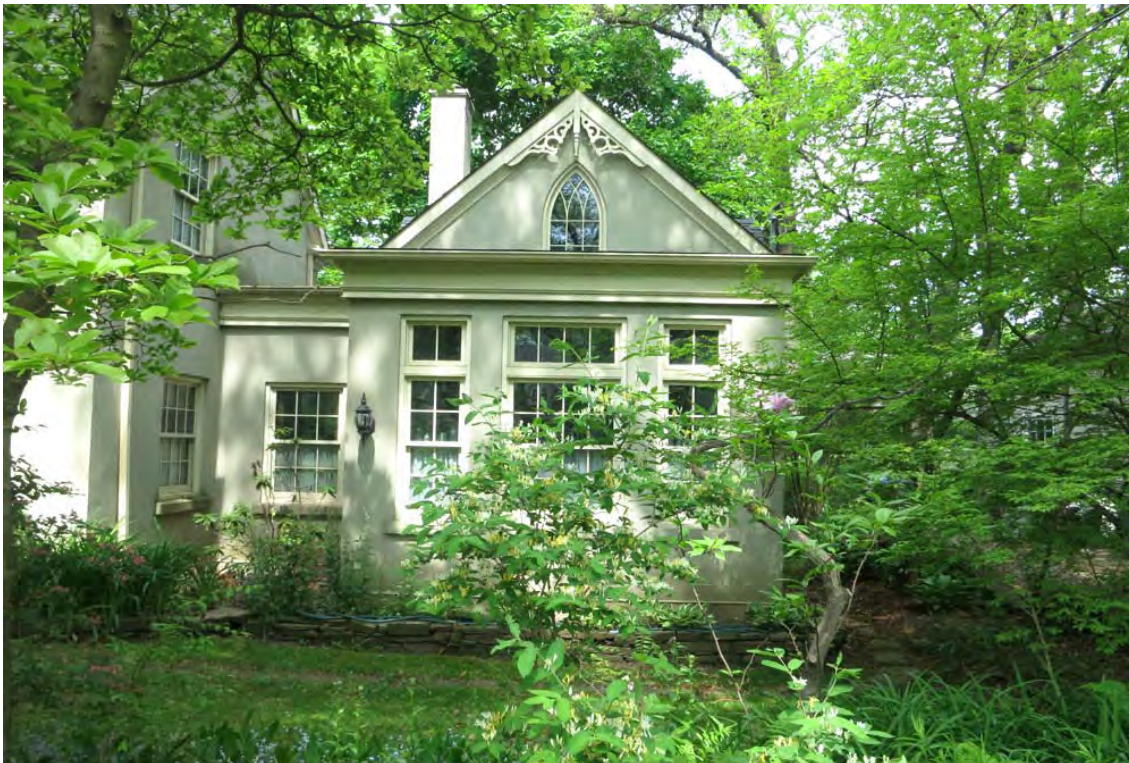
Photo 29: Front façade of the front-gabled addition showing the triple window of the spa room, and the linking flat-roofed section recessed behind the east window of the dining room. (H-25-6-2016)

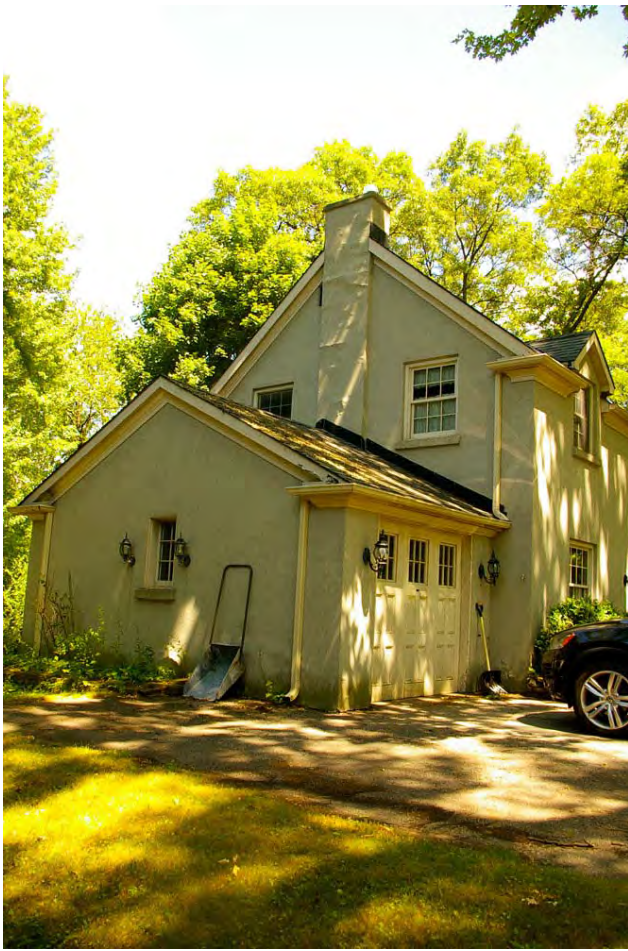
Photo 30: West side of the house and garage, showing the chimney, two bedroom windows and small window in the side wall of the garage. (P-2-7-2016)

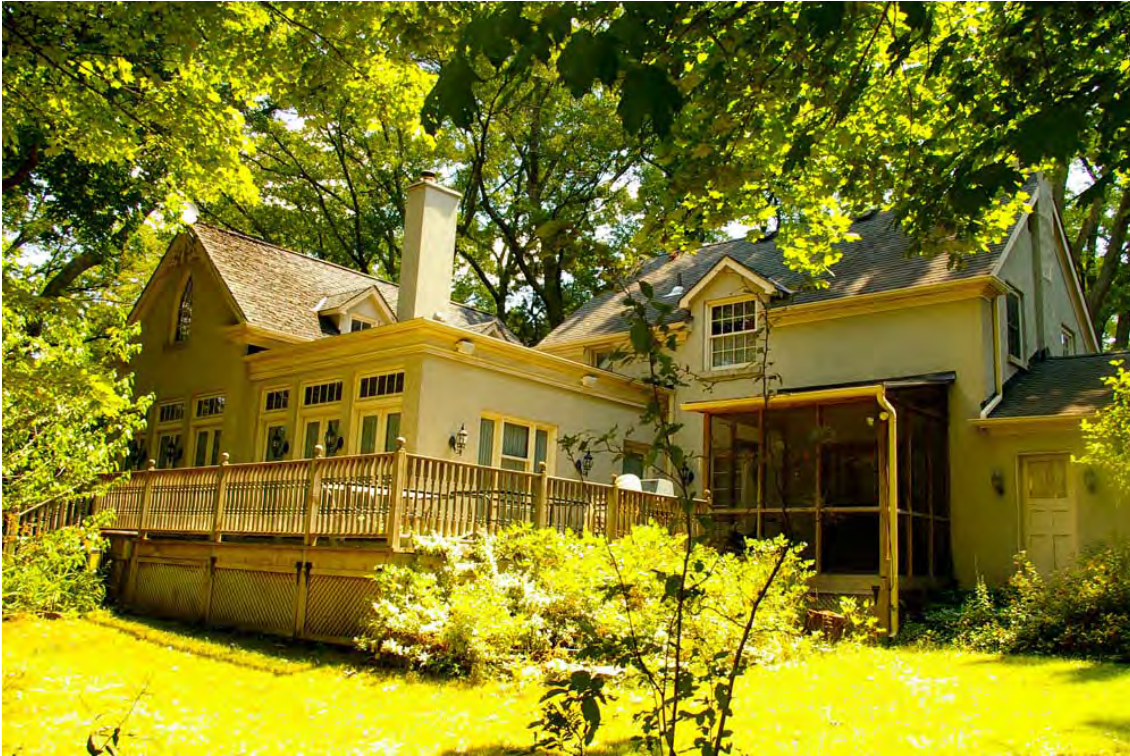
Photo 32: Rear façade looking south-east of the original dwelling, with its screened porch and the 1995 addition, with its spacious wrap-around deck. Shows the original rear door of the garage, which was identical to the original rear door from the house (doorway partially visible through the screened porch). (P-2-7-2016)

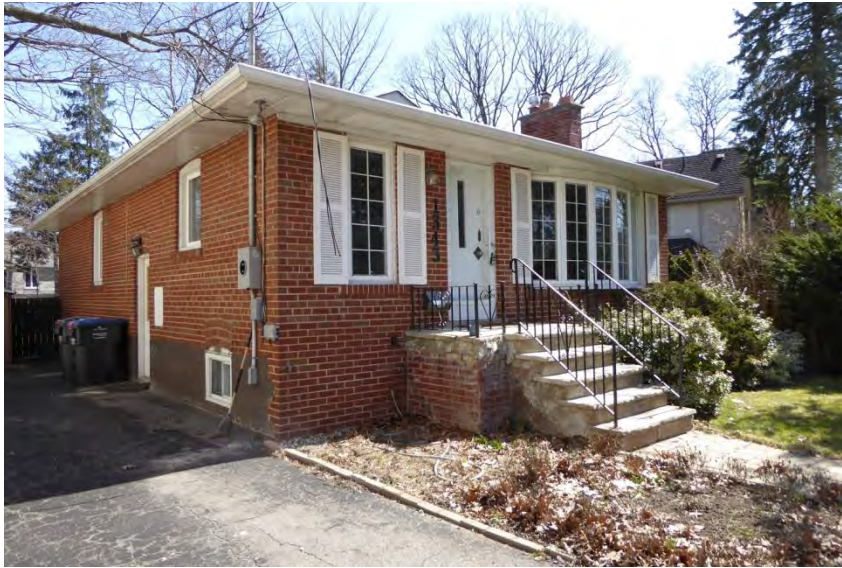
Front & side elevation

House was built approximately in 1954 - has an original footprint. Exterior elevation features original brick and metal railing. All windows have been replaced, it looks like front window was converted into bow window and some basement windows openings were enlarged to fit new, vinyl windows as well. In the rear elevation new sliding doors were installed. Roof shingles and soffits were changed as well.

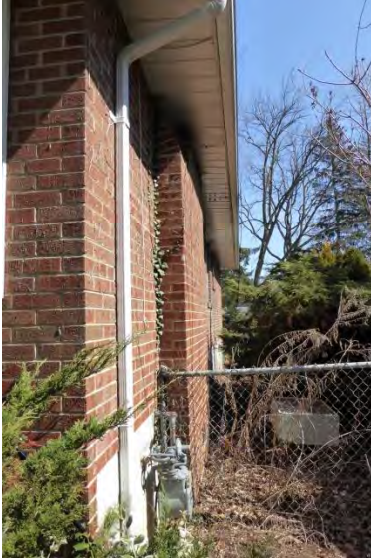
Side elevation

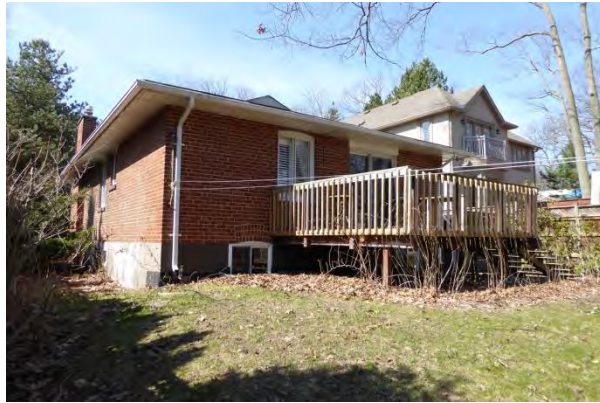
Rear elevation and deck

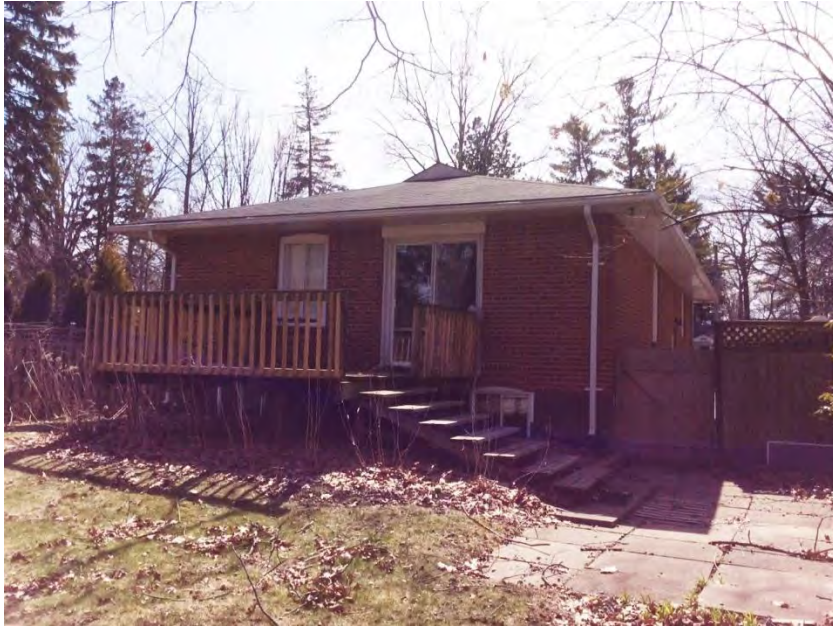
Rear of the house with existing wood deck and stairs.

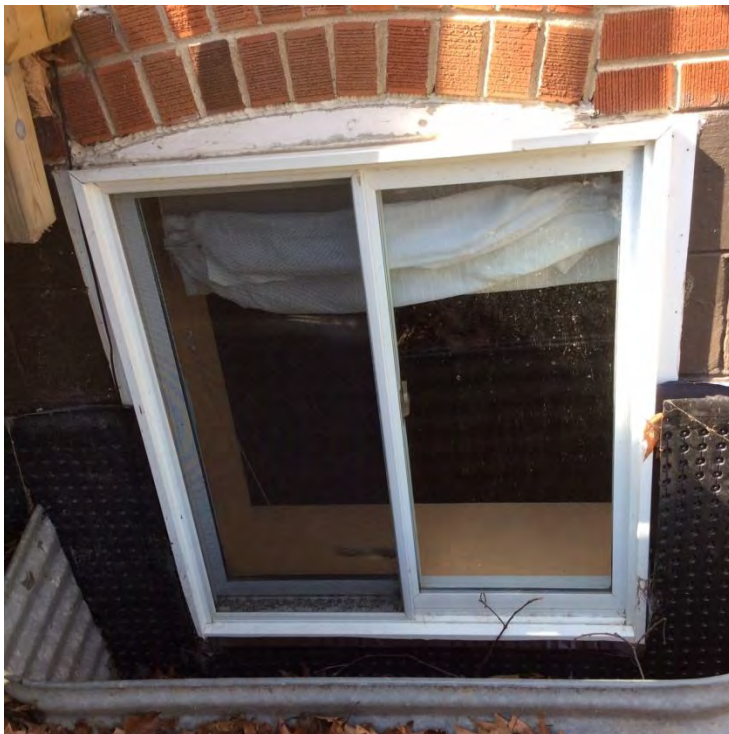
Basement window in enlarged opening (rear elevation)

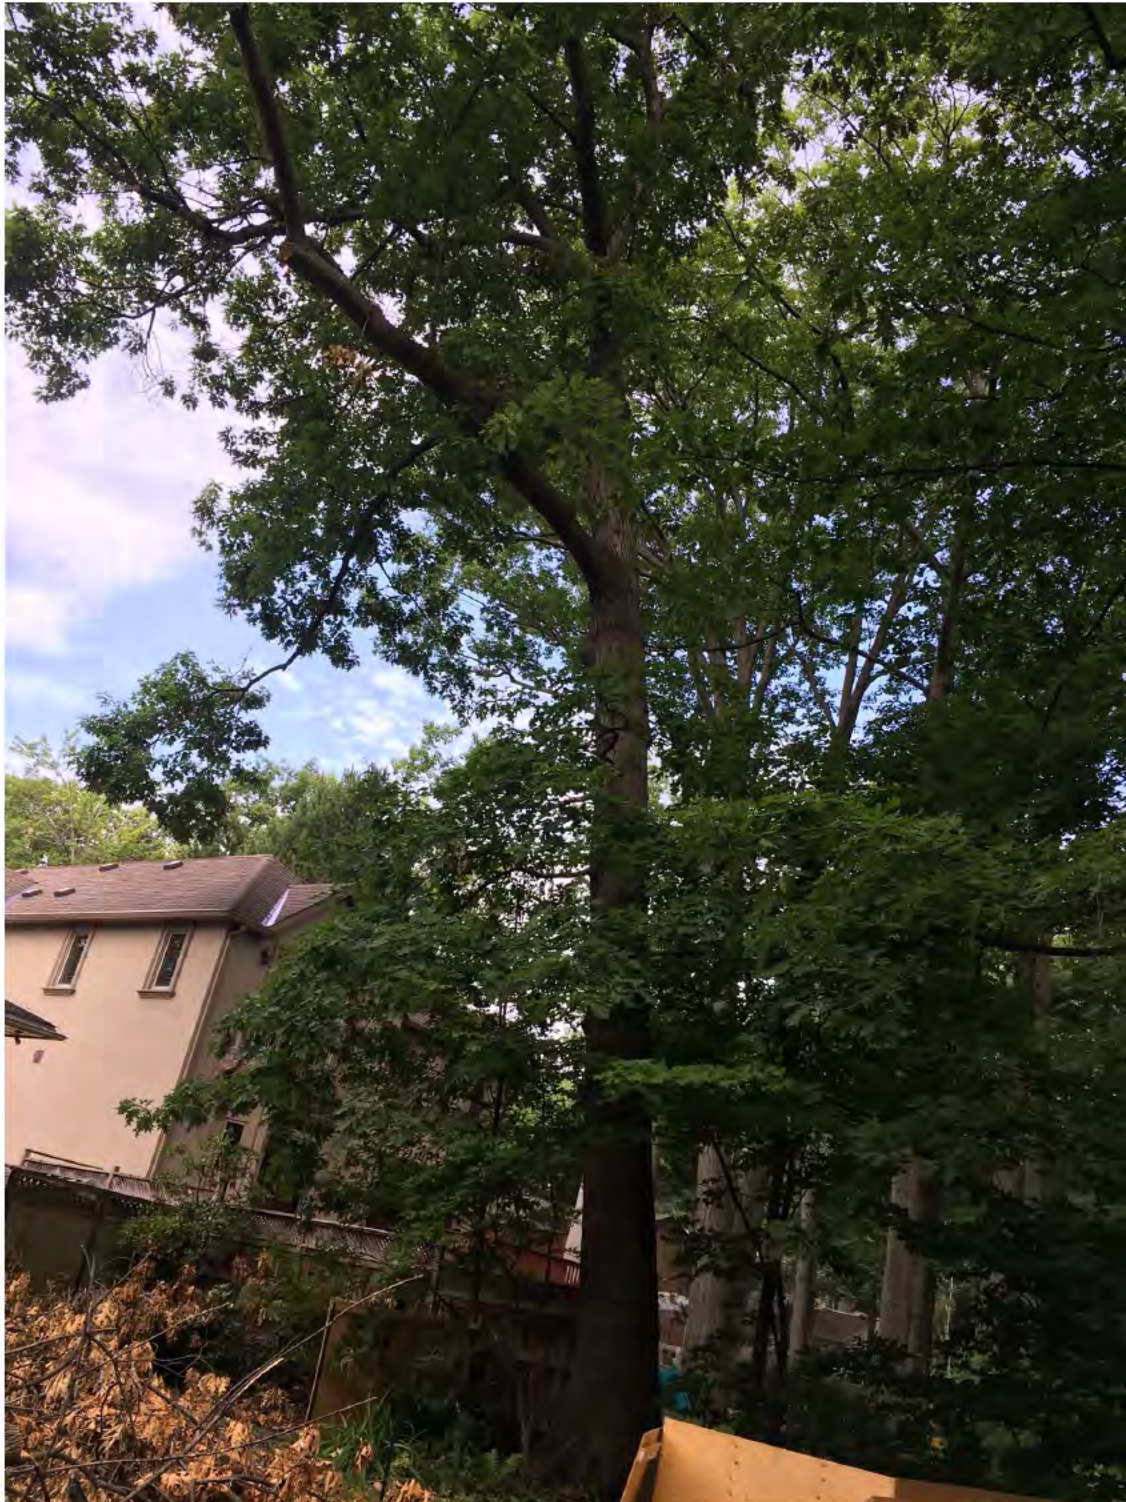
The proposed development for a 2-storey stone and siding dwelling at 1343 Milton Avenue encroaches on the protected root zone of an 89 cm. Red Oak (Tree 1). The site plans have been modified to protect the root system of this tree. The original foundation has been reduced on the north corner (see the pink lines on the accompanying protection plan) in order to maintain 5.4 meters of the Oak's protected root zone, which accounts for the over dig required to construct the foundation. The first and second floor will be cantilevered atop a pier to be installed within the tree protection zone. The excavation for the pier will be hand dug in order to ensure no structural roots are damaged during installation. There is some flexibility with the location of the concrete pier so the excavator should consult with the arborist on site to determine the best location. This may require some exploratory digging. Because work will be required within the tree protection zone hoarding an ISA (International Society of Arboriculture) Certified Arborist is required for site supervision. No excavated materials should be stored within the tree protection zone. As supporting beams are being installed just above grade, care should be taken within the protected root zone to prevent compacting the soil. Machinery (excavator, bobcat, etc.) should not be used within the TPZ at any time. Once supports have been installed for cantilevering the first and second floors of the house the tree protection fencing should be modified according to the illustration on the accompanying protection plan. Following these detailed measures, which have been developed to ensure the safety and survival of the mature Oak (Tree 1), will ensure the tree continues to provide its many benefits for years to come.

Tree 1: Privately-owned backyard Red Oak in conflict with proposed development

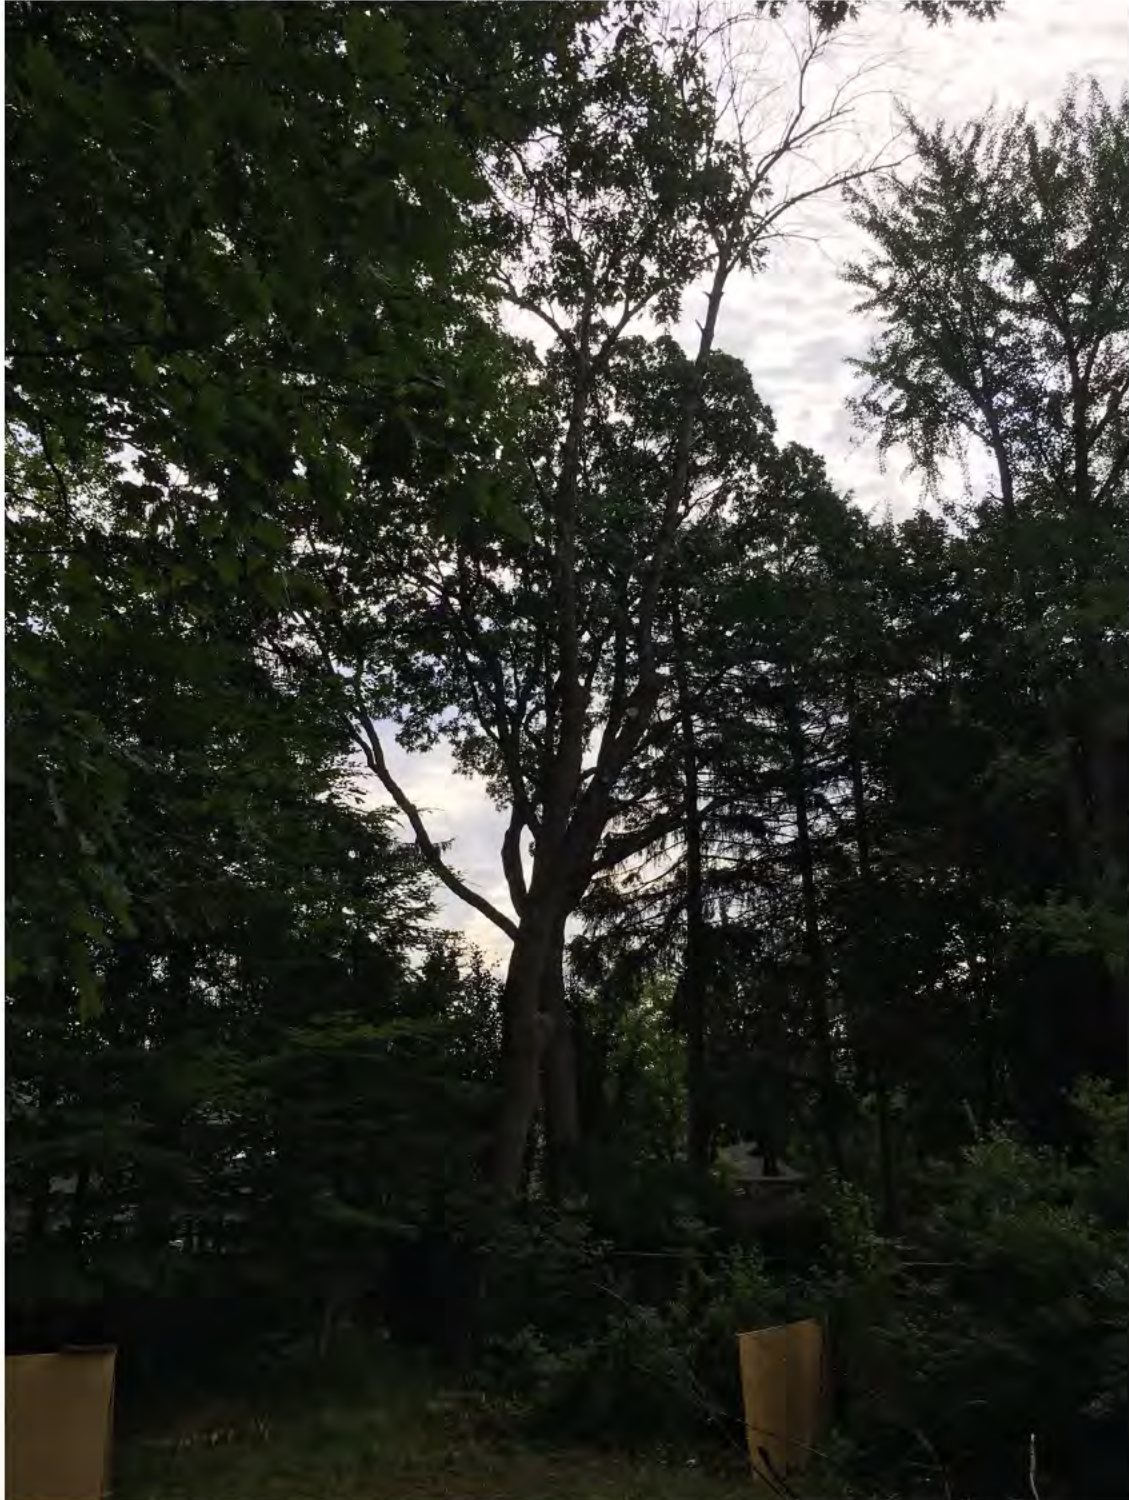
Tree 4: Privately-owned backyard Green Ash (dead tree) at 1343 Milton Avenue

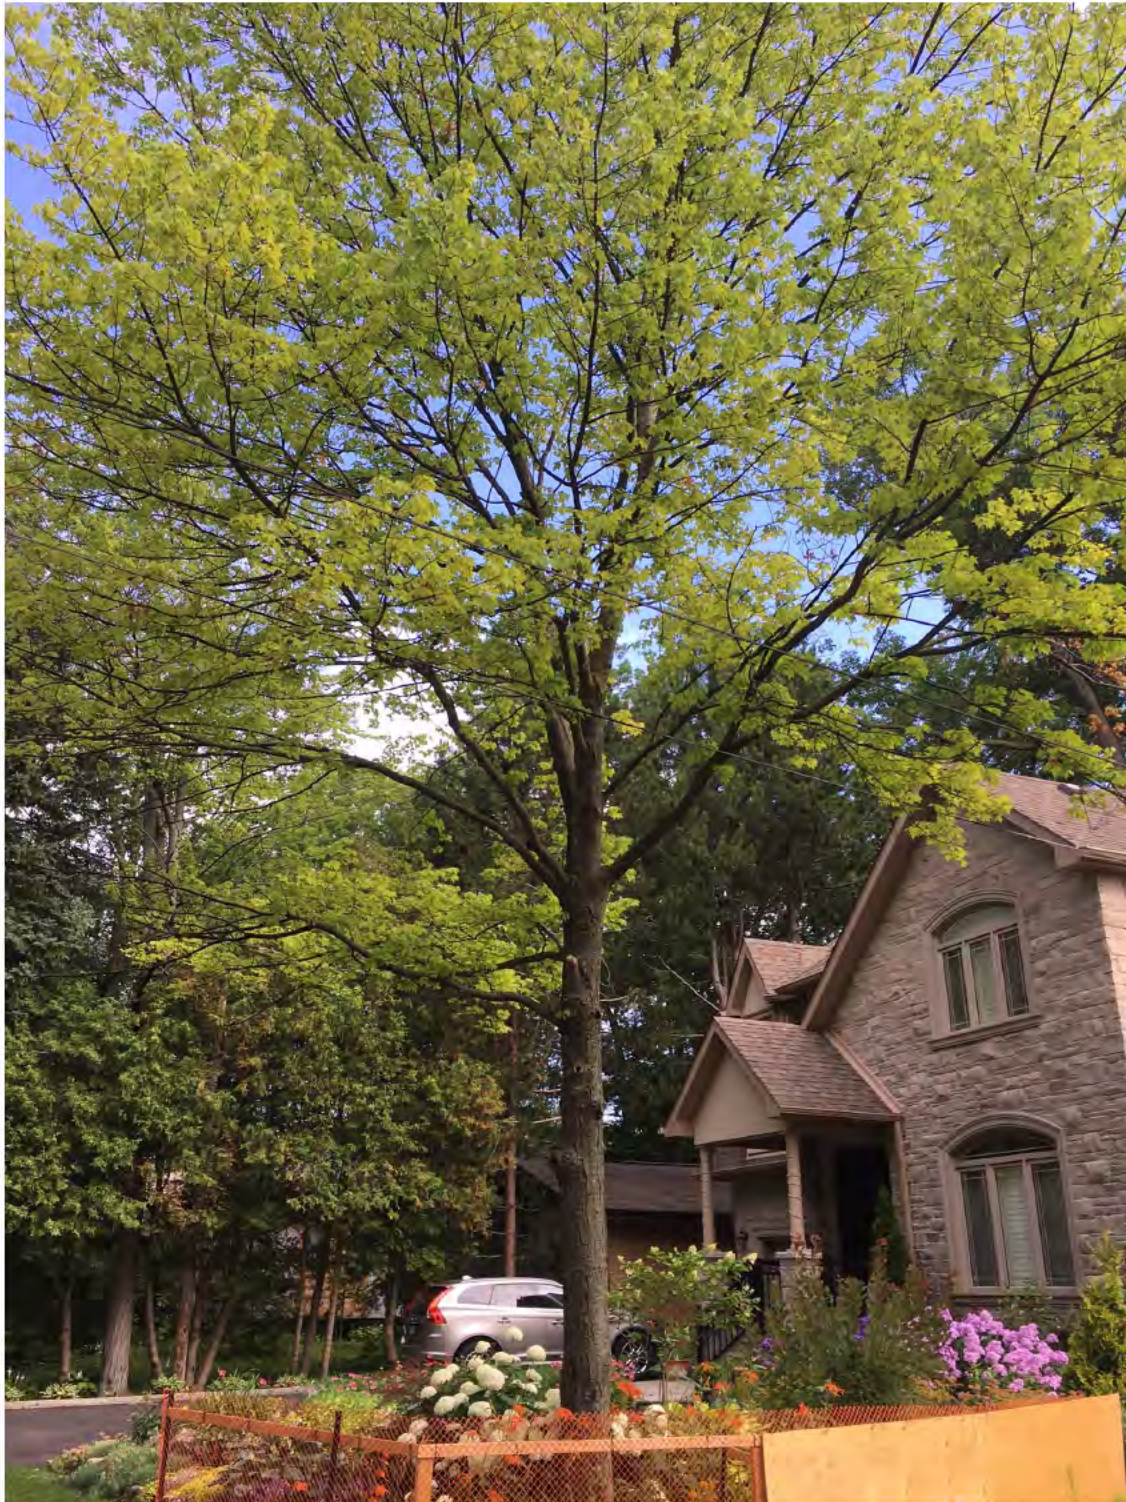
defects				
8	Red Maple (<i>Acer rubrum</i>)	1	35	Severely chlorotic, sign of iron/micronutrient deficiency	Preserve	5	Fair-Poor-2.5	1.6 m.
9	Austrian Pine (<i>Pinus nigra</i>)	1	36	10% deadwood, minor browning of interior needles	Preserve	5	Good-1	2.0 m.
10	Austrian Pine (<i>Pinus nigra</i>)	1	36	10% deadwood, minor browning of interior needles,	Preserve	5	Fair-2	2.0 m.

Tree 8: City-owned front yard Red Maple on road allowance

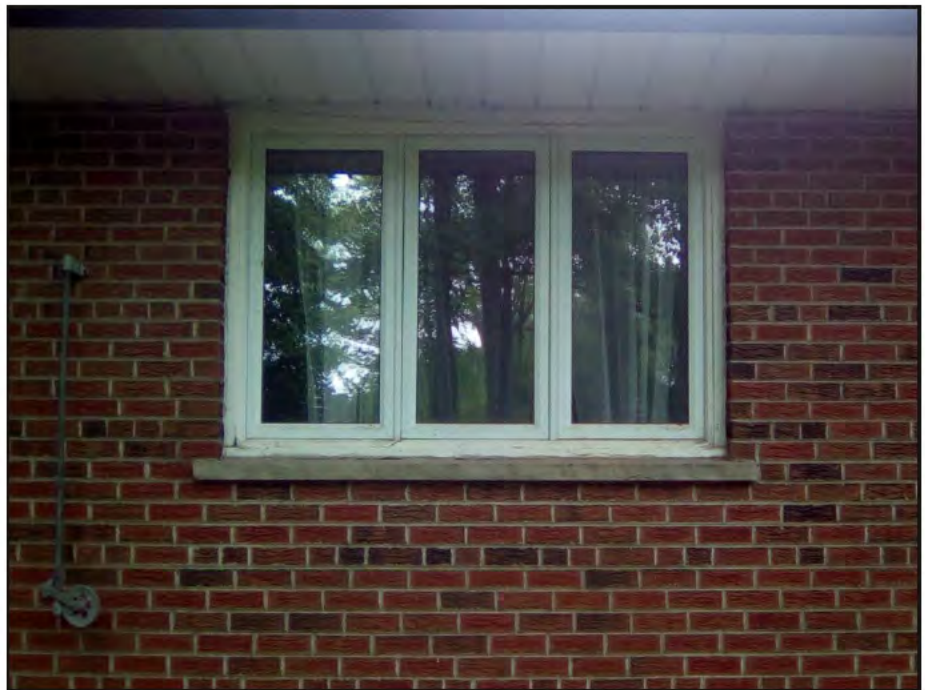
Detail of modern, replacement windows

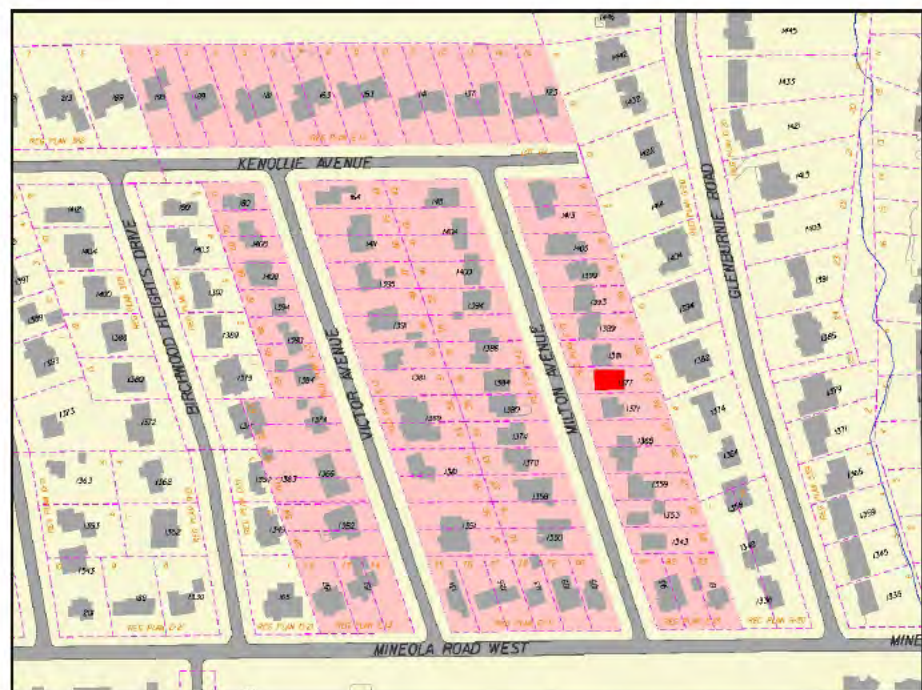
Plan E-13, with the subject property highlighted in red.

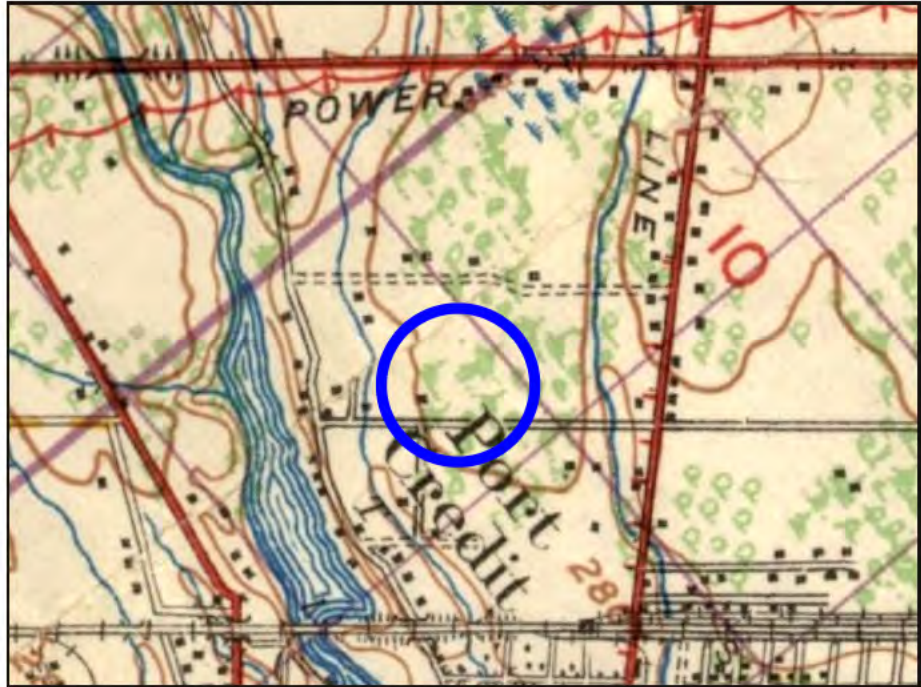
The 1922 topographic map, issued nine years after Skynner's Plan E-13 was registered, shows no roads yet surveyed within the plan.

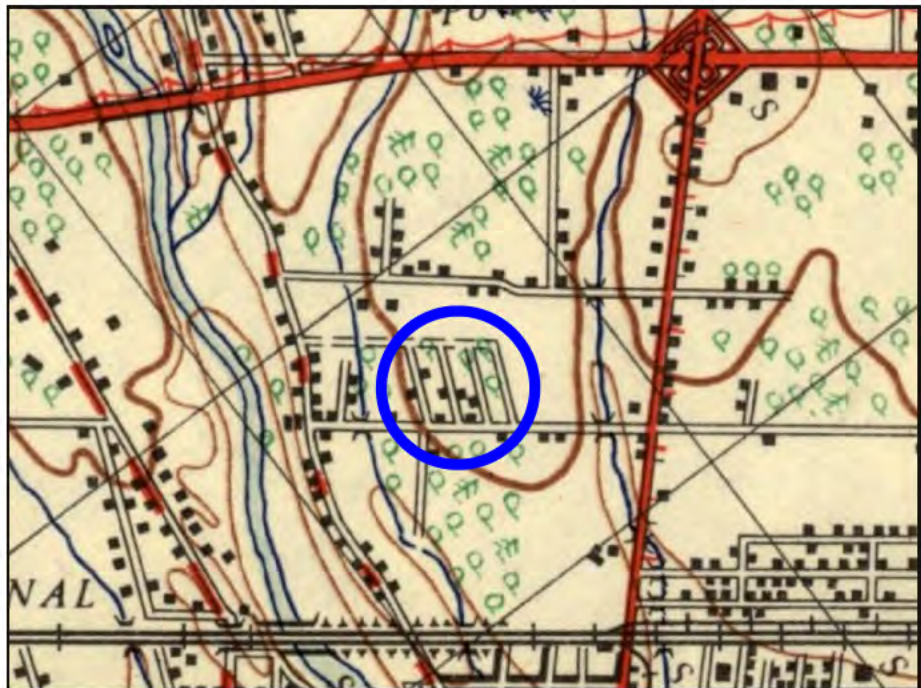
This topographic map, issued 30 years after the above map, shows roads in Plan E-13, but still few houses.

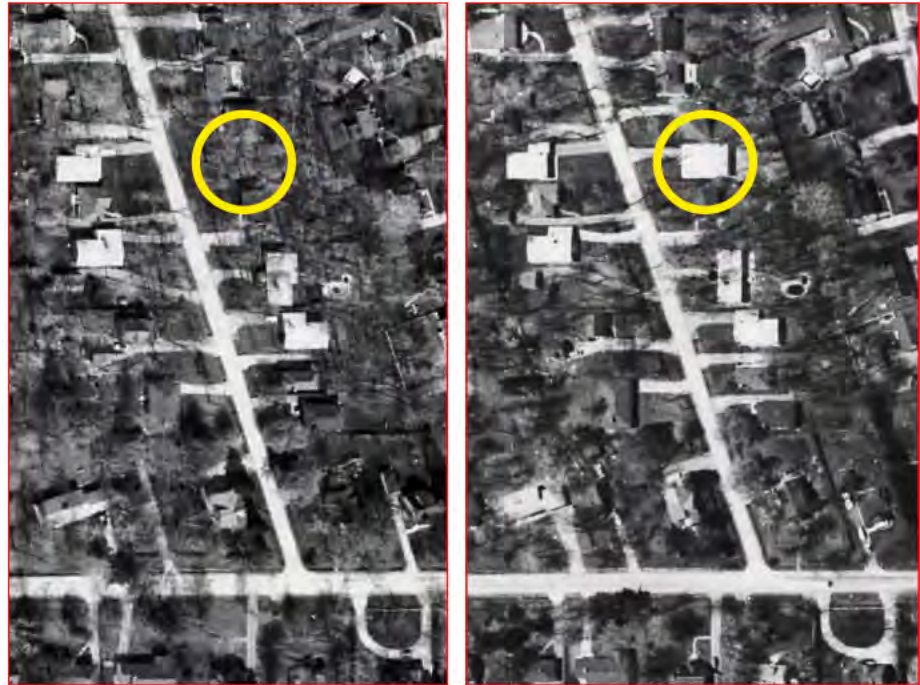
The residence at 1377 Milton Avenue is not present on the 1960 image (left) but is present on the 1961 image.
