Heritage Advisory Committee

2016/10/11

1. *That the property at 1216 Mississauga Road, which is listed on the City's Heritage Register, is not worthy of heritage designation, and consequently, that the owner's request to demolish proceed through the applicable process.*
 2. *That prior to demolition, the owner provide measured drawings of the structure currently on the property as described in the corporate report.*
 3. *That the owner provides a demolition documentation report with information as described in the corporate report.*
- 7.2. Request to Demolish a Heritage Listed Property: 243 Oakhill Road (Ward 1)
Corporate Report dated September 15, 2016 from the Commissioner of Community Services.

That the property at 243 Oakhill Road, which is listed on the City's Heritage Register, is not worthy of heritage designation, and consequently, that the owner's request to demolish proceed through the applicable process.

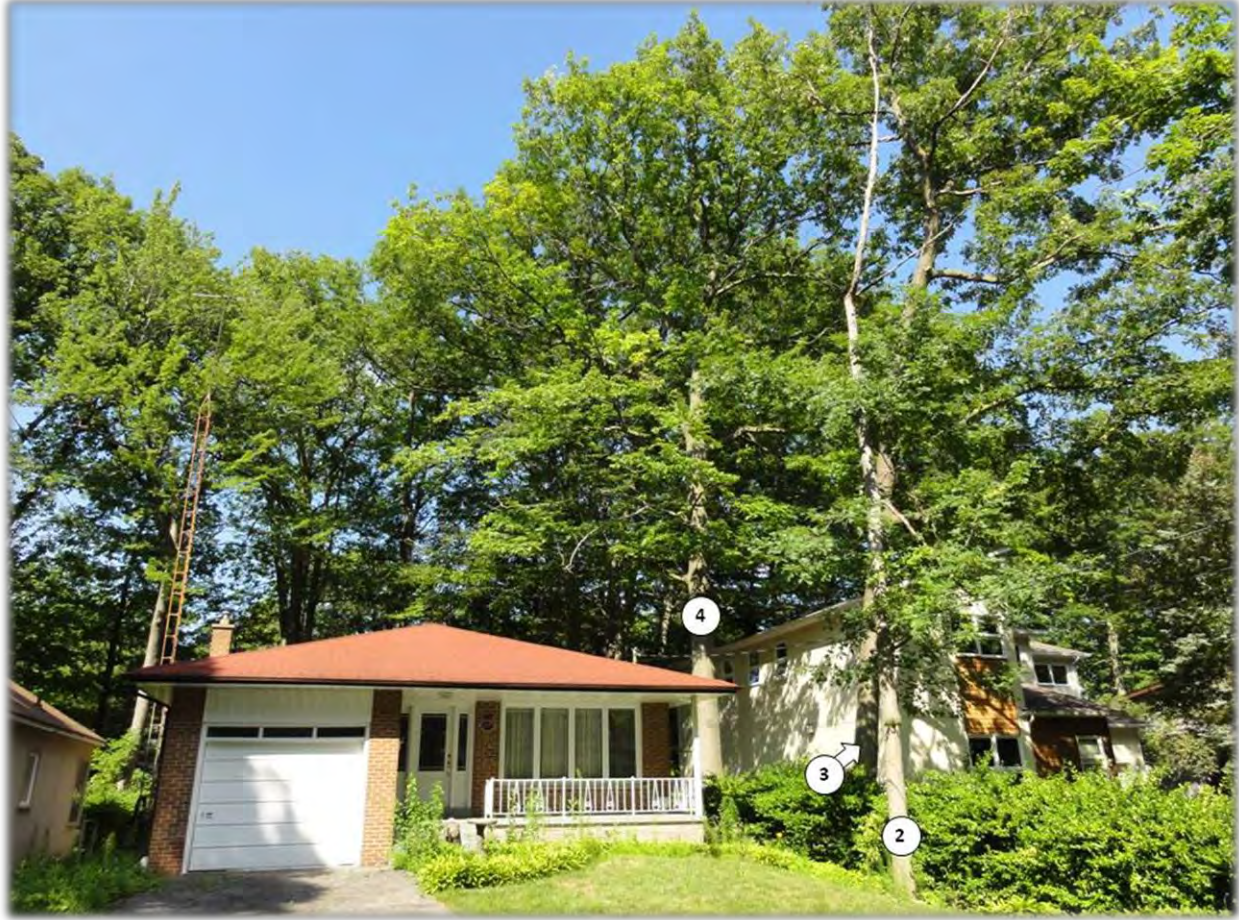
Figure 2: The subject site, 1377 Milton Avenue, Mississauga, Ontario.

- Trees #1 and 2 (Fig. 2) shall be protected jointly behind framed plastic web fencing (to maintain road sightlines). Fencing dimensions shall protect the full radius of the TPZ of tree #1, whereas construction of the proposed dwelling will necessitate a reduction to the hoarding dimensions of tree #2, resulting in tree injury. Excavation associated with the new dwelling must be preceded by root-sensitive excavations, utilizing hand-digging, hydrovac or pneumatic soil excavation, and be accompanied by proper root pruning by a Certified Arborist.

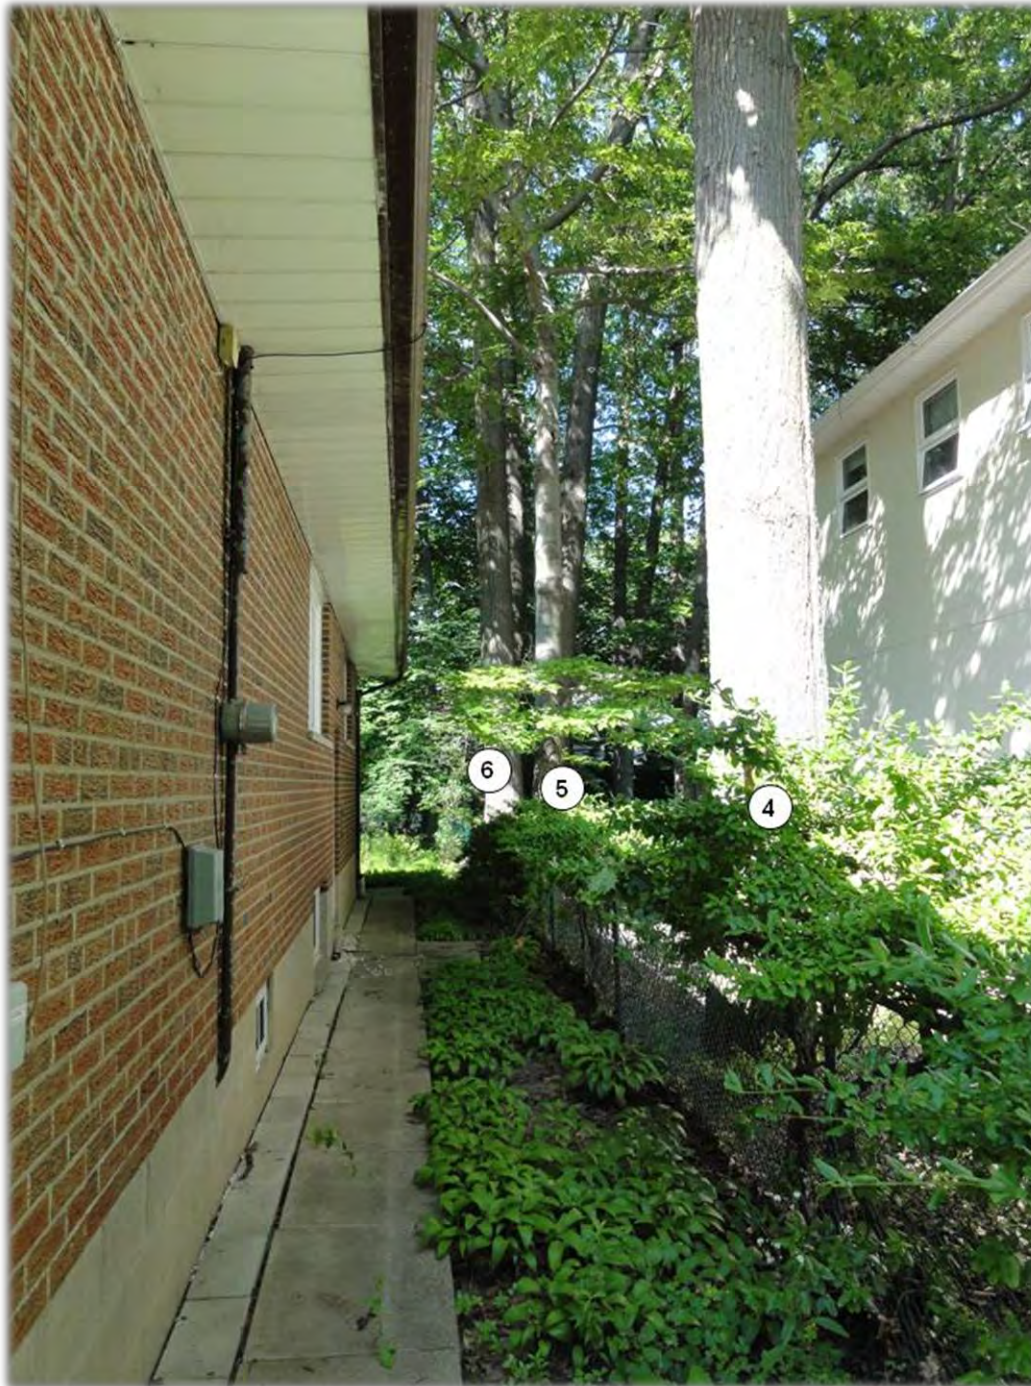
Figure 3: Excavation within the Tree Protection Zone of any subject site and off-site tree must be preceded by root-sensitive excavation and be accompanied by proper root pruning by a Certified Arborist.

- Trees #3-6 (Fig. 3) shall be protected by the existing chain link fence located at the property line to 1371 Milton Avenue. Demolition of the existing dwelling and construction of the new dwelling are proposed within the TPZs of all three trees and will therefore result in injury to each tree. Excavation associated with the new dwelling must be preceded by root-sensitive excavation, utilizing hand-digging, hydrovac or pneumatic soil excavation, and be accompanied by proper root pruning by a Certified Arborist. The interlock walkway must be installed with no excavation to avoid unnecessary damage to the roots of trees #3-6, which are present within the area proposed for the new walkway. Alternately, a dry laid walkway should be considered for this area.
