Heritage Advisory Committee

Heritage Impact Statement

1484 Hurontario Street
Mississauga, Ontario

HERITAGE IMPACT STUDY
IMPACT OF PROPOSED DEVELOPMENT
1248 MINAKI ROAD, MISSISSAUGA

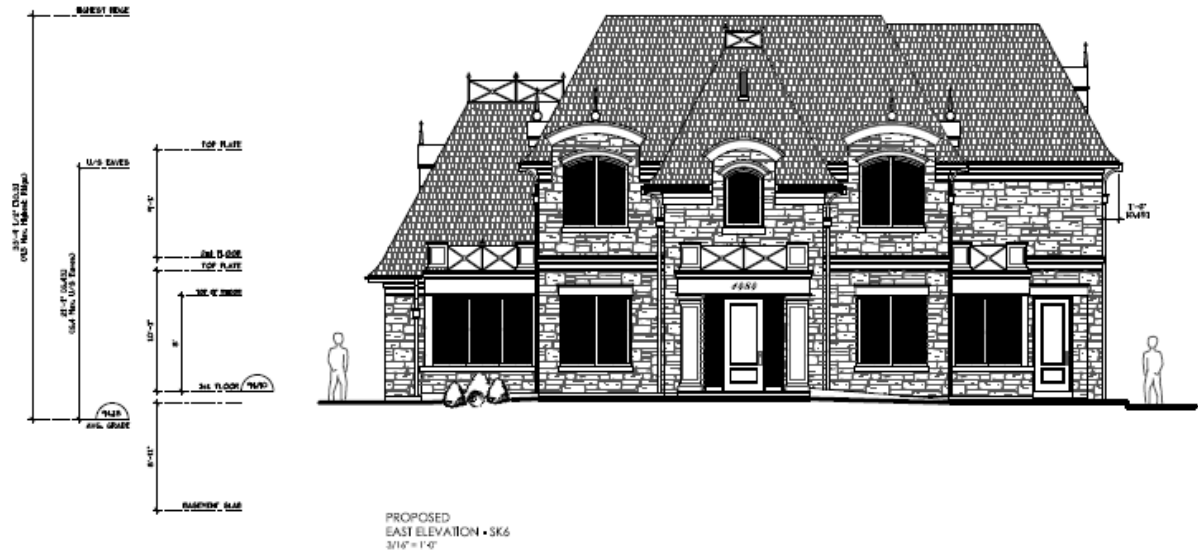
Front Elevation

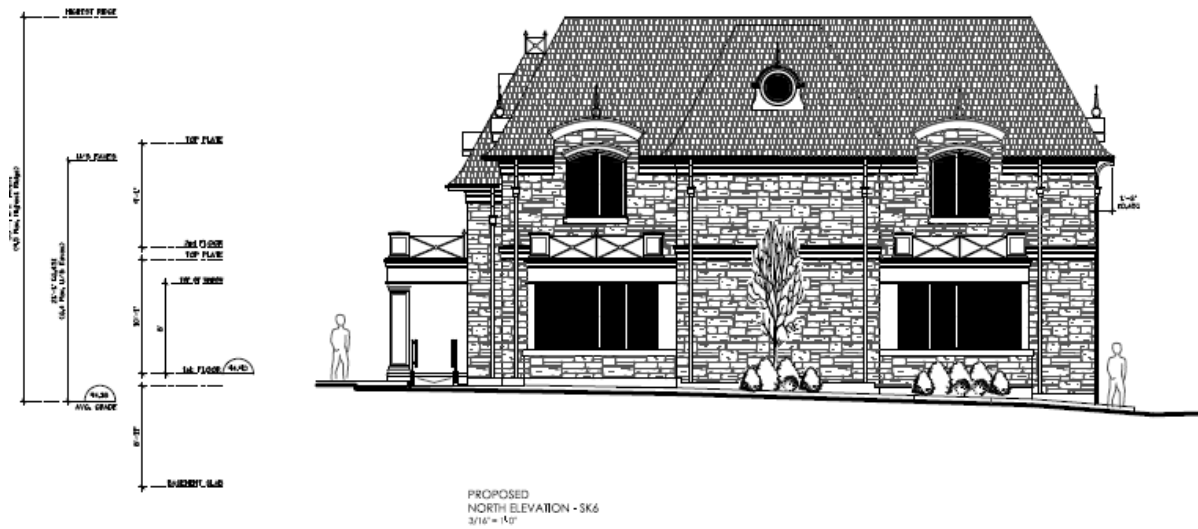
North Side Elevation

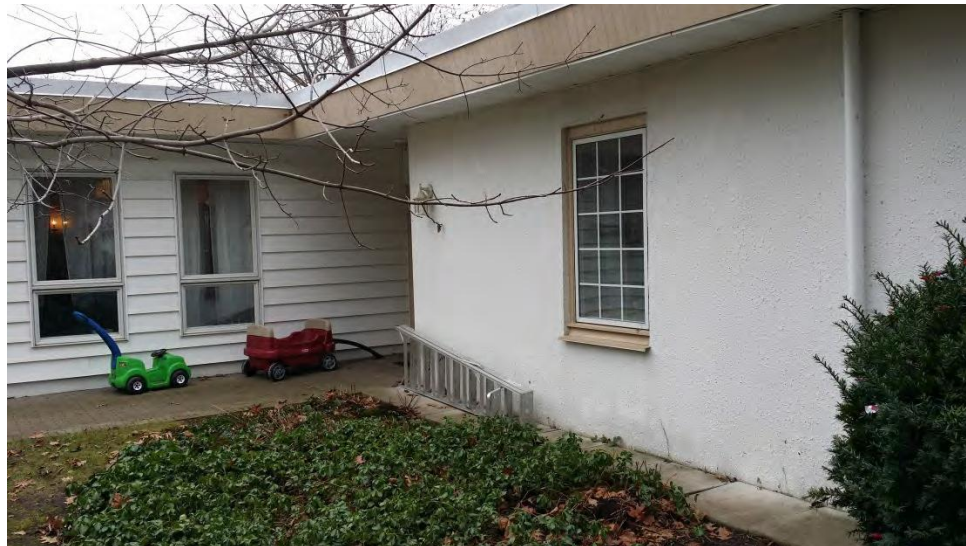
The window and door openings on the original building appear to be as-built but the window and door units are all newer replacements.

Original wall cladding and window detailing at right, later addition at left. Note downpipe at right

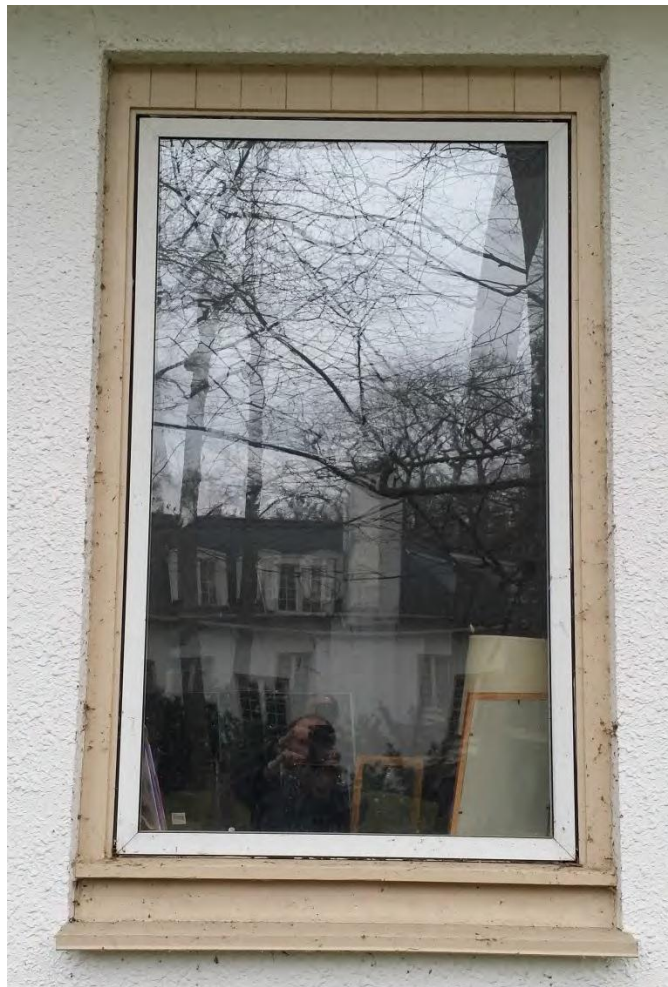
Original window detail (note oversized, punched opening, extruded metal sill)(note newer sash and glazing)

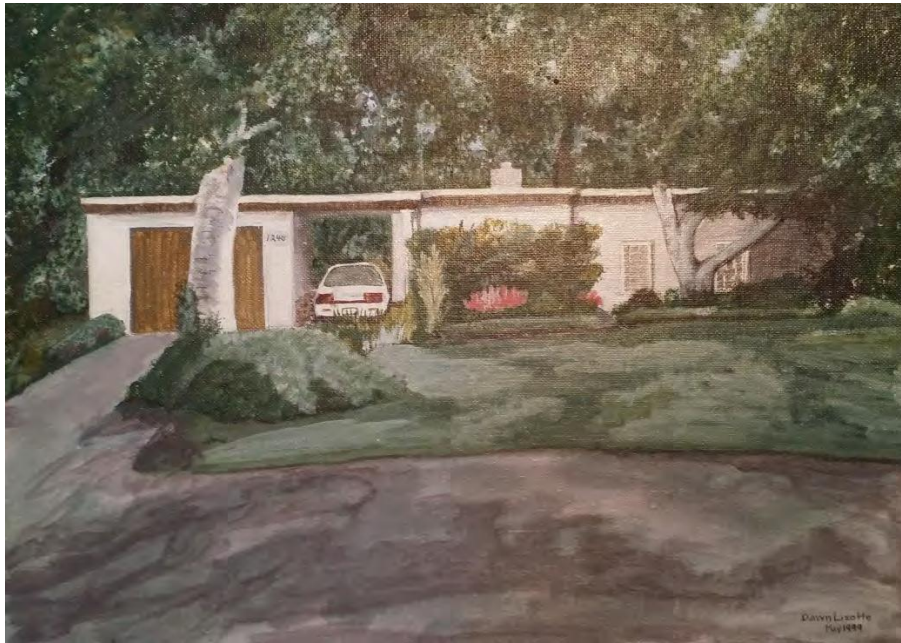
Oil painting depicting original front elevation (note detached garage and covered parking adjacent to house)

The house as constructed consisted of the entry, living room, bedrooms and main bathroom as presently configured. The present dining room was likely the kitchen and the play room was a covered parking area. The 1995 addition connected the garage to make it integral with the home, eliminated the covered parking and added a much larger kitchen. It took a corner of the former kitchen to make a powder room and left the rest as a dining room. While the addition provided additional living space for the family it seriously disrupted the flow and spatial arrangements in the home and created some awkward plan conditions. The dining room is an inappropriate size and shape and having to pass through it to enter the kitchen is an unfortunate condition. The playroom is similarly oddly situated and awkward to access.

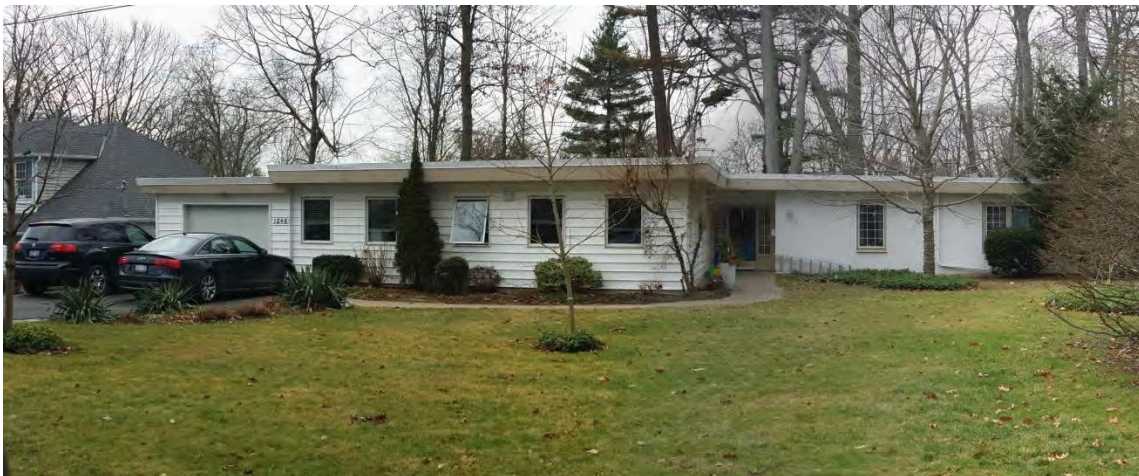
1248 Minaki Front Elevation c.2016 (original building at right, 1995 addition at left)

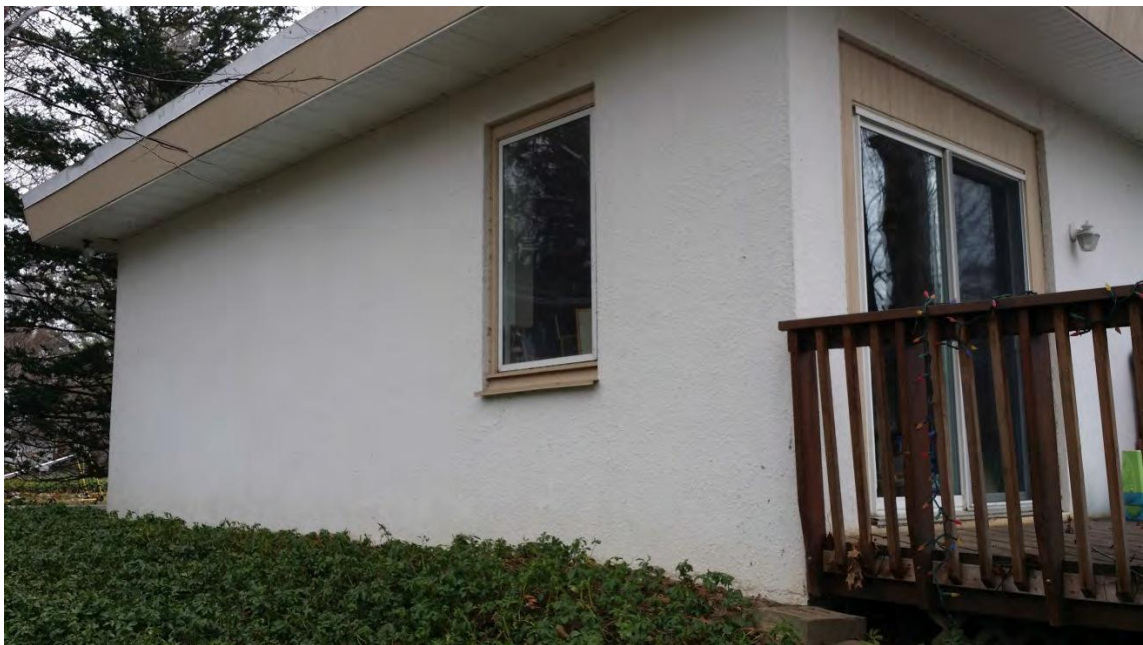
North elevation (note detail at window, door openings)

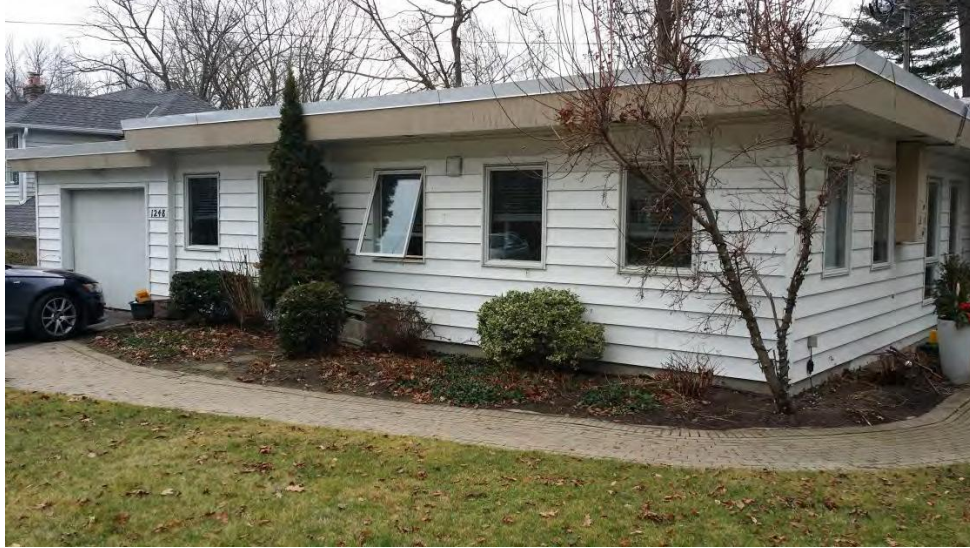
Partial Front Elevation showing 1995 addition

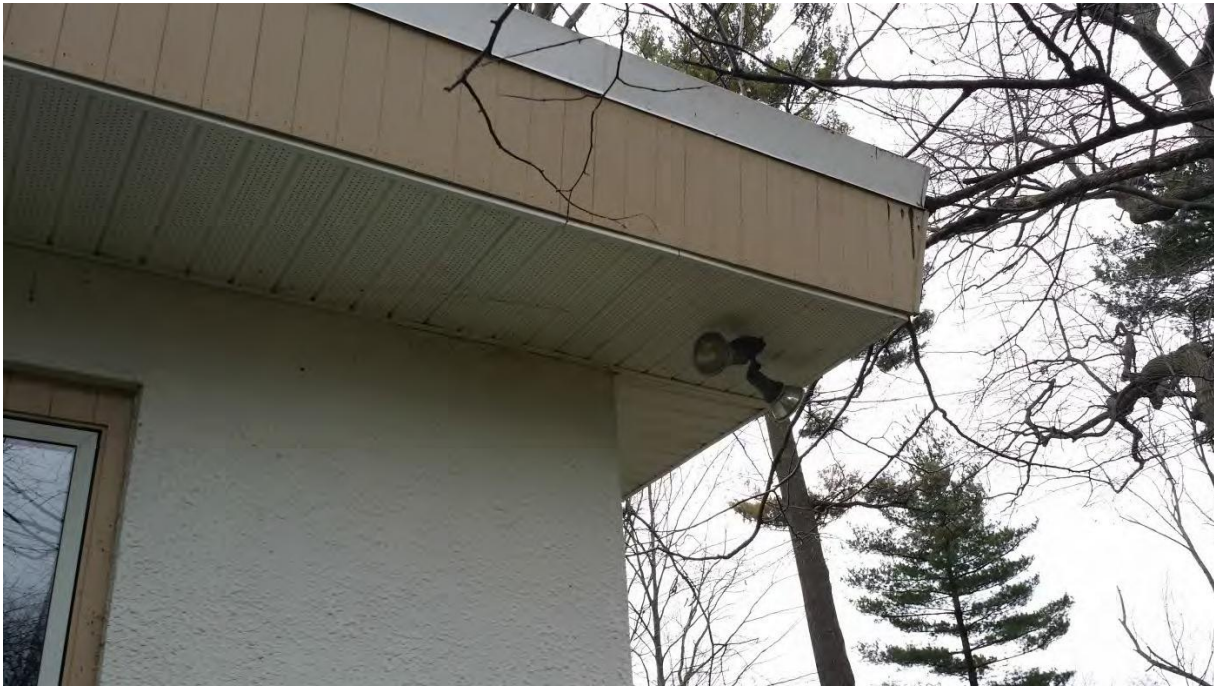
Typical soffit condition (original building)

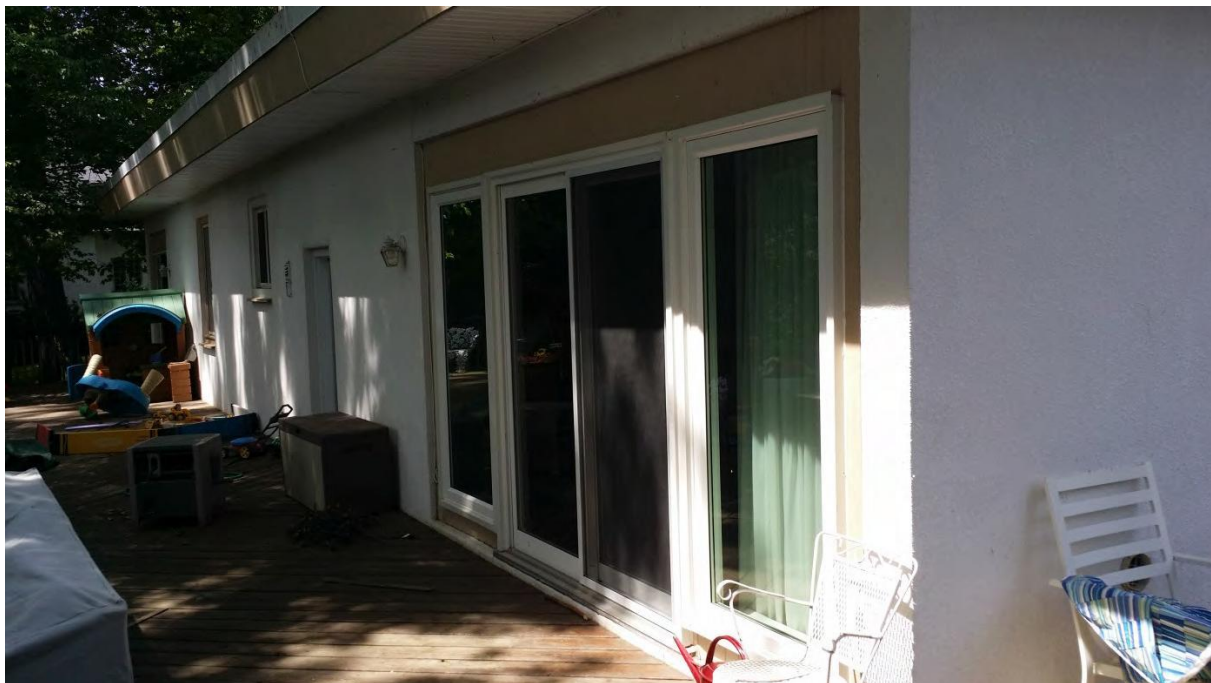
Back wall at deck (note punched opening detail at sliding door)
