Heritage Advisory Committee

2017/04/11

1. CALL TO ORDER
2. APPROVAL OF AGENDA
3. DECLARATION OF CONFLICT OF INTEREST
4. MINUTES OF PREVIOUS MEETING
 - 4.1. Heritage Advisory Committee Minutes - March 7 2017
5. DEPUTATIONS
6. **PUBLIC QUESTION PERIOD** - 15 Minute Limit (In accordance with Section 43 of the City of Mississauga Procedure By-law 0139-2013, persons who wish to address the Heritage Advisory Committee about a matter on the Agenda may ask their question limiting it to 5 minutes, as the public question period total limit is 15 minutes.)
7. MATTERS TO BE CONSIDERED
 - 7.1. Request to Alter a Heritage Designated Property: 31 Mississauga Road South (Ward 1)

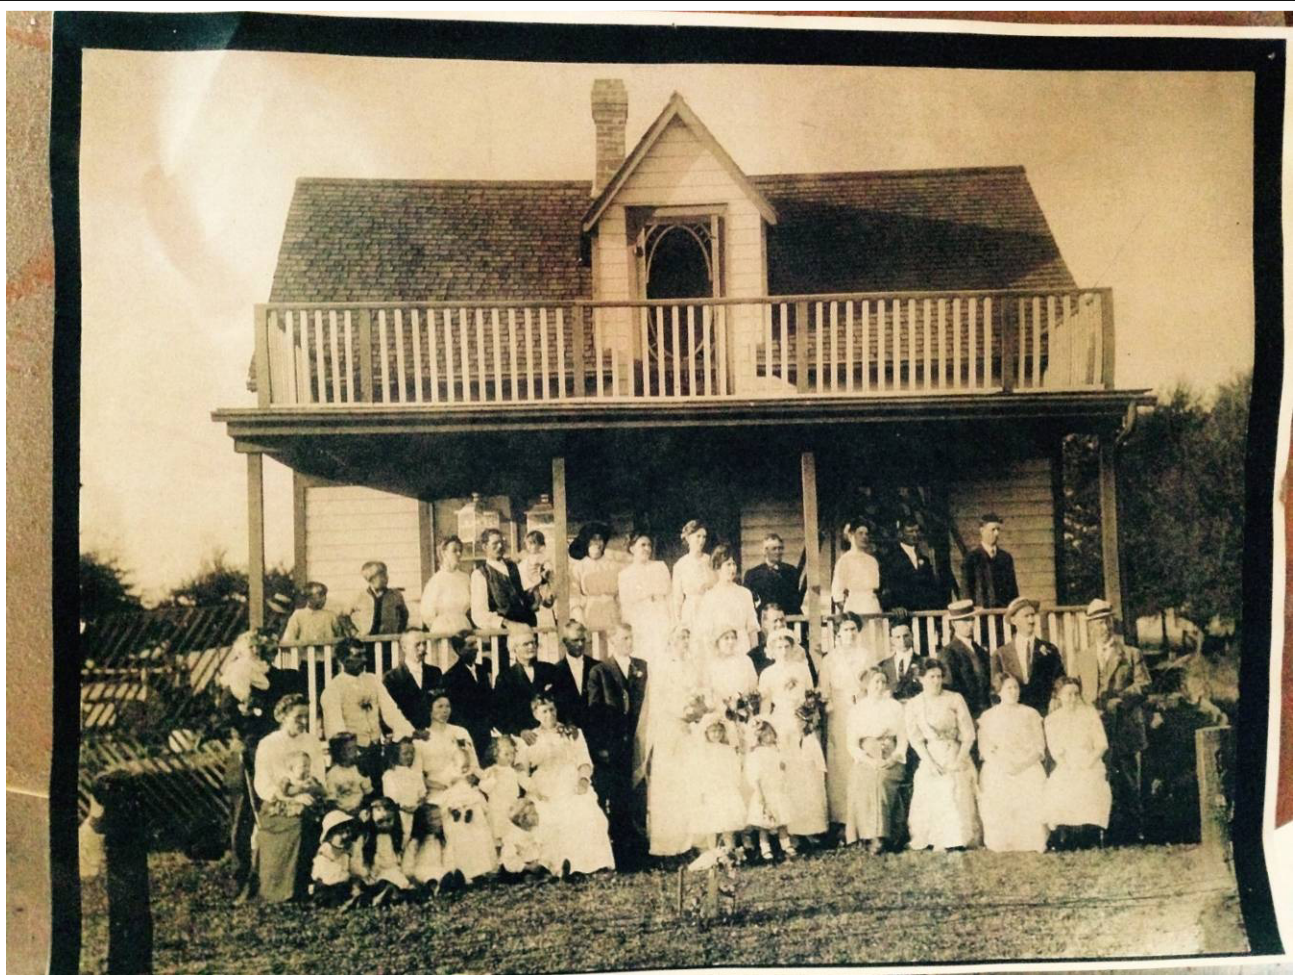
Figure 3. Wedding party circa 1911. Note that the existing dormer was part of the original house. The unadorned verandah had a flat roof with a railing around it, and the dormer was fitted out with a door to give access to the upper gallery. The siding appears to be wood clapboard with corner boards, and the roof appears to be wood shingle. The central chimney is no longer there.

- The ridge of the front side-gable roof is to be raised 2 feet to match the ridge of the existing tail.
- The enclosed front verandah is being replaced by a two-level open verandah, similar to the original as shown in figure 3.
- The existing exterior chimneys will be removed.
- New window openings—ground floor south façade towards rear of front portion; ground floor east façade new patio door in centre of wall.
- Add two small dormers flanking existing centre dormer on front roof slope.
- Remove 2013 deck and handicap ramp addition and reuse existing stair which was left beneath it.
- All windows will be new, 2 over 2 double hung, to match the original windows as seen in figure 3.
- Remove 8” aluminum clapboard siding and replace with 4” vinyl siding, in keeping with the siding profile of the original house as seen in figure 3.

Removal of the existing single-level enclosed verandah—dating from about 1945—and its replacement with an open two-level verandah in keeping with the original design as seen in the 1911 photograph (figure 3).

Replacement of existing unsympathetic replacement windows with new windows that replicate the 2-over-2 double hung windows seen in the 1911 photograph (figure 3.)

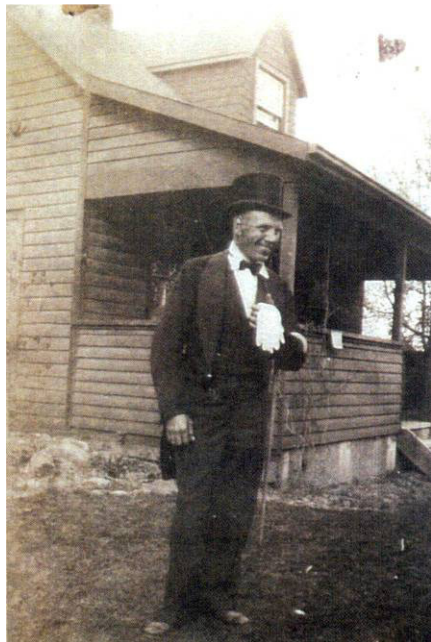
Figure 4. Unknown person, unknown date. Verandah has been changed from original.

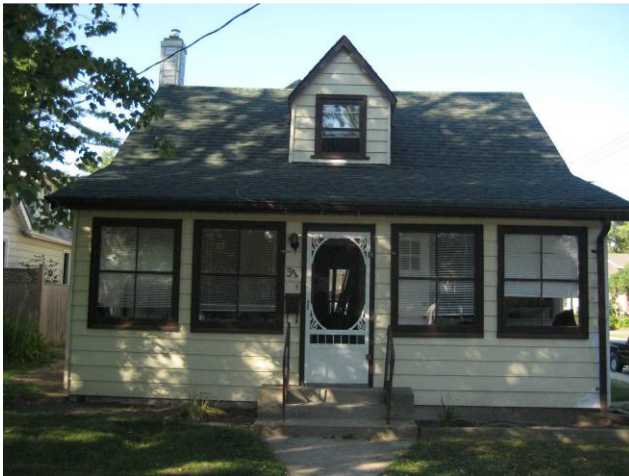
Figure 5. Front of the house, facing Mississauga Road South.

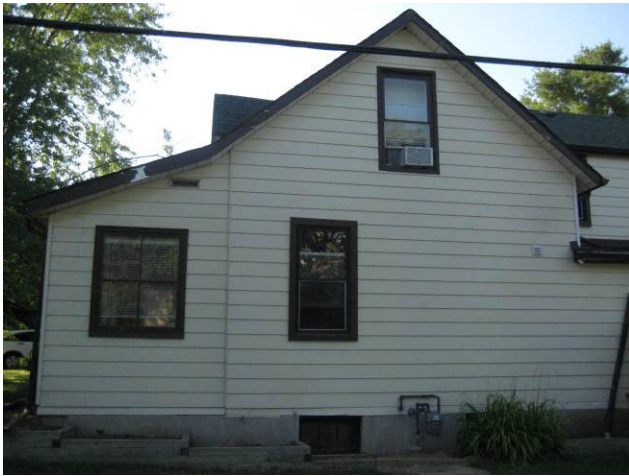
Figure 6. South side of the house, facing Bay Street.

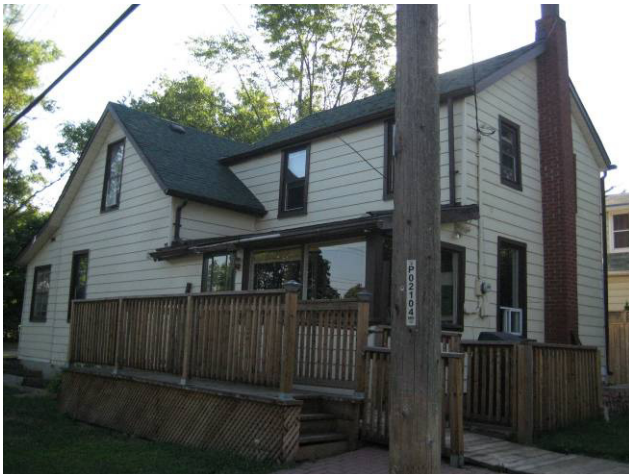
Figure 7. View from Bay Street looking northwest. Note exterior chimney replacing original central one.

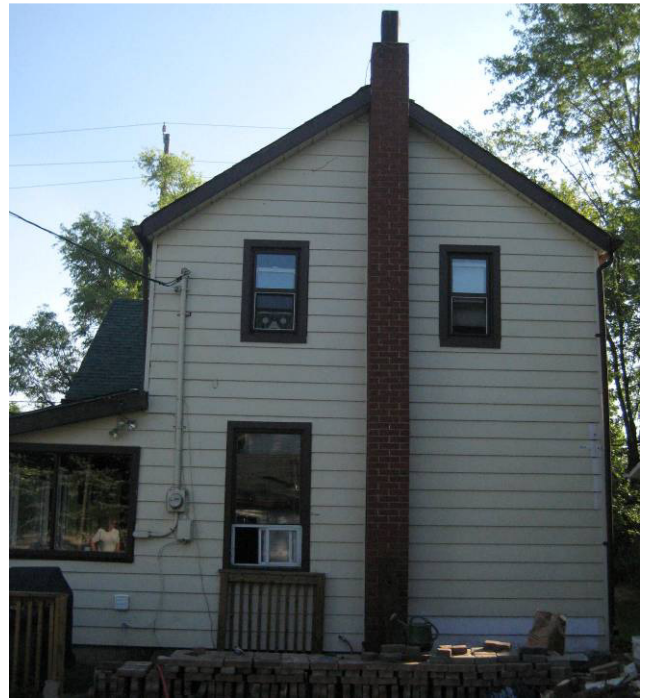
Figure 8. The rear (east) side of the house.

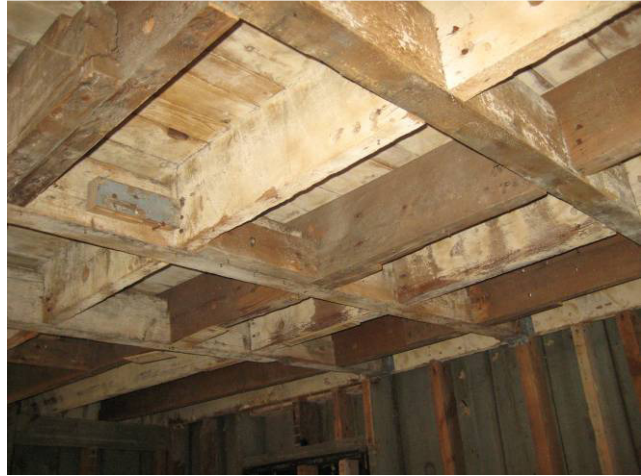
Figure 10. The interior of the house has been gutted in order to effect structural remediation.

The interior of the house has been much altered. Walls have been removed to create a more open plan than what would have been the original layout. New closets, with double width doors have been created in place of what would have been much smaller ones. All interior trim, including doors, door and window casings and baseboards have been replaced with modern items.

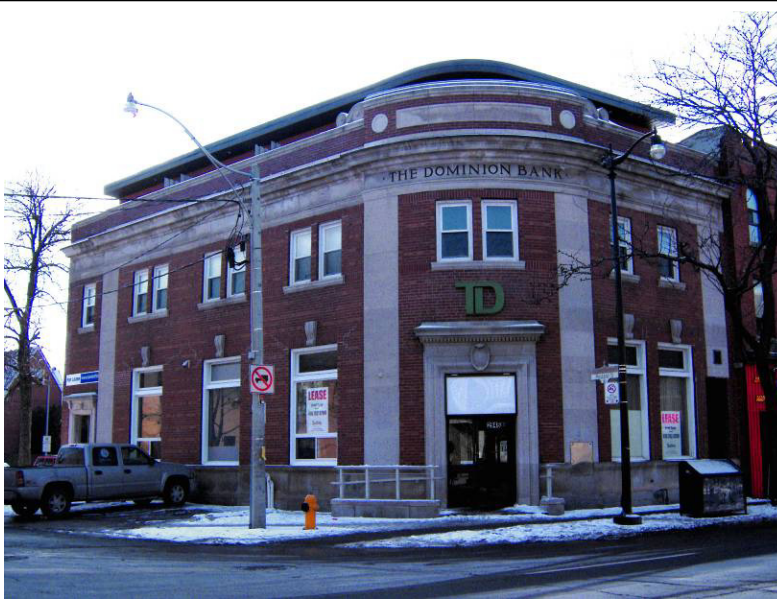
Setting back the third-floor addition allowed the restored bank building to retain its street presence, and maintain the detail significance of the cornice and entry-bay decoration. Preservation Services provided oversight for work under the façade improvement program.

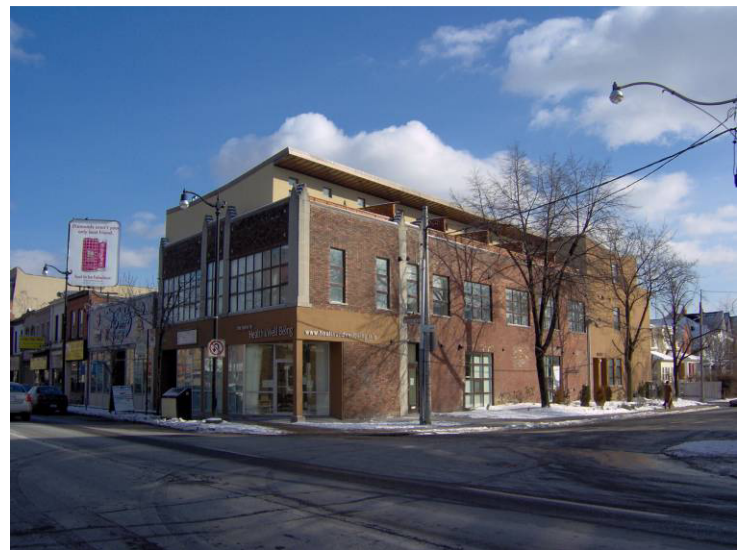
This building has a set-back addition similar to the one at the Dominion Bank across the street. In this case the penthouse has a Moderne design, reflecting the Art Deco style of the original building.

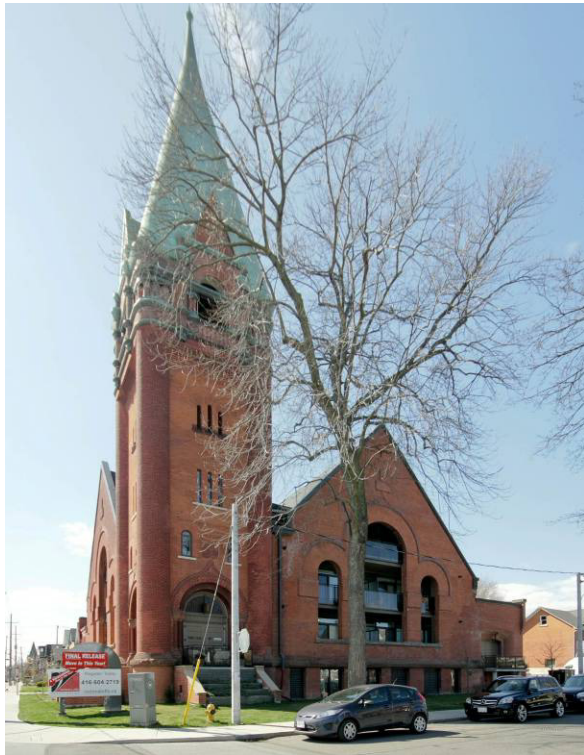
Balconies behind the original arches double the window area to meet the requirements of residential use, without cutting new openings in the historic masonry structure.

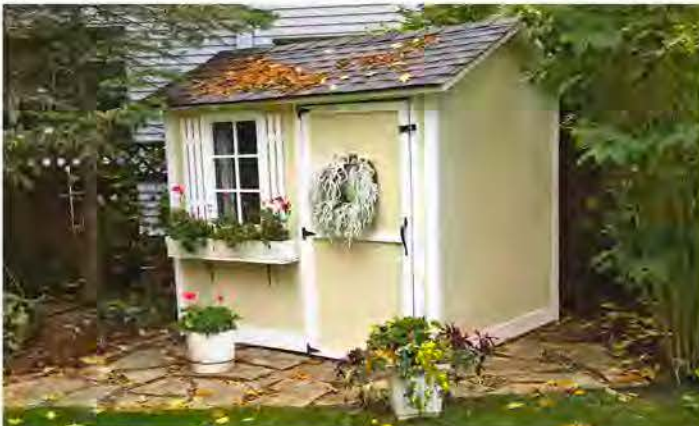
**Garden Shed Located
Near West Property Line**

The decorative garden shed is designed to resemble a little cabin with a gable roof, a two panel entry door and a 6 pane casement window complete with window box.

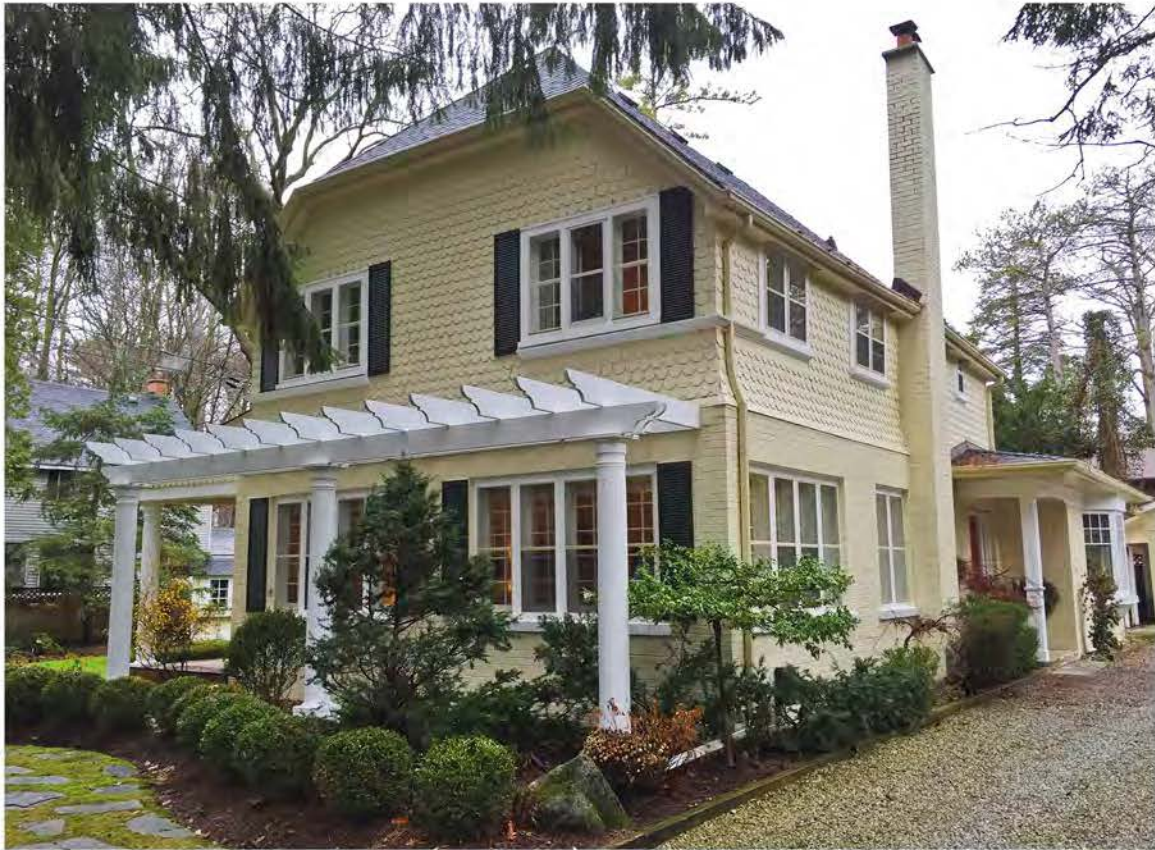
**913 Sangster Avenue
South East 3/4 View
Of Original Cottage
With Modifications
And Additions To
The Rear (above)**

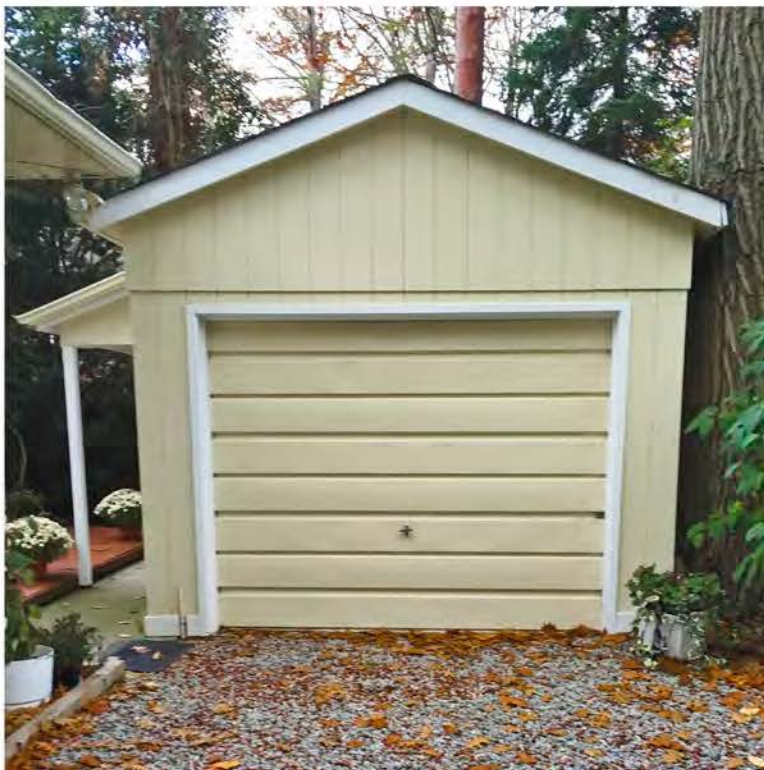
**South Elevation Of
The Single Car
Garage Showing The
Large Tree At The
South East Corner
(left)**

The garage was built close to the very large tree on the north east corner of the garage. The garage has had a corner removed to accommodate the tree. (see Architects Site Plan Drawing). However, the tree has grown larger since the garage was built, now in order to accommodate the tree, it is proposed to shorten the garage by moving the front elevation of the garage to the north, back of the tree. (see photo below)

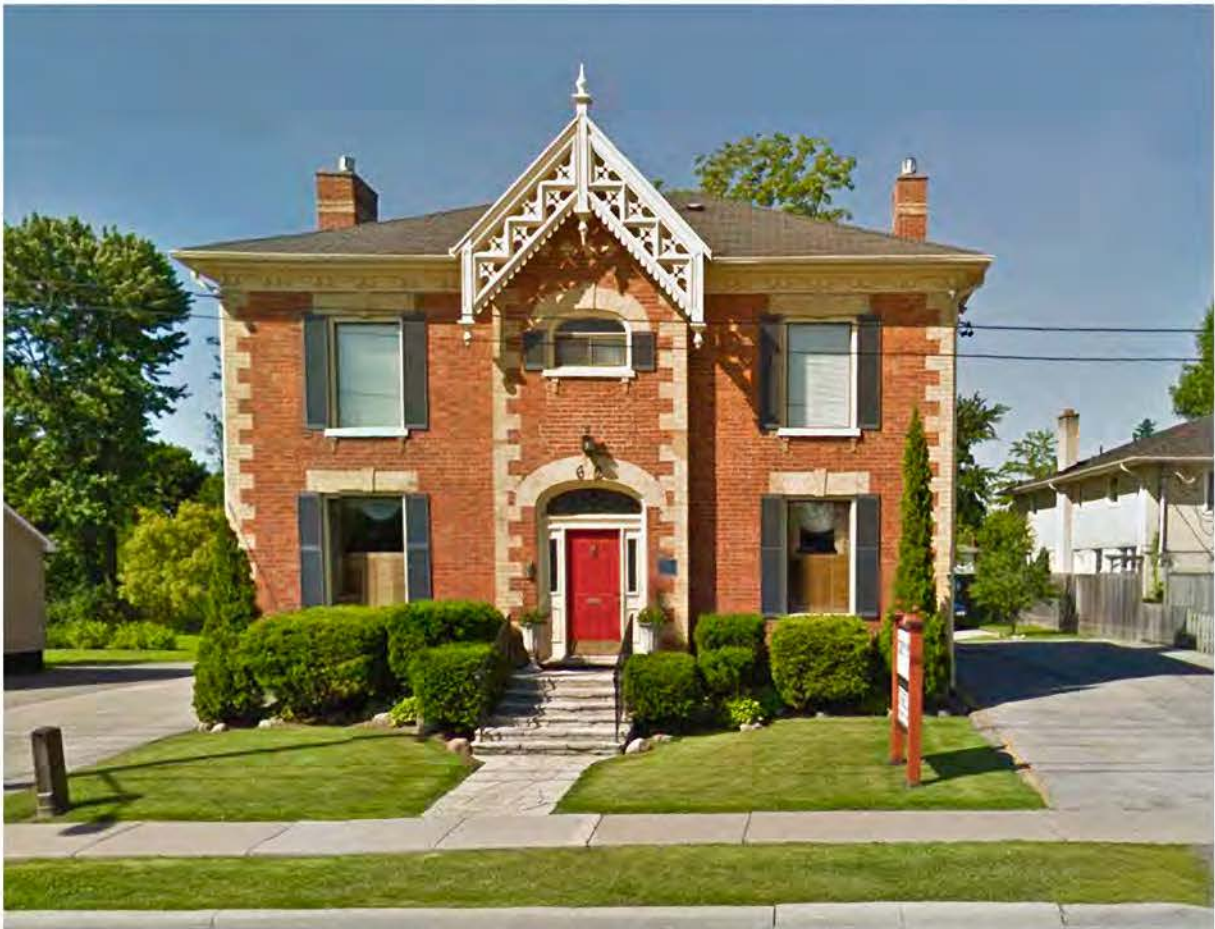
The John Graydon House at 62 Queen Street South (designated) as it is today. Some modifications have taken place - the verge boards have been altered and some changes made on the centre bay. However it shows a well built house with fine craftsmanship and attention to detailing.

His own house at 62 Queen Street South, which he built in 1865, is a large square plan, brick Italianate house, which is now designated, and shows that his buildings had fine quality workmanship with attention to detailing.

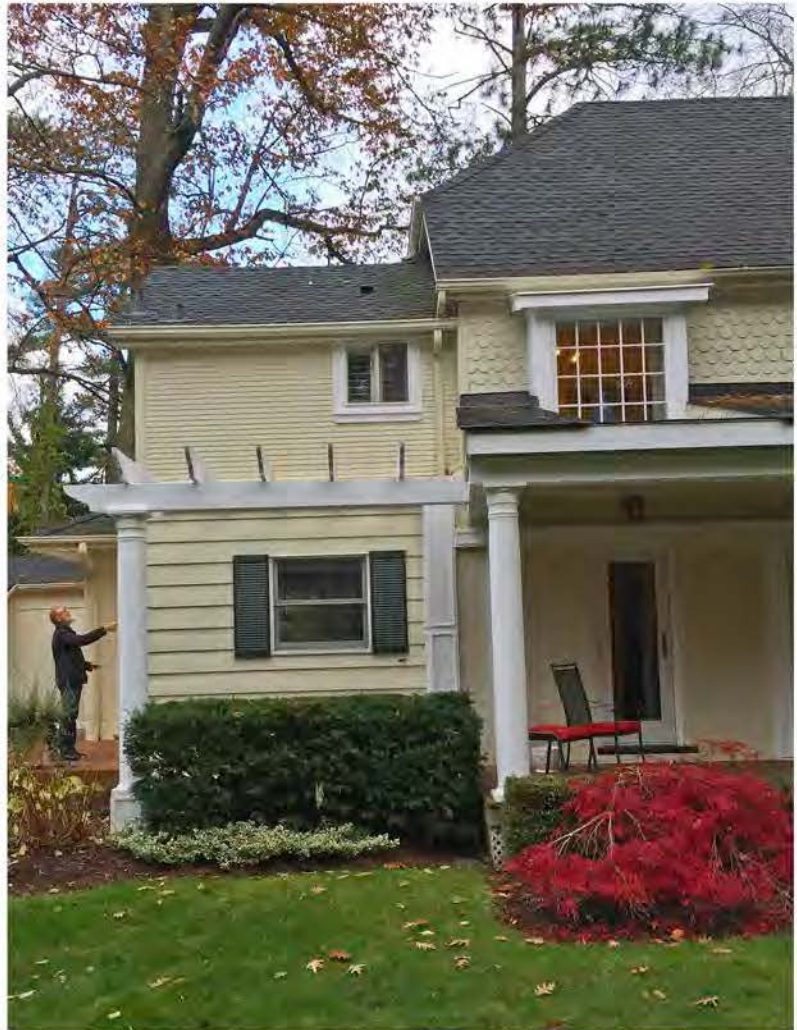
The original cottage has a distinctive monk's hood gable roof that is presently clad in asphalt shingles. The original roof would most likely have been in Ontario white cedar shingles, as asphalt shingles were not available until the beginning of the 1900's. The roof on the 1 1/2 storey addition is a gable roof, and the one storey addition has a hip roof, both have asphalt shingles, and as they are of a later date it is possible that this was the original shingle material. There is a shed roof with asphalt shingles over the later deck on the west elevation, which may also have been the original roofing material. It would appear that the bay window on the west elevation was built at the time of the first addition, and the roof over the deck was built later as it obscures the side windows of the bay window even though there is a recessed roof under the bay window.

West Elevation - North End Showing The Various Roof Configurations And Bay Window Detail

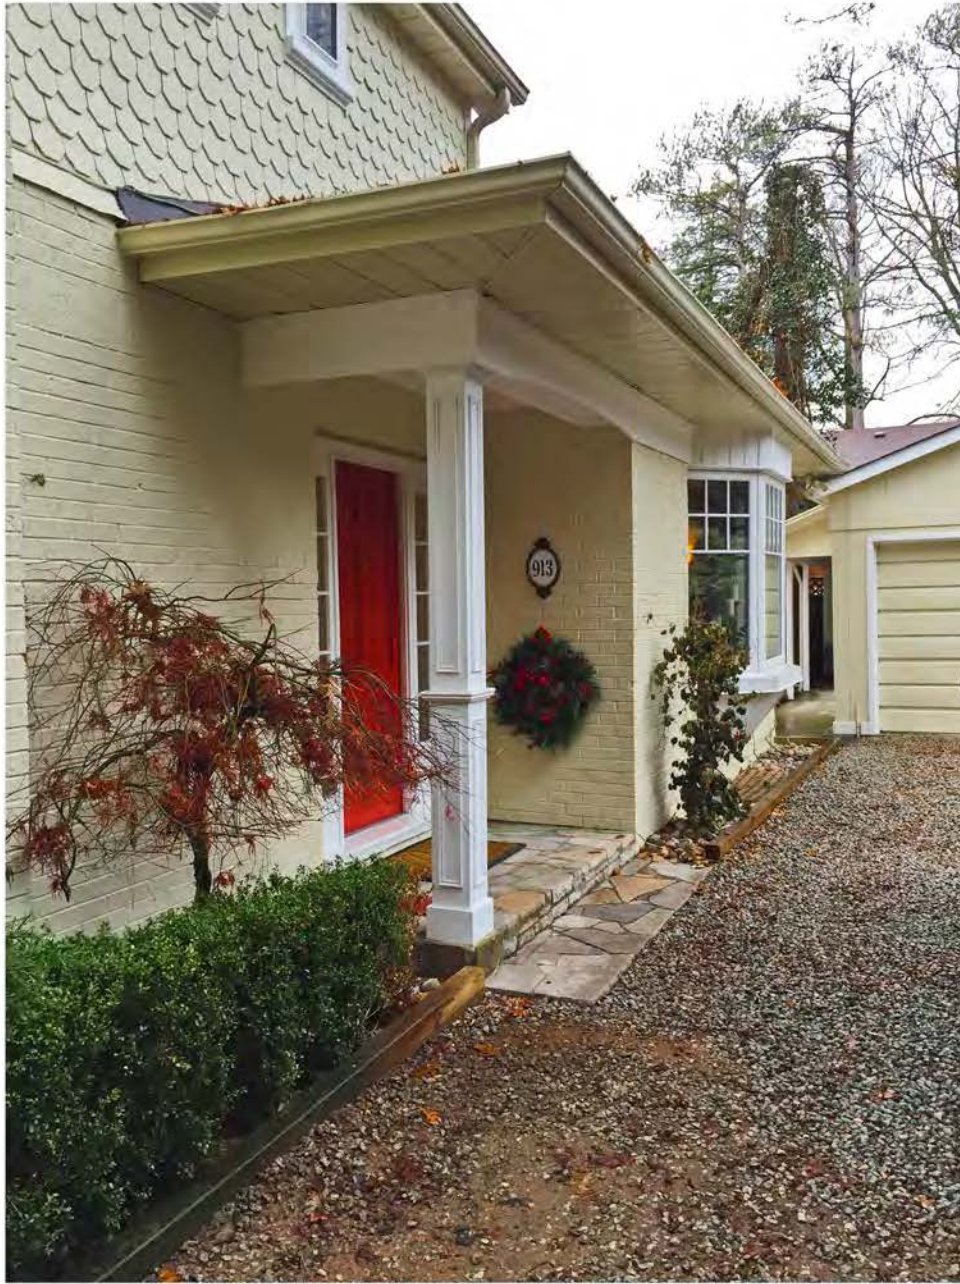
The main entry to the house was relocated from the center of the south elevation to the north end of the east elevation and a Georgian inspired door with side lights was installed. This work may have done at the time that the 1 storey addition was added, as the roof on the addition is continued toward the south, forming the cover over the new front entry. (see photo next page)

Georgian Inspired New Front Entry On East Elevation, Garage Behind

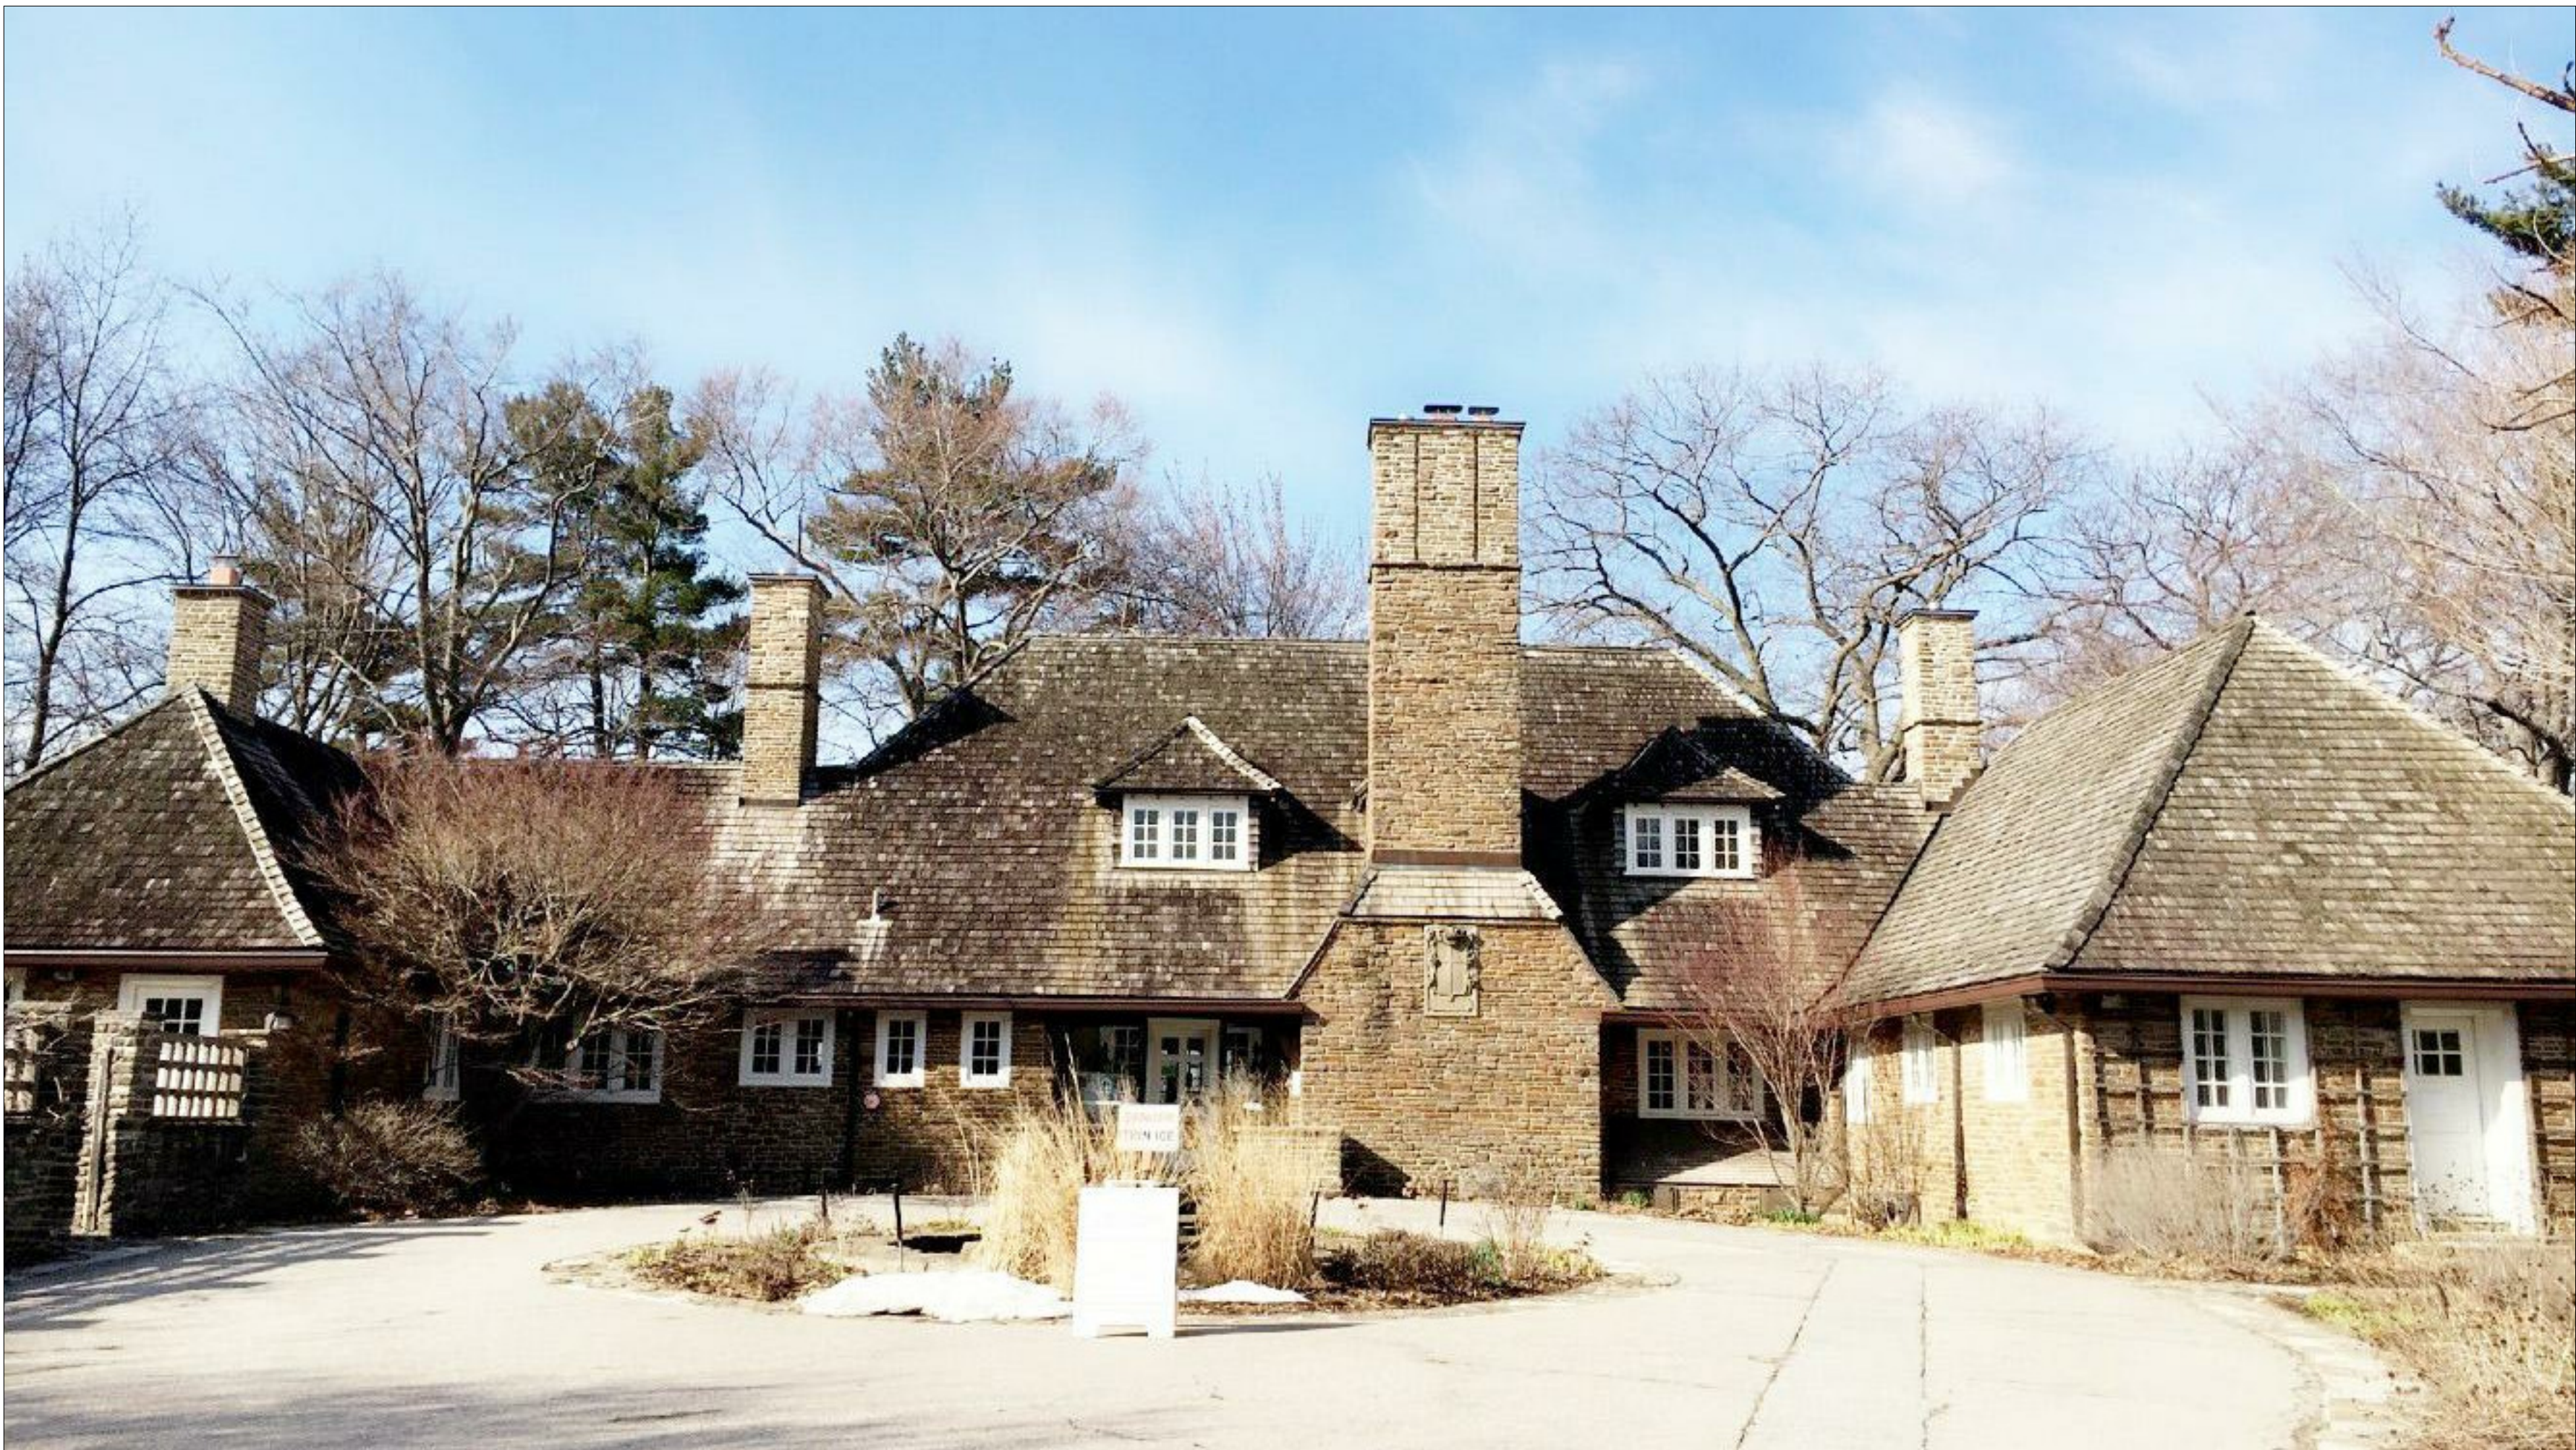
16-1115 CHAPPELL HOUSE WINDOW RENOVATION

The proposal by the City of Mississauga is to rehabilitate the existing condition of exterior windows in order to to minimize air leakage and reduce energy consumption, while preserving the heritage character of the Chappell House.

The windows have lost their weather-tightness and operability with age. Consequently, points of high air infiltration are located where the sealant is missing around the window sash. 70% of the windows were caulked shut during the Summer of 2012. For windows with fresh sealant, it is proposed to add caulk in areas where the sealant is damaged or missing. In 13% of the windows, where the caulk is deteriorated or never applied, it is proposed to return the stuck window sashes to their original operation. This would include making them weather tight and energy efficient by weather-stripping around the sash and readjusting hardware. The deteriorated sealant is to be removed from windows prior to weather-stripping.

All pertinent windows will be cleaned, and repainted only where the paint is flaking, blistering or alligating, and protected with a clear coating to preserve the quality of wood. Adding caulk where it is missing or weather-stripping the windows will prevent warm air from escaping in the winter and cool air in the summer, thus saving energy, as well as heating and cooling costs. Furthermore, it will create greater comfort for Chappell Estate's full-time employees and visitors. Please see the attached report summarizing the existing condition of the windows and the proposed work.

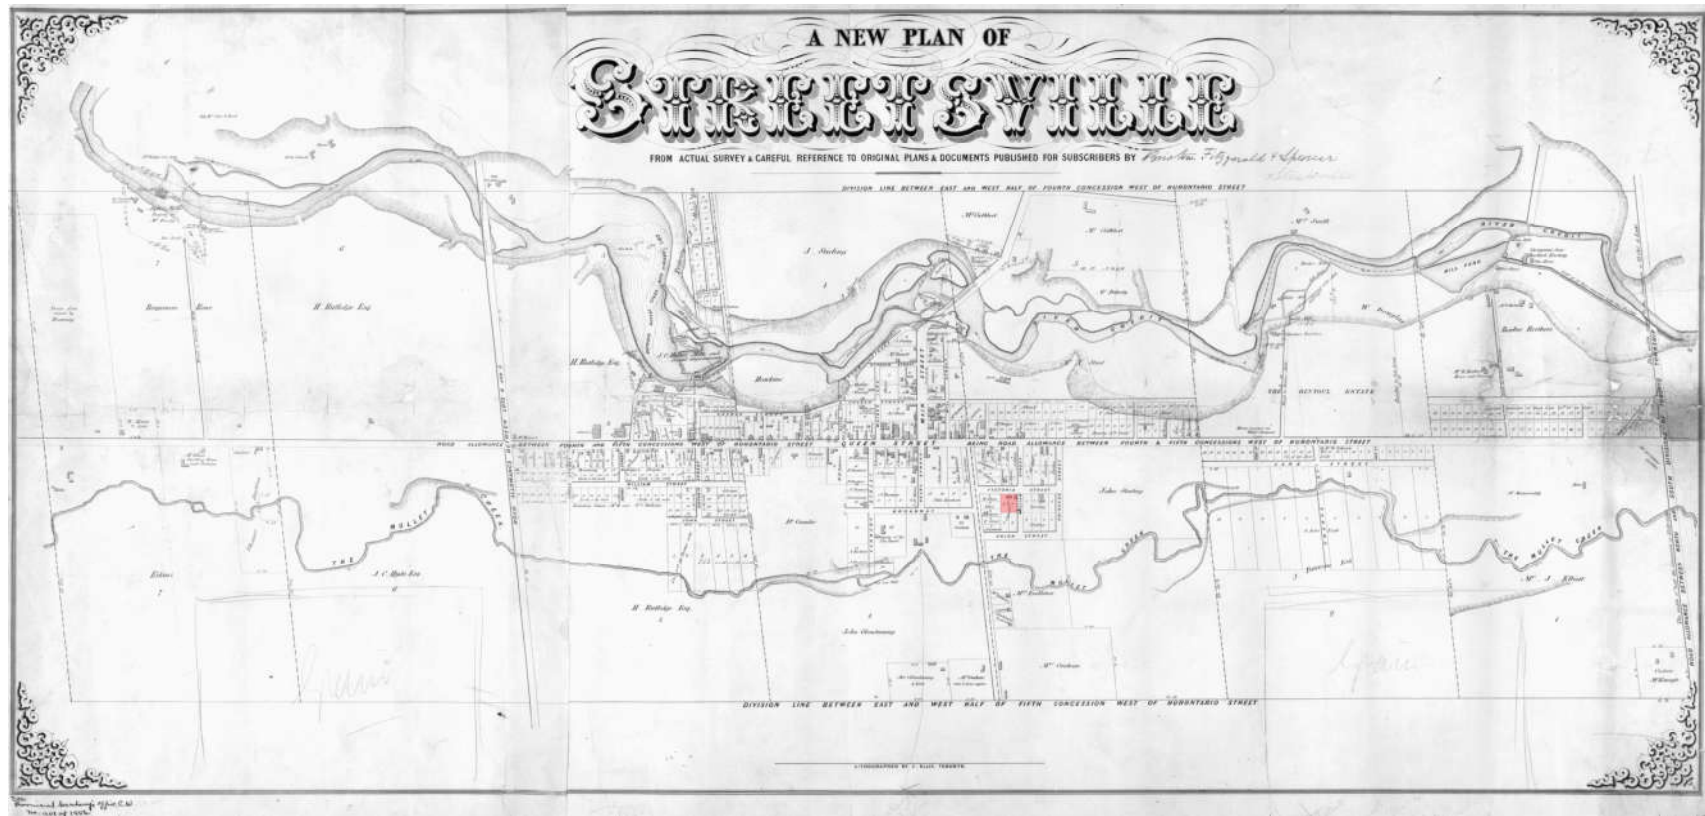
"A New Plan of Streetsville", 1856 - Library and Archives Canada - subject property in red

McMaster sold to Adam Simpson in 1857 for £394. According to the City of Mississauga's heritage inventory, 272 - 274 Victoria Street was built for Adam Simpson in the 1840s as a single family house and converted to a semi-detached after 1884.^{5, 6, 7} Figure 2 is "A New Plan of Streetsville from actual survey & careful reference to original plans & documents published for subscribers by Bristow, Fitzgerald & Spencer".⁸

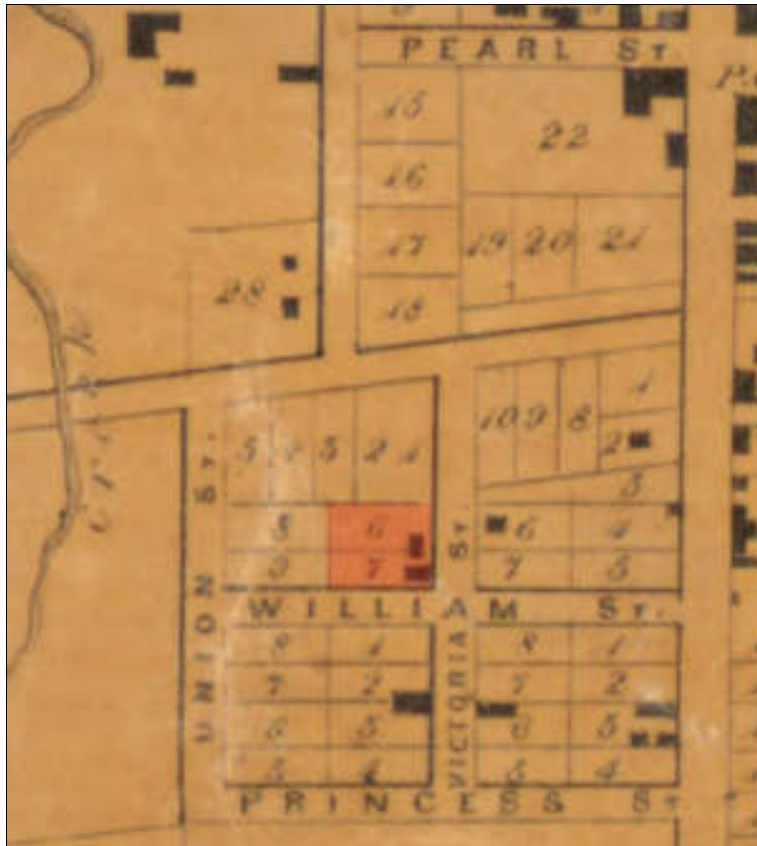
Figure 5

detail from *Tremain's Map 1859*

Tremaine's map of 1859⁹ (Figures 4 & 5) shows a similar situation as that of "A New Plan of Streetsville" with 272 - 274 Victoria Street being the only built-upon property in the block.

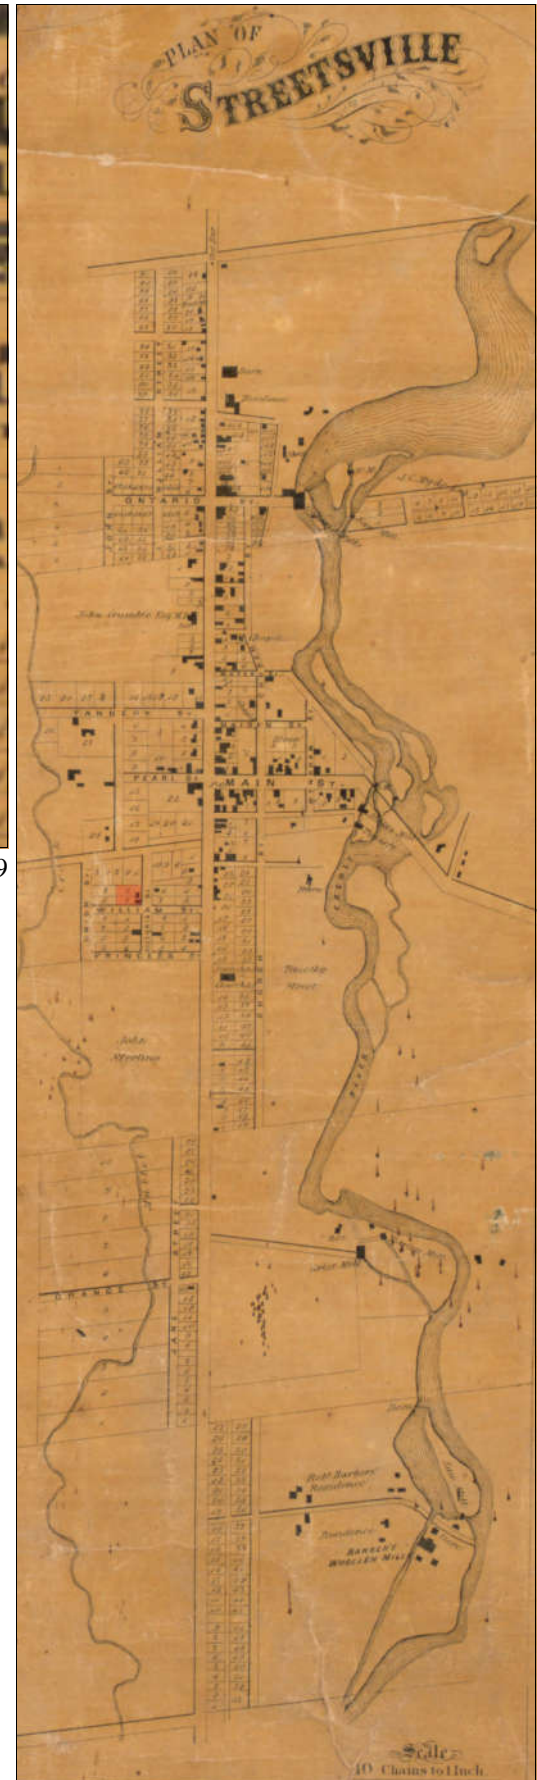
Figure 4

Tremain's Map 1859

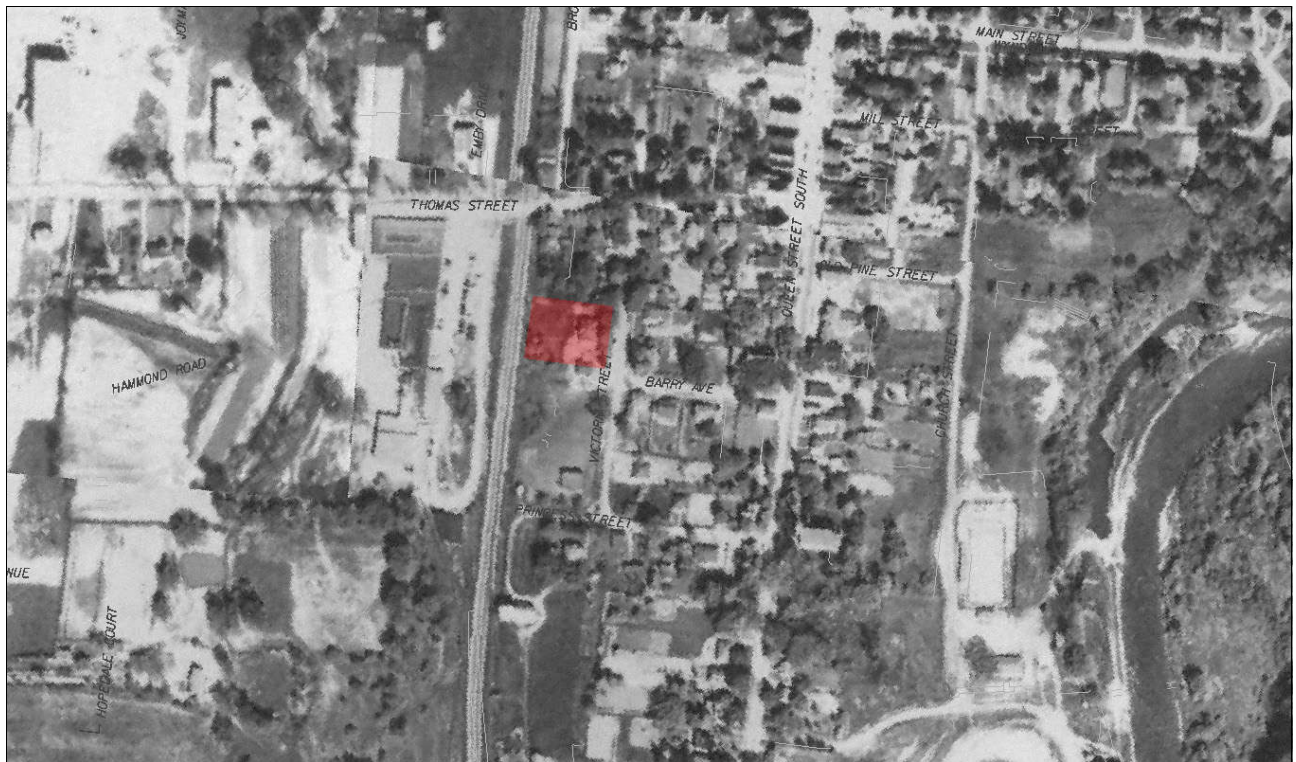
Figure 6 - subject property & environs 1954

A series of airphotos of the neighbourhood, from 1954 to 2015 (Figures 6 through 13) shows the evolution of the area. In 1954, there is only one other house on the west side of the street. Lands across the railway tracks are industrial. Houses line both sides of William Street/Barry Avenue (Figure 6).

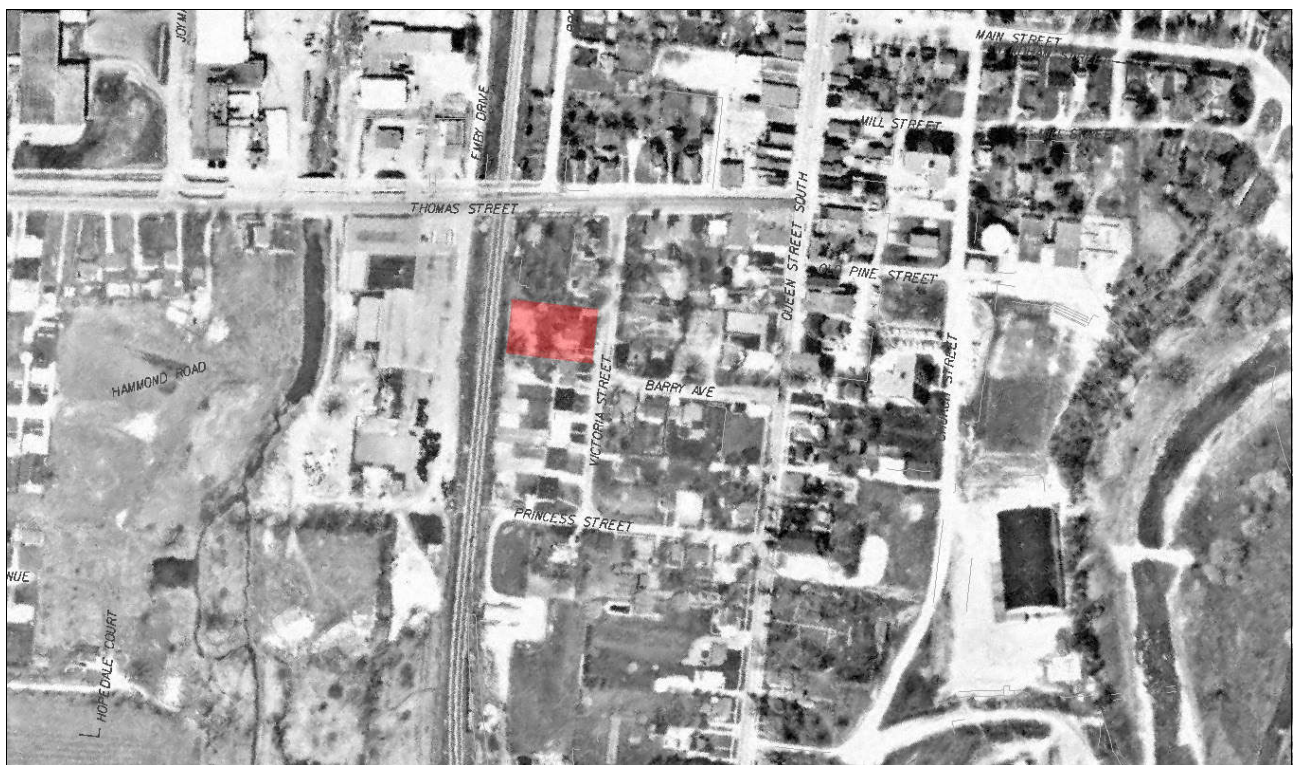
Figure 7 - subject property & environs 1966

By the middle of the next decade, a series of bungalows have been built south of the subject property on the west side of Victoria Street (Figure 7). A Streetsville United Church parking lot now occupies one of the lots on Barry Avenue.

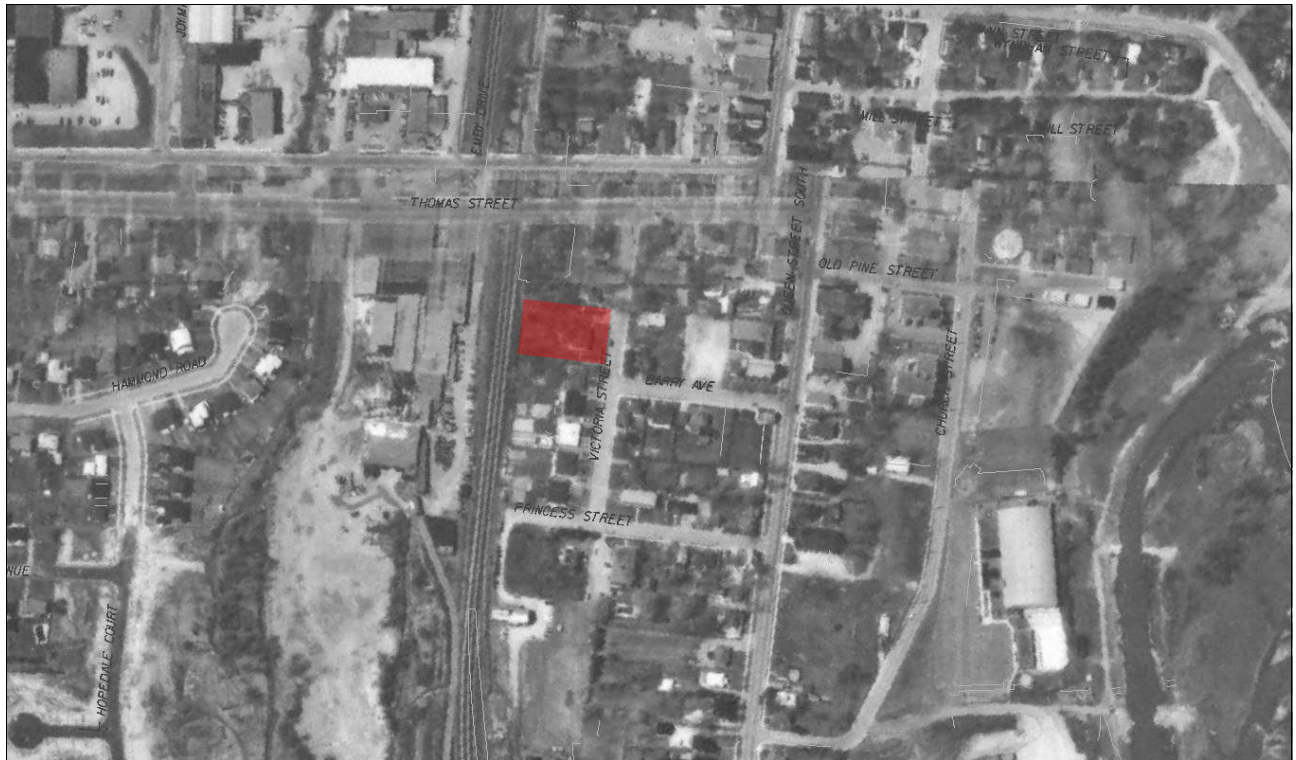
Figure 8 - subject property & environs 1975

There is little obvious change from 1966 to 1975 (Figure 8). Lands to the south of Princess Street have been developed by 1985 (Figure 9).

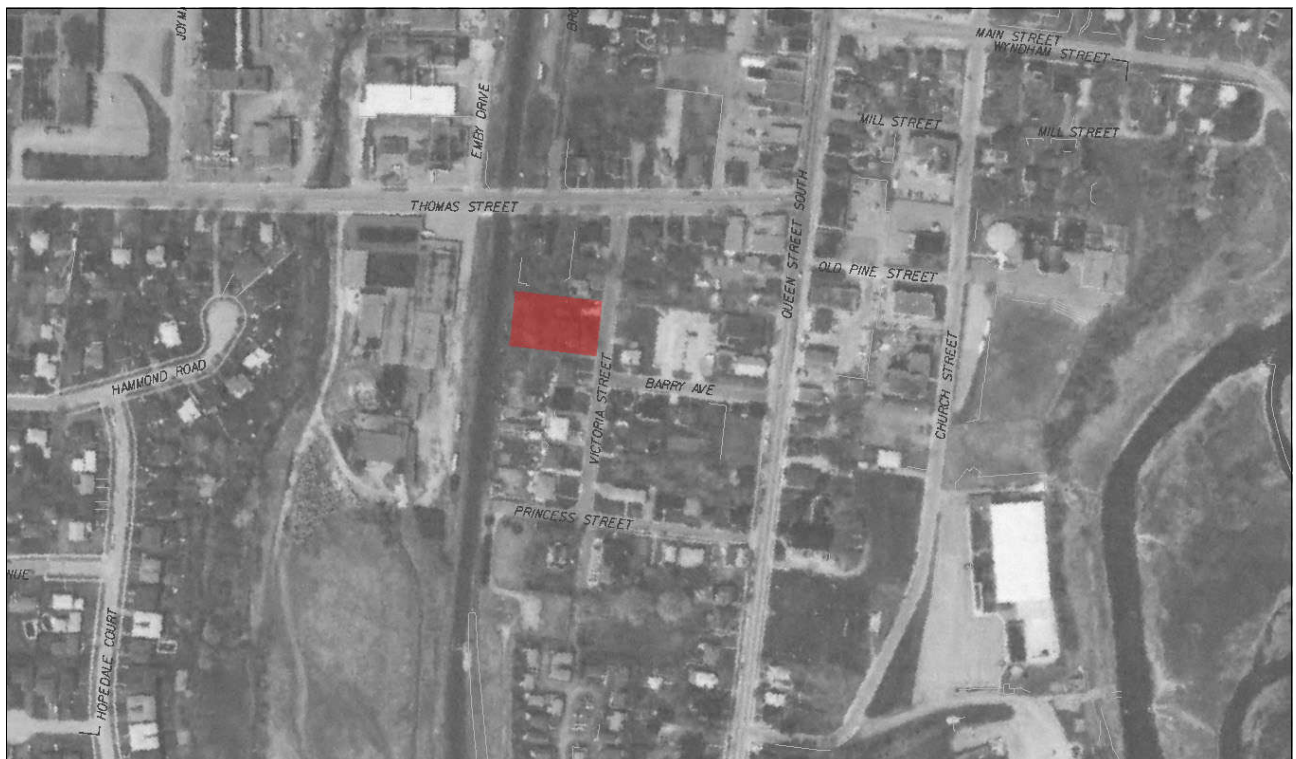
Figure 9 - subject property & environs 1985
