Heritage Advisory Committee

2017/04/11

1. CALL TO ORDER
2. APPROVAL OF AGENDA
3. DECLARATION OF CONFLICT OF INTEREST
4. MINUTES OF PREVIOUS MEETING
 - 4.1. Heritage Advisory Committee Minutes - March 7 2017
5. DEPUTATIONS
6. **PUBLIC QUESTION PERIOD** - 15 Minute Limit (In accordance with Section 43 of the City of Mississauga Procedure By-law 0139-2013, persons who wish to address the Heritage Advisory Committee about a matter on the Agenda may ask their question limiting it to 5 minutes, as the public question period total limit is 15 minutes.)
7. MATTERS TO BE CONSIDERED
 - 7.1. Request to Alter a Heritage Designated Property: 31 Mississauga Road South (Ward 1)

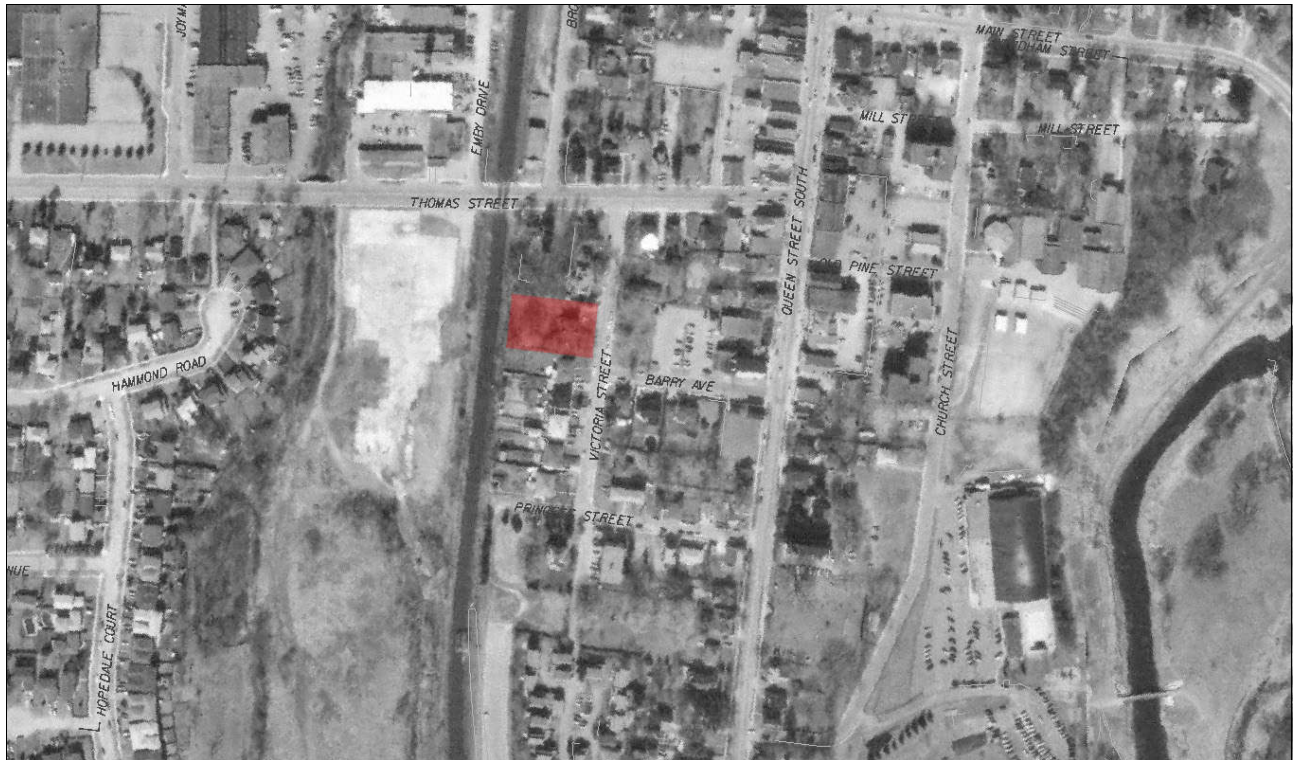
Figure 10 - subject property & environs 1992

By 1992, the industrial development west of the tracks has been demolished, levelling the site for its future use. The house at the corner of Victoria and Barry has been demolished as well.

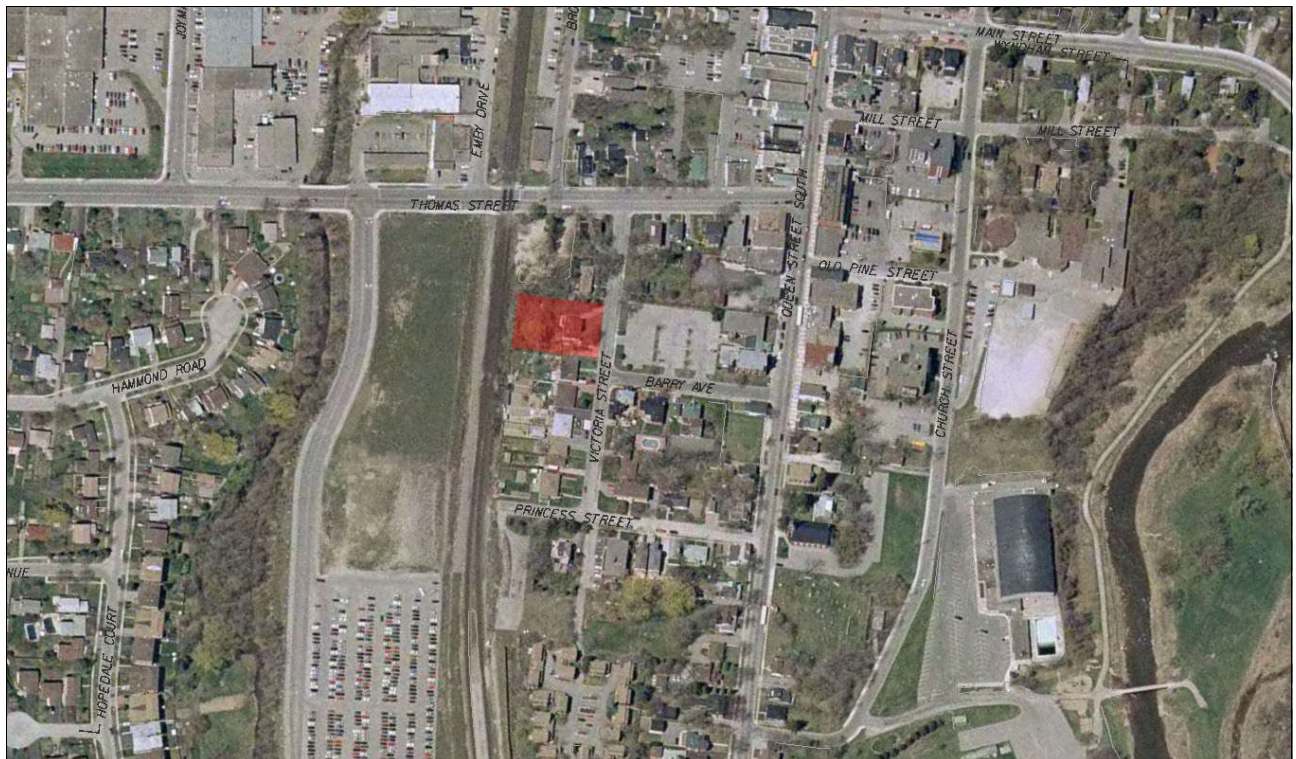
Figure 11 - subject property & environs 1999

The United Church parking lot has expanded to the corner of Victoria and Barry and a commuter rail parking

lot has been constructed west of the railway tracks on the former industrial site.

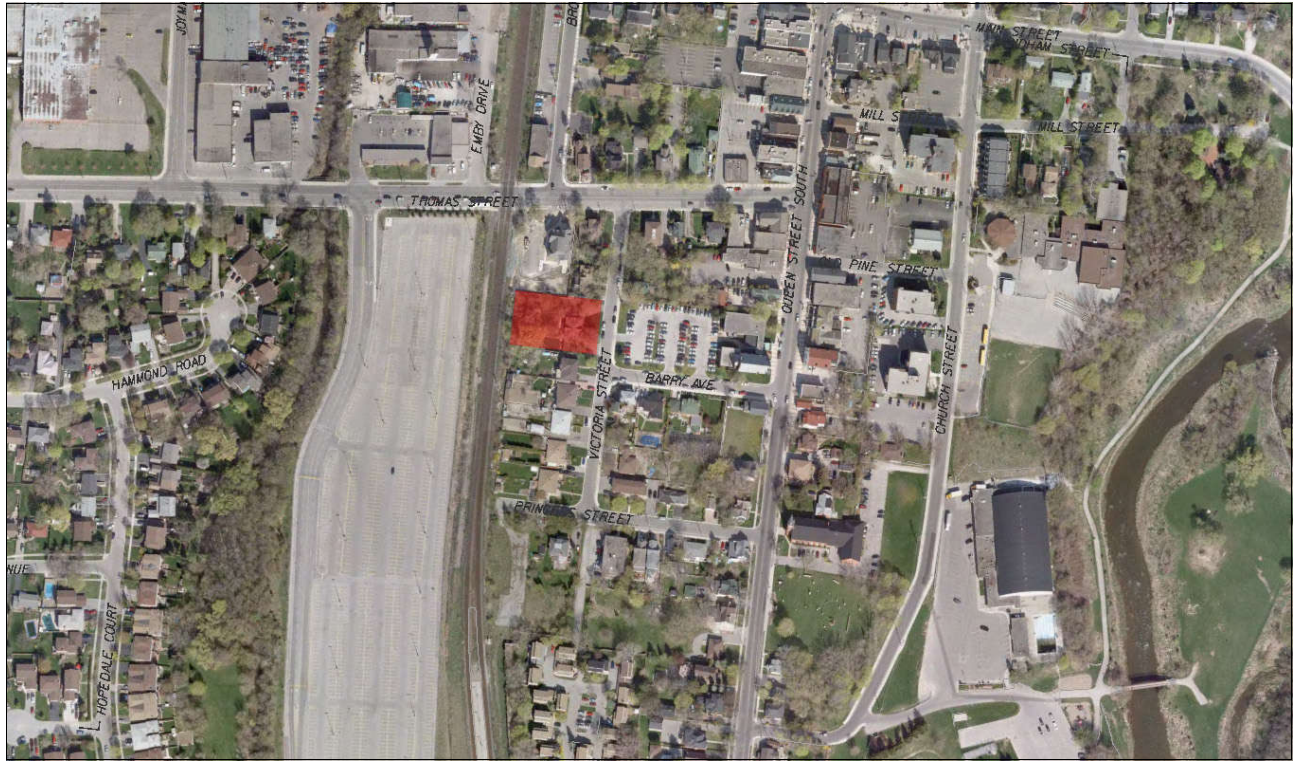
Figure 12 - subject property & environs 2006

The rail commuter lot has been expanded to fill the entire former industrial site and the property at the railway tracks and Thomas Street (south side) has been redeveloped (see Figure 53).

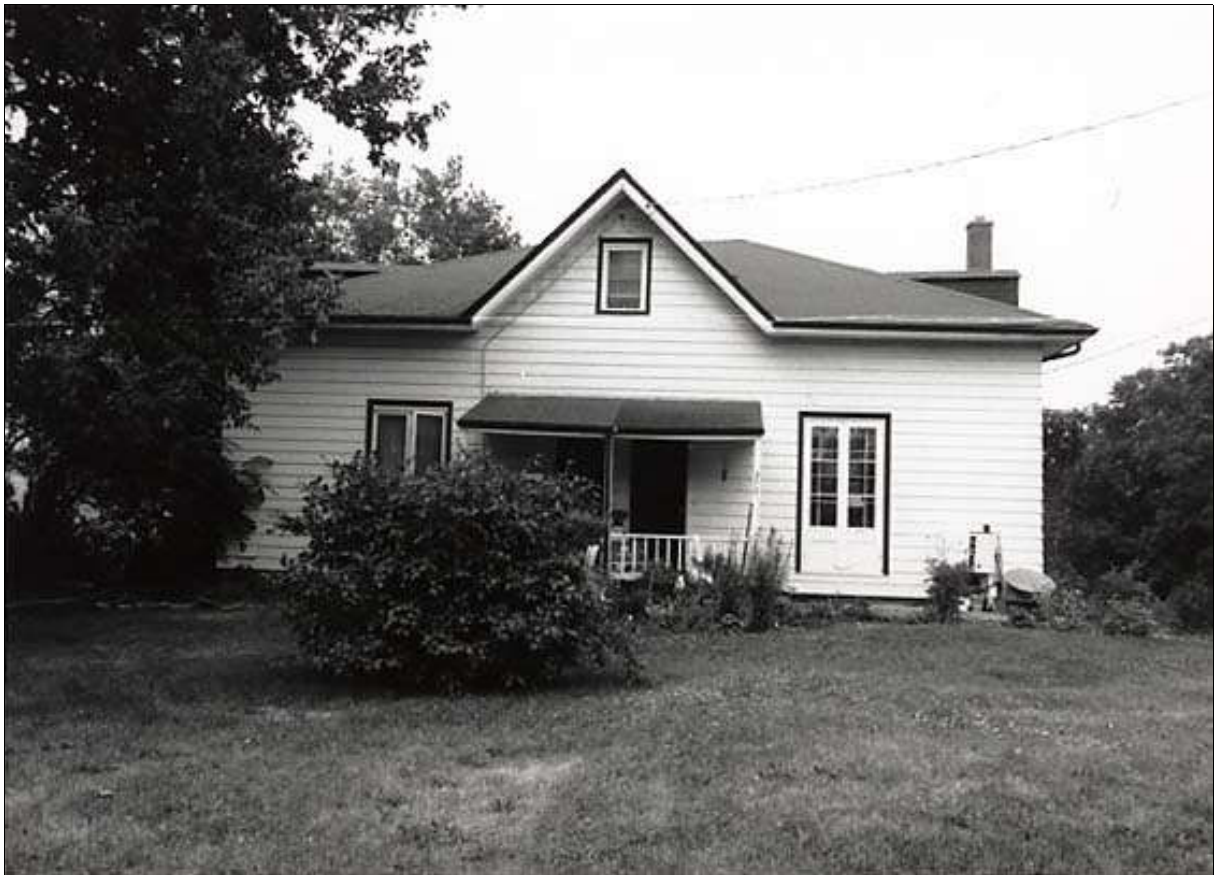
1989 - <http://www.mississauga.ca/portal/residents/streetsvillegallery?>

The front facade (Figure 21) is much altered from the original, and even the post-division era, as the french doors added in the 1960s have been replaced with modern windows and siding infill. The small gable window is also a modern replacement. Contrast Figure 21 with Figure 18 to see the changes in the past 27 years.

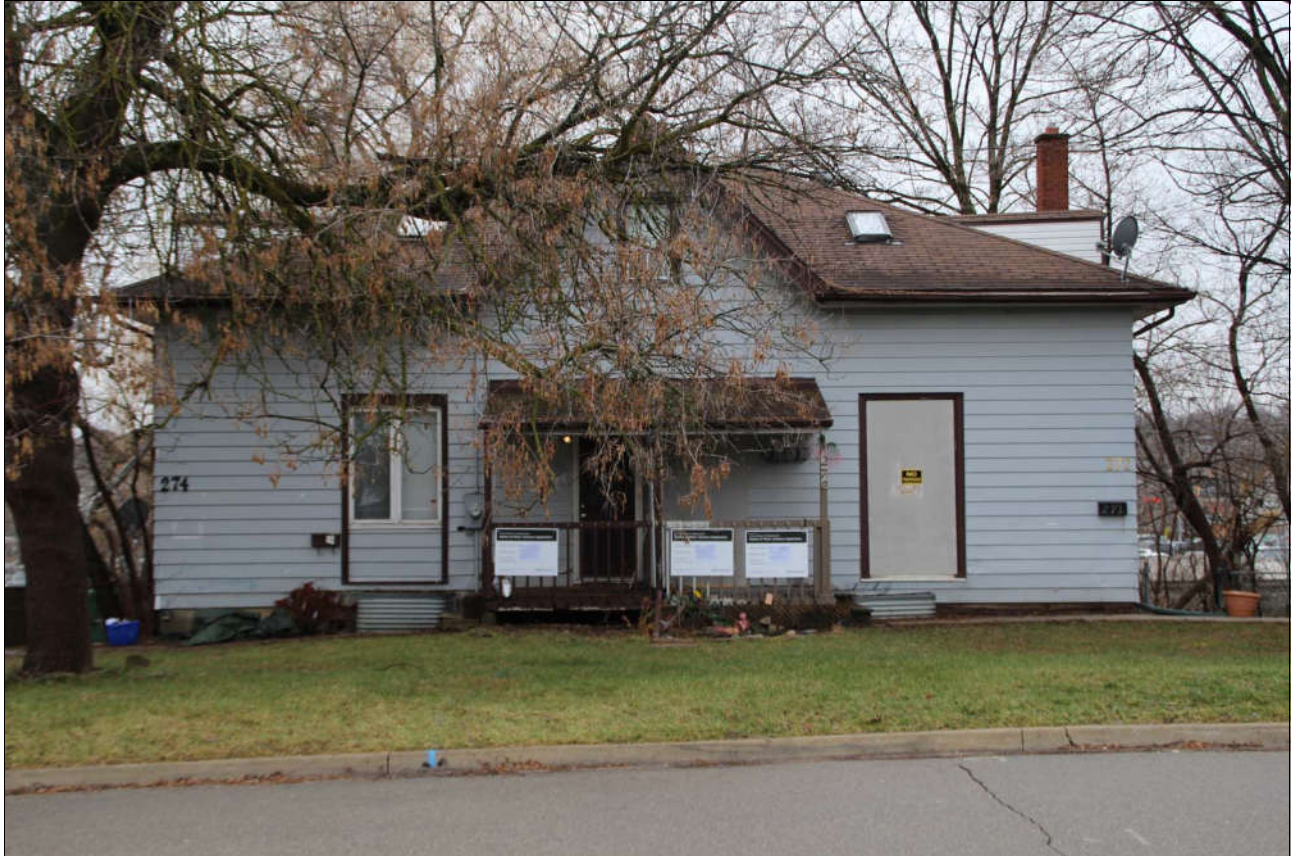
Figure 21

front (east) facade

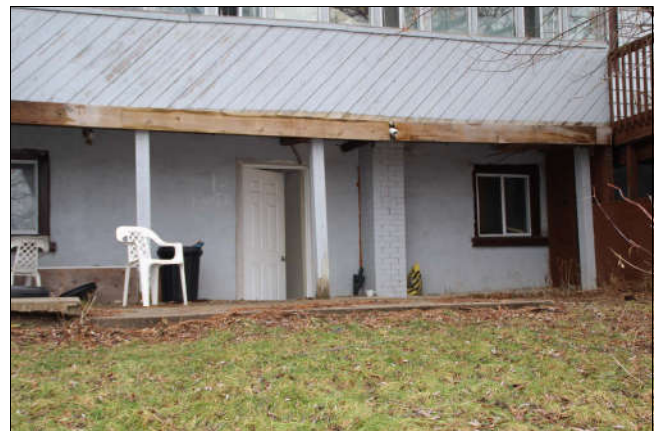
Figure 22

The rear facade (Figures 22 & 23) is two-storeys as a result of the steeply sloping lot which originally was the east bank of the Mullet Creek valley. An enclosed porch and elevated deck are found on the first floor. Entrance to the basement apartment of 272 Victoria street is at the rear (Figure 22). A 20th century brick chimney pierces the porch and gable soffit (Figure 23).

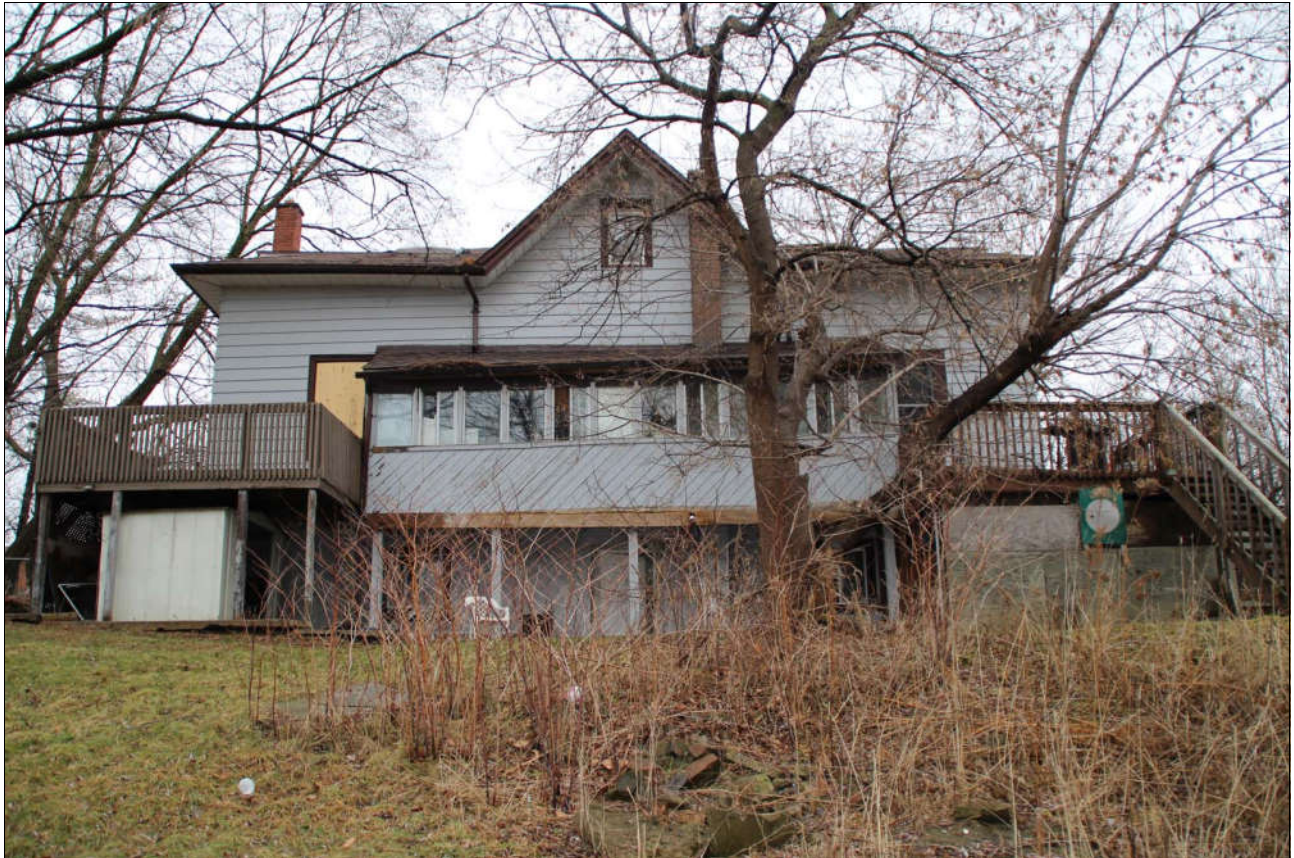
Figure 23

rear (west) facade

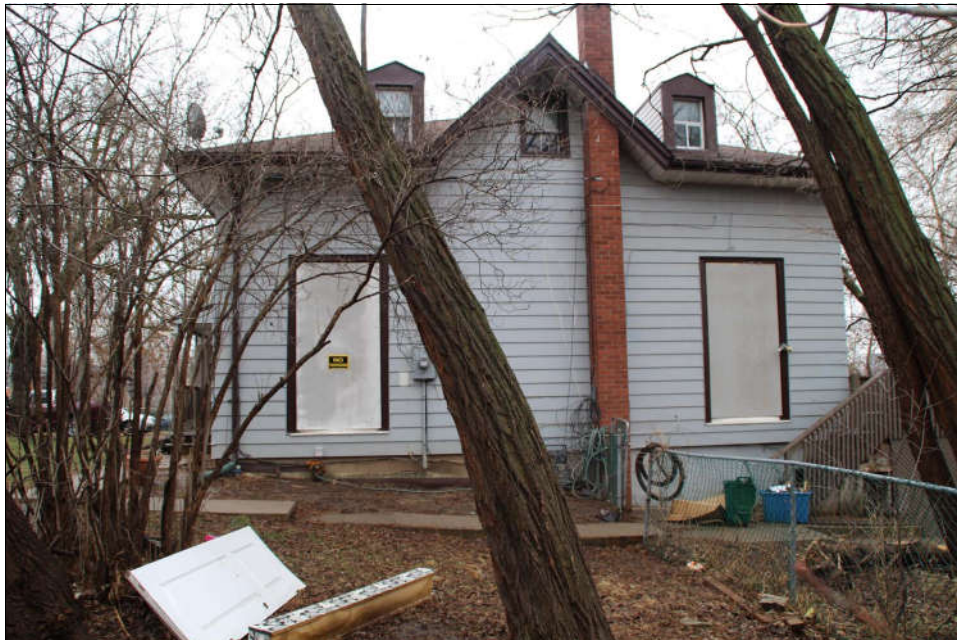
Figure 24

272 Victoria Street is vacant and the openings are secured with plywood. The north facade has two small roof dormers, a small gable with window and two windows on the first floor, creating a symmetrical facade, broken by the off-centre 20th century brick chimney (Figure 24).

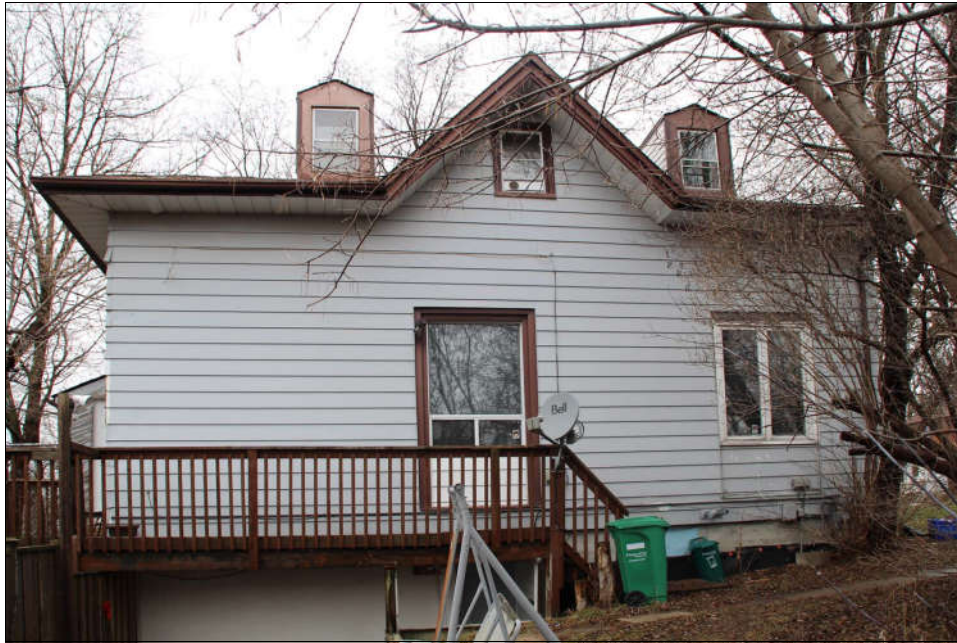
Figure 25

south facade

The south facade (Figure 25) may have been originally symmetrical like the north side, but window openings have been moved and altered over time. The entrance to the occupied basement apartment is at this side under the deck.

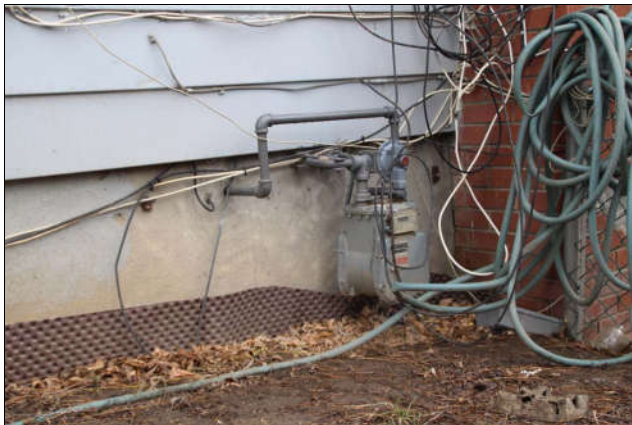
Figure 26

The foundation is poured concrete (Figures 26 & 27). At some point in recent years, the house has been lifted from its original foundation and a new concrete foundation installed. Dimpled foundation drainage board is visible. There is no evidence of a Building Permit for this on the City's website, so the date has not been determined.

north side foundation & drainage board

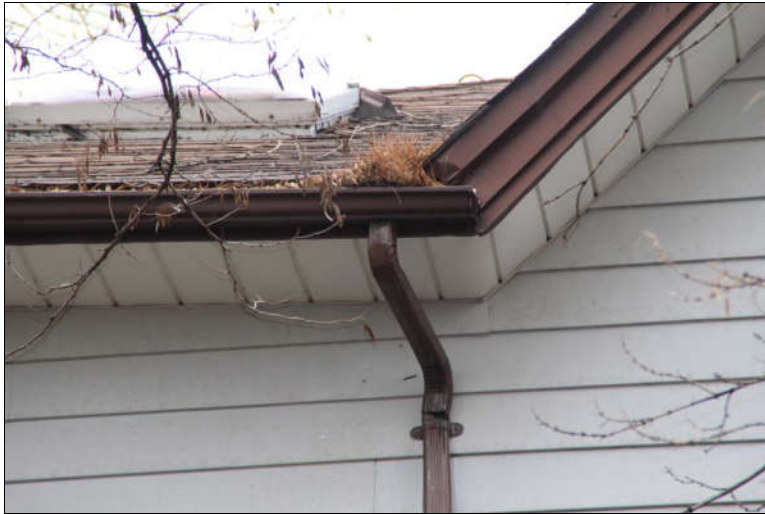
Soffits, fascia, window surrounds, eavestroughs and downspouts are aluminum (Figures 28 & 29).

Figure 28 aluminum soffits, fascia, troughs & downspouts

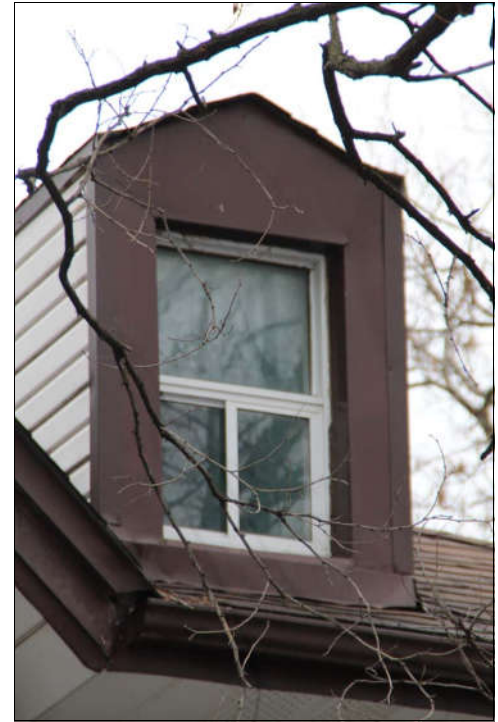
Figure 29 aluminum cladding on dormer

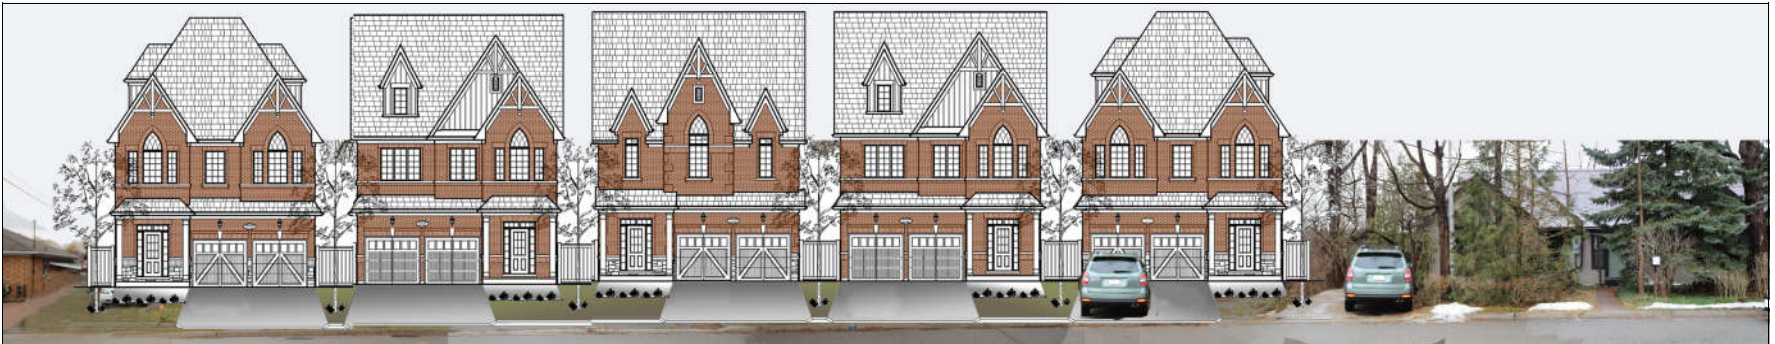
Figure 50

The development proposal for this property and the adjacent property at 278 Victoria Street is illustrated in Figure 50. 278 Victoria Street is not listed on the City's Heritage Register.

proposed streetscape - after *RN Design*, March 22, 2016

The proposed buildings (Figure 50) reflect the scale of nearby newer buildings, but not the immediately adjacent 1960s ranch bungalows or the mix of neighbourhood 19th century 1½ and 2 storey buildings.

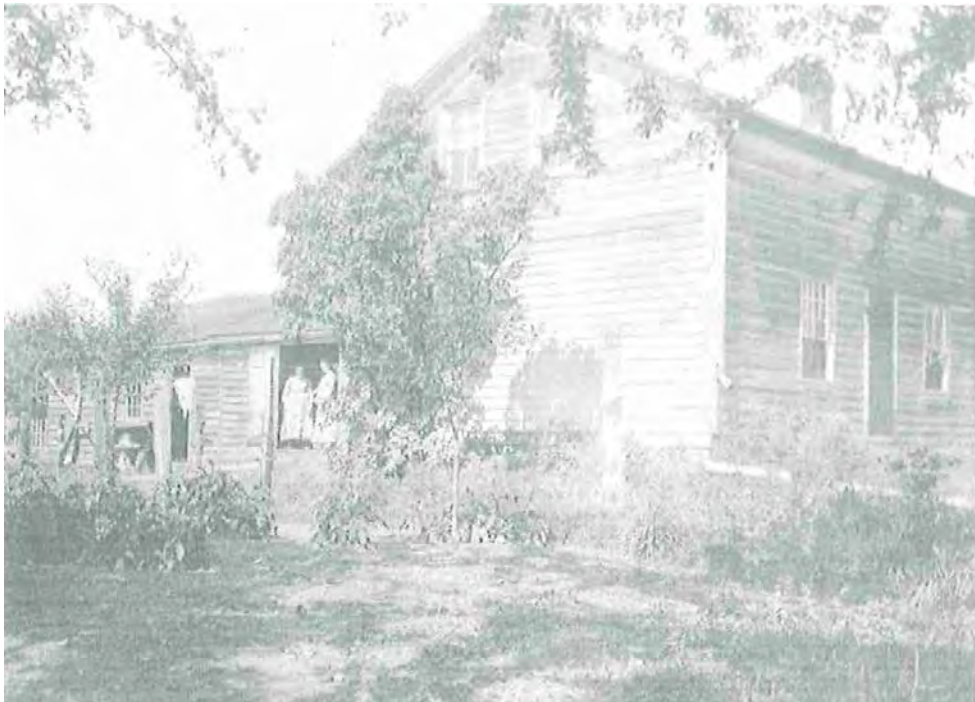
1895 IMAGE OF SUBJECT PROPERTY (NOTE GRADE CHANGE TO PRESENT CONDITION). THE BUILDING BEHIND THE MAIN STRUCTURE WAS LIKELY AN OUTBUILDING DEMOLISHED TO MAKE WAY FOR THE CORRIDOR ADDITION. COMPARE WINDOWS ON FRONT ELEVATION IN THIS PHOTO WITH MORE RECENT PHOTOS – FRONT WINDOWS WERE SUBSEQUENTLY ENLARGED AND MOVED OUTWARD

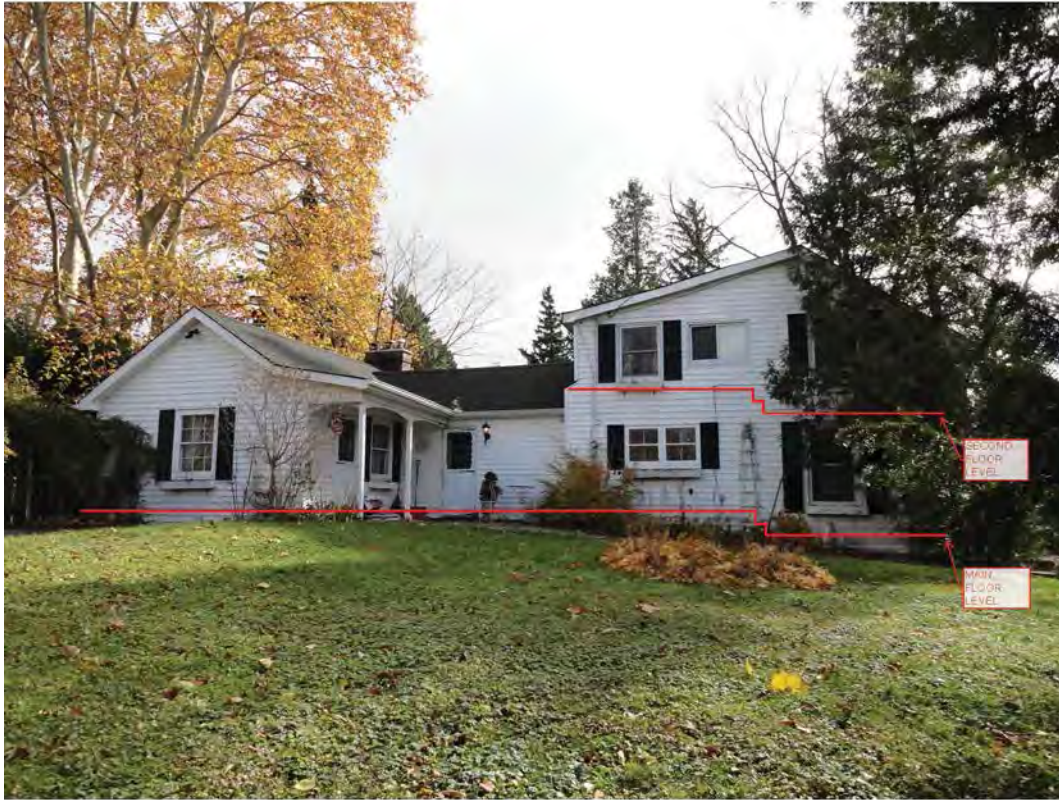
The building is a simple wood frame structure with vinyl siding and asphalt shingle roof. It is obvious at once that it is composed of a series of distinct elements.

NORTH ELEVATION SHOWING REVERSE SALTBOX VOLUME AT RIGHT, ONE-STOREY VOLUME AT LEFT, LINK ELEMENT AT CENTER, FLOOR LEVELS

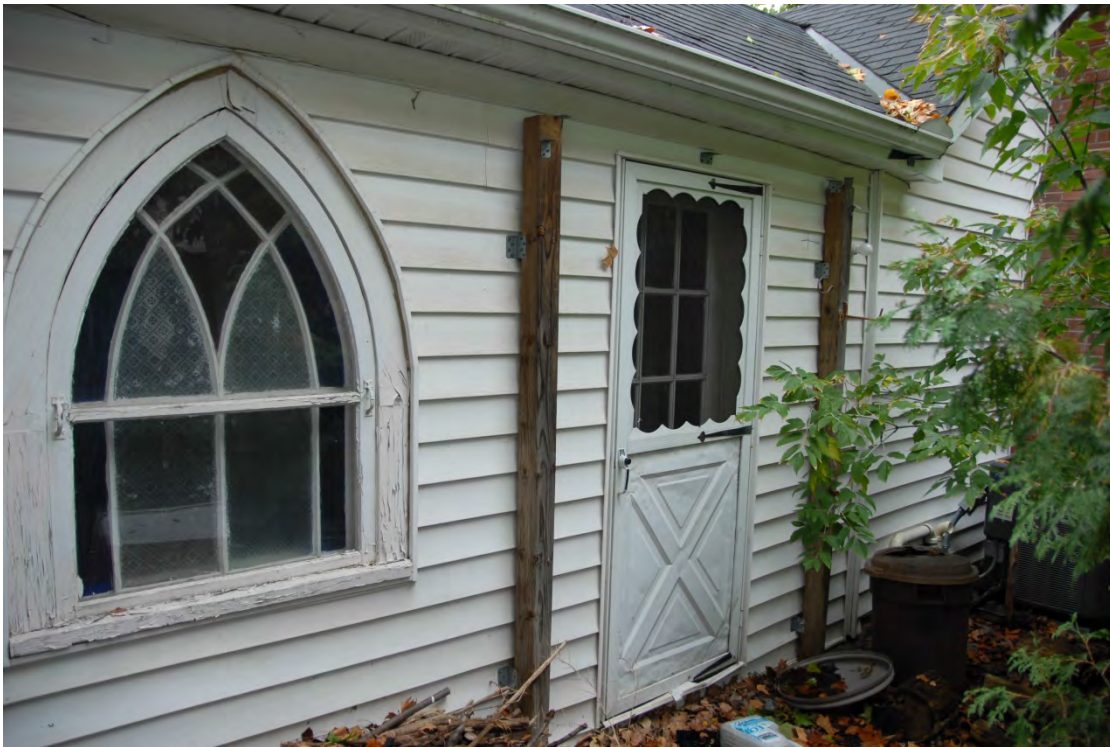
PARTIAL SOUTH ELEVATION (NOTE LANCET WINDOW)

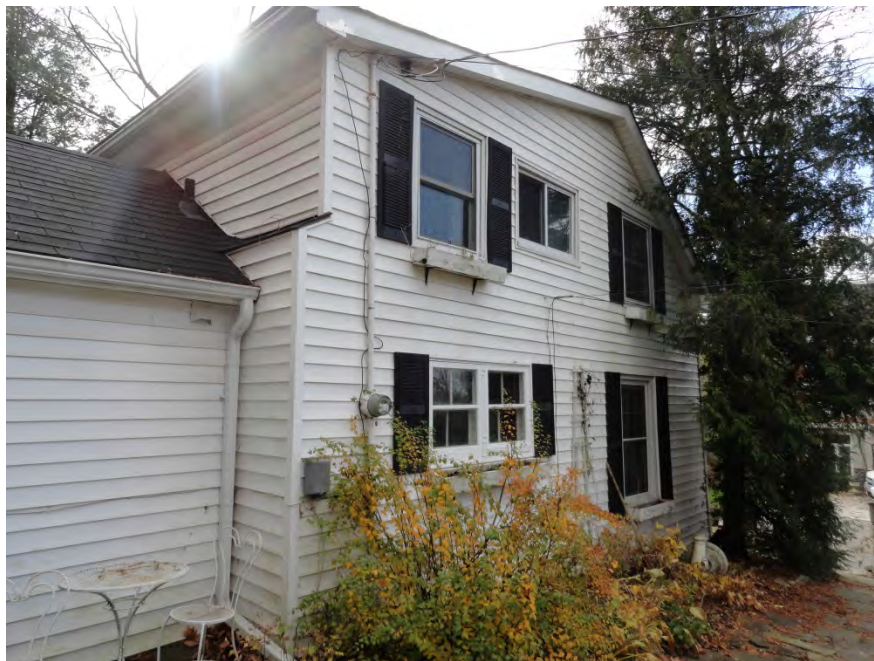
The overall condition of the building is very poor. As noted above, there is significant differential settlement and unevenness in much of the building and lack of a proper foundation in much of it. Clearly there is evidence of deterioration of structural members and collapse of foundation elements. There is a visible sag in the main roof ridge and in some of the rafters. Numerous instances of water penetration are obvious and there is a strong smell of dampness present. There is evidence of vermin and raccoon infestation. If more of the interior finishes were to be removed than what was done to facilitate this study, it is highly probable that mold and deterioration would be widespread.

PARTIAL NORTH ELEVATION – NOTE RANDOM, MIS-ALIGNED WINDOWS, CONTEMPORARY FINISHES, ABSENCE OF DETAILING

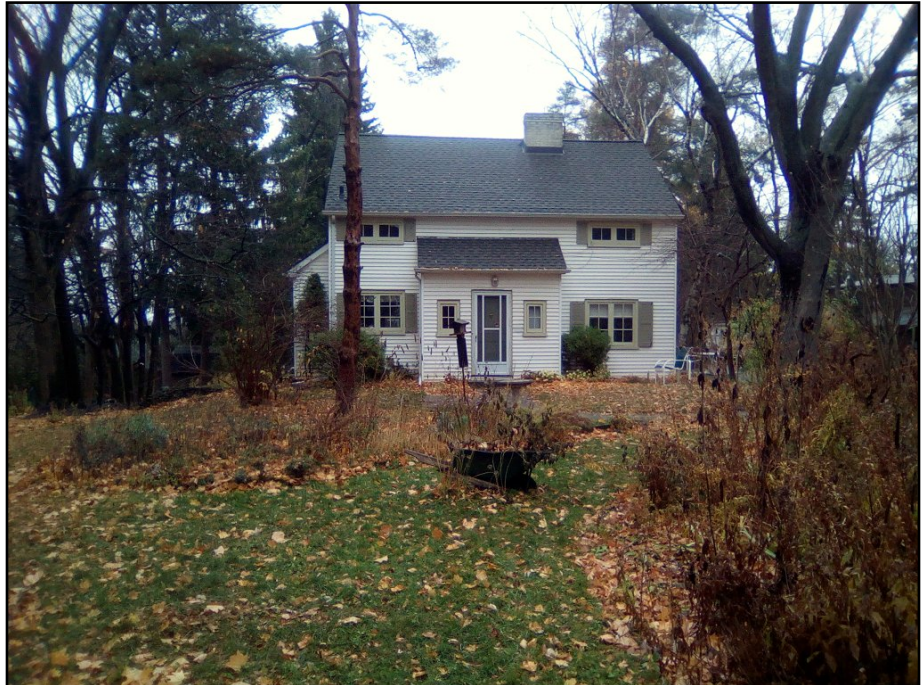
South facade, and front yard; looking north.

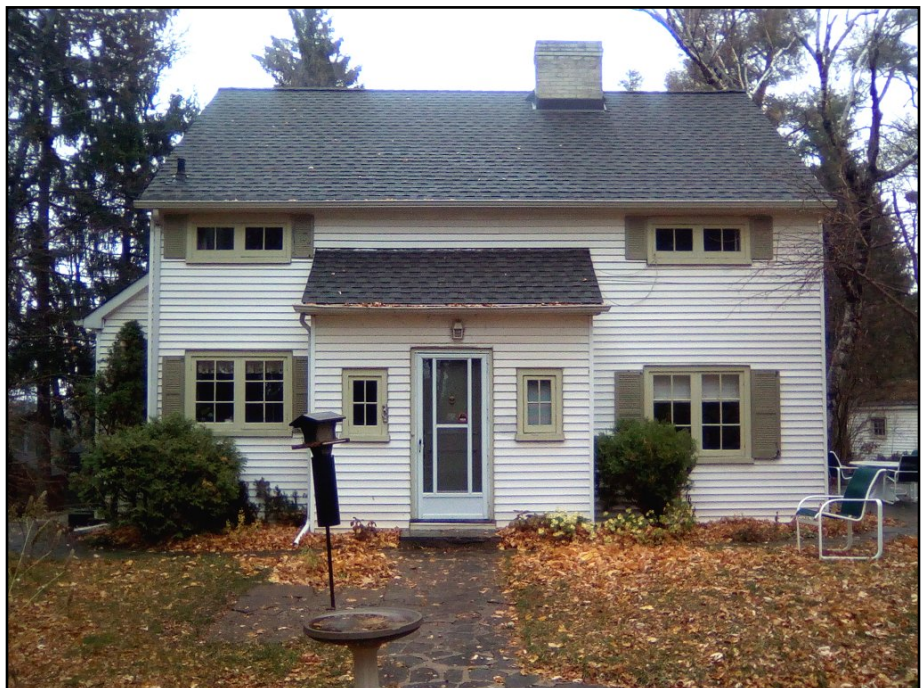
South (front) facade, looking north.

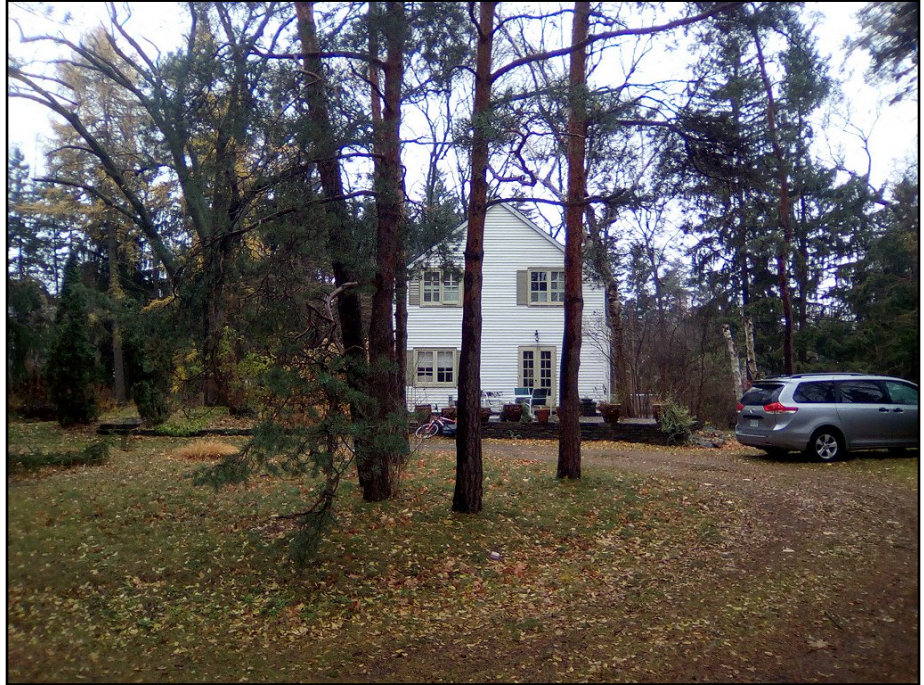
East facade, and yard; looking west.

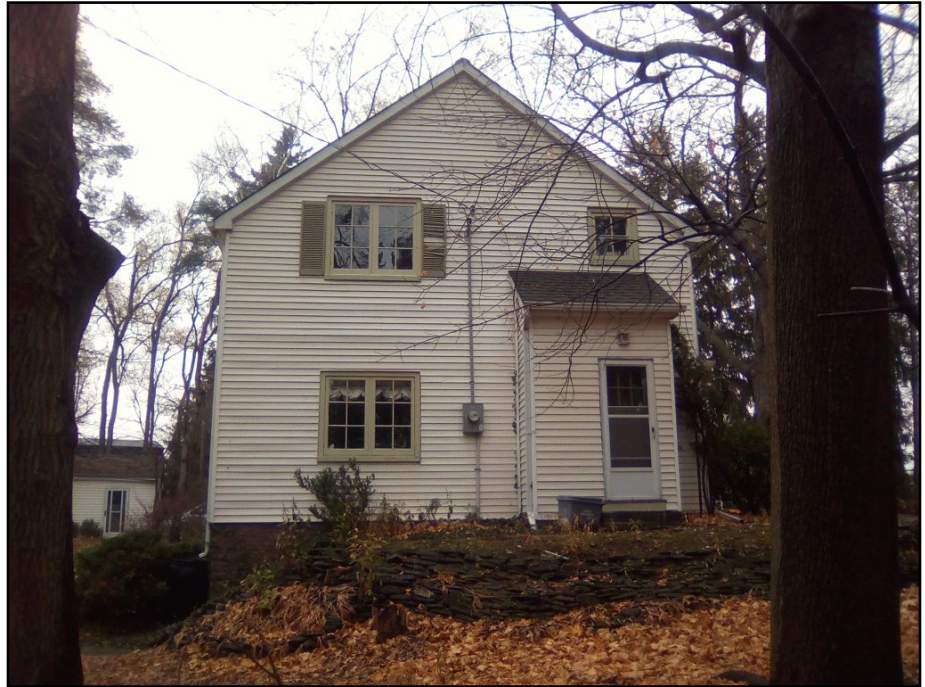
West facade, looking east.

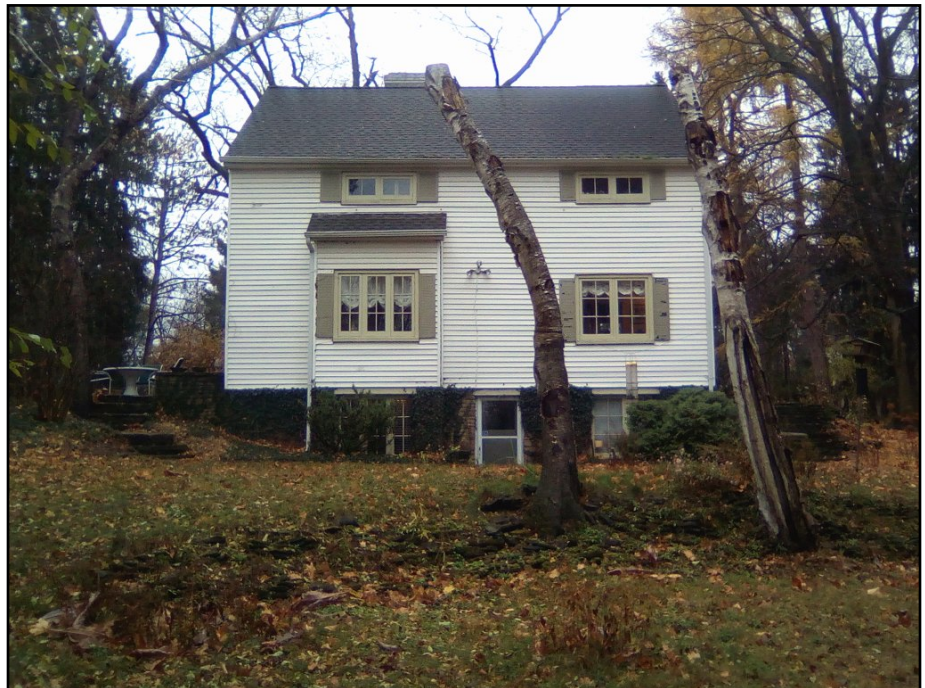
North (rear) facade, looking south.

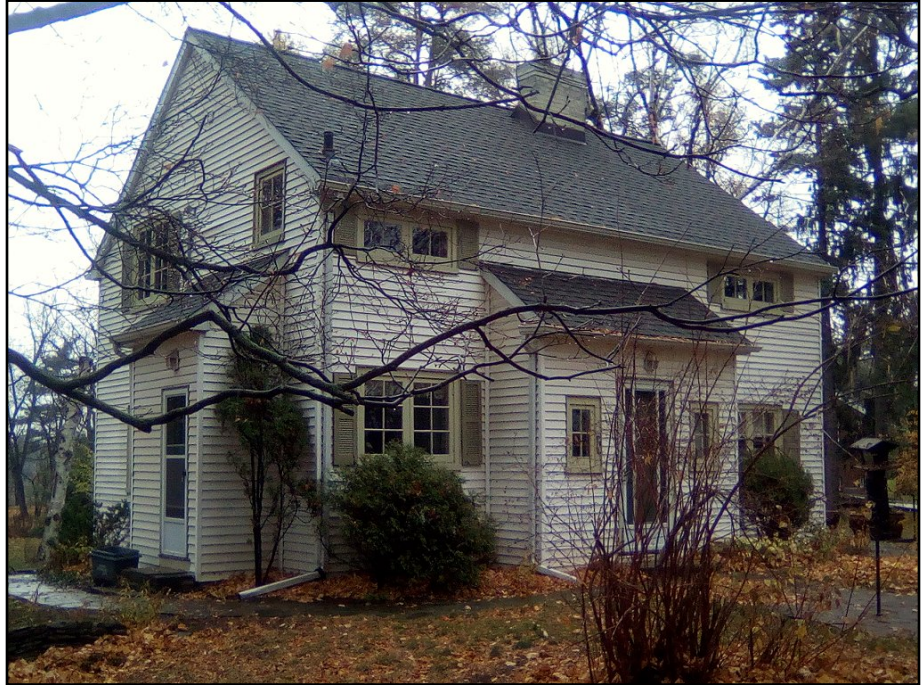
South and west facades.

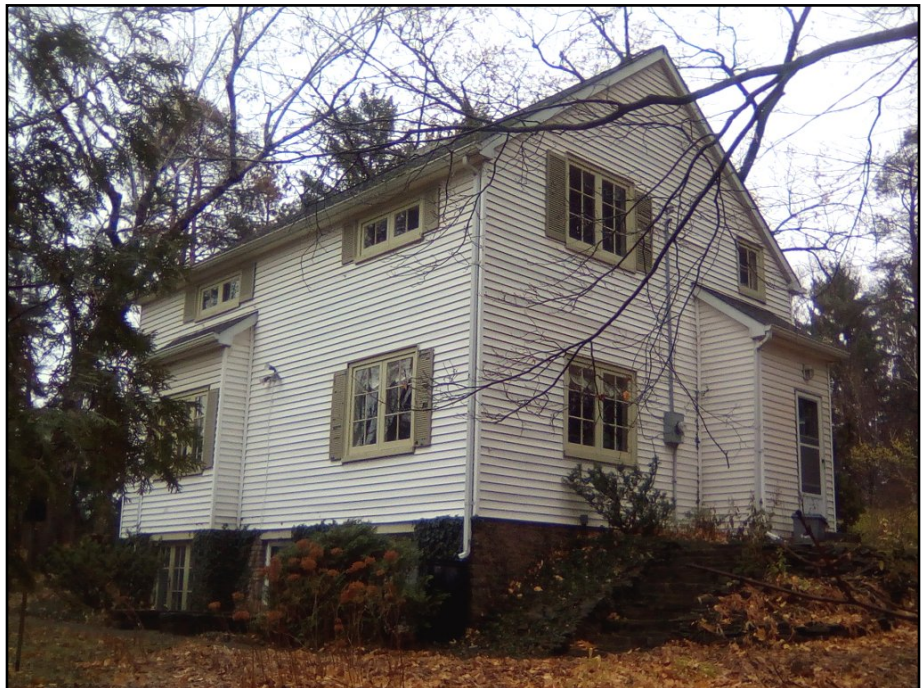
North and west facades.

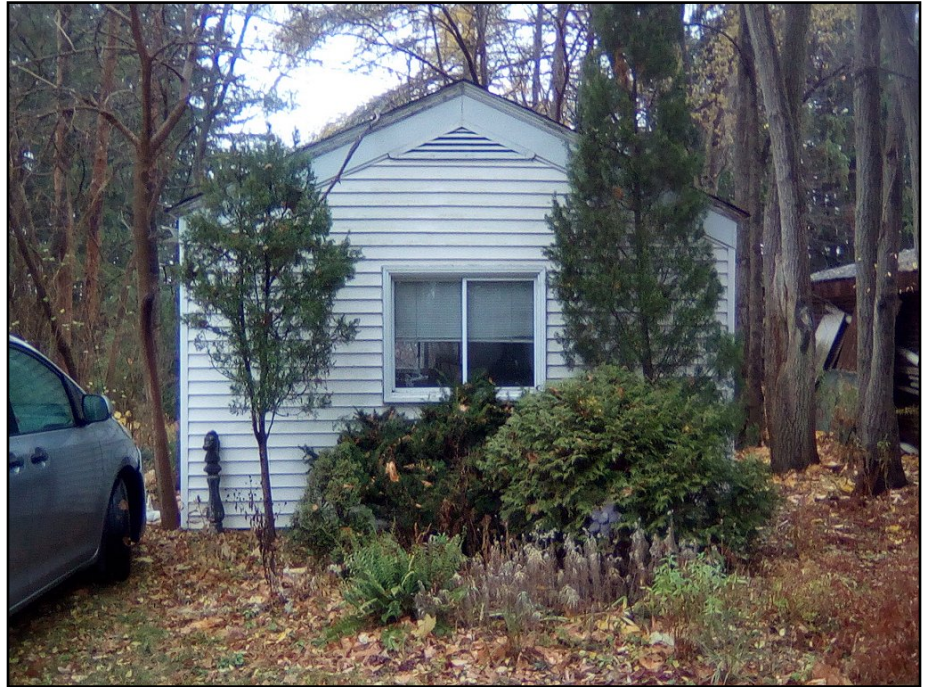
Garage, south facade.

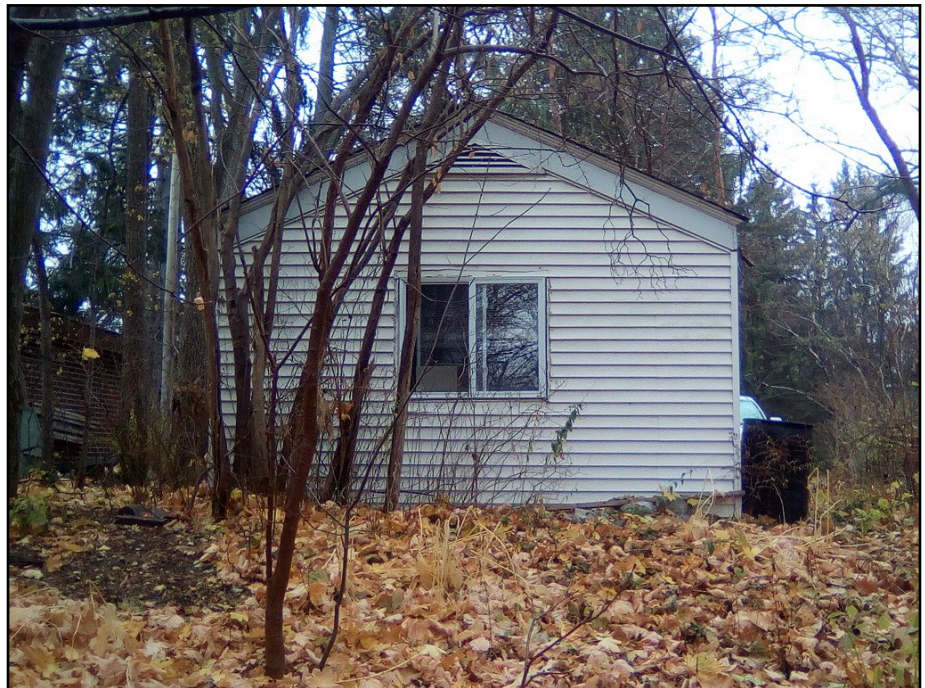
Garage, north facade.

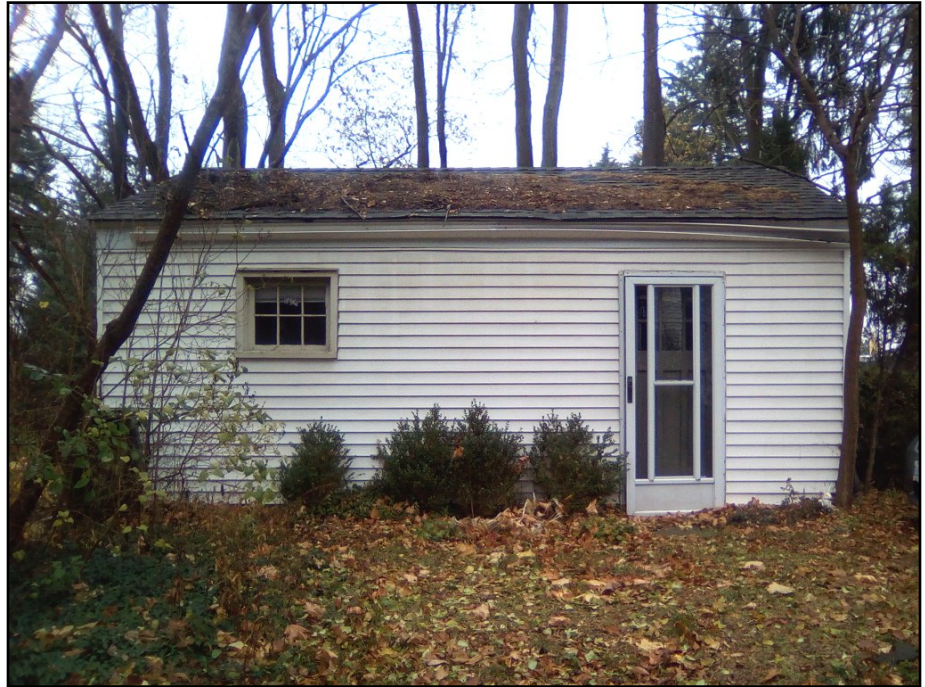
Garage, west facade.

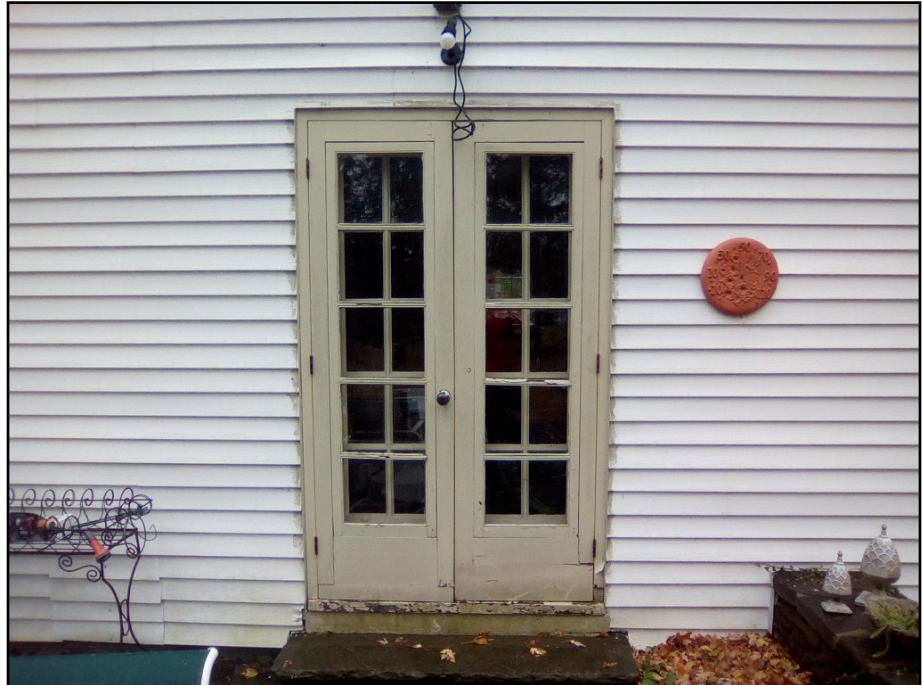
Detail; east door.

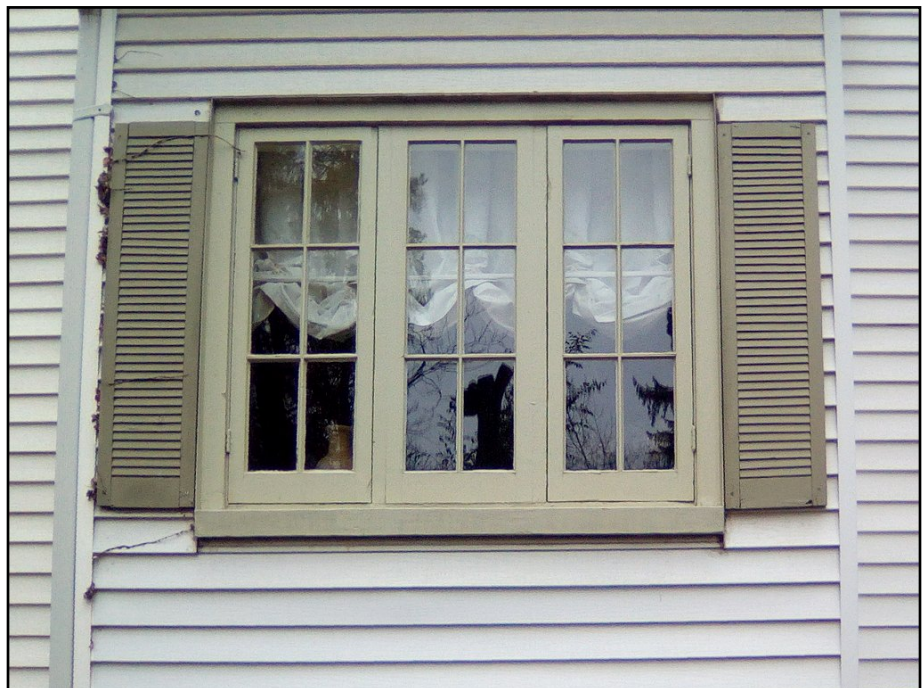
Detail; main living room window (south facade).

Because the main residence and garage on the subject property are not architecturally or structurally unique, there are minimal salvage opportunities. The exterior wood siding, while in relatively good condition, is not rare or unique. Windows, doors and frames are of a conventional design.
