Heritage Advisory Committee

2017/04/11

1. CALL TO ORDER
2. APPROVAL OF AGENDA
3. DECLARATION OF CONFLICT OF INTEREST
4. MINUTES OF PREVIOUS MEETING
 - 4.1. Heritage Advisory Committee Minutes - March 7 2017
5. DEPUTATIONS
6. **PUBLIC QUESTION PERIOD** - 15 Minute Limit (In accordance with Section 43 of the City of Mississauga Procedure By-law 0139-2013, persons who wish to address the Heritage Advisory Committee about a matter on the Agenda may ask their question limiting it to 5 minutes, as the public question period total limit is 15 minutes.)
7. MATTERS TO BE CONSIDERED
 - 7.1. Request to Alter a Heritage Designated Property: 31 Mississauga Road South (Ward 1)

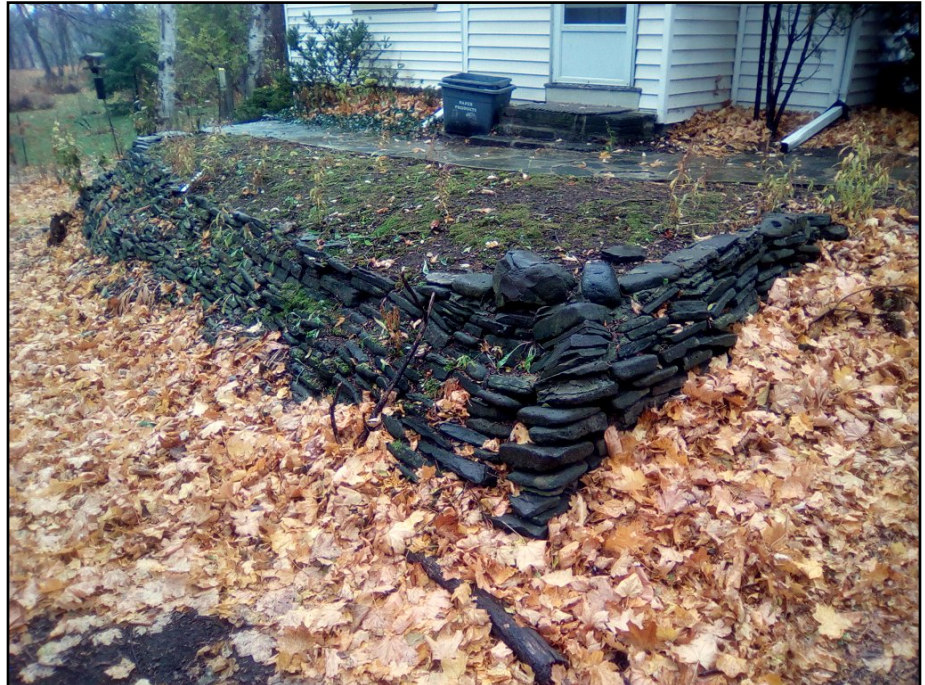
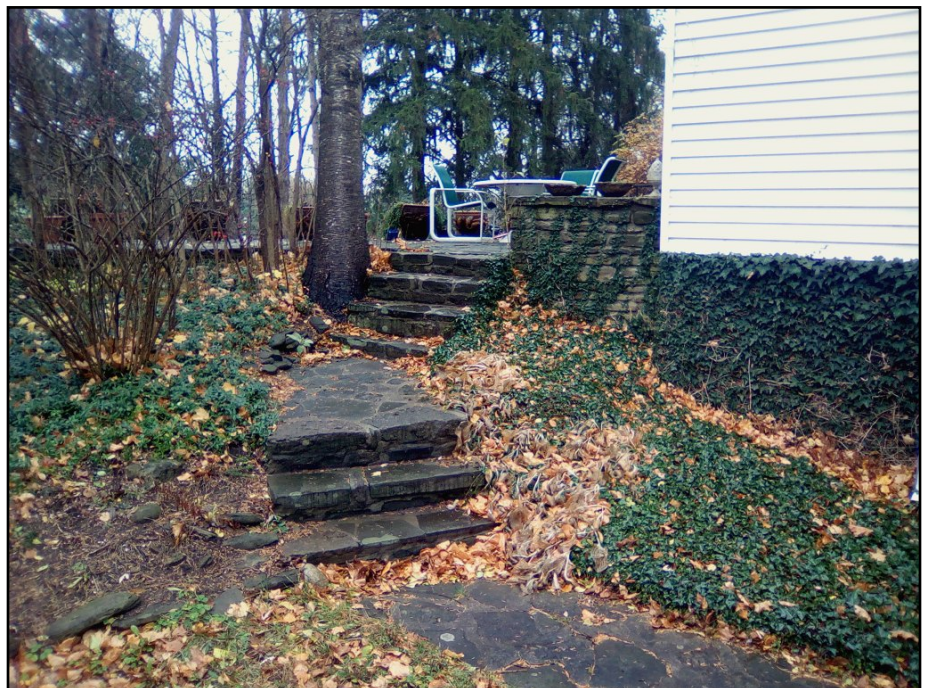
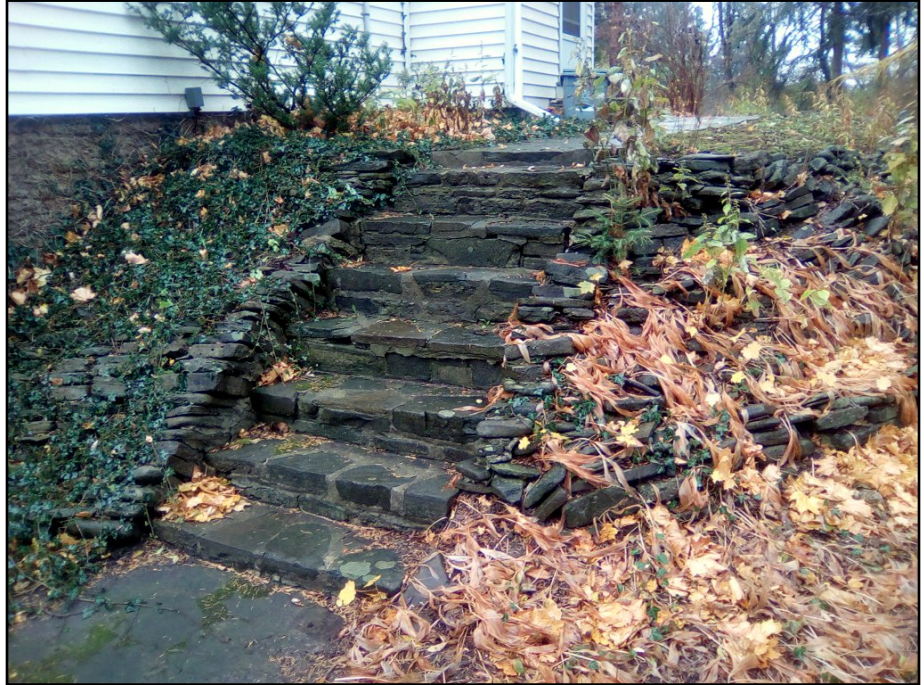
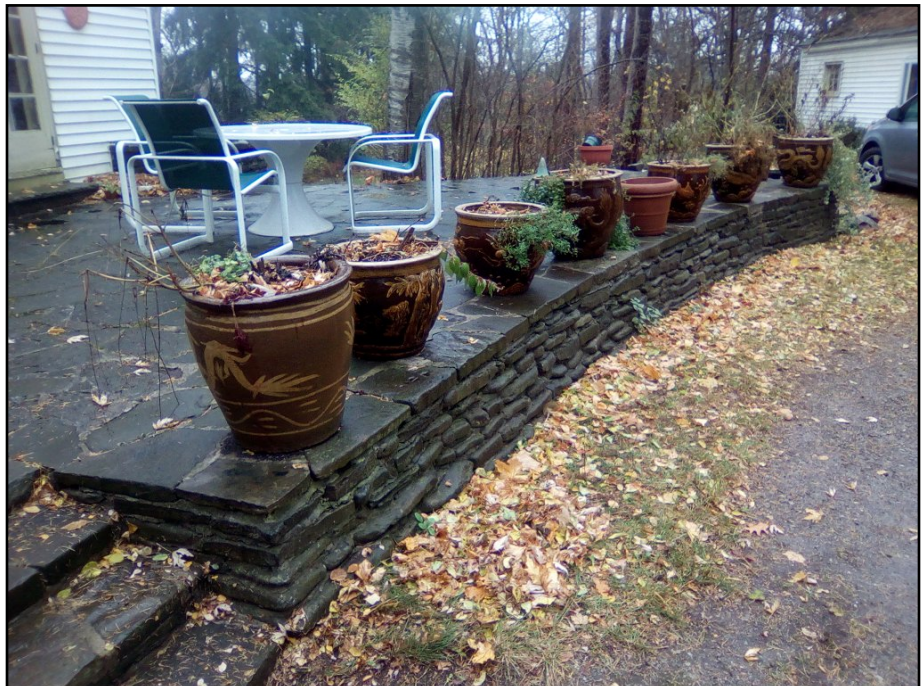
The main residence and garage are both of wood-frame construction. The main residence has a stone and concrete foundation. Stonework is present to the north and east of the main residence for stairs and a patio.

Stonework, east side of residence.

If the foundation of the current main residence is to be used as all or part of a future development, the flat lakestones currently used for stairs and landscaping could be incorporated in a new-build.

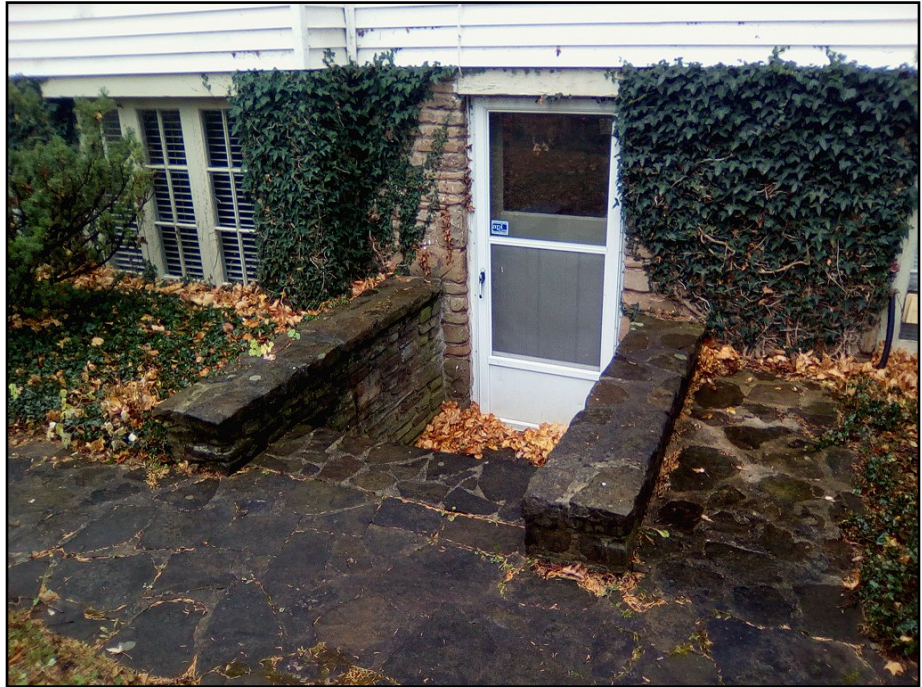
Stonework, north side of residence.

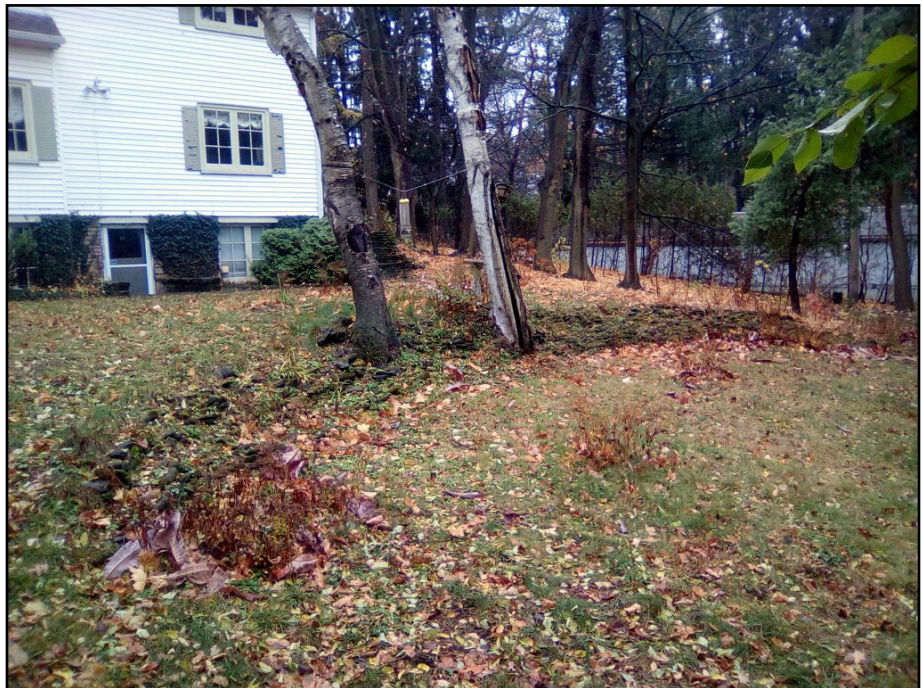
Stone landscaping; north (back) yard.

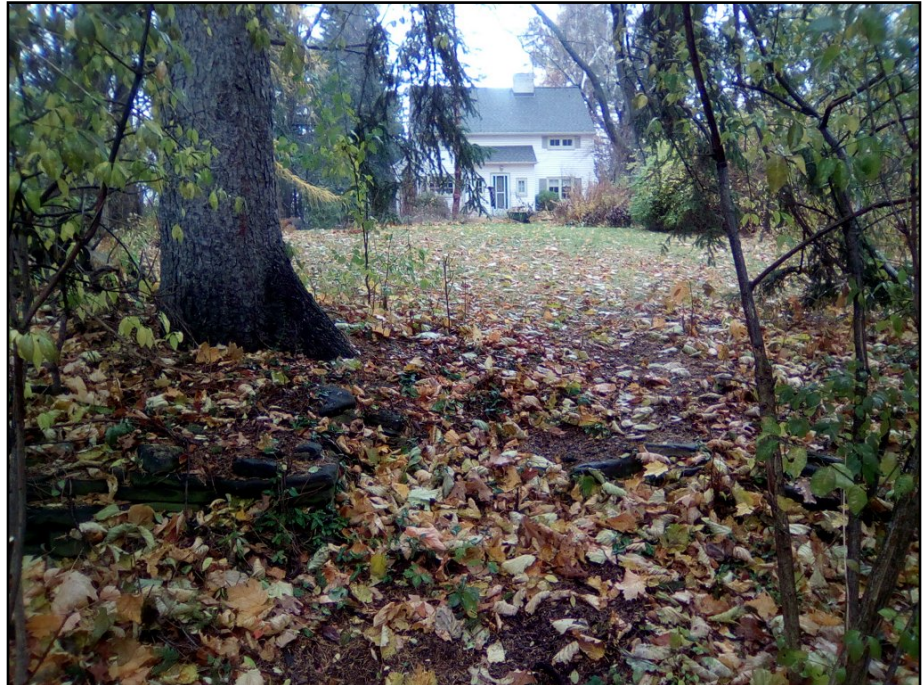
It is likely that Mullet was the first owner to develop the property. When he sold the property to Francis and Nellie Perkins a year later the land value had more than doubled to \$13,500, suggesting that Mullet had improved the property; probably with a homestead. The City of Mississauga's records state that the current residence at 1625 Blythe Road dates from the 1910s, but Donald Van Every – son of a later landowner – mentioned on his second visit to the current property owner that there had been an old cottage in the front yard, and asked if any remnants had been found. There is a cleared area about 50 metres south of the current residence, with some lakestone landscaping, which could indicate the site of a now-demolished structure.

*Stonework landscaping of possible earlier structure, in foreground,
looking north to current residence.*

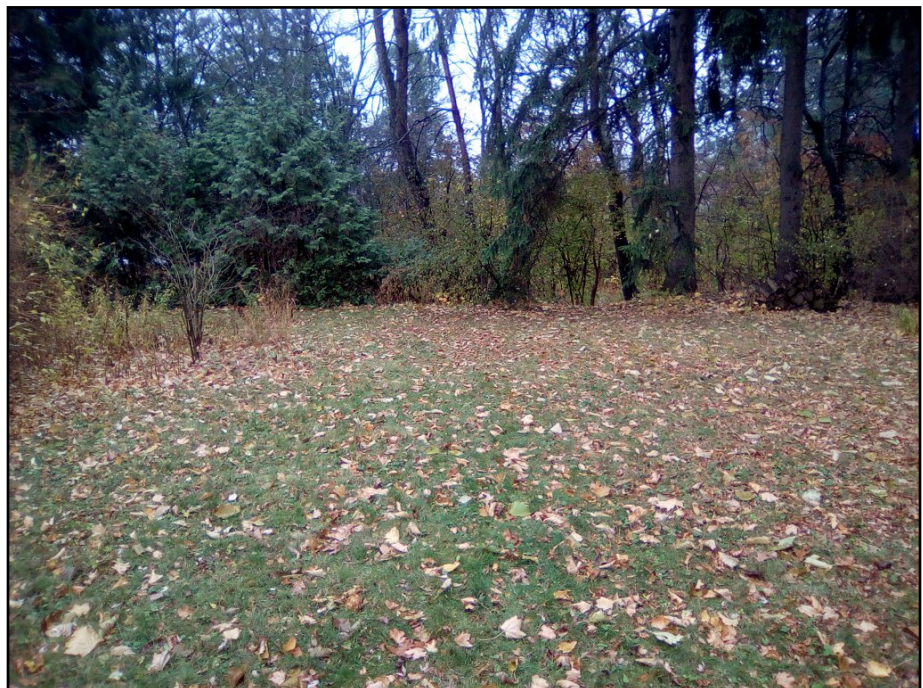
*Clearing at the site of possible earlier structure,
looking south.*

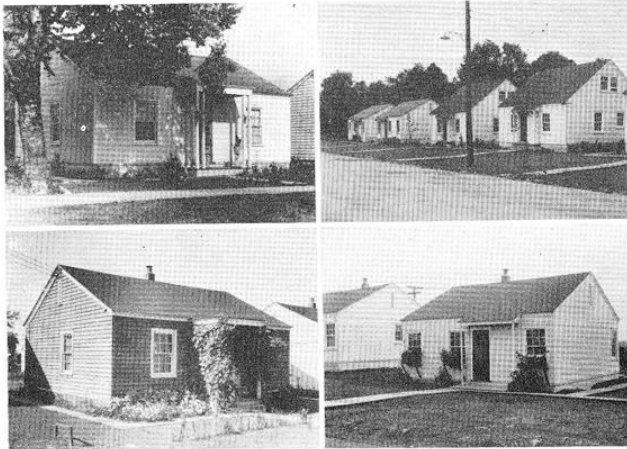
Top left: Larger 4-room bungalow, Collingwood, Ont. Top right: Showing large 6-room and small 4-room bungalows at Woodstock, Ont. Lower right: Shingled 4-room bungalow at Kingston, Ont. Lower left: Ivy graces the porch on St. Catharines Wartime Home.

Figure 3: Extract from a wartime publication, *Homelife and Community Interests*, Vol. 3, No. 3. The "Lower left" dwelling is similar in design to that at 3064 Churchill Avenue when built.

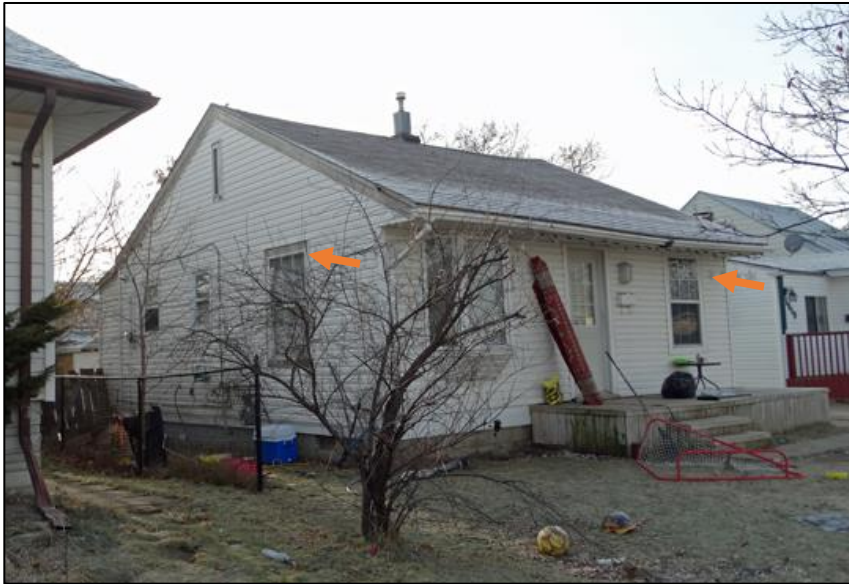
Figure 6: East and front facades of 3064 Churchill Avenue, 2017. The 6x6 panes type sashes (indicated by arrows) reproduce the original sash type.

- The wood window sashes and frames have been replaced with metal sashes fitted within new wood surrounds. Some of these sashes replicate the original 6x6 panes, double hung type.

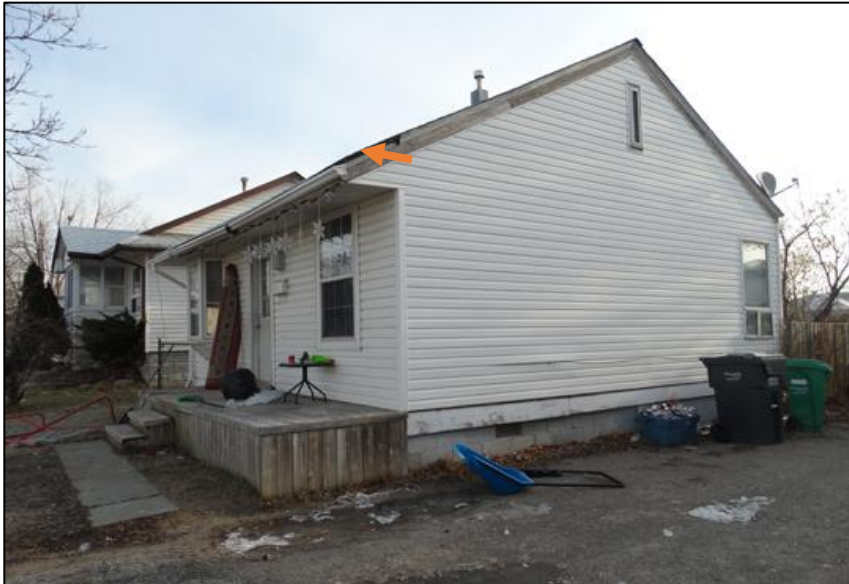
Figure 7: West and front facades of 3064 Churchill Avenue, 2017. The front edge of the roof appears to have been elongated to create a deep eave. This may have resulted from the removal of a centre porch and the application of the vinyl siding.

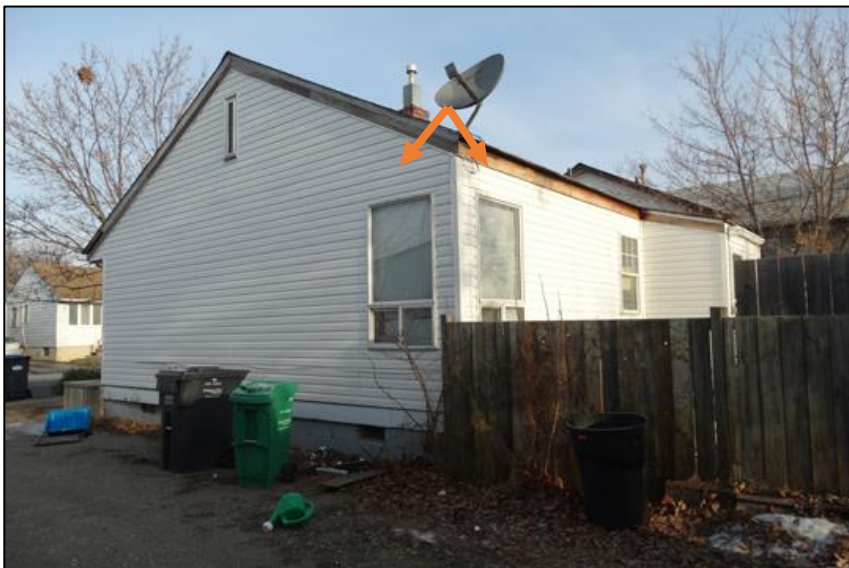
Figure 8: West and rear facades of 3064 Churchill Avenue, 2017. The original window opening on the west may be under the vinyl siding. The two windows at the corner have been added.

- The exterior clapboard has been overlaid (or replaced) with vinyl siding.
- The vinyl siding on the west (side) and south (rear) facades may be covering original window openings. The installation of the siding made possible the insertion of new window openings.
- The front east window opening has been replaced with a bay window type.

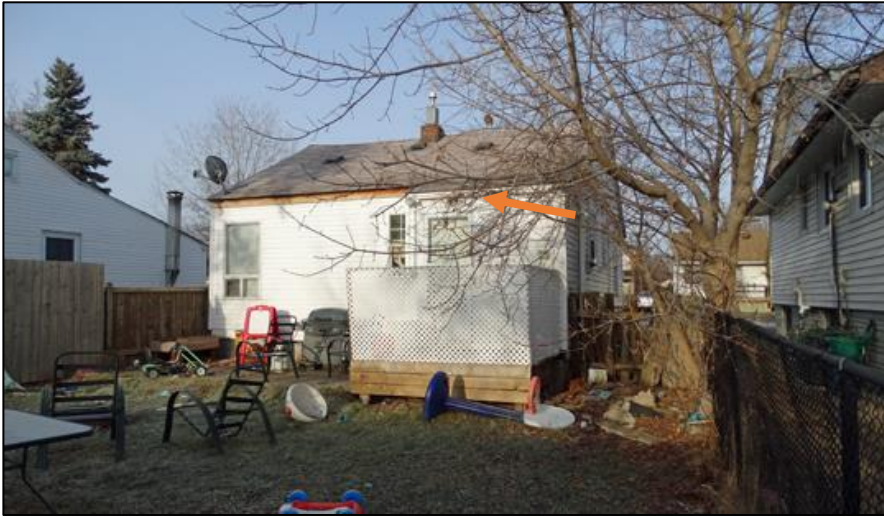
Figure 9: Rear facade of 3064 Churchill Avenue, 2017. The rear enclosed entrance has been added.

The interior likely began as a centre hall plan with rooms (kitchen, living room, two bedrooms, bathroom) along each side of the hall. The common plan was for the centre hall to terminate at the bathroom at the rear of the space (Figure 5). This has been changed and that area enlarged by the addition of the enclosed entranceway at the southeast corner. Figure 11 plots the existing floor plan.

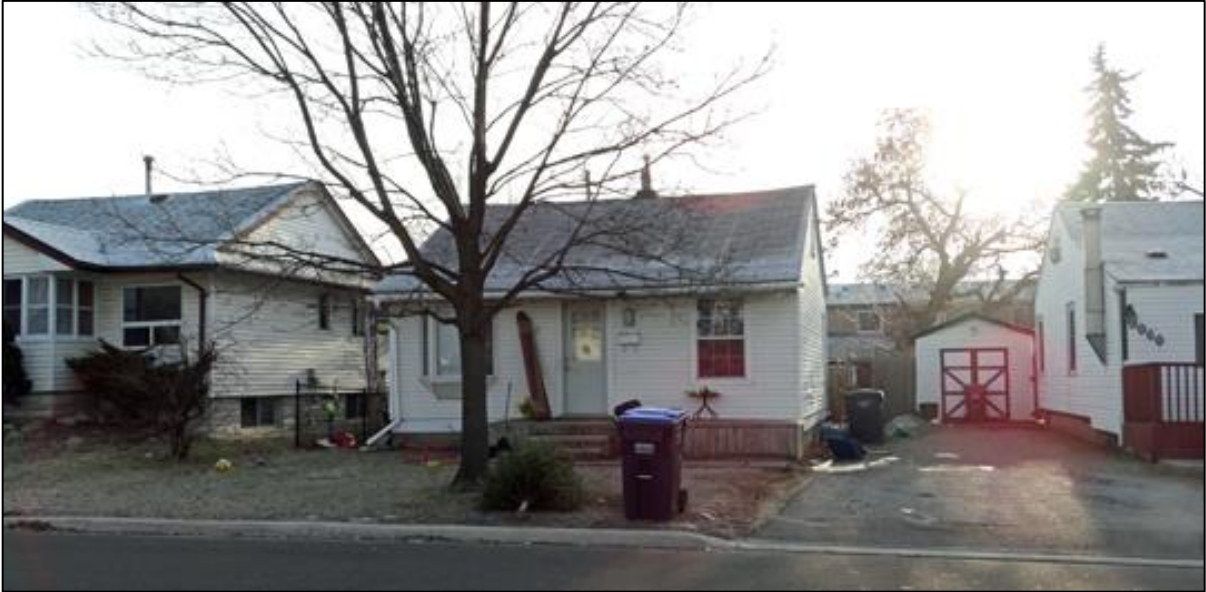
Figure 12: Streetscape Context, 2017

Above: 3064 Churchill Avenue shown in centre; shared driveway on right

Below: 3064 Churchill Avenue on left, looking southwest along Churchill

Both sides of the Churchill Avenue streetscape in the vicinity of No. 3064 have wartime housing type dwellings (Figures 12 and 13). These are one and 1.5 storey, frame structures built using the original roster of standardized plans and materials. Each has been modified since construction and now incorporates a variety of siding types, verandahs, landings, entranceways, windows, basements, and additions using newer materials and technology.

If constructed, this dwelling will be the only two storey structure on this stretch of Churchill Avenue. Its height as shown in Figure 16 will be slightly taller than that of the 1.5 storey units on the street, notably 3056 Churchill, two properties to the west (Figure 12, lower image). The proposed dwelling will be the only brick structure within this segment of Churchill. Infill dwellings to the distant east, south, and north as shown in Figures 10, 13, and 14 are also two storey, brick; indicative of the infill trend in this area. The design feature of an integral garage within the front façade, accessed by a driveway, will be new to this segment of the street.

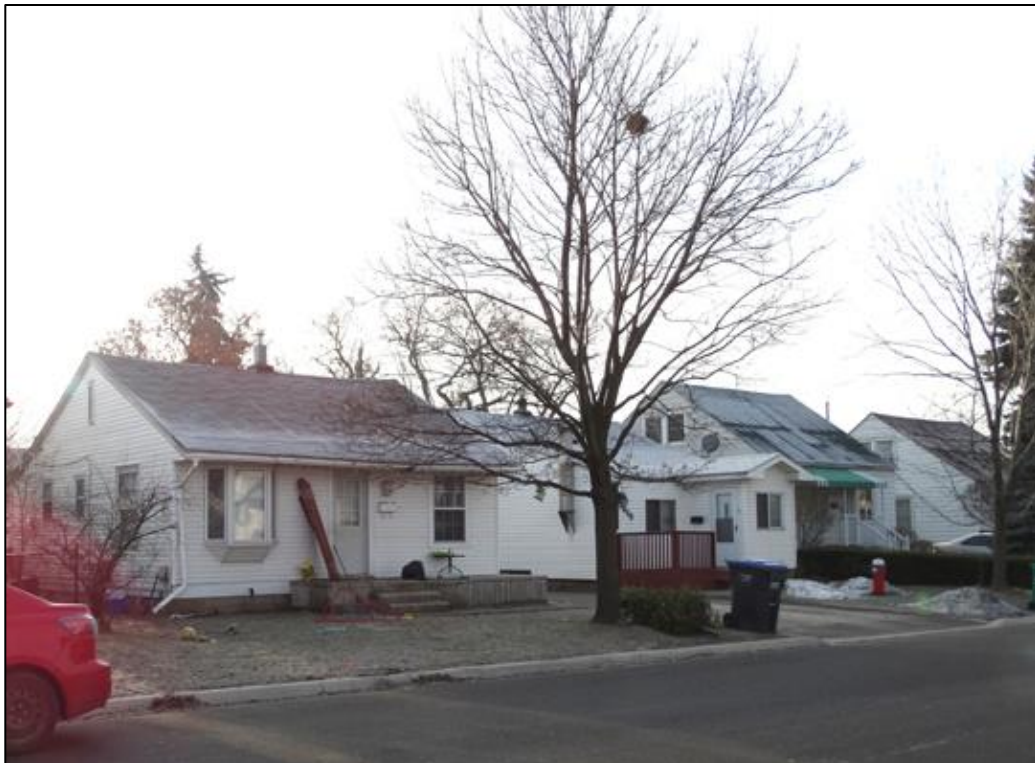
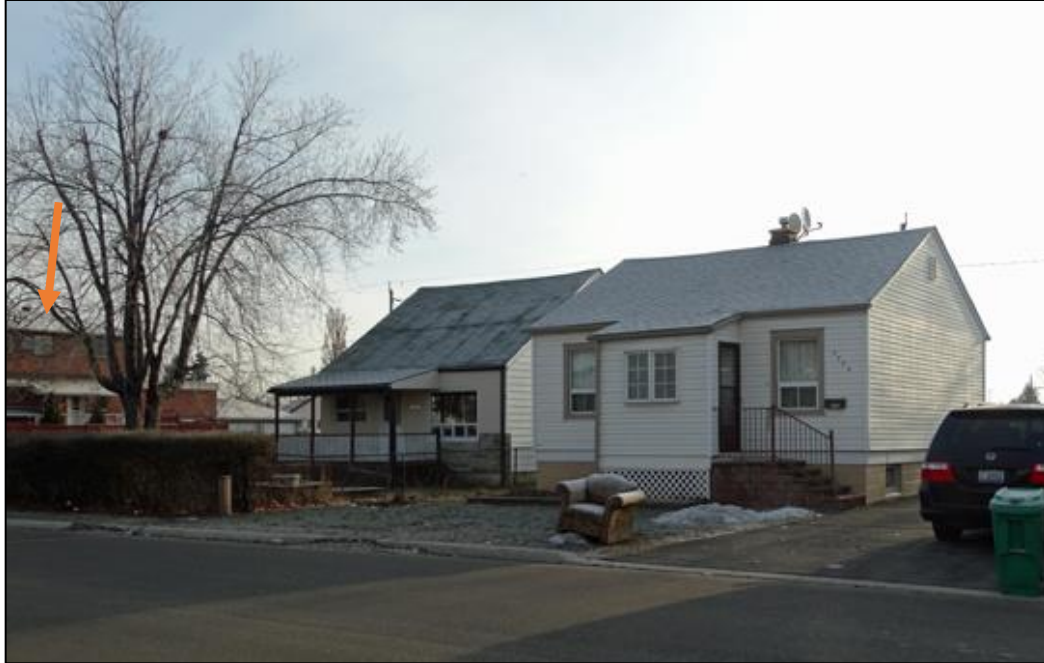
Figure 13: Streetscape Context, 2017

Above: South side of Churchill Avenue looking east to infill at Victory Crescent

Below: North side of Churchill Avenue opposite No. 3064. The rear of the infill dwelling at 3056 McNaughton Avenue is on the left.

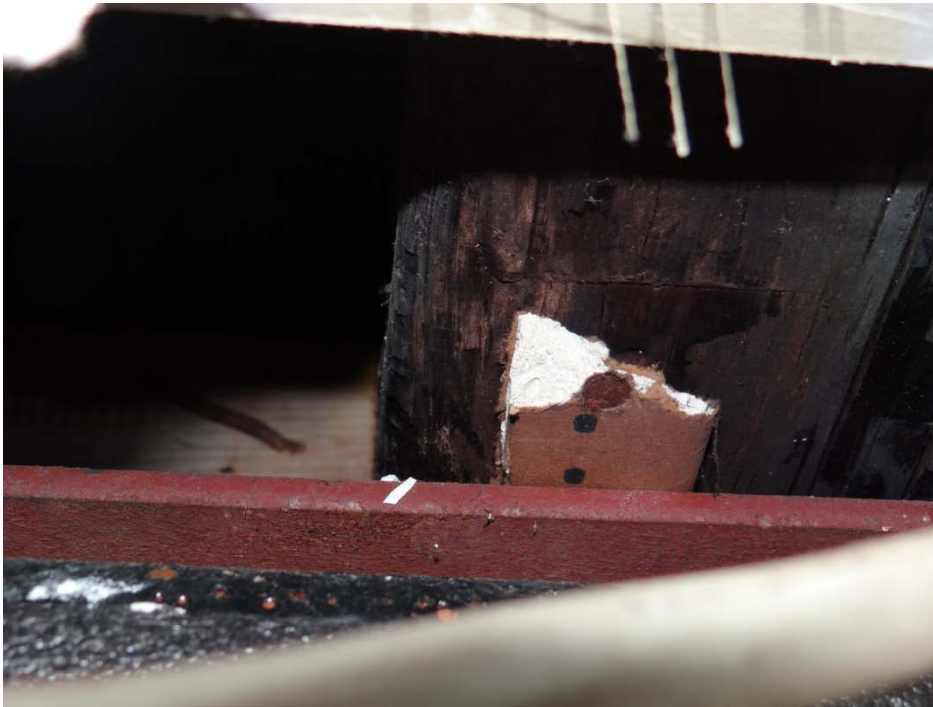
Plate 34: Detail of potentially hewn beam.

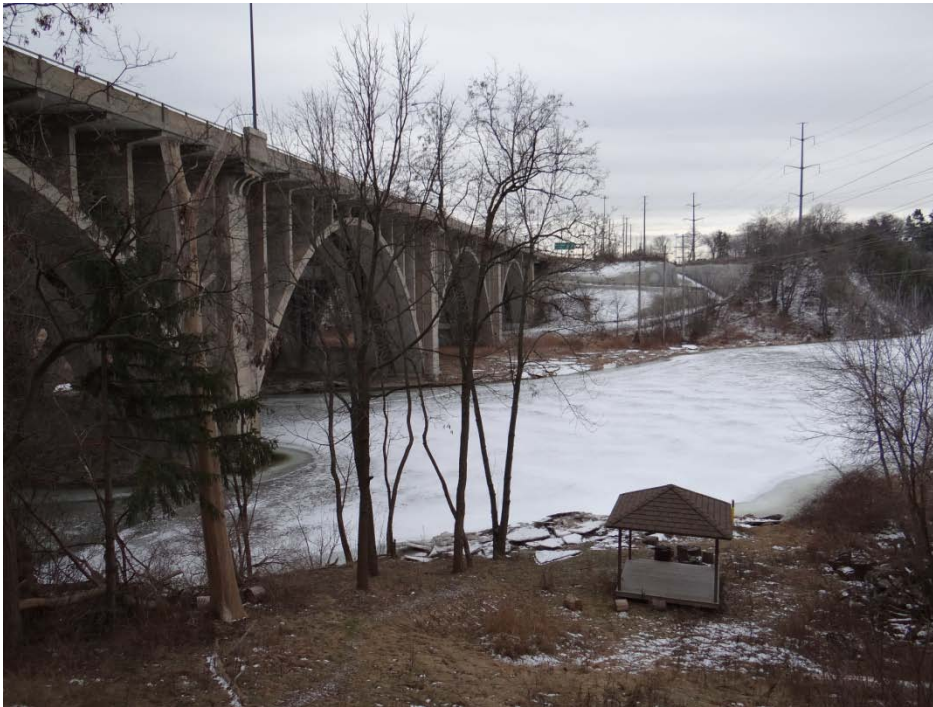
Plate 45: View of the Credit River and the Credit River bridge from the secondary structure.

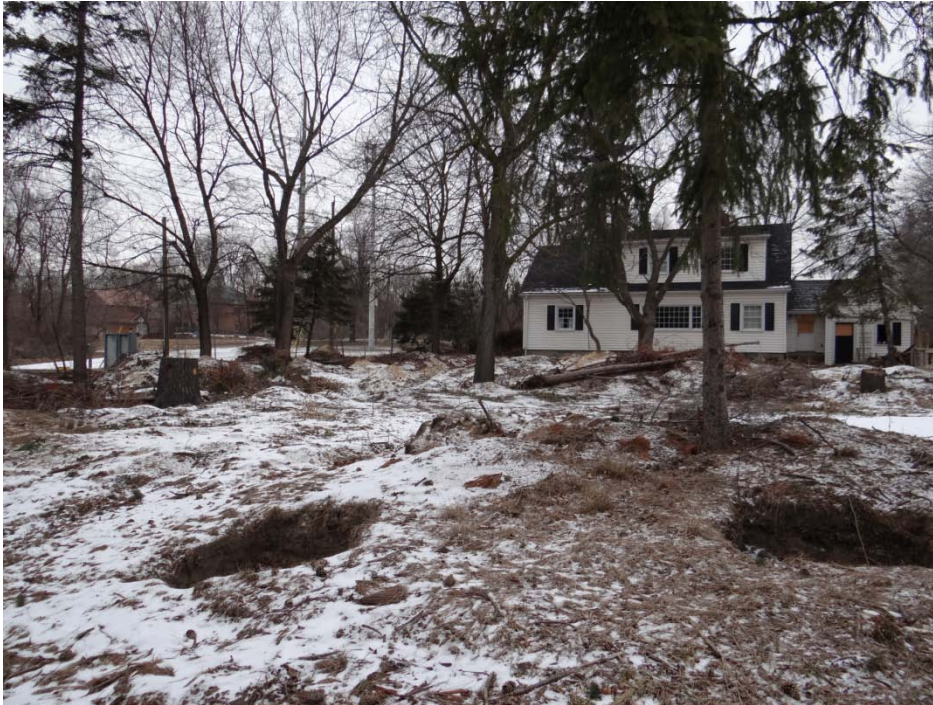
Plate 47: Looking north toward the rear of 2002 Stavebank Road.

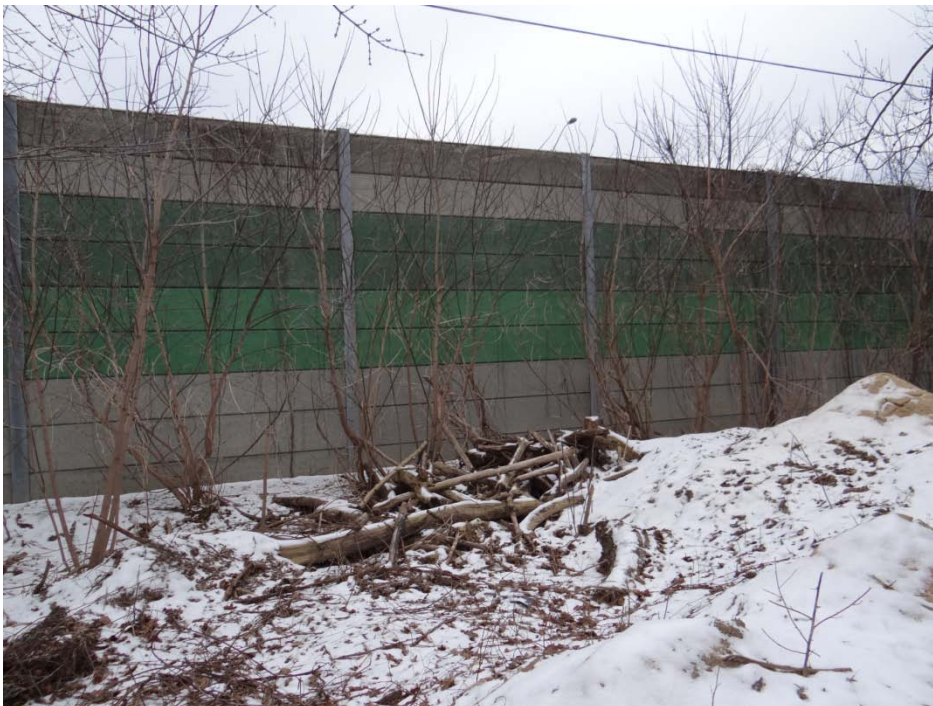
Plate 48: View of the QEW barrier walls which form the eastern boundary of the subject property.

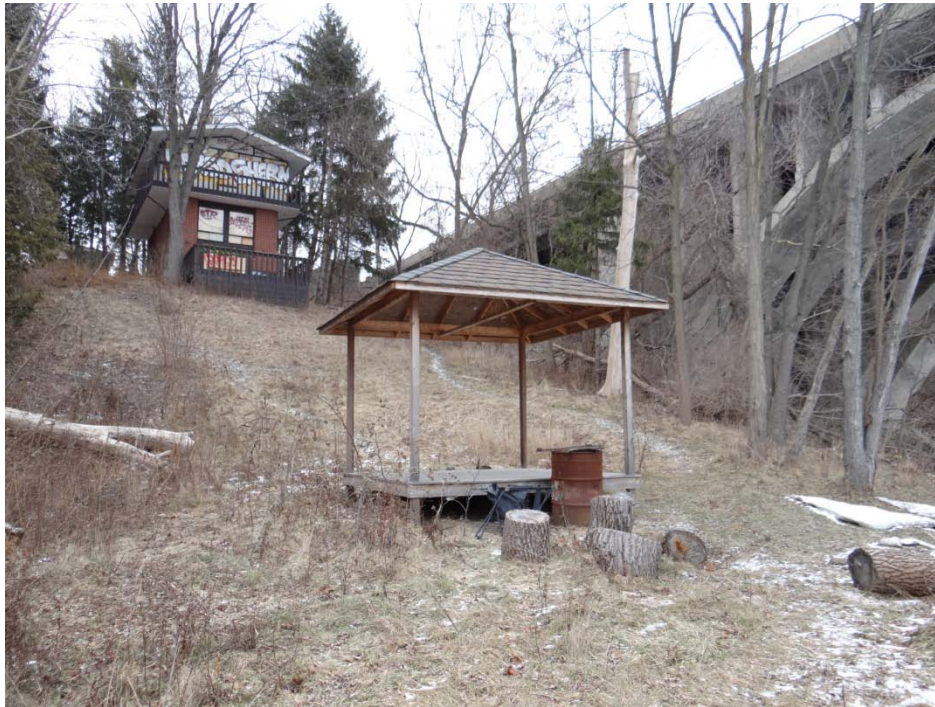
The property retains a number of mature and established trees, including large willow and spruce trees, and is characterised by its fairly steep natural slope leading down to the Credit River, as well as its views of the river and the Credit River Bridge. The latter is especially visually and audibly remarkable due to its proximity to the property. The southwest corner of the property is occupied by marshy lands (Plates 45 to 51).

Plate 49: Looking north from the edge of the Credit River at the steep slope of the subject property. Note the proximity of the Credit River Bridge.

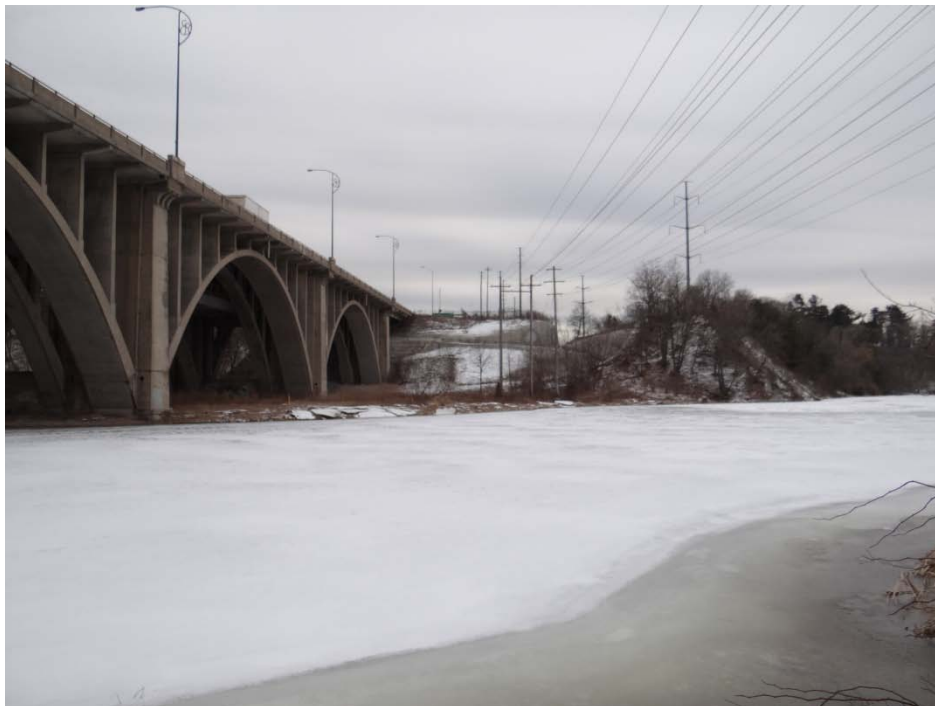
Plate 50: The Credit River and Credit River bridge from the southern edge of the subject property.

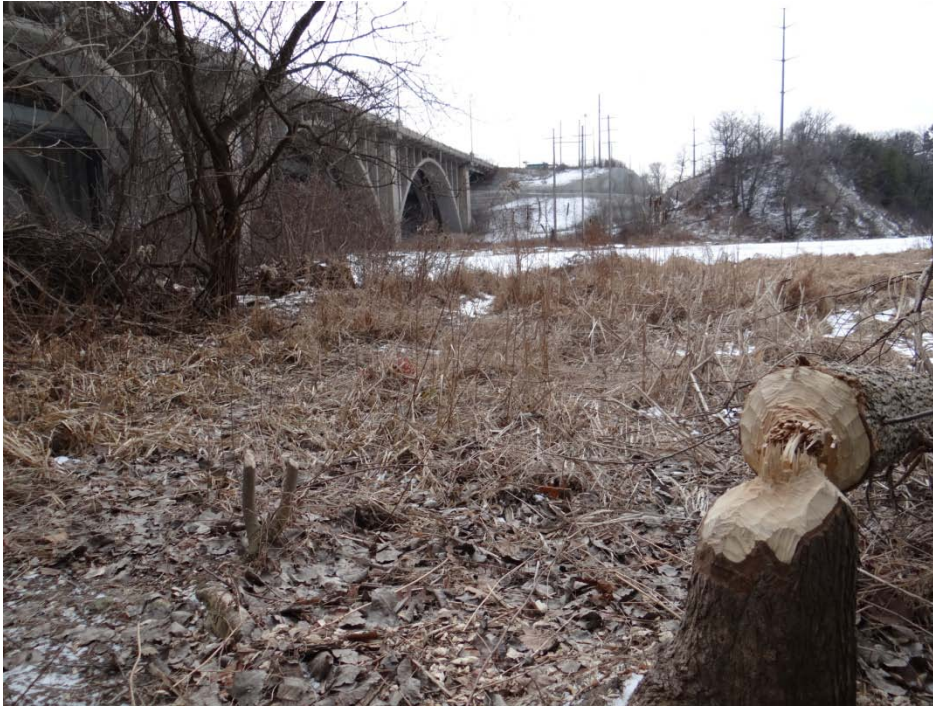
Plate 51: View of the low-lying marsh land along the southern edge of the subject property.
