Heritage Advisory Committee

2018/01/09

- MATTERS TO BE CONSIDERED
- 7.1. Request to Alter a Heritage Designated Property: 41 Bay Street (Ward 1) Request
- 7.2. to Alter a Heritage Designated Property: 1155 Willow Lane (Ward 11) Request to

- 7.3. Alter a Heritage Designated Property: 1066 Old Derry Road (Ward 11) Request to
- 7.4. Alter a Heritage Designated Property: 1059 Old Derry Road (Ward 11) Request to

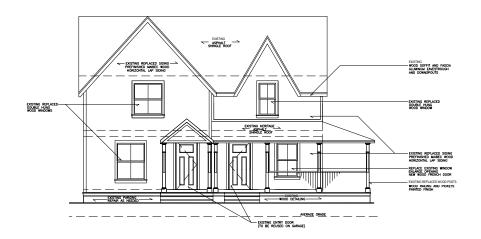
EXISTING NORTH ELEVATION - CURRENT

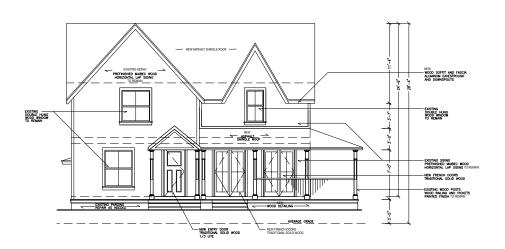
Heritage Addition

North Elevation - Proposed

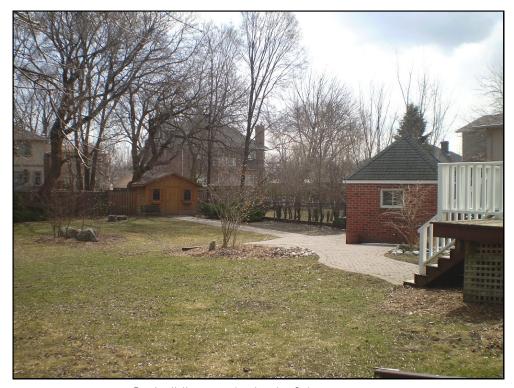
Outbuildings at the back of the property.

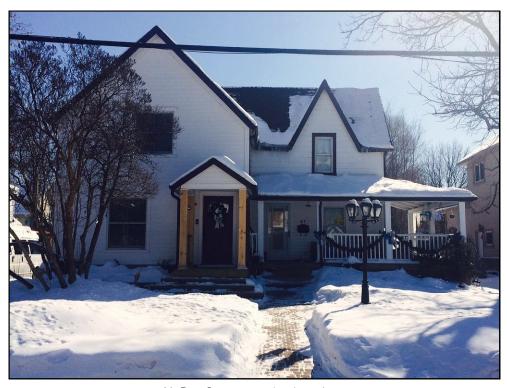
41 Bay Street: north elevation.

"This is a one and one half storey frame structure is constructed of wood and aluminum siding. The building is in a L-shape, with a covered porch in the "L" which wraps around to the side. There is a steep pitched gable roof with a peak dormer and asphalt shingles. Sky lights have been added to the rear roofline, but are not visible from the street. There is a four bay facade on the north face of the structure. A small portico covers the entrance in the projecting "L", in addition there is also an entrance under the porch. The pillars are squared with fan brackets under the eaves. The balustrade is also squared, all in proportion with the other porch detail. The windows are double hung one over one. There is a stone foundation, stuccoed. There is a garage on the property. The "L"-shaped, frame house occupies one of the original one-quarter acre lots in the village survey."

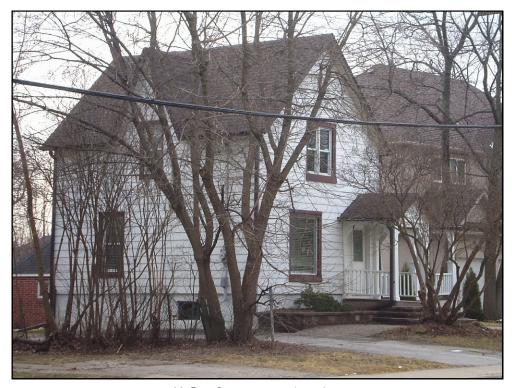
41 Bay Street: east elevation.

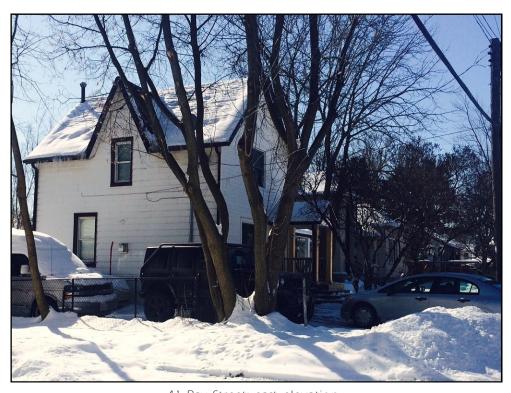
41 Bay Street: east elevation.

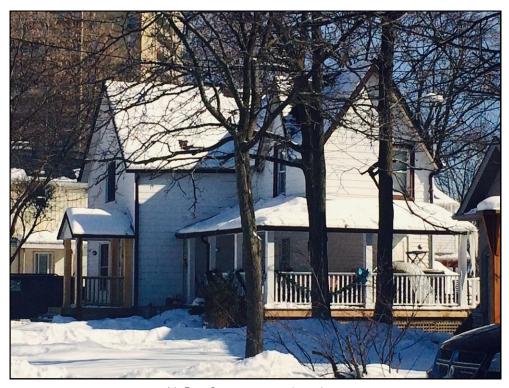
41 Bay Street: west elevation.

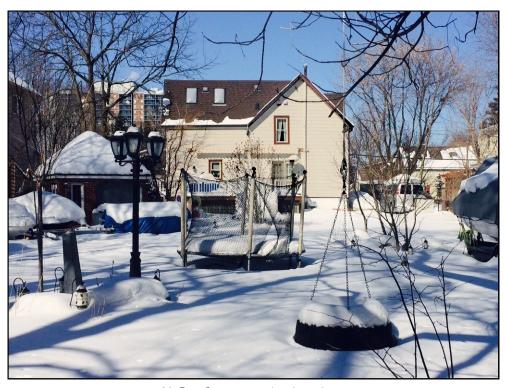
41 Bay Street: south elevation.

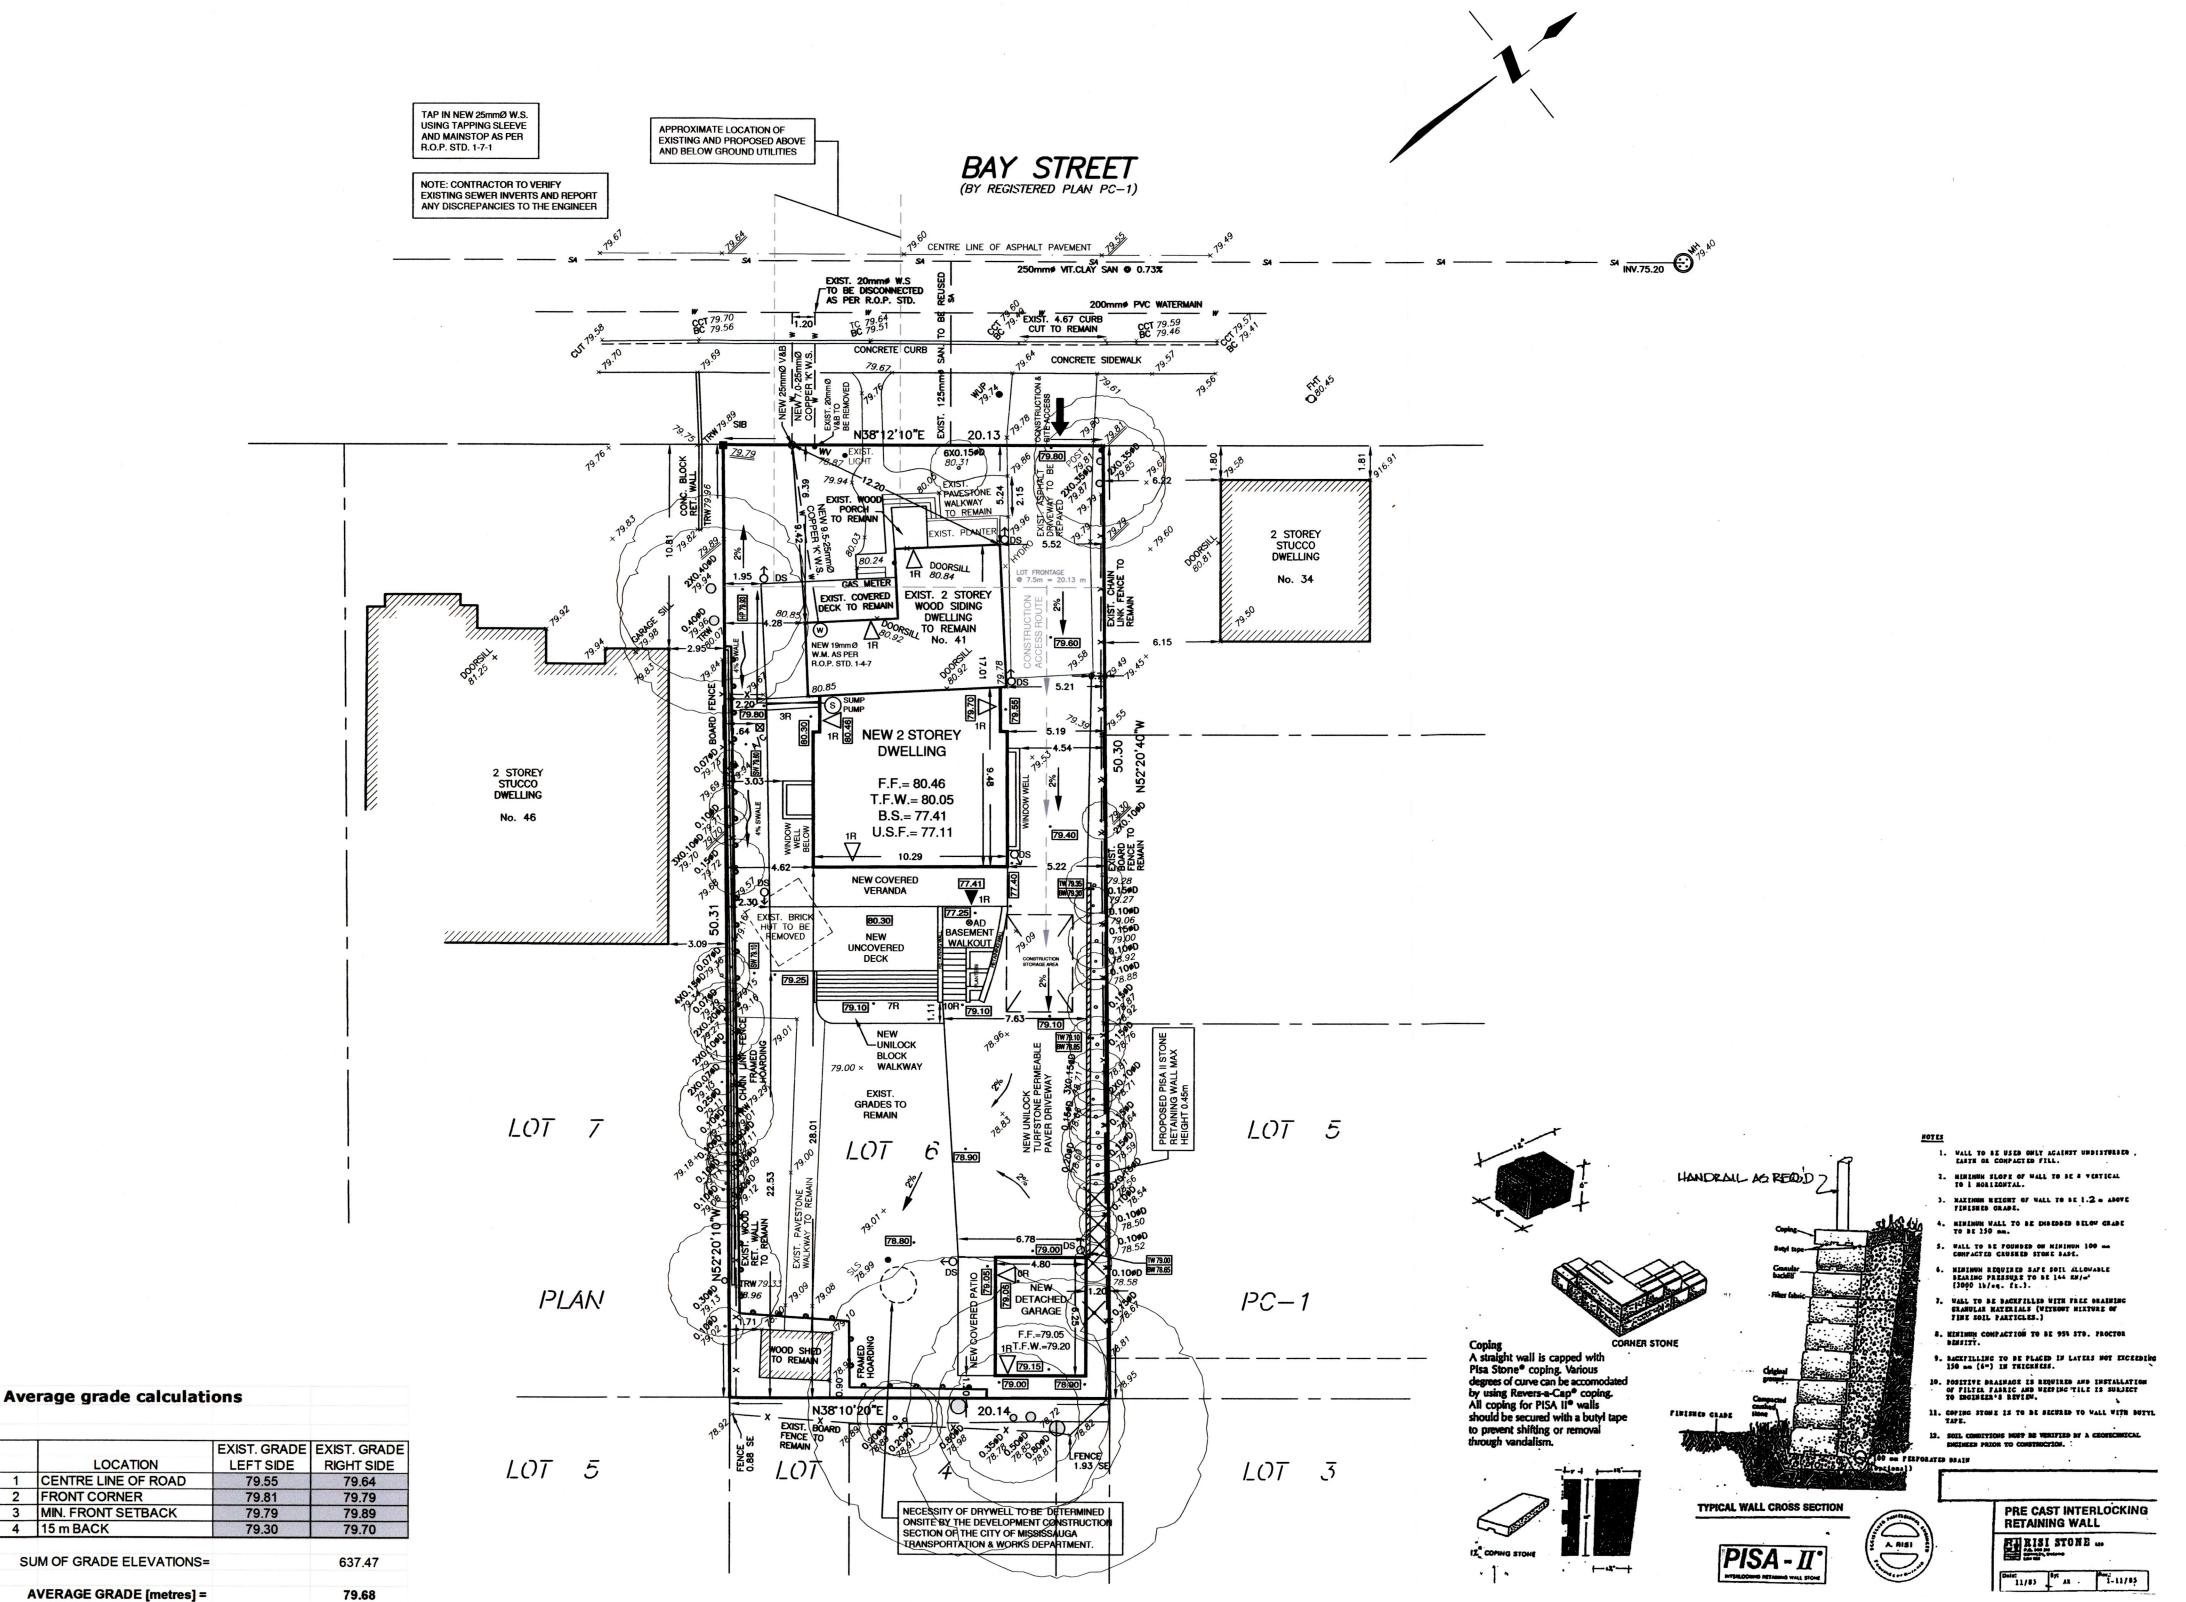
FRAMED HOARDING DETAIL (nts)

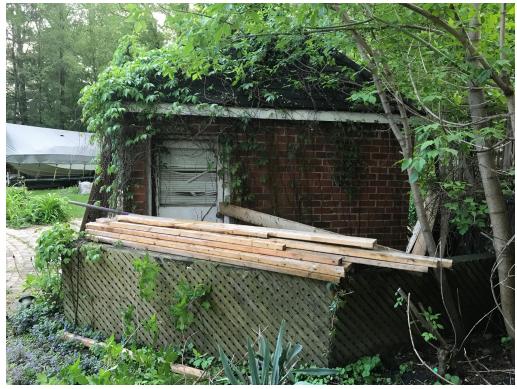
North Elevation:

The existing pool house was built in 1988 when the pool was installed, or shortly after. Below are elevation photos of the current building, in disrepair:

Current photos of the existing pool house are provided below. This brick building originally functioned as a pool house and storage. It was built in 1988 when the pool was installed or shortly after. The building is red brick with a black roof and does not share any of the same materials as the house. It was situated poolside but now that the pool has been removed the pool house is noticeably oddly placed on the property and in relation to the house.

The building is not in good shape, has been repeatedly and problematically inhabited by raccoons and is in need of a new roof, doors and windows. This building holds no significant heritage value. It is not only in disrepair, but is currently situated where the new extension would be located, requiring it to be removed.

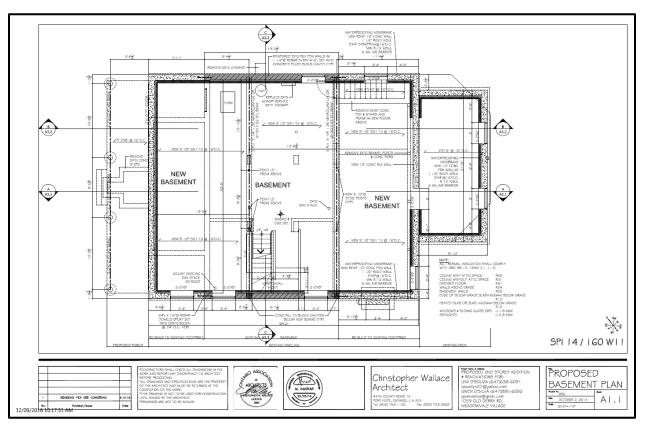
Figure 1: Basement plan

As part of the original designs and permit submitted, it was inteneded to have a wooden deck in the back of the house. In Aug - 2016, we submitted a revision to this plan. The revised plan proposed a cold room under the backyard deck and a porch at the front of the house without a crawl space. We removed the crawl space from our proposal as we were concerned about the integrity of a very mature tree at the front of the house. (see figure 1)

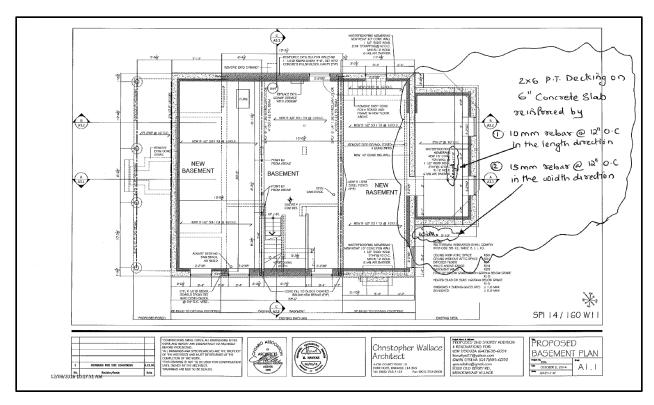
Figure 2: Top view of basement showing backyard deck plan

During construction, we were advised that there was a good chance of rain or snow leaking into the cold room below the backyard deck since the deck was without a roof (ex: Pergola, Awning). The contractor recommended a concrete deck. We submitted this change as part of BPA-9896 to the city of Mississauga, Planning & building on Dec 13- 2016. As illustrated in the picture 2 and 3, the proposal was to have a concrete deck that would be cladded with pressure treated decking wood.

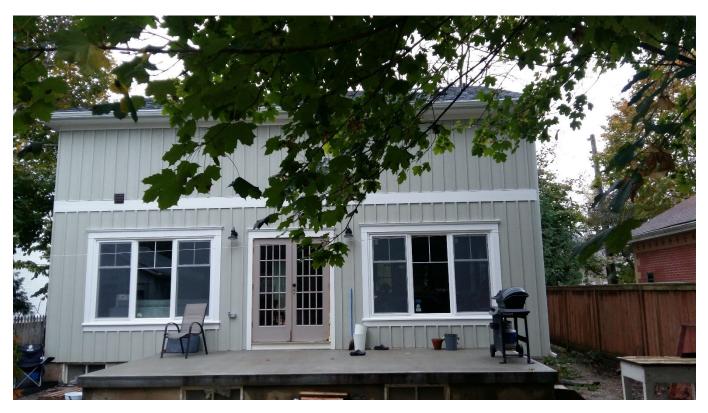
Figure 4: View of Concrete deck from backyard – note width of deck is less than width of house

My proposal is to leave the concrete deck exposed and not to put any pressure treated wood cladding over the concrete deck. Doing so would be a waste of financial resources and does not add value to the property. Being in the rear of the house and coupled with the fact that the deck is narrower than the width of the house, this deck is not visible from Old Derry road or from the adjacent roads. As the backyard is fenced in, it is impossible for this deck whether it is concrete or wood clad to be visible to neighbors or passerby's. (See Figure 4,5)

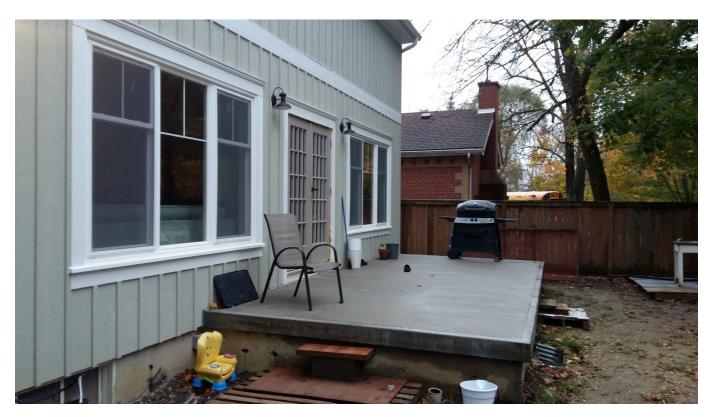
Figure 5: Side view of Concrete deck from backyard - note width of deck is less than width of house

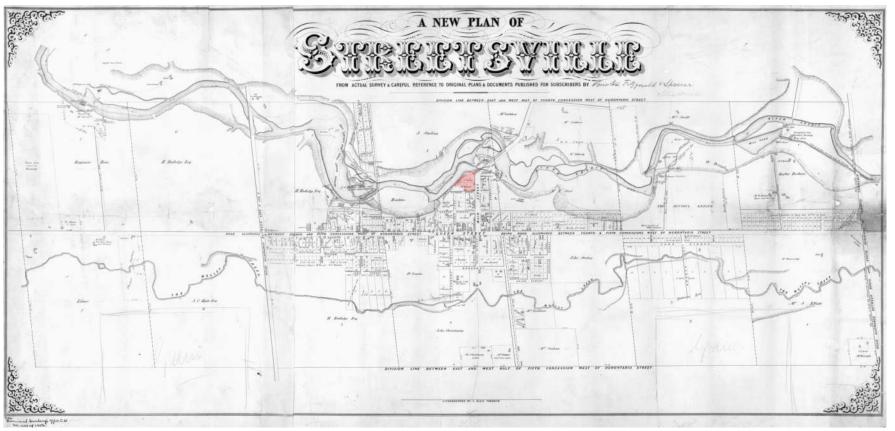
Figure 2

"A New Plan of Streetsville", 1856 - Library and Archives Canada - subject property in red

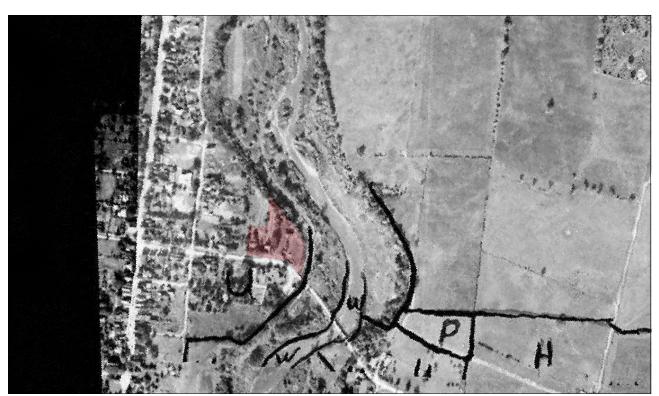
Figure 7 - subject property & environs 1944

In both the 1944 and 1954 airphotos, the east side of the Credit River is farmland and the Village hugs the west bank (Figures 7 & 8). The subject property is in red

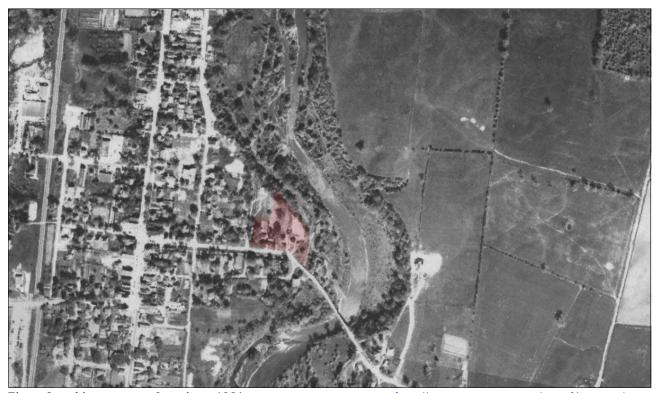
Figure 8 - subject property & environs 1954

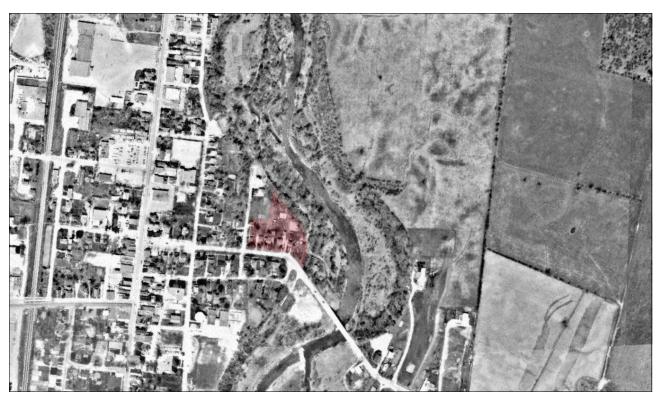
Figure 9 - subject property & environs 1966

By 1966 Wyndham Street had been developed and a building north and west of the subject property had been erected (Figure 9). Nearly 20 years later, there was little obvious change or growth in the immediate environs or on the east side of the river except for the construction of an apartment building on the west side of Wyndham Street (Figure 10).

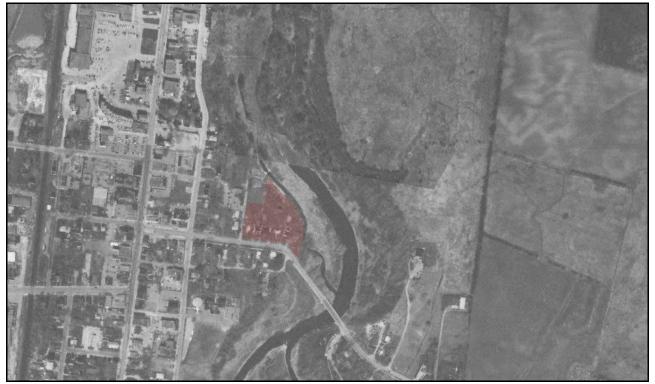
Figure 10 - subject property & environs 1985

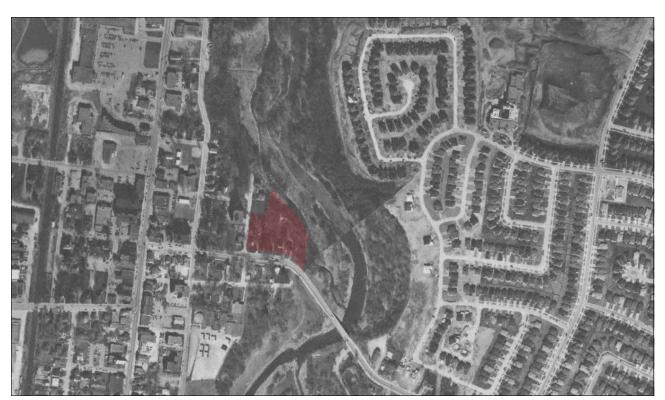
Figure 11 - subject property & environs 1989

The change in the landscape on the east side of the river is dramatic (Figure 11). Little has changed in the immediate environs of the subject property. The 5 houses fronting on Main Street are extant in this 2007 photograph. Four houses are now found on Wyndham Street (Figure 12).

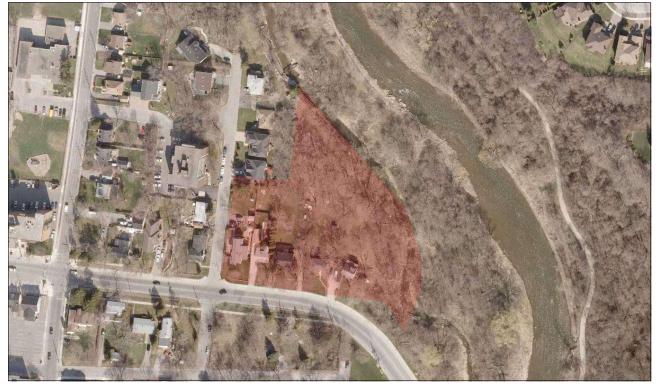
Figure 12 - subject property & environs 2007

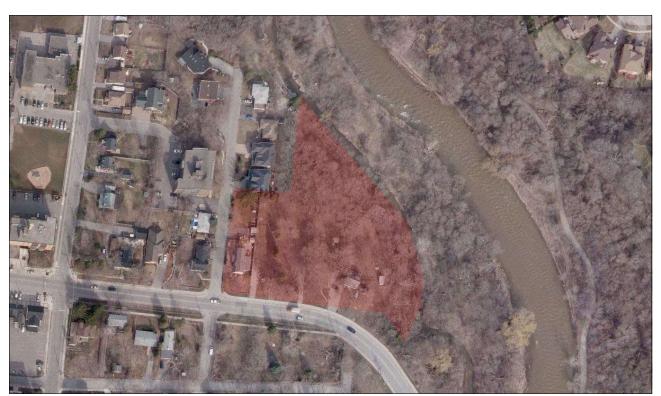
Figure 13 - subject property & environs 2008

One year later (2008), there were 2 houses remaining on the Main Street frontage (Figure 13). By 2009, only one house remained, 36 Main Street (Figure 14).

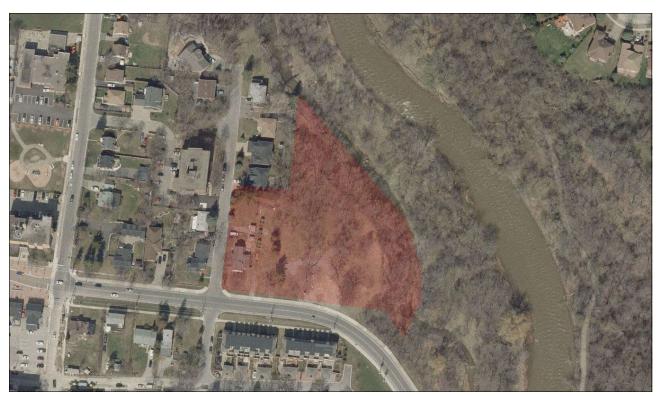
Figure 15 - subject property & environs 2017

The 2017 airphoto (Figure 15) shows the townhouse redevelopment of the south side of Main Street opposite the subject property, the first major change in the immediate environs in ten years (development of Wyndham Street north).

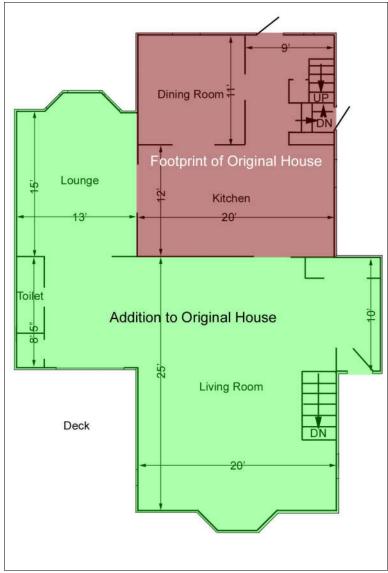
Figure 19

The date of construction of the house is unknown. As the property sold in 1932 for \$200, it is unlikely that the house was built before that date. A search of the City files for Building Permits shows only one permit being granted, and that for an addition in 1998. The first substantial mortgage recorded for the property (\$2,000) was in 1950 when the property was in the ownership of Ruby and Charles Rundle who had purchased the property in 1928. The house has been modified over time with structural features that might provide clues of its age covered. The foundation appears to be concrete. In places, the foundation has been veneered with concrete brick. Siding is vinyl; soffits and fascia are aluminum. The interior has been gutted and recently vandalized. Stud walls for the most part are of contemporary dimensional lumber (2 x 4s) indicating mid 20th century to date construction.8 The exception is the small front portion of the house where the studs are rough sawn pre WW II 2" x 4" (Figure 19). While an investigation of the fullheight basement might have offered more information, it is inaccessible, as was the upper floor during the author's site visits.

footprints of original house & addition(s)

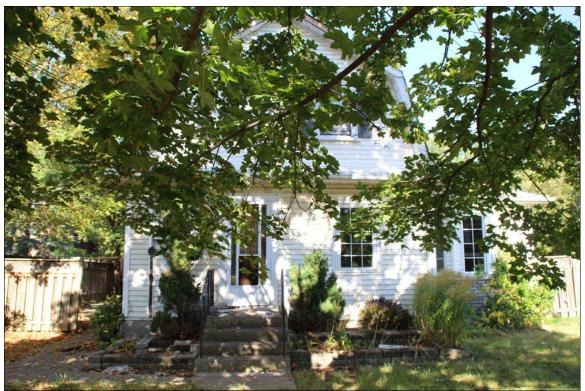
Figure 21 front facade - 36 Main Street

The front facade (Figure 21) shows a symmetrical top floor and asymmetrical ground floor with the entrance to the left side. The 1998 addition is set back on the right from the front facade. Faux window muntins are apparent.

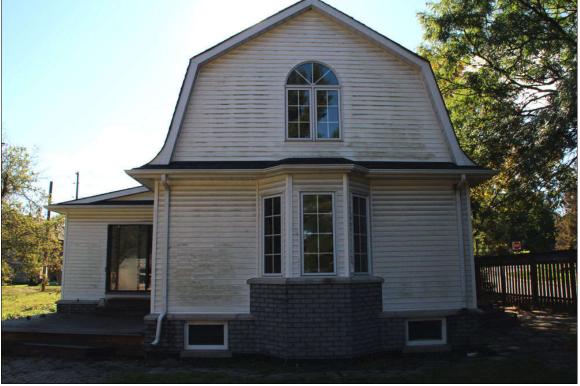
Figure 22 rear facade - 36 Main Street

The rear facade (Figure 22) sports a bay window on the ground floor. Concrete brick has been applied to the foundation. Sills are concrete as well. The 1998 addition has sliding patio glass doors.

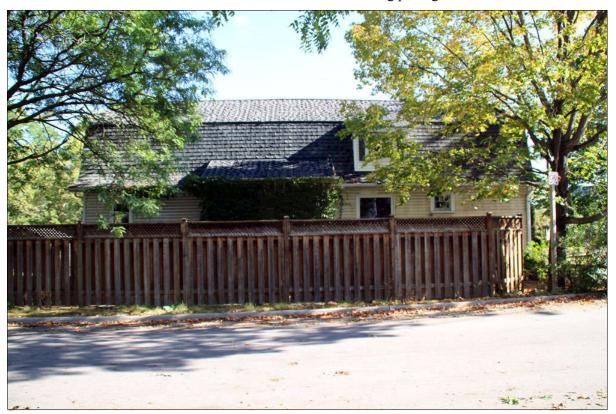
Figure 23

west elevation on Wyndham Street

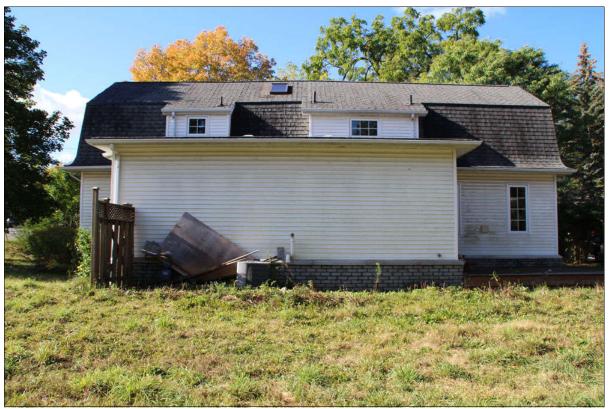
Figure 24

east elevation showing addition & 2nd storey dormers in gambrel roof

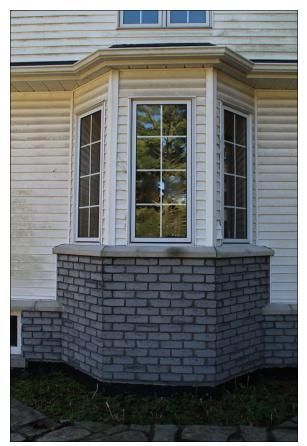
Figure 27 bay window at rear - concrete brick veneer

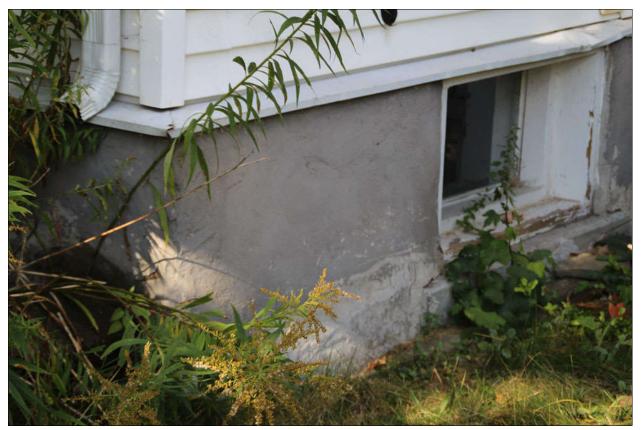
Figure 29

concrete foundation at southeast corner

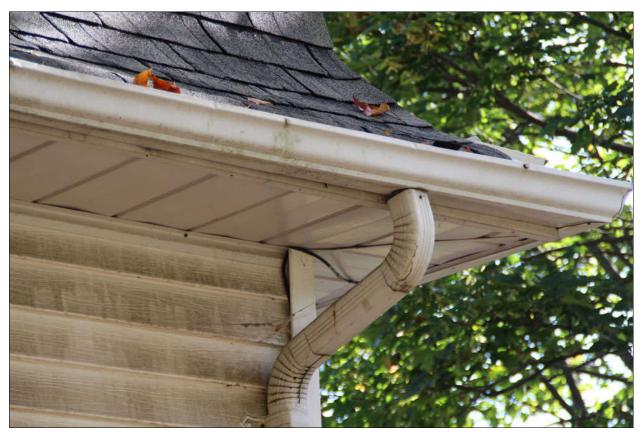
Figure 30

vinyl siding, aluminum soffits, troughs & downspouts

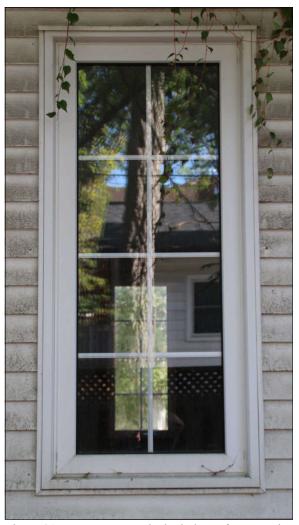
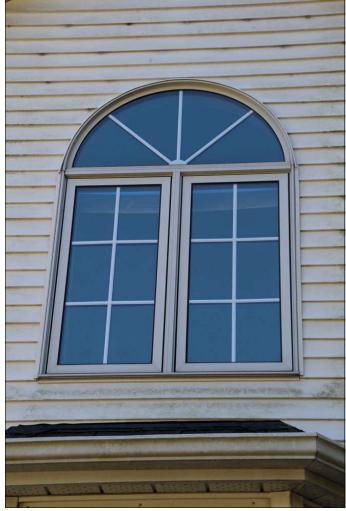
Figure 31

typical window - faux muntins

upper storey casement and half-round window

All windows appear to be relatively new, perhaps installed with the 1998 addition. All have faux muntins. The interior has been vandalized and appears to be of recent vintage. There is evidence that for roughly two-thirds of the house, all trim, flooring, wall materials, studs, *etc.* are *circa* late 20th century (Figures 33 - 34).

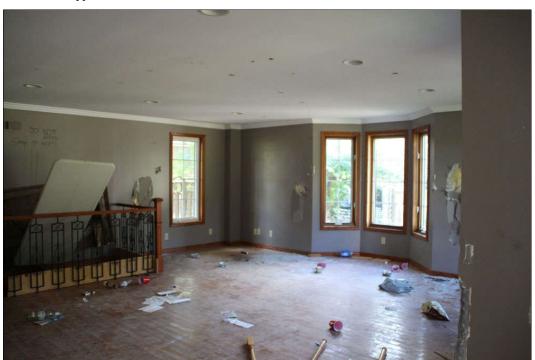
Figure 33

living room at rear with bay window

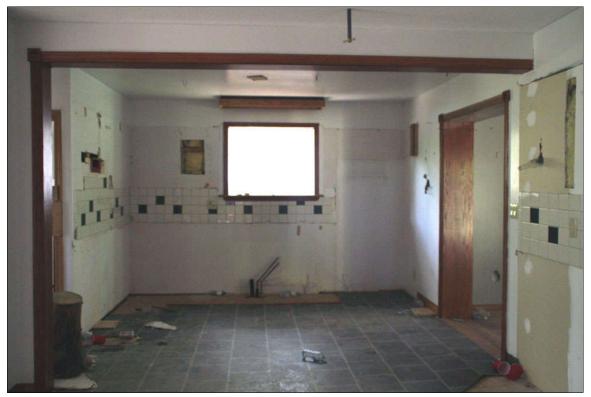
Figure 34

kitchen (original portion of house) - looking west

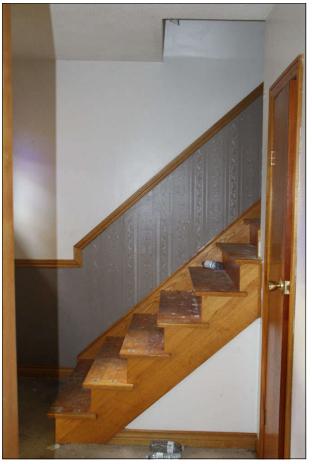
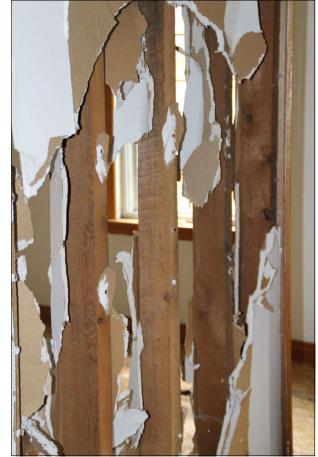
Figure 39 stair to upper floor

Figure 40 rough sawn, pre WW II 2" x 4" studs

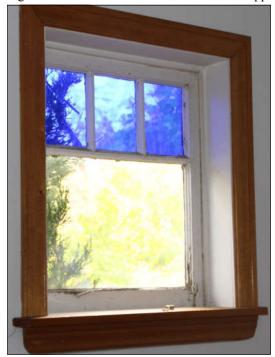
Figure 41

one of 2 original windows

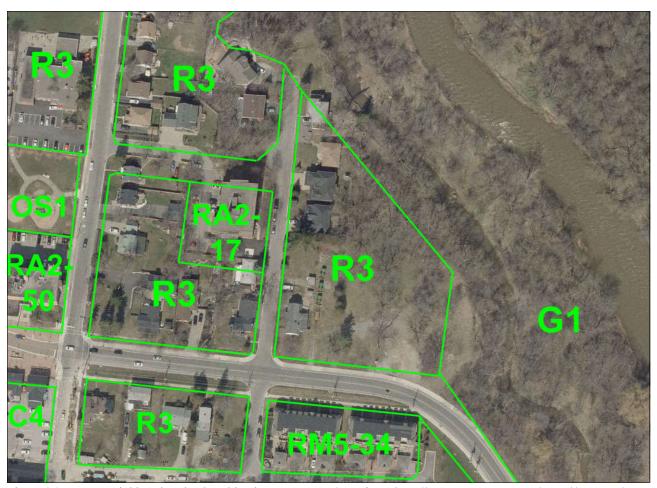
Figure 36 is an aerial view of the context within which the subject property is located. The area is comprised of a mix of single family, apartment, town house, commercial, conservation & open space zoning.

Figure 36 neighbourhood cultural landscape context & zoning - http://www.mississauga.ca/portal/services/maps

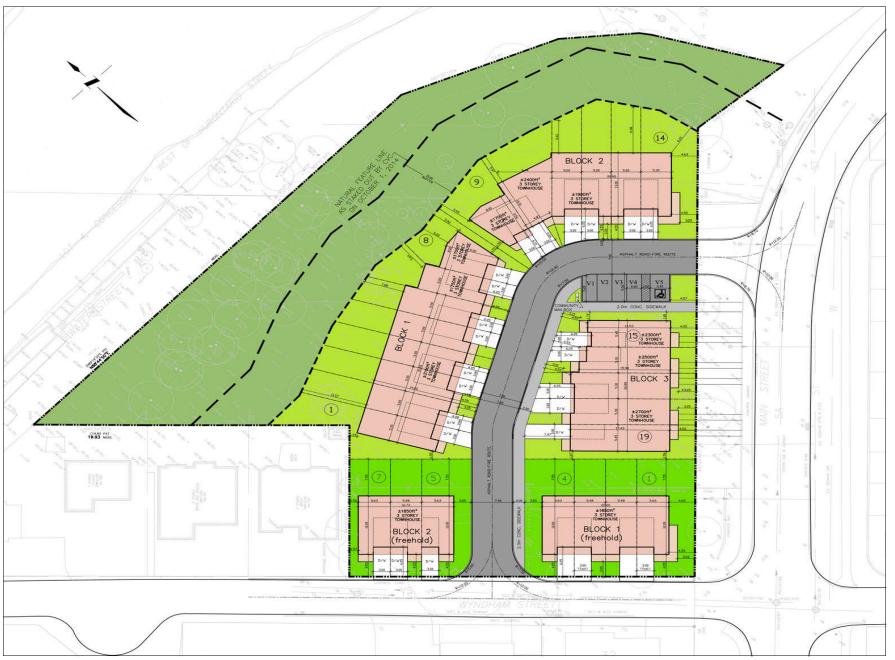
Figure 48

Proposed Site Plan - flanagan beresford & patteson architects, 05 August 2017

Nineteen, 3-storey, freehold townhomes fronting on Wyndham Street, Main Street, and an internal street are proposed to replace the existing dwelling. Site statistics are found in Figure 49. The proposed development complements the relatively recent townhome development across Main Street in scale, materials and massing.

A proposed Site Plan is illustrated in Figure 48.

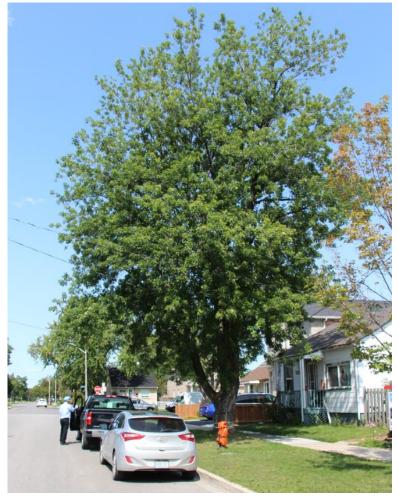
Figure 4 – Silver maple in front of 7177 Lancaster Avenue (Photo: RHC 2017).

All properties identified by the Cultural Landscapes Inventory (2005), which includes the Victory Wartime Housing cultural landscape, have been listed as non-designated on the City of Mississauga's Heritage Register. The subject dwelling has limited architectural design value on its own but does contribute to the overall character of the Victory CL having retained its original 1-storey, L-plan massing and side gable roof form. The large, mature silver maple tree in the boulevard in front of 7177 Lancaster Avenue (Figure 4) is a proud survivor that is likely from the original or early subdivision plantings.

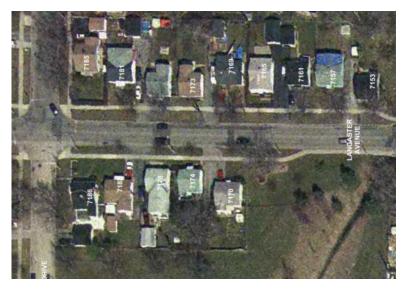
Figure 14 - Air photo 2002 (Image: City of Mississauga Online Mapping)

A comparison of 2002 and 2017 air photos (Figures 14 and 15) shows that of the nine original wartime houses on the east side of Lancaster Avenue below Etude Drive, four have been demolished and replaced with what in RHC's opinion are unsympathetic and inappropriate residential designs that are not compatible with the heritage character of the Victory War Housing cultural landscape.

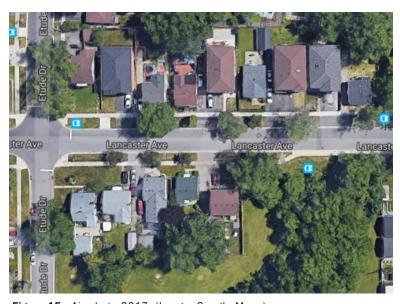
Figure 15 - Air photo 2017. (Image: Google Maps)

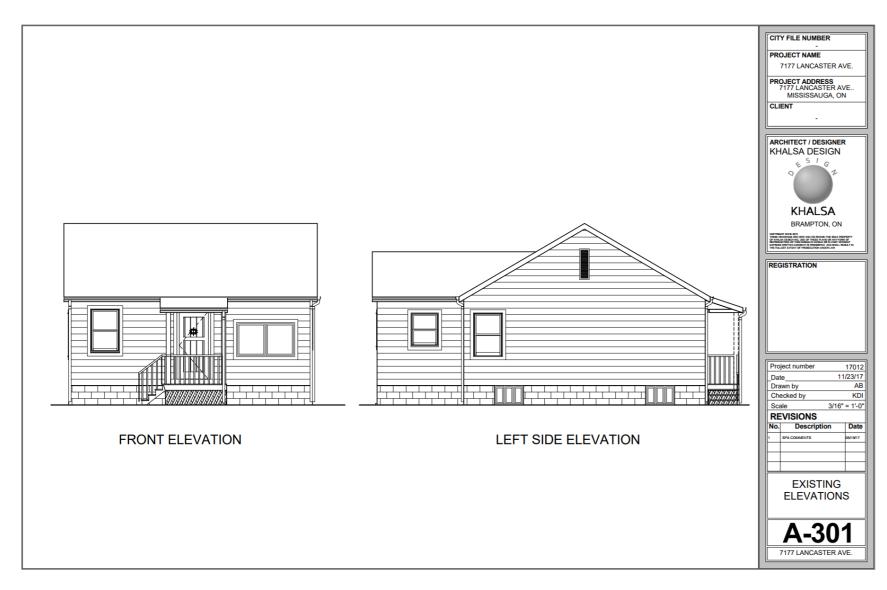
Figure 18 -7177 Lancaster Avenue. Existing front and left elevations. (Image: Khalsa Design, Nov 23, 2017)

The front elevation has three bays with a centre door (Figure 18). The front left window opening position is original but the front right window opening has been altered to become a horizontally oriented, 2-pane unit attempting to achieve a wider "picture" window for the living room – a feature that became popular in mid-20th century residential design. The left window on the right (south) side elevation has been filled in with matching siding. The standard WHL designs (e.g. H22) had a window in this location but it may be that a decision as made to fill these in – in such a way that would make it easy to uncover the opening in future.

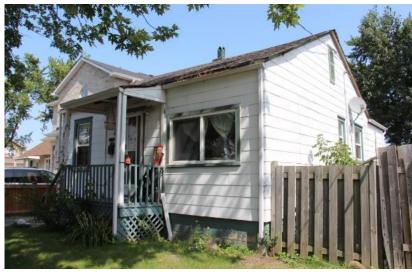
Figure 30 - 7177 Lancaster Avenue. (Photo: RHC 2017)

The original house at 7177 Lancaster Avenue is in many ways similar the Wartime Housing Limited's "H22" design (Figure 29) with a medium side gable roof and a 3-bay front with a centre door. The main block footprint of the single-storey building measures roughly 24' x 24'. The house has concrete block foundation walls and a full height basement.

The WHL dwellings were built with modular, prefabricated 4' x 10' floor and wall sections. The side gable roof has a slope of roughly 8/12 and the remains of the original, red brick chimney stack rises from near the centre of the roof ridge. The attic is ventilated by a narrow, louvered, rectangular opening near the peak of both side gable walls. At 7177 Lancaster, this feature has been subsequently covered by what appears to be a decorative, aluminum window shutter – likely added when the building was re-clad with the existing siding.

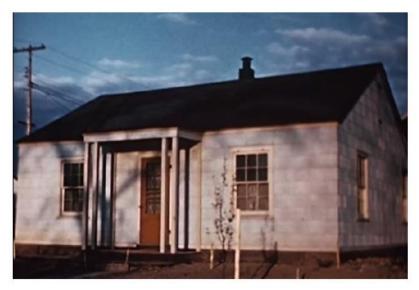
Figure 31 - Design H22 used by Wartime Housing Limited. (Image: National Film Board, 1942)

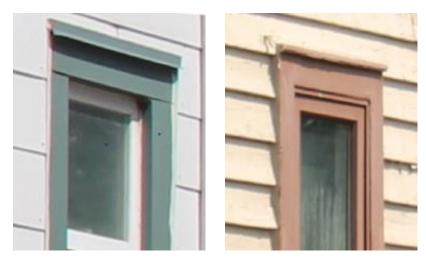
Figure 32 - Window comparison: (left) 7177 Lancaster Ave; (right) 3216 Merritt Drive. (Photos: RHC 2017)

fibre-cement product.⁴ A comparison of the same window in 7177 Lancaster and 3216 Merritt Avenue (Figure 20) reveals that the existing siding on 7177 Lancaster Avenue has been applied over the original cladding making the existing siding almost flush with the window frame.

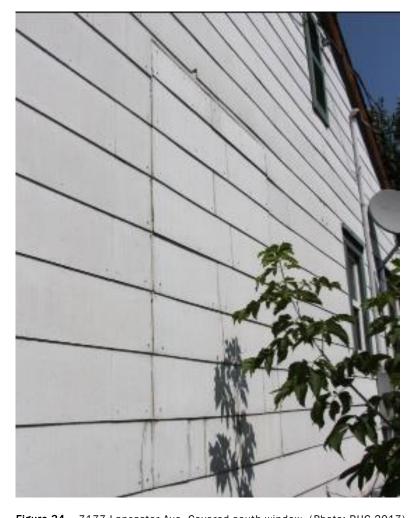
Figure 34 - 7177 Lancaster Ave, Covered south window. (Photo: RHC 2017)

The left window on the right side elevation of both houses has been filled in with matching siding (Figure 22). The standard H22 design had a window in this location but it may be that home owners decided to fill these in in such a way that would make it easy to uncover the opening in future.

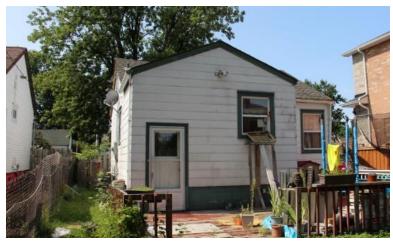
Figure 36 - Rear tail and entrance door. (Photo: RHC 2017)

The northeast corner of the rear has a typical early Modernist architectural feature of the era with a window on both angles of the rear corner (Figure 23). At the rear of the house is an extension at the southeast corner with a back door leading to a split stairway leading to the kitchen area or the basement (Figures 24 and 26).

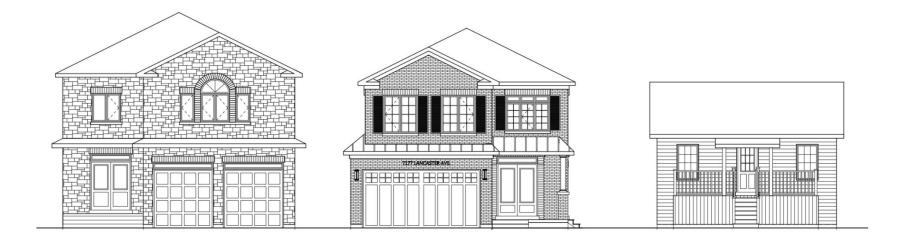
Figure 48 – Proposed front elevation design for 7177 Lancaster Ave, compared with current front elevations of 7181 and 7173 Lancaster Avenue. (Image: Khalsa Design)

The proposed new dwelling for 7177 Lancaster Avenue has applied some of the recommendations of this report in the choice of lighter coloured brick and arrangement of windows in order to lower the impact with the remaining wartime streetscape but generally is more like the newer houses on the block in height, design and massing.

Further mitigation of the height of the proposed dwelling may be attained by changing the second storey cladding to a wood clapboardlike material in a colour lighter (but complementary to) the brick on

the first floor keeping contrasting colour to a minimum. A gable roof form would be more appropriate as well as using coupled 6-over-6 window arrangements and a 3 bay main body of the house stepping back the garage instead of projecting.

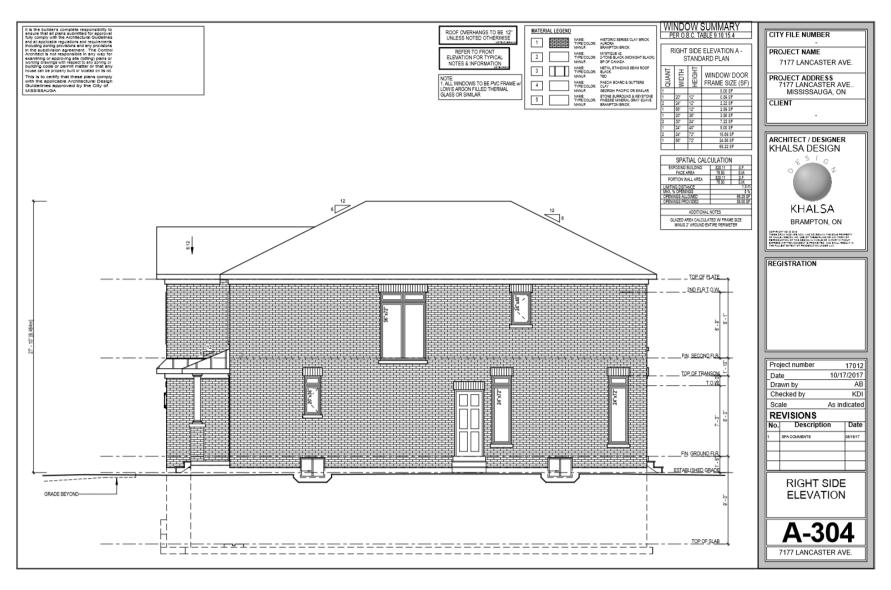
Figure 56 - Right (south) Side Elevation A-304. (Image: Khalsa Design)

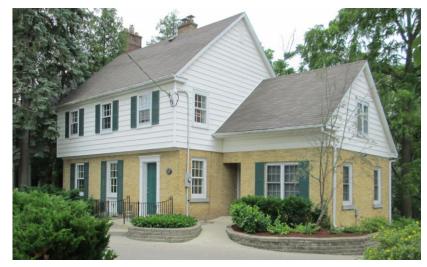
Figure 57 - 57 Albert St., Waterloo. (Image: Martin Chiropractic Clinic, Waterloo; accessed through Google maps, 2017)

The home at 57 Albert Street in the City of Waterloo (Figure 57) is roughly contemporary to the subject dwelling and could be seen as the type of house that a successful wartime worker might have aspired to move up to when they could afford it. In his suggestions for mitigation of the proposed design in the new house built at 7181 Lancaster Avenue (next door to the subject property) (Figure 22), heritage consultant and planner Paul Dilse (Dilse 2013) had recommended the emulation of 57 Albert Street in the City of Waterloo. The full 2-storey side gable design is mitigated by using light coloured brick on the ground floor and a lighter weight horizontal siding in the upper floor. This design expands the single-storey, threebay form of the typical "H1" house design. The garage is set back from the house front so that the front door remains prominent. Any expansion of the original form will reduce the sense of spaciousness of the lots that is a defining feature of the cultural heritage landscape the stepped back portion helps mitigate this.

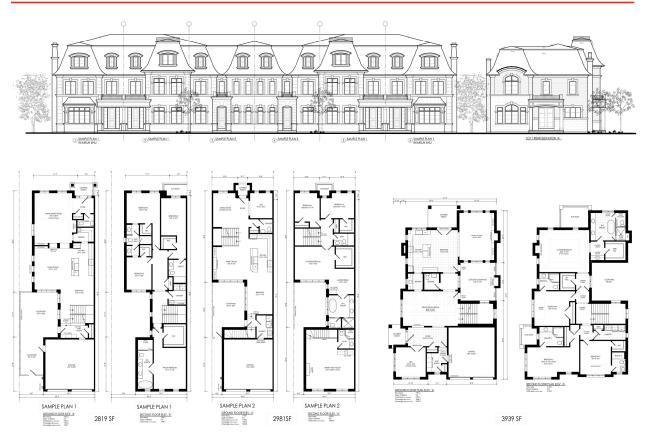
Figure 16: Proposed Development, 2016 Credit: RN design, 2016

The site is bordered on the east side by the Credit River Valley (part of the Credit River Corridor Cultural Landscape) and on the west side by Mississauga Road (part of the Mississauga Road Scenic Route Cultural Landscape). The townhouses are set well back from the Credit River Vally and will not be visible from the valley. The front entrance and covered porch of the detached corner unit is located on Mississauga Road.

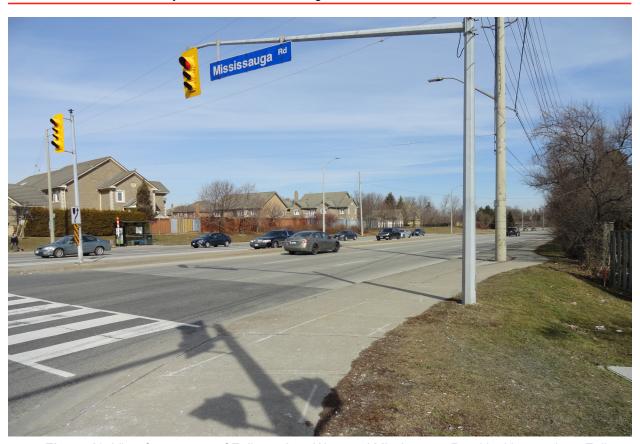
Figure 18: Measured Streetscape along Mississauga Road Credit: RN design, September 2017

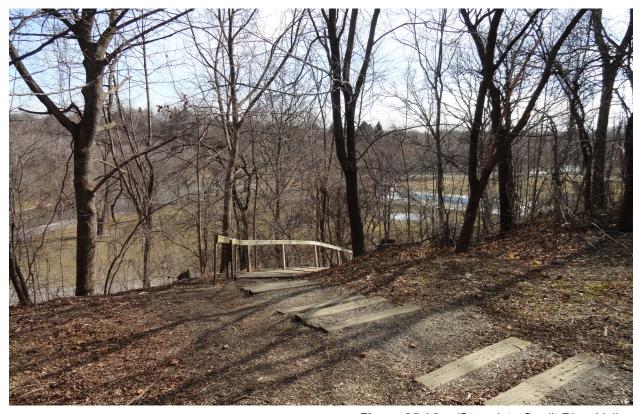
Figure 24: Credit River Valley (site beyond trees) Credit: SBA, 2016

The back portion of the property contributes to the Credit River Corridor. As illustrated in *Figure 24* and 25, rising from the river's edge is an almost vertical shale cliff of considerable height with dense foliage along the edge which then dissipates to an open field. It is assumed that these features contribute to its natural environment. As per the Concept Landscape Plan provided, the natural lands will be undisturbed.

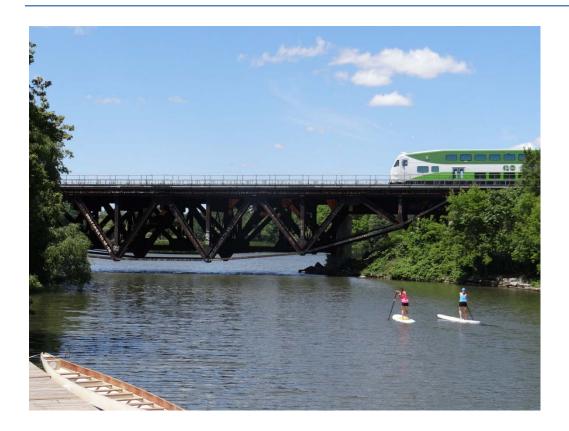
Figure-1-2: South elevation of the Credit River Bridge in the City of Mississauga, Ontario

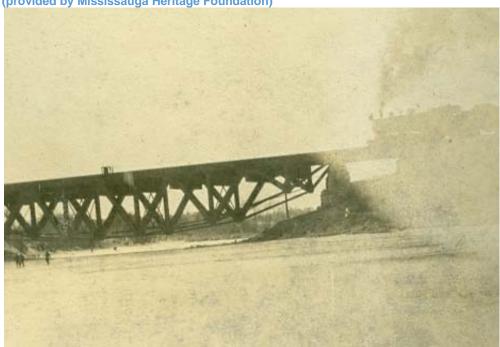
Figure 9-7: View of the new iron bridge at Port Credit, looking north, date unknown (provided by Mississauga Heritage Foundation)

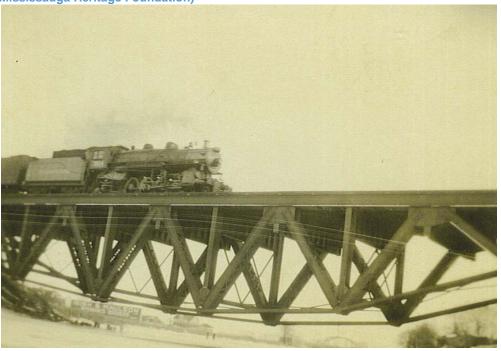
Figure 9-8: View of the Credit River Bridge, looking south, c.1910 (provided by Mississauga Heritage Foundation)

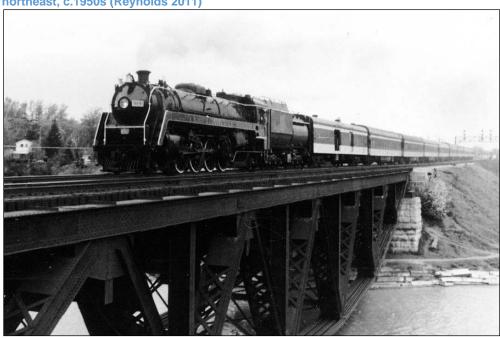
Figure 9-9: Mountain Type Locomotive 6060 crossing the Credit River, looking northeast, c.1950s (Reynolds 2011)

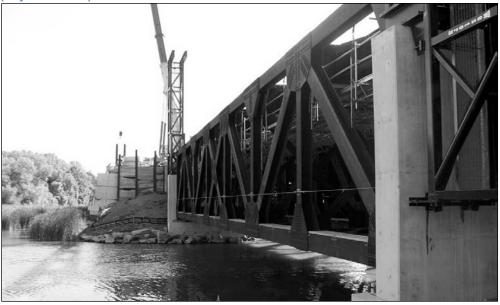
Figure 9-12: View of the new bridge to accommodate a third track, looking east, 2008 (Reynolds 2011)

of new track, 15 interlockings, and 25 bridges (AECOM n.d.). Work on a new bridge to carry the third track over the Credit River, on the north side of the existing bridge, began in 2007. The concrete substructure was completed in the fall of 2007 and work on the deck truss span began in spring of 2008 (Figure 9-12). The new bridge was lowered into place on August 9th/10th, 2008, between 1:00 am and 8:00 am. According to Reynolds (2011):

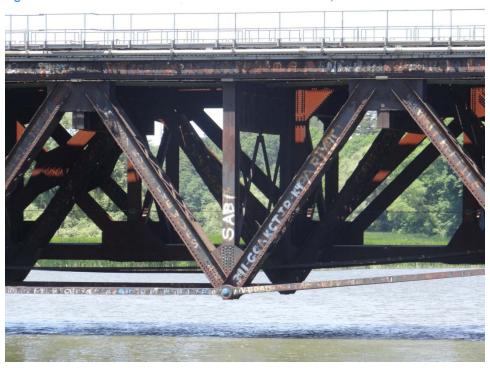
Figure 9-22: Detail of the central section of the deck truss, south elevation.

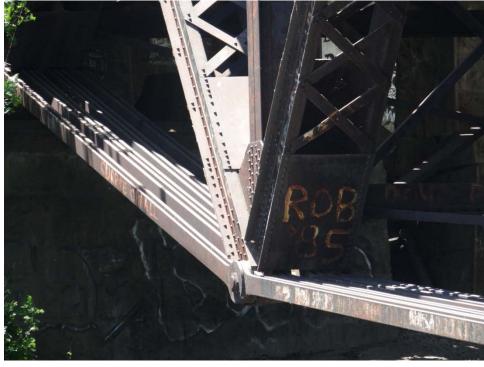
Figure 9-23: Detail of eastern-part of the deck truss, south elevation.

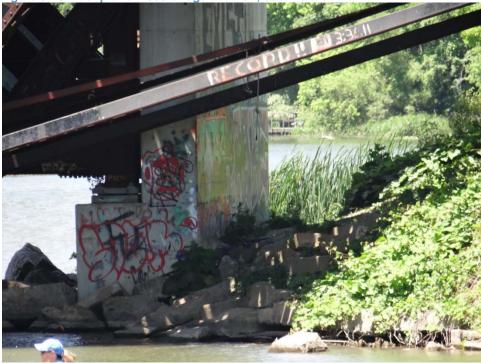
Figure 9-26: East pier of 2008 bridge addition, south elevation.

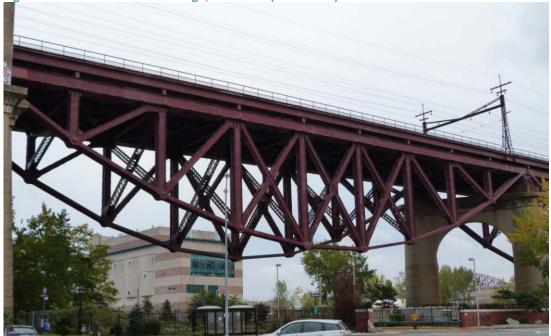
Figure 9-29: Little Hells Gate Bridge, New York (Holth 2013)

Bridge is a typical example of a deck truss bridge (which is not arched) for comparison purposes (Figure 9-28), while the Little Hell Gate Bridge (Figure 9-29) is similar to the Credit River Bridge.
