Heritage Advisory Committee

2018/01/09

- MATTERS TO BE CONSIDERED
- 7.1. Request to Alter a Heritage Designated Property: 41 Bay Street (Ward 1) Request
- 7.2. to Alter a Heritage Designated Property: 1155 Willow Lane (Ward 11) Request to

- 7.3. Alter a Heritage Designated Property: 1066 Old Derry Road (Ward 11) Request to
- 7.4. Alter a Heritage Designated Property: 1059 Old Derry Road (Ward 11) Request to

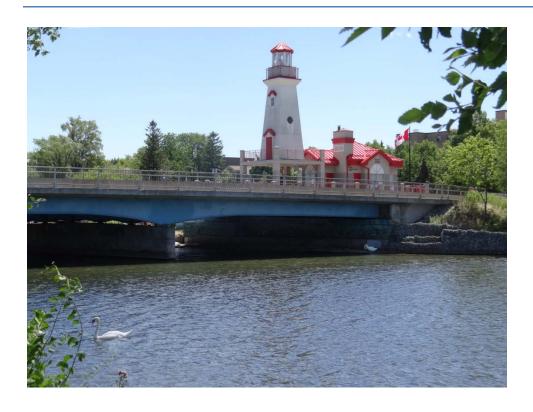
Figure 9-30: View of the c.1960 Lakeshore Road West Bridge, north elevation (ASI 2016)

Another bridge in the vicinity of the subject bridge is the Lakeshore Road West Bridge over the Credit River. Located approximately 42 metres downstream (southeast) of the subject bridge, the Lakeshore Road West Bridge is a steel beam bridge built in 1960 (Figure 9-30). Previous bridges at this location include the two-lane concrete bowstring arch bridge built in 1919 (Figure 9-31), the 1895 iron through truss bridge built by the Peterborough Bridge Engineering Company, and pre-1895 there were at least two wooden trestle bridges which each were destroyed by storms and flooding (Mississauga Library System n.d.).

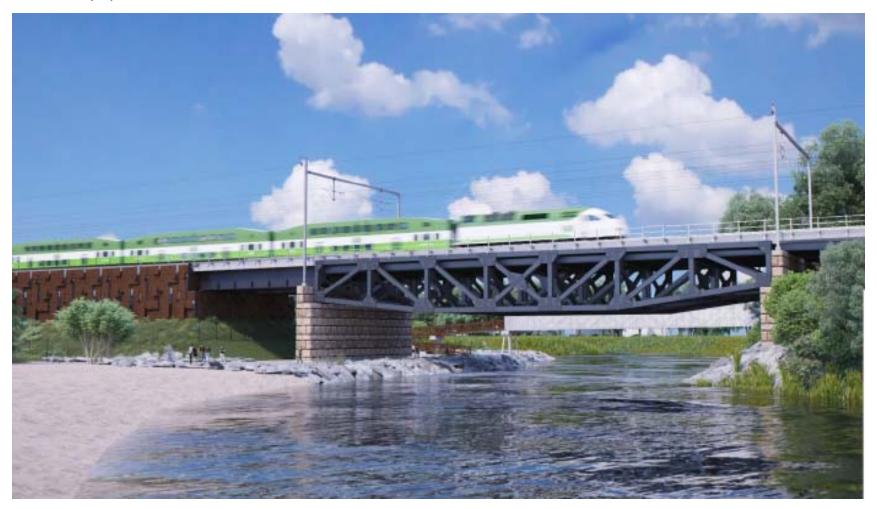
Figure 4-1: Visualization of new OCS infrastructure at the Rouge River Crossing. Note that this visualization has been included for comparative and illustrative purposes. Source: Metrolinx 2017

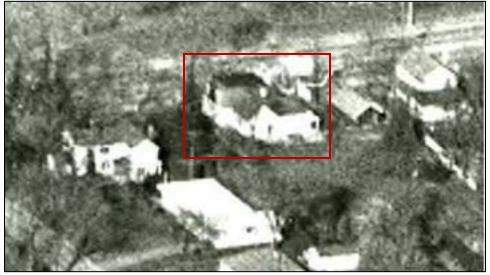
Figure 9: Aerial photo of the Taylor-Froebel House c.1967-1970. (UTM Library Archives Sec. 2-1, Box 274 File 0087-10)

The 1954 and 1966 aerial photos show the Taylor-Froebel House and the original building at 1576 Dundas Street West (Figure 18 and Figure 19). The original buildings on site are clearly visible in a photo from c.1967-1970, which shows a one storey structure with a gable roof adjacent to the Taylor-Froebel House (Figure 9). The Taylor-Froebel House appears the same as it does today, though a rear porch is evident where the sunroom exists today, which suggests that the sunroom is likely an enclosed porch. An additional photo from 1978 reveals that the one-storey structure is a wooden garage located on the existing parking lot (Figure 10). This garage likely serviced the Taylor-Froebel House as a staircase lead from the garage to the house. The appearance of the Taylor-Froebel House in 1978 is identical to its contemporary appearance. The 1989 and 1992 aerials show the changes to 1576 Dundas Street West as the original garage was town down for the construction of the existing Erindale Academy school, which was constructed in 1990 (Figure 20 and Figure 21).

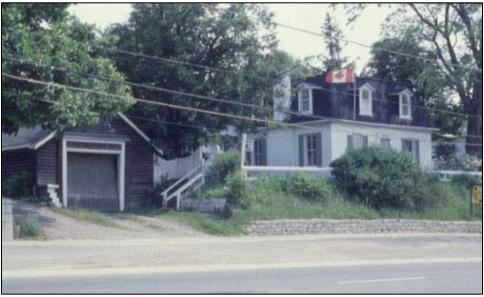
Figure 10: Taylor-Froebel House c.1978 (Mississauga Library B529)

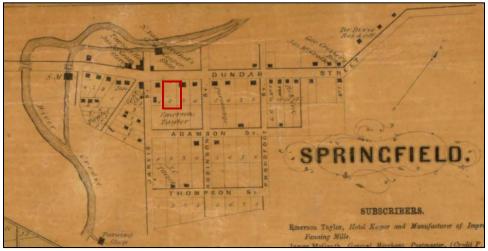
Figure 13: 1860 Tremaine Map. Subject property in Red (Tremaine 1860)

The 1830 *Plan of the Town of Toronto* shows the lots and roads of the village (Figure 12). No ownership information is provided for Lots 2 and 3. On the 1860 Tremaine Map, the village (now known as Springfield) is well developed with many buildings along Dundas Street (Figure 13). While the south side of Dundas Street is largely developed, Lot 2 does not contain a building. Emerson Taylor, the builder of the Taylor-Froebel House is noted as owning Lots 1-4 in Range Two, just south of the subject property.

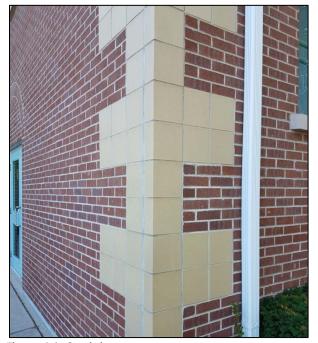
Figure 26: Quoining

The structure at 1576 Dundas Street West is a two-storey institutional brick building, inspired by Victorian architecture. The hipped asphalt shingle roof features a dentil cornice, faux central bell tower, and gables on all four sides (Figure 14 and Figure 15). The building incorporates quoining throughout (Figure 12). The building faces west with an entrance with sidelights and an awning located in the middle of three bays (Figure 8). The entrance is flanked by large flat-headed windows with brick soldier courses and pre-cast concrete sills. The second storey features large flat-headed windows with brick soldier courses and pre-cast concrete sills in each bay. A central gable with a circular vent below is located above the second storey. South and north wings each contain a single flat-headed window with brick soldier courses and pre-cast concrete sills.

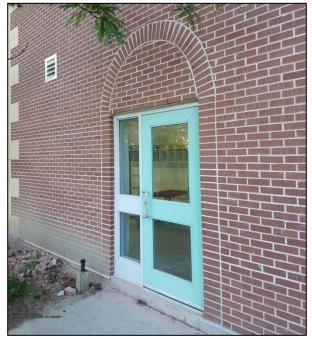
Figure 27: Brick arch above the north elevation doors

The north (Figure 10) and south (Figure 9) elevations are nearly identical with two entrances with sidelights. The north facade features arched brickwork above the door (Figure 13), while the south elevations contain brick soldier courses. The second storey on both elevations contains three flat-headed windows with pre-cast concrete sills. A circular vent is located beneath the gable. The east elevation contains a series of six flat-headed windows with brick soldier courses and pre-cast concrete sills (Figure 11). The second storey features a row of ten windows of various sizes with pre-cast concrete sills.

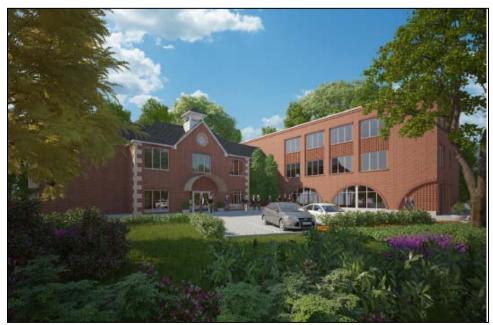
Figure 43: Rendering of the proposed addition (Weiss Architecture and Urbanism Ltd.)

The proposed addition is constructed of brick, which is complimentary to the existing building at 1576 Dundas Street West in both style and materials. The north elevation features two archways with recessed glass on the first floor. The design of these arches will be reflected in a new canopy for the existing school building. An additional half arch is filled in with a dogs-toothed brick pattern. The second and third storeys are divided into four bays with three windows similar in size and shape to those found on the existing building. The windows contain stone sills and lintels and a dogs-toothed brick pattern between the second and third storey. An additional set of three windows is located on the third floor above the existing building. The southern end of the hipped roof of the existing building will be extended to meet the facade of the proposed addition.

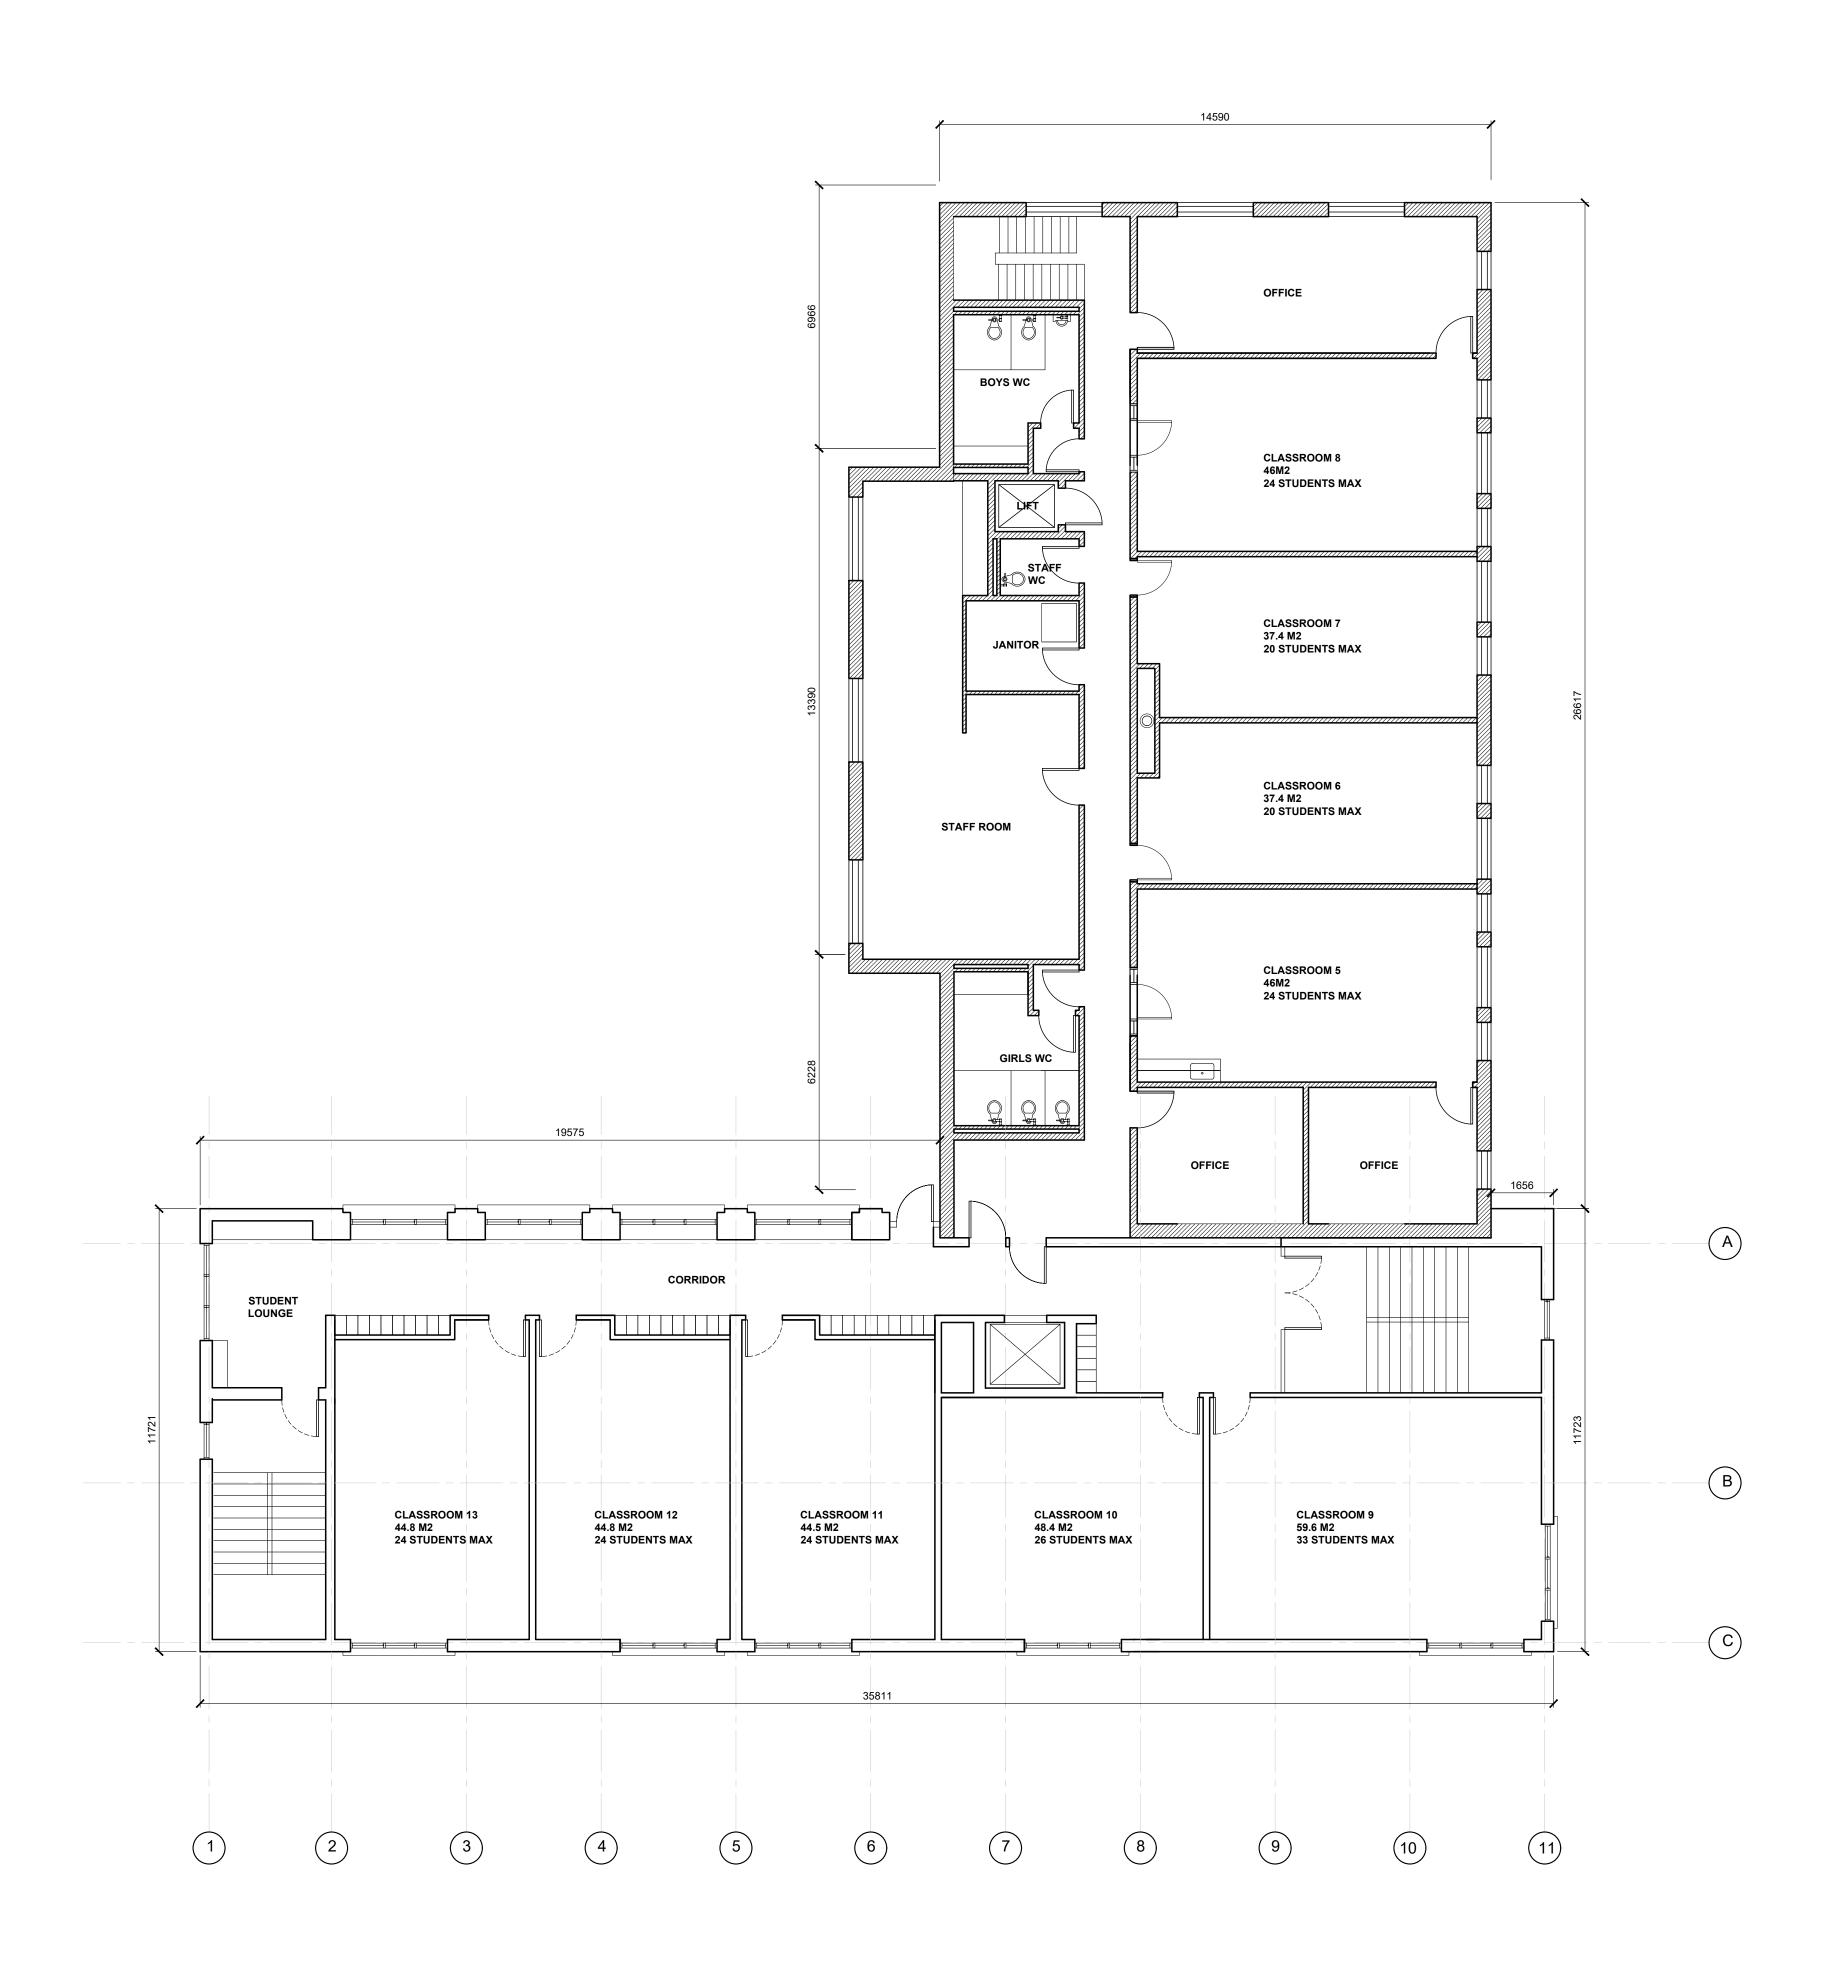
Project No. 1711	Sheet No.
Date:	A202
Scale: 1:100

Schematic Design Ground Floor Plan

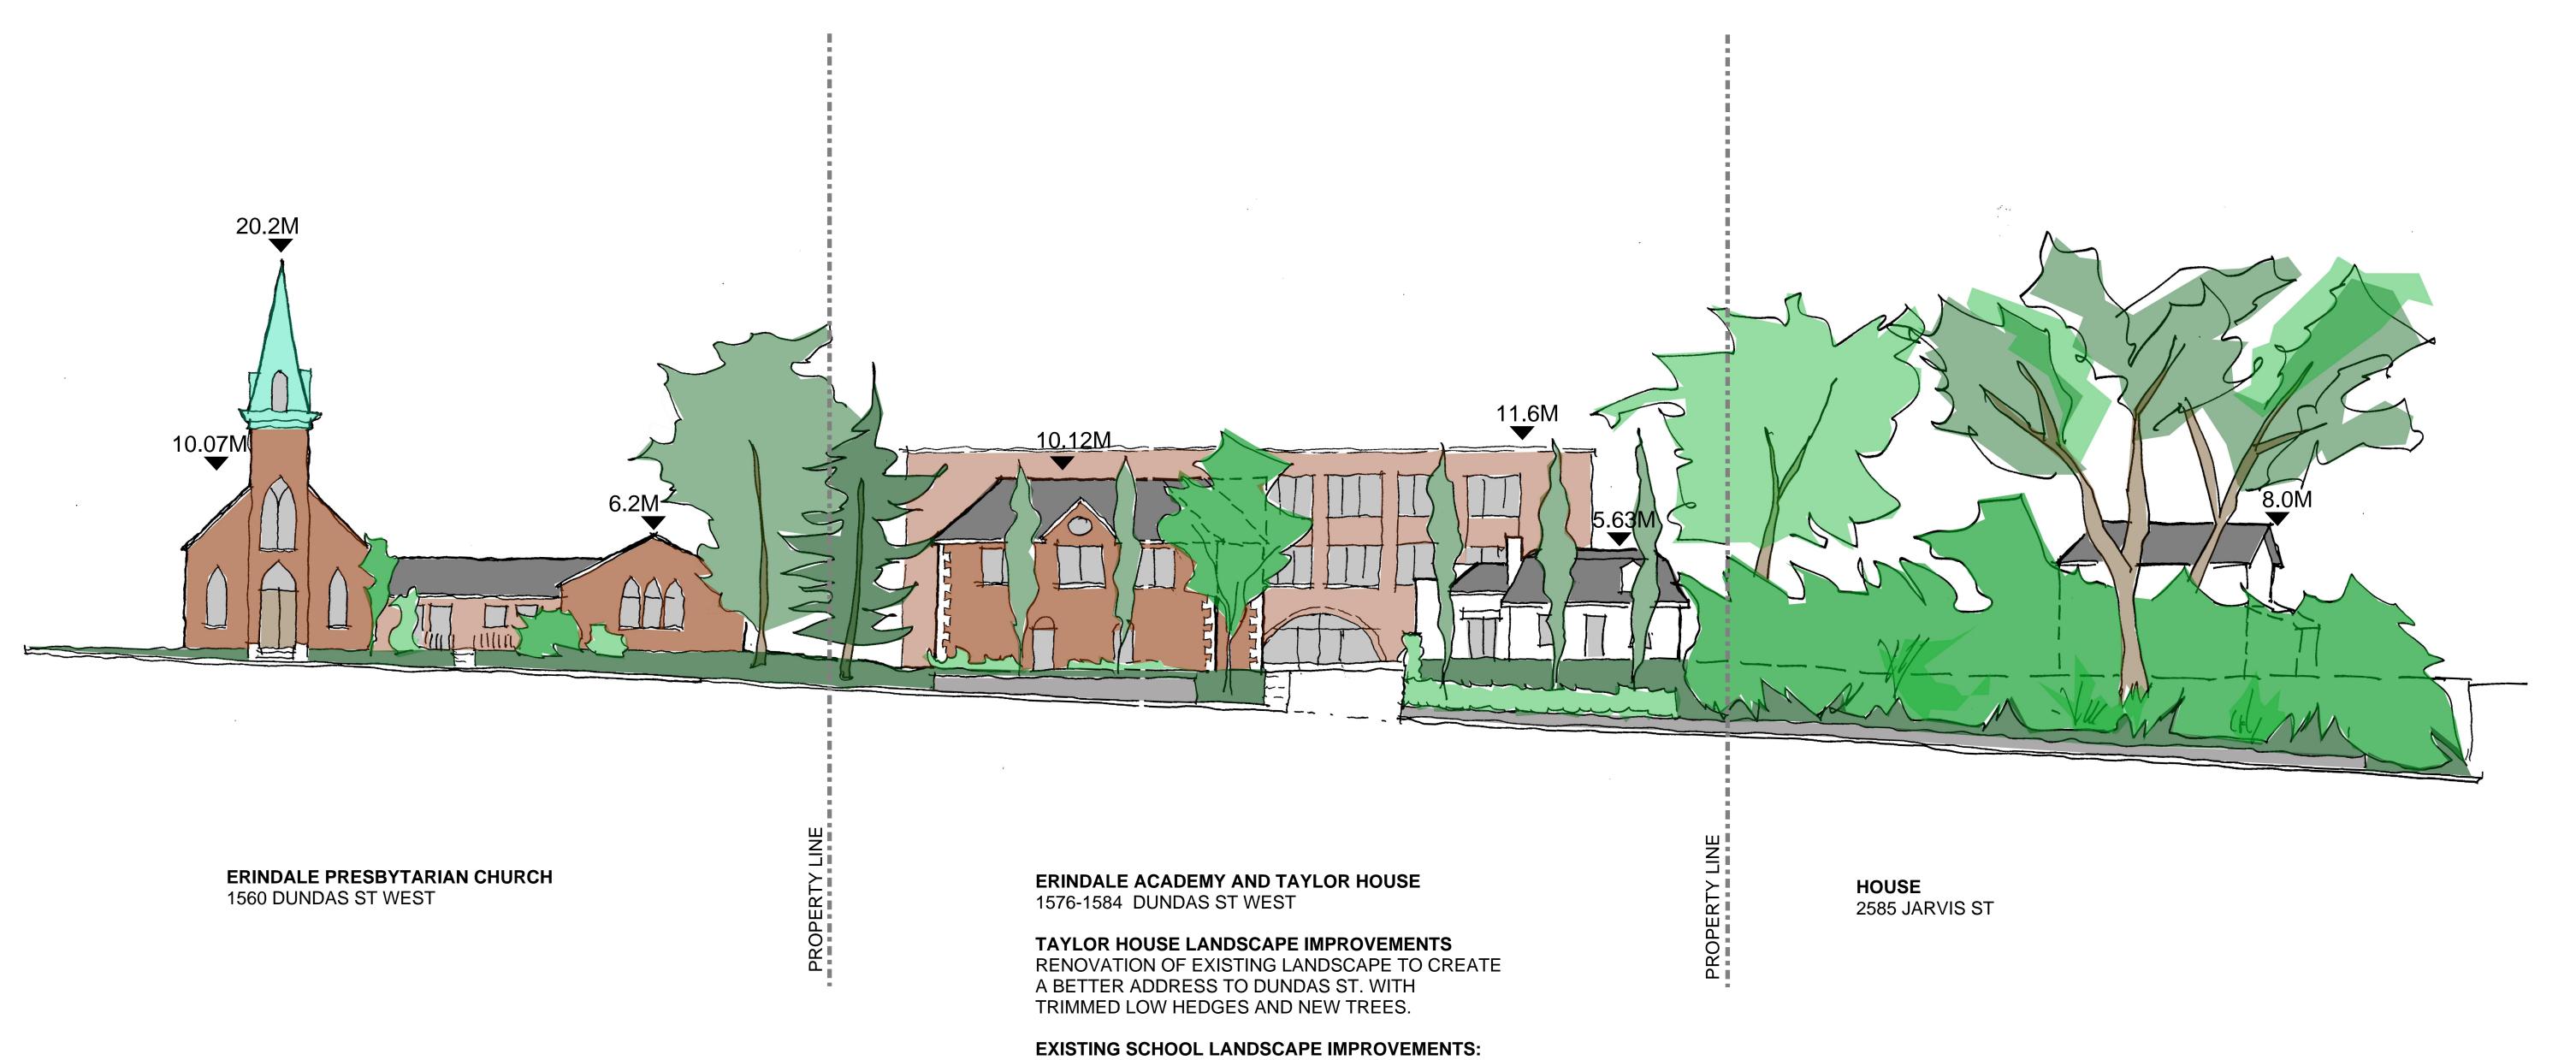
Project No. 1711	Sheet No.
Date:	A302
Scale: 1:100

Schematic Design East Elevation South Elevation

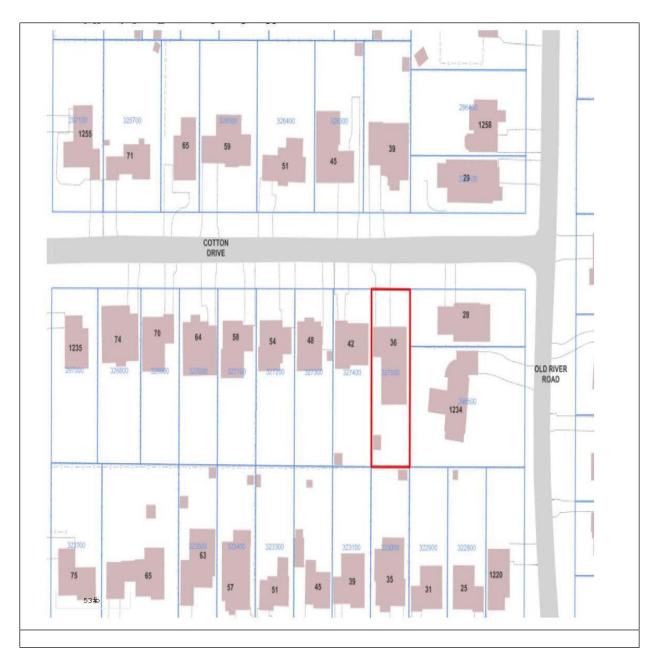
There is no need for this report to establish the importance of this neighboring house, built and occupied by one of the earliest residents and entrepreneurs in Toronto Township. The following block plan, indicates the relationship of the existing house footprint to the Cotton-Hawksworth House.
