Agenda

Heritage Advisory Committee

2018/02/06

- 7. MATTERS TO BE CONSIDERED
- 7.1. Request to Alter a Heritage Designated Property: 5155 Mississauga Road (Ward 11)
- 7.2. Request to Alter a Heritage Designated Property: 1352 Lakeshore Road East (Ward 1)

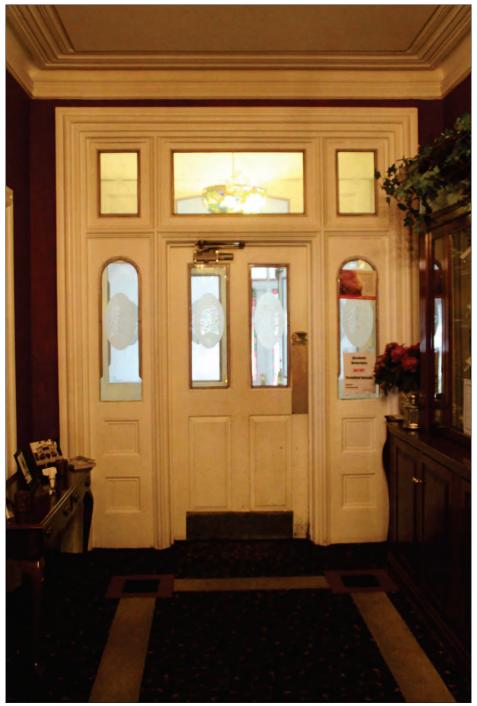
Figure 41 inside front door, transom & sidelights (replacement glass), ceiling moulding

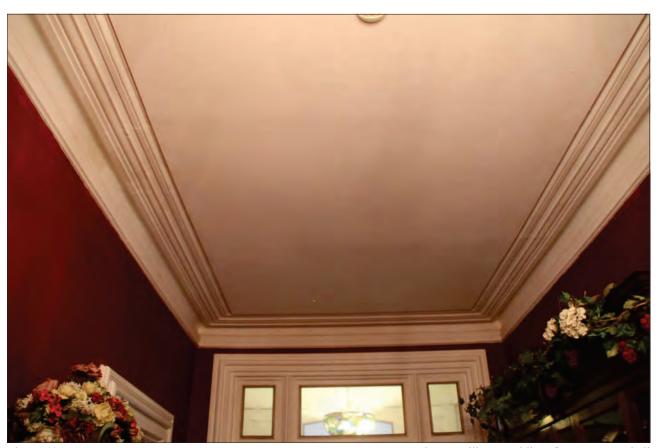
Figure 42

plaster ceiling moulding, front entrance hall

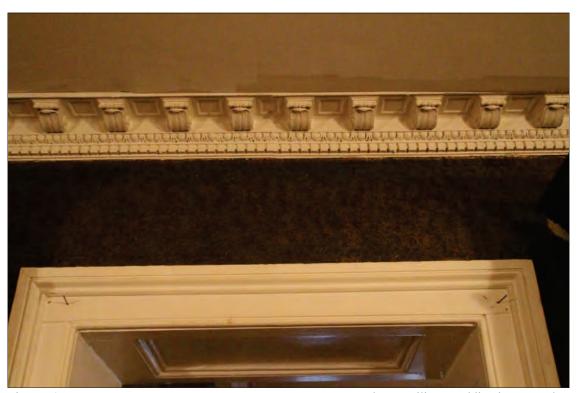
Figure 50

plaster ceiling moulding in current bar

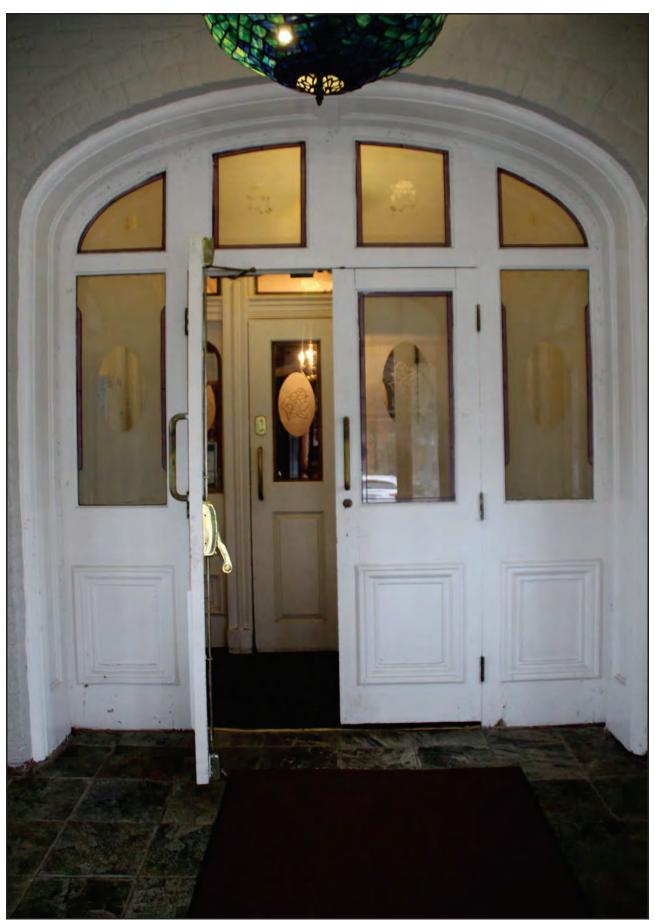
Figure 51

doors, top lights and sidelights (replacement glass & hardware) to umbrage from exterior

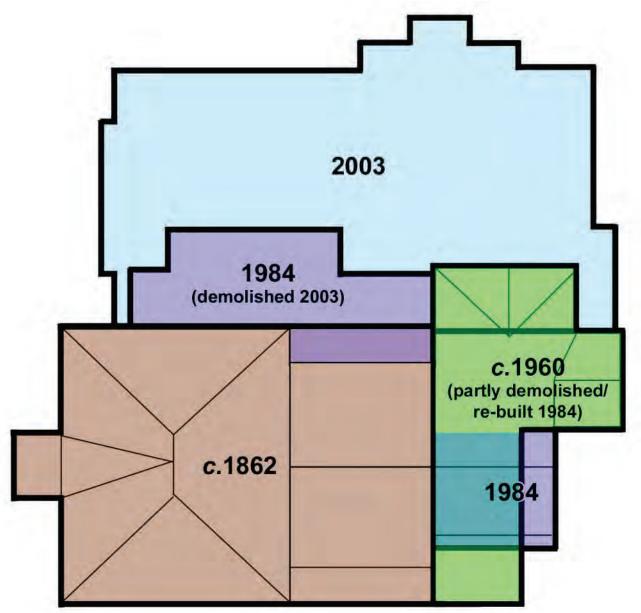
Figure 52 William Barber House construction dates - building outline from: Proposed Site Plan, Old Barber House Ltd., Michael Spaziani Architect Inc., August 28, 2003

Numerous additions and alterations have been constructed over the years, the most recent and largest in scale being for the restaurant conversion in 1984 and an enlarged facility in 2003^{18} . A greenhouse, built c. 1960 once occupied the rear of the building. Additions have been demolished and/or re-built in 1984 and 2003. Renovations and restorative works to the original house interior have been generally well done, and to the untrained eye, appear to be mainly original with few exceptions, such as glazing, use of Robertson screws, etc. Figure 52 illustrates the additions and demolitions that have occurred since c. 1862.

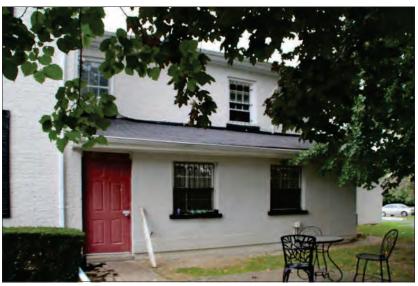
Figure 55 2015 1877

The shuttered, blind, upper and lower front windows on the south side have been replaced with blind, glazed windows. Brick has been painted white. Brick chimneys have been rendered and painted.

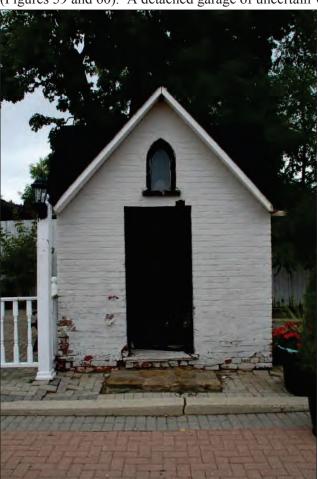
Figure 59

The property also includes a small, square, brick, 19th century outbuilding, its former function possibly a privy (Figures 59 and 60). A detached garage of uncertain vintage was demolished in 1984 (Figure 61).

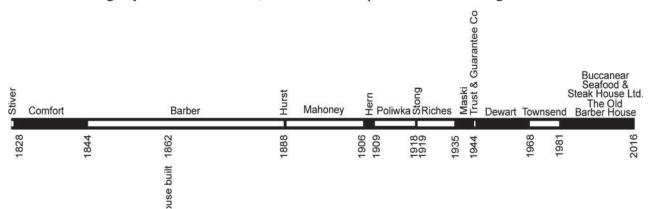
Figure 2 Time Line 1828 - 2016

An extensive photographic record of the subject property is included in the HIA. The development application submission includes an arborist's report, landscape plan, servicing plan, planning report, *etc*. The HIA includes a summary of the history of the property outlining its development over time within a time frame context and documentation of land ownership from the original Crown Grant and subsequent records from the Land Registry Office. A time line, from 1828 to the present is shown in Figure 2.

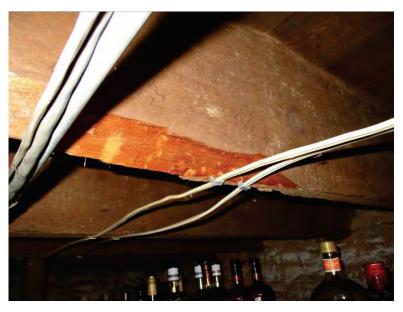
Figure 1: Deteriorated floor framing

Limited areas of the main floor framing appear to have sustained some deterioration, likely due to moisture exposure.

The floor joist shown in Figure 1 can be found below the central hallway. It is estimated that between 5 and 10 of these joists will require some form of remedial work. The majority of the basement ceiling has been fire-rated and as such the framing was not visible at the time of the review. A more comprehensive review of the floor framing should be carried out during any proposed renovation design work.

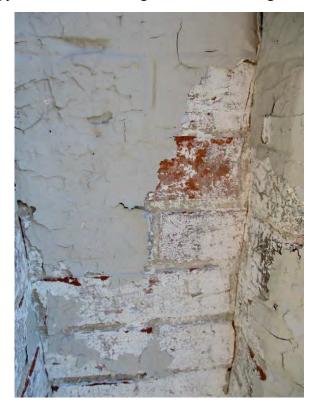
Figure 2: Exterior coatings

The brick has been coated with at least two (2) different coatings. Remnants of a third coating were visible, and it is possible that this lowest layer is a composite of a repeated lime wash, known to have been applied to other buildings of a similar vintage and construction.

The outermost coating is very thick and has flaked off in many locations, most notably at interior corners or other locations more prone to moisture accumulation. The coatings exposed below are in varying states of decay, and have deteriorated to a form of powder, possible lime, in some locations. Where exposed below the coatings, the brick was found to be extremely soft.

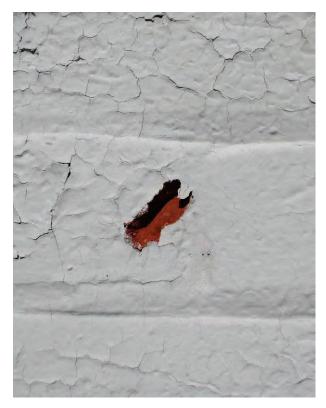
Figure 3: Soft brick exposed below coatings

It was possible to scrape a depression of up to $\frac{3}{4}$ " deep into the brick with a screwdriver and moderate pressure.

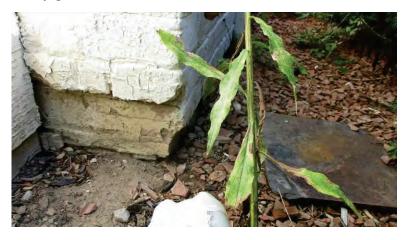
Figure 4: Deteriorated coatings near grade

Coatings at or near grade are showing signs of more advanced deterioration, particularly where the wall is sheltered by gardens.

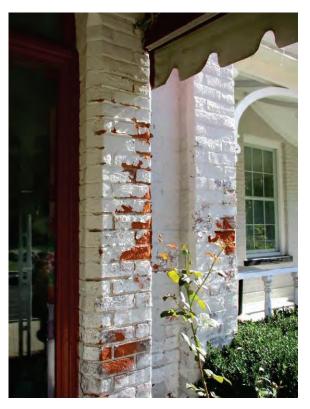
Figure 5: Deterioration on south side of entry canopy

Advanced deterioration of the coatings and the underlying brick was noted on the south side of the entry canopy.

It appears that the concentration of run-off from the canopy has resulted in saturation of the brick at this location, and the loss of coatings has lead to advanced deterioration of the brick.

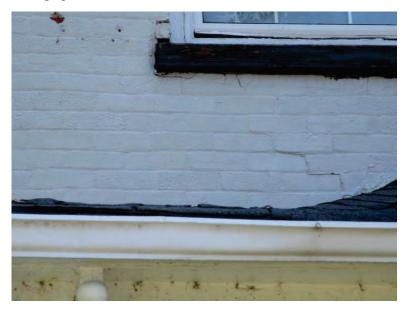
Figure 7: Step cracking below second storey window

A step crack was noted on the front elevation below the second storey north window. The presence of the coatings precludes comment on the extent or width of the crack.

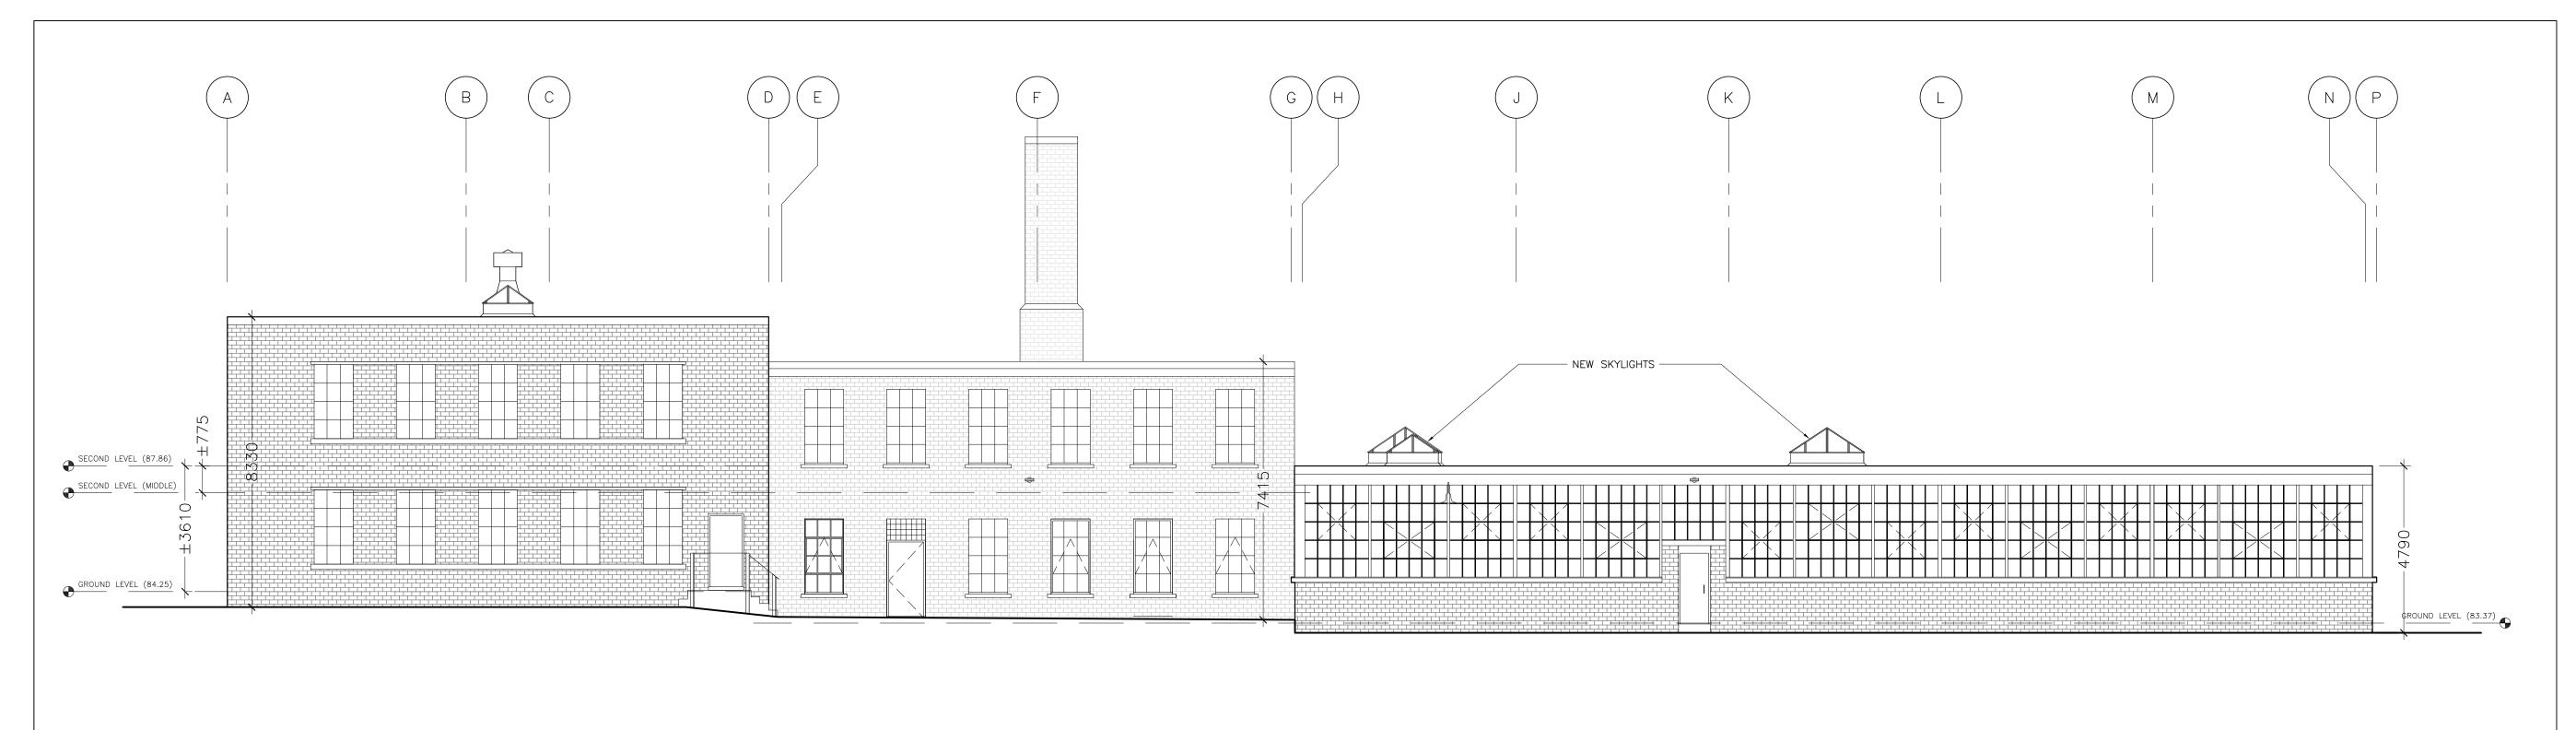
WEST ELEVATION - NEW
1:100

3. TYPICAL SCOPE OF WORK FOR EXISTING WINDOWS & SKYLIGHTS AT PHASE 1 AREA AS FOLLOWS: ABATEMENT OF HAZARDOUS MATERIALS INCLUDING PAINT & WINDOW PUTTY, REMOVAL OF EXISTING GLAZING (OR OTHER INFILL MATERIAL), RESTORATION OF STEEL FRAMES, RESTORATION OF EXISTING PIVOT VENT OR HORIZONTAL PIVOT HARDWARE, PRIME & PAINT STEEL FRAMES, AND INSTALLATION OF NEW GLAZING TO BE FIXED IN PLACE AS PER HERITAGE SPECIFICATION.

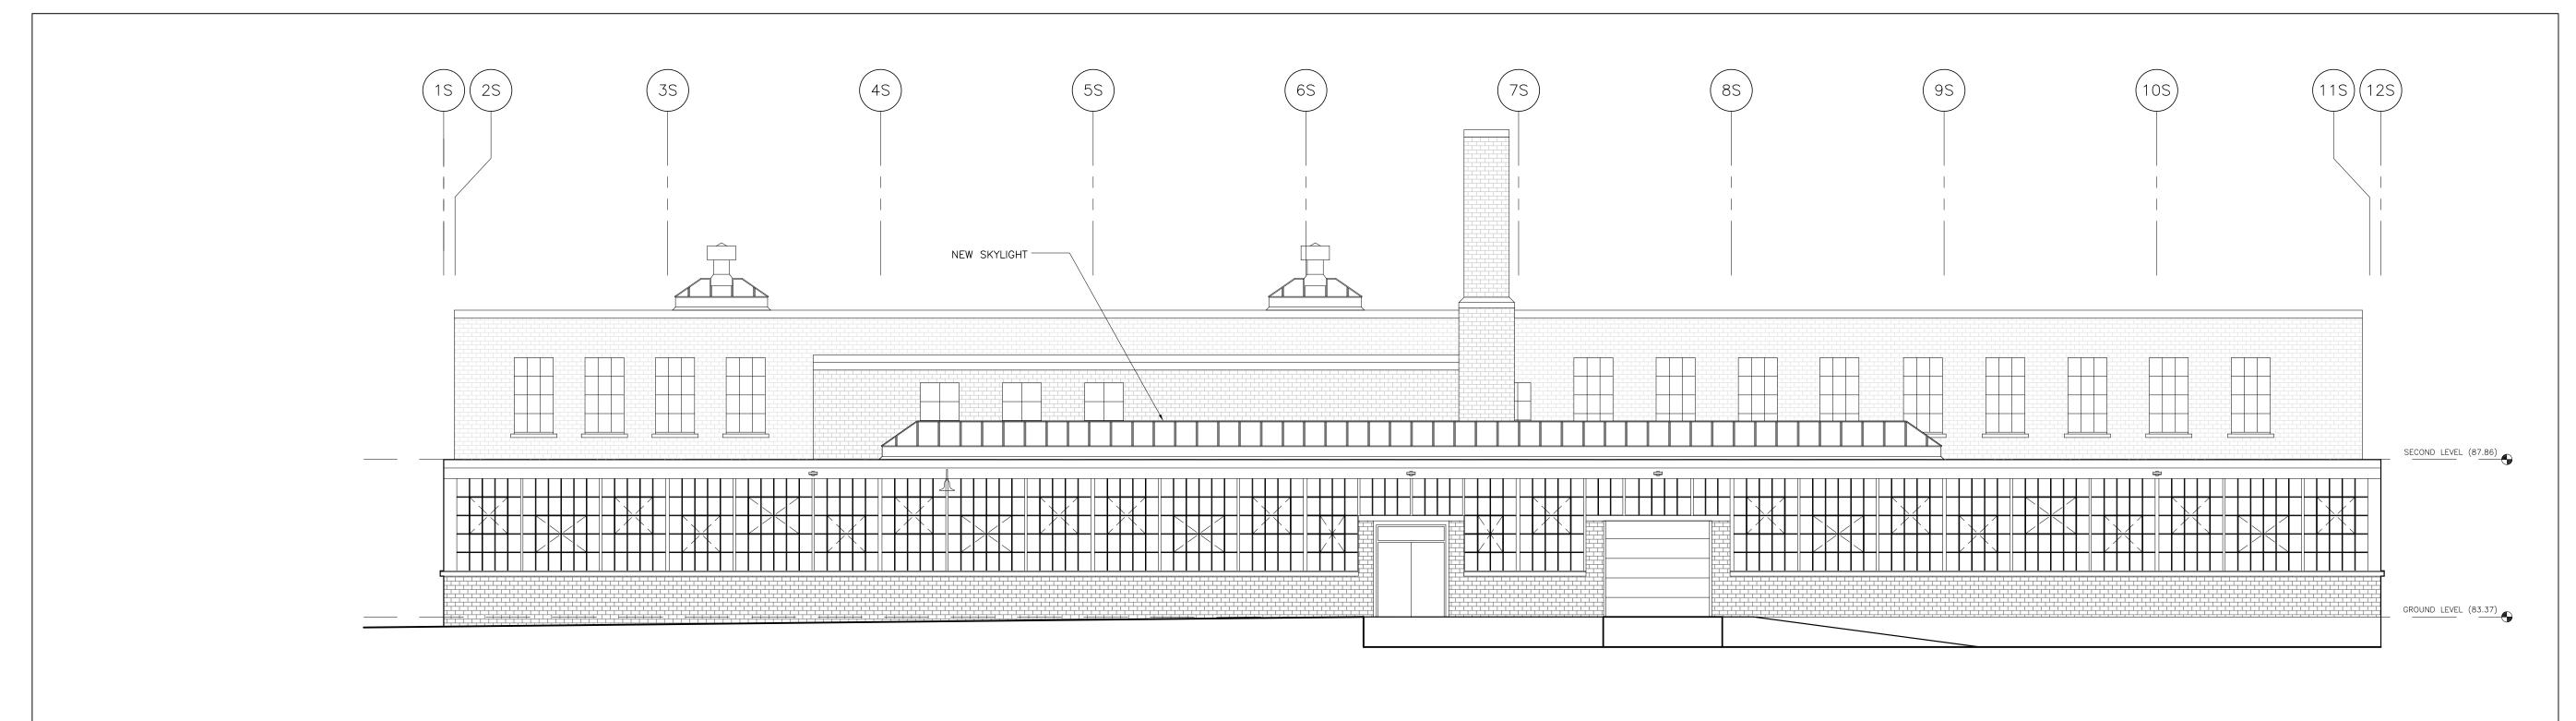
SOUTH ELEVATION - NEW
1:100
