Heritage Advisory Committee

2018/07/10

3. The total speaking time shall be five (5) minutes maximum per speaker.
 7. MATTERS TO BE CONSIDERED
 - 7.1. Request to Alter a Heritage Designated Property: 5155 Mississauga Road (Ward 11)

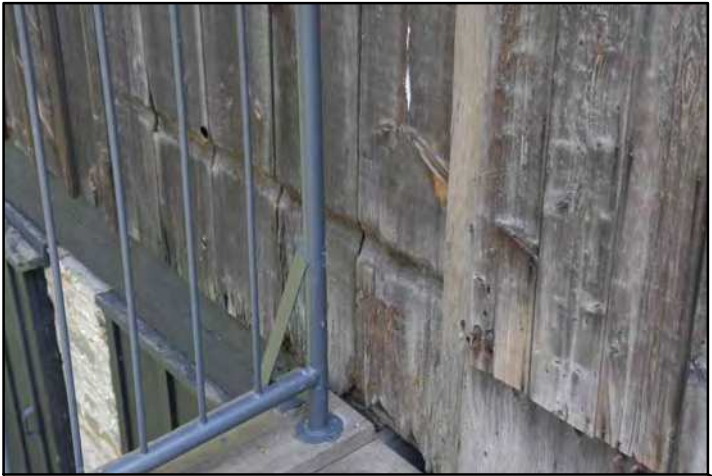
BARN DOOR MISSING BOTTOM GUIDE - NOTE GROOVE WORN IN SIDING BOARDS

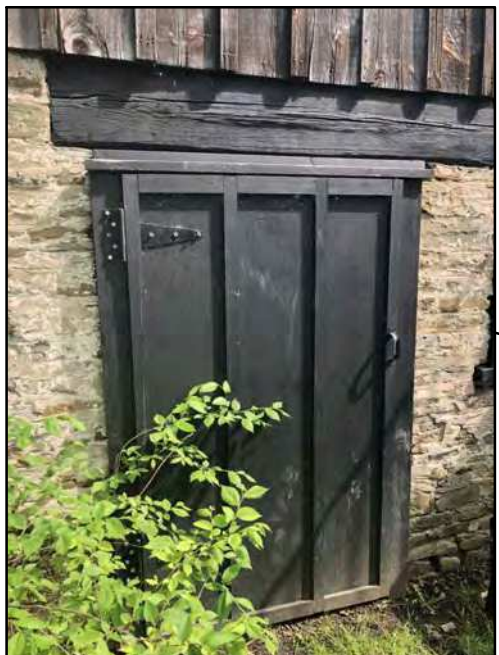
DOOR IN GOOD CONDITION

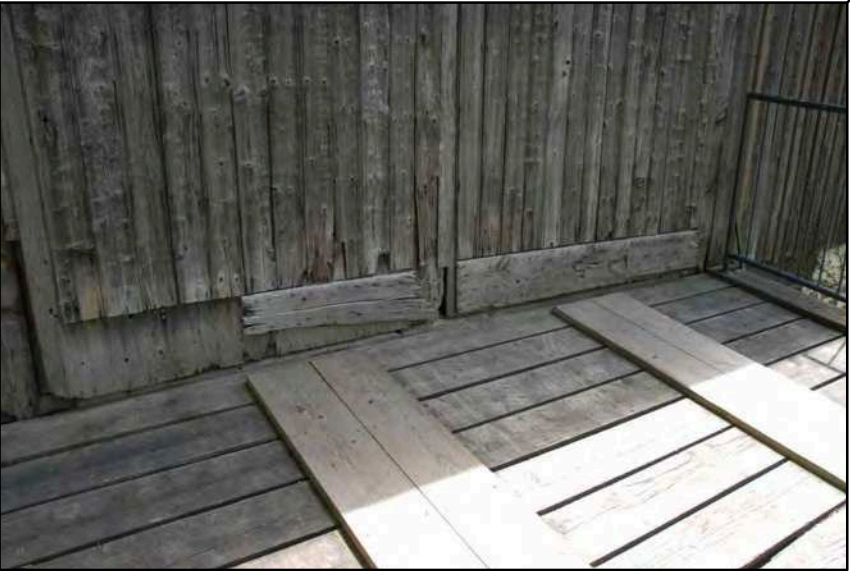
BARN DOOR MISSING/BROKEN PIECES AT BOTTOM

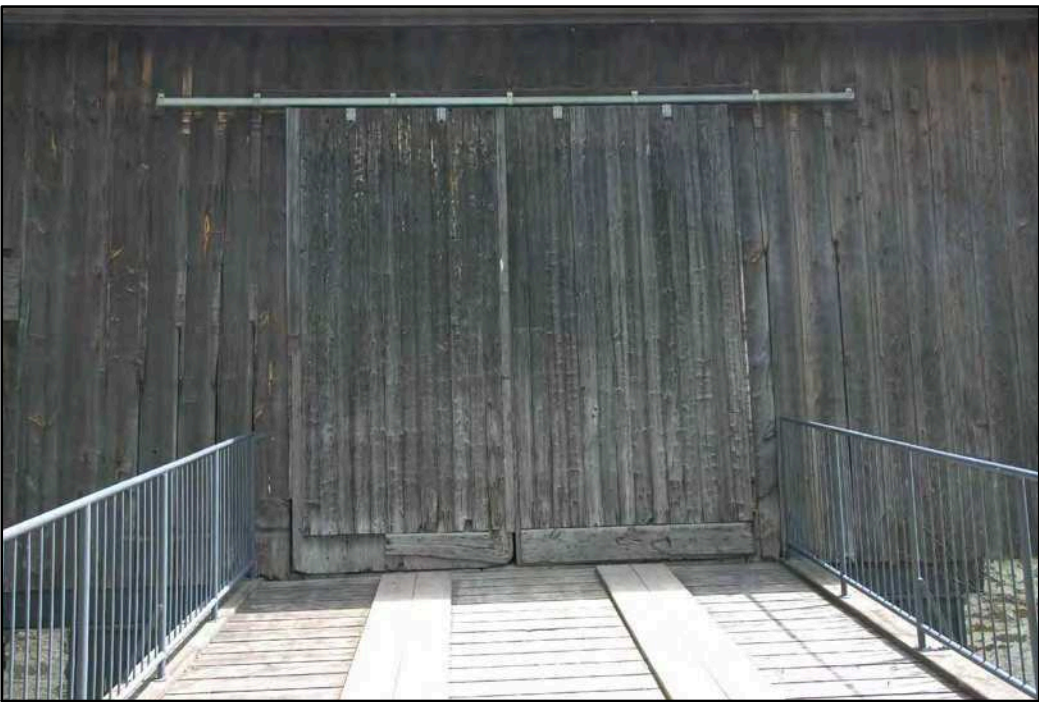
BARN DOOR ASSEMBLY - NOTE NEWER GUARDS, RAILS AND RAMP

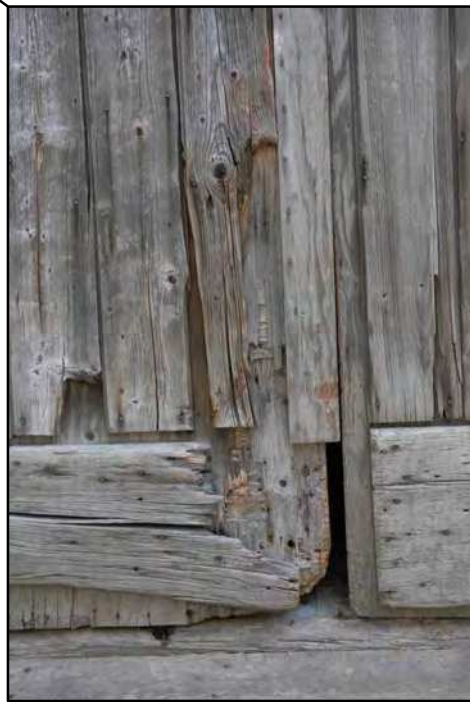
BARN DOOR GENERAL DETERIORATION

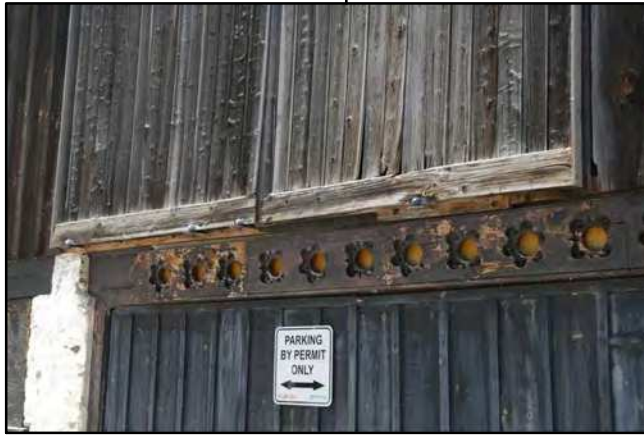
NOTE GENERAL DETERIORATION OF UPPER DOOR, FILAGREE DETAIL

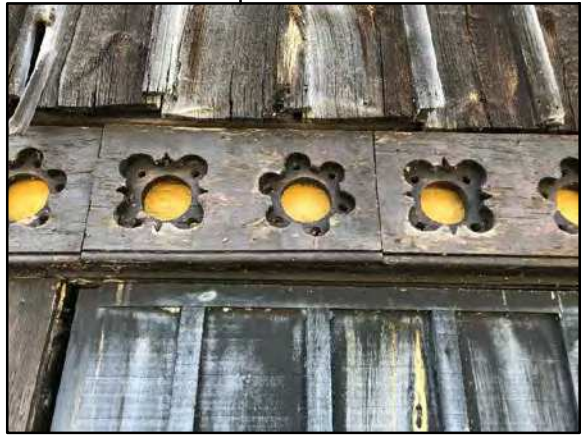
FILAGREE DETAIL AT SOUTH DOORS TO BE CONSERVED.
NOTE DETERIORATION OF BOARDS & BATTENS ABOVE, NEWER PAINTED GARAGE DOOR

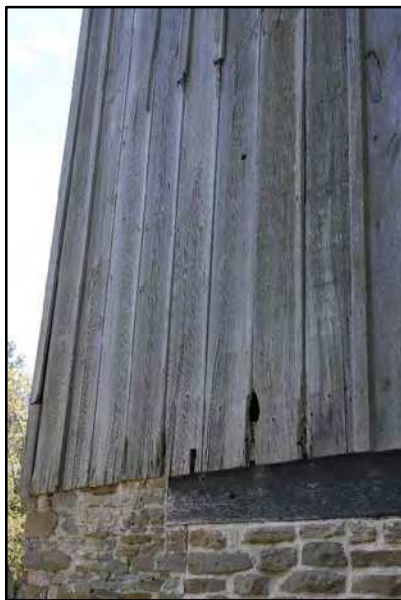
NOTE DETERIORATED BOARDS,
MISSING BATTENS, TYP ALL
ELEVATIONS

General – Board & Batten siding: *The board & batten siding must be inspected on all elevations. There are numerous instances of missing battens, deteriorated and split boards, etc. Battens that are split or broken should be removed and discarded. Remnant pieces of broken battens should be removed and discarded. Boards that are significantly deteriorated should be removed. The removed board material should be inspected and if serviceable portions (generally 1.2m long or longer) from these removed boards can be recovered they should be cut out and saved for potential re-use or repair elsewhere.*

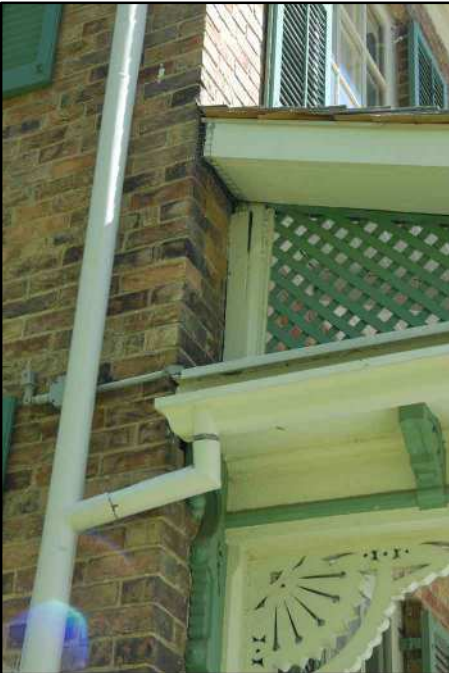
SOFFIT SHOWING ANIMAL INTRUSION, TRIM SHOWING DETERIORATION

Soffits: the soffits will be repaired and/or replaced following the conservation strategy developed above. Where necessary the soffits should be replaced using materials matching the existing in dimension, profile and species. The underside of the soffits should be lined with 50mm x 50mm 10 gauge galvanized welded wire mesh. This should be discreetly fastened with stainless steel clips and wood screws.

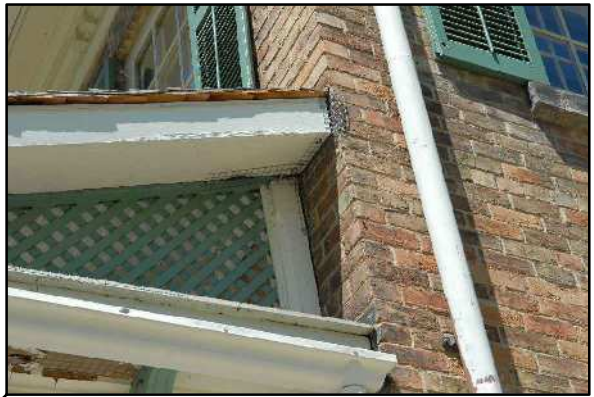
SOFFIT SHOWING WATER DAMAGE, ANIMAL INTRUSION

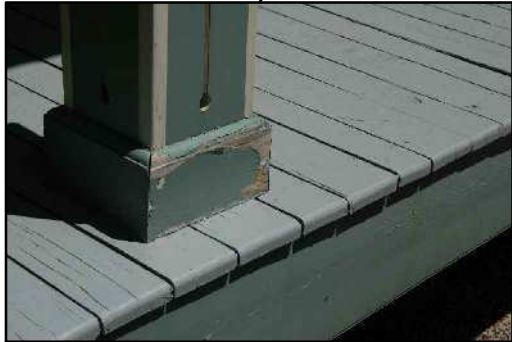
POST BASE SHOWING PAINT LOSS, DETERIORATION (TYP ALL POSTS)

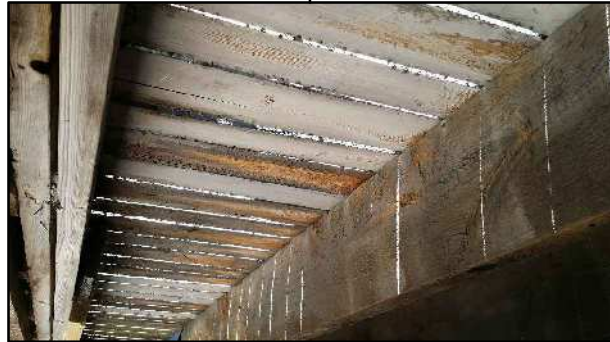
UNDERSIDE OF PORCH SHOWING OLDER JOISTS, DECK BOARDS, NOT SOME DECK BOARDS FINISHED ON UNDERSIDE, OTHERS NOT

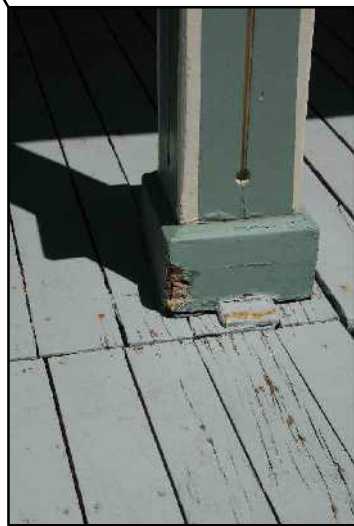
COLUMN BASE SHOWING MECHANICAL DAMAGE, DETERIORATION

-where wood elements are deteriorated, repairs should be conducted with low modulus epoxy fill for small patches and Dutchman repairs for larger areas of deterioration

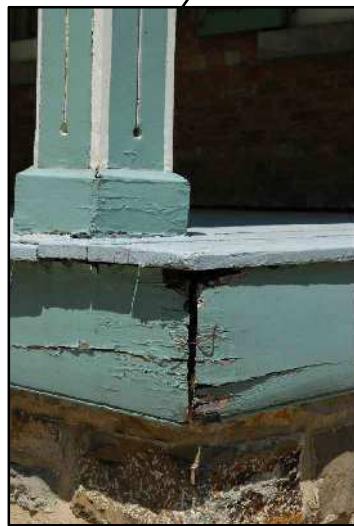
SKIRTING BOARD SHOWING DETERIORATION

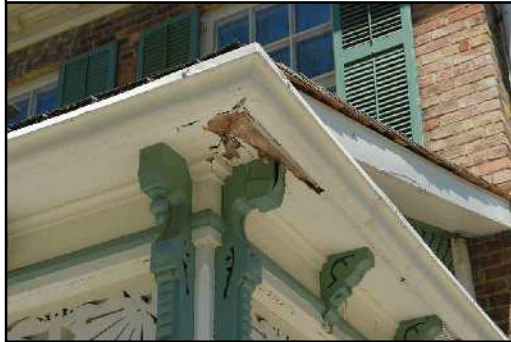
SOFFIT SHOWING WATER DAMAGE

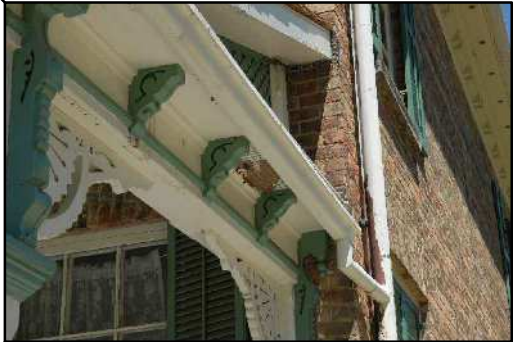
SOFFIT SHOWING WATER DAMAGE, ANIMAL INTRUSION

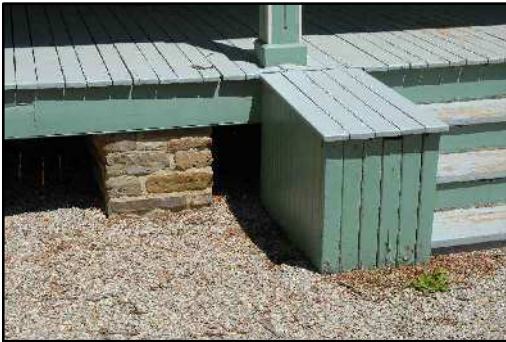
PORCH BASE SHOWING STONE FOUNDATION

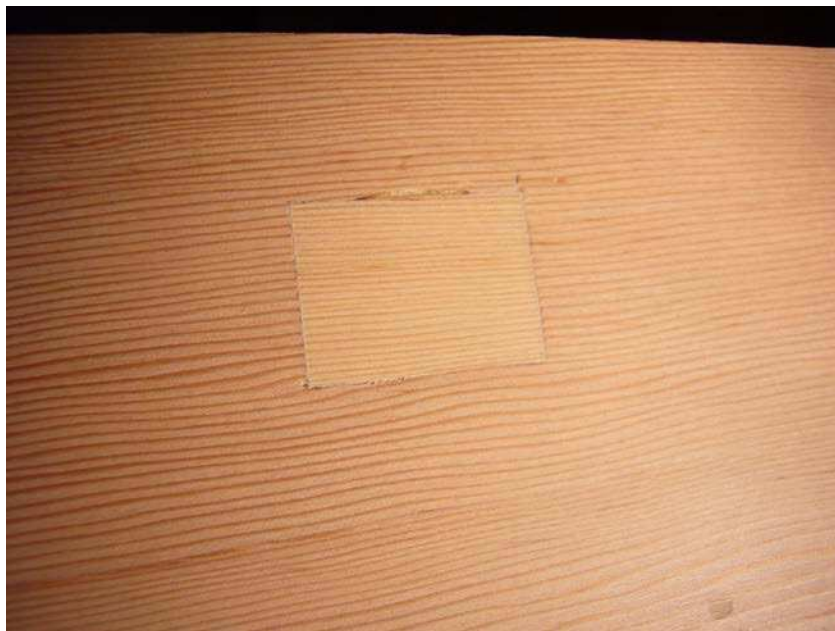
Typical "Dutchman" repair in finish grade wood – term refers to the cutting out and replacement of damaged or rotted wood elements and replacement with new wood cut to fit and glued in place

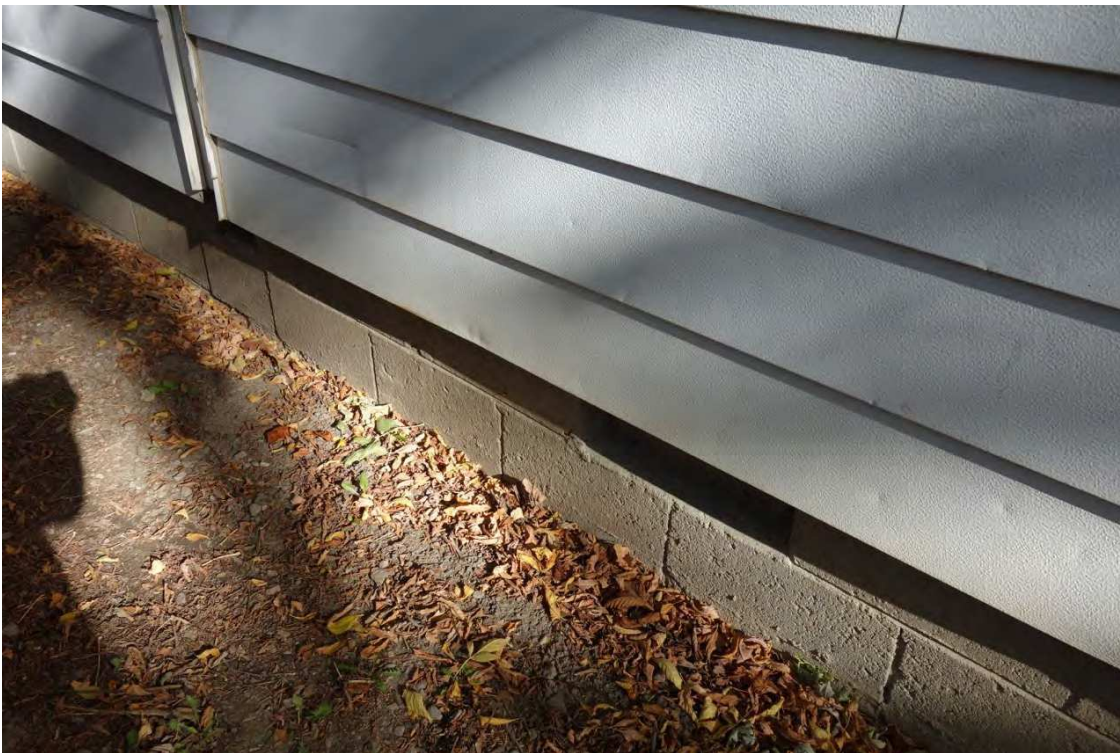
Figure 10: Raised concrete block foundation, vinyl siding.

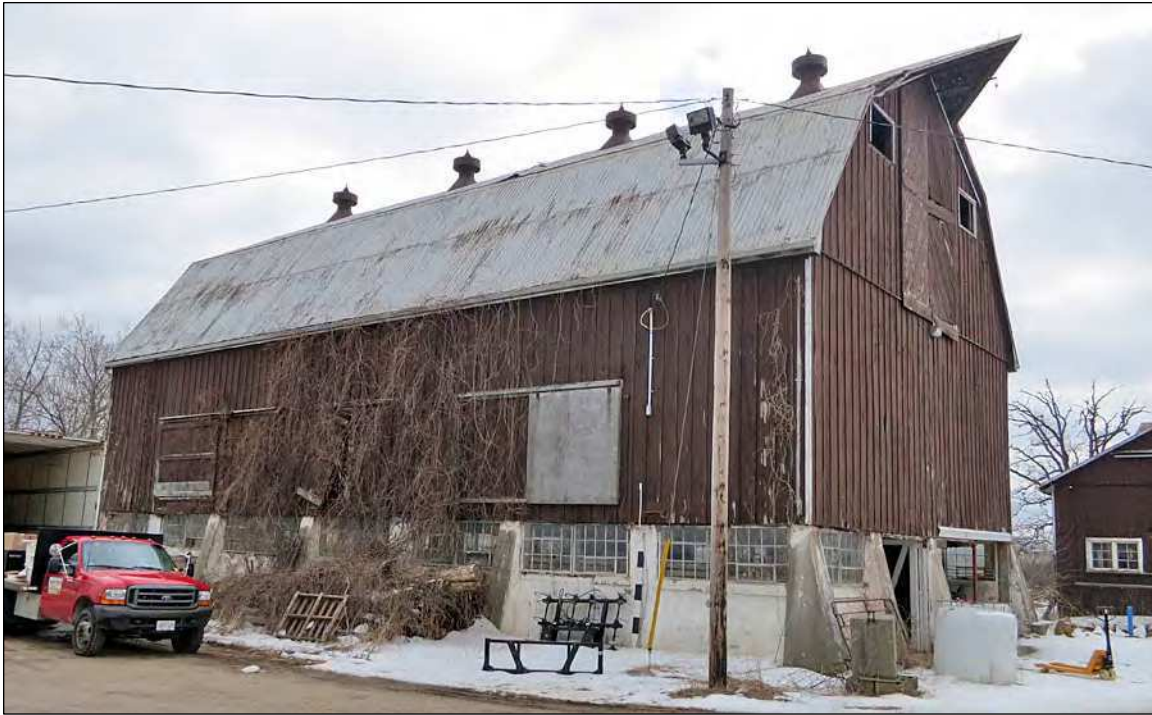
1. The two-storey Upper Barn has a cast-in-place concrete foundation, plank frame superstructure clad in board and batten siding and gambrel roof finished in corrugated sheet metal.

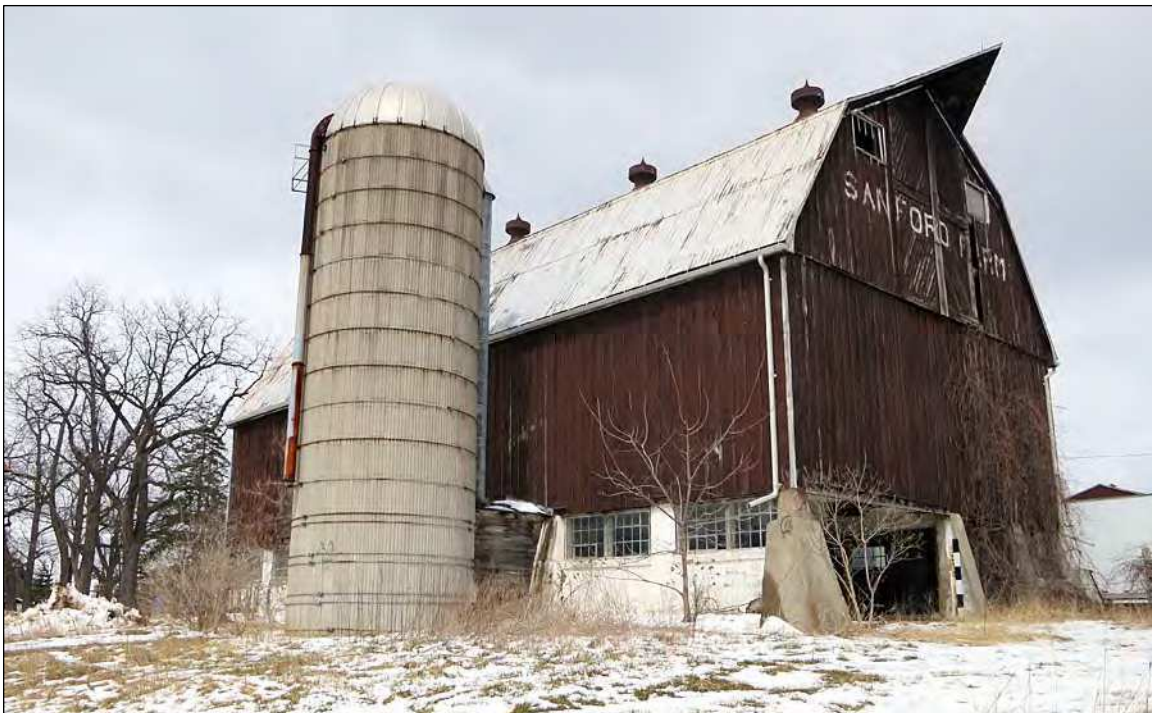
2. Concrete buttresses around the foundation wall may have been added to provide additional structural support.

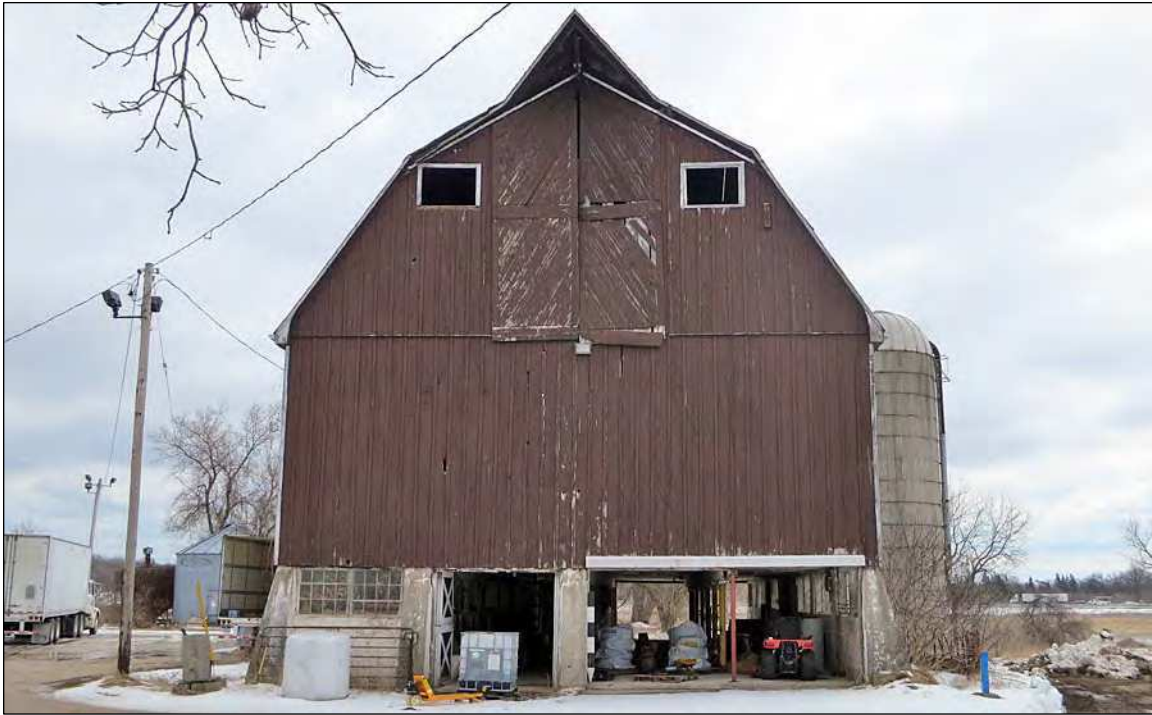
3. Large openings in the foundation wall provided access to the lower level for livestock and equipment. Note the large opening on the upper level for the movement of hay to the mow.

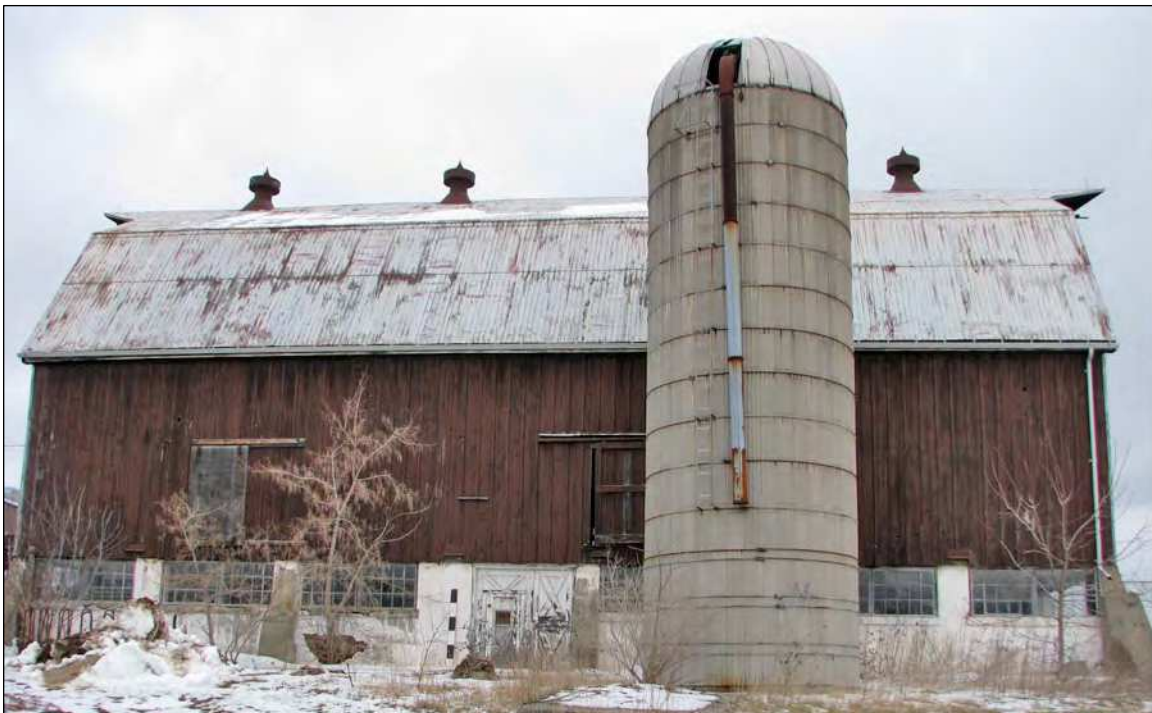
4. The concrete silo was built sometime after the construction of the Upper Barn in the 1930s. Additional doorways along side of the barn open into the upper level.

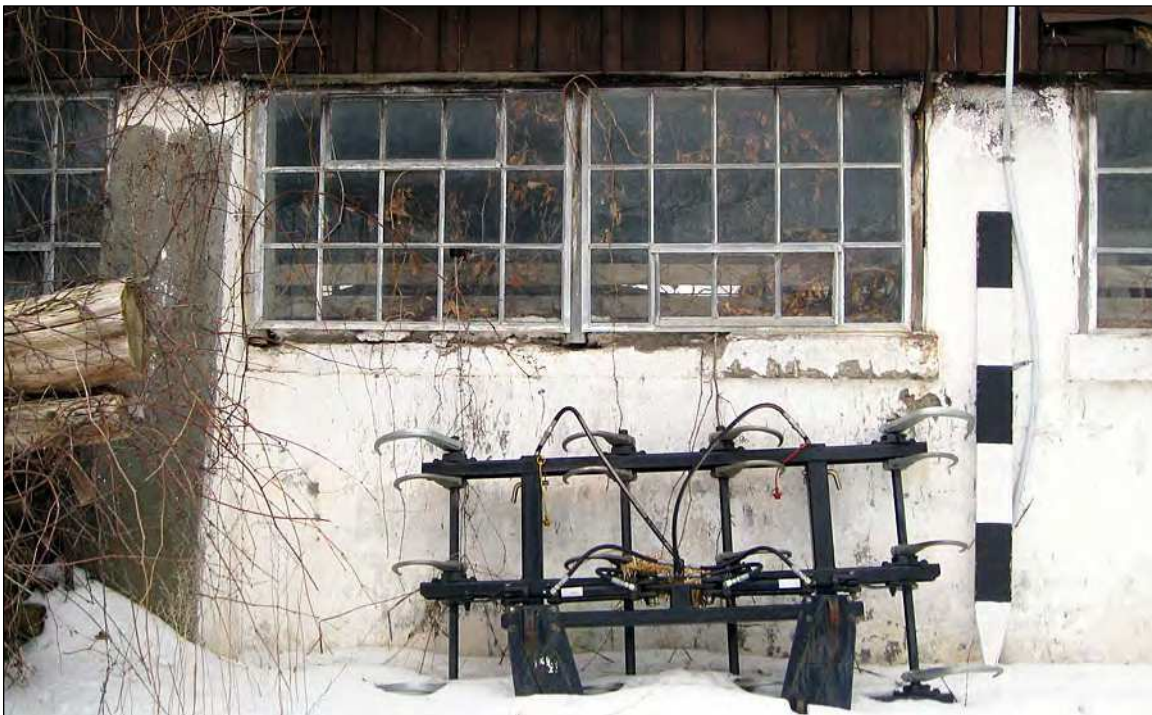
6. Pairs of window openings fitted with multi-paned metal sash are located in the upper part of the foundation wall. A portion of the sash is operable for ventilation purposes.

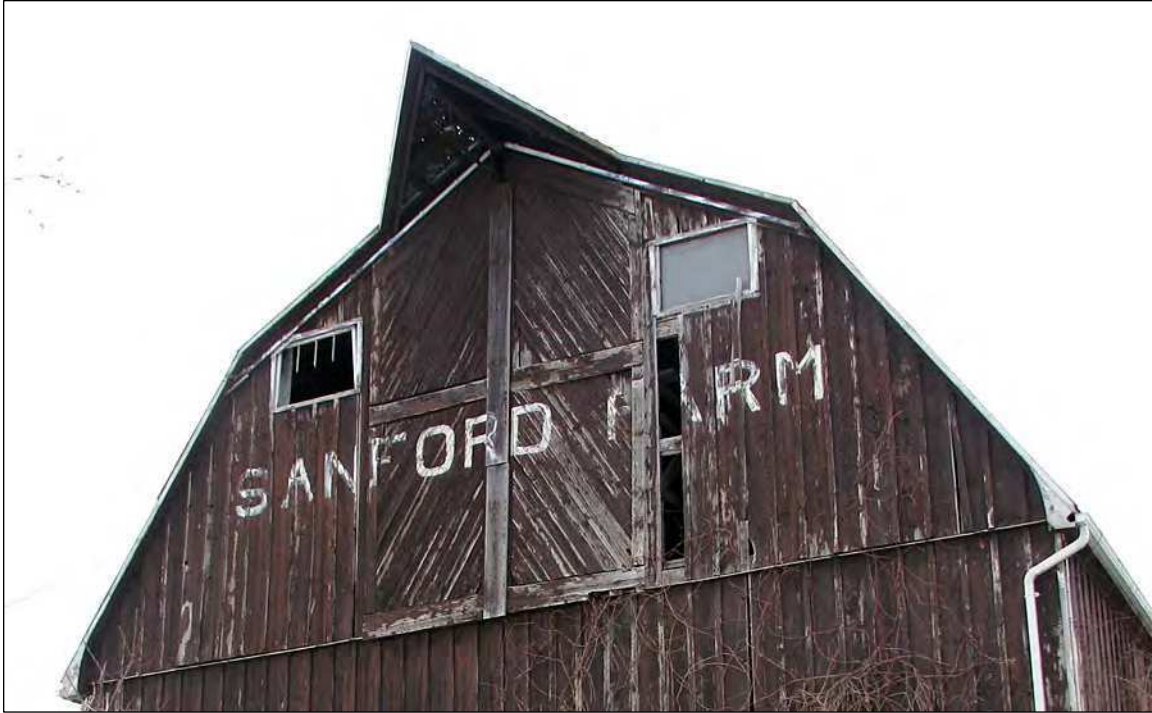
7. A detail of the south gambrel end wall depicts the 'Sanford Farm' sign, the window openings and the doorway into the mow.

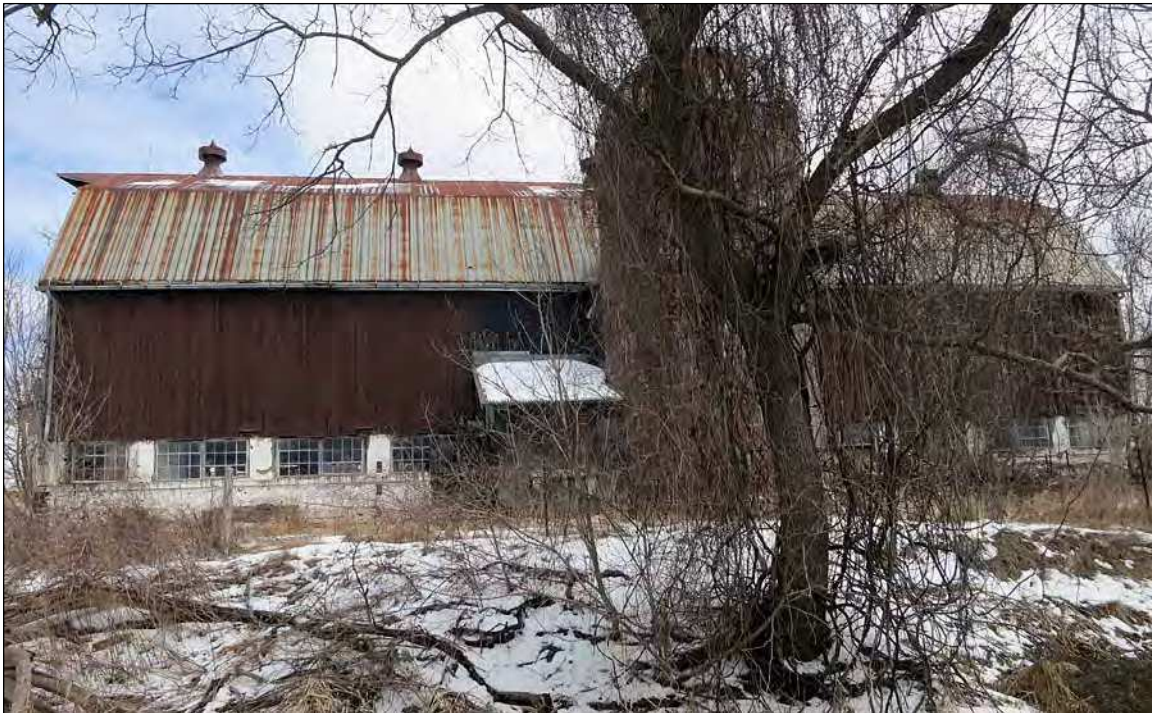
22. Characteristic elements of the Lower Barn include pairs of windows in the foundation wall, dark coloured board and batten siding and metal clad gambrel roof with ventilators.

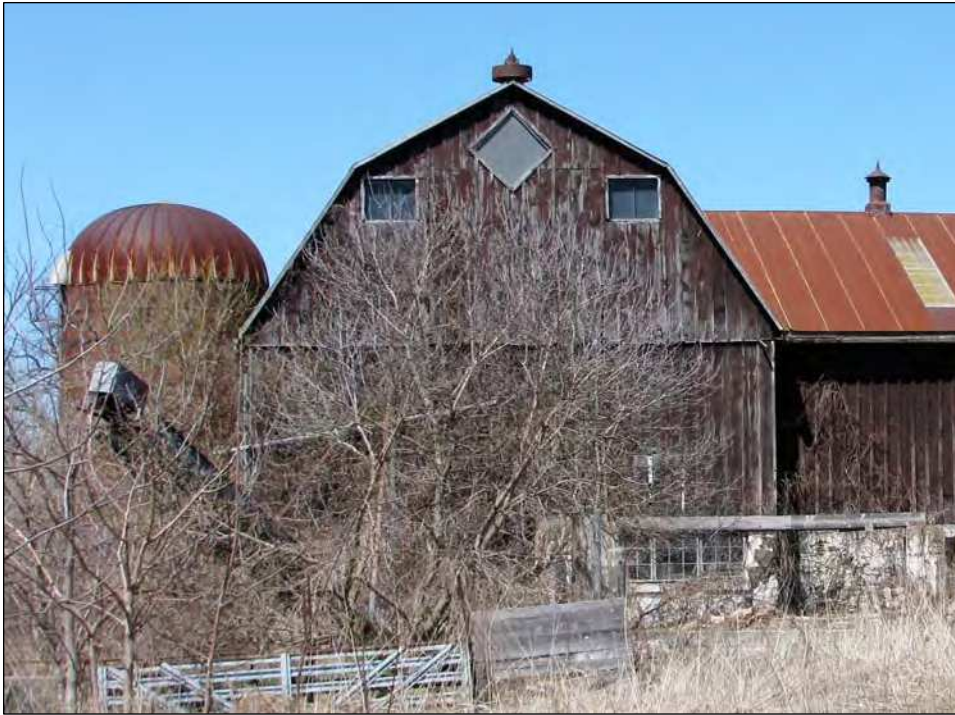
23. Although obscured by vegetation, the south gambrel end contains a large entranceway for livestock access to the adjacent yard.

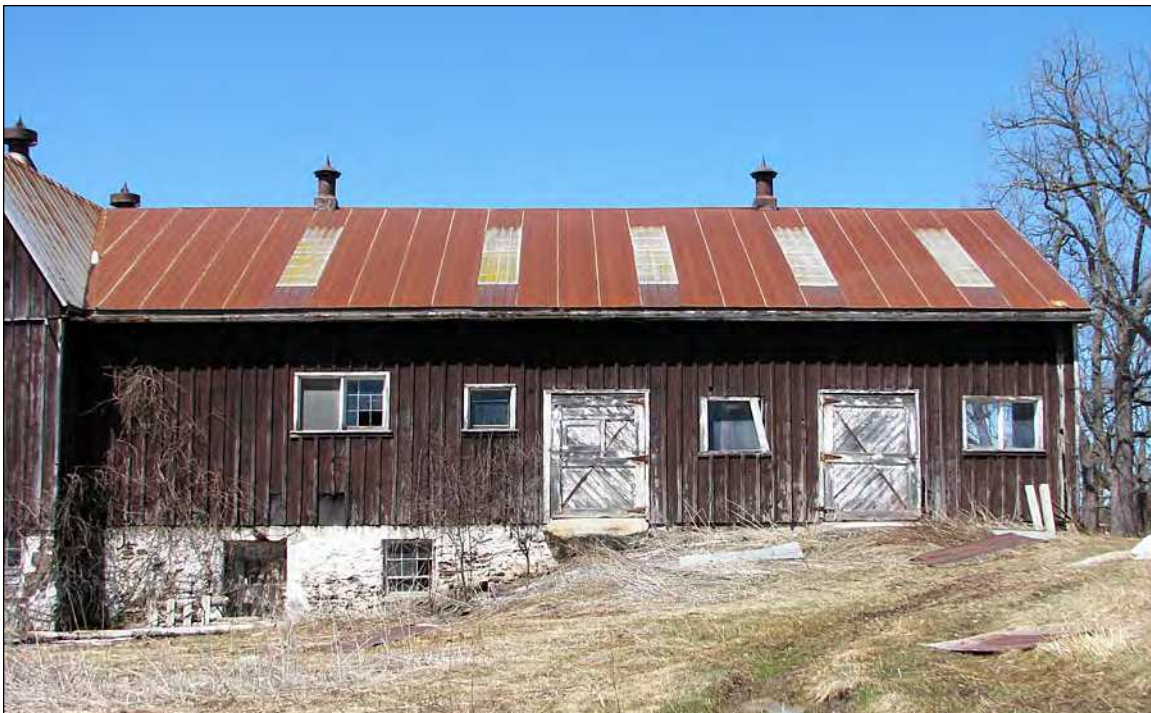
24. The exposed south foundation wall of the small barn is rubblestone. The doors on the upper level may relate the horse stable use of the building.

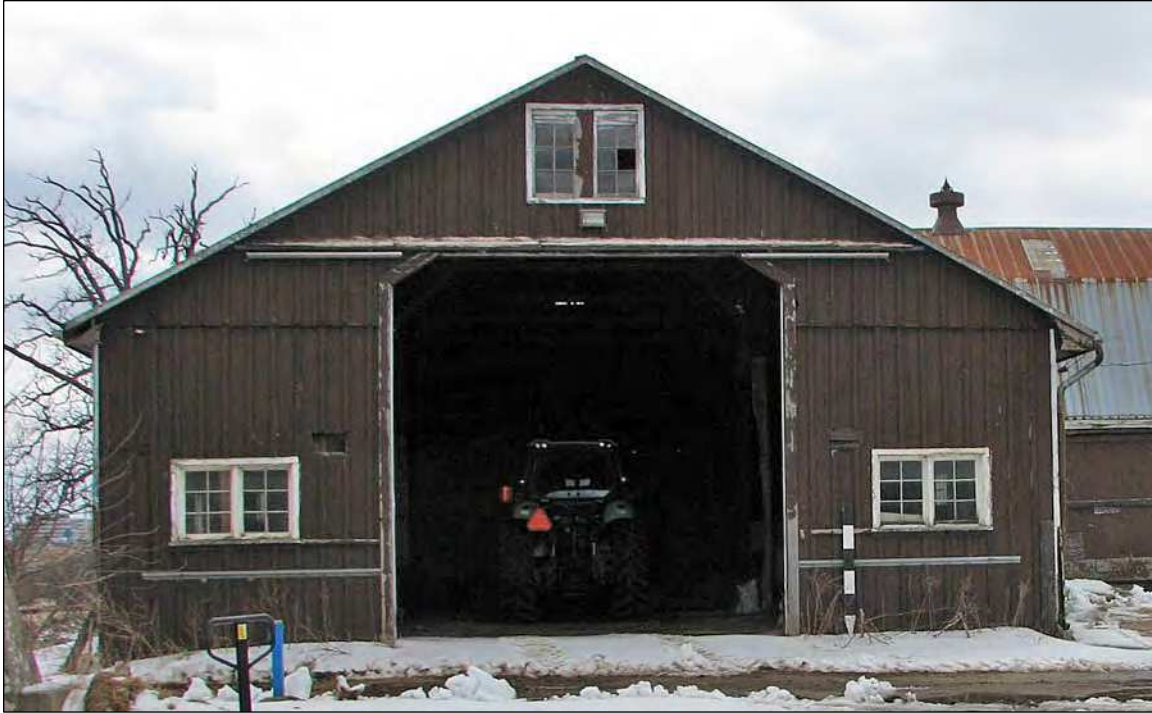
25. A large entry on the east gable end allows for the storage of large equipment in the small barn.

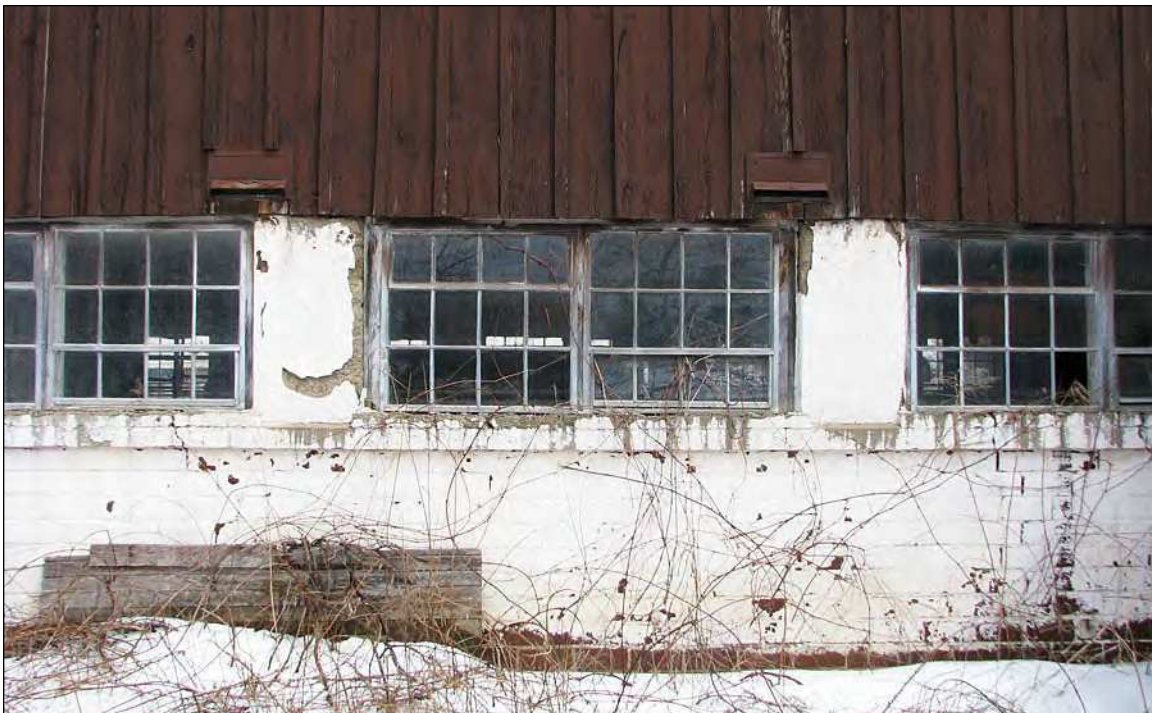
28. A detail of the foundation depicts the paired window openings set between concrete piers and with concrete sills in upper wall. The white paint obscures the hollow-clay tile of the lower wall.

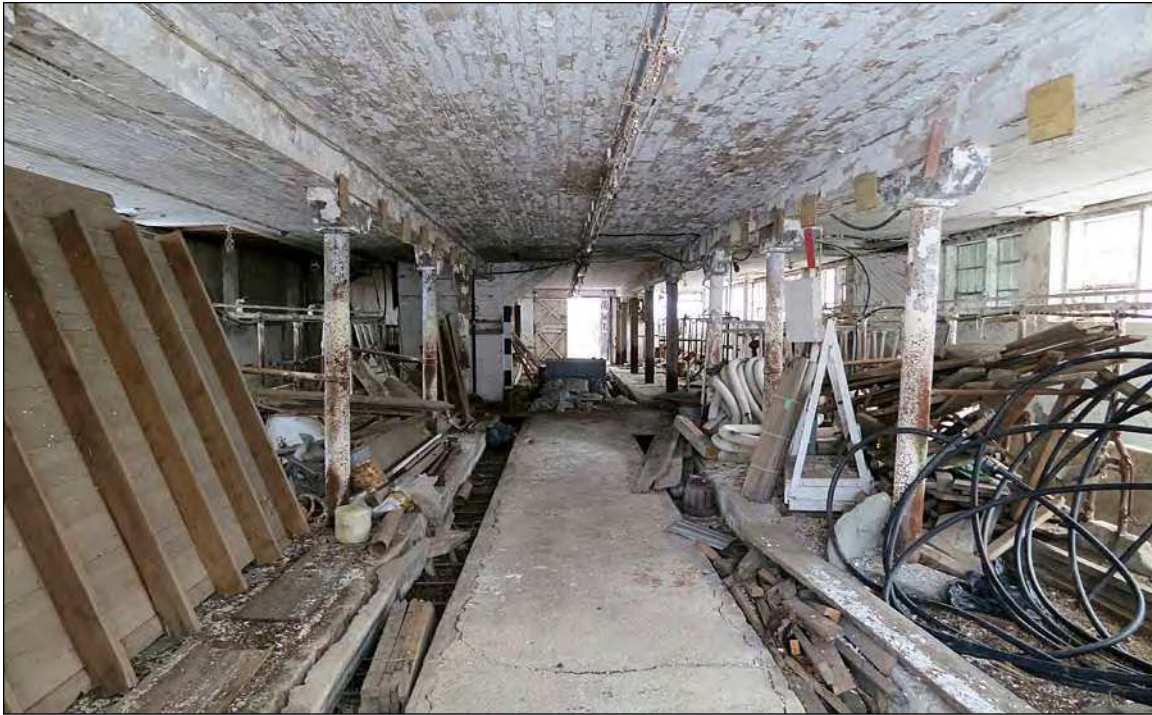
29. The lower level was laid out with a centre aisle running the length of the building and pens to either side.
