Heritage Advisory Committee

7.1. Request to Demolish three structures on a Heritage Listed Property: 1200 Old Derry Road

18110692-R01

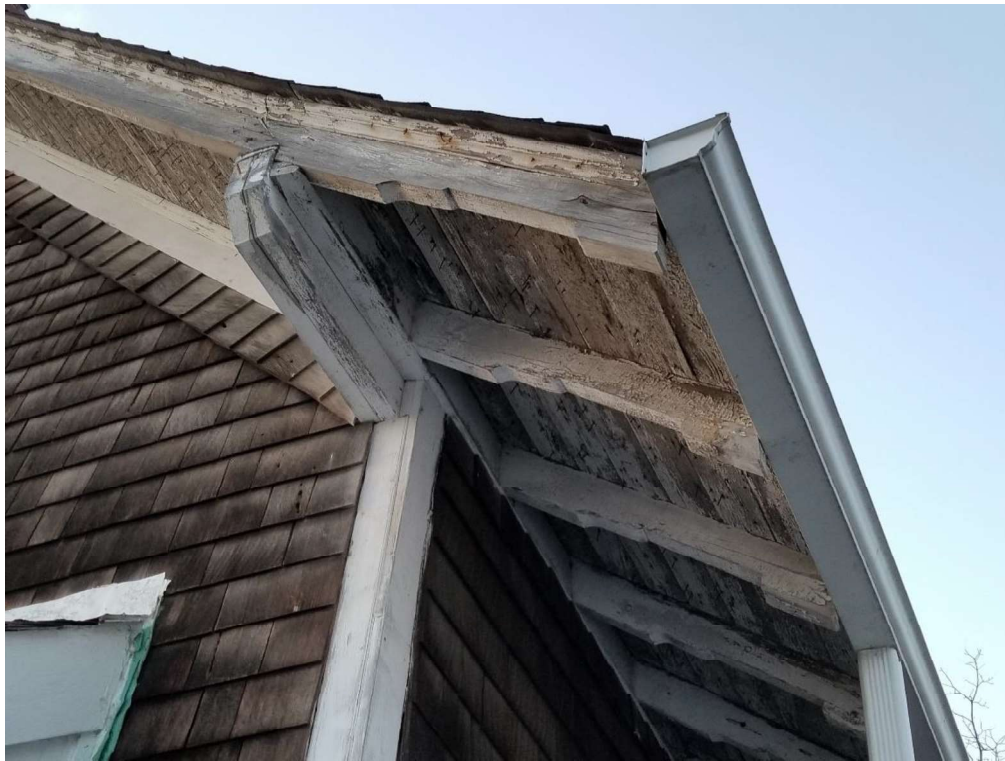
Figure 23: Projecting eaves with exposed purlins and plain fascia.

The Foreman's Residence is a wood nailed frame, one-and-a-half storey structure finished in wood shingles which sits upon a poured concrete foundation and full basement. The side medium gable roof is clad with asphalt shingles and has projecting wood eaves with exposed purlins and a plain fascia (Figure 23). There are shed dormers on the upper storey: one on the east façade and two on the west facade (Figure 24). There are two single chimneys to the offset left centre and exterior side right, one constructed of brick and another of concrete.

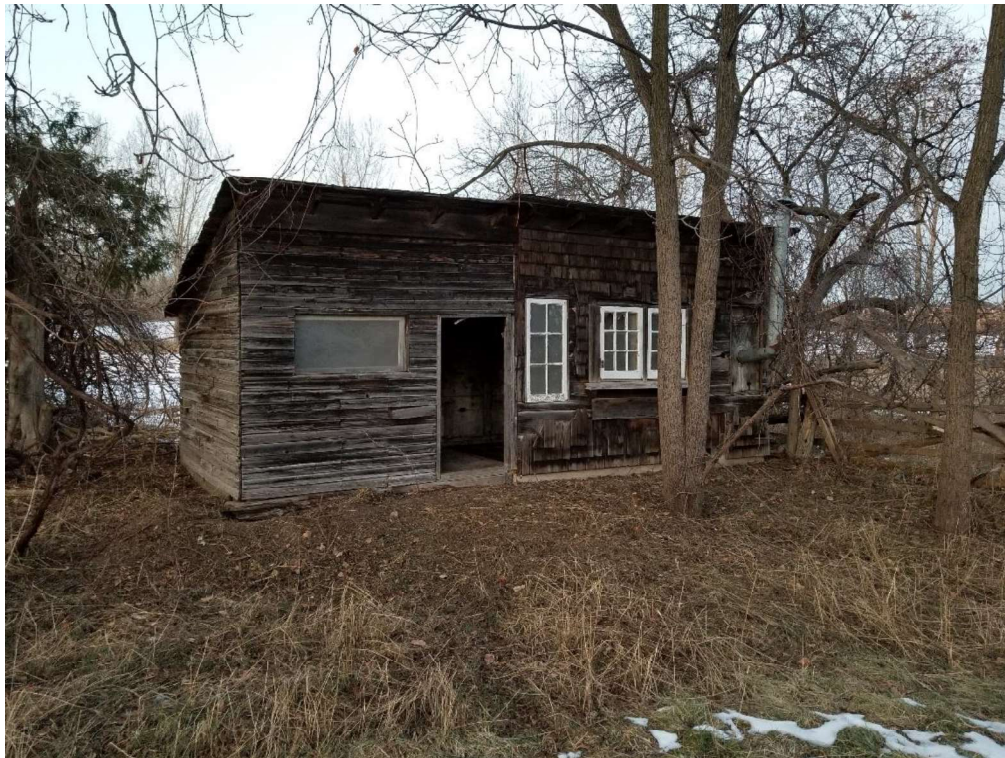
Figure 72: Exterior of the shed to the northeast of the Foreman's Residence.

The shed is located to the northeast of the Foreman's Residence and north of Simpson-Humphries House. The exterior is clad in horizontal wood with a sloped roof and flat fenestration: one horizontal frosted window; one six-pane and two nine-pane windows (Figure 72). The interior of the shed has horizontal wood clad walls with plywood floors (Figure 73).

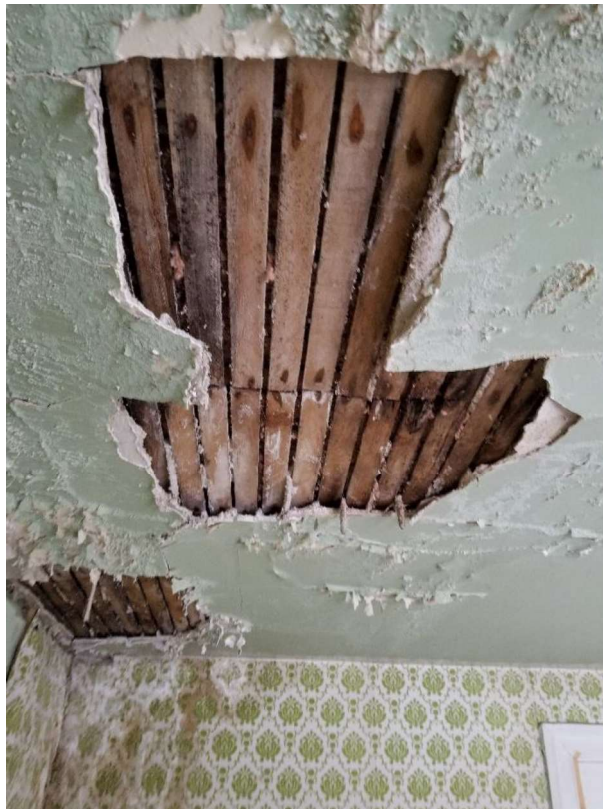
Figure 77: Exposed circular sawn lath and plaster in east living space, evidence of water damage in the left corner.

Internal Roof Structure / Ceilings	<ul style="list-style-type: none"> Overall appears to be in good condition. Plaster has begun to peel in the east living space, suggesting water damage (Figure 77).
Floors	<ul style="list-style-type: none"> Wood flooring is in good condition and no evidence of sagging. Vinyl flooring has begun to peel in the kitchen.

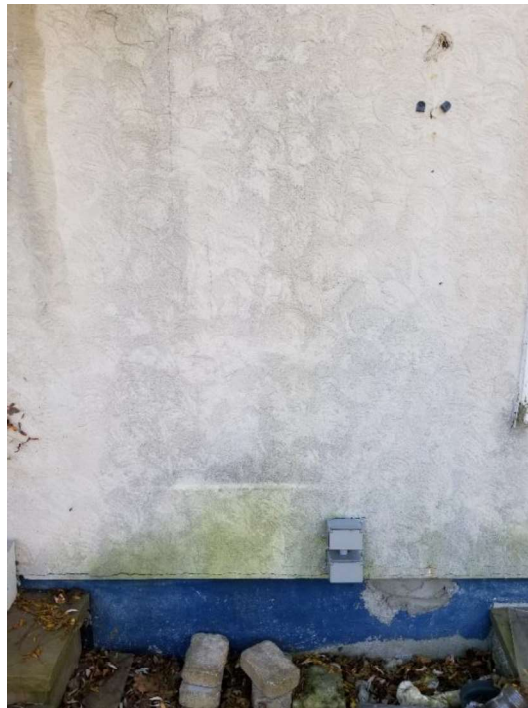
Figure 83: Concrete foundation and stucco-clad walling.

The Owner's Residence stands on a poured concrete foundation. All façade walls are nailed balloon frame and clad in stucco (Figure 83). The medium gable roof has asphalt shingling, projecting eaves, plain fascia and frieze, a moulded soffit, and boxed eaves at the gables (Figure 84). There is a single stack concrete chimney extending through the centre rear side of the roof.

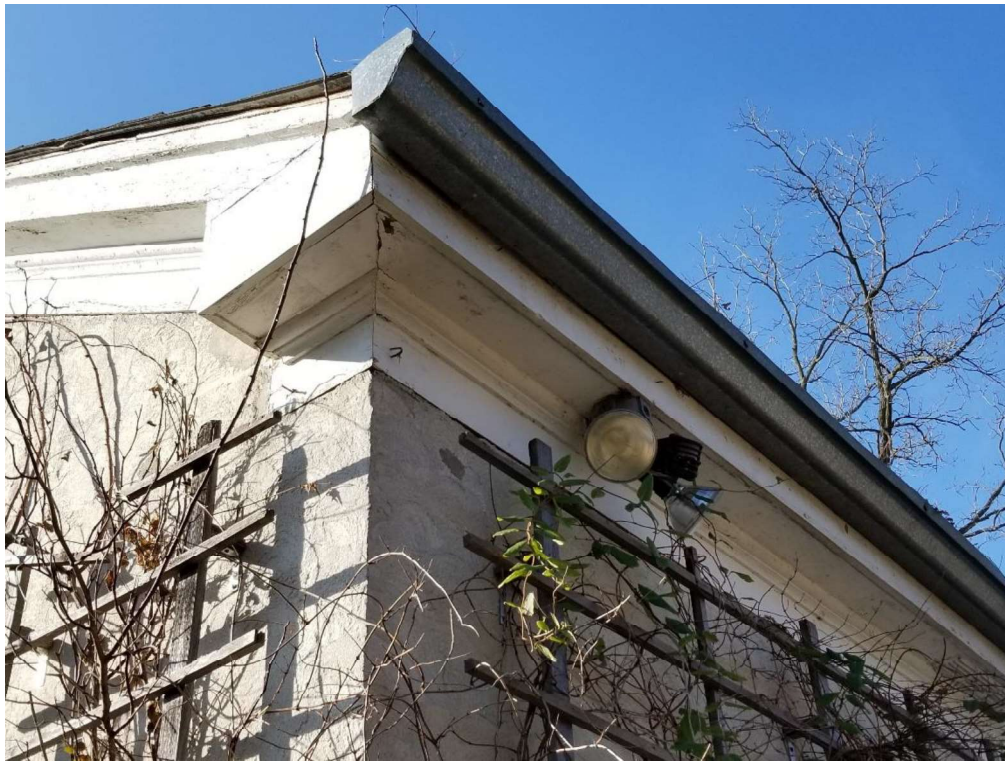
Figure 84: Boxed gable eaves and plain frieze, moulded soffit, and plain fascia of the projecting eaves and verges.
