Phase 1 Environment Site Assessment - 3111 & 3123 Cawthra Road, City of Mississauga

Project 15\*4209 April 27, 2015

Re: Phase I Environmental Site Assessment

3111 and 3123 Cawthra Road, City of Mississauga

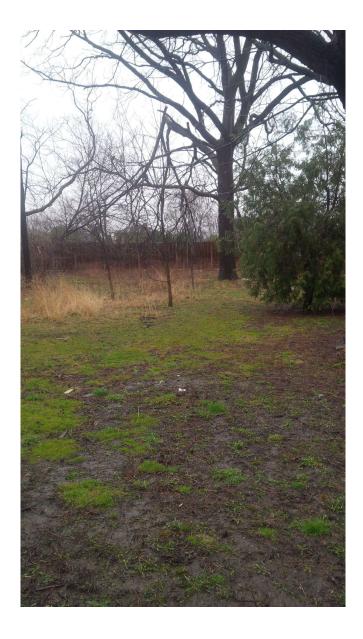
View to East - Rear Yard

Shallow Dug Well

3111 Cawthra has a well which must be considered as abandoned, requiring decommissioning by a licensed well technician in accordance with the requirements of O. Regulation 903. This process requires disinfection, filling, sealing and filing of a well record with MOECC. There is probably an abandoned septic tank associated with 3111, which will require exploration and removal together with foundations in conjunction with the demolition of adjacent foundations. Workers must protect against contact with mold when contacting aesthetically impacted surfaces within 3111 Cawthra.

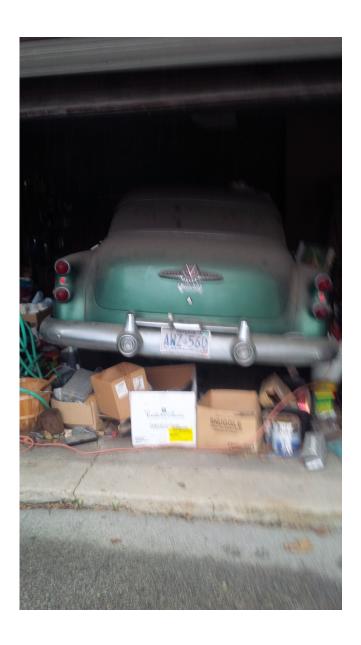
Garage

View to Southeast

3111 Cawthra has a three bay detached garage separated from the residence. The garage is completely filled with dimensional wood, small tools, old fixtures and fittings and metal debris. No hazardous wastes were visible, however the tightly packed nature contents resulted in most materials obscured from view or access.
