Construction Arborist Report: 0 Bernida Road, Mississauga, Ontario

Prepared on behalf of the property owner

Date: April 17th, 2020

Prepared by: Serg Litvinov, B.Sc., ISA # ON-2281A
Consulting Arborist - Tree Doctors Inc.
SLitvinov@treedoctors.ca

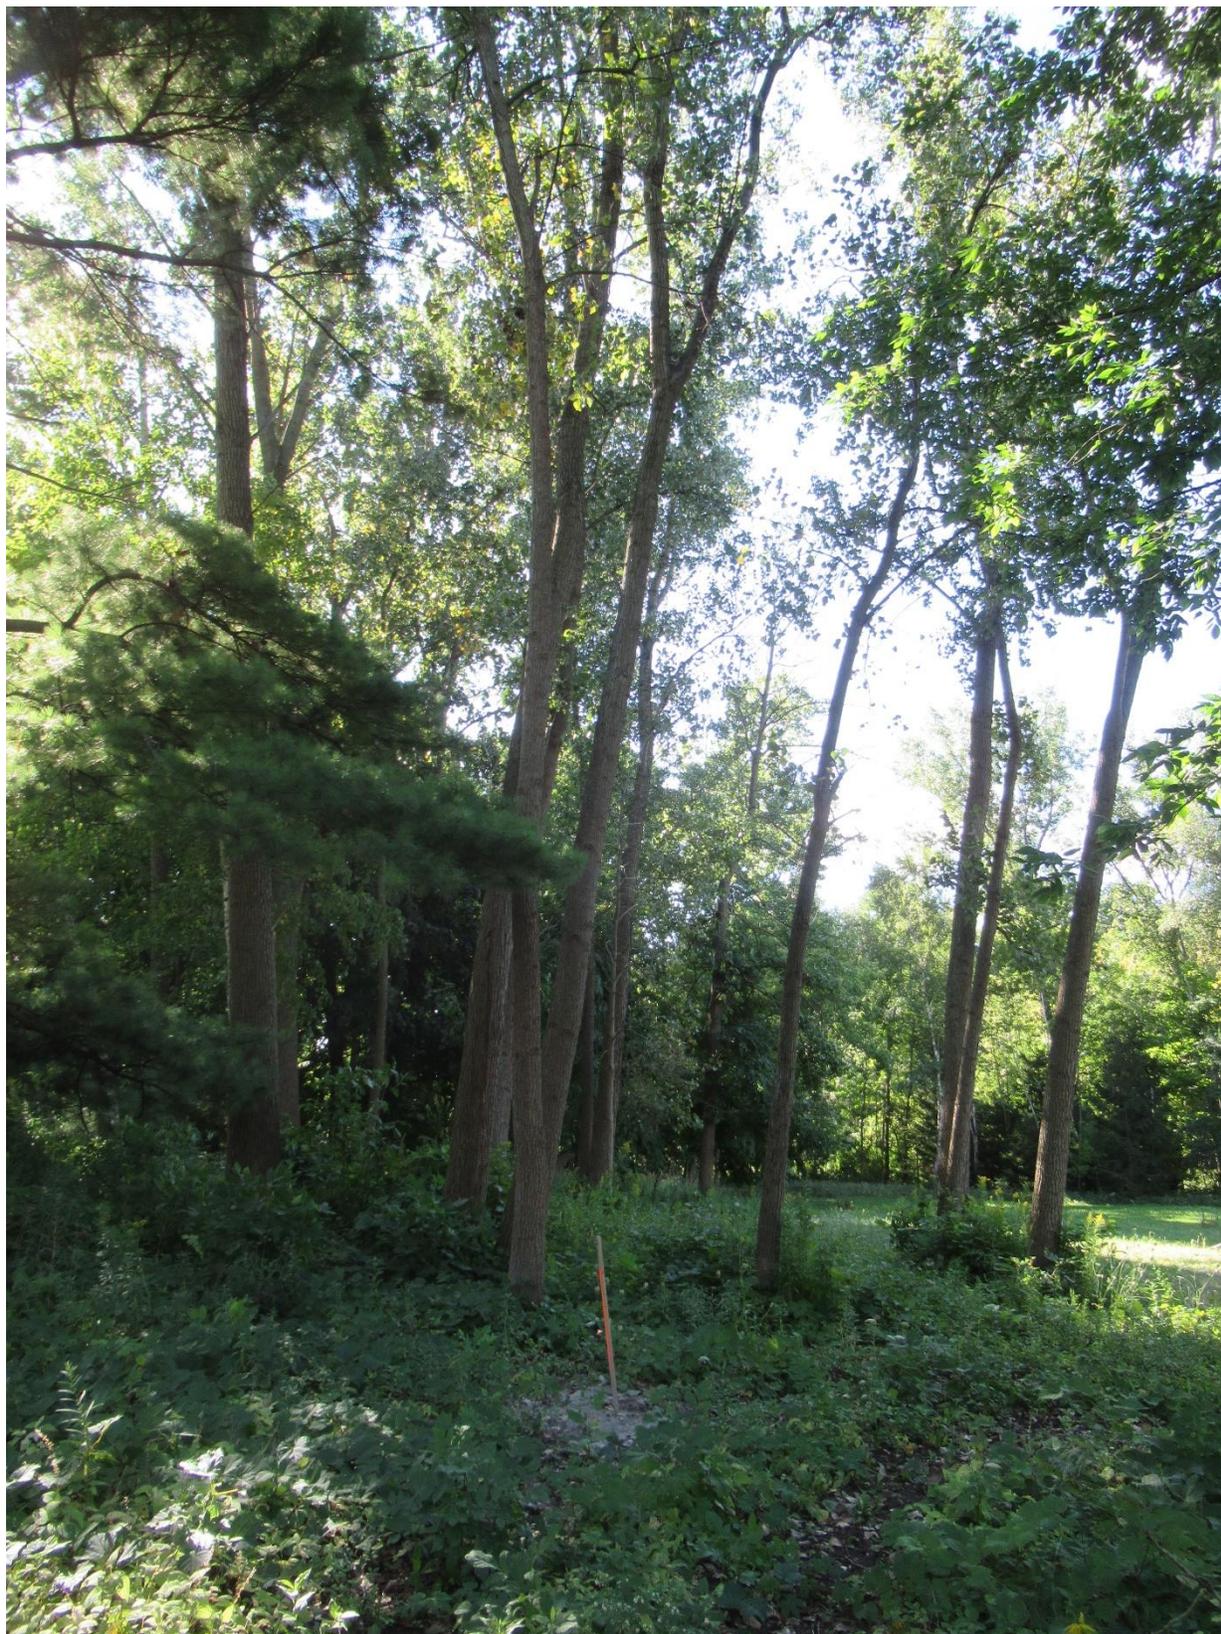
Picture 12: Trees #34-37

37	Cottonwood	42.5	Protect	3	Good-Fair	8	1	Minor amount of small diameter deadwood present.
38	Ash	30.5	Protect	2.4	Poor	7	1	EAB present.
39	Cottonwood	41.5	Protect	3	Good-Fair	7	1	Botanically in good condition. Minor amount of small diameter deadwood present.
40	Red Maple	28	Protect	2.4	Good	6	1	Botanically in good condition. Previously pruned. Minor amount of small diameter deadwood present.
41	Cottonwood	35	Protect	2.4	Good-Fair	6	1	Crown lean. Minor amount of small diameter deadwood present.
42	Weeping Willow	74.5	Protect	4.8	Fair-Poor	14	1	Large stem previously failed. Moderate amount of small diameter deadwood present. Epicormic growth present.
43	Manitoba Maple	37, 41	Protect	3	Fair	9	1	Several torn limbs. Significant trunk lean. Minor-moderate amount of small diameter deadwood present.

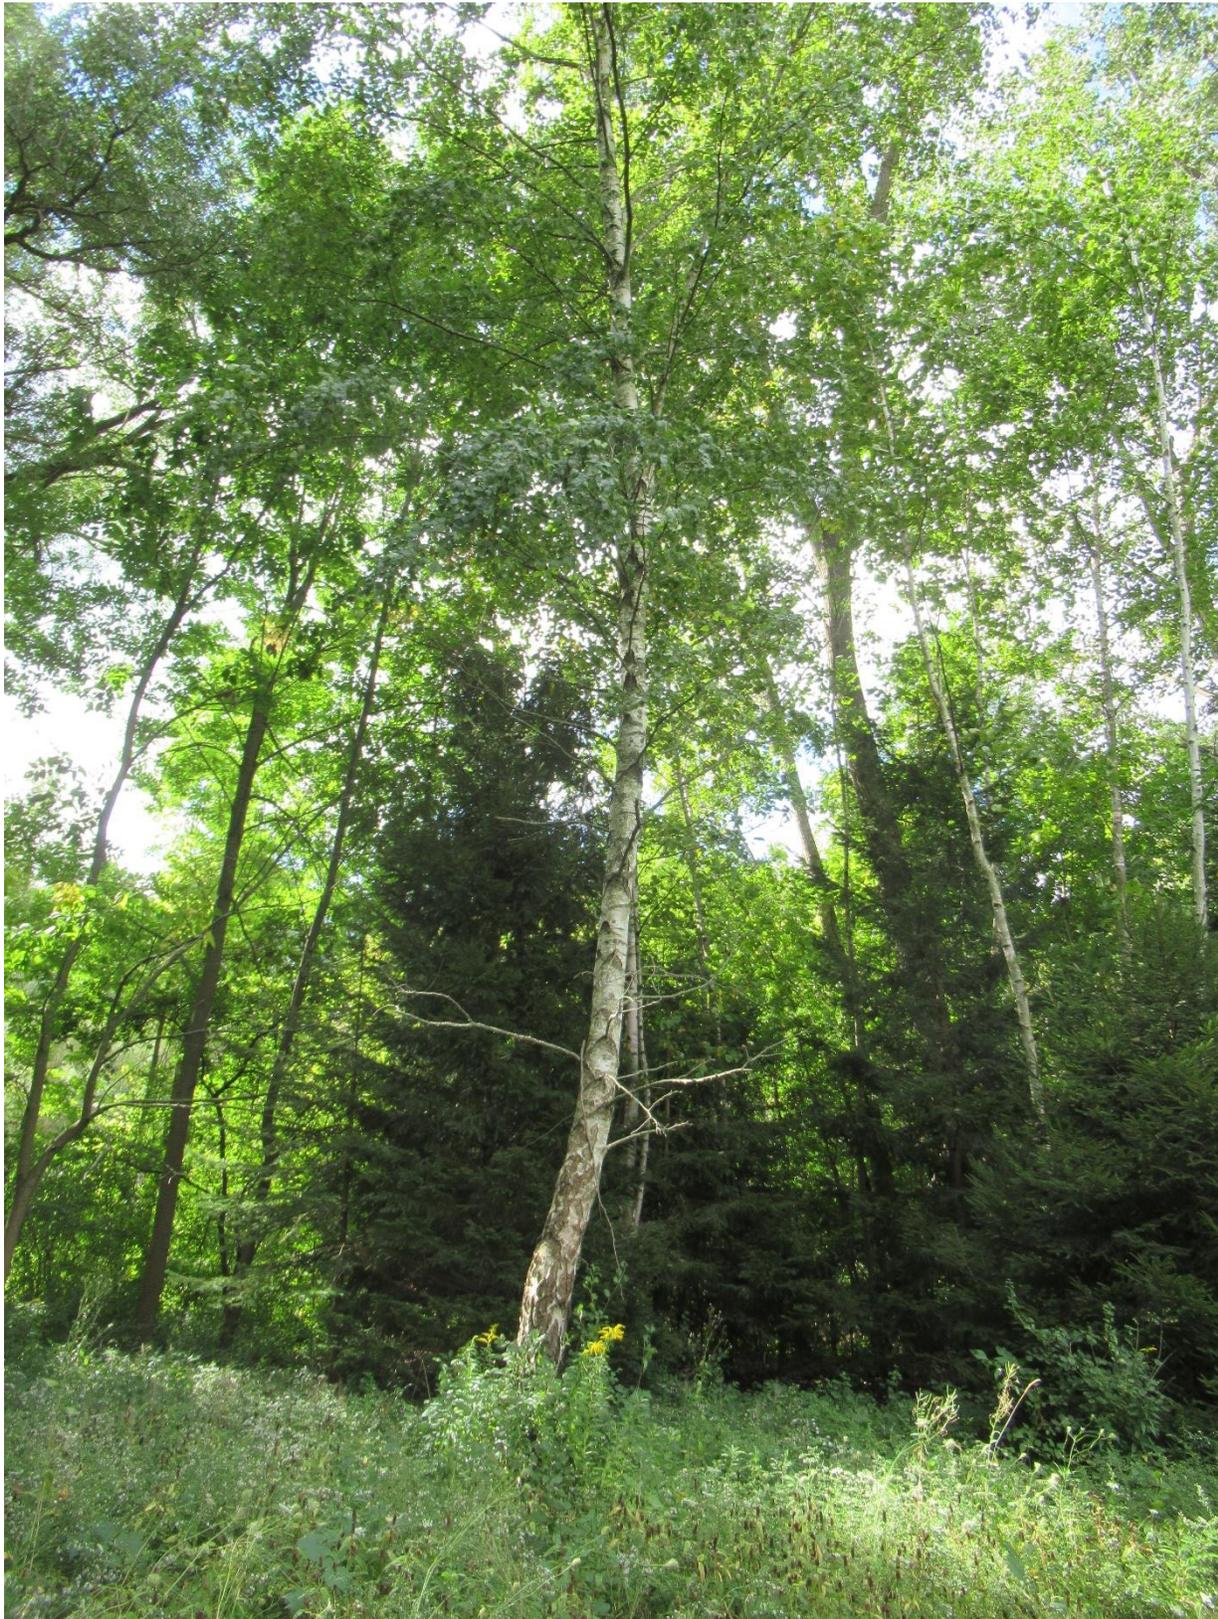
Picture 17: Tree #44

44	White Birch	28.5	Protect	2.4	Good-Fair	6	1	Minor amount of small diameter deadwood present. Trunk curve.
45	White Birch	15	Protect	2.4	Good	5	1	Botanically in good condition.
46	Black Willow	40, 42	Protect	3	Good-Fair	8	1	Minor amount of small diameter deadwood present. Included bark at stem union. Trunks fused together.
47	White Spruce	17	Protect	2.4	Good	6	1	Botanically in good condition.
48	White Spruce	17	Protect	2.4	Good	5	1	Botanically in good condition.
49	Cottonwood	16.5, 41	Protect	3	Fair	8	1	Moderate amount of small diameter deadwood present.
50	Cottonwood	32.5	Protect	2.4	Fair	7	1	Moderate amount of small diameter deadwood present.
51	White Pine	29.5	Protect	2.4	Good	7	1	Botanically in good condition.
52	Cottonwood	41	Remove	N/A	Fair	8	1	Moderate to significant amount of small diameter deadwood present.
53	Apple	17, 20.5	Injury	2.4	Fair	6	1	Epicormic growth present. Moderate to significant deadwood present.

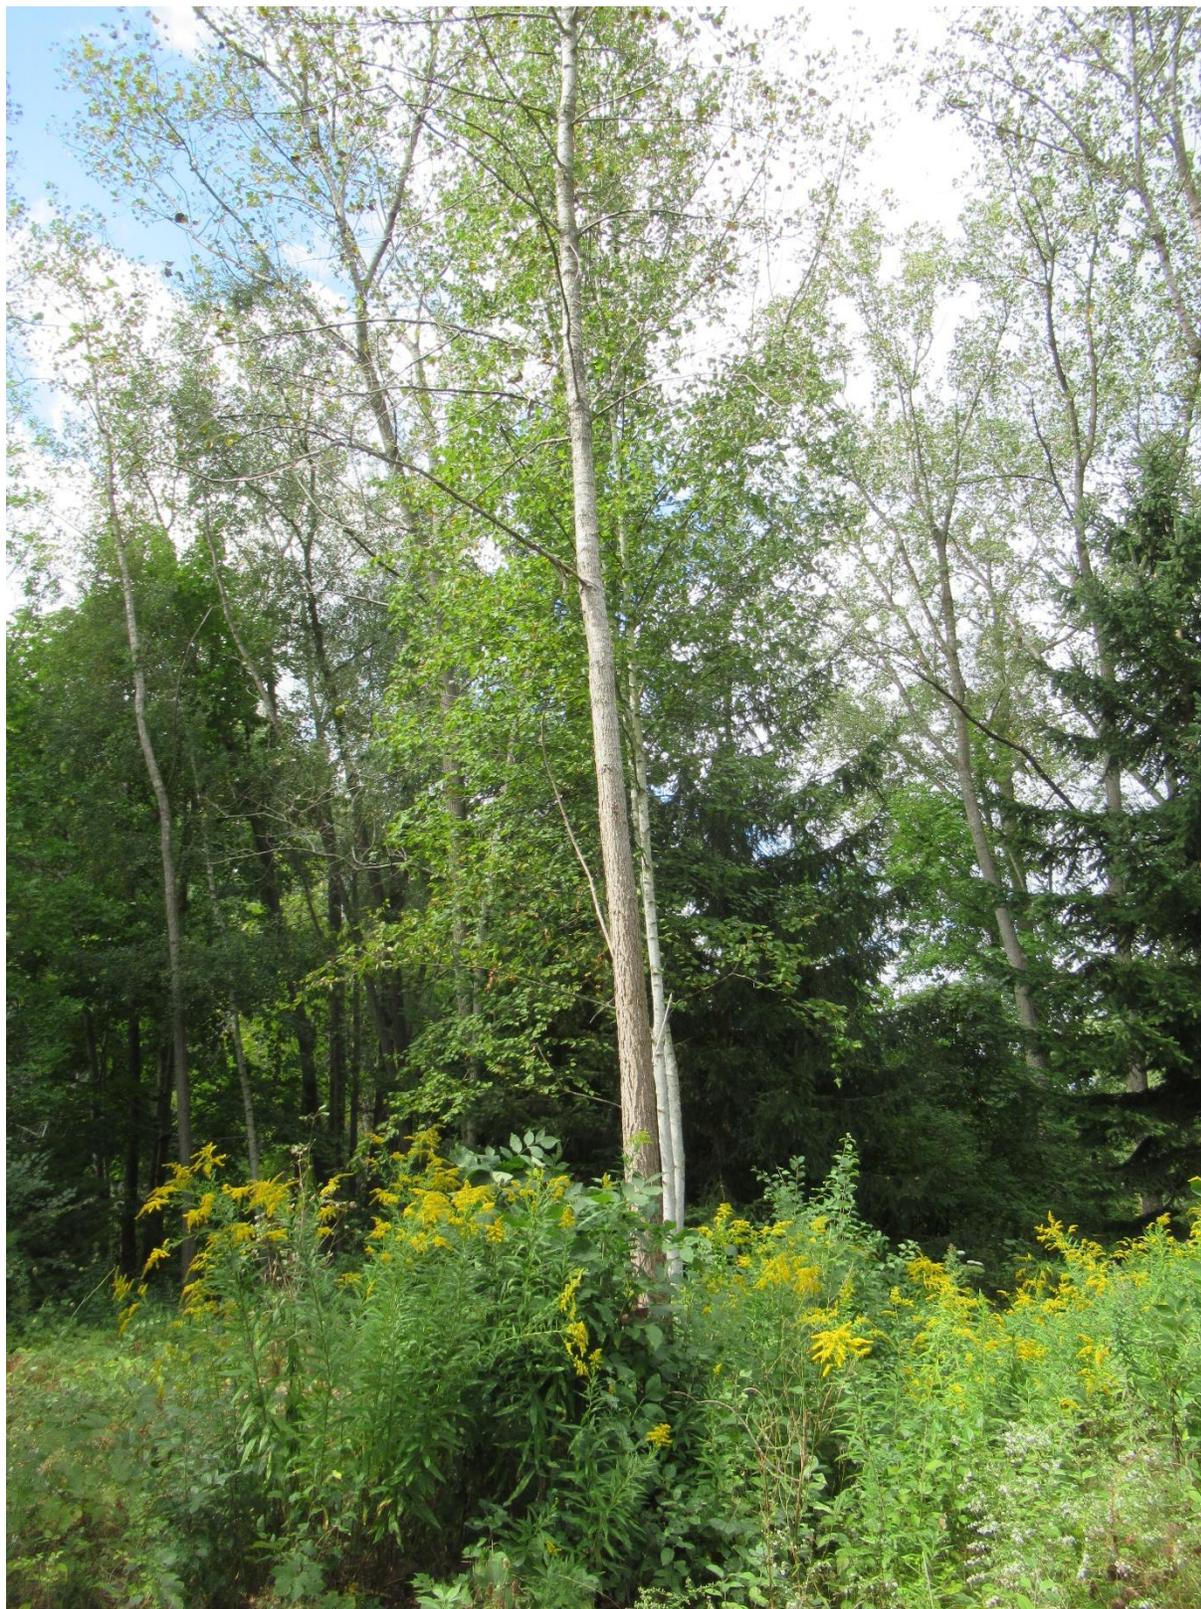
Picture 26: Tree #61

61	Cottonwood	18	Protect	2.4	Good-Fair	6	1	Moderate amount of small diameter deadwood present. Sparse crown.
62	Ash	16	Injury	2.4	Good-Fair	6	1	Minor amount of small diameter deadwood present. Vine covered trunk.
63	Black Willow	34, 41	Injury	3	Fair	8	1	Vine covered trunk. Poor form. Significant trunk lean on one stem.
64	Cottonwood	35, 42	Injury	3	Good-Fair	8	1	Codominant stems. Minor amount of small diameter deadwood present. Vine covered trunk.
65	Black Walnut	26	Remove	N/A	Fair	7	1	Vine covered trunk. Recently torn leader.
66	White Birch	16	Remove	N/A	Good	6	1	Botanically in good condition.
67	Ash	25.5	Remove	N/A	Good-Fair	7.5	1	Minor amount of small diameter deadwood present.
68	White Pine	18	Protect	2.4	Good-Fair	7	1	Yellowing needles. Botanically in good condition.
69	White Pine	19.5	Protect	2.4	Good-Fair	7	1	Yellowing needles. Botanically in good condition.
70	Manitoba Maple	37	Protect	2.4	Good-Fair	7	1	Trunk lean. Included bark at stem union.

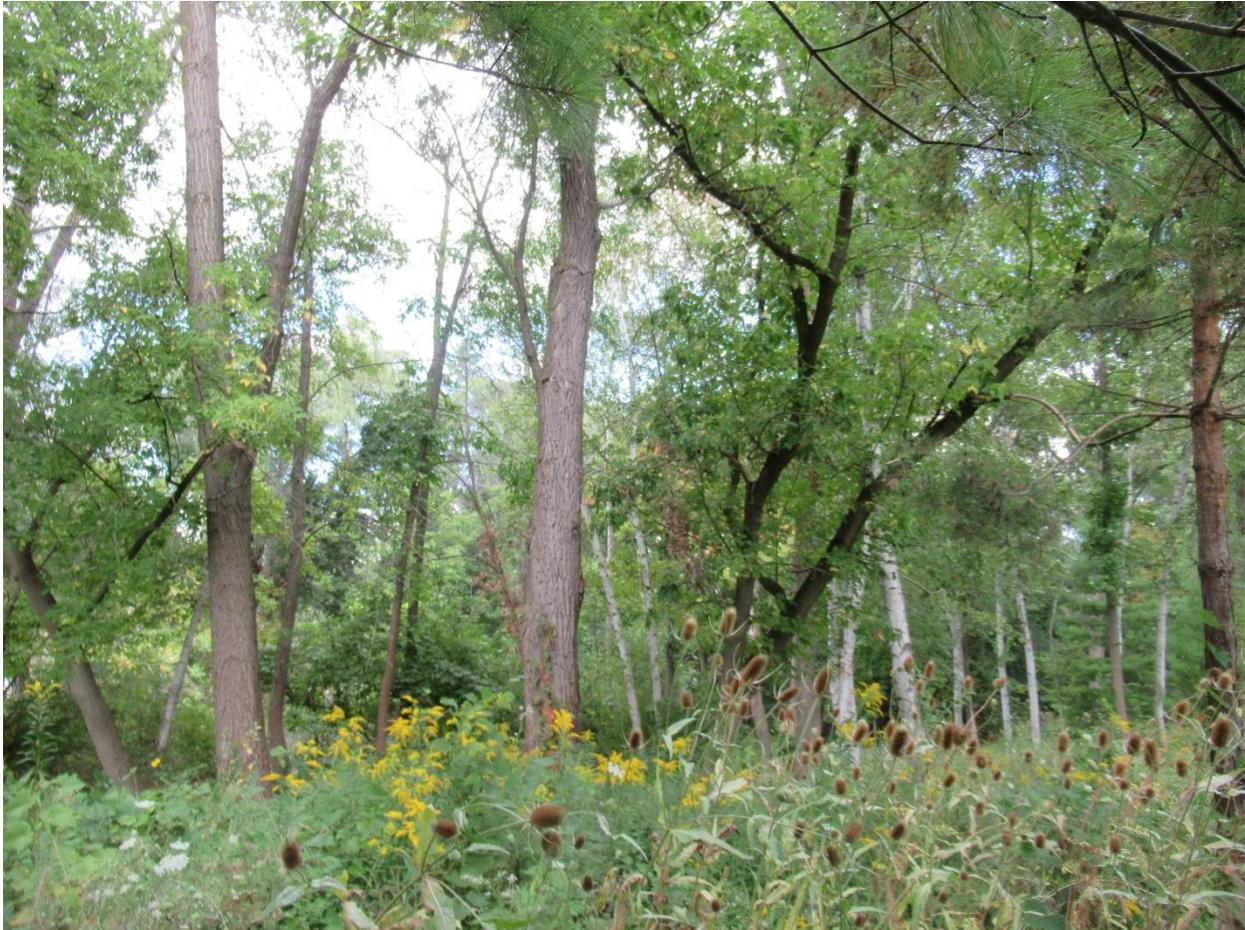
Picture 31: Trees #70-73

71	Black Willow	78	Protect	4.8	Fair	14	1	Moderate amount of small diameter deadwood present. Several large diameter dead stems in crown.
72	Cottonwood	54	Protect	3.6	Good-Fair	12	1	Minor-moderate amount of small diameter deadwood present. Trunk lean.
73	White Birch	30	Protect	2.4	Good	8	1	Botanically in good condition. Vine covered.
74	White Birch	23	Remove	N/A	Good	7	1	Botanically in good condition.
75	White Oak	21	Remove	N/A	Fair	6	1	Moderate to significant amount of small diameter deadwood present.
76	Cottonwood	38	Injury	2.4	Good-Fair	8	1	Minor-moderate amount of small diameter deadwood present. Trunk lean.
77	White Birch	21	Protect	2.4	Good	6	1	Botanically in good condition.
78	Cottonwood	45	Protect	3	Good-Fair	9	1	Vine covered trunk. Minor-moderate amount of small diameter deadwood present.

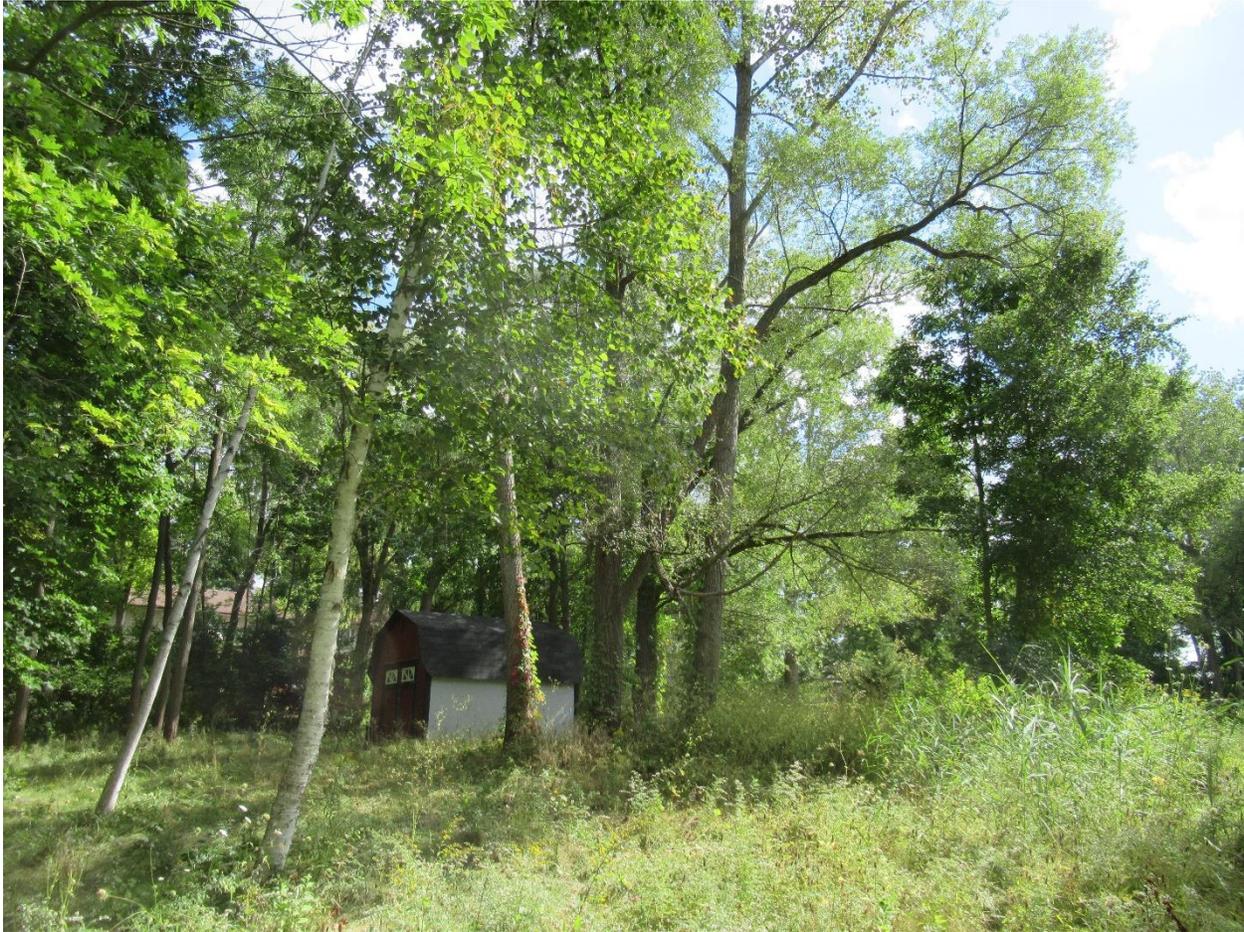
Picture 34: Trees #77-82

79	Black Willow	53	Protect	3.6	Good-Fair	10	1	Vine covered trunk. Minor-moderate amount of small diameter deadwood present.
80	Cottonwood	51	Protect	3.6	Good-Fair	10	1	Vine covered trunk. Minor-moderate amount of small diameter deadwood present.
81	White Birch	19.5	Protect	2.4	Good-Fair	6	1	Botanically in good condition. Trunk lean.
82	Ash	15.5, 17	Protect	2.4	Good-Fair	6	1	Minor amount of small diameter deadwood present. Vine covered trunk. Included bark at stem union.
83	Black Willow	59	Protect	3.6	Fair	10	1	Several torn limbs in crown. Minor-moderate amount of small diameter deadwood present. Vine covered.
84	Norway Maple	17	Protect	2.4	Good-Fair	6	1	Minor amount of small diameter deadwood present. Vine covered trunk.
85	Norway Maple	20	Protect	2.4	Good	6	1	Botanically in good condition.
86	Ash	24	Protect	2.4	Dead		1	
87	Ash	23.5	Protect	2.4	Fair	6	1	EAB present.
88	Ash	23	Protect	2.4	Fair	6	1	EAB present.

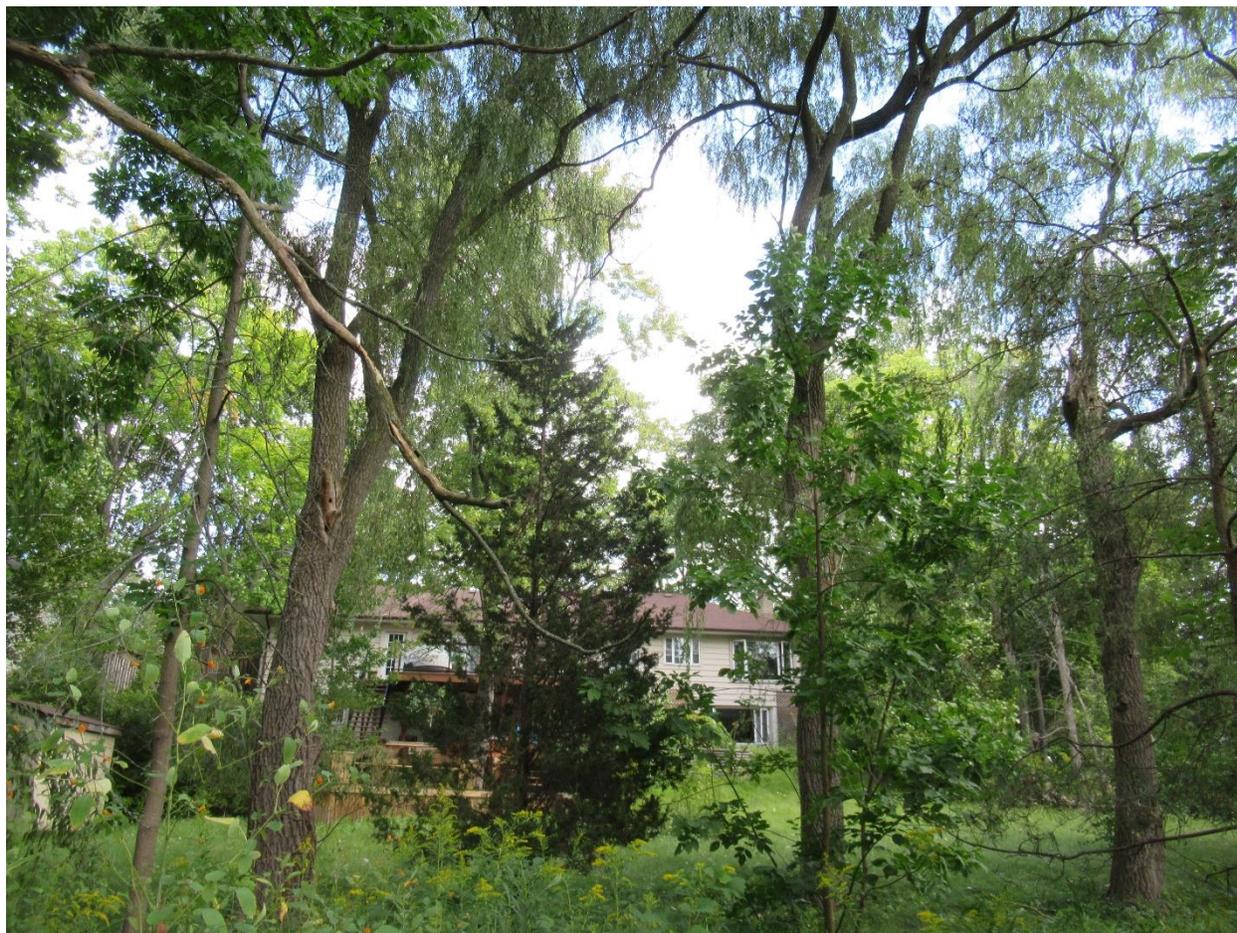
Picture 37: Trees #89-91

89	Weeping Willow	68	Protect	4.2	Fair	12	2	One stem torn and cavity forming. Minor amount of small diameter deadwood present.
90	Weeping Willow	53	Protect	3.6	Fair	10		Minor-moderate amount of small diameter deadwood present.
91	Weeping Willow	49	Protect	3	Fair-Poor	10	2	Moderate amount of small diameter deadwood present. Torn stem in crown. Significant woodpecker damage.
92	Weeping Willow	52	Injury	3.6	Fair	10	2	Several small cavities. Moderate amount of small diameter deadwood present.
93	Cottonwood	40	Remove	N/A	Fair	9	1	Sparse crown. Asymmetrical crown. Moderate amount of small diameter deadwood present.
94	Cottonwood	71	Protect	4.8	Good-Fair	14	1	Minor-moderate amount of small diameter deadwood present.

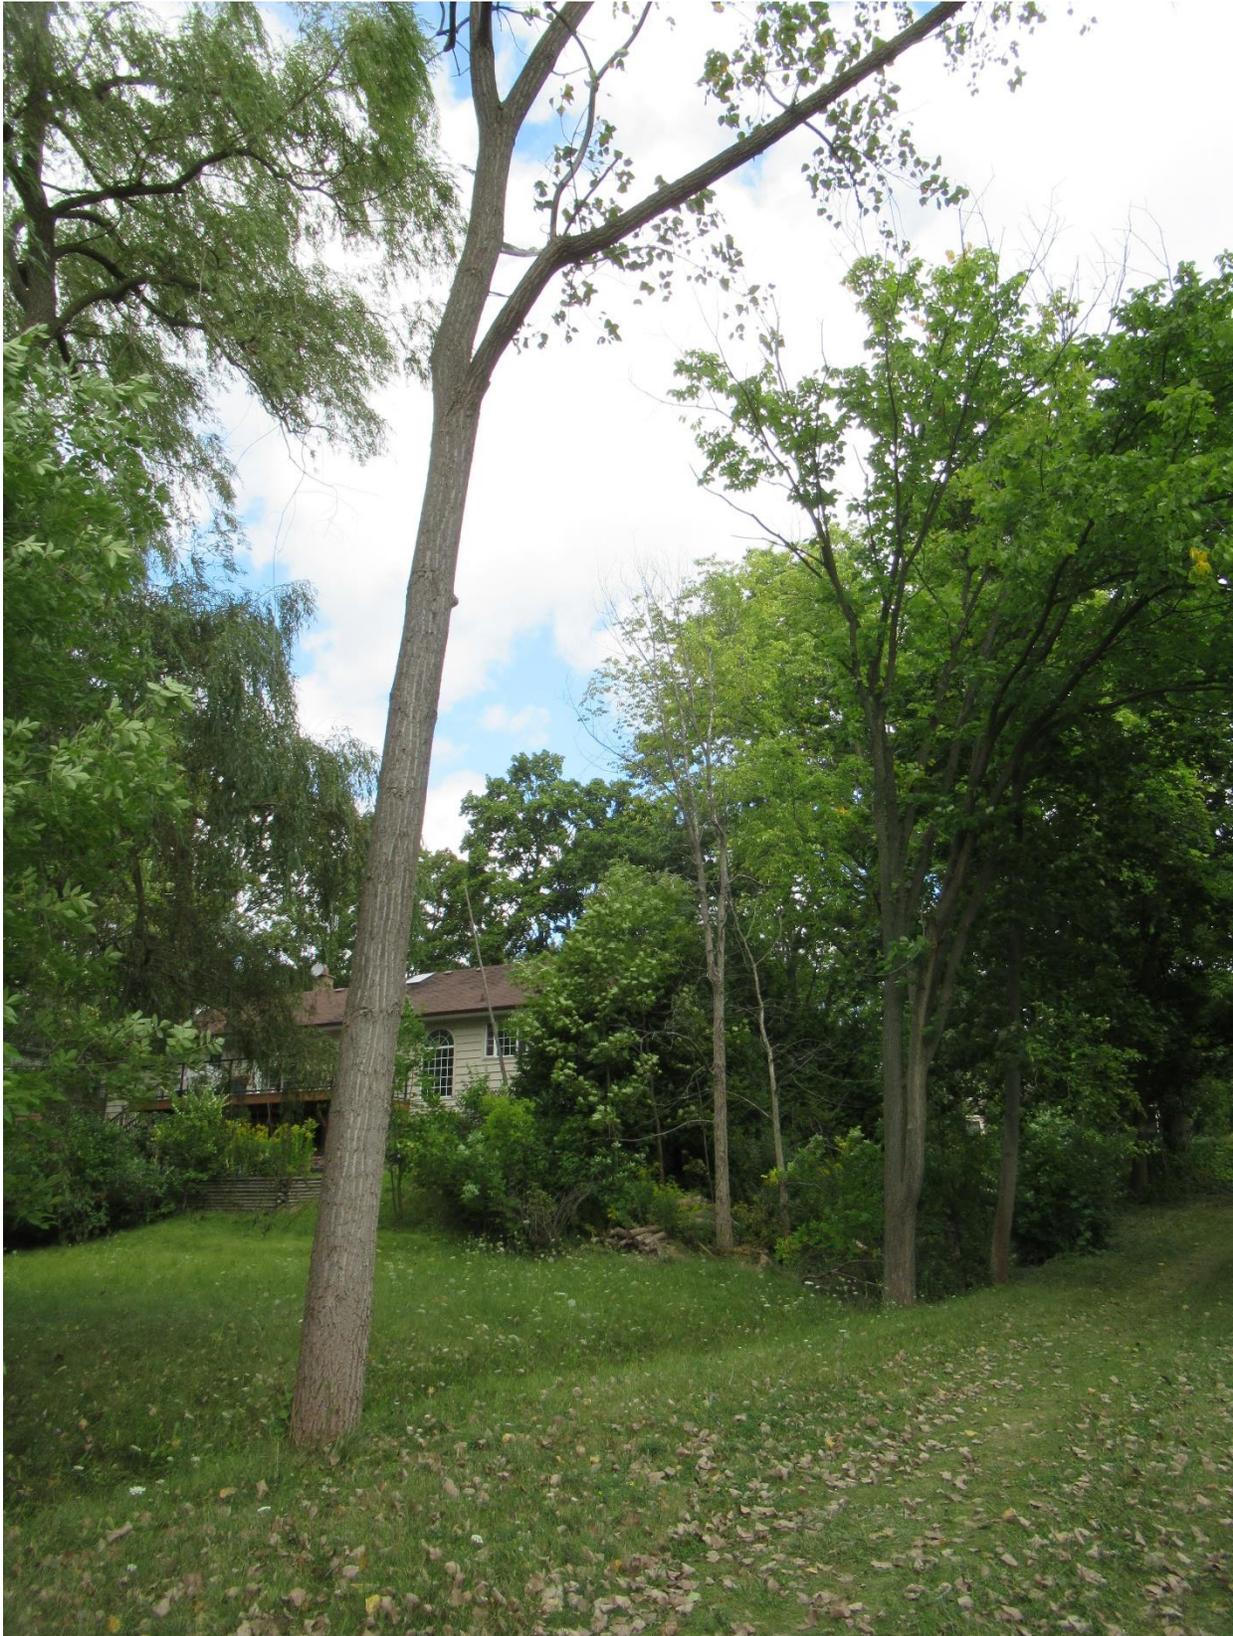
Picture 39: Trees #93, #95 and #96

95	White Elm	43	Remove	N/A	Good-Fair	10	1	Minor-moderate amount of small diameter deadwood present.
96	Norway Maple	23	Remove	N/A	Good-Fair	6	1	Minor amount of small diameter deadwood present.
97	Dead	21	Injury	2.4	Dead	6	2	Dead.
98	White Elm	22.5, 40	Remove	N/A	Good-Fair	9	1	Botanically in good condition. Minor amount of small diameter deadwood present.
99	Norway Maple	32	Remove	N/A	Good	8	1	Botanically in good condition. Minor amount of small diameter deadwood present. Exposed roots.
100	Ash	35	Remove	N/A	Fair	8	1	EAB present.
101	Dead	18	Remove	N/A	Fair	6		Trunk lean over pathway.
102	Norway Maple	15	Remove	N/A	Good	5	1	Botanically in good condition. Shaded by adjacent trees.
103	Cottonwood	76	Remove	N/A	Fair	14	1	Previously pruned. Moderate amount of small diameter deadwood present.
104	Red Oak	63	Injury	4.2	Good-Fair	12	2	Minor amount of small diameter deadwood present. Growing on slope. Previously pruned.
