Schedule B Class Environmental Assessment – Project File

**Applewood Creek Erosion Control Project –
Lakeview Golf Course**

A project file submitted by:
Aquafor Beech Ltd.

August 31st, 2020

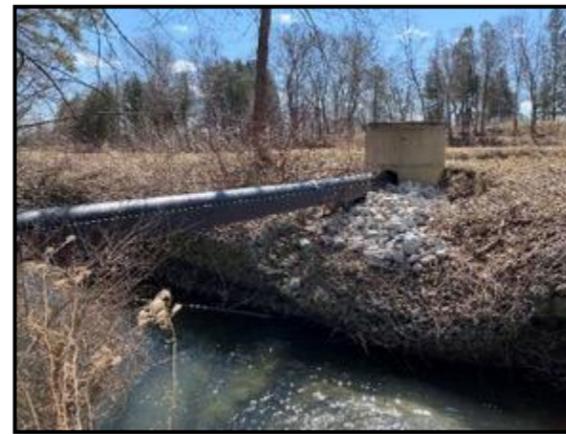
B2. Slumping gabion baskets undermining and scouring around chamber structure

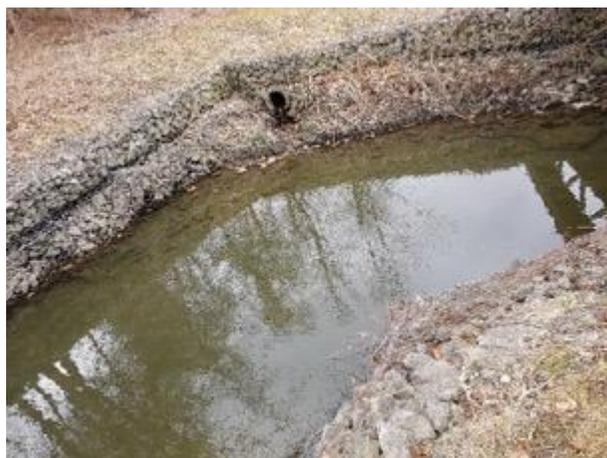
Photo 1. Plunge Pool Downstream of Footbridge.

At the time of sampling, the average wetted width of Applewood Creek was 2.5 m. The average depth of the watercourse at crossovers was approximately 15 mm, with a maximum sampled depth of nearly 600 mm. This deep plunge pool exists one of three pool habitats that were observed throughout the site and it is located approximately 5 m downstream of a pedestrian/cart path bridge. This pool is depicted in **Photo 1**. The pool was likely formed as a result of the realignment of the creek, as demonstrated by a nearly 90-degree bend in the gabion-lined banks. Also shown in **Photo 1** is a sewer outfall that could have contributed to the formation of the deep pool. The other pools were also likely formed as a result of anthropogenic disturbance. The furthest downstream pool, illustrated in **Photo 2**, can be directly attributed to the GO Line crossing culvert(s) and the riffle crest elevation that exists upstream of them (potential sediment loading). These culverts and elevated riffle crest did not represent significant barriers to fish movement at the time of assessment. The furthest upstream pool, shown in **Photo 3**, was observed to have been formed as a result of a weir structure that consists of two steel I-beams and wooden stop logs, that would have likely been used to control water levels upstream of the structure. This weir structure did not represent a significant barrier to fish movement at the time of assessment. Adjacent to the weir structure is an offline pond that outlets into the creek via corrugated steel pipe outlets, also shown in **Photo 3**.

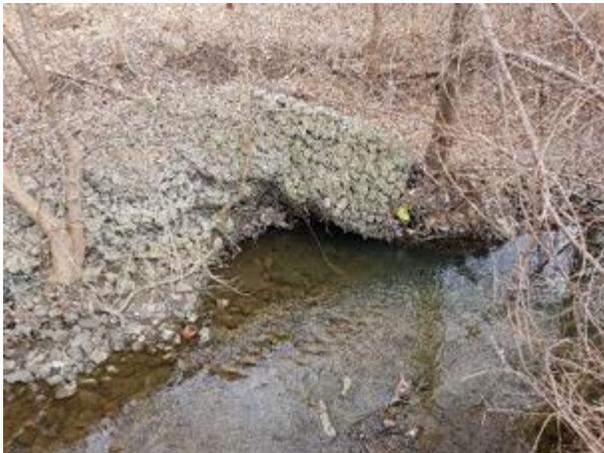
Photo 4. Typical Substrate.

The remainder of the habitat observed throughout the site consisted predominantly of shallow-to-medium-depth glides (hydraulic head of 4-7 mm), slow riffles (8-17 mm), and fast riffles (> 17 mm). Instream cover was fairly consistent throughout the site with much of it found to be in the form of unembedded round and flat rock, likely attributed to the failing gabion baskets that line the bank. Typical substrate is shown in **Photo 4** (with an example of a failing gabion bank shown in **Photo 5**). Instream vegetation was moderate at the time of assessment, consisting of filamentous algae and some macrophytes (**Photo 6**). Overhanging vegetation was observed to be minimal at the time of assessment since the banks were predominantly comprised of gabion baskets (**Photo 7**). However, some vines and dogwood contributed to shade/cover and three stretches of forested banks (**Photo 8**) are located along the watercourse. Throughout the study reach, riparian vegetation contributed to a canopy cover of 15%, since the vegetation community that is located along much of the length of the banks comprised maintained turf grass right up to the edge of the gabion-lined banks **Photo 7**. Substrate point particles consisted mainly of fine sand and gravel, with cobble comprising the maximum particle as depicted in **Photo 4**.

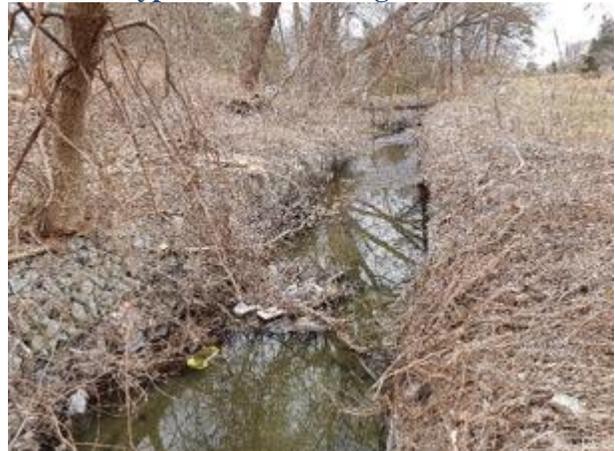
Photo 7. Typical Bank Composition.

As discussed, nearly all of the banks consist of gabion baskets, all of which observed to be leaning at an angle of 45 degrees or greater. The gabion baskets exhibit undercutting, which presents an acute risk of failure (as shown in **Photo 9**). Some gabions have already failed as discussed above.

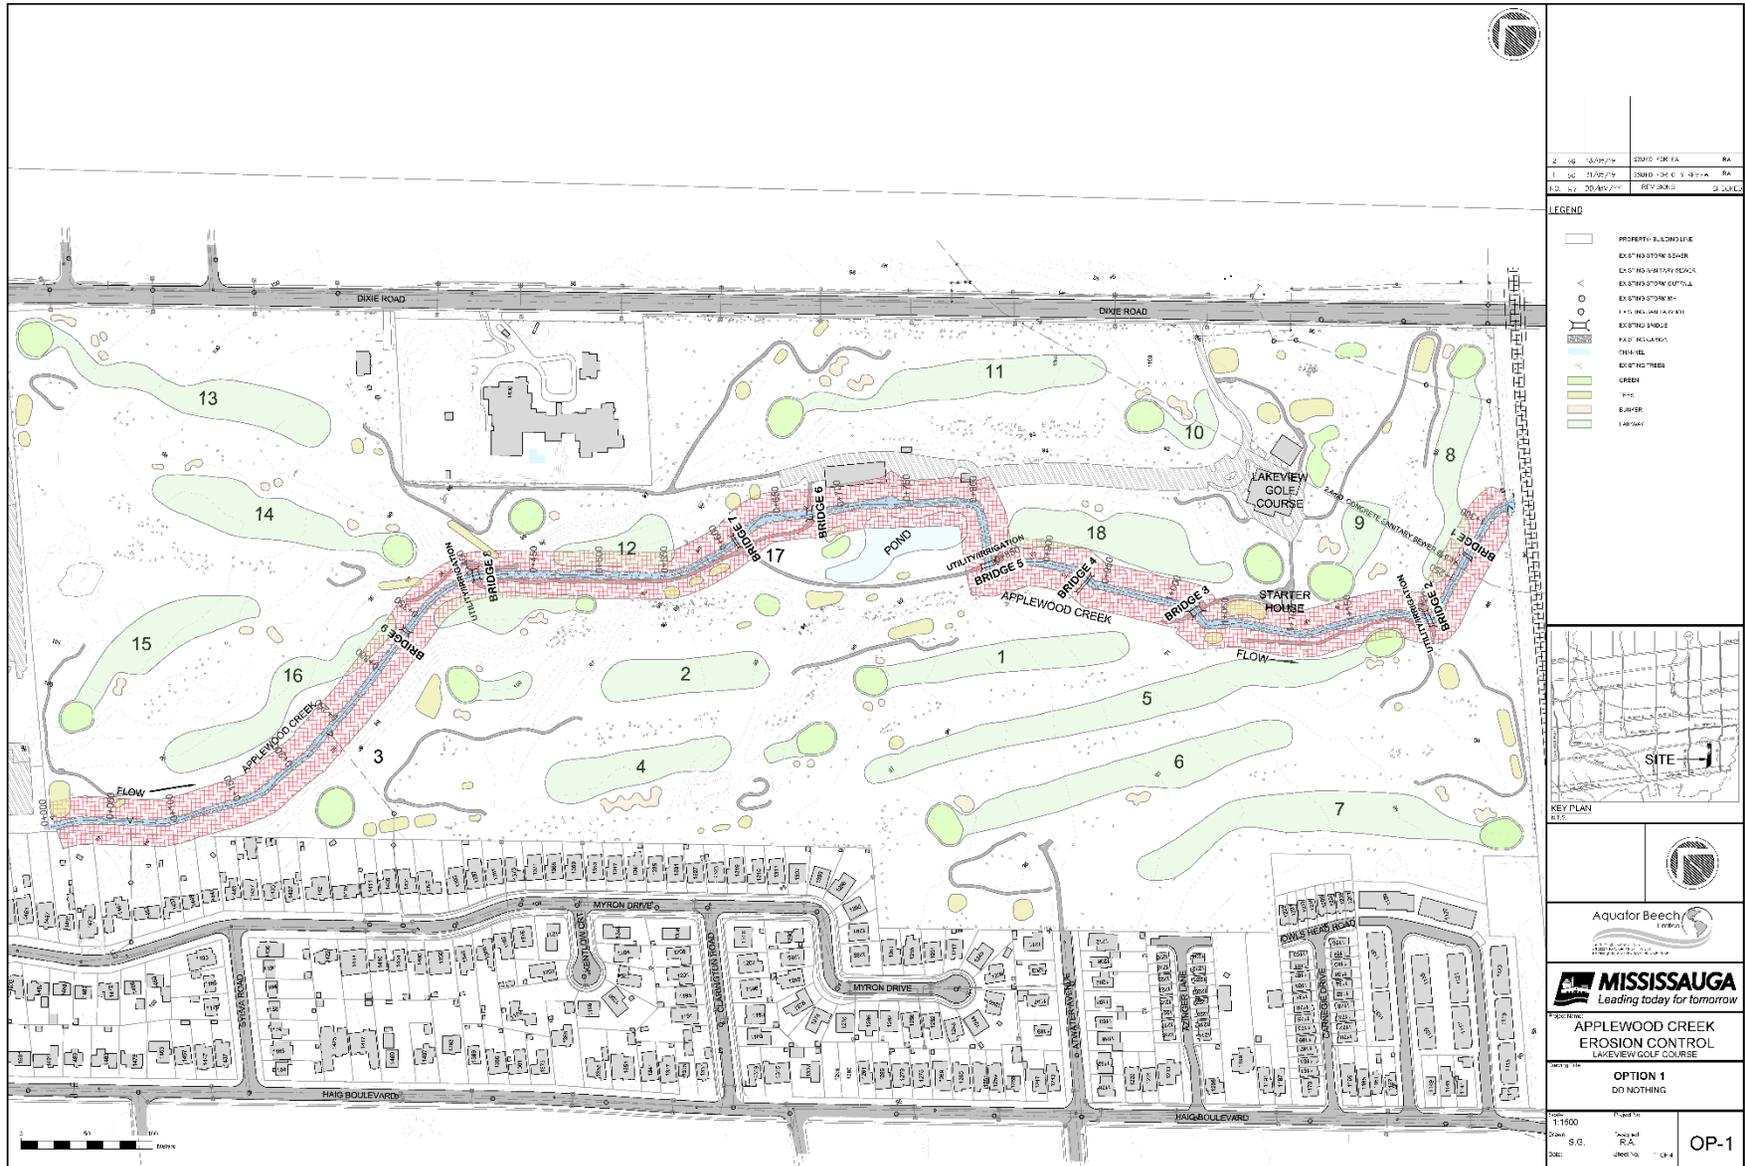
Figure 4-3. Alternative No. 1 – Do Nothing.

Figure 4-1 and Figure 4-2 included below depict the on-going deterioration of the gabion baskets and safety risks to the golf course users. A 10 m buffer has been applied to line that denotes the location of the existing banks of Applewood Creek in planform as shown in Figure 4-3. This figure also highlights the long-term erosion hazards.
