Appendix E **ARBORIST REPORT**

**Living Arts Drive Extension,
Mississauga, Ontario
Arborist Report**

165011016

November 20, 2017

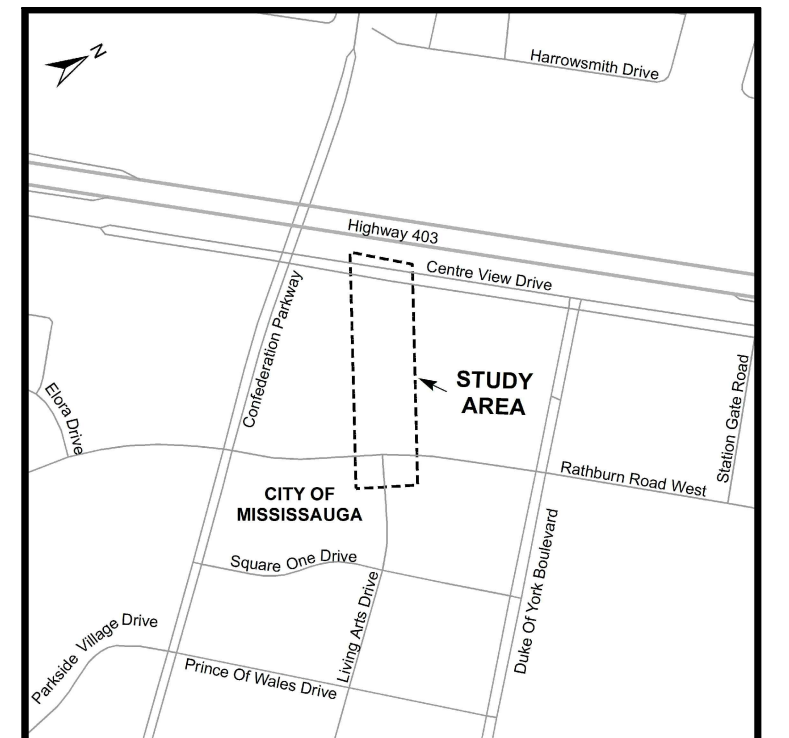
TABLE 1. Detailed Tree Inventory - Living Arts Drive, Mississauga, Ontario
Date: June, 14th 2017

Tag #	Botanical Name	Common Name	DBH (cm)	Dripline Radius (m)	Condition				Comments	Action
					Trunk Integrity	Crown Structure	Crown Vigour	Overall Condition		
261	<i>Gleditsia tricanthos var. inermis</i>	Honeylocust	23	3	G	G	G	G		Retain
262	<i>Gleditsia tricanthos var. inermis</i>	Honeylocust	23	3.5	G	G	G	G		Retain
263	<i>Gleditsia tricanthos var. inermis</i>	Honeylocust	16	2.5	G	G	G	G		Retain
264	<i>Gleditsia tricanthos var. inermis</i>	Honeylocust	13	2.5	P	G	G	P	Wound at base, will compromise growth of tree.	Remove
302	<i>Gleditsia tricanthos var. inermis</i>	Honeylocust	23	4	G	G	G	G		Remove
303	<i>Gleditsia tricanthos var. inermis</i>	Honeylocust	21	3.5	G	G	G	G		Remove
304	<i>Gleditsia tricanthos var. inermis</i>	Honeylocust	20	3	G	G	G	G		Remove
305	<i>Gleditsia tricanthos var. inermis</i>	Honeylocust	21	3.5	G	G	G	G		Remove
306	<i>Gleditsia tricanthos var. inermis</i>	Honeylocust	20	3	G	G	G	G		Remove

TOTAL TREES INVENTORIED:	44
TREES TO BE RETAINED:	8
TREES TO BE REMOVED:	36
Trees to be Removed (Good to Fair Condition):	29
Trees to be Removed (Poor Condition):	7
