Lisgar District Basement Water Infiltration Investigation Presentation of Final Report City of Mississauga

March 26, 2015

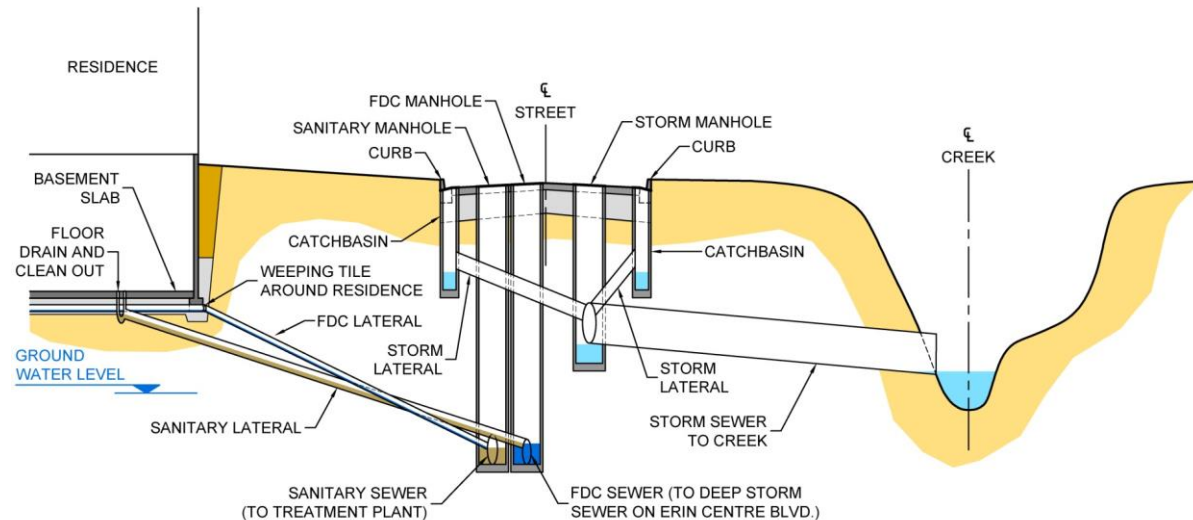
Cross-connection

- Groundwater levels
- Sanitary Sewer system
- Private Weeper System (cross-connections and weeping tile system condition)
- Stormwater Leakage to Utility Trench

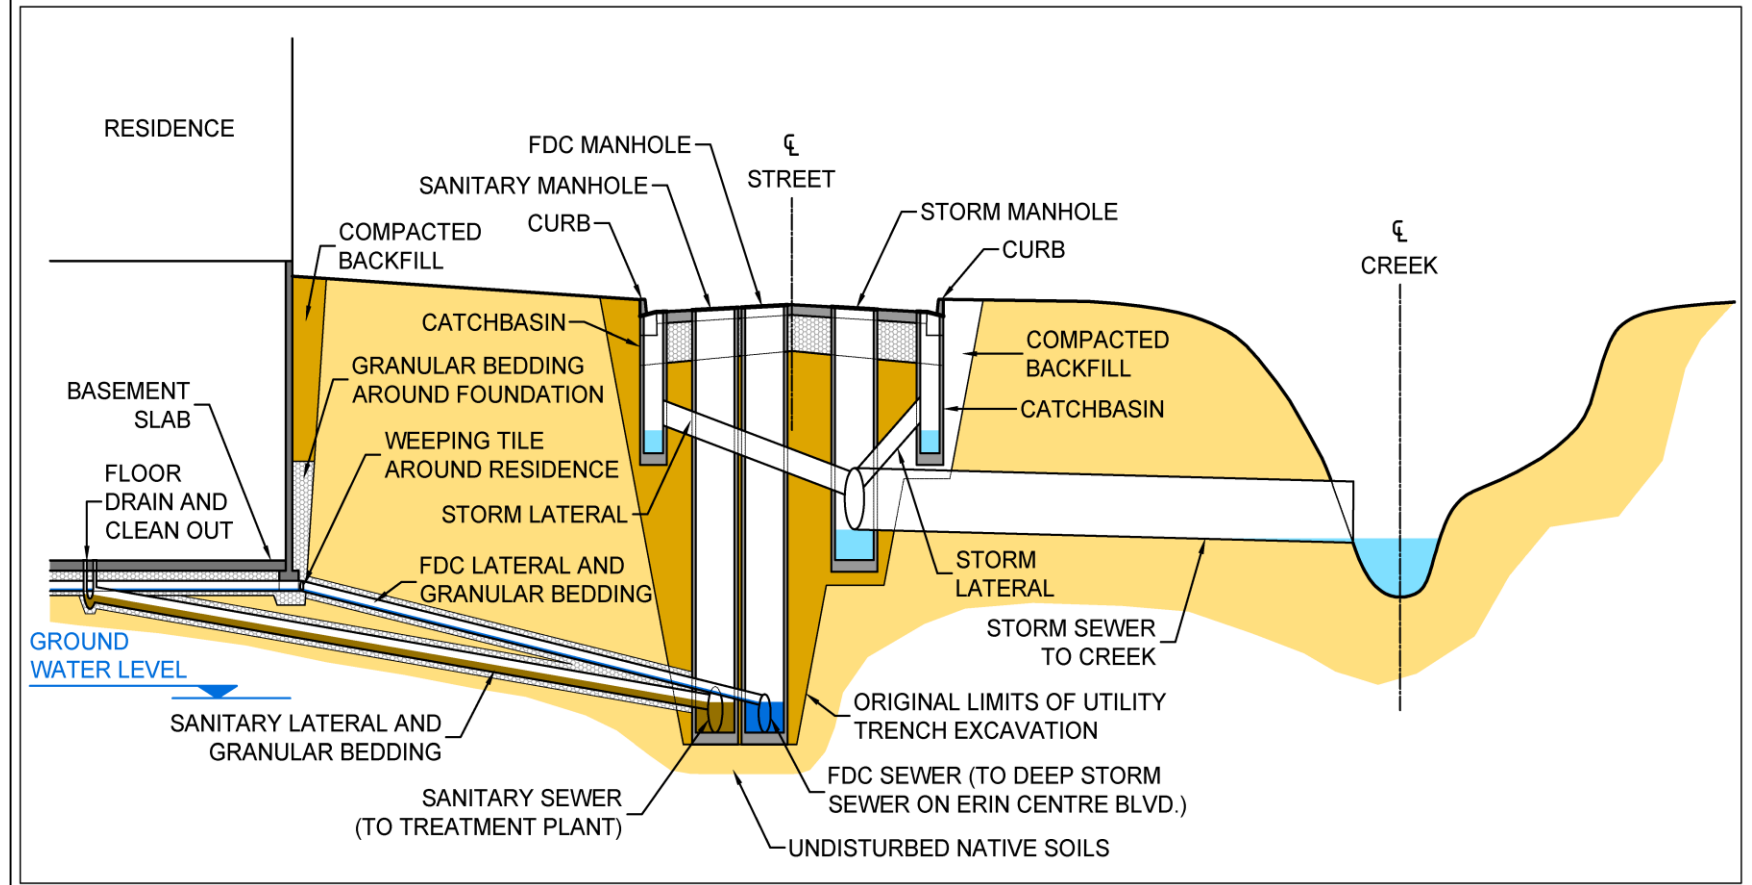
1. TYPICAL UTILITY TRENCH CROSS-SECTION

Primary Cause – Stormwater to the Utility Trench

- Leakage from the storm sewer system (which is a normal and expected occurrence), combined with the presence of slow draining native soils (around the utility trench) results in water build-up
- If the build-up of water is significant, it travels up the bedding material around the Foundation Drain Collector (FDC) laterals servicing the homes and into the foundation weeping tiles
- Water then drains directly into the FDC pipes through the weeping tiles which can surcharge (overload) the system
- This condition, in combination with certain storm conditions (preceding rainfall followed by a sufficiently large storm event) and local lot drainage may lead to water around the home's weeping tiles being unable to drain and potentially seeping into the basements of homes.
