**LISGAR DISTRICT  
BASEMENT WATER INFILTRATION INVESTIGATION  
SUMMARY REPORT**

**City of Mississauga**  
Mississauga, Ontario

**Amec Foster Wheeler Environment & Infrastructure**  
**A division of Amec Foster Wheeler Americas Limited**  
3215 North Service Road  
Burlington, ON L7N 3G2

**March 2015**

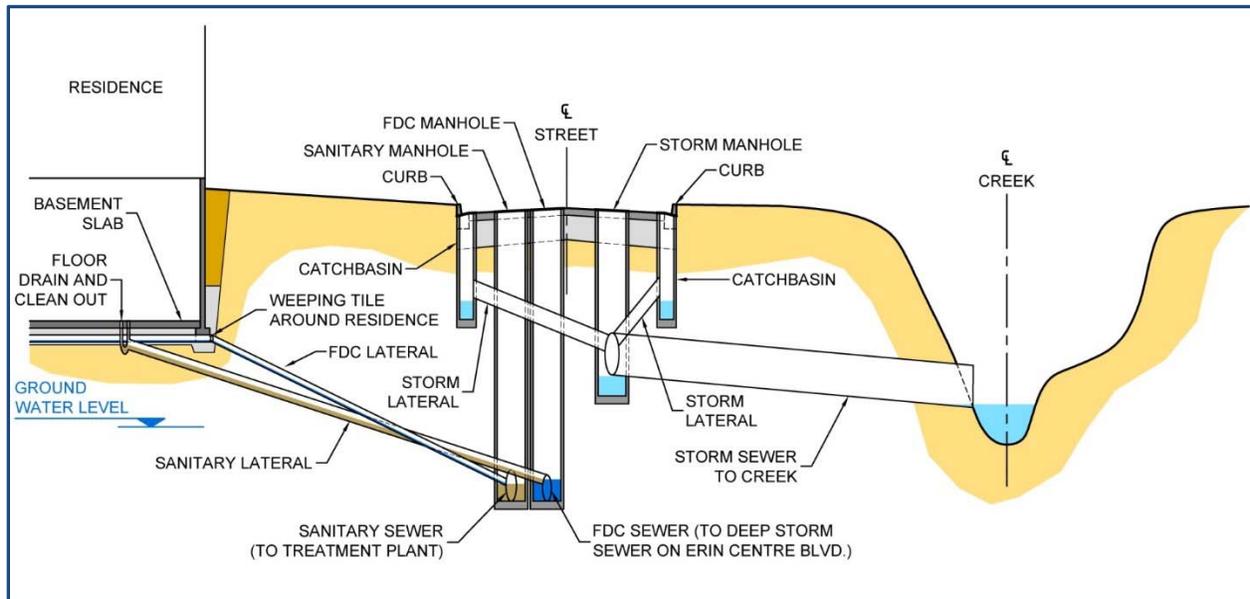
**Figure 7: Schematic of Sewer Cross-Connection**

The City used investigative techniques (video inspections and dye and smoke tests) to identify homes where cross-connections were suspected; specifically where a residential foundation drain is connected to the sanitary sewer system and the residential sanitary lead is connected to the FDC. Such an occurrence would be expected to increase flows to the FDC sewer system.

The investigation identified two cross-connections. Both have since been repaired.

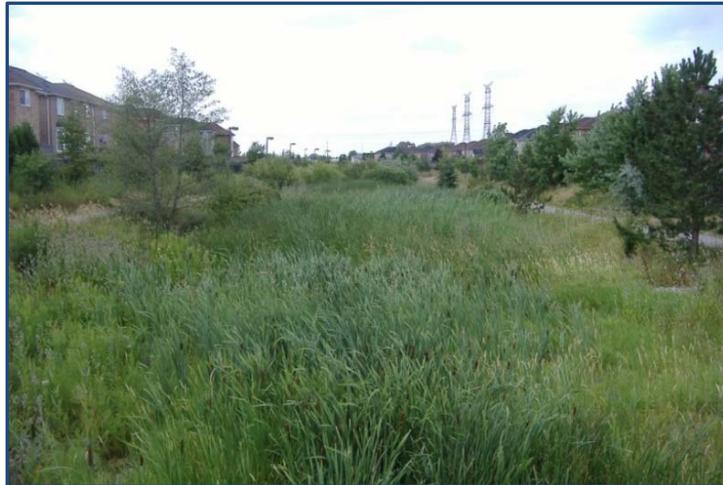
*Creek block maturing with vegetation*

As the vegetation along the tributary of the east branch of Sixteen Mile Creek has matured over time, the carrying capacity of this channel, which local storm sewers drain into, has reduced somewhat. This vegetation also traps sediment causing a further loss in capacity, and thereby reduces the efficiency of the tributary to move water. However, the FDC system that conveys water from the foundations of basements does not outlet into this tributary. Nevertheless, investigations were carried out to determine if there are other ways that the tributary may potentially contribute to the basement water infiltration issue.

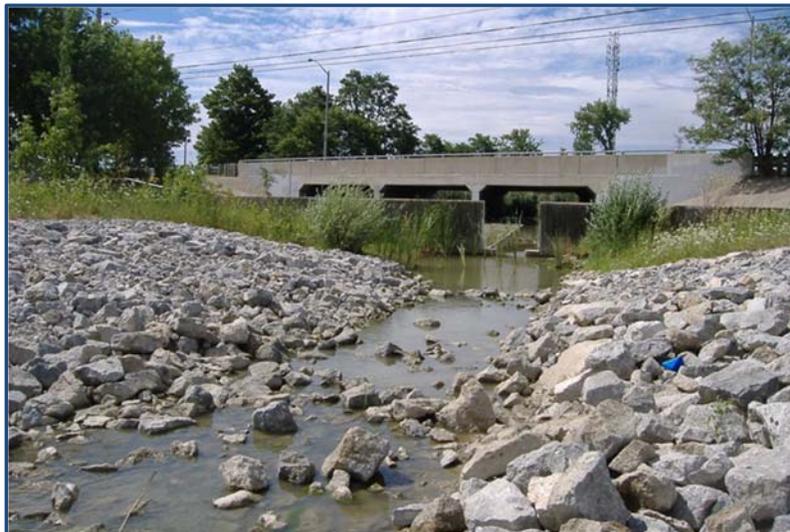
The Osprey Marsh Stormwater Management Pond has been seen by some residents as a barrier to water conveyance from the tributary of the east branch of Sixteen Mile Creek. However, the pond serves the dual purpose of providing water quality treatment and quantity control for the upstream development lands.

It should be noted that the FDC system that conveys water from the foundations of basements does not outlet into this pond. However, further investigation was carried out to determine if other connections exist between the pond and the basement water infiltration issue.

As previously mentioned, the City had a planned and approved capital project to remove and reconfigure the outlet structures of the Osprey Marsh Stormwater Management Pond, prior to the City becoming aware of the scale of water seepage in basements of homes. As a proactive measure, two outlet structures in the pond, which had accumulated sediment and vegetation resulting in a higher than normal water level (1 m +/-), were cleaned out to improve drainage from the pond. The City has since completed the capital project to reconfigure the outlet of the pond, further reducing the drawdown time of the pond following large rainfall events.

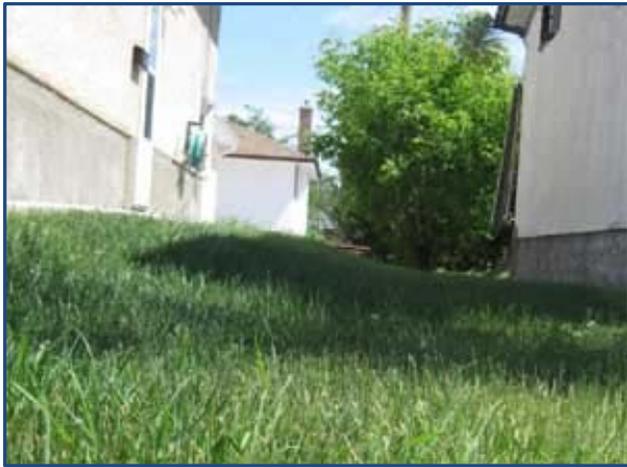
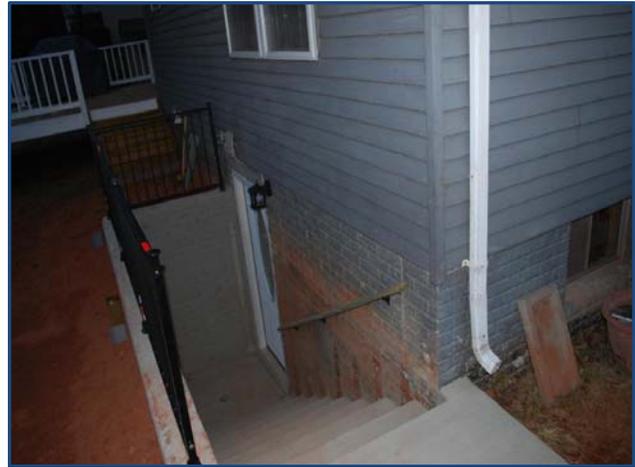
Changes to homes/properties (lot grades, basement walkouts)

Over time, lot grades may change due to the settlement of soils or through physical alterations by homeowners. Depending on this change, the grades on a property may allow water runoff to flow back towards the house, instead of away, thereby increasing the amount of water which may drain to the foundation. However, there is insufficient information to predict with any certainty the level of influence altered grades may have on the basement water infiltration issue.

There are also a significant number of homes in the Lisgar District in which basement walkouts have been built. Rain water and runoff from the lot or roof which flows into a basement walkout can contribute directly to the FDC system since this water may be collected by a drain connected to the home's weeping tiles. While the lack of available information has made it difficult to determine if basement walkouts have contributed to basement water infiltration, further analysis was undertaken based on assumptions regarding the level of influence basement walkouts may be having on the operation of the FDC system.
