Re: 3480 Havenwood Dr and 1480 Williamsport Dr (Ward 3)

Arborist Report – Construction/Tree Protection

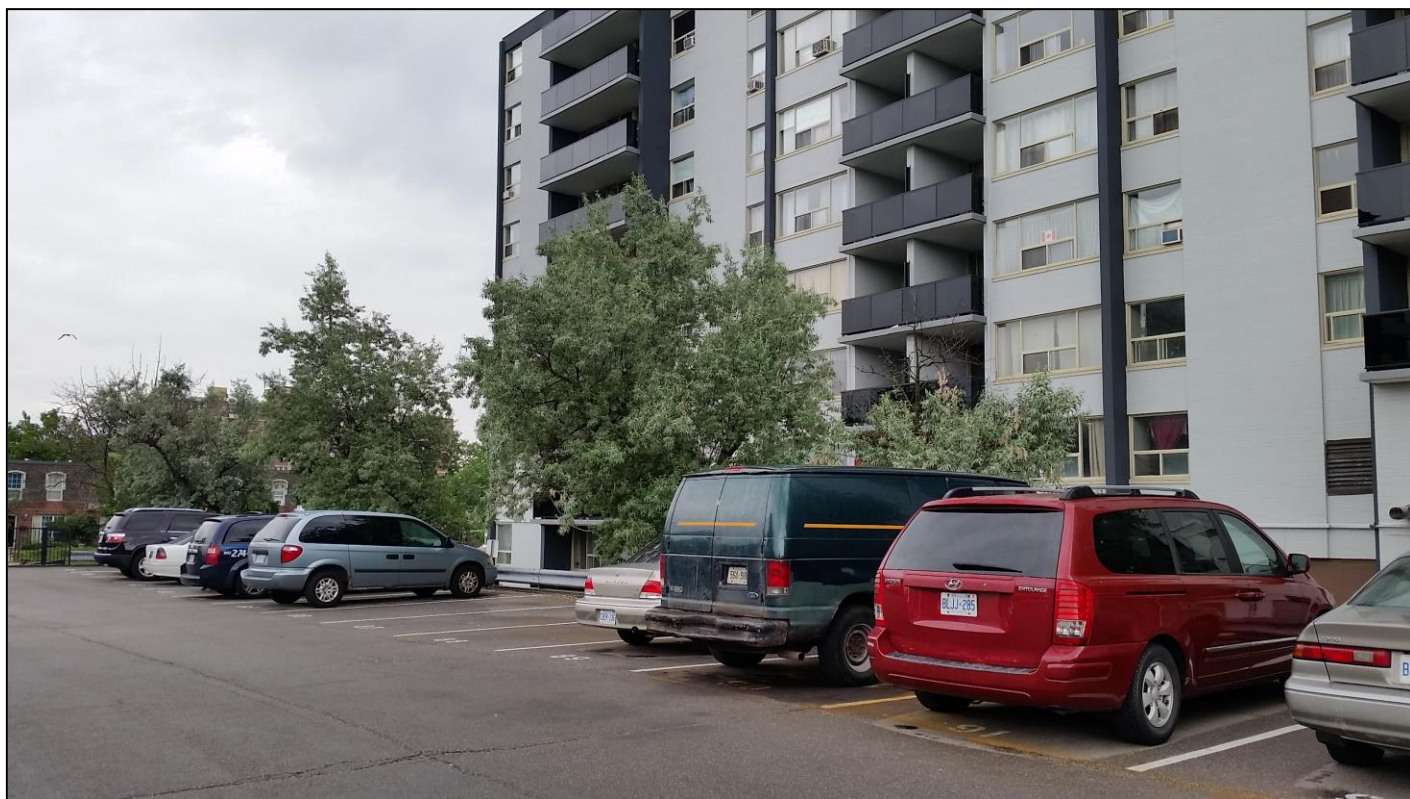
Photo 12: (Left to right) Trees 222, 221, 220A, 220, 219, 218, and 217.

221	Russian Olive	<i>Elaeagnus angustifolia</i>	Fair	Fair-Poor	1	22	1.8	Leans at 60 degrees, suckers throughout, base suckers.	Requires permit to be removed , due to new loading area
222	Russian Olive	<i>Elaeagnus angustifolia</i>	Fair	Fair	1	24, 22	1.8	co-dominant, small deadwood throughout, suckers.	Requires permit to be removed , due to new loading area
223	Ash	<i>Fraxinus sp.</i>	Poor	Fair	1	32	2.4	Mostly dead Emerald Ash Borer infested.	Recommended for removal
224	Ash	<i>Fraxinus sp.</i>	Poor	Fair	1	30	2.4	Mostly dead Emerald Ash Borer infested.	Recommended for removal
224A	Honey Locust	<i>Gleditsia triacanthos</i>	Good	Fair	3	9	1.2	Healthy	Requires permit to be removed , due to new curb cut
225	Ash	<i>Fraxinus sp.</i>	Dead	Poor	1	30	2.4	Dead	Recommended for removal
226	Ash	<i>Fraxinus sp.</i>	Poor	Fair	1	44	3.0	Emerald Ash Borer infested	Recommended for removal
227	Ash	<i>Fraxinus sp.</i>	Poor	Fair	1	34	2.4	Emerald Ash Borer infested	Recommended for removal

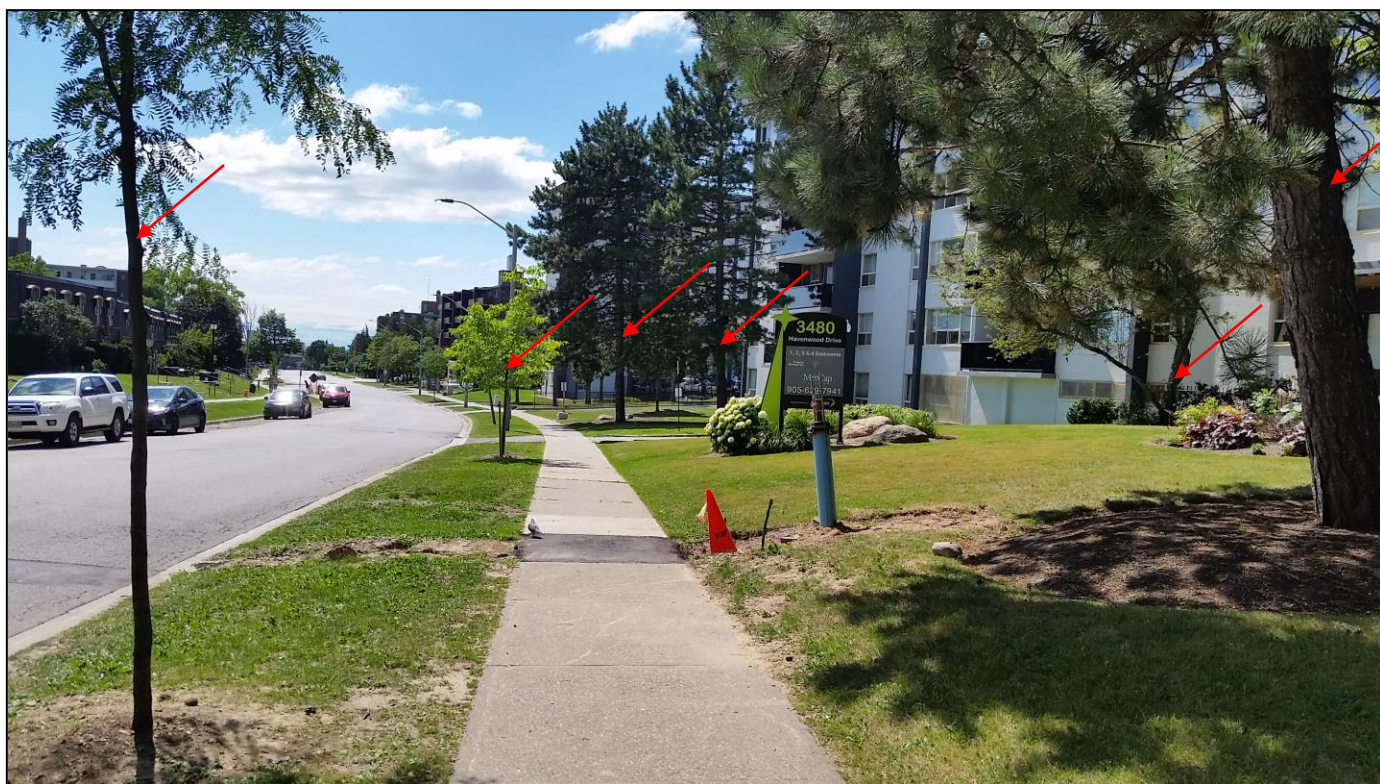
Photo 23: (Left to right) Trees 253A, 252A, 249, 250, 251, and 253.

249	Austrian Pine	<i>Pinus nigra</i>	Good -Fair	Good	1	39	2.4	Shaded, competition with #250	Fully protect
250	Austrian Pine	<i>Pinus nigra</i>	Fair	Fair	1	46	3.0	shaded by #249; canopy sparse, some diplodia	Fully protect
251	Crabapple	<i>Malus sylvestris</i>	Fair	Fair	1	24, 16, 19	1.8	Multi stemmed, suckers throughout, sparse, leafspots, dead leader, included bark	Not affected by proposed construction
252	Manitoba Maple	<i>Acer negundo</i>	Good -Fair	Fair	1	63	4.2	Leans, suckers throughout, sparse, lots of cracks, old failures	Not affected by proposed construction
252A	Hackberry	<i>Celtis occidentalis</i>	Good	Good	3	8	1.2	Healthy	Not affected by proposed construction
253	Austrian Pine	<i>Pinus nigra</i>	Fair	Fair	1	44	3.0	co-dominant stem, small dead wood throughout	Not affected by proposed construction
253A	Honey Locust	<i>Gleditsia triacanthos</i>	Good	Good	3	8	1.2	Healthy	Not affected by proposed construction

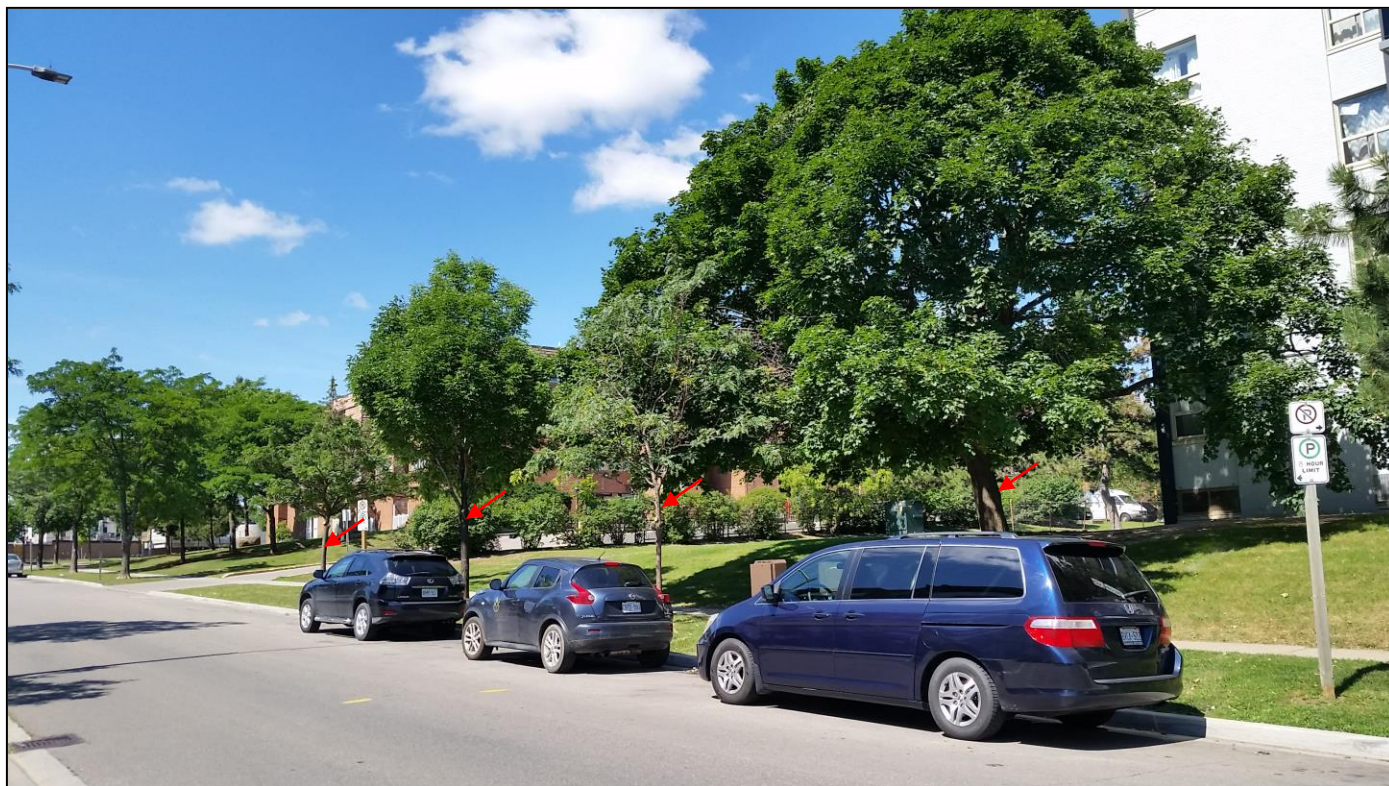
Photo 26: (Left to right) Trees 243E, 243F, 243G, and 243.

Tree #	Species	Latin Name	Health	Structure	Category	DBH (cm)	TPZ (m)	Comments	Recommended Action
243	Norway Maple	<i>Acer platanoides</i>	Good -Fair	Fair	1	57	3.6	Girdling, Small dead wood throughout, some large deadwood	Fully protect
244	Austrian Pine	<i>Pinus nigra</i>	Good -Fair	Fair	1	50	3.0	Sparse, small dead wood throughout, leaning	Not affected by proposed construction
245	Austrian Pine	<i>Pinus nigra</i>	Fair	Fair	1	42	3.0	Sparse, small dead wood throughout, leaning, diplodia	Not affected by proposed construction
245A	Mulberry	<i>Morus Nigra</i>	Good	Good	0	14.5	1.8	Healthy	not permit sized
245B	Honey Locust	<i>Gleditsia triacanthos</i>	Good	Fair	3	44	3.0	Vertical seam, small dead wood throughout	Not affected by proposed construction
245C	Ash	<i>Fraxinus sp.</i>	Fair	Good	3	12	1.8	Base wound, top dieback, bark peeling, leaves are unusually shaped, Emerald Ash Borer infested	Not affected by proposed construction
