Lakeview Village Shoreline Hazard Assessment

Mississauga

January 14 2019 | 13012.101

Baird.
Innovation Engineered.

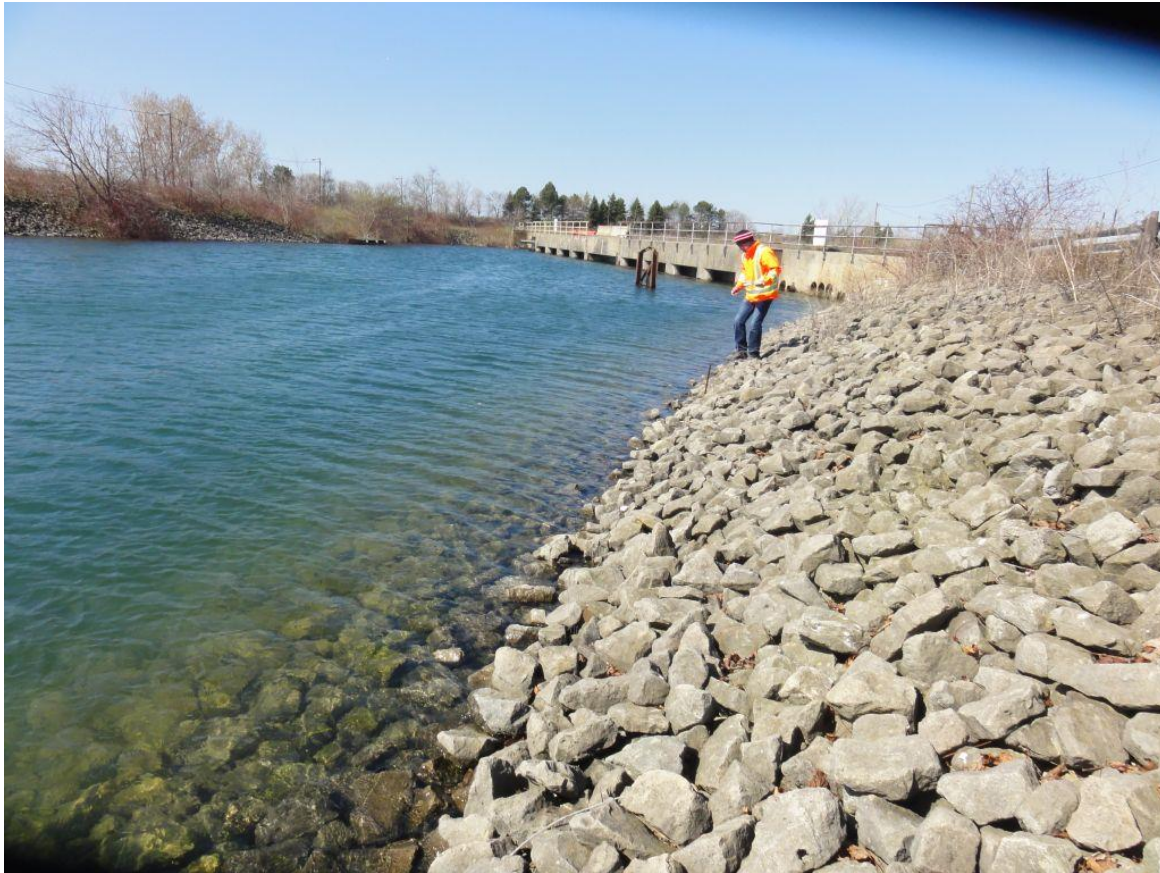
Figure 2.9: Site reconnaissance of riprap slope protection at Intake Forebay/Channel North

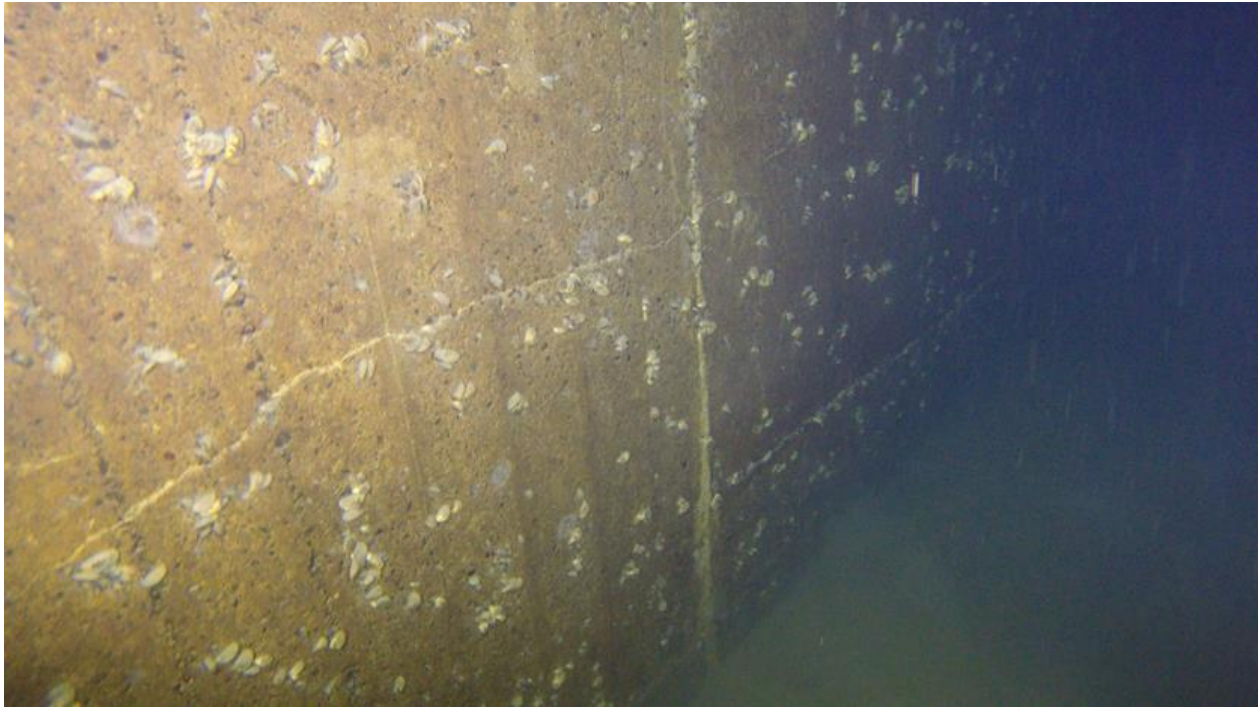
Baird's submersible remote operated vehicle (ROV) (Figure 2.21) was used to examine some of the underwater marine structures, including the steel inlet grates at a pumphouse intake structure and portions of the interior of the concrete discharge tunnels (see Figure 2.22). An expanded ROV and diving investigation of the discharge tunnels is planned in January 2019.

Figure 2.22: ROV view of interior concrete wall in discharge tunnel

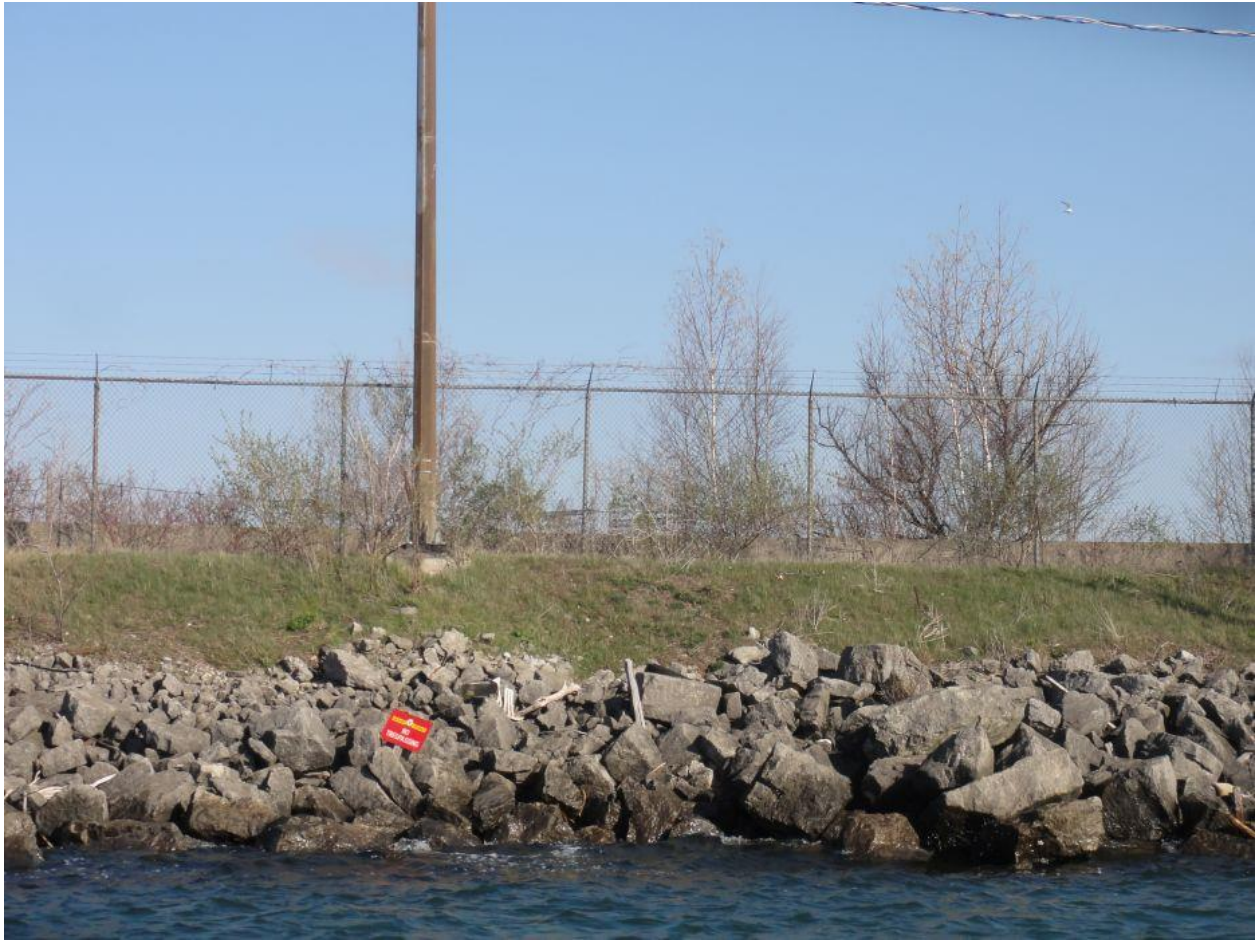
Figure 2.25: View from water of typical protection at easterly portion of Outer Shore (OS184 to OS590)

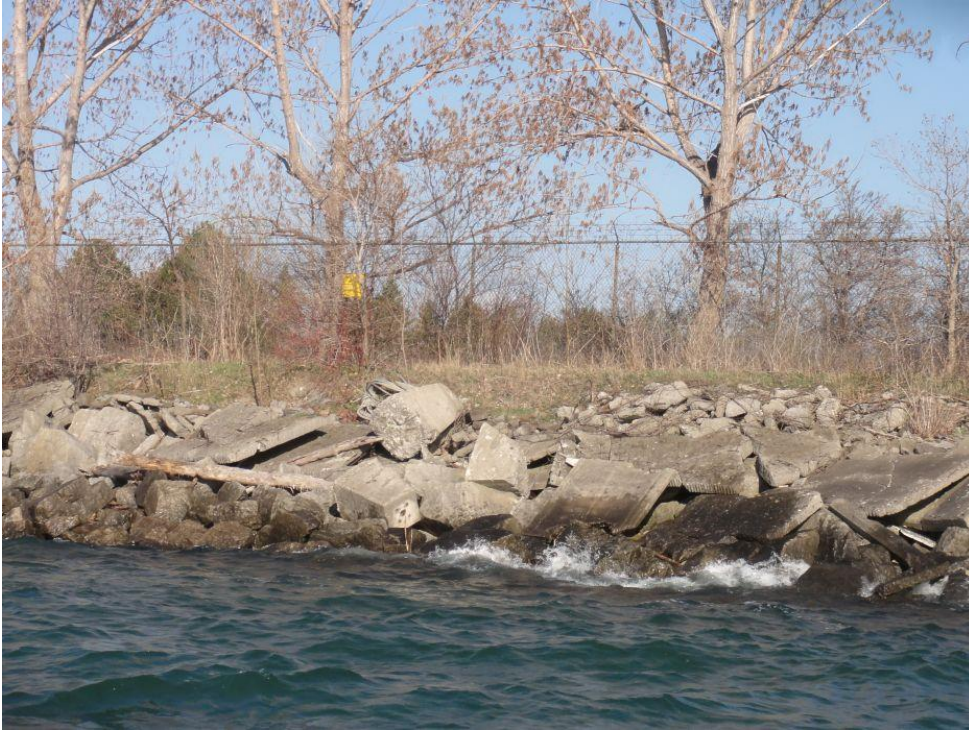
The shoreline protection at the site generally appears to be in satisfactory to good condition and remains functional; the westerly portion of the Outer Shore shows some evidence of deterioration and will require repairs and upgrades. Where required, the existing shoreline protection will be upgraded and incorporated into the new shoreline design in accordance with accepted engineering practice. The design life of the new protection will be 60 years. The works will be designed by a professional engineer with experience and qualifications in coastal engineering.

Figure 2.30: Example of concrete rubble on revetment at westerly portion of Outer Shore

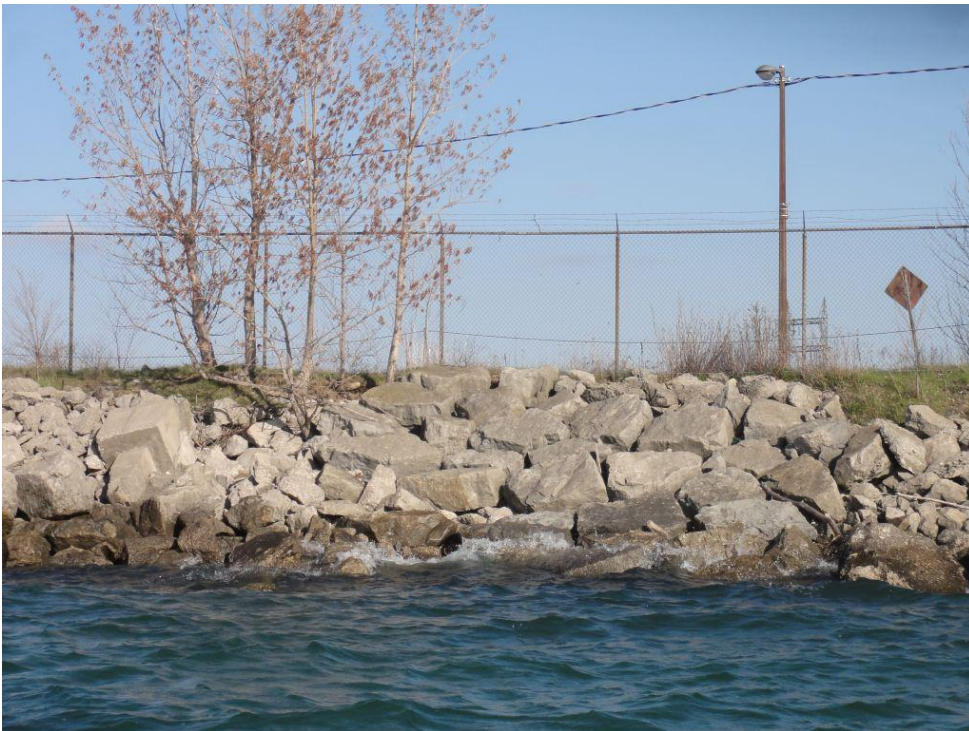
Figure 2.31: Example of additional armour stone on shoreline protection at westerly portion of Outer Shore

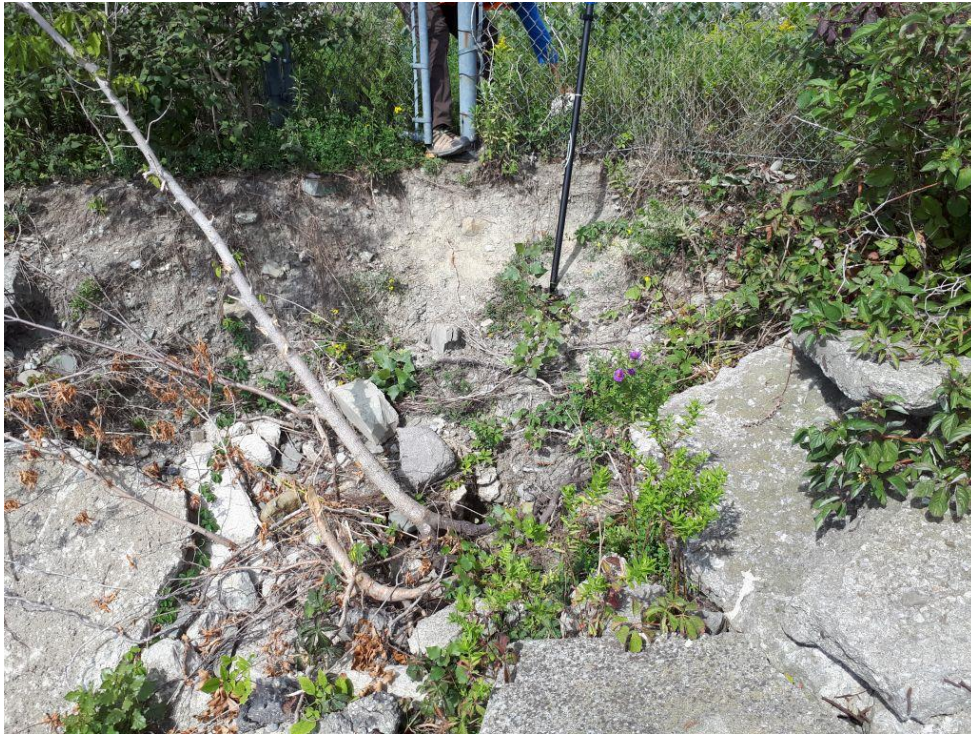
Figure 2.32: Localized wave uprush erosion at top of slope at westerly portion of Outer Shore

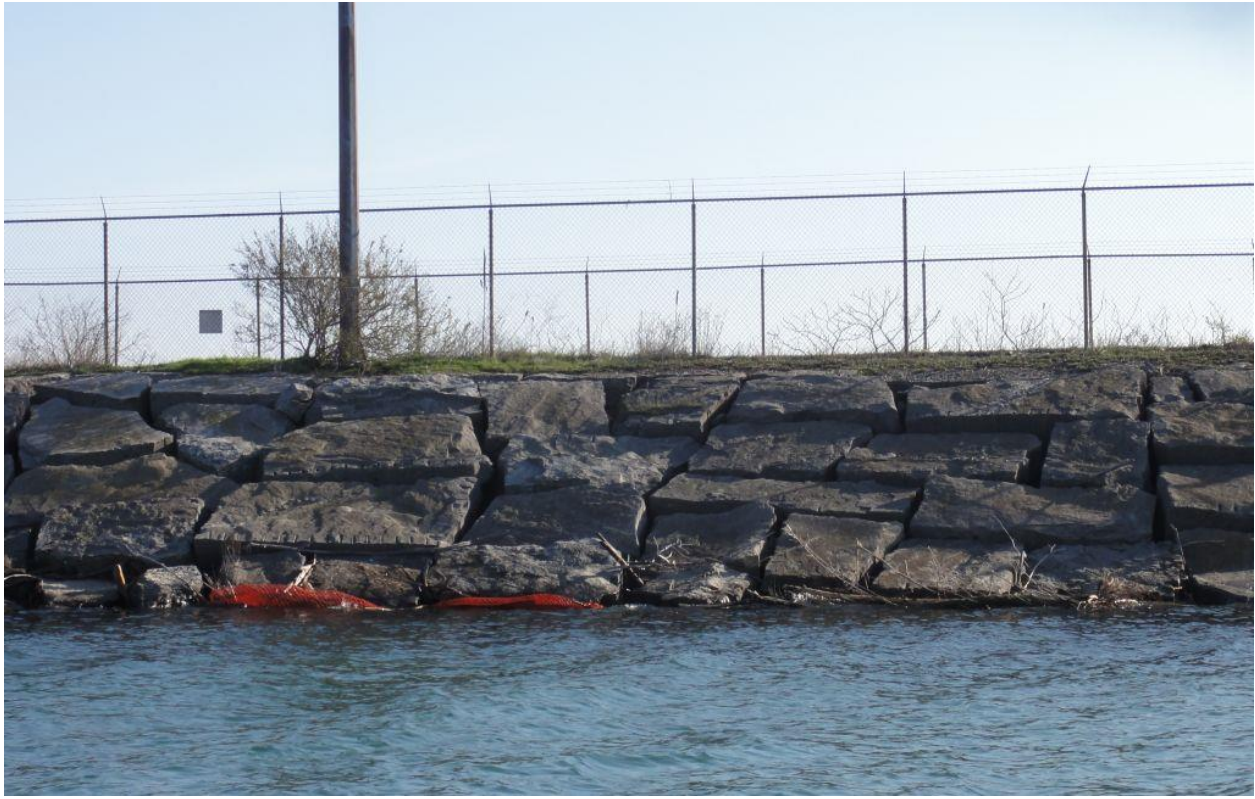
Figure 2.36: View from water of large, tightly placed armour stone on west side of Western Pier rubble mound mole

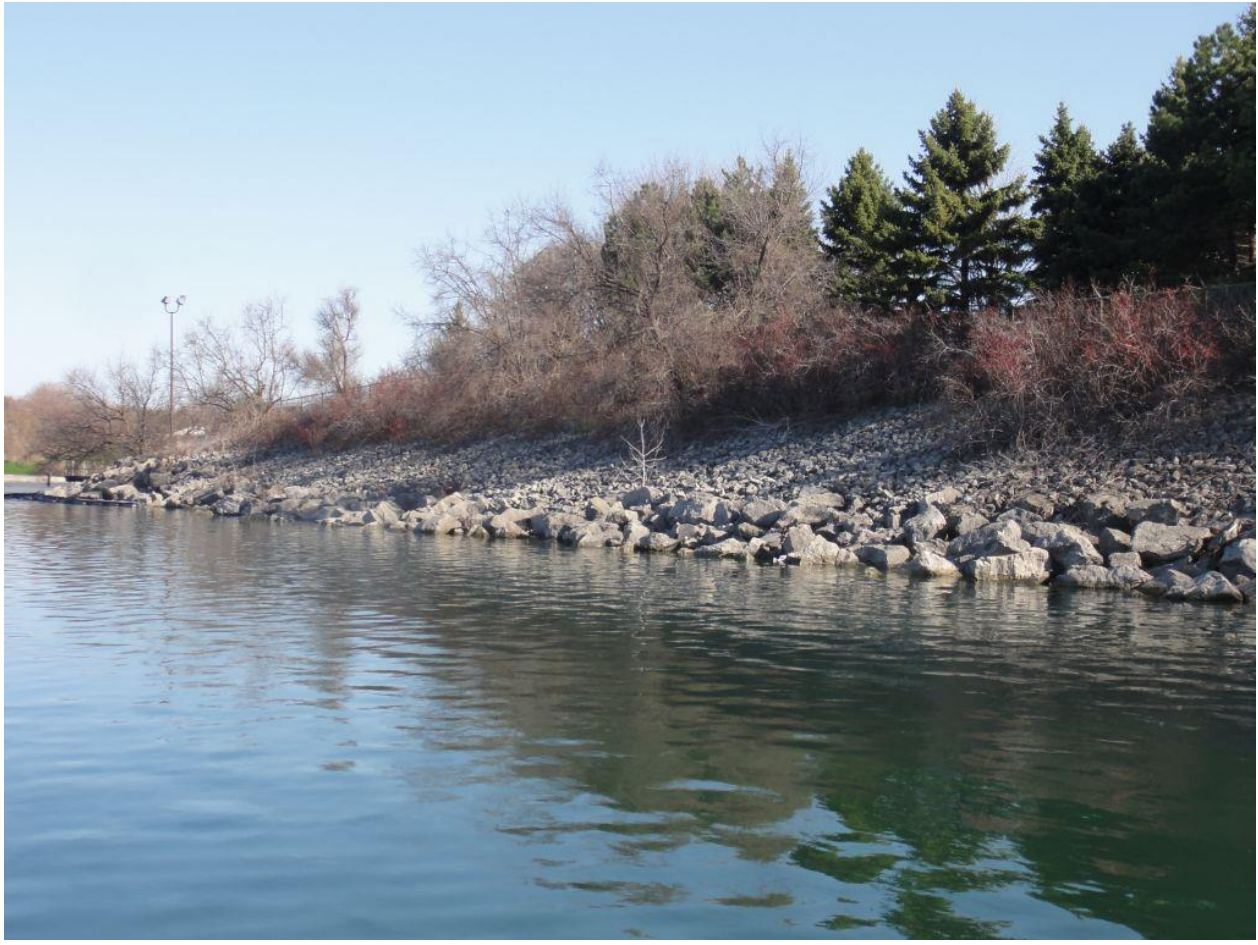
Figure 2.38: View from water of West Shoreline with armour stone at water's edge and riprap up the slope

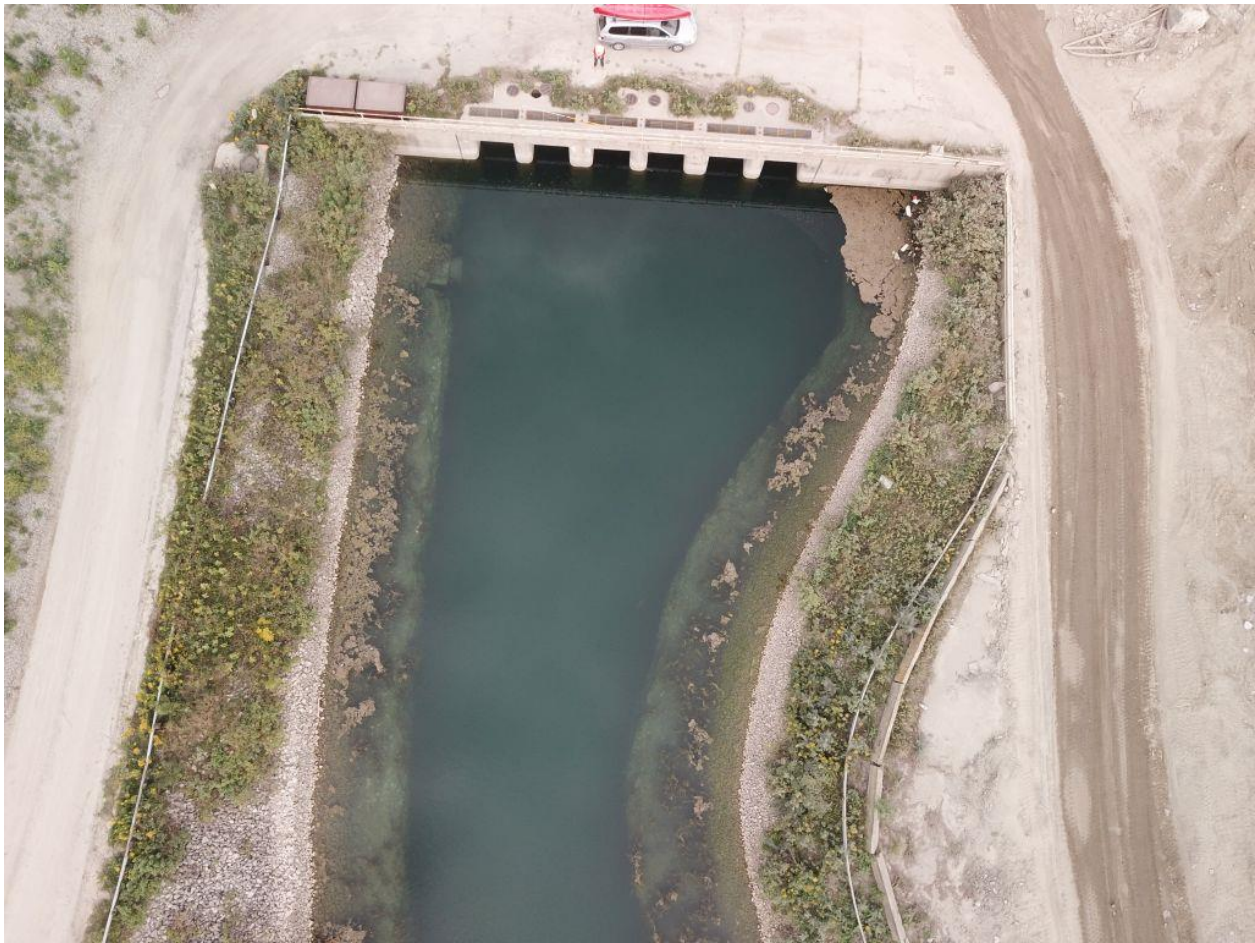
The Discharge Channel East Side extends approximately 180 m from the concrete discharge tunnel headwall (for powerhouse Units 1 to 6) at the head of the channel (approximately DE000 to DE030; Figure 2.42) and along the southeast side of discharge channel to just beyond the second concrete discharge headwall and wingwall for powerhouse Units 7 and 8 (at approximately DE154 to DE164).

Figure 2.42: Headwall for discharge tunnels (Units 1 to 6) and channel excavated into bedrock

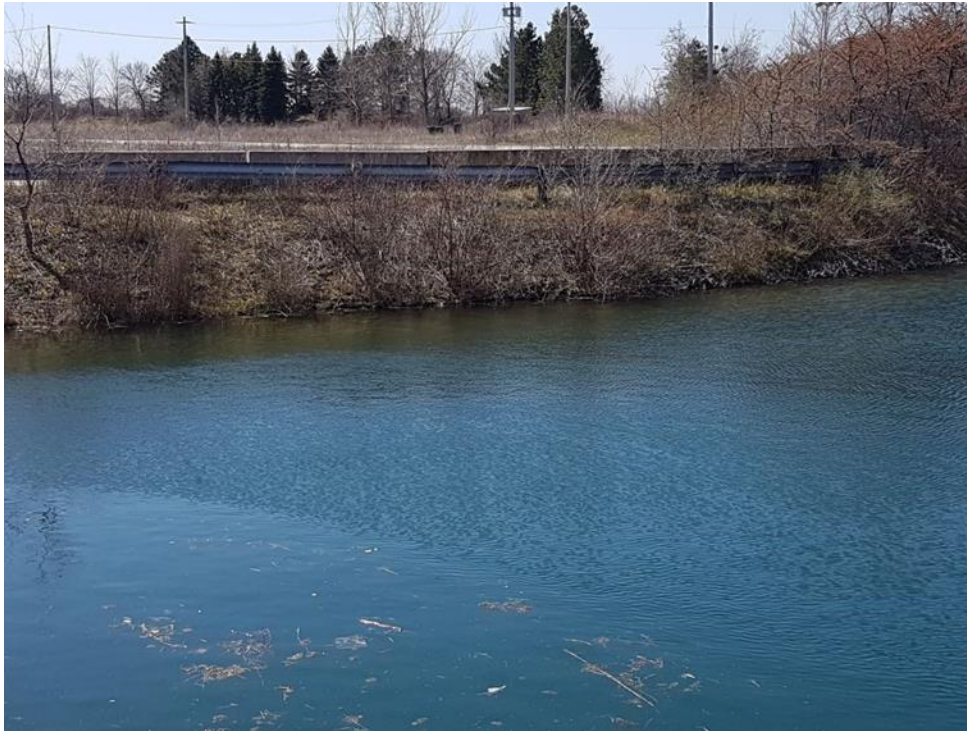
The shoreline protection along the east side consists of a sloping riprap revetment with extensive vegetation established on the slope (Figure 2.43). The top elevation of the stone protection is adequate. From the historical drawings¹³, the toe of the revetment slope is founded on a bedrock bench at elevation 73.9 m (242.5 ft) which has been cut down below the natural bedrock elevation (Figure 2.44). As noted, the discharge channel is cut down deeper into the bedrock. The riprap shore protection is not exposed to wave action and there is no longer any flow in the discharge channel. The shore protection is in good condition and can readily be incorporated into the Masterplan for the shoreline in accordance with accepted engineering practice and landscape design. Naturalization features and aquatic habitat elements will be incorporated into the protection works where appropriate. The design life of the new protection will be 60 years.

Figure 2.43: Discharge Channel East –riprap with extensive vegetation

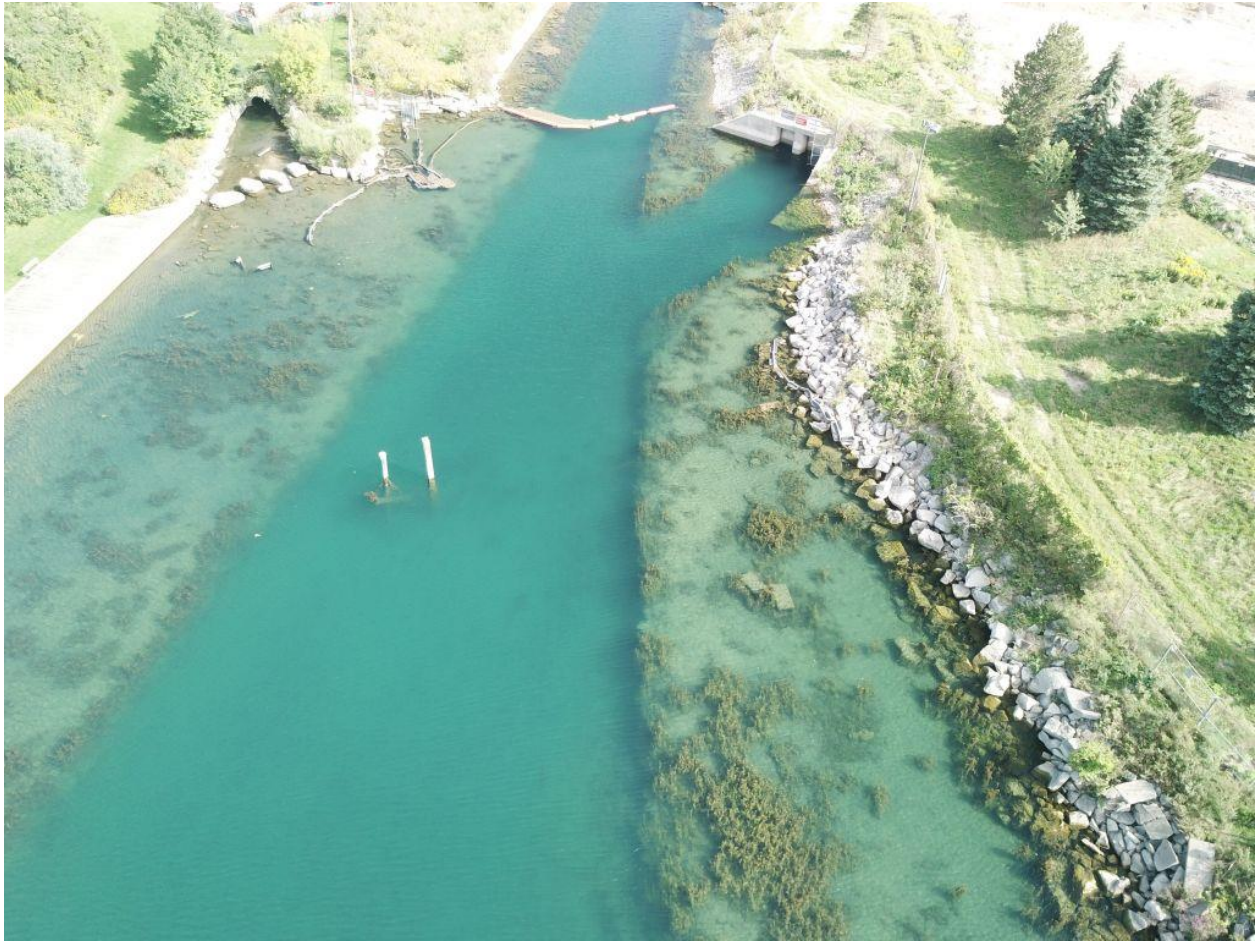
Figure 2.45 shows the concrete headwall for the discharge tunnels from Units 7 and 8. Other miscellaneous structures (e.g., boom dock) at the shore will likely have to be removed for public safety and aesthetics.

Figure 2.45: Discharge Channel East – concrete headwall for Units 7 and 8 (right hand side of photo)

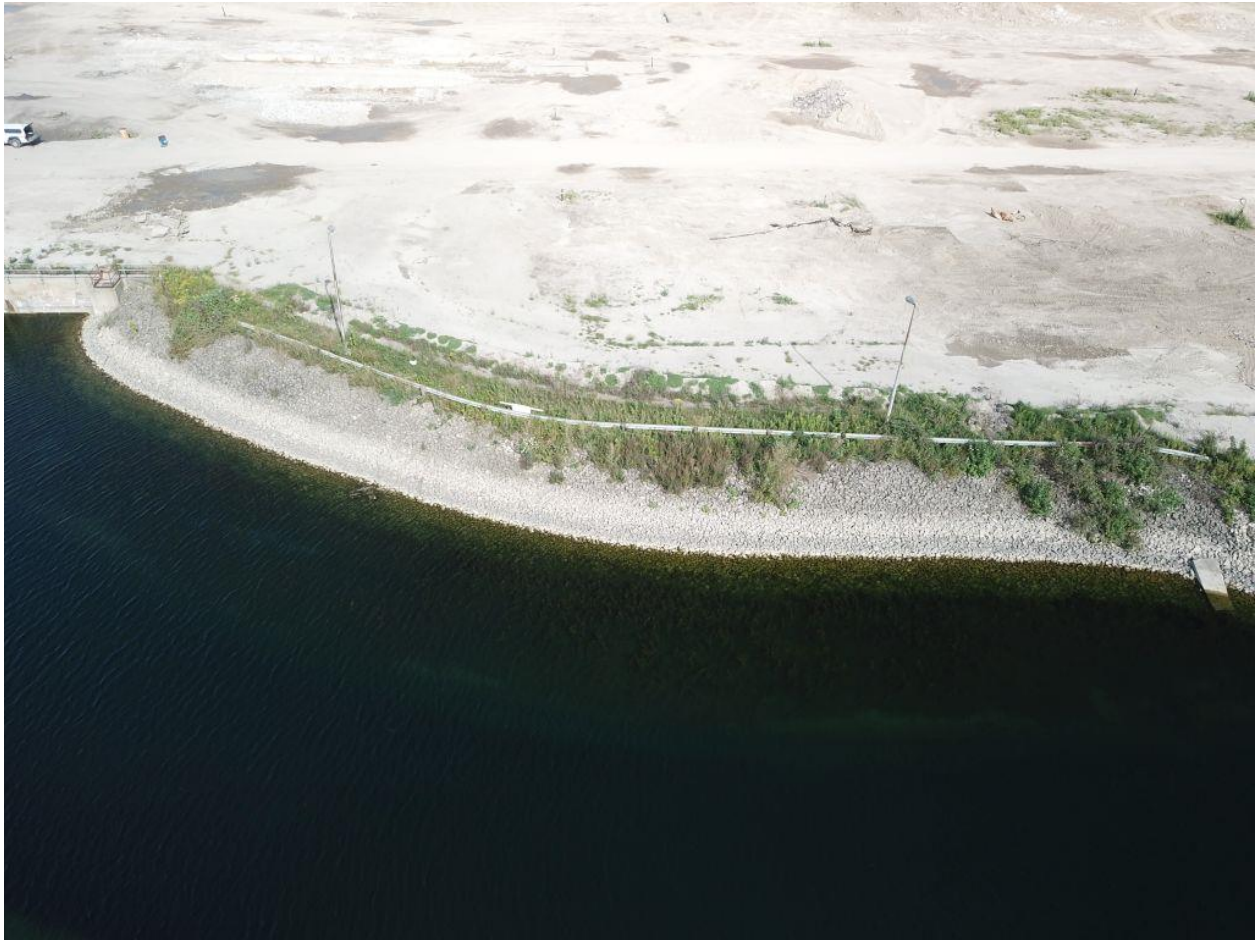
Overall, the riprap shore protection at Inner Forebay North is in good condition and has adequate crest elevation for wave runup and overtopping protection. The existing protection work will be upgraded and incorporated into the shoreline Masterplan in accordance with accepted engineering practice with a design life of 60 years. Naturalization features and aquatic habitat elements will be incorporated into the protection works where appropriate.

Figure 2.49: Riprap slope protection at west end of Intake Forebay/Channel North (IFN680 to IFN740)

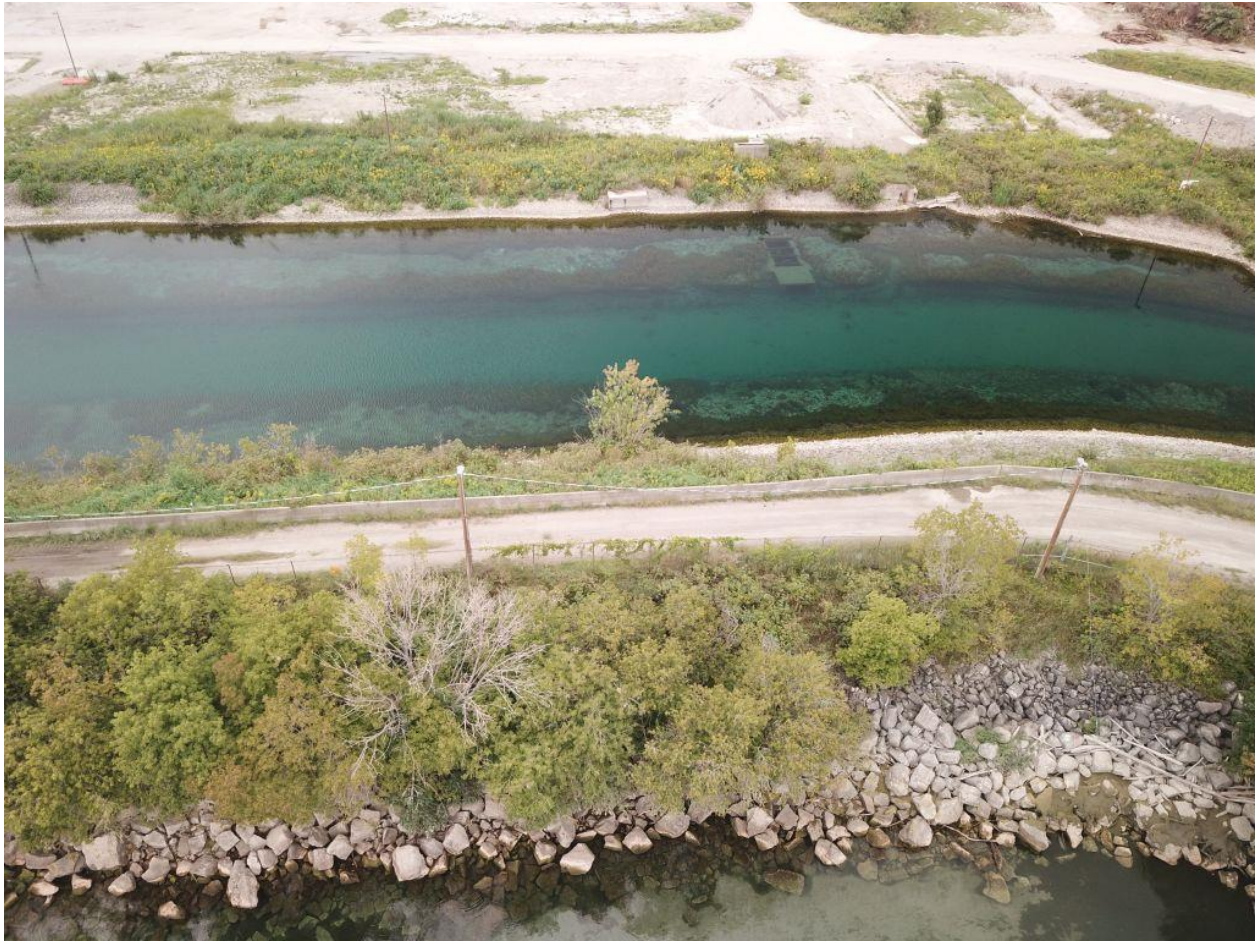
Figure 2.50: Riprap slope protection at east end of Intake Forebay/Channel North (background of photo; Outer Shore in foreground)

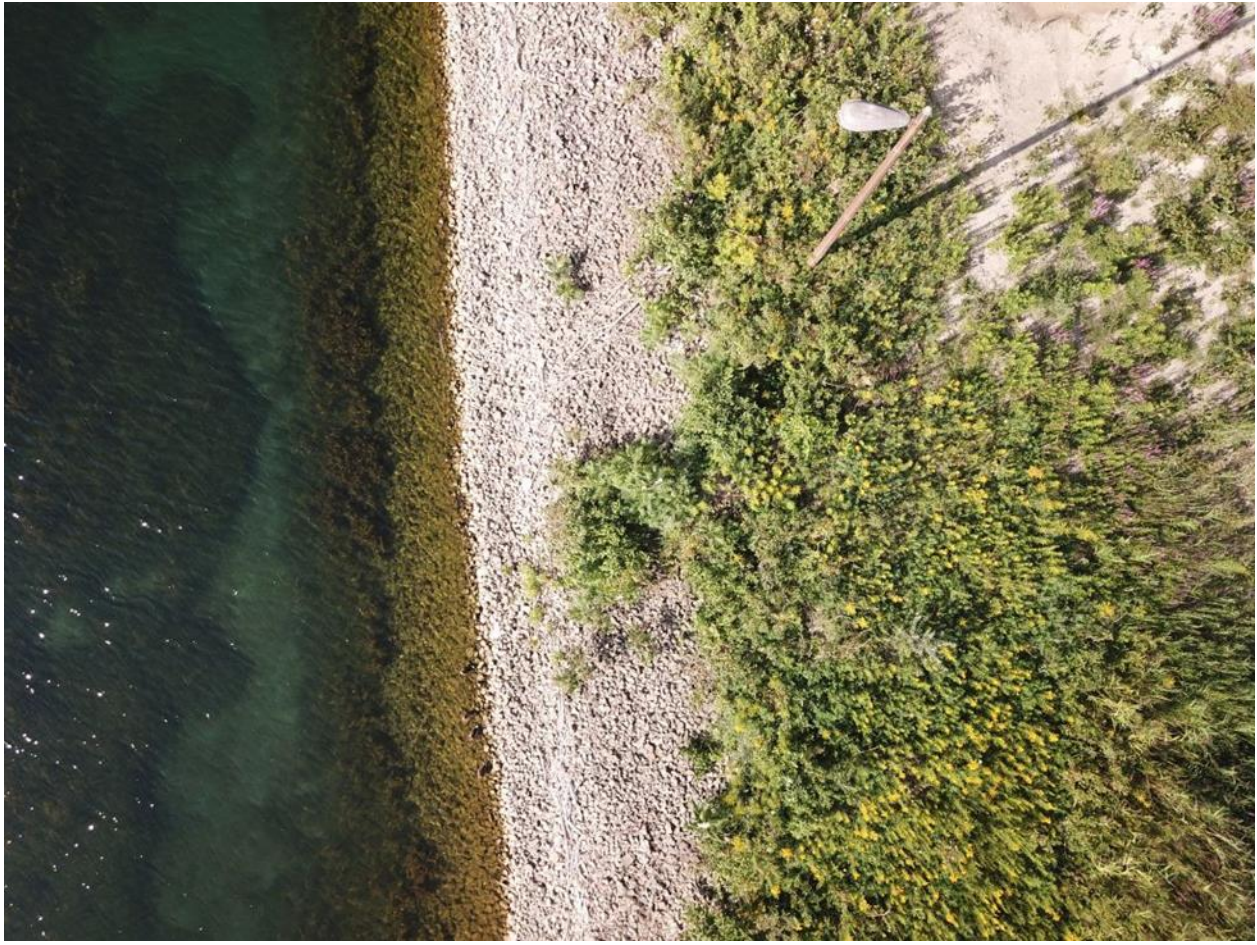
Most of the IFN shoreline is not exposed to lake wave action or potential erosion except near the easterly end where waves travelling northwards between the West and East Piers can reach the shore. Figure 2.52 shows the typical riprap slope protection on the sheltered north side of the intake channel. Figure 2.53 shows the riprap stone size between IFN660 and IFN735. The riprap does vary in size and top elevation at the more exposed location at the easterly end; here the size of the stone protection is larger (Figure 2.54, Figure 2.55 and Figure 2.56).

Figure 2.52: Riprap slope protection at Intake Forebay/Channel North

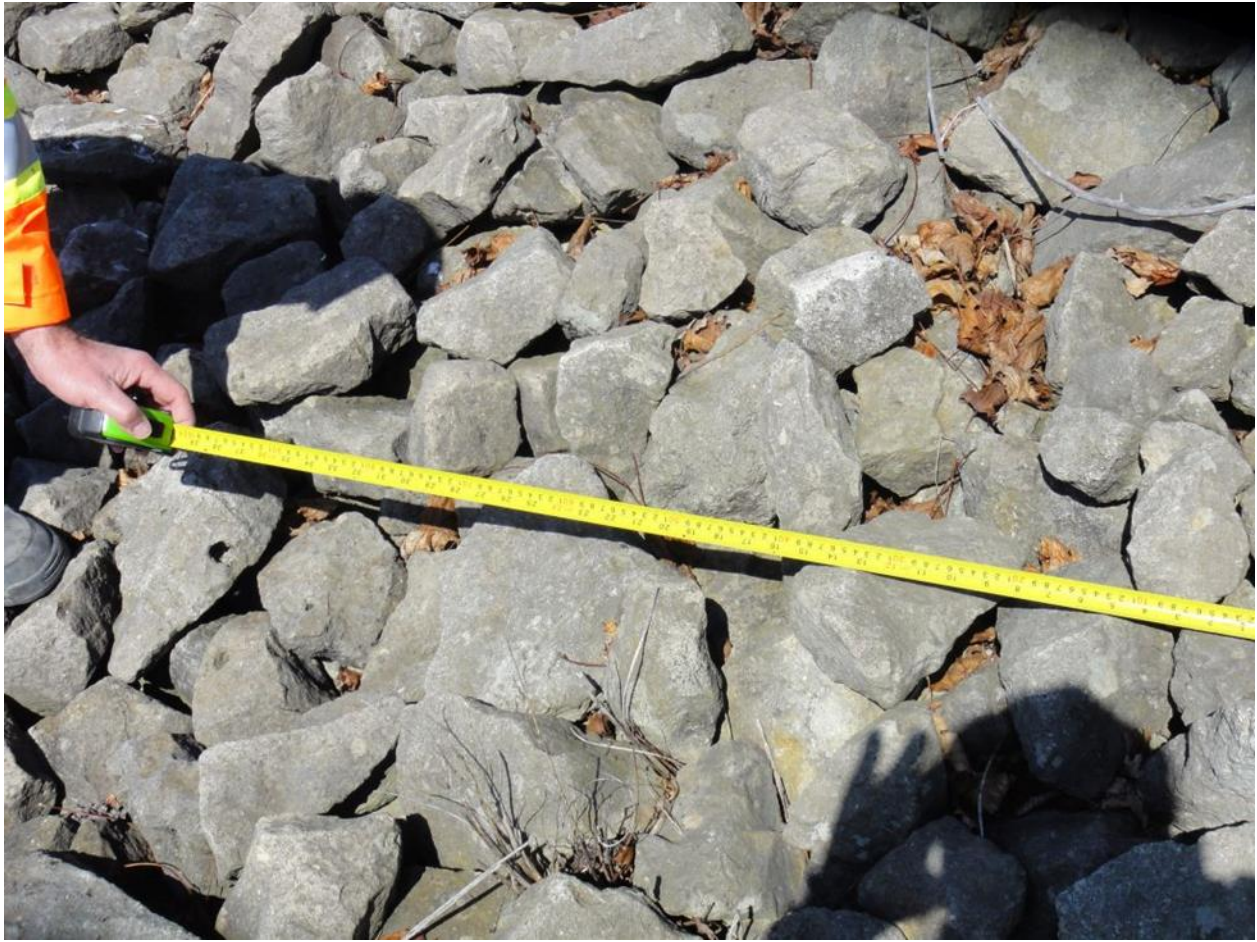
Figure 2.53: Example of riprap stone size at revetment along Intake Forebay/Channel North (between IFN660 and IFN735)

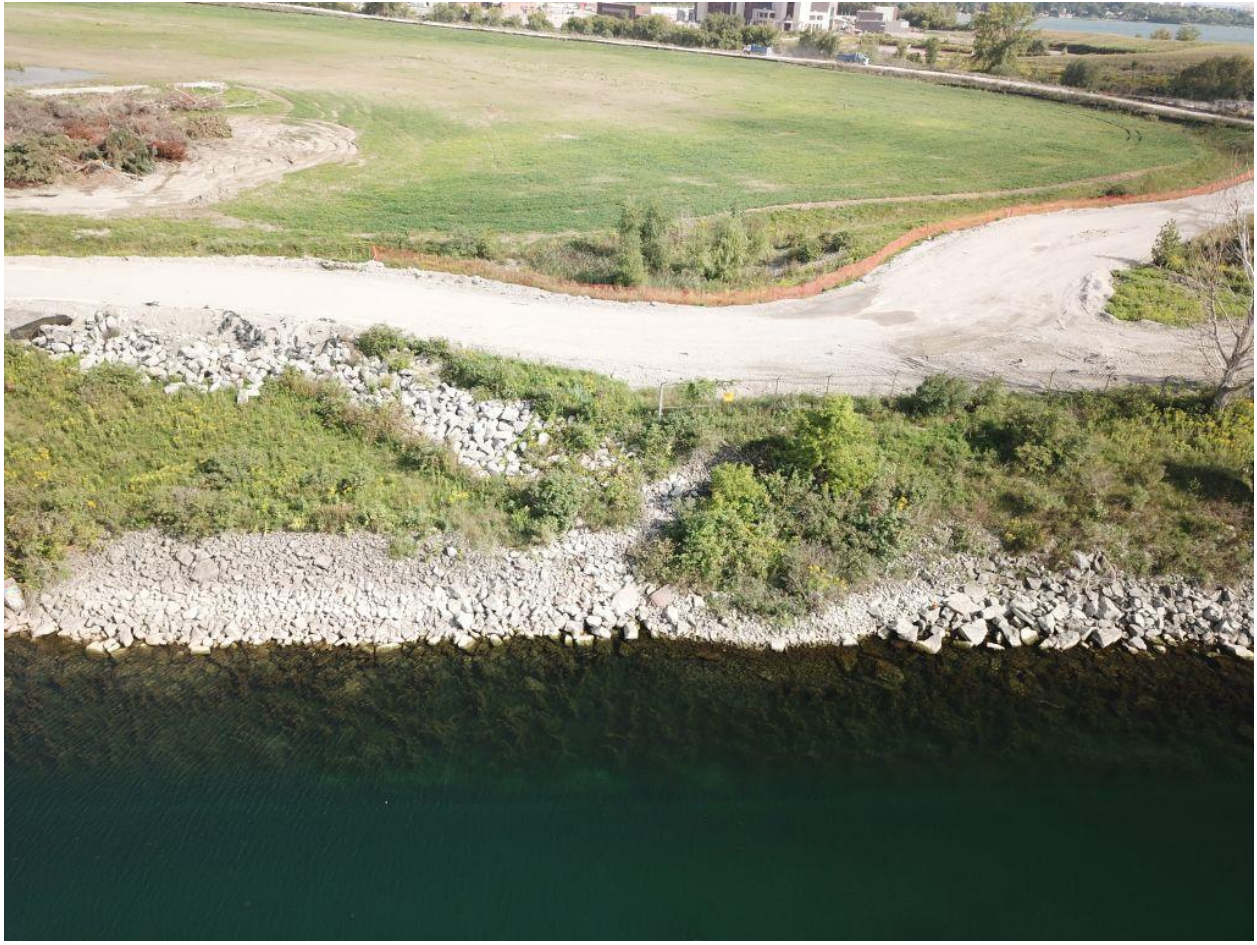
Figure 2.54: Transition of stone size at easterly end of Intake Forebay/Channel North (more sheltered from wave action to the left; less sheltered from wave action to the right)

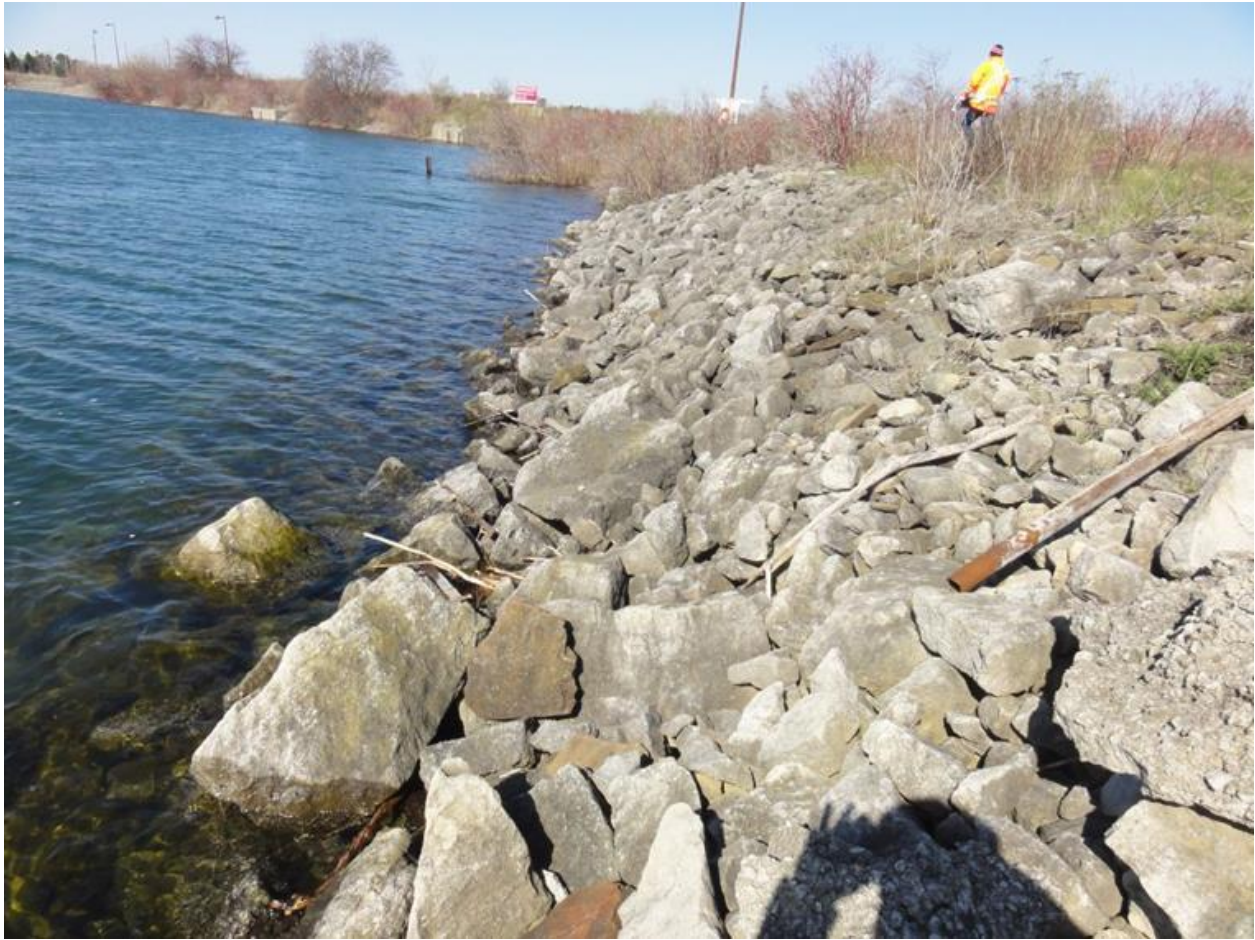
Figure 2.55: Intake Forebay/Channel North – larger riprap slope protection near easterly end, closer to entrance channel between piers

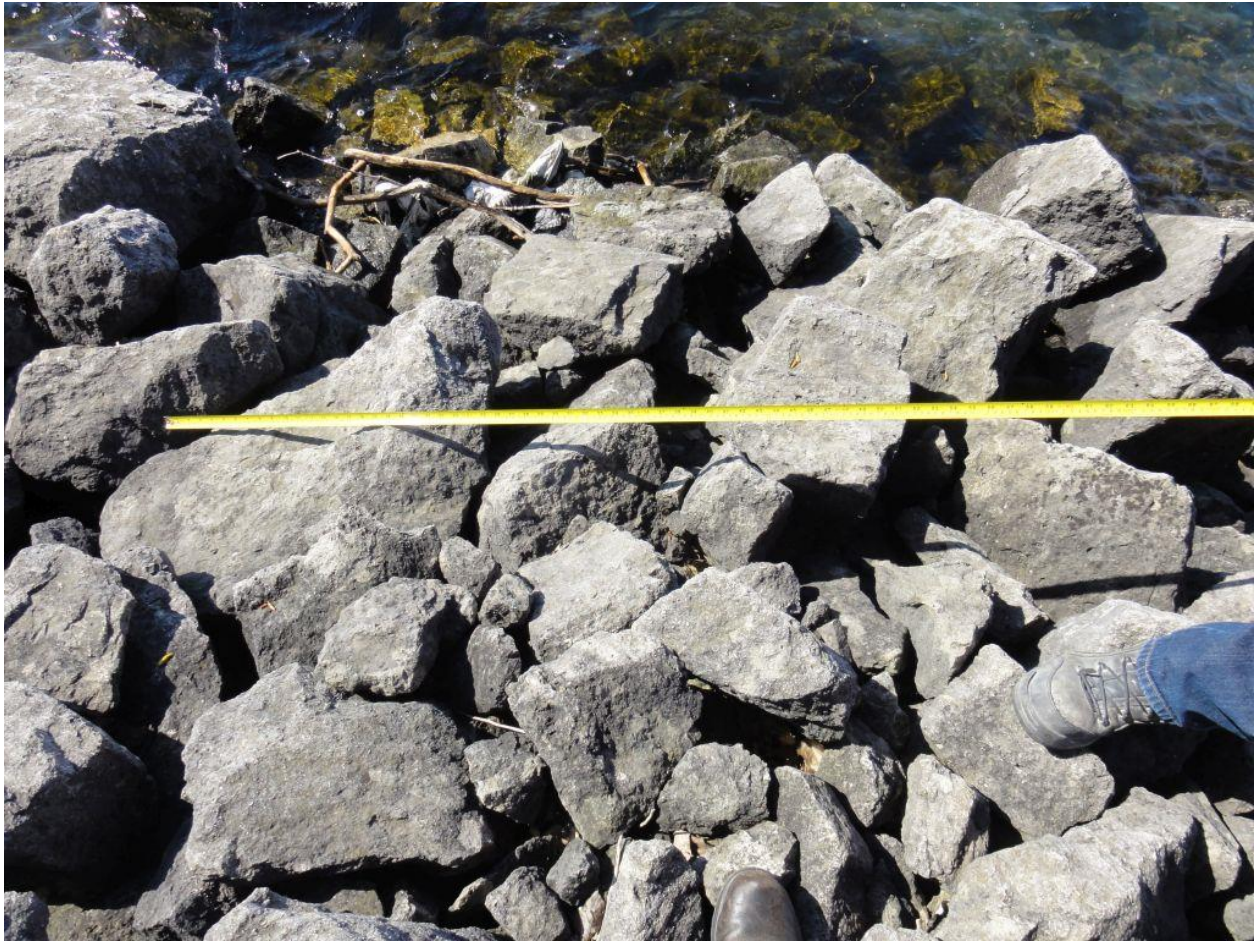
Figure 2.56: Larger riprap stone size along IFN shoreline nearer entrance

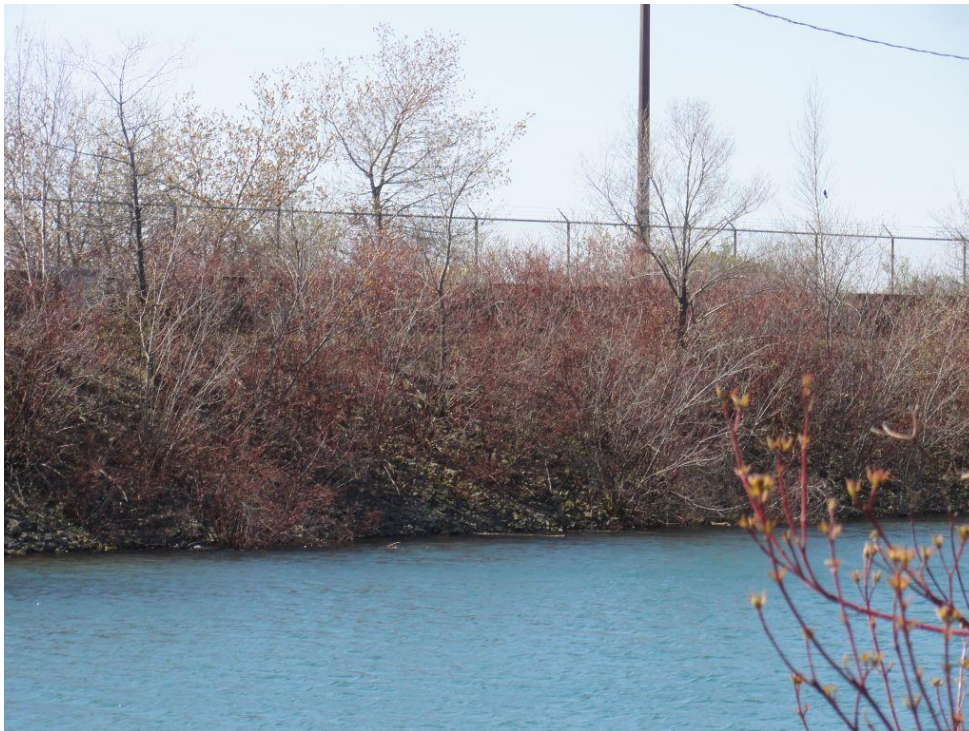
The riprap revetment is in good condition with well-established vegetation (see Figure 2.58 and Figure 2.60). The top elevation of the stone protection is adequate.

Figure 2.60: Example of riprap slope protection with extensive, established vegetation at Intake Forebay/Channel South

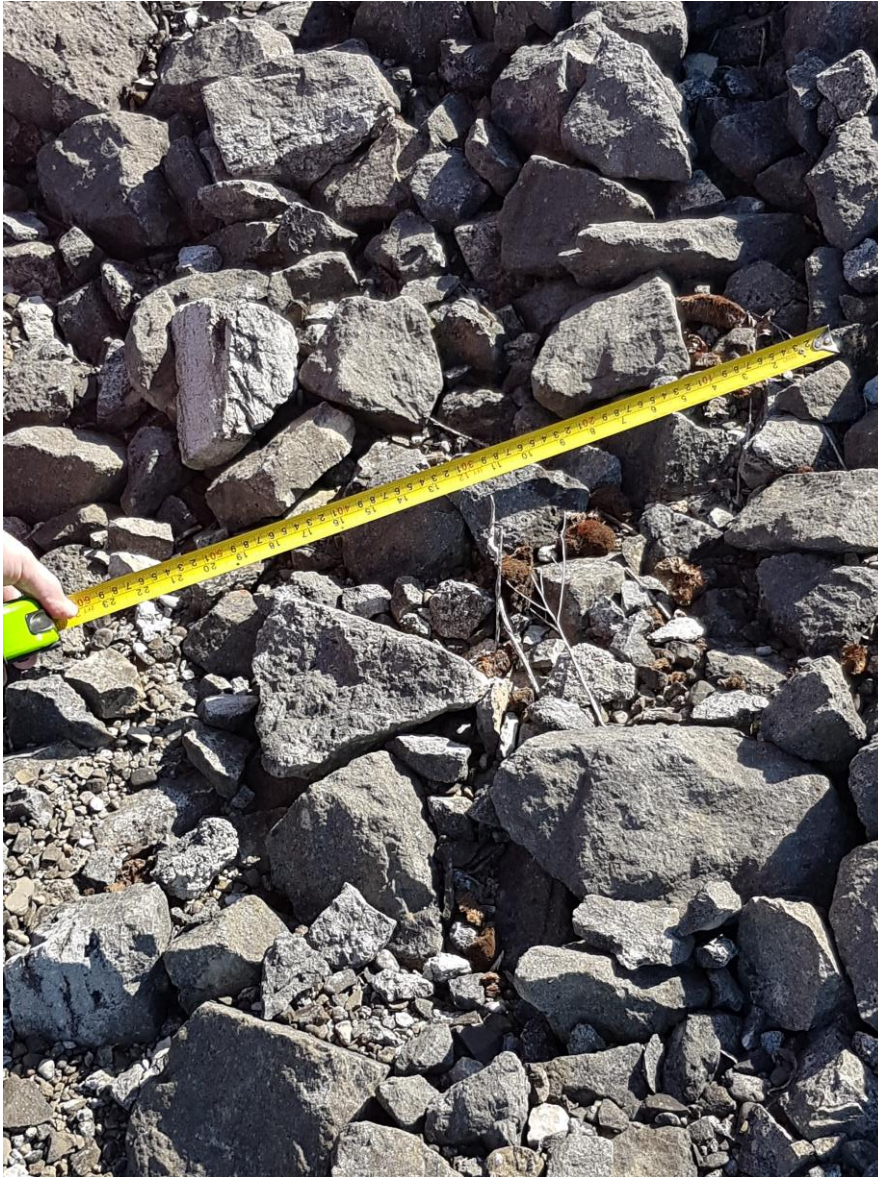
From about IFS230 to the west end of IFS, the stone size is about 50 to 150 mm diameter (see Figure 2.61). Closer to the entrance (nearer to the Lake, from about IFS176 to IFS230), the stone material is larger; approximately 200 mm to 600 mm diameter.

Figure 2.61: Example of riprap stone size at Intake Forebay/Channel South (IFS340)

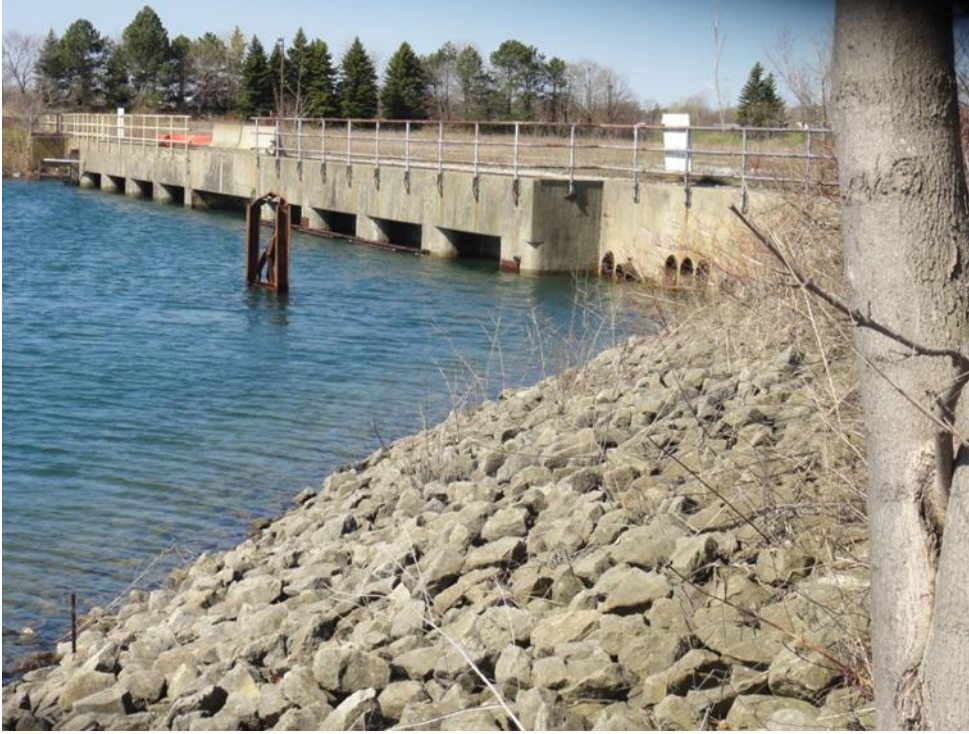
Various isolated concrete and steel structures were observed in the channel (e.g., see Figure 2.17 and Figure 2.64). These structures could pose a hazard to navigation and will be charted and marked with warning buoys or removed.

Figure 2.64: Concrete Pumphouse 3 (for Units 5, 6, 7 & 8) at Intake Forebay/Channel North
