Lakeview Village Shoreline Hazard Assessment

Mississauga

January 14 2019 | 13012.101

Baird.
Innovation Engineered.

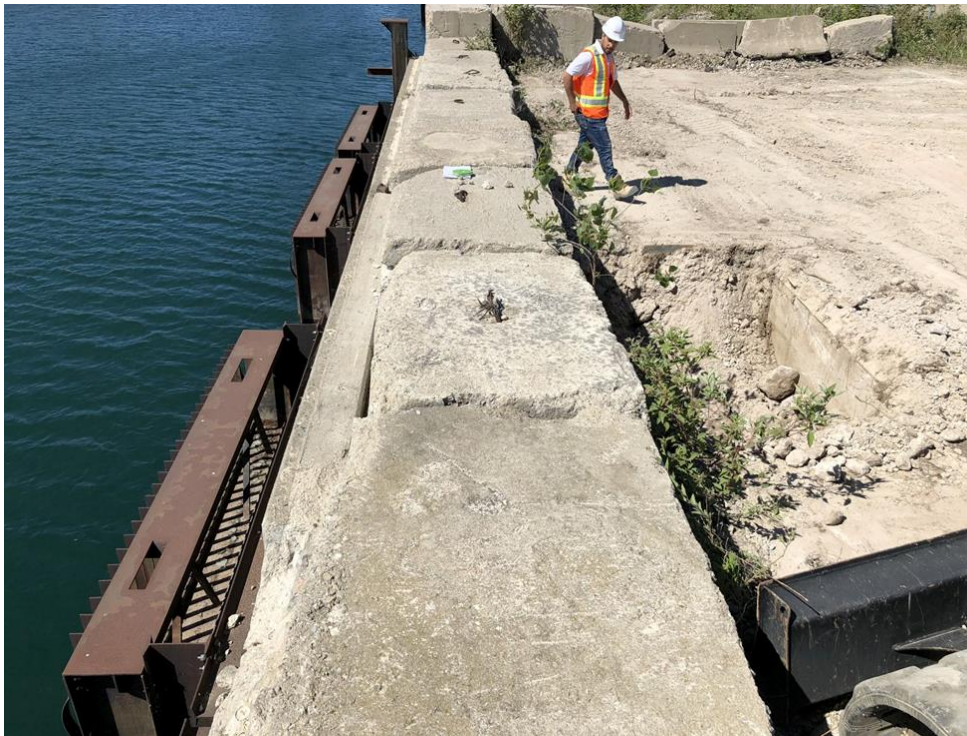
Pumphouses 1 and 2 have exterior intake grates/screens (Figure 2.69 and Figure 2.70). Pumphouse 3 does not appear to have exterior grates. The openings into the pumphouses are below water.

Figure 2.69: Intake grate/screen at Pumphouse 1

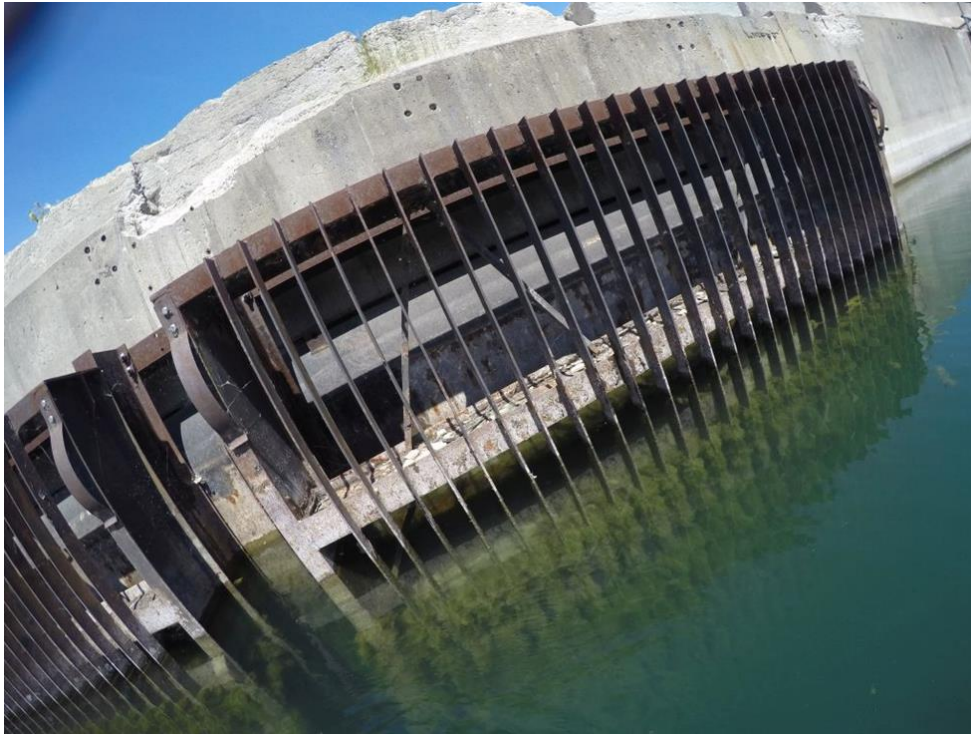
Figure 2.70: View from water of intake grate/screen at Pumphouse 1

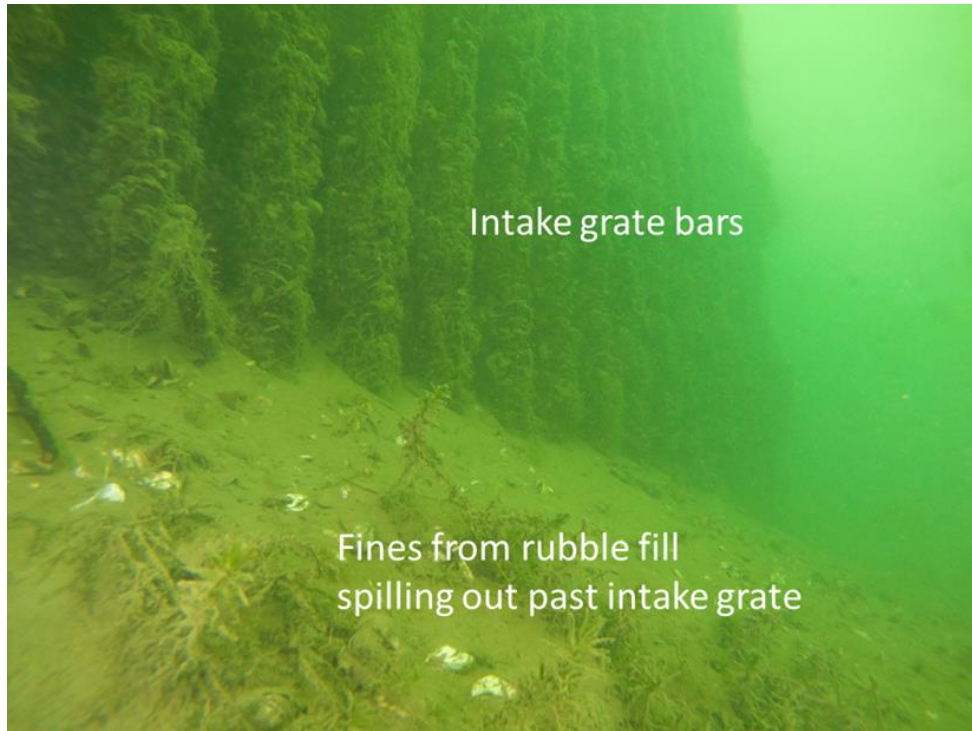
Figure 2.72: Underwater view of exterior of intake grate/screen at Pumphouse 1 showing fines from rubble fill spilling out through the grate

The massive concrete pumphouse structures have been stabilized by the rubble fill and are to remain in place as part of the development. To ensure that the pumphouse structures remain stable for the planning horizon of the project, it is proposed that the intakes will be further secured by placing rubble mound berms in front of the intakes; the berm will buttress the existing rubble fill inside the pumphouses. Figure 2.76 presents a sketch of the concept to buttress the intakes. The intake pipes that extend to the plant will be cut and sealed near the shoreside of the pumphouses. Other appropriate measures to ensure public safety (e.g., railings), provide public access and enhance the aesthetics will be incorporated into the remedial works. Naturalization features and aquatic habitat elements will be incorporated into the protection works where appropriate.

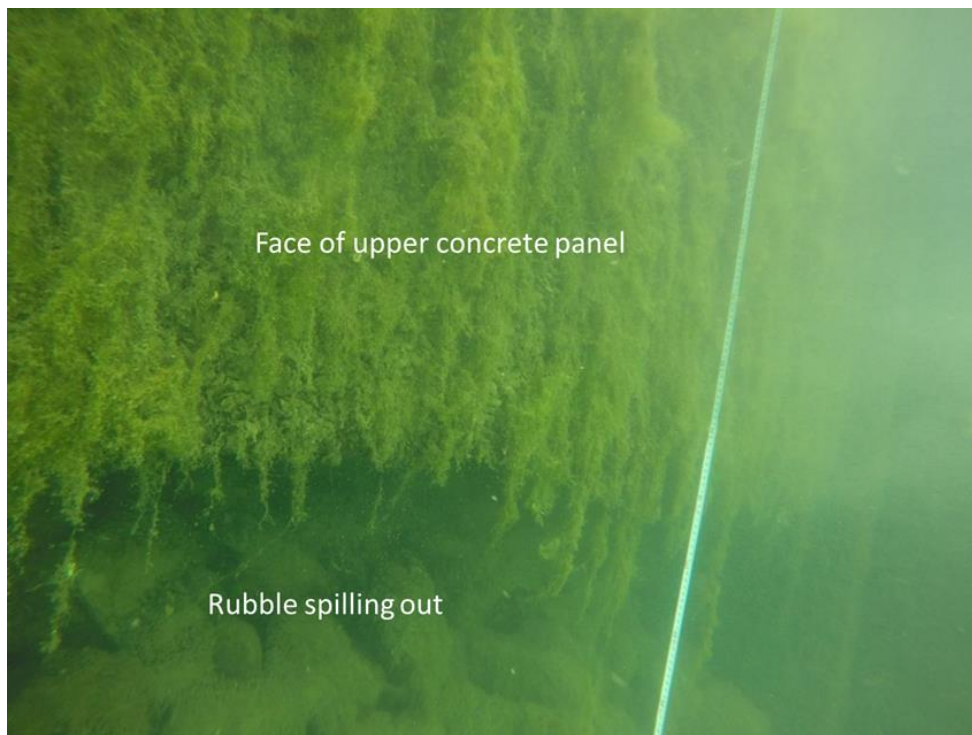
Figure 2.73: Concrete rubble spilling out below concrete upper outer face wall at Pumphouse 3

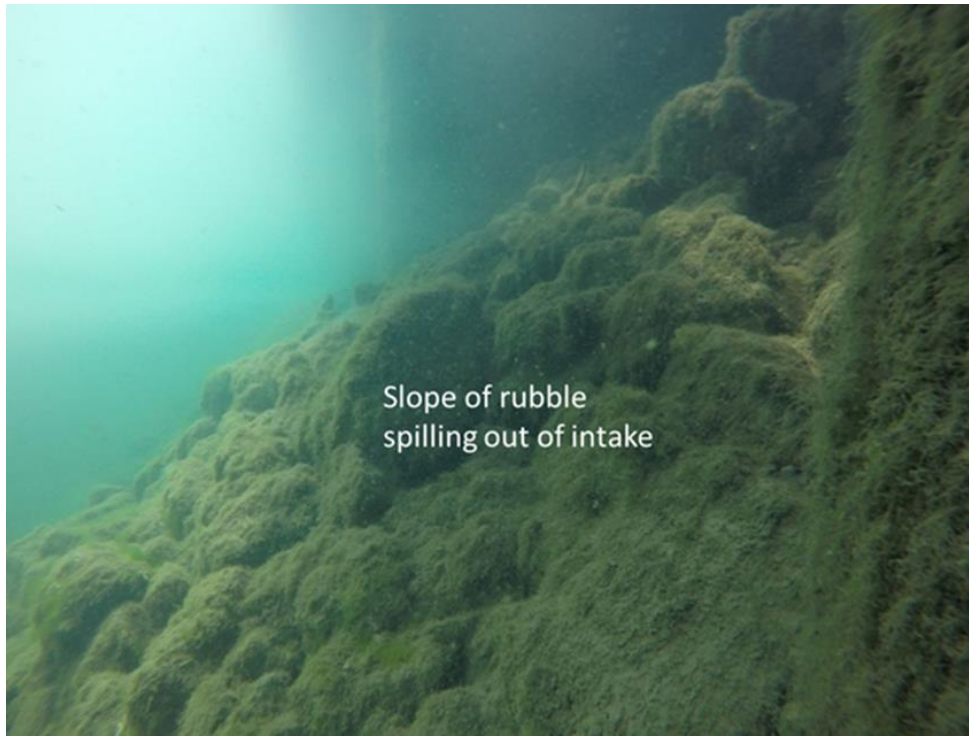
Figure 2.74: Rubble slope spilling out of intake at Pumphouse 3

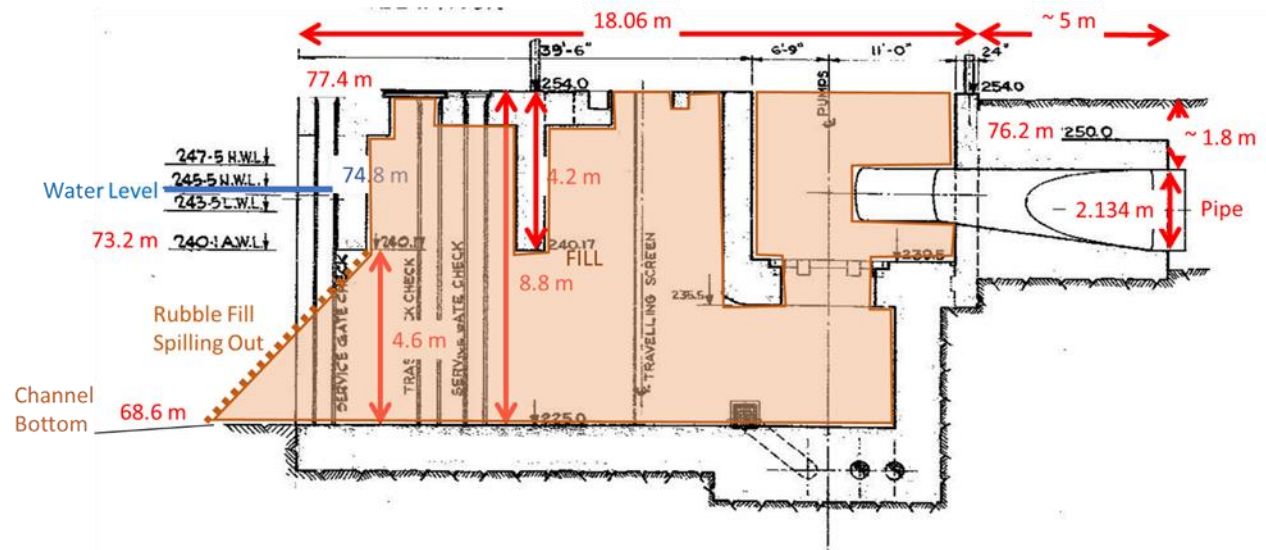
Figure 2.75: Schematic cross-section of Pumphouse 3 showing rubble fill (brown shading) inside pumphouse and spilling out from pumphouse (dashed brown line) onto intake channel bottom

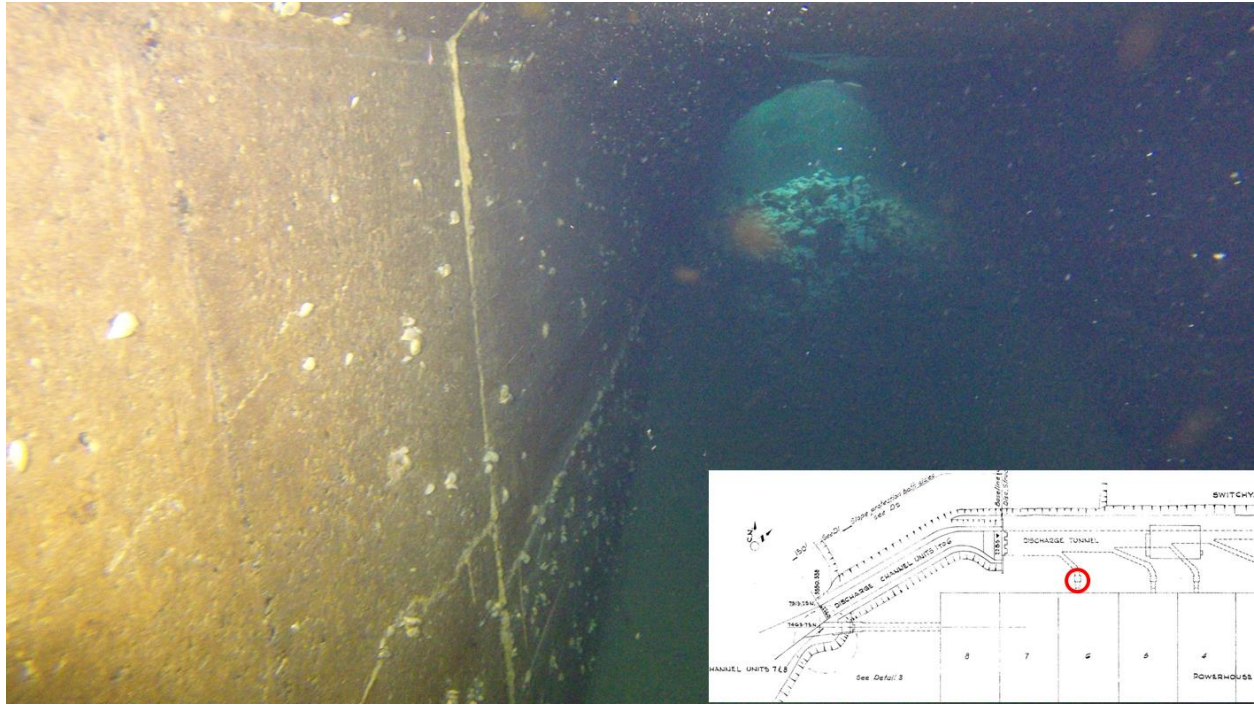
Figure 2.79: ROV view inside of Unit 6 discharge tunnel showing transition from box to circular pipe and fallen debris through an opening up to demolition of plant

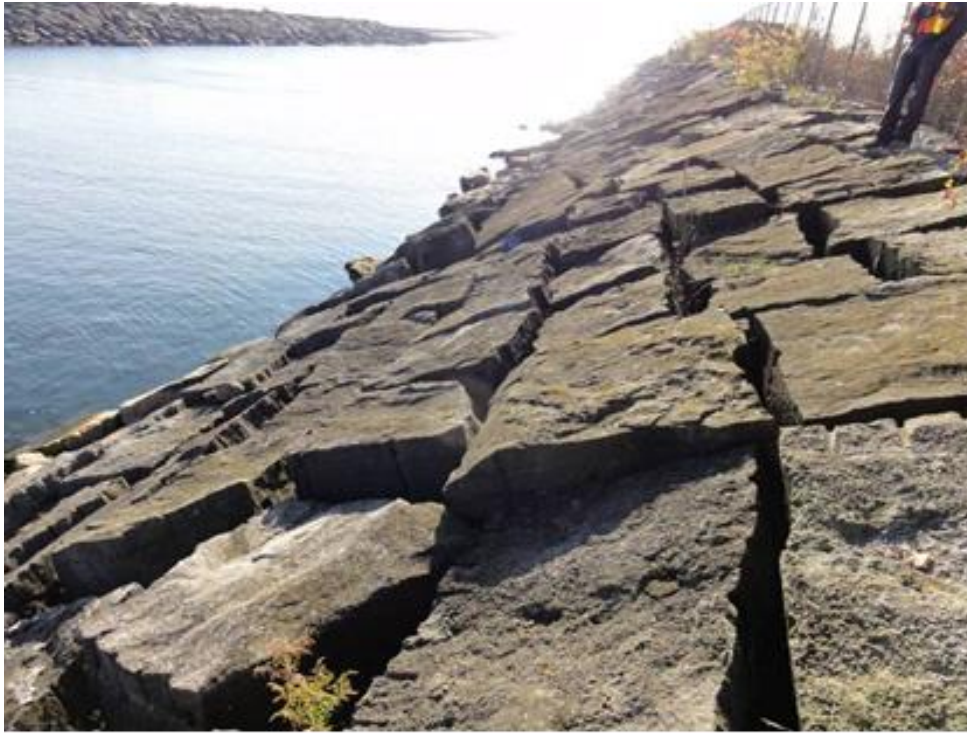
Generally, the above water rubble mound portion of the pier was in good condition. The stone was generally well-placed in a tight configuration, as shown in Figure 2.35 and Figure 2.82. There does not appear to have been significant settlement at the crest or any notable failure of the armour protection. It was not possible to see the underlayer of the rubble mound structure due to the tightly-packed armour layer, which is a sign of good stone placement. The stones appear to be dolomite or limestone, and their edges and corners are still well defined, with few cracks or splits, indicating good resistance to weathering. A few armour stones show minor surface deterioration; some deterioration of some stones is to be expected for a structure of this age and is acceptable.

Figure 2.82: Typical section on east side of rubble mound mole portion of Western Pier
