**GEOTECHNICAL INVESTIGATION FOR
PERFORMING SLOPE STABILITY ANALYSIS
PROPOSED DEVELOPMENT
51 TANNERY STREET
MISSISSAUGA, ONTARIO**

**PATRIOT ENGINEERING LTD.
Consulting Engineers**

Project 37105
March 24, 2017

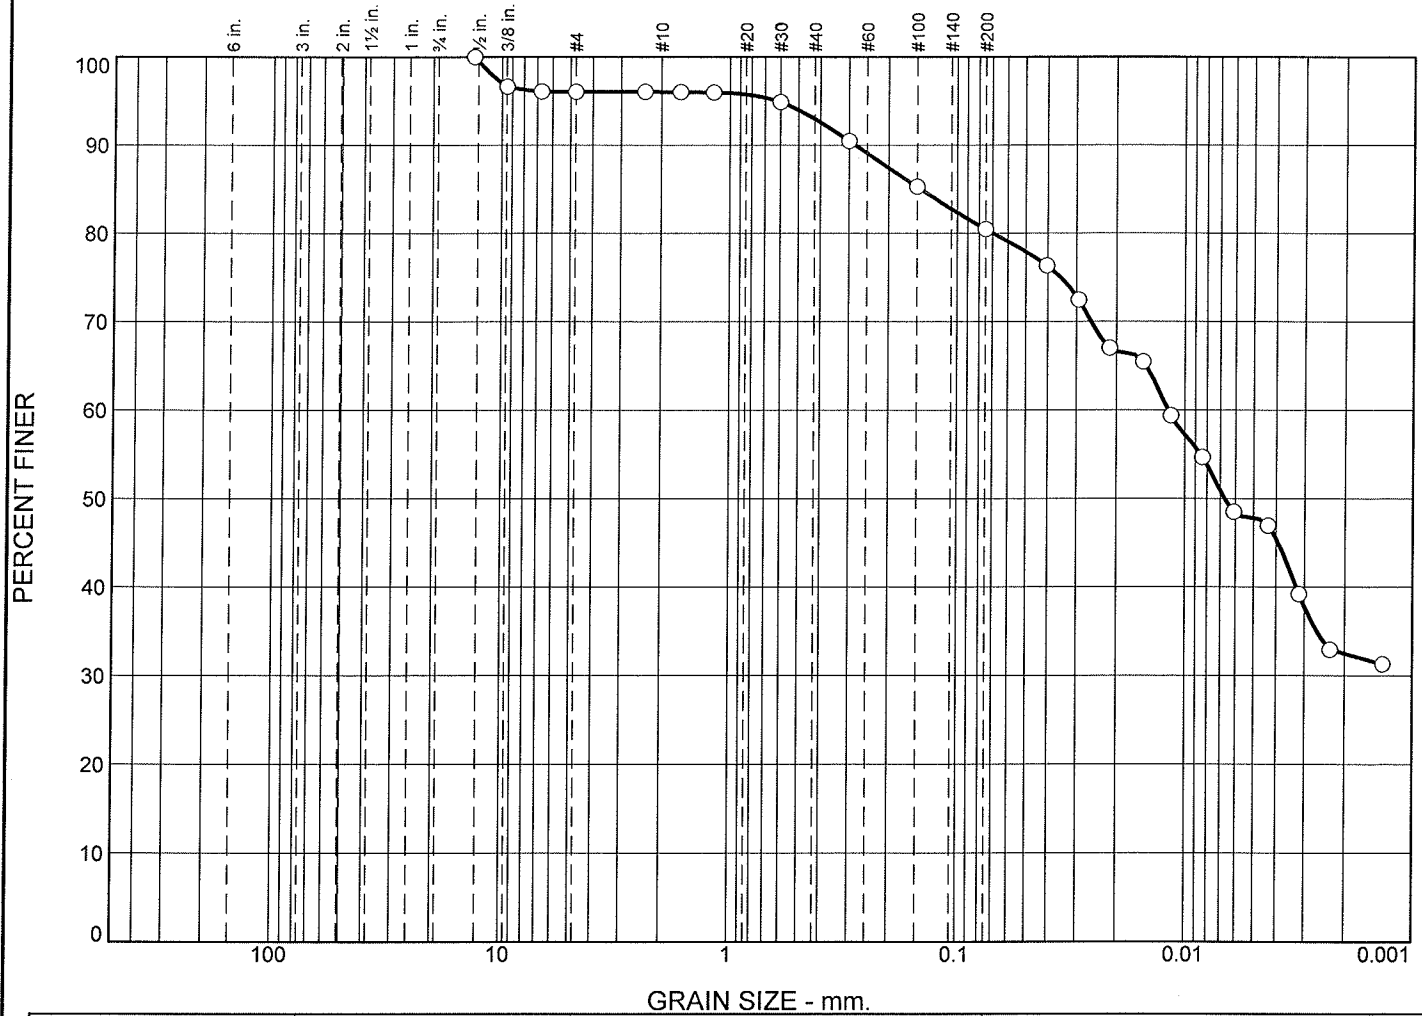
Particle Size Distribution Report

% Cobbles	% Gravel		% Sand			% Fines			
		Coarse	Fine	Coarse	Medium	Fine	Silt	Clay		
○	0.0	0.0	4.0	0.0	3.0	12.5	48.0	32.5		
⊗	LL	PL	D ₈₅	D ₆₀	D ₅₀	D ₃₀	D ₁₅	D ₁₀	C _c	C _u
○			0.1447	0.0119	0.0067

Material Description	USCS	AASHTO
○ Clayey silt, some sand, trace gravel

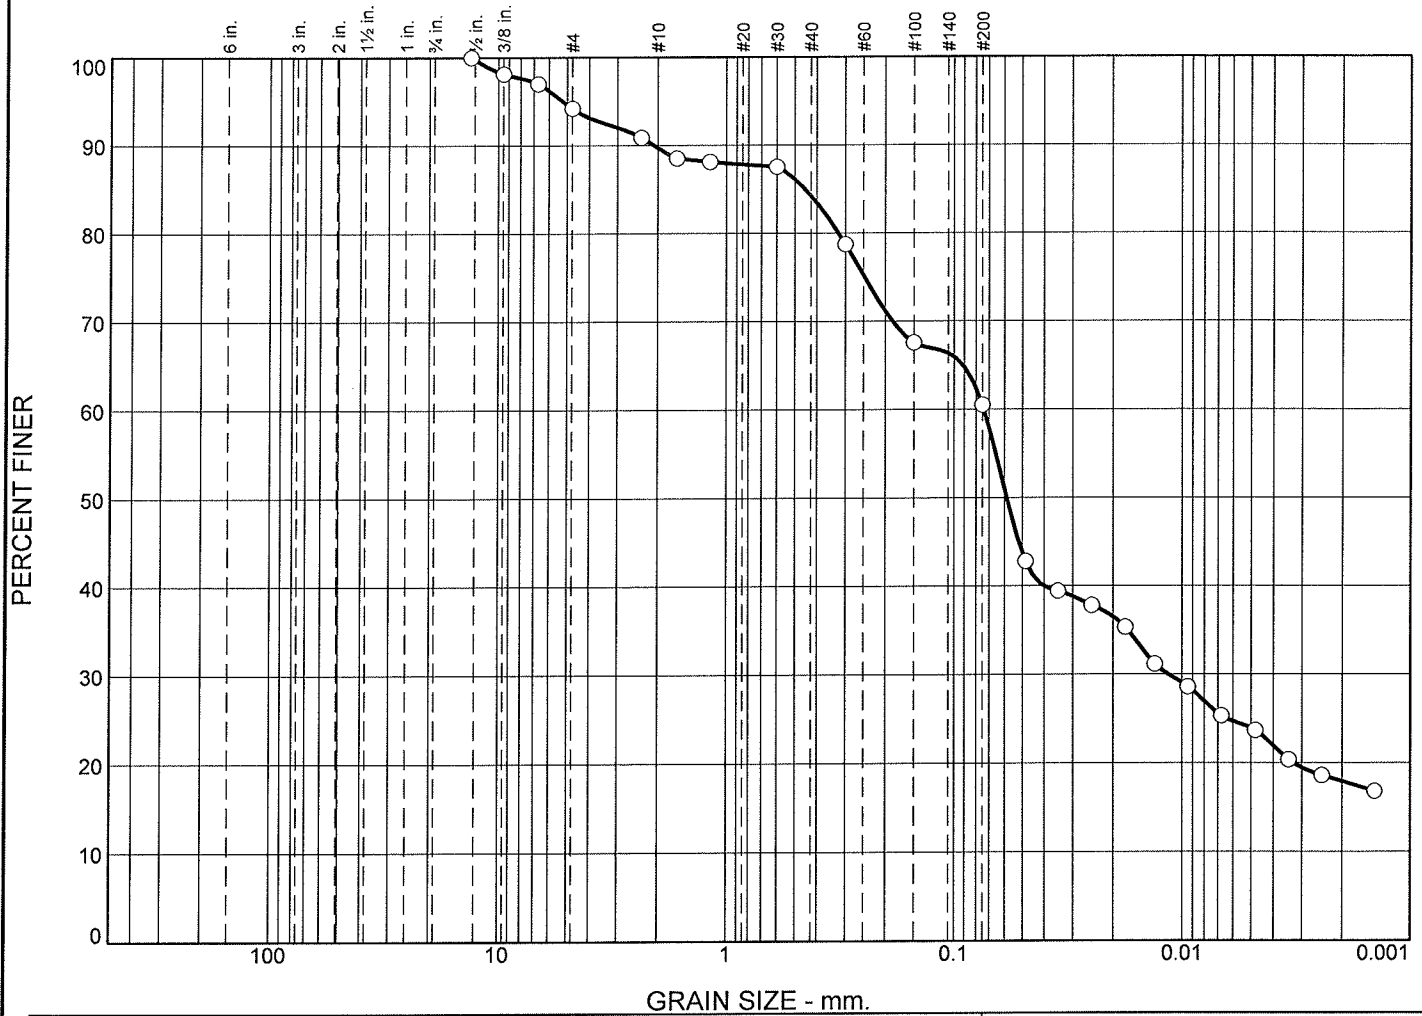
Particle Size Distribution Report

% Cobbles	% Gravel		% Sand			% Fines			
		Coarse	Fine	Coarse	Medium	Fine	Silt	Clay		
○	0.0	0.0	5.8	4.5	5.4	23.8	42.6	17.9		
×	LL	PL	D ₈₅	D ₆₀	D ₅₀	D ₃₀	D ₁₅	D ₁₀	C _c	C _u
○			0.4511	0.0739	0.0586	0.0115

Material Description	USCS	AASHTO
○ Sandy silt, some clay, trace gravel
