PROJECT: **PROPOSED STACKED TOWNHOUSE DEVELOPMENT**
 65-95 JOYMAR DRIVE
 MISSISSAUGA, ONTARIO

DRAWING TITLE: **EXISTING TREE INVENTORY AND PRESERVATION PLAN**

SCALE: AS SHOWN PROJECT No. 19-5173
 DATE: MAY 2019
 DRAWN BY: SS DRAWING No. V100
 CHECKED BY: MG

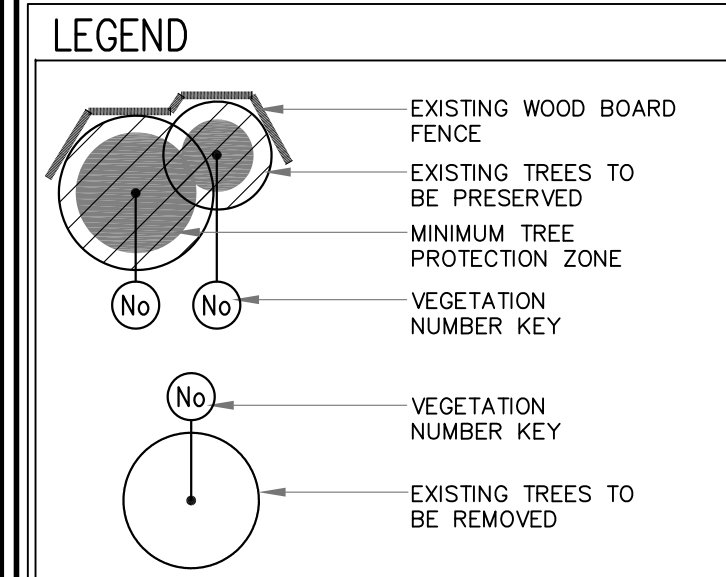
EXISTING TREE INVENTORY

KEY	SPECIES	CALIPER (in cm)	CROWN (in m)	HEALTH	STRUCTURE	COMMENTS	PRESERVATION DIRECTION	MIN. TPZ	KEY
1	NATURALIZED GROUPING	WHIP-65	VARIES	VARIES		MIXED, NATURALIZED GROUPING OF TREES AND SHRUBS WHICH OCCURS ALONG THE TOP OF EXISTING BANK AND ALONG CREEK SLOPE. THIS GROUPING IS DOMINATED BY DECLINING ASH TREES AND SEVERAL MANTOBA MAPLES. A SMALLER NUMBER OF CRACK WILLOW MOSTLY ALONG THE EAST CREEK BANK ARE PRESENT. THE MAJORITY OF THE TREES EXHIBIT MULTIPLE STEMS AND ONE SIDED FORMS DUE TO CROWDING. OVERALL, THE VEGETATION ALONG THE WEST SIDE OF THE CREEK IS COMPOSED EITHER OF EXOTIC, INVASIVE SPECIES OR DEAD OR DECLINING ASH TREES. THIS GROUPING IS IN GENERALLY POOR CONDITION. THE EXISTING TOP OF BANK APPEARS TO BE FILL MATERIAL AND DEBRIS.	(SELECTIVE REMOVALS OF THE IMMATURE, NATURALIZED AND INVASIVE TREES ALONG THE STACKED TOP OF BANK MAY BE REQUIRED DUE TO THE PROPOSED GRADING TO RE-ESTABLISH THE TOP OF BANK)	NA	1

2	CRACK WILLOW	65.0	15.0	FAIR	MULTI-STEMMED	MATURE, MULTI-STEMMED TREE LOCATED ALONG THE EXISTING CREEK BANK. SOME DIEBACK THROUGHOUT IS NOTED AS WELL AS SEVERAL POTENTIALLY WEEK BRANCH UNIONS	PRESERVE	4.2	2
3	SIBERIAN ELM	15.30	9.0	POOR-FAIR	MULTI-STEMMED	ASYMMETRICAL FORM, CROWDED BY ADJACENT TREE. DIEBACK THROUGHOUT, INCLUDED BANK	REMOVE	2.4	3
4	MANTOBA MAPLE	16.0	6.0	FAIR	HORIZONTAL	LEANING, CROWDED BY ADJACENT TREE	REMOVE	1.8	4
5	SIBERIAN ELM	17.0	6.0	GOOD	MULTI-STEMMED	NARROW FORM, CROWDED BY ADJACENT TREE	PRESERVE	1.8	5
6	SIBERIAN ELM	18.0	6.0	GOOD	MULTI-STEMMED	FENCE INGROWN, DIEBACK ON LOWER BRANCHES	REMOVE	1.8	6
7	SIBERIAN ELM	25.0	6.0	GOOD	DOUBLE STEM	DAMAGE TO LOWER BRANCHES	REMOVE	1.8	7
8	SIBERIAN ELM	18.0	5.0	POOR	IRREGULAR FORM	FENCE INGROWN, DIEBACK THROUGHOUT	REMOVE	1.8	8
9	ASH	6.0	6.0	DEAD			REMOVE	NA	9
10	MANTOBA MAPLE	29.0	6.0	POOR-FAIR	ASYMMETRICAL FORM	CROWDED BY ADJACENT TREE; SOME DIEBACK THROUGHOUT	REMOVE	1.8	10

11	NORWAY MAPLE	32.0	6.0	FAIR	ASYMMETRICAL FORM	CROWDED BY ADJACENT TREE; SOME INTERNAL DIEBACK	REMOVE	2.4	11
12	NORWAY MAPLE	24.0	7.0	GOOD	GOOD FORM	MINOR INTERNAL DIEBACK	REMOVE	1.8	12
13	ASH	40.0	6.0	DEAD			REMOVE	2.4	13
14	MANTOBA MAPLE	60.0	18.0	DEAD			REMOVE	3.6	14
