Meadowvale Heritage Conservation District Advisory Sub-Committee

HERITAGE IMPACT STUDY
IMPACT OF PROPOSED RENOVATION
7004 SECOND LINE W., MISSISSAUGA

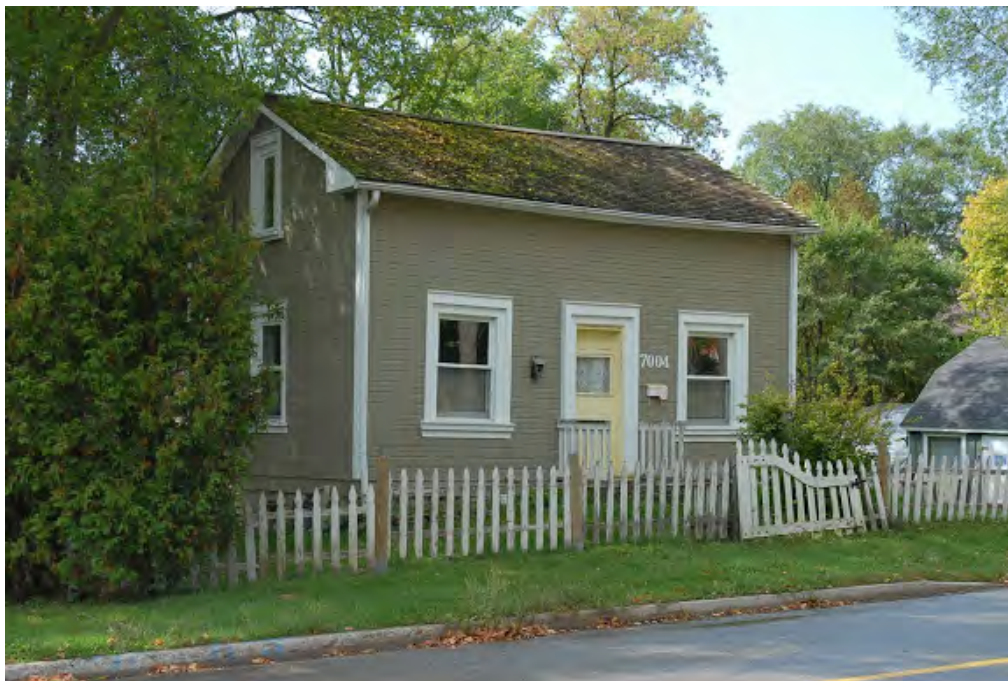
South-East view of existing building

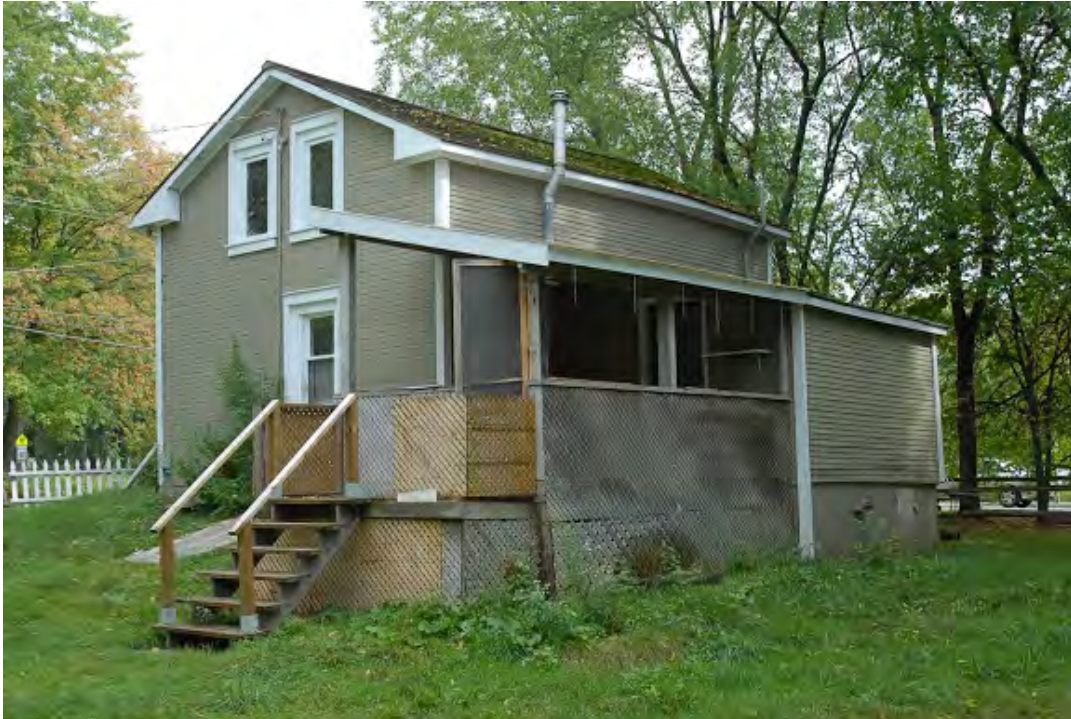
North-West view of existing building

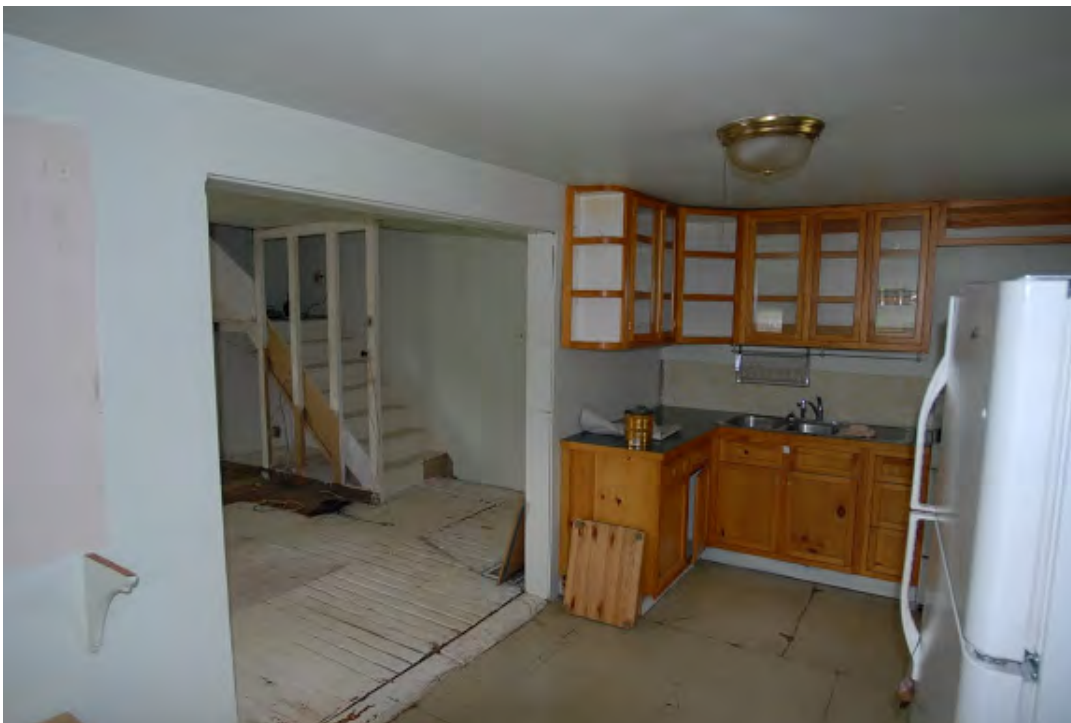
Existing Kitchen - Living Room beyond

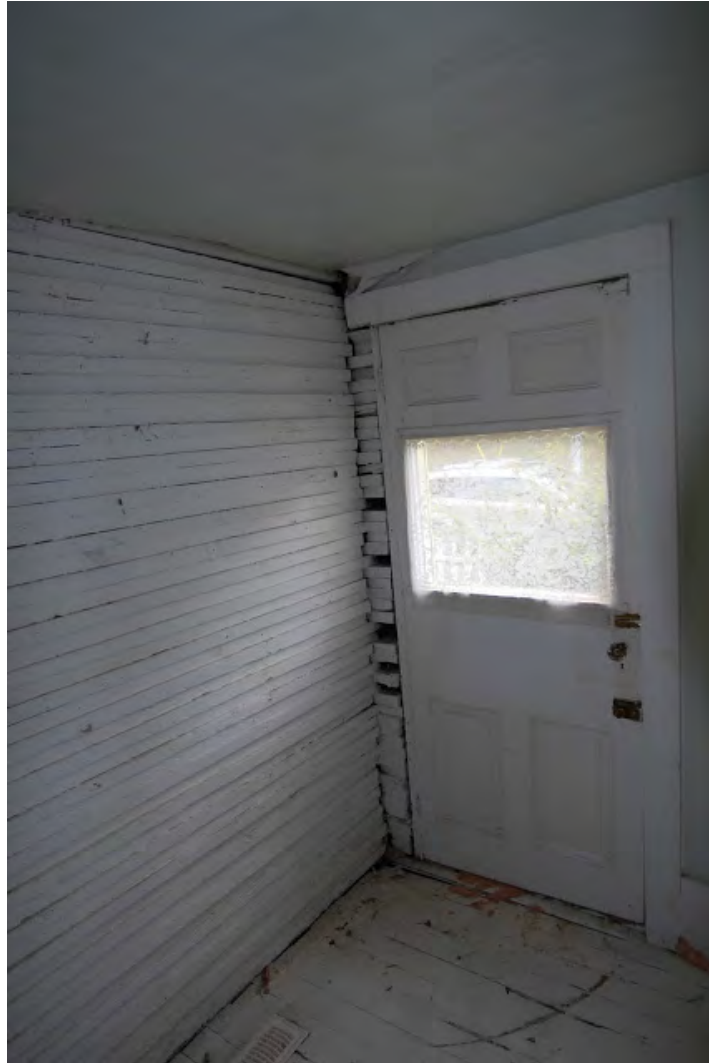
Stacked plank construction viewed from the inside. Note crossed boards at the inside corner. This wall appears to never have been clad in plaster as was the usual practice

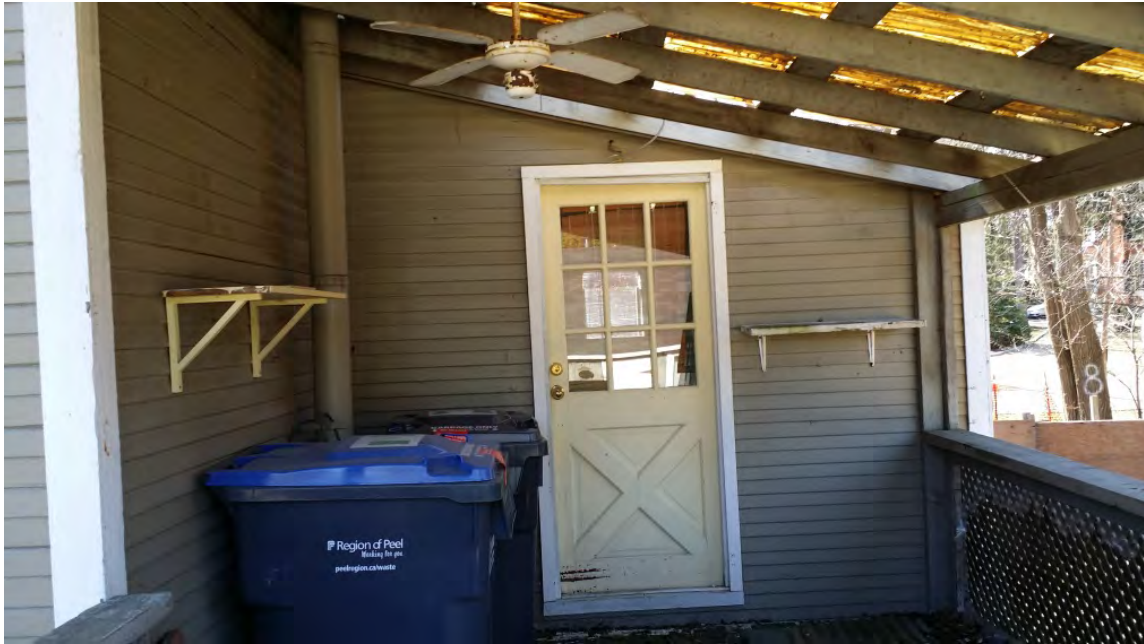
North elevation of rear addition. Note later translucent roof above porch

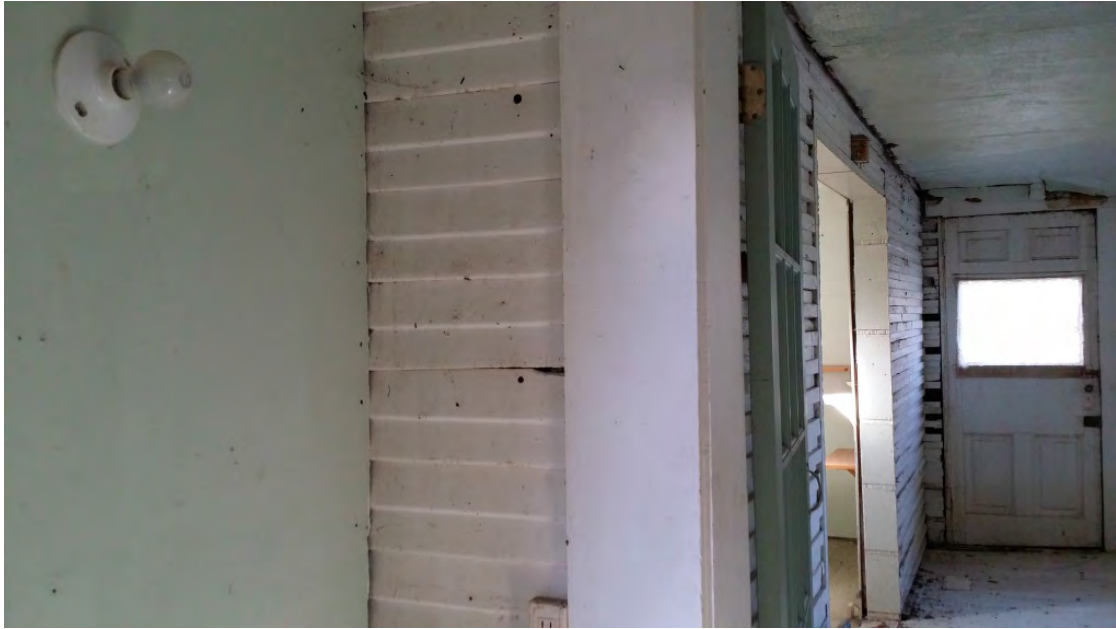
Interior view from vestibule toward front door. Note newer drywall on north wall of vestibule, older siding material on west wall of vestibule, stacked plank construction visible in living room beyond

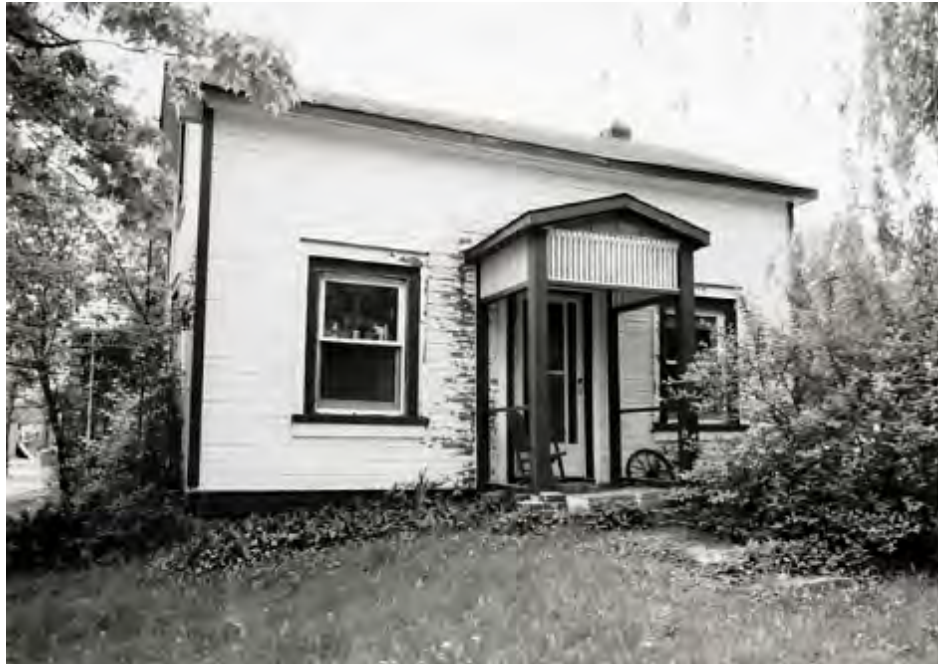
1990 front elevation showing landing with canopy (since demolished)

Available photos from the 1980's and 1990's show the porch in place with a wooden canopy supported by square corner posts. The canopy was an unusual detail with a kind of picket fence appearance to the upper structure. It was almost certainly not original to the home. It was of awkward appearance and proportions and was not a benefit to the appearance of the heritage building. It has since been demolished and no trace of it remains with the exception of the concrete slab and step.

The slab has no heritage value as an artifact but it does have some importance in that it identifies the original front door of the building and as such it is appropriate that some memory of it remain. The present design proposes that the slab be demolished and the existing grade at the front door increased slightly to allow one step from the grade to the front door. The amount of this increase would be very minimal. Presently the grade differential is between 7" and 10". It would have to be levelled out to give a consistent differential of 7". A flagstone landing could then be laid on the ground in approximately the same shape and size as the present concrete landing. The new landing would serve the same purpose as the existing and would preserve the heritage value of the existing by identifying the front door but because it would be flagstones set on the ground and not a permanent structure it would not be

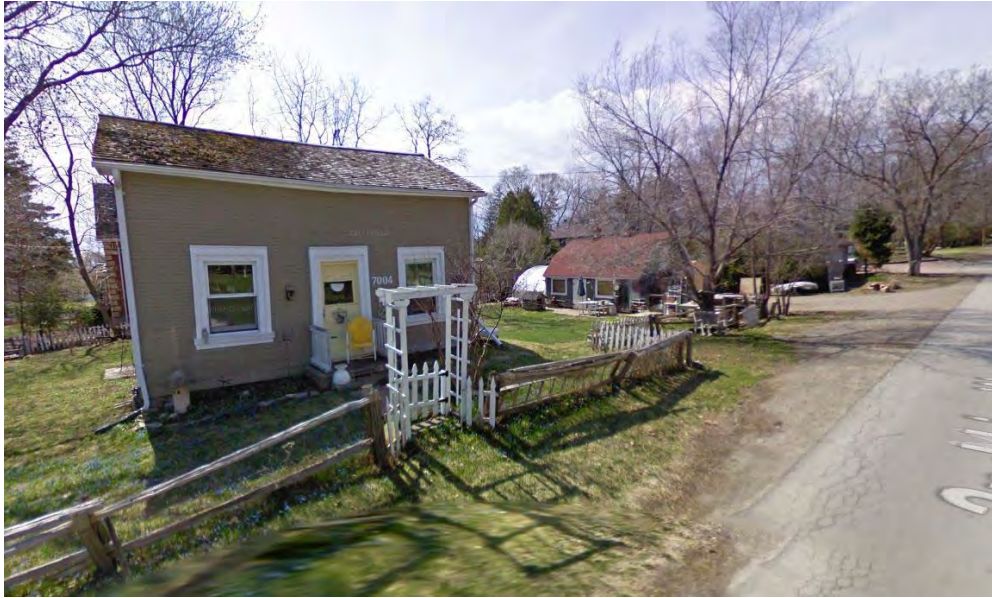
Google Street View image from 2009 showing cedar split rail fence along east side of property. This was apparently removed by the previous owner

The request by the City to remove this fencing is reasonable in this instance. Fencing, especially low picket fencing, is an appropriate way to define the limits of a property in a semi-rural context such as this and there are many similar examples in the village. If sufficient space were available between the front wall of the building and the street it would be advisable to replace the fencing. In this case, however, because the space is very limited the effect of the fence is to exaggerate the closeness of the existing building to the street. Typically a fence such as this would be located much closer to the street line than it would be to the house. In this case, because the distance between the edge of the street and the fence and that between the fence and the house is roughly the same it creates an awkward proportion and exaggerates the closeness of the building to the street. The various historic images available show that the type and extent of fencing around this property has changed multiple times and the fencing as it exists now is a relatively new element. The removal of this fence will not be a loss to the heritage value of the building.

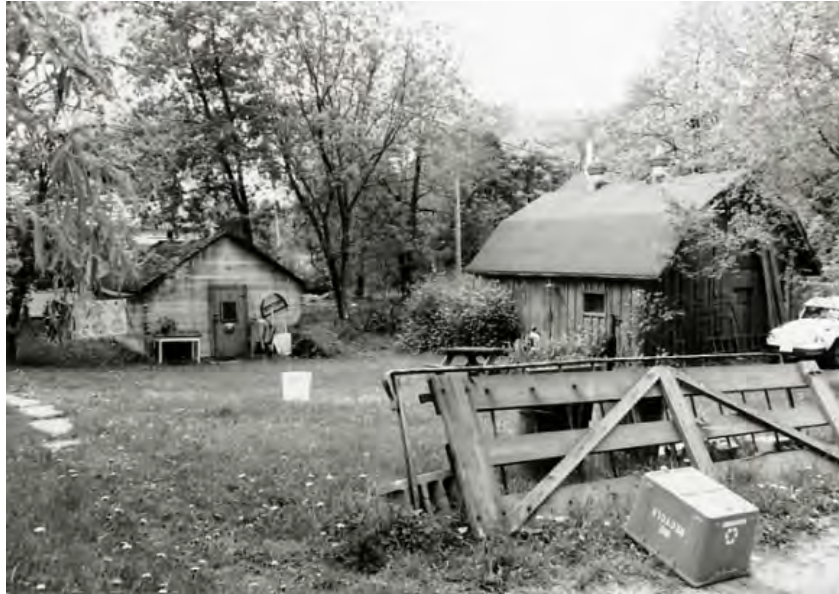
Image from the City of Mississauga Historic Images Database showing the "barn" accessory building at right. The accessory building at left is no longer in place. Note the absence of the stairs to the loft presently at the front of the building or of the framed greenhouse at the rear. Note also the lack of fencing around the property. The blue box recycling bin in the foreground would date this photo to the mid-1980's or later

The barn building is in moderate to poor condition. The stairs to the loft are in very poor condition, a relatively new addition (as witnessed by their absence in the mid-1980's photo) and are unsafe and should be removed. The greenhouse on the west elevation is a home-made structure of pipe, wood and sheet plastic, was similarly absent in the mid-1980's and should be removed. Both are in danger of collapse from deterioration.
