LAKEVIEW VILLAGE

CHANNEL DESIGN BRIEF

DECEMBER 2019

Serson Creek Geomorphic Assessment and Rehabilitation Design Lakeview Village City of Mississauga

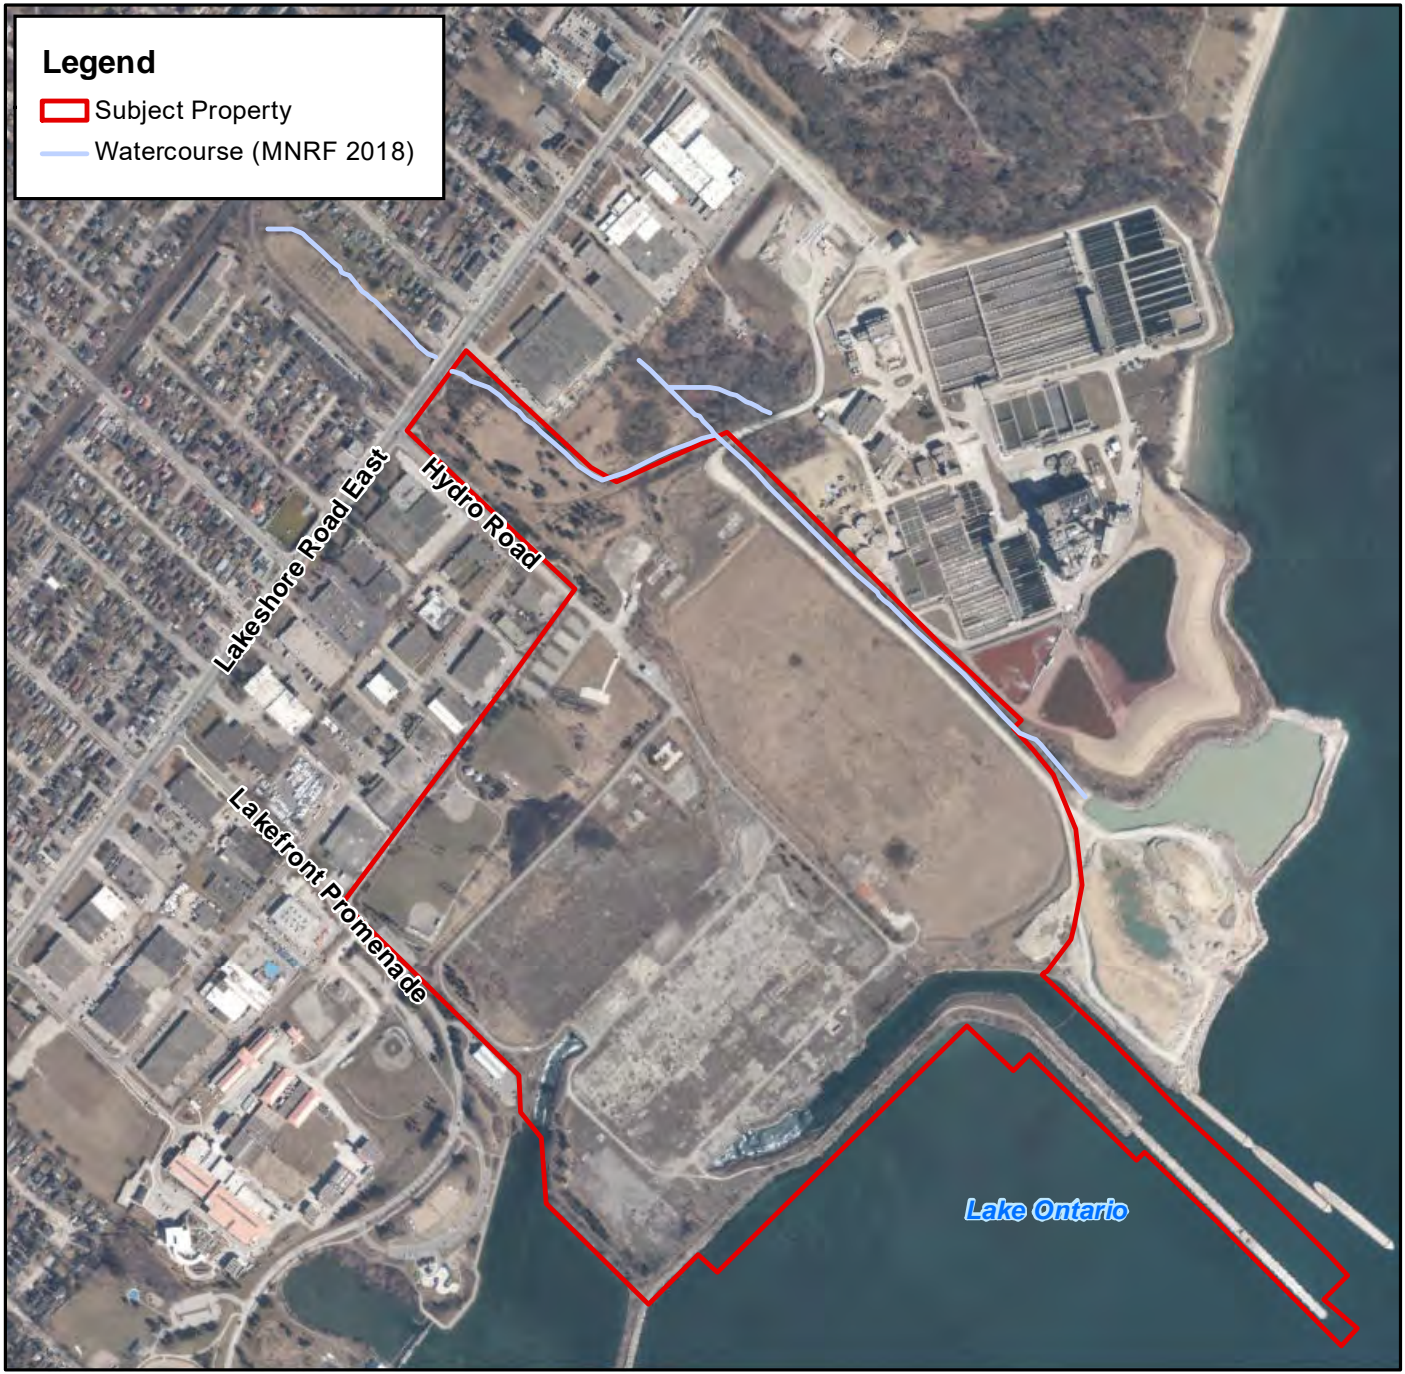
- Subject Property
- Watercourse (MNR 2018)

Beacon Environmental Limited (Beacon) was retained by Lakeview Community Partners Limited (LCPL) to undertake a geomorphic assessment and channel rehabilitation design of Serson Creek within the property located at 800 Hydro Road in the City of Mississauga ('subject property'). The subject property is located between Lakeshore Road East and Lake Ontario, immediately east of the Region of Peel's G.E. Booth Wastewater Treatment Facility (WWTF), within the former Ontario Power Generation coal plant lands known as the Lakeview Generating Station (**Figure 1**).

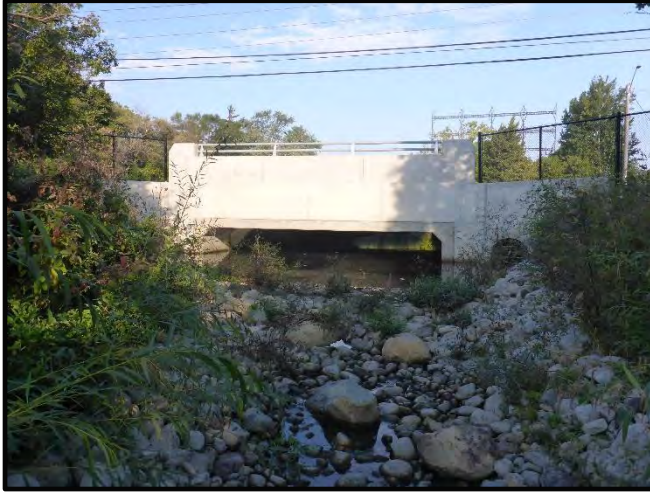
Photo 1. Location 1.
Reach S3. Upstream view of designed cobble lined channel and Lakeshore Road E culvert. September 21, 2018.

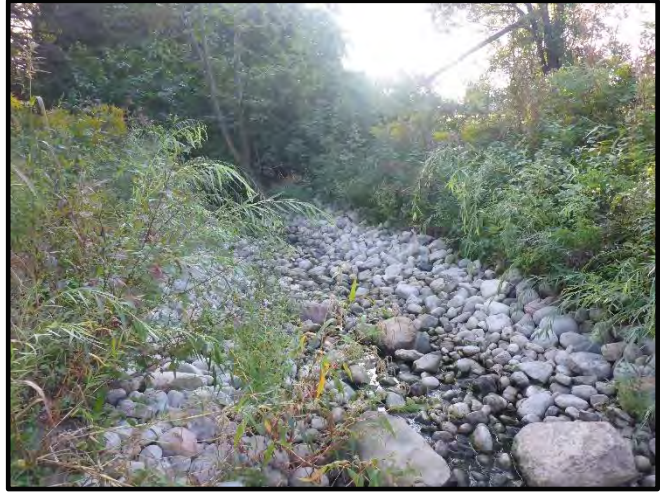
Photo 2. Location 1.
Reach S3. Downstream view of designed cobble lined channel. September 21, 2018.

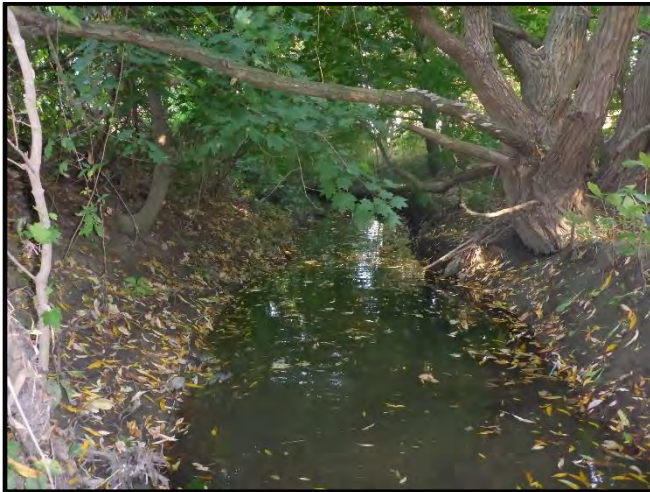
Photo 3. Location 2.
Upstream view of Reach S3 general conditions. September 21, 2018.

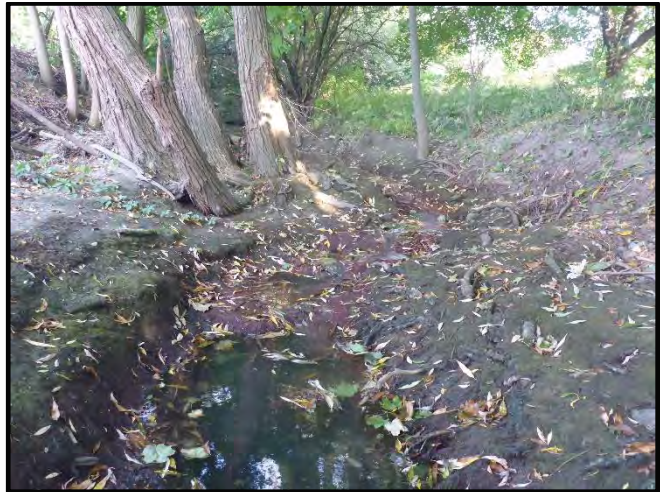
Photo 4. Location 3.
Reach S3. Upstream view of rooted knickpoint leading into pool. September 21, 2018.

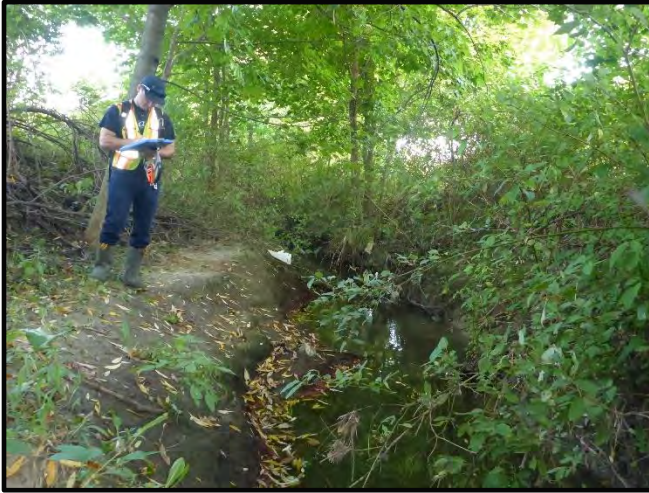
Photo 5. Location 4.
Reach S3. Upstream view of pool with terracing on right bank. September 21, 2018.

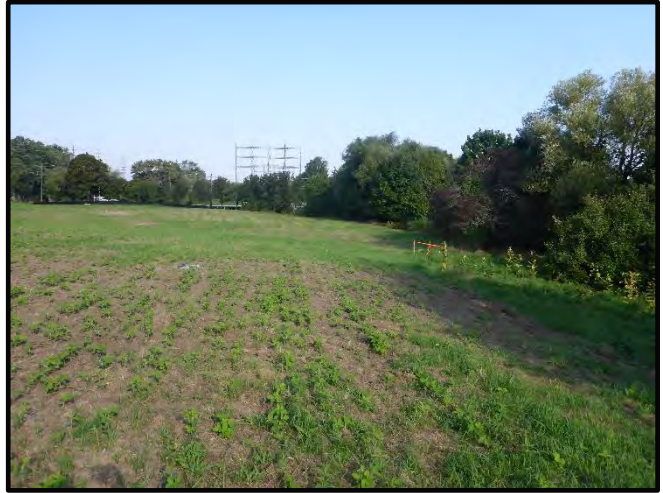
Photo 6. Location 5.
Reach S3. Floodplain along top of right bank, view towards Lakeshore Road E. September 21, 2018.

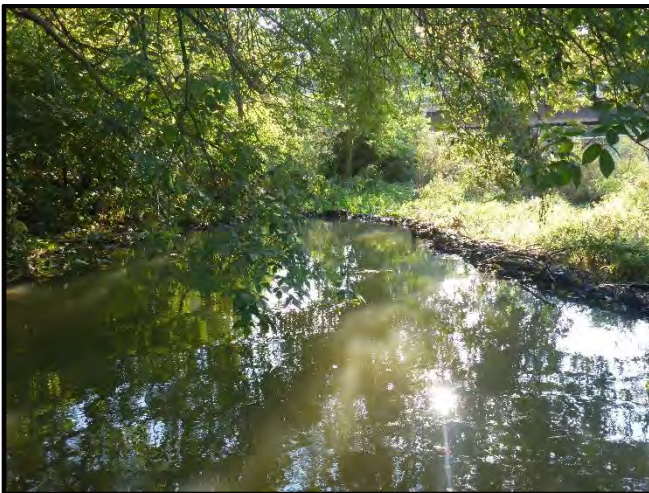
Photo 7. Location 6.
Reach S3. Downstream view of backwatering from beaver activity at channel confluence. September 21, 2018.

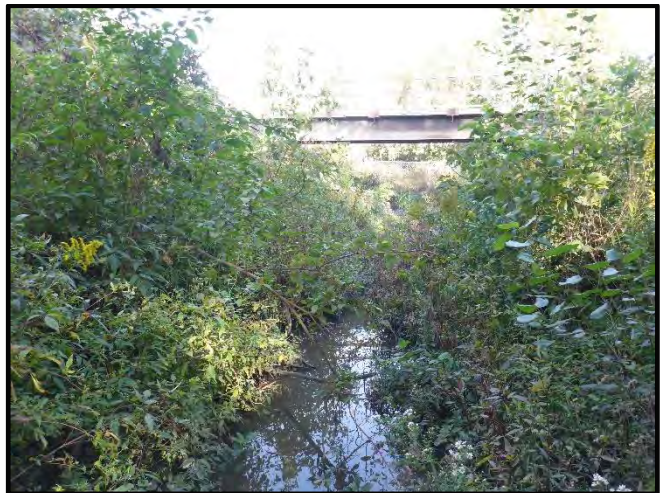
Photo 8. Location 7.
Reach S2. Upstream view towards property line at top end of reach. September 28, 2018.

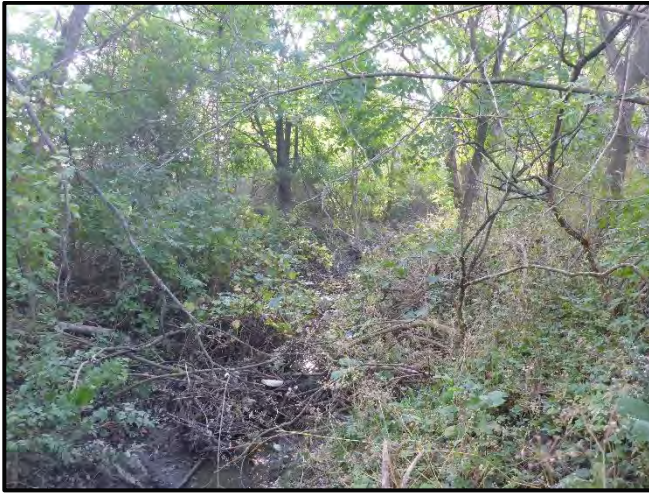
Photo 9. Location 8.
Reach S2. Downstream view of woody debris jam.
September 28, 2018.

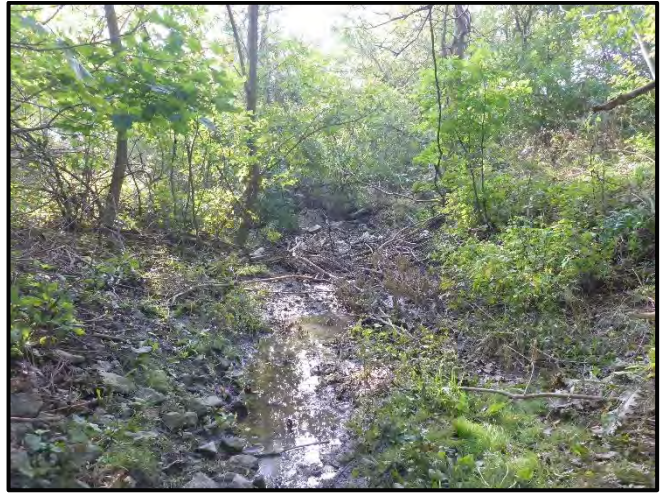
Photo 10. Location 9.
Reach S2. Downstream view of typical valley section: confined slope on right bank. September 28, 2018.

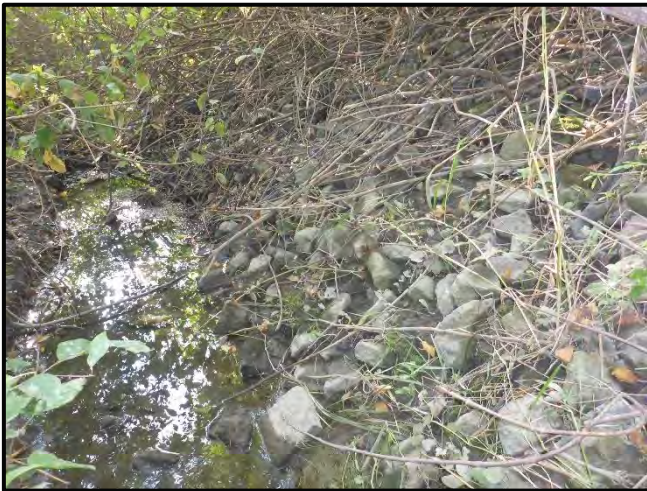
Photo 11. Location 10.
Reach S2. Rip-rap protection along lower bank.
September 28, 2018.

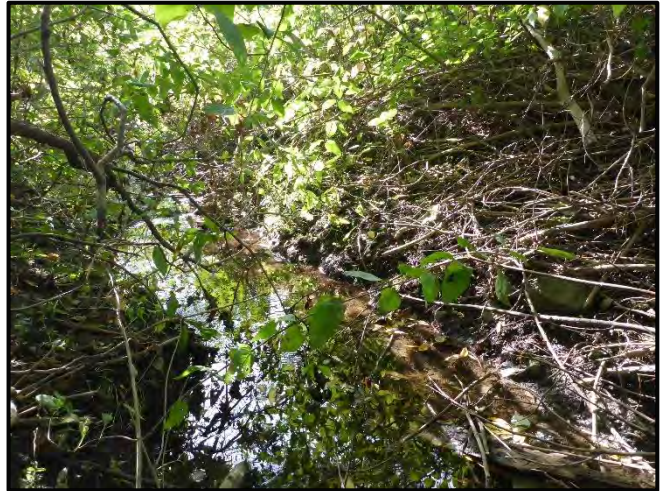
Photo 12. Location 11.
General conditions downstream in Reach S2.
September 28, 2018.

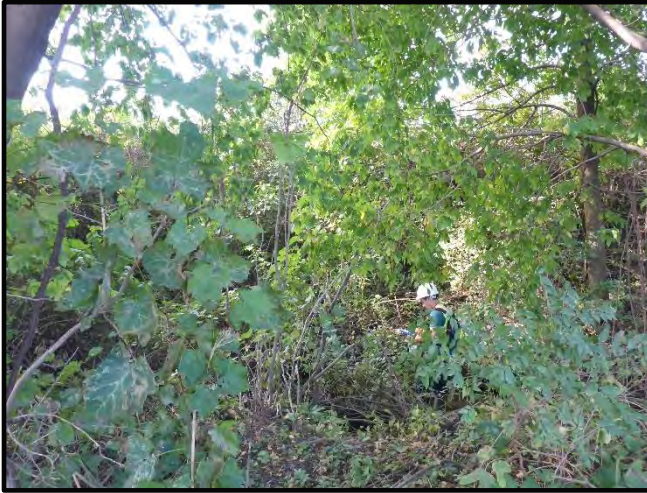
**Photo 13. Location 12.
Reach S2. General wooded valley and channel
location. September 28, 2018.**

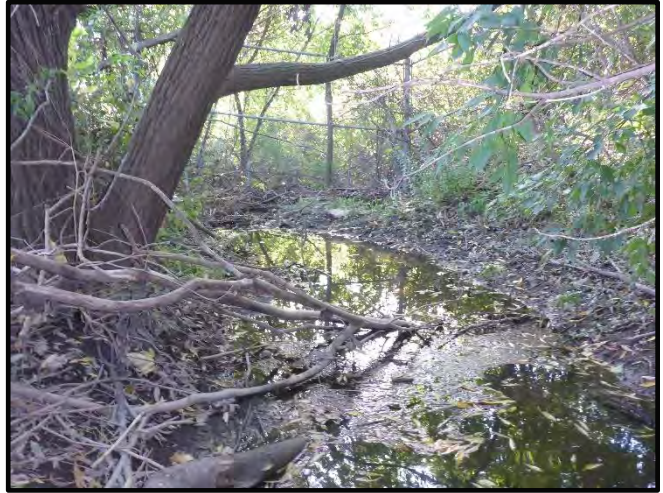
**Photo 14. Location 13.
Reach S2. Widening channel at property line due
to backwatering and variable lake levels.
September 28, 2018.**

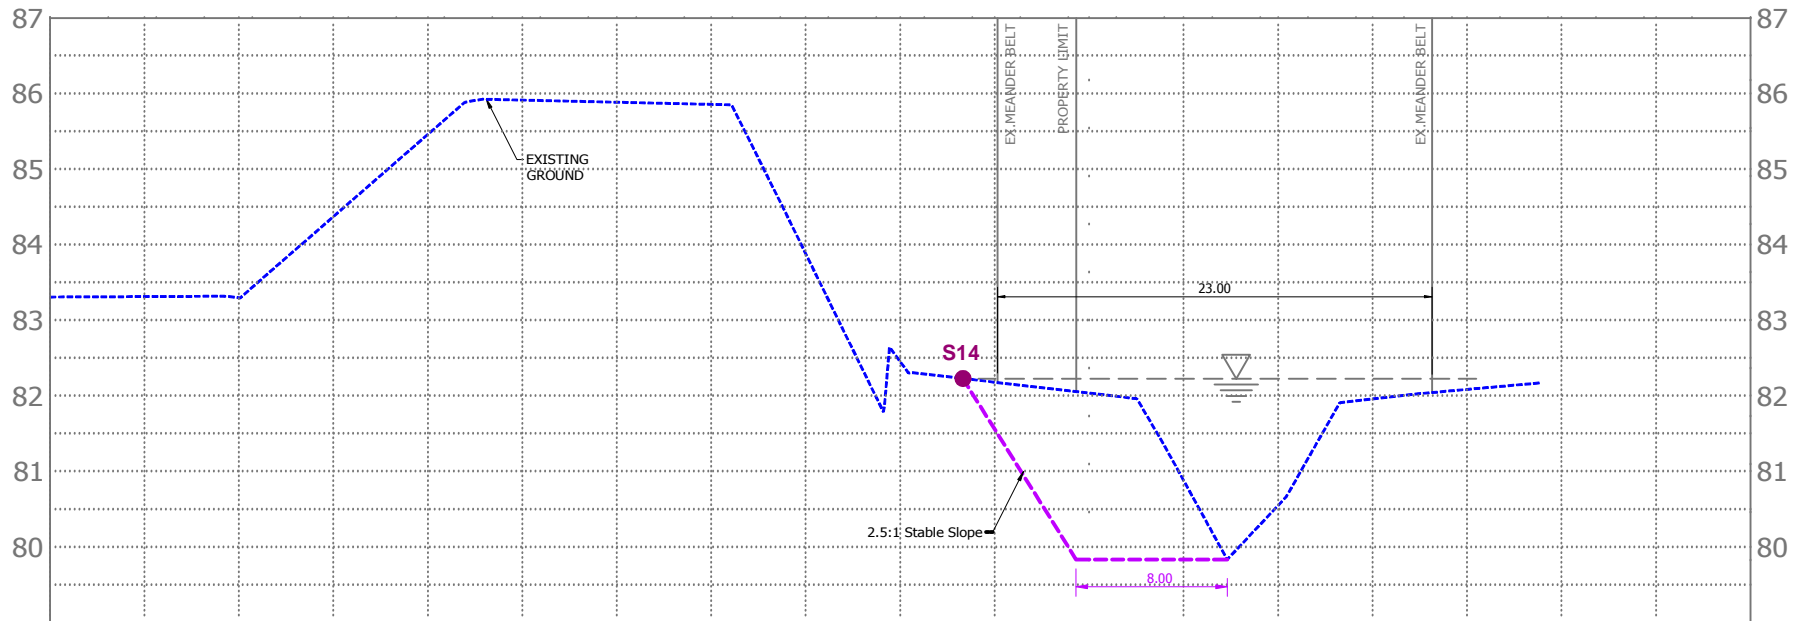
<p>DS CONSULTANTS LTD. 6221 Highway 7, UNIT 16 Vaughan, Ontario L4H 0K8 Telephone: (905) 264-9393 www.dsconsultants.ca</p>	Project: SERSON CREEK SLOPE STABILITY ASSESSMENT		
	Title: SLOPE PROFILE AT SECTION N-N		
Client: LAKEVIEW COMMUNITY PARTNERS LIMITED	Size: 8.5 x 11	Approved By: F.Z	Drawn By: S.Y
	Rev.	Scale: As Shown	Date: July 2019
		Project No: 18-519-102	Figure No. 15

Based on the slope stability analysis results presented above, Points “S1”, “S12” and “S14” in Figures 19 to 21 represent the long-term stable top of slope (LTSTOS) at Sections A-A, L-L and N-N, respectively. Accordingly, Points “S1”, “S12” and “S14” are also shown in profile Figures (Figure 2, Figure 13 and Figure 15) at Sections A-A, L-L and N-N, respectively.

- Point “S13” on Figure 14 represents the long-term stable top of slope at Section M-M.
- Point “S14” on Figure 15 represents the long-term stable top of slope at Section N-N.

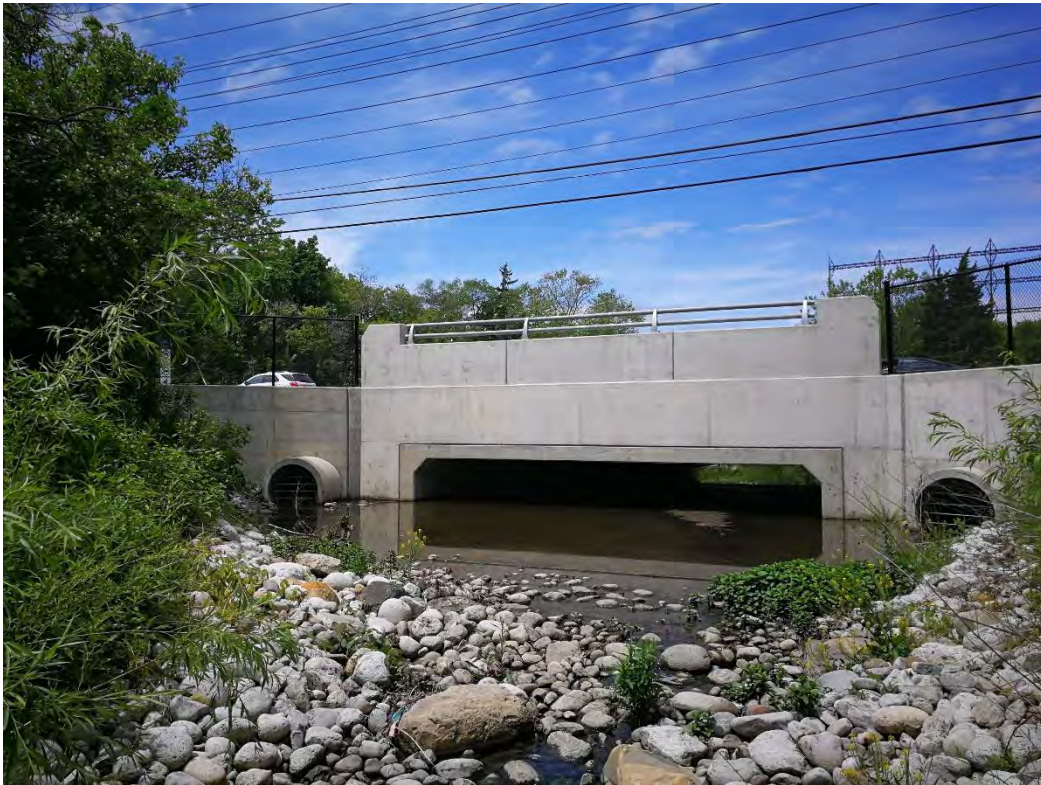
Photo B1: Creek and Concrete Culvert at Lakeshore Blvd (looking north - upstream)

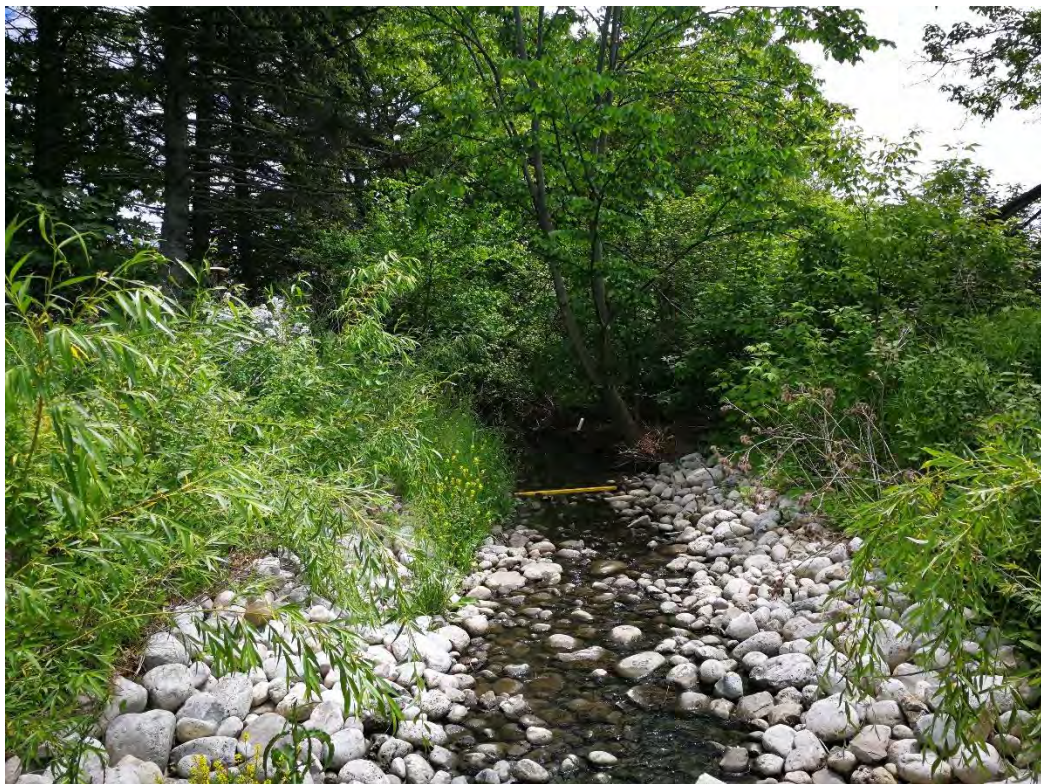
Photo B2: Creek conditions at south of Lakeshore Blvd (looking south - downstream)

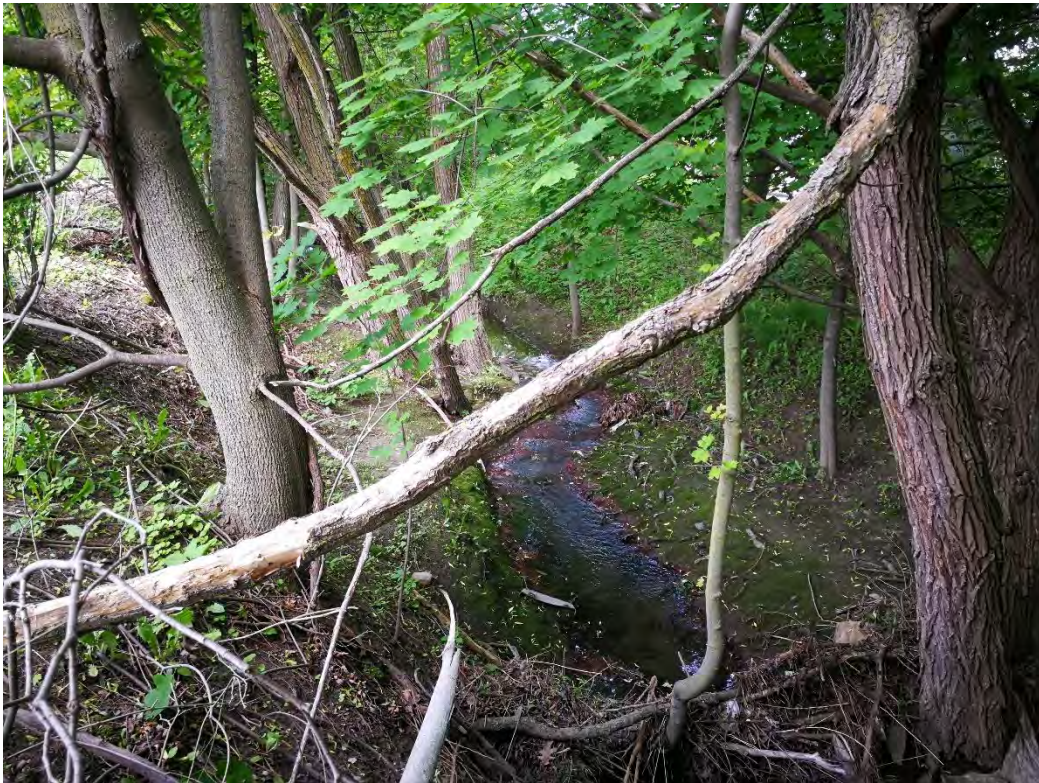
Photo B3: Creek conditions at north of Section L-L (looking north - upstream)

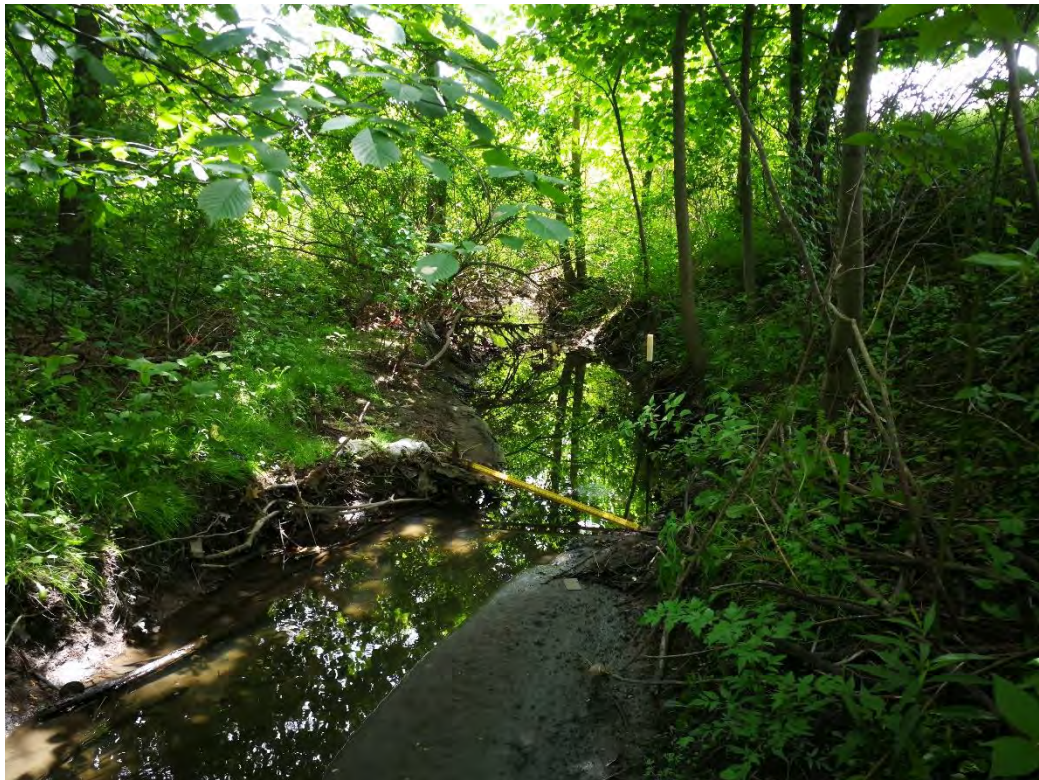
Photo B4: Creek conditions at north of Section L-L (looking south - downstream)

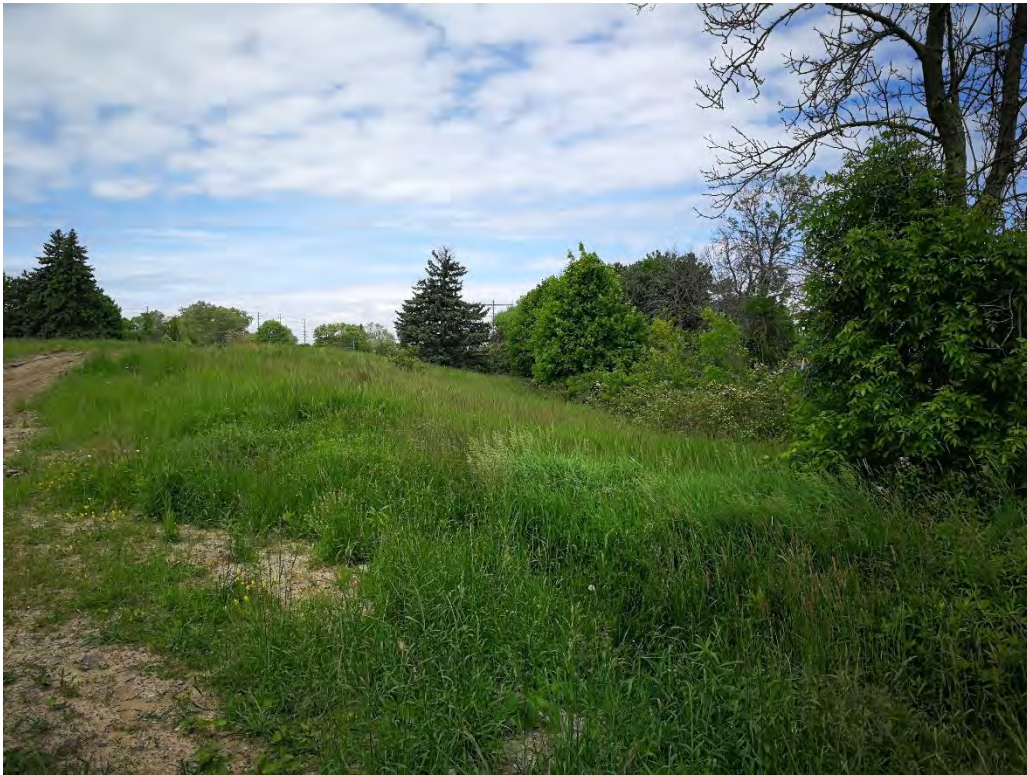
**Photo B5: Top of slope conditions to north of Section M-M
(looking north toward Lakeshore Blvd)**

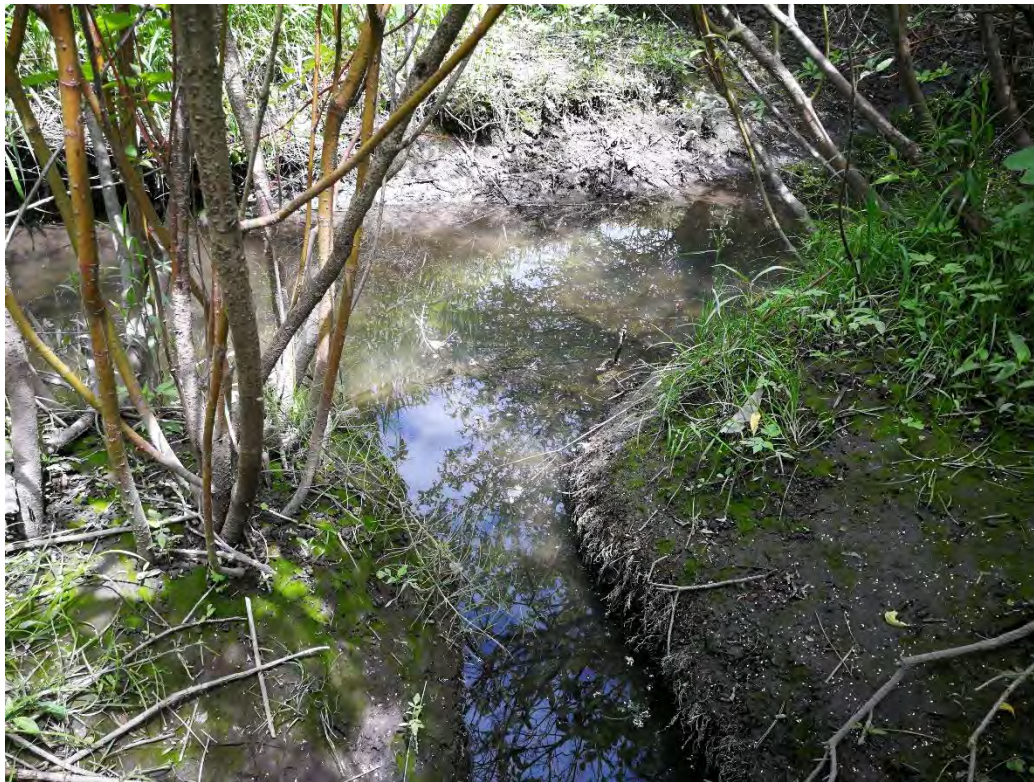
**Photo B6: Creek conditions at the turning point to south of Section M-M
(looking northeast)**

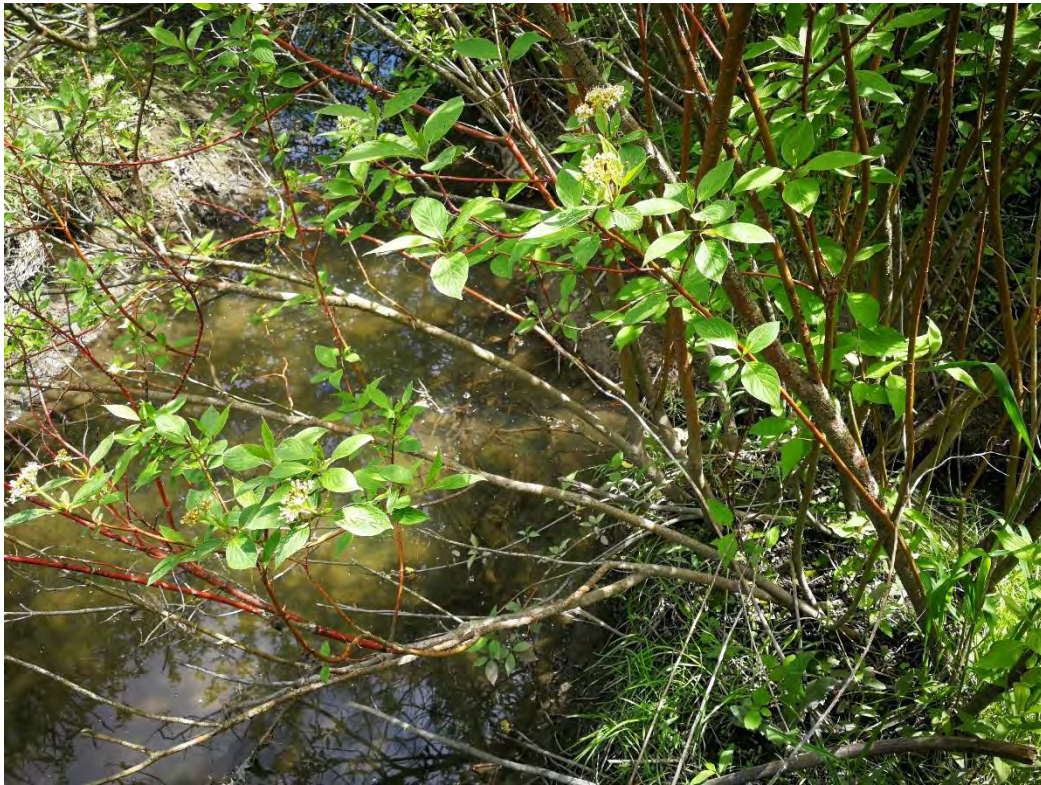
Photo B7: Creek conditions at west of Section N-N (looking east)

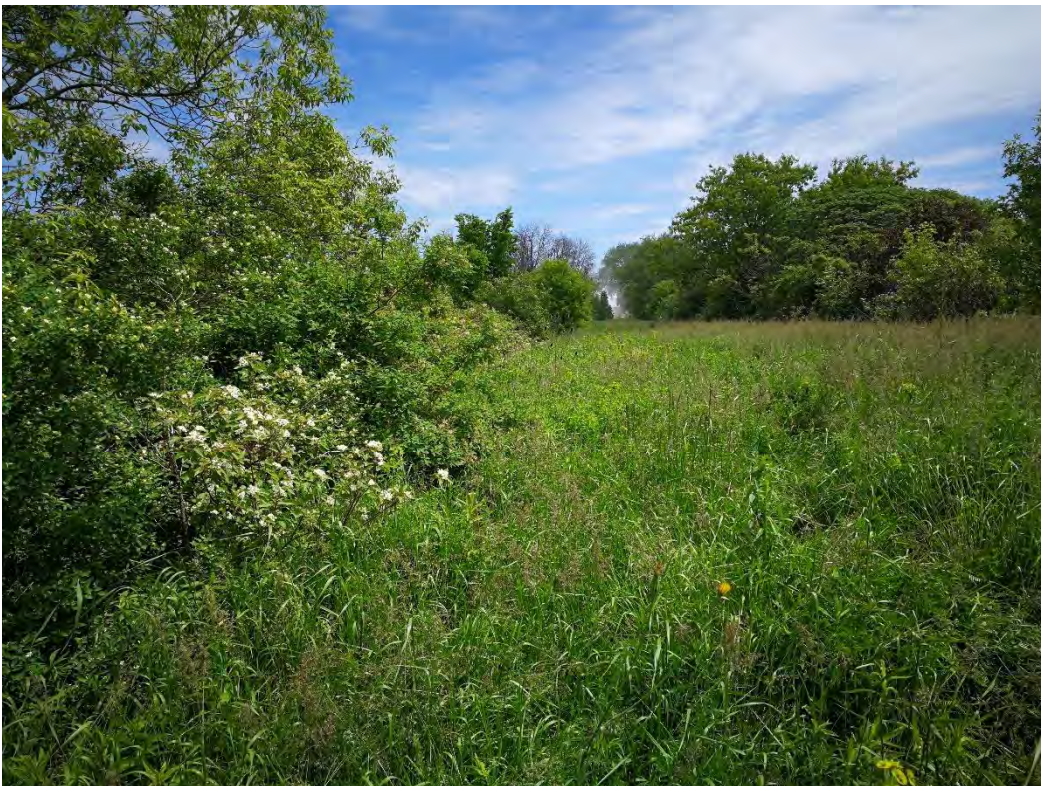
**Photo B8: Top of slope conditions in area of and to west of Section N-N
(looking east from Borehole BH18-41 area – See Appendix A)**

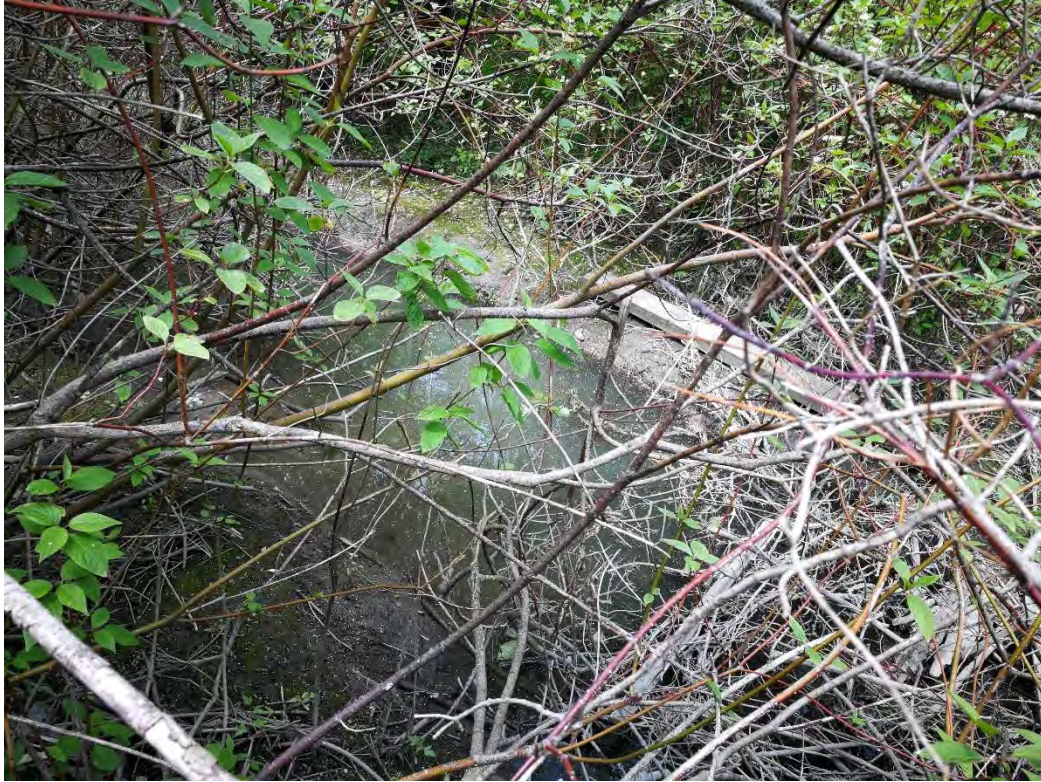
Photo B9: Creek conditions at west of Section N-N (looking northwest)

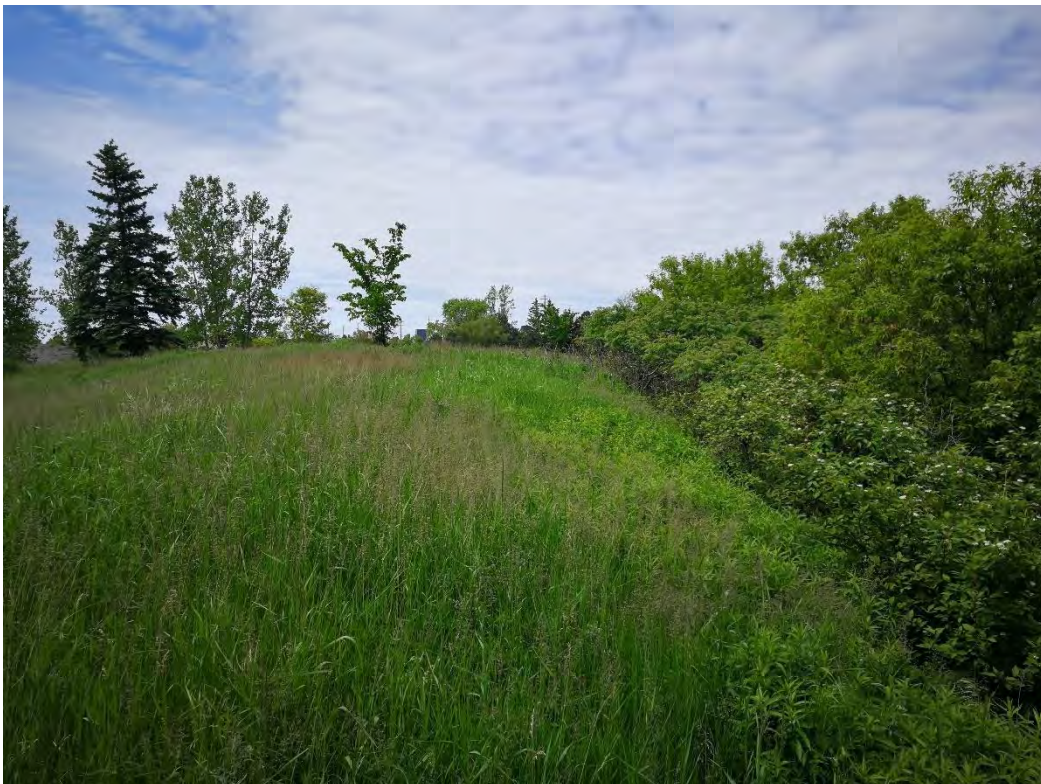
Photo B10: Top of slope conditions to west of Section N-N (looking west)

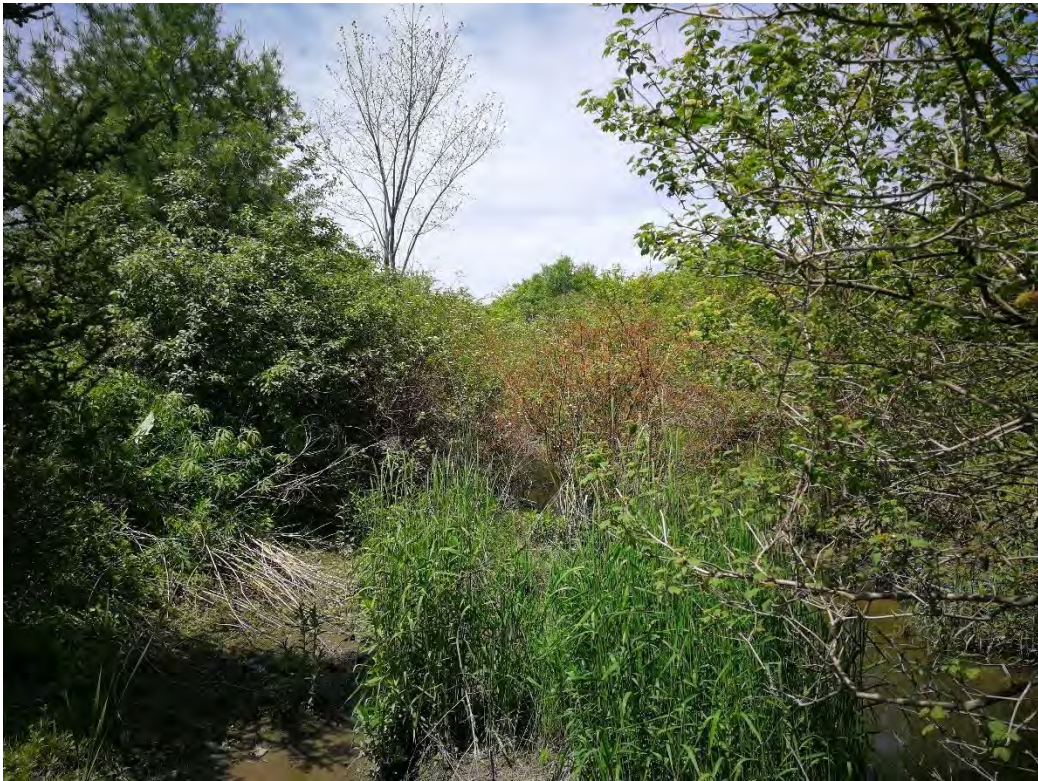
Photo B11: Slope conditions to east of Section N-N near road bridge (looking west)

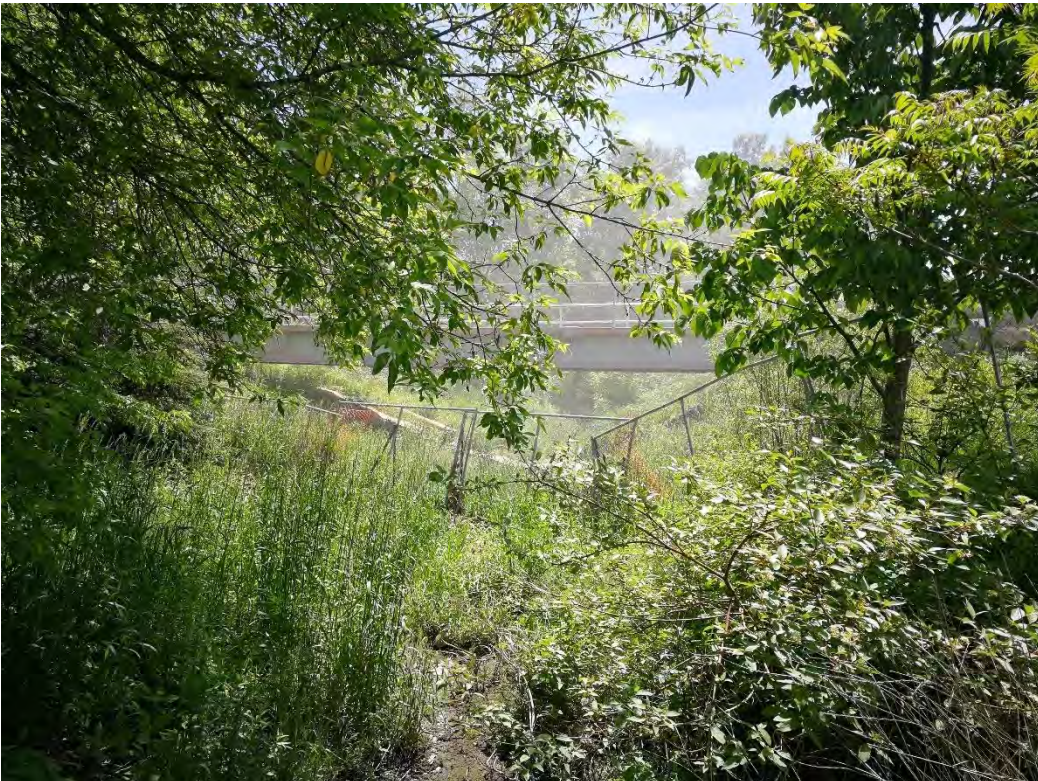
Photo B12: Creek conditions at north of Bridge (looking south - downstream)

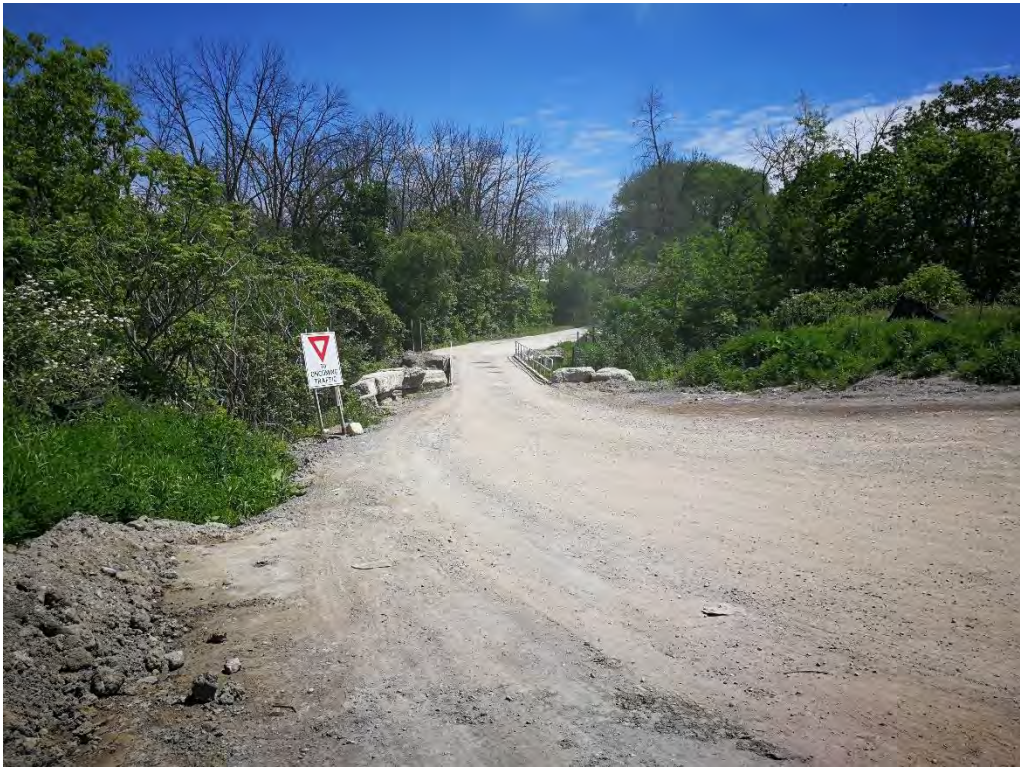
Photo B13: Road Bridge area (looking east)

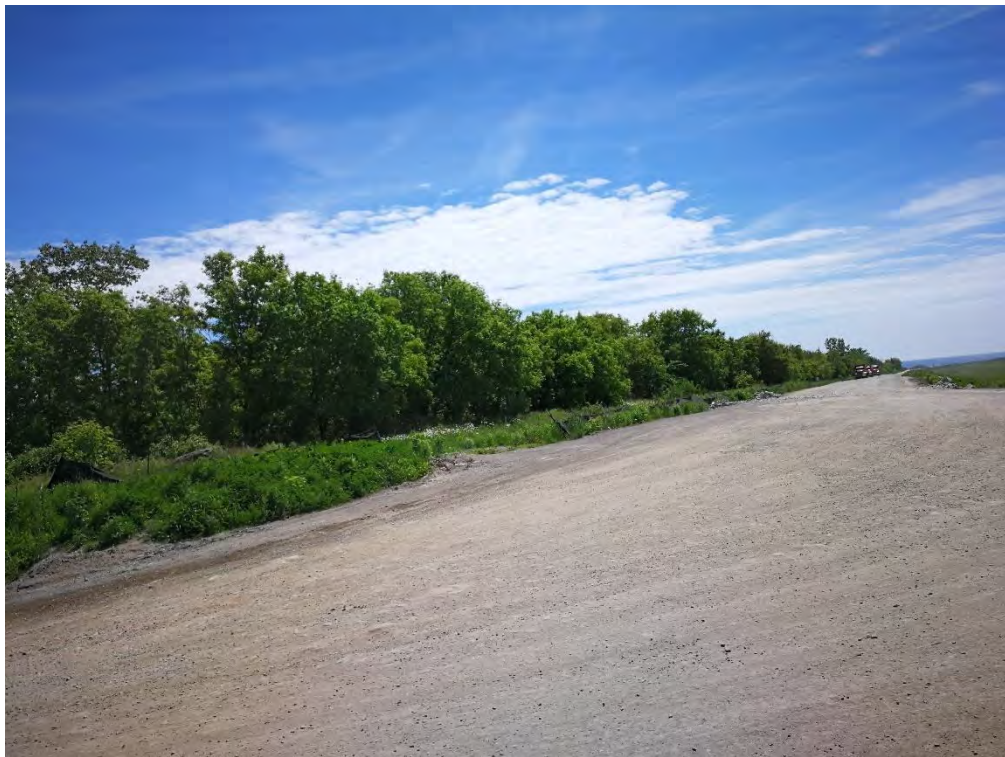
Photo B14: Top of slope conditions and road to west of creek in Reach S2 area (looking south)

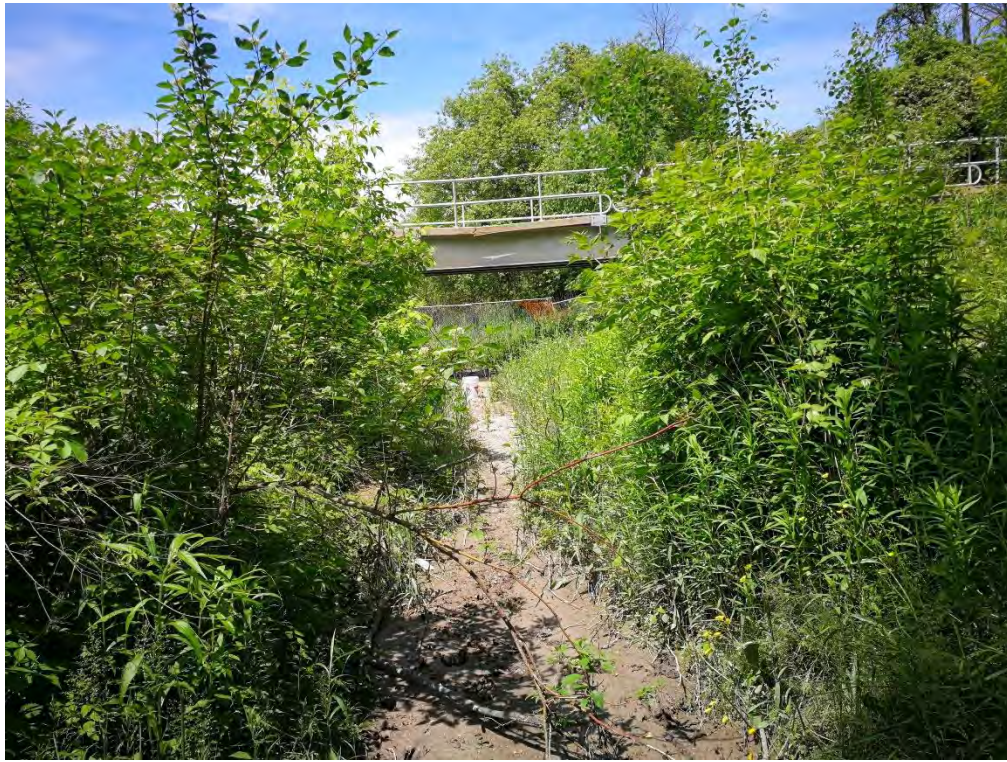
Photo B15: Creek conditions to south of bridge (looking north - upstream)

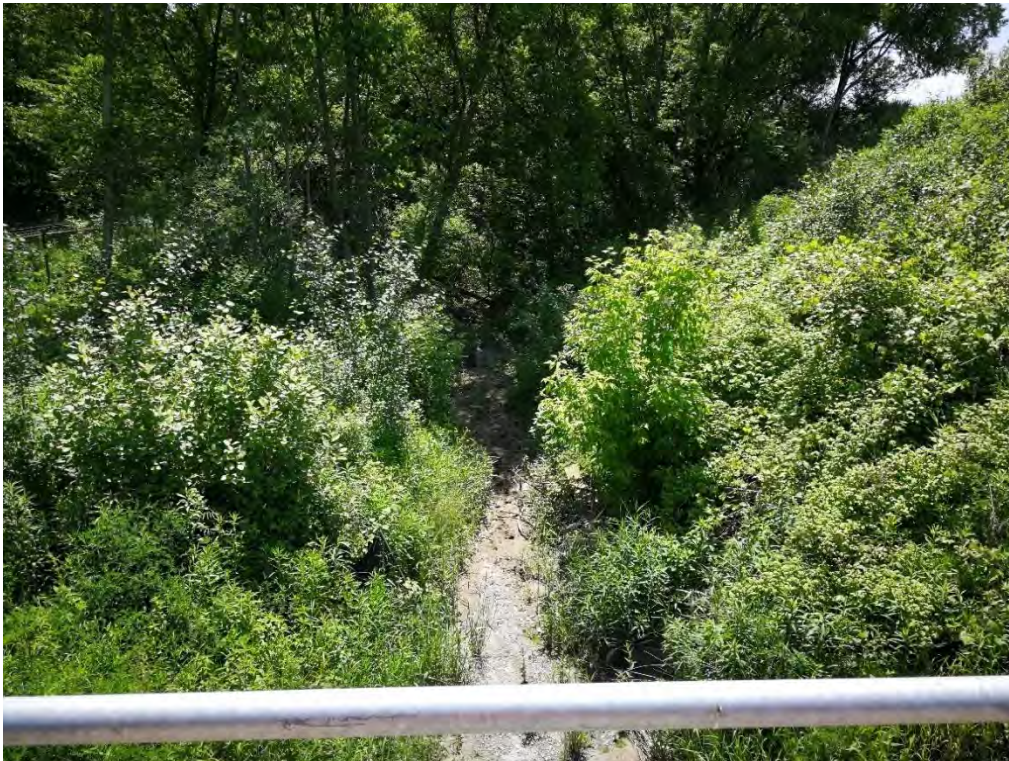
Photo B16: Creek and slope conditions to south of bridge (looking south from bridge – looking downstream)

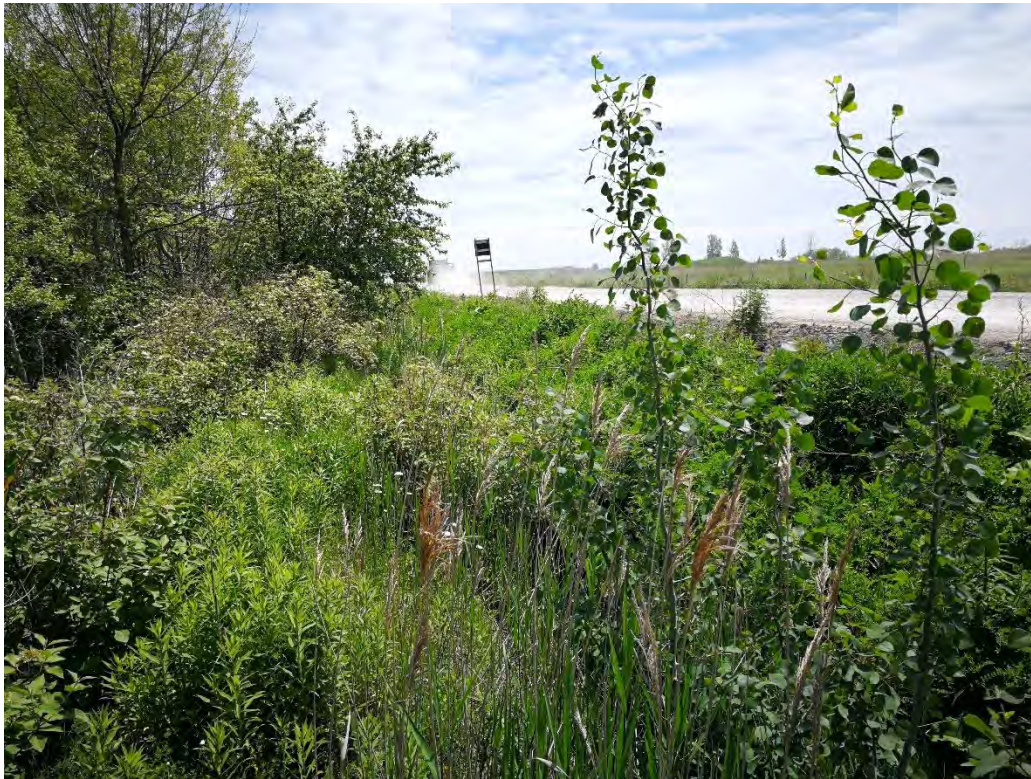
**Photo B17: Ditch between Creek and Road at south part of Reach S2 area
(looking south - downstream)**

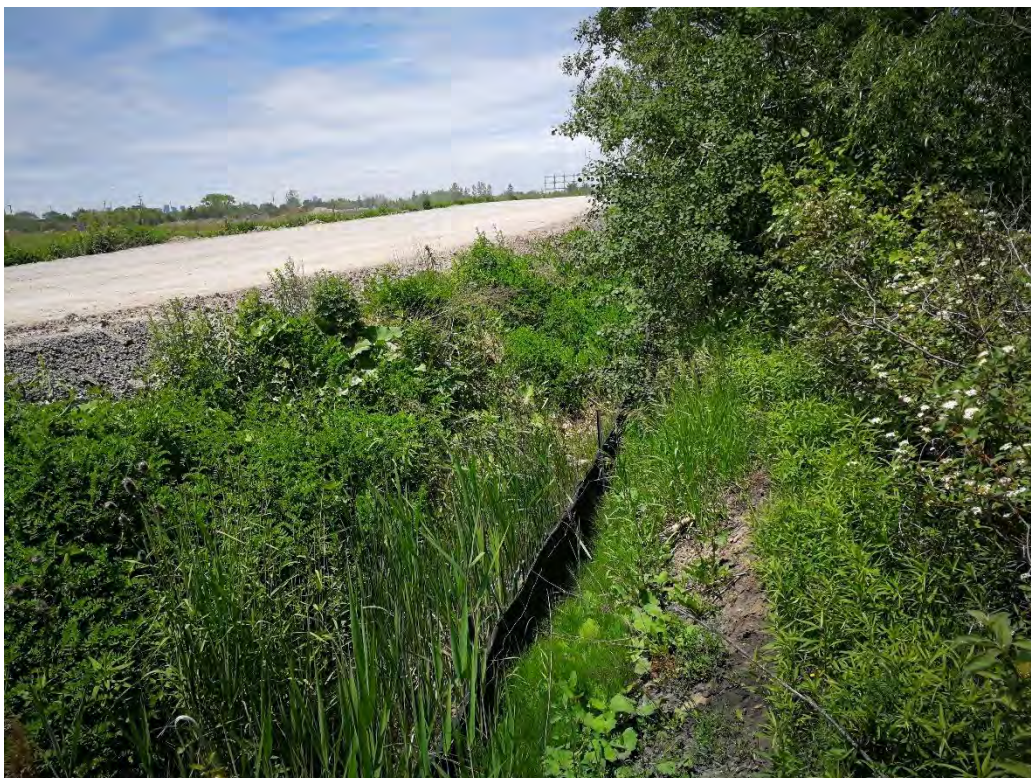
**Photo B18: Ditch between Creek and Road at south part of Reach S2 area
(looking north - upstream)**
