LAKEVIEW VILLAGE

CHANNEL DESIGN BRIEF

DECEMBER 2019

Serson Creek Geomorphic Assessment and Rehabilitation Design Lakeview Village City of Mississauga

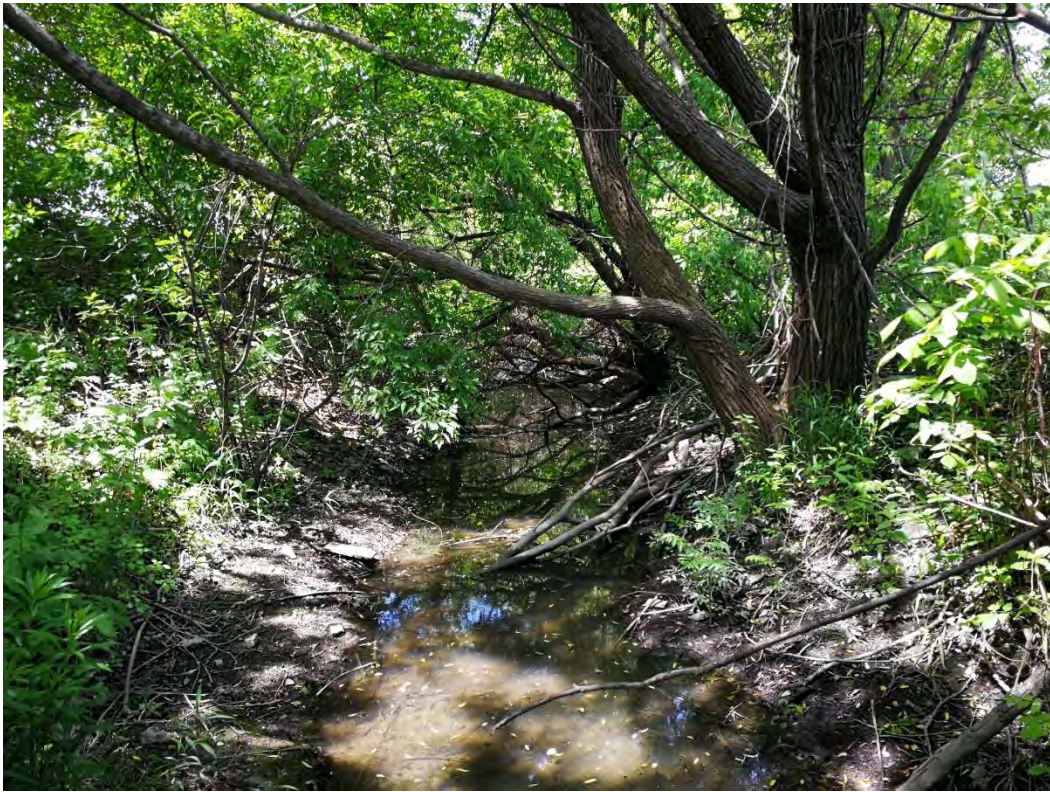
**Photo B19: Creek Conditions to South of Steel Wire Fence
at south end of Each S2 (looking north - upstream)**

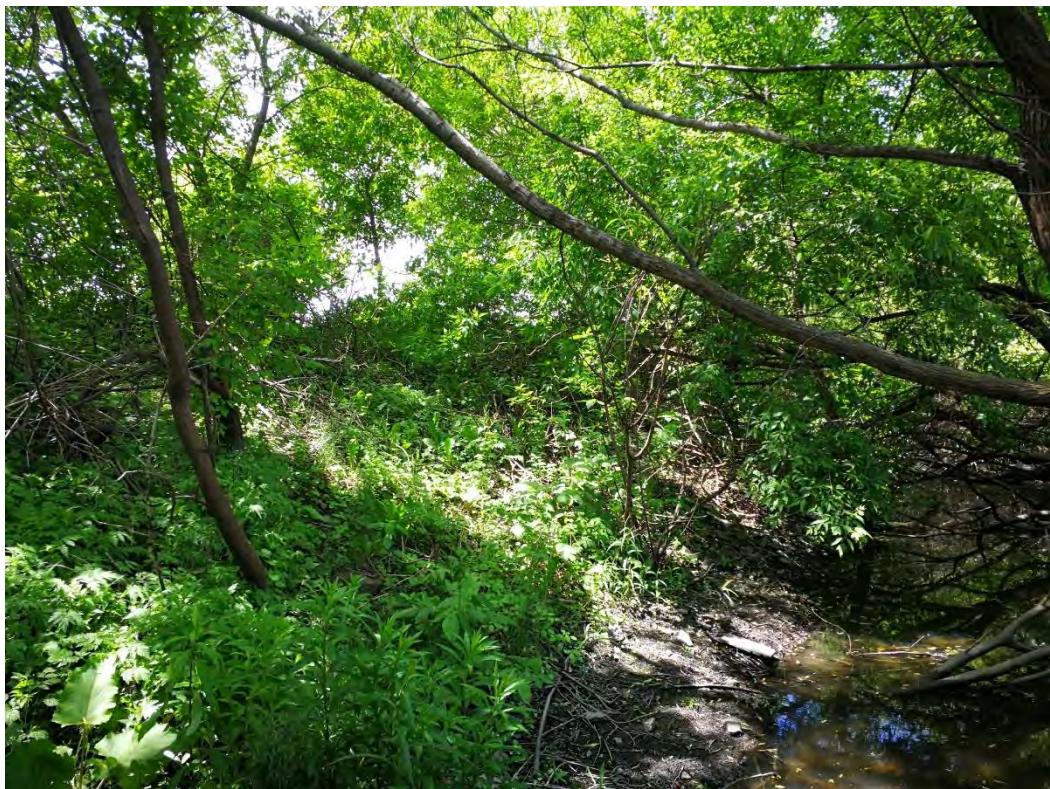
**Photo B20: Slope Conditions at South of Steel Wire Fence
to south end of Reach S2 area (looking northwest)**

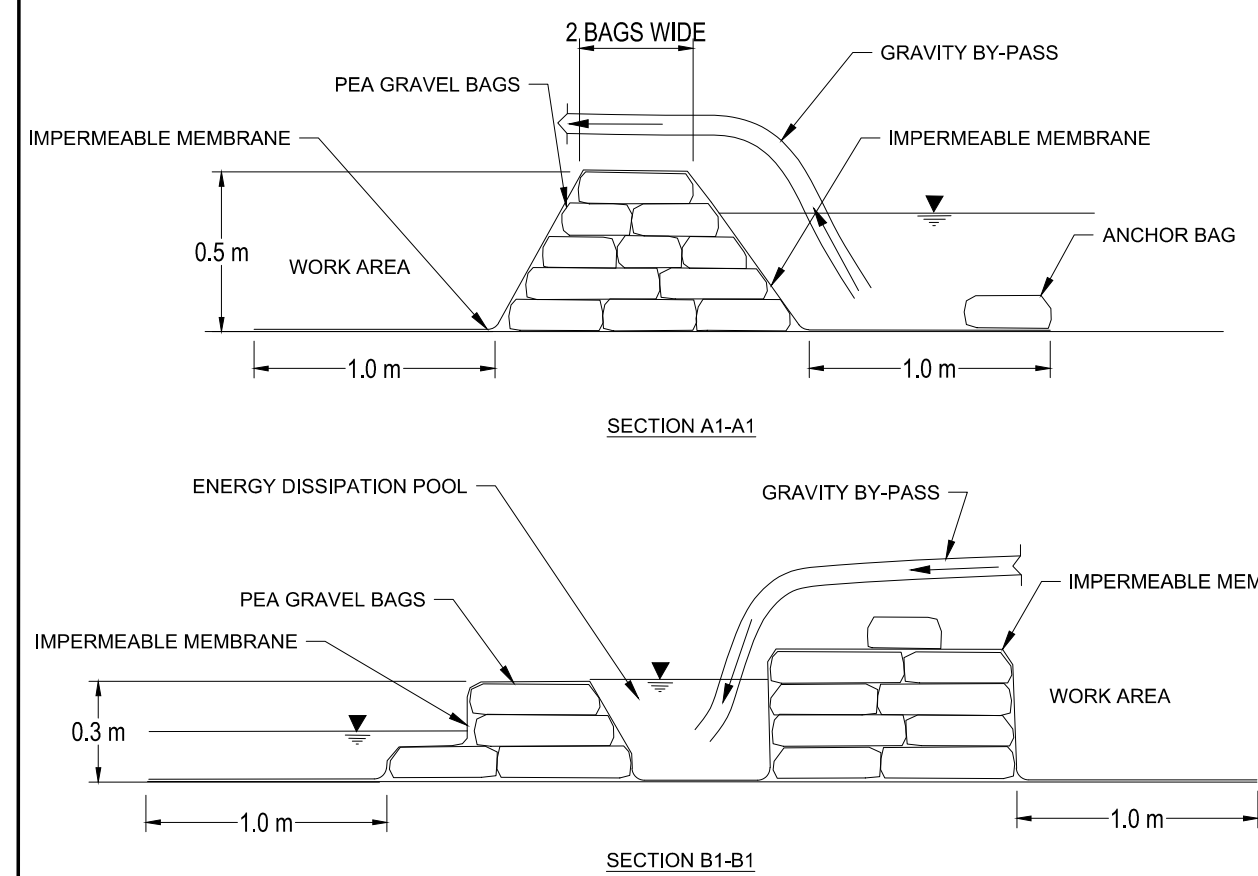
1. METRE BAGS TO BE FILLED WITH PEA GRAVEL.
2. HEIGHT OF COFFERDAMS SHALL MATCH THE HEIGHT OF EITHER CHANNEL BANK, WHICHEVER IS LOWER.
3. IMPERVIOUS MEMBRANE SHALL COVER THE METRE BAGS TO LIMIT WATER ENTRY INTO WORK AREA.
4. PUMPING CAPACITY TO BE A MINIMUM, TO CARRY FLOWS AROUND WORK AREA.
5. SCREEN TO BE INSTALLED AT INTAKE END OF HOSE TO LIMIT FISH MORTALITY.
6. PUMPED WATER SHALL BE DISCHARGED INTO THE ENERGY DISSIPATION POOL.
7. A BACKUP PUMP AND HOSE SHALL BE KEPT ONSITE IN THE EVENT THAT INCREASED FLOWS CANNOT BE PUMPED IN THE PRIMARY SYSTEM.
8. THE CONTRACTOR SHALL MONITOR WEATHER CONDITIONS AND WILL NOT PROCEED WITH WORKS IN THE EVENT OF A STORM EVENT, OR IF IT IS ANTICIPATED THAT FLOWS CANNOT BE PUMPED AROUND AS REQUIRED.
