**PRE-DESIGN REPORT / ENVIRONMENTAL STUDY REPORT
PORT CREDIT HARBOUR WEST PARKS**

**PORT CREDIT HARBOUR WEST PARKS
PRE-DESIGN REPORT / ENVIRONMENTAL STUDY REPORT**

Dillon Consulting Limited

Shoreplan Engineering Limited

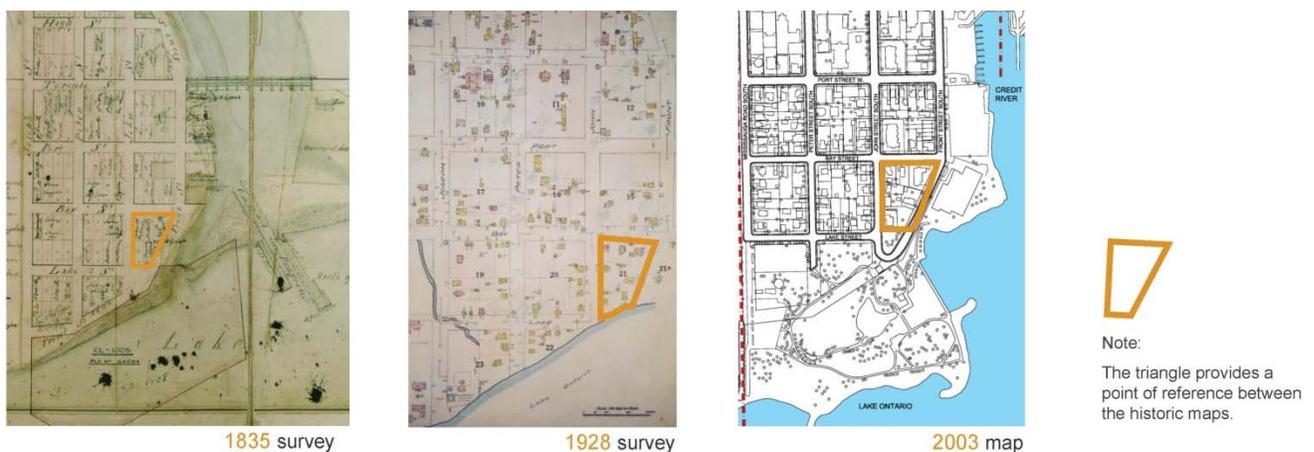
Figure 1: Changes to the Port Credit Waterfront Shoreline (Heritage Conservation Feasibility Study, 2003)

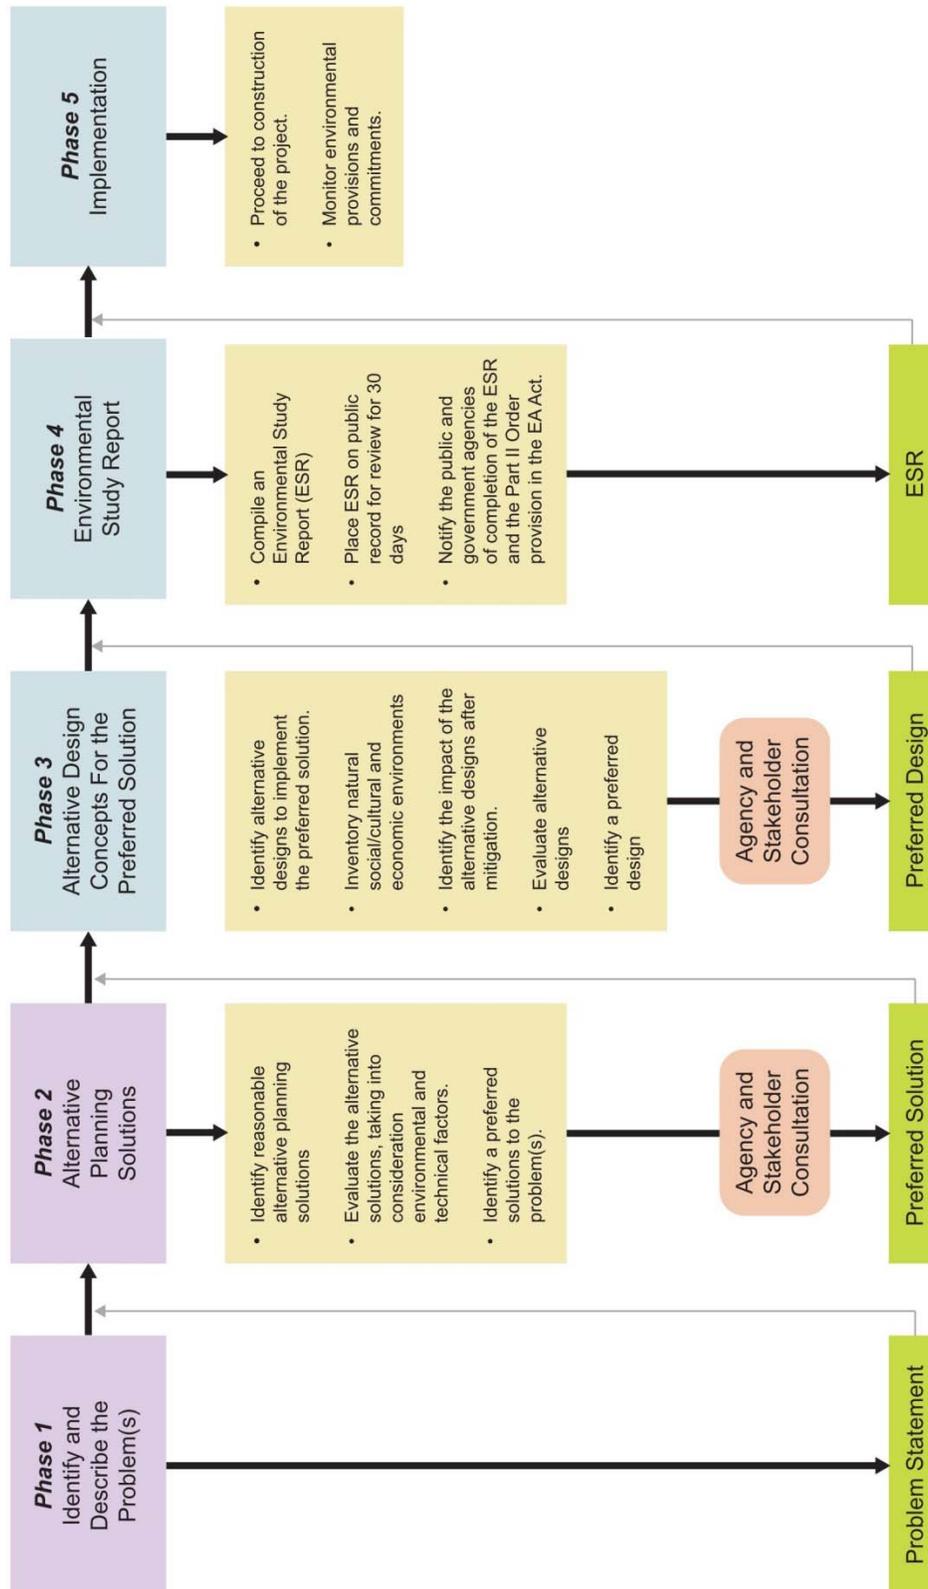
Figure 2: Municipal Class Environmental Assessment Process

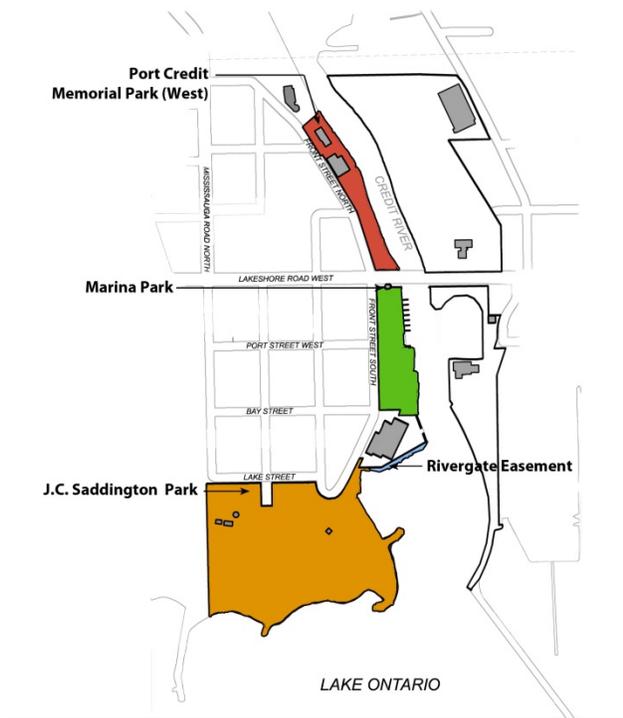
Figure 3: Port Credit Harbour West Parks

The study site includes three parks located on the west bank of the Credit River: Port Credit Memorial Park (West) located north of Lakeshore Road, Marina Park and J.C. Saddington Park located south of Lakeshore Road (see **Figure 3**). The Rivergate easement is a ribbon of riverfront property that connects Marina Park to JC Saddington Park. The City leases the easement from the Credit Valley Conservation and is also included in the study area. This section of the report provides context on the existing conditions within the study area and the policies that will guide redevelopment of the Port Credit Harbour West Parks. This information is provided in the following subsections: Planning Context; Socio-Economic Existing Conditions; Natural Environment Existing Conditions; Shoreline and Wave Existing Conditions and Infrastructure Existing Conditions.

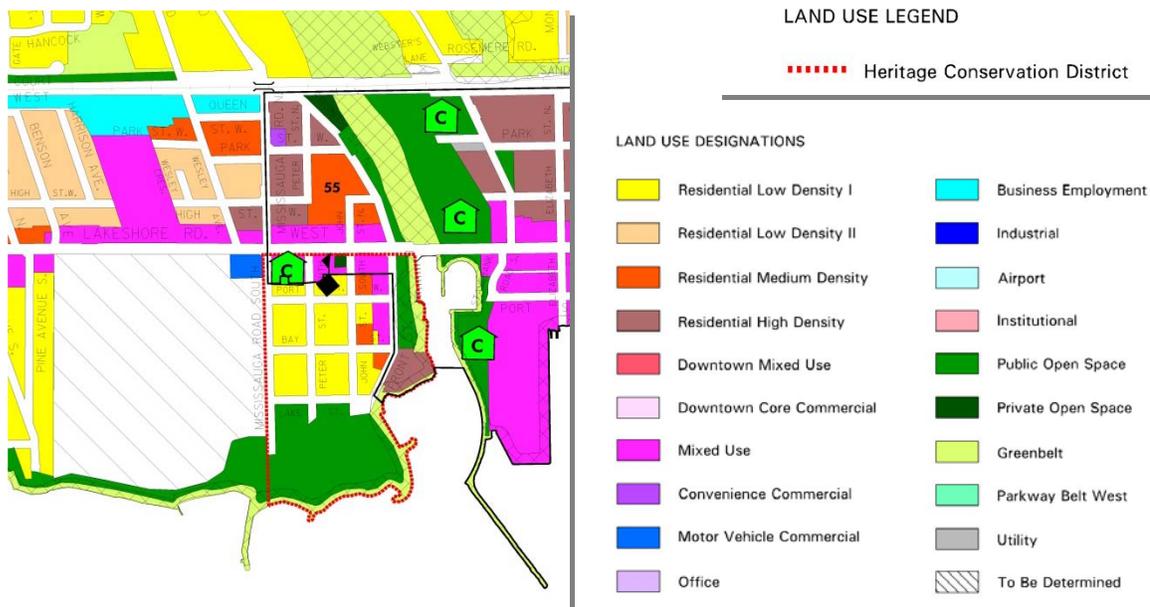
Figure 4: Schedule 10 Land Use Designations, Sept. 2011, Mississauga Official Plan (City of Mississauga)

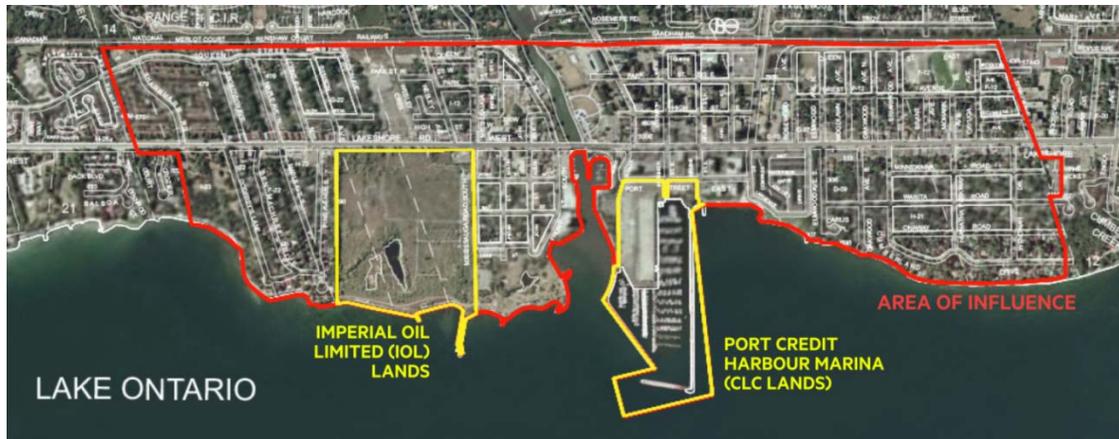
Figure 5: Inspiration Port Credit Study Area Boundaries (City of Mississauga)

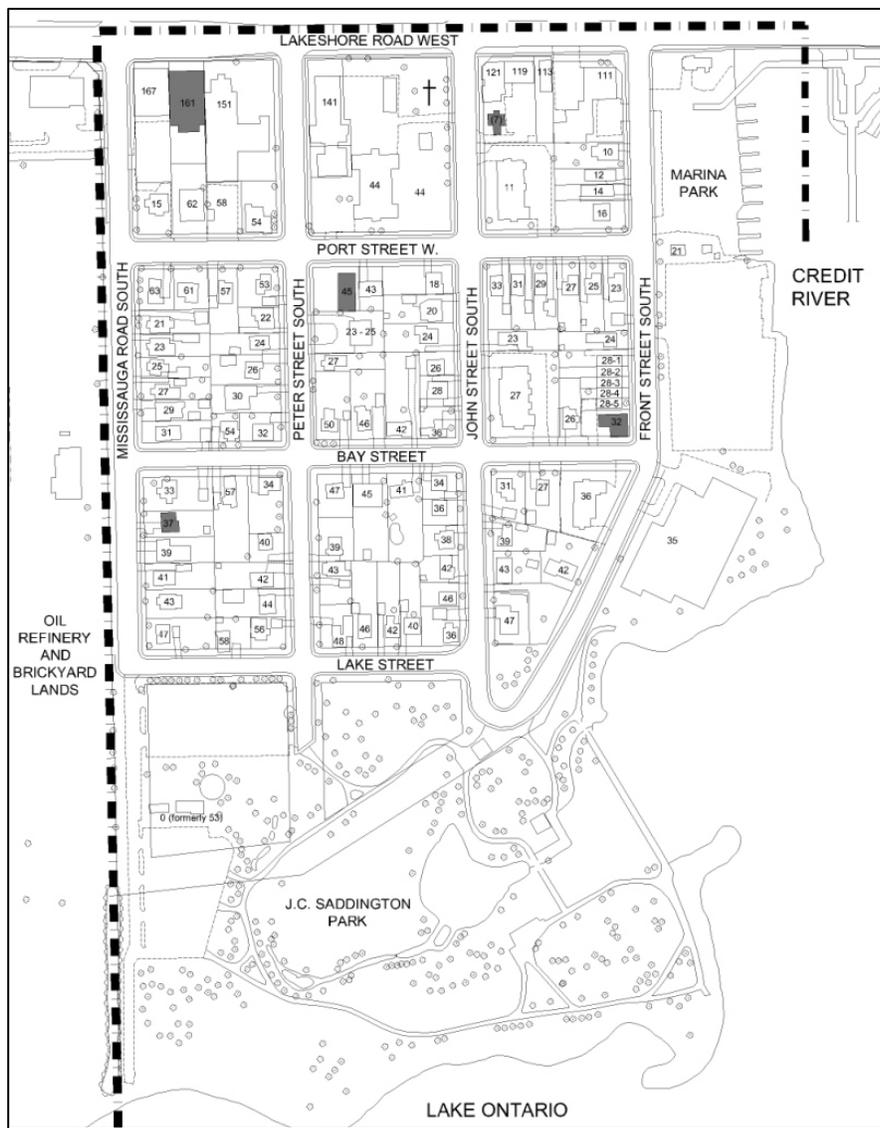
Figure 6: Heritage Conservation District Planning Area
 (Old Port Credit Village Heritage Conservation District Plan, 2004)

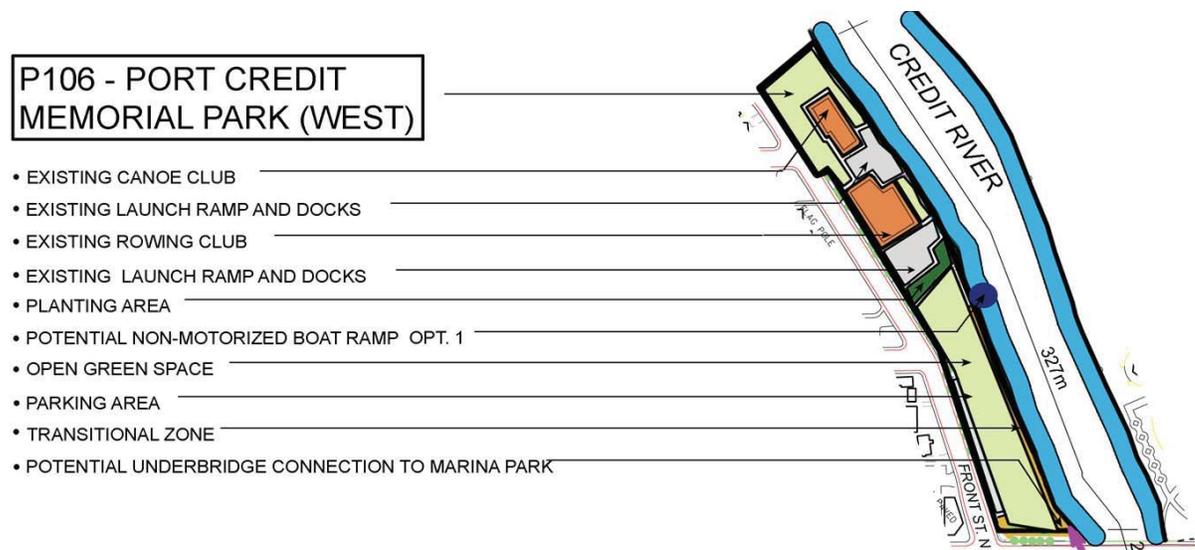
Figure 7: Port Credit Memorial Park (West) Concept (City of Mississauga)

The WPS recommended specific park activities and use, park elements and shoreline treatments to be considered in the improvement of Port Credit Memorial Park (West) as illustrated in **Figure 7**, including:

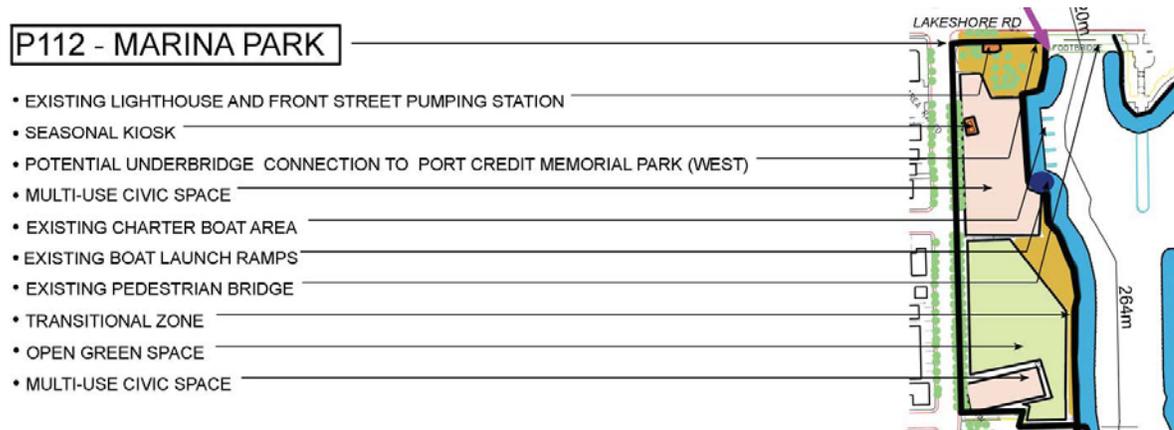
Figure 8: Marina Park Concept (City of Mississauga)

The WPS recommended specific park activities and use, park elements and shoreline treatments to be considered in the improvement of Marina Park as illustrated in **Figure 8**, including:

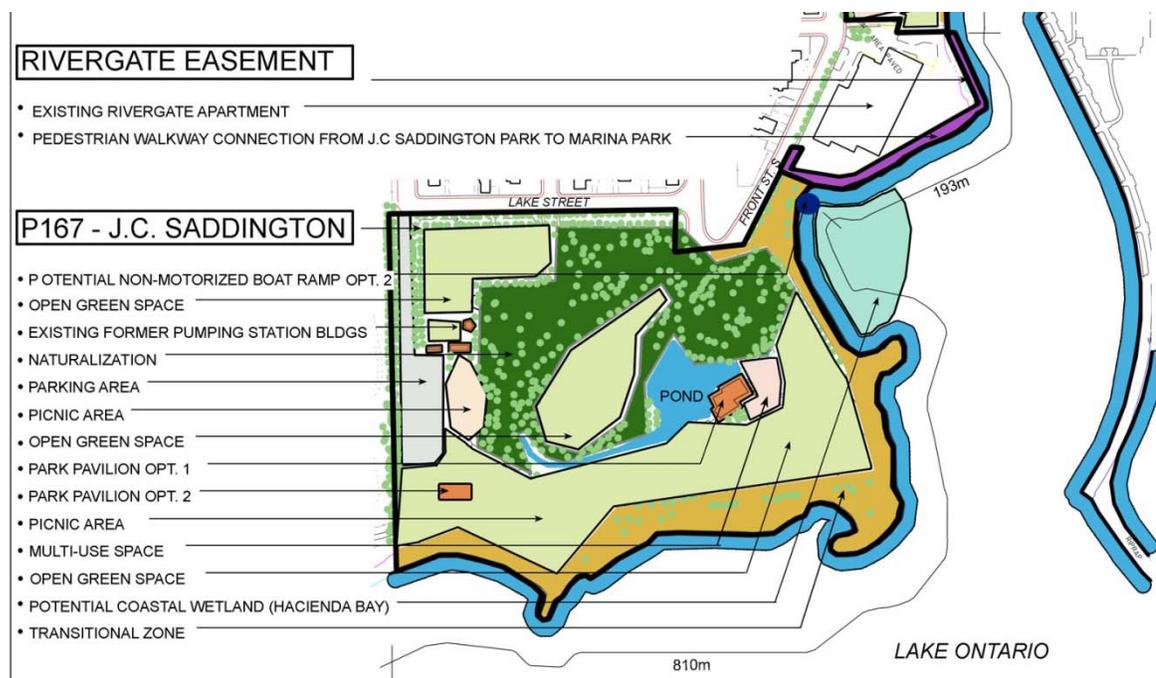
Figure 9: J.C. Saddington Park and Rivergate Easement Concepts (City of Mississauga)

The WPS proposed that the Rivergate easement may provide a river's edge walkway connection between Marina Park and J.C. Saddington Park as illustrated in **Figure 9**.

The WPS recommended specific park activities and uses, park elements and shoreline treatments to be considered in the improvement of J.C. Saddington Park as illustrated in **Figure 9**, including:

- Shoreline should be re-engineered to control erosion and promote fish habitat as well as pedestrian access to the water's edge and be considered for coastal wetland restoration in Hacienda Bay.
- Protect the natural features and processes of the Credit River and Lake Ontario.
- Possible location for small, non-motorized watercraft launching facilities in Hacienda Bay – requires further study.
- Opportunity for a connection to Marina Park via an on-land walkway along the shoreline – require further study of Rivergate easement.
- Adaptive re-use of existing washroom and heritage buildings, potential formation of outdoor square.

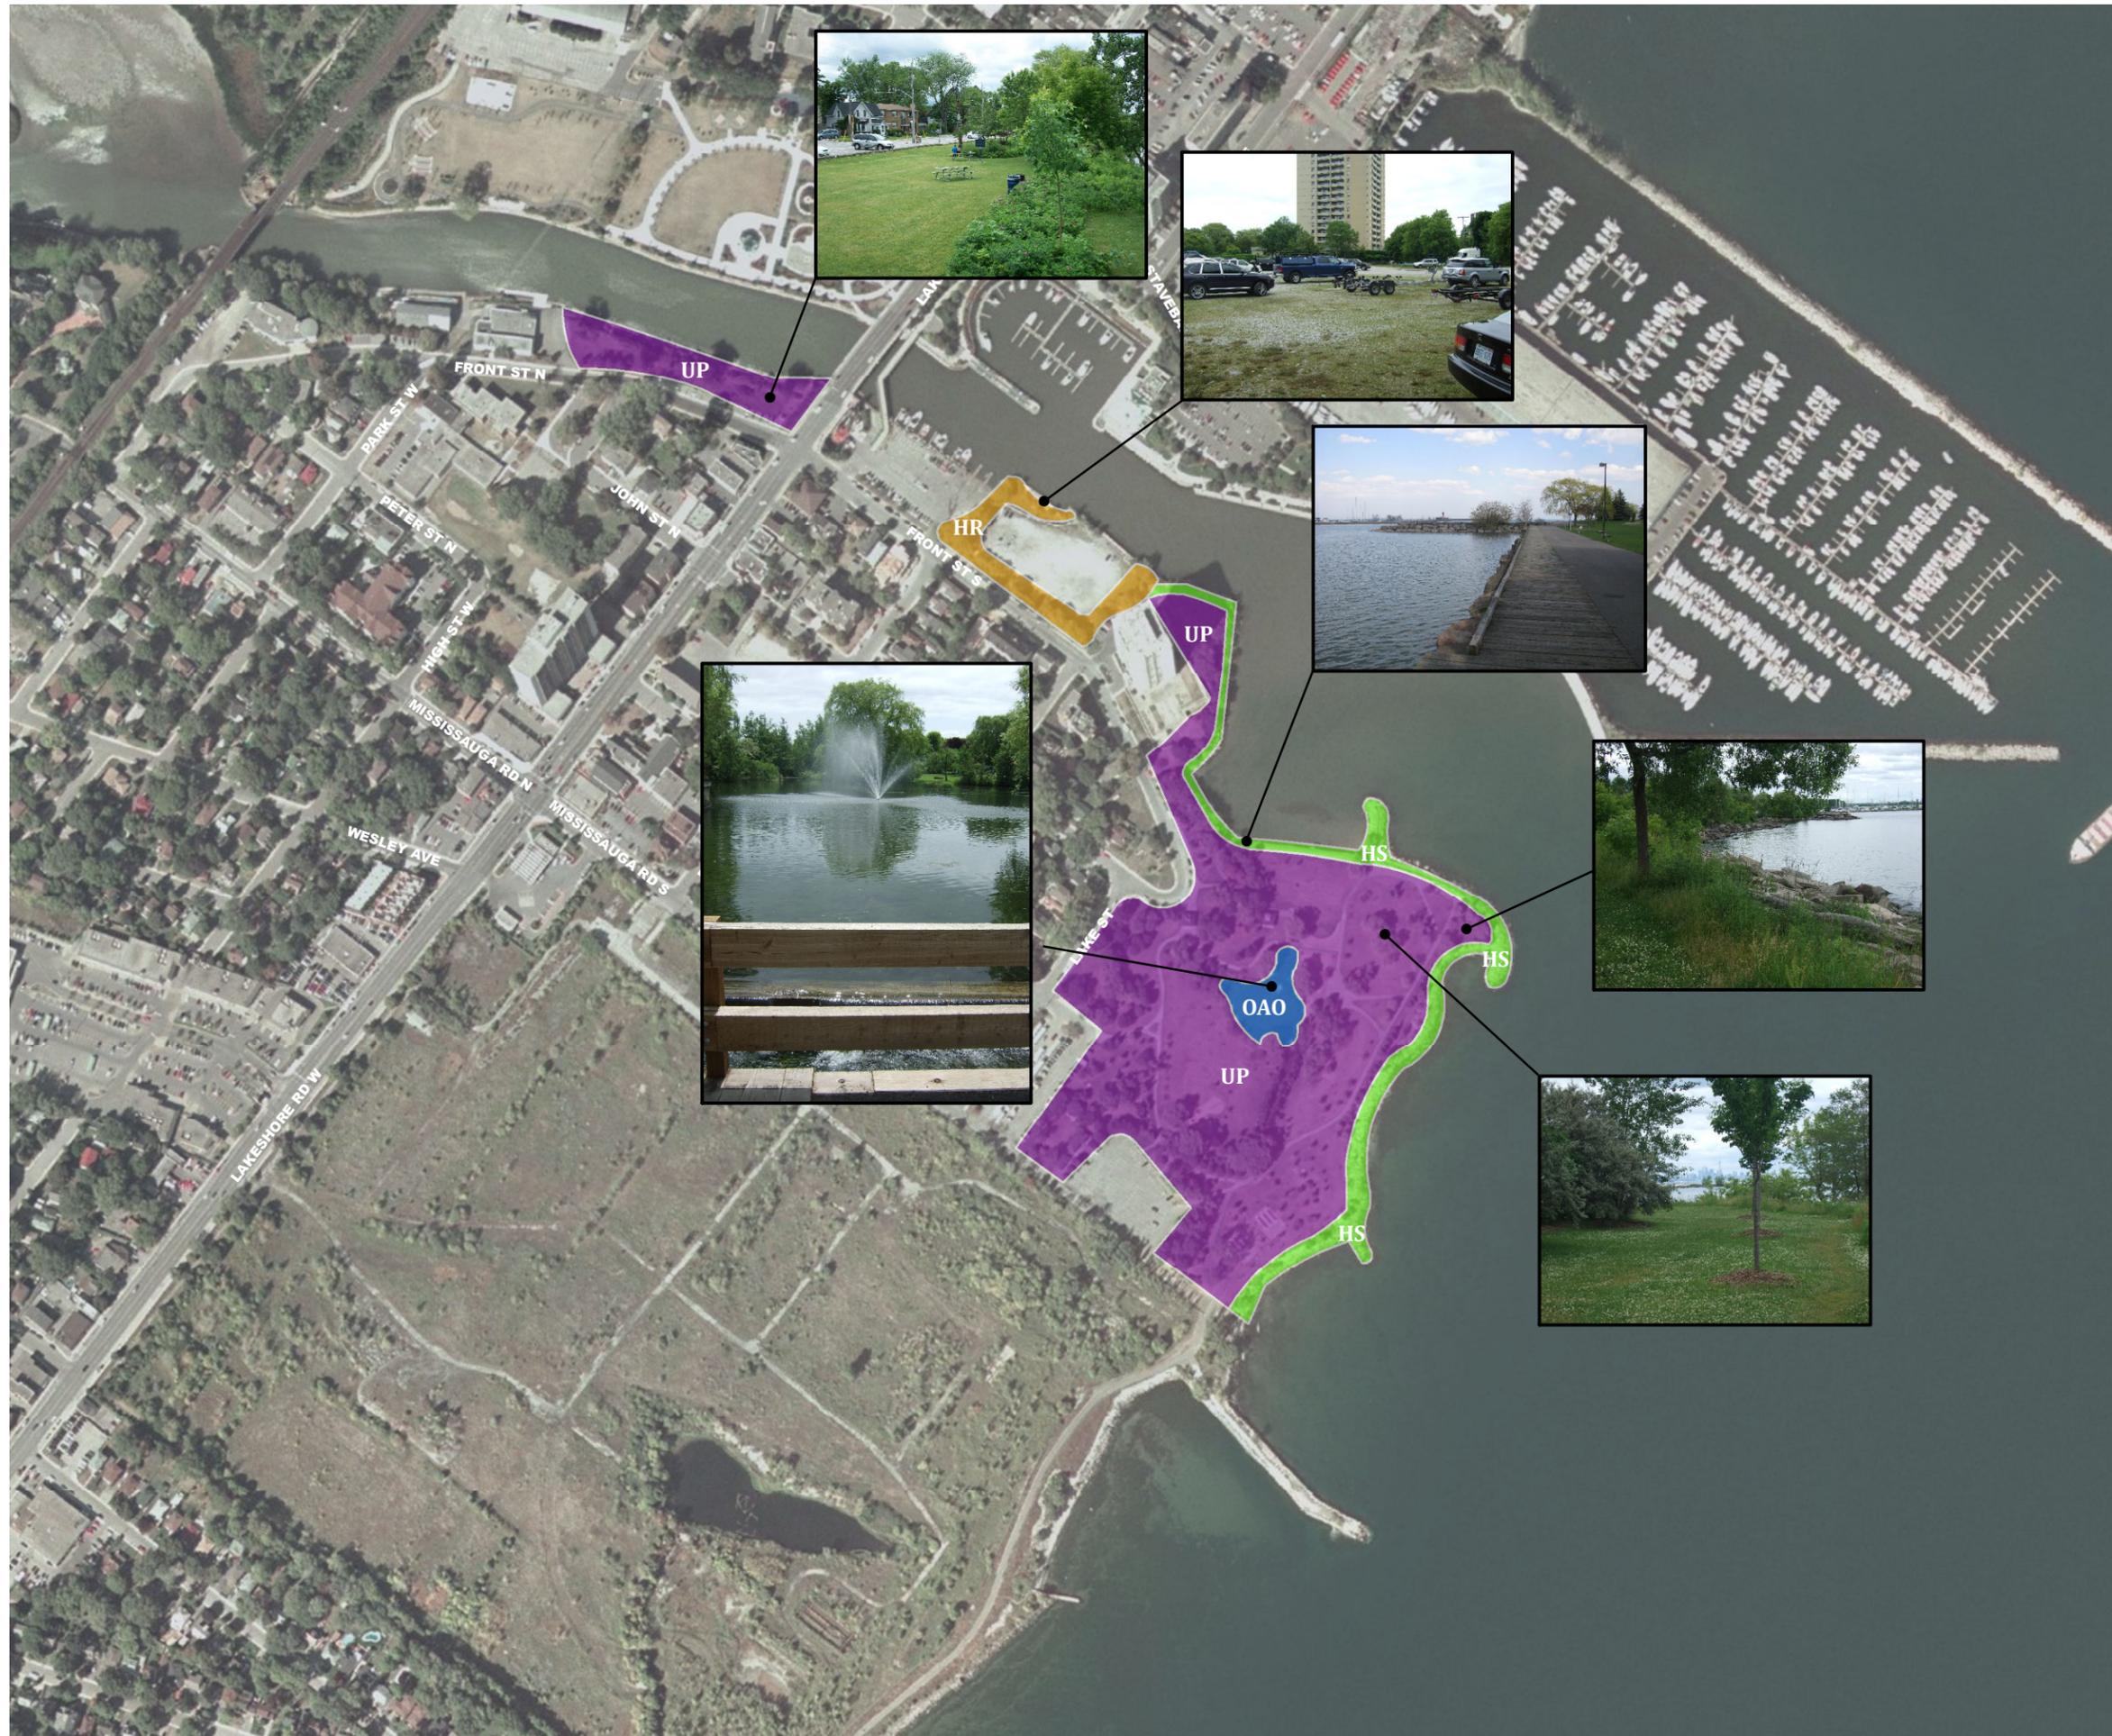
**ECOLOGICAL LAND CLASSIFICATION
FIGURE #10**

Vegetation communities have been mapped on aerial to graphically represent the specific spatial pattern in the vegetation cover according to species composition, physiognomy, and physical site characteristics (see **Figure 10**).

No natural vegetation communities occur within the Port Credit Harbour West Parks. Rather, vegetation is part of an urban park landscape that contains vegetation that is primarily manicured (e.g., single/multiple trees or shrubs surrounded by cut grass) or hedgerows (e.g., unmaintained opportunistic tree growth). In a few locations of J.C Saddington Park the edge of the hardened shoreline has been left uncut and provides some additional wildlife cover and plant diversity. Similarly, areas of the Rivergate easement hardened shoreline have thick tree and shrub vegetation that provides cover and greater plant diversity. The riparian vegetation surrounding the open aquatic area of J.C Saddington Park, while manicured, does provide some diversity and wildlife cover. The hedgerow surrounding the south and east perimeter of Marina Park contains opportunistic tree growth which has not been maintained and provides limited wildlife cover.

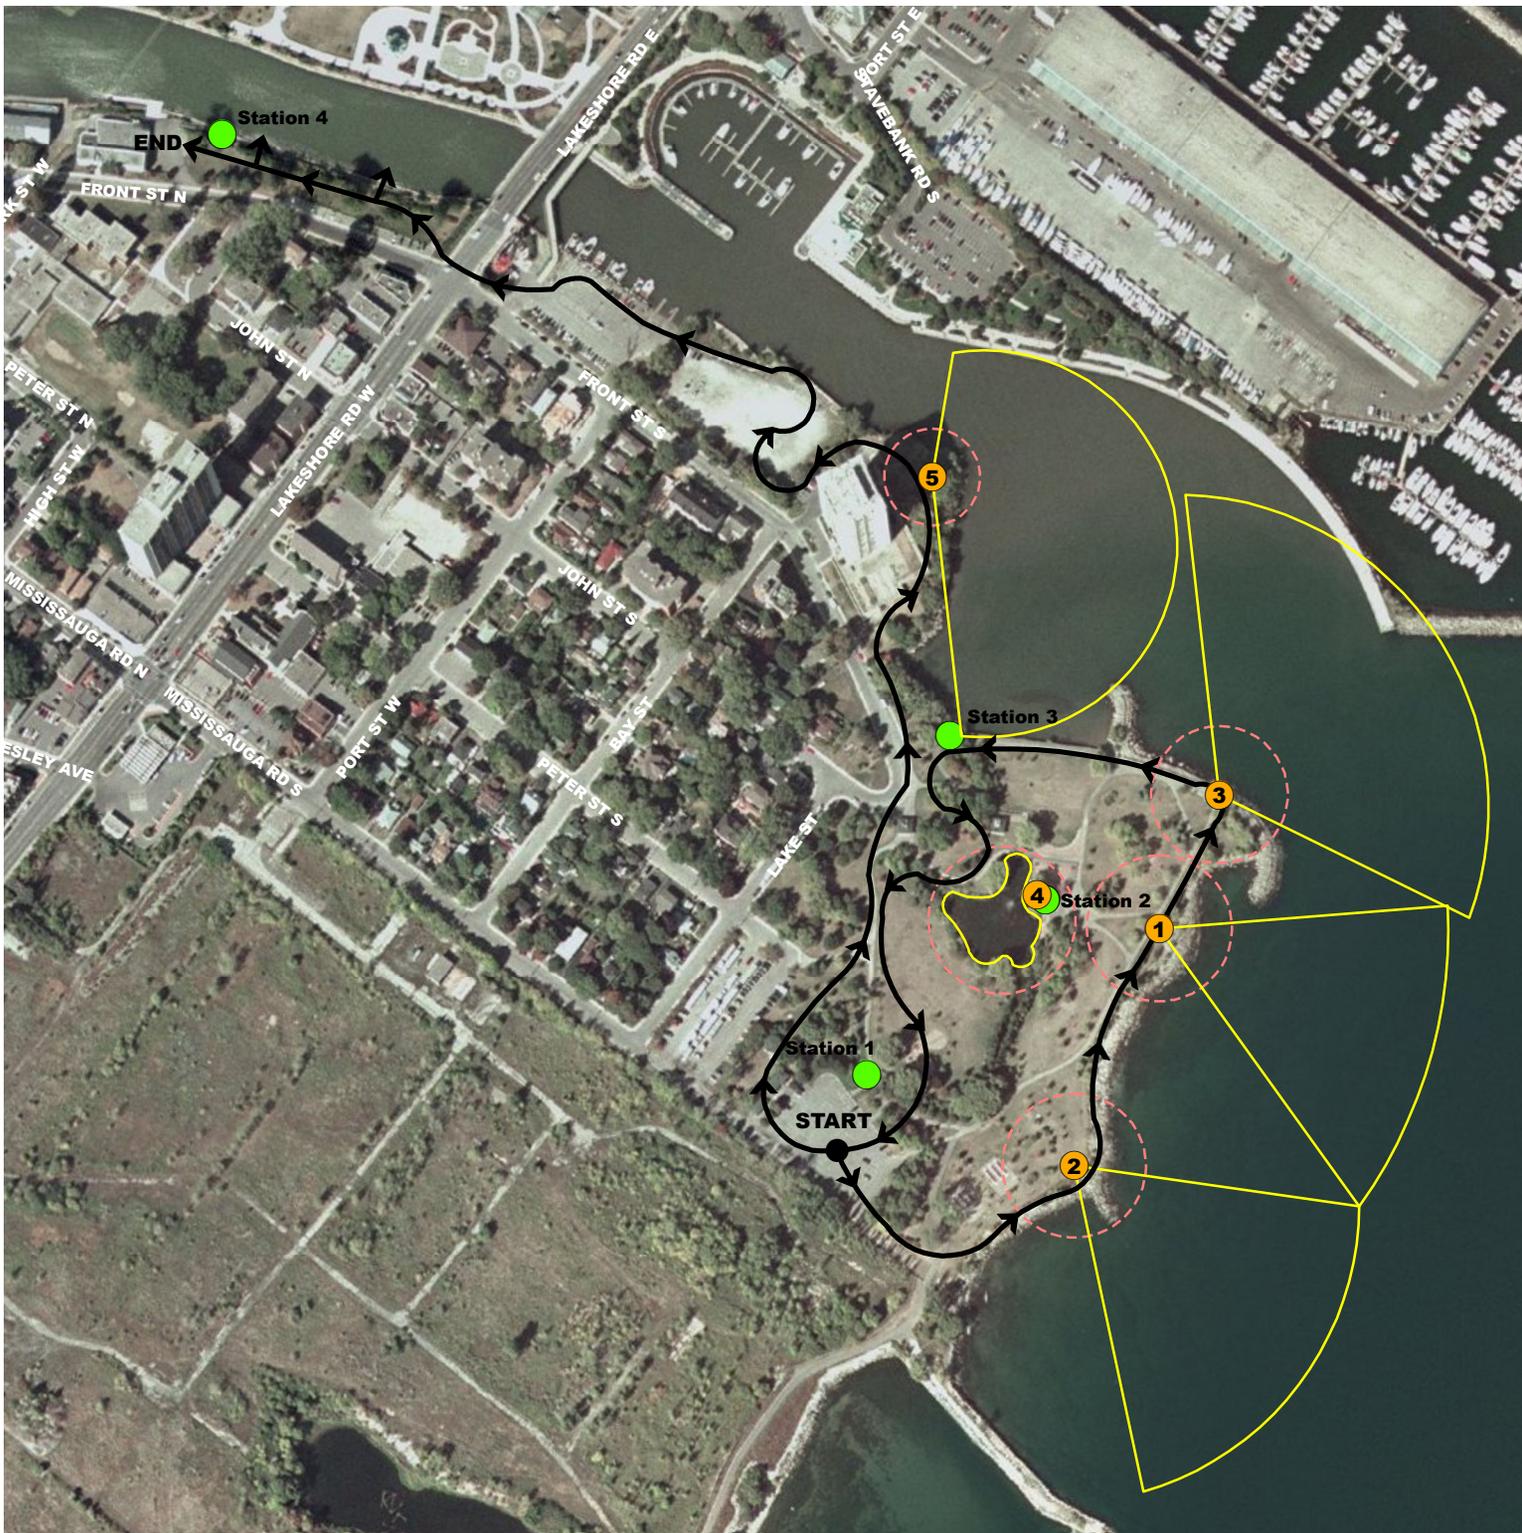
SURVEY LOCATIONS FIGURE #11

Bird migration assessments were completed in April and October 2012 at five point counts (see **Figure 11**). This assessment focused primarily on waterfowl species using the Lake Ontario and Credit River for staging. However, all birds heard or observed were documented. For point counts 1 to 3, observed waterfowl species were recorded under two distance markers:

their young. Walking transects were used throughout the project location as shown in **Figure 11**.

Amphibian monitoring followed the Marsh Monitoring Program protocol (Bird Studies Canada 1994). Three different surveys at four survey locations (see **Figure 11**) were conducted between May and July 2012, with at least two weeks between each survey. Surveys began at least one half hour after sunset during evenings with a minimum night temperature of 5°C, 10°C, and 17°C for each of the three respective surveys.

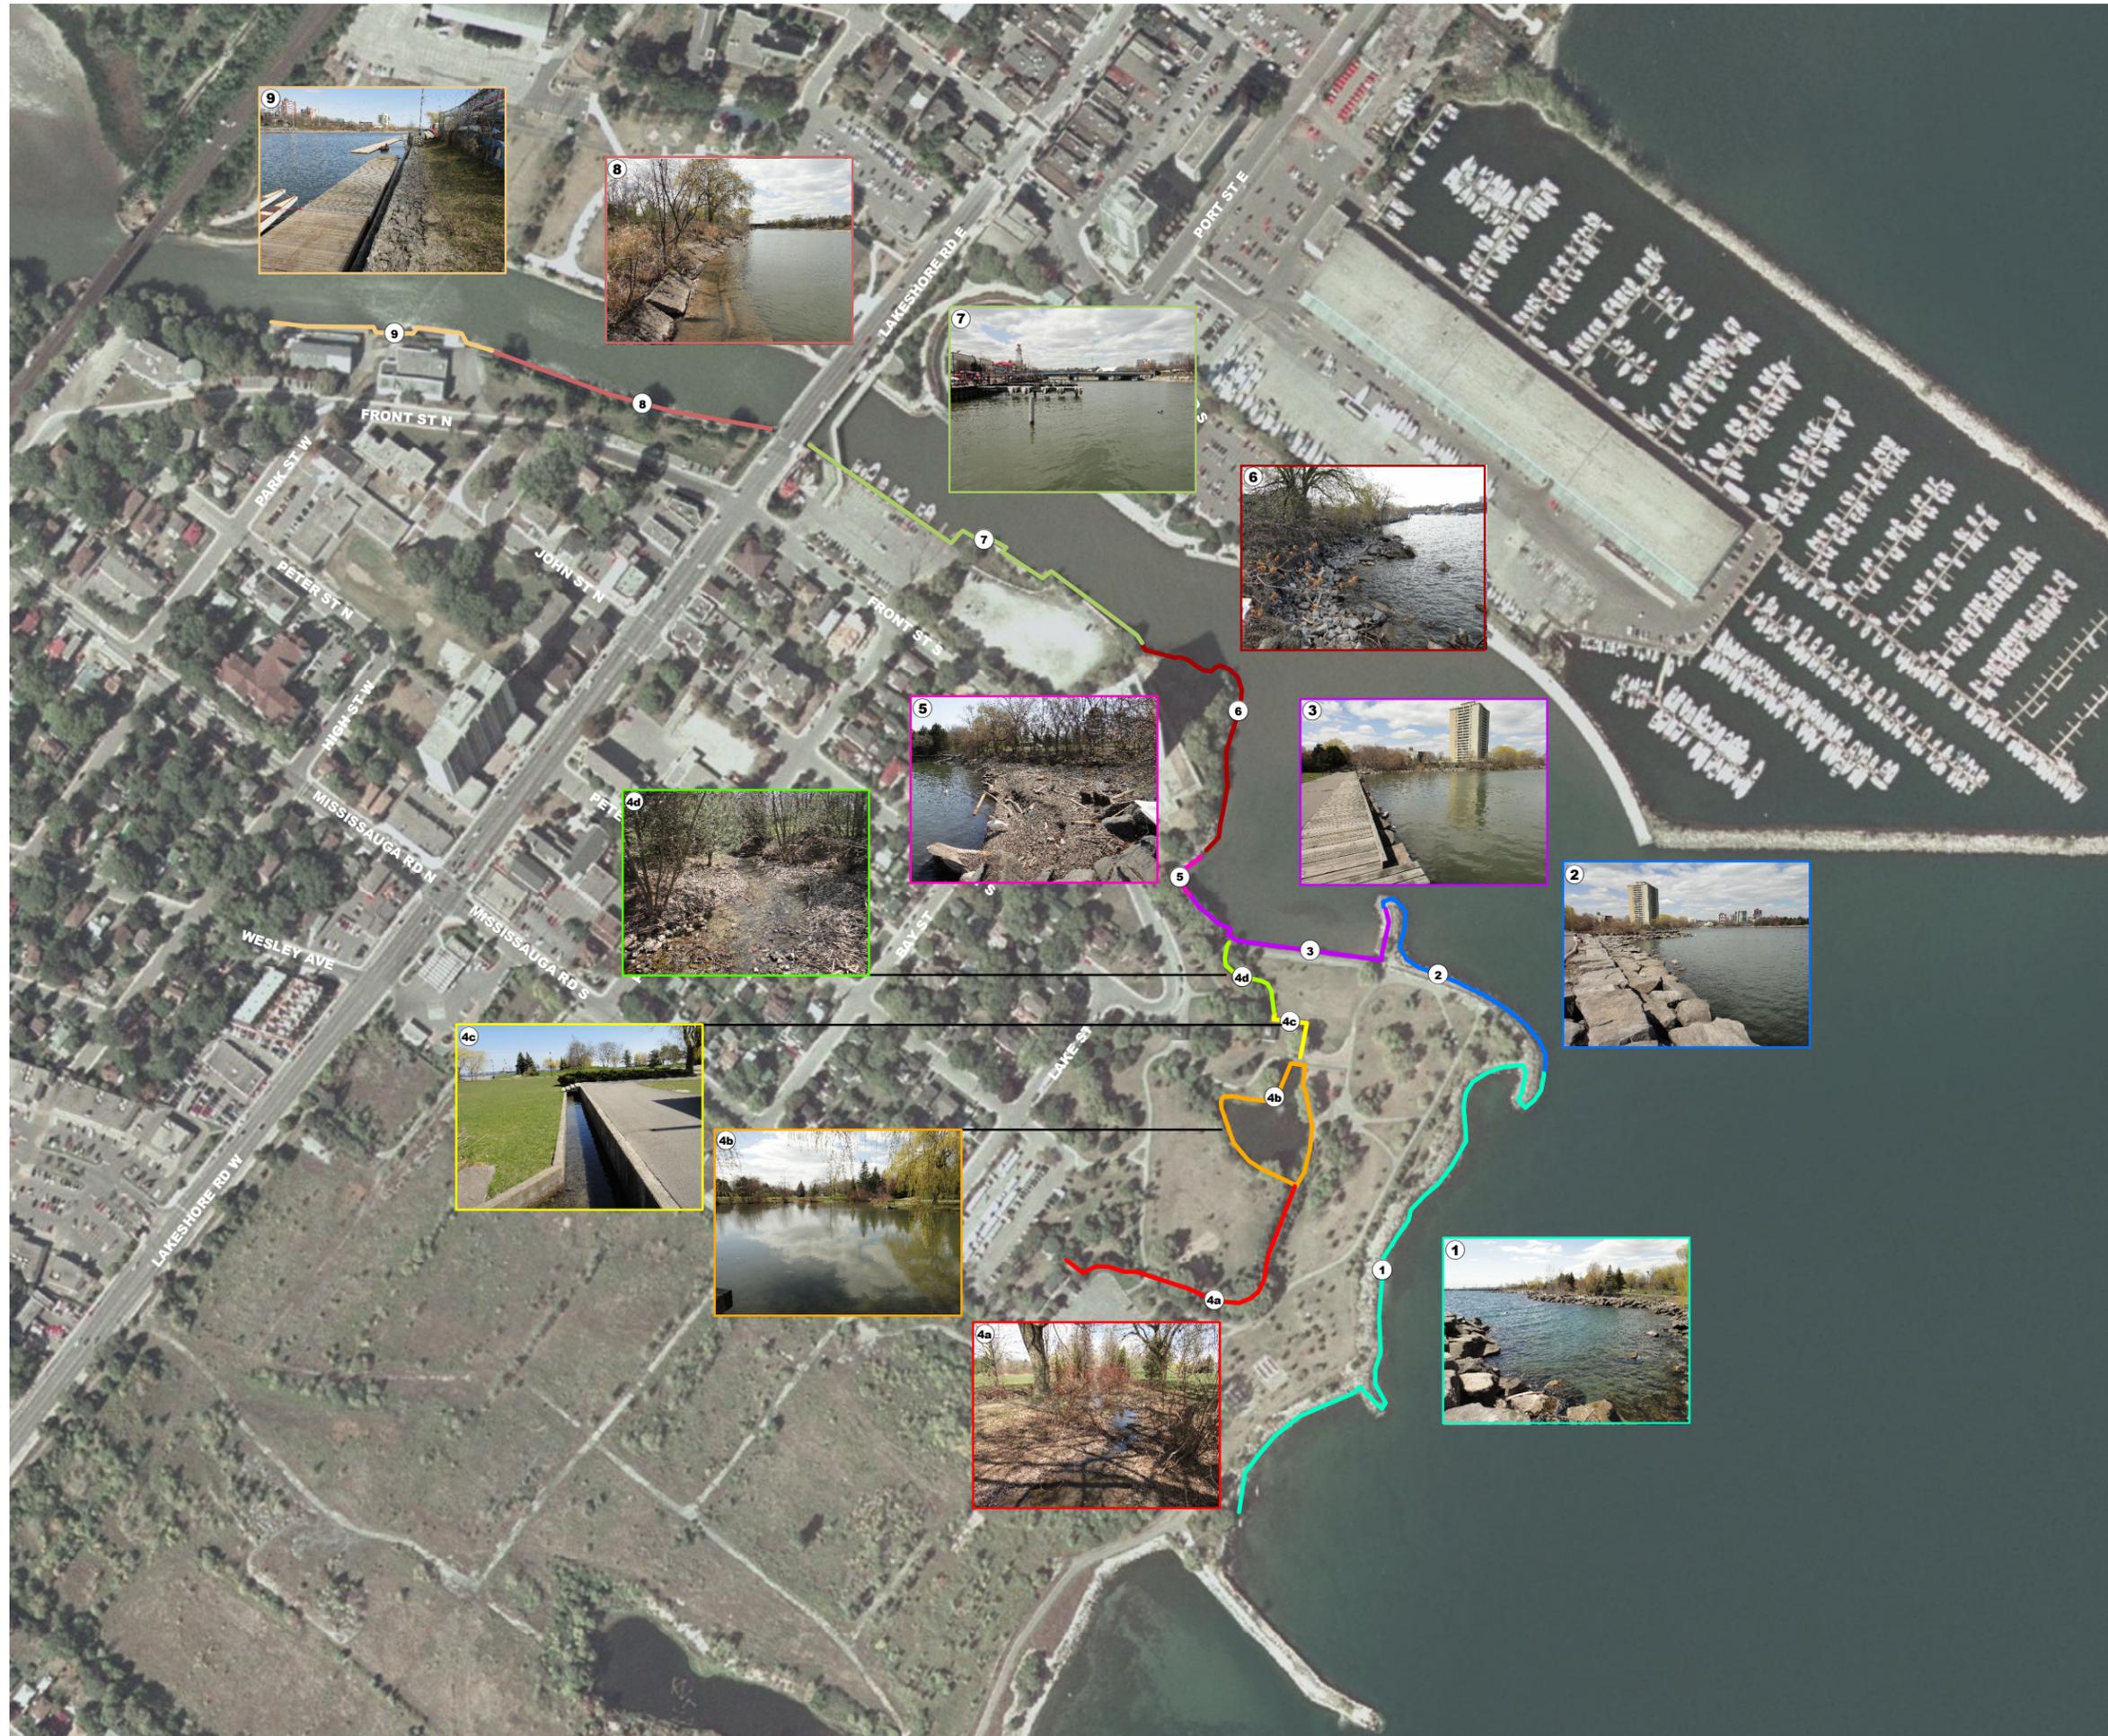
**FISHERIES RECONNAISSANCE
FIGURE #12**

Fisheries reconnaissance field work was completed to build upon general habitat descriptions and fish species listed in background resources. This field work was used to document shoreline treatments, natural and artificial cover structures, observations of aquatic plants/substrates visible from shore and incidental shore-based observations of fish utilization. Observed habitats were divided into sections based on shoreline treatments along Lake Ontario and the Credit River (see **Figure 12**).

Fish habitat reconnaissance was completed on April 12, 2012 from accessible areas along the Credit River mouth and Lake Ontario shoreline. The results of the existing conditions, challenges and potential enhancement opportunities are outlined in **Table 3**. According to the background fish sampling records provided by DFO and CVC, a wide range of fish species utilize the mouth of the Credit River and offshore areas of Lake Ontario near the project area. All species observed are considered *Secure*, *Apparently Secure* or *Not Applicable* (non-native) in Ontario except for Greater Redhorse which is considered *Vulnerable*. These surveys represent a species presence in the general project location area and are not indicative of specific habitat utilization of the discussed features.

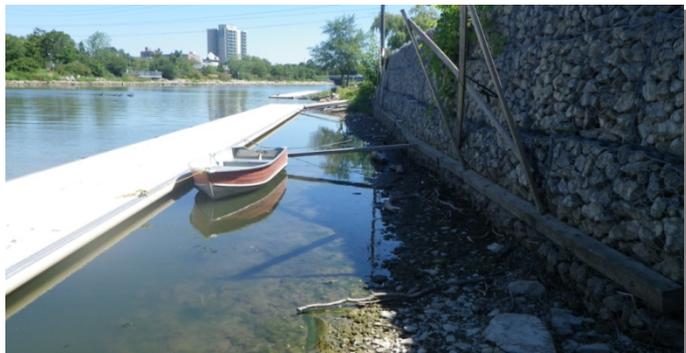
A2: Docks and Gabion Wall in front of Mississauga Canoe Club

The shoreline in front of Mississauga Canoe Club is approximately 65 metres long and is protected with a gabion basket wall. The gabion basket retaining wall and launch ramp were constructed in the early 1990s. The wall has two exposed rows at the north end of the property with a top elevation of 77.0 metres and steps up to three exposed rows at the south end of the shoreline with at-top elevation of 78.0 metres. A fourth buried row is visible along the shore at the south end of the wall. A concrete launch ramp is at the north end of the property. The gabion basket retaining wall extends along the bank adjacent to the launch ramp. The gabion baskets are galvanized steel that are filled with 100 to 150-millimetre diameter stone. The existing grade behind the wall varies from level with the wall to approximate elevation of 77.5 metres behind the wall at the south end. The area behind the wall is paved for vehicular access to the boat storage in the building.

Two shore-parallel docks are moored in front of the wall. The docks appear to be anchored to the gabion basket wall. A timber has been secured along the top of the bottom buried row of gabion baskets. The southern dock is anchored to the timber. Small diameter rock is found along the toe of the wall and into the nearshore.

The wall appears to be in good condition at the north end of the site. The bottom row of gabion baskets appears to be bulging at the south end of the wall where the dock is connected to the timber attached to the baskets. Otherwise, the south end of the wall appears to be in good condition. Photos A1 to A3 in **Appendix 3** show views of the gabion basket wall and launch ramp at the Mississauga Canoe Club.

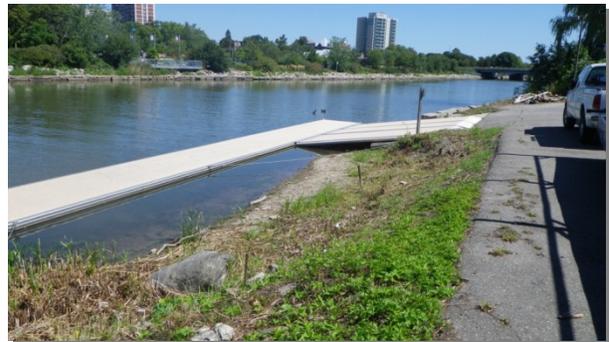
A6: Access Ramp and Dock in front of Don Rowing Club

Approximately 15 metres of natural unprotected bank continues further south. The bank is steep and showing signs of erosion. The area behind the natural bank is paved. A launch ramp is located at the south end of the natural shore. The ramp consists of concrete slabs. A removable ramp is resting on the launch ramp to provide access to a shore parallel floating dock. Photos A6 and A7 in **Appendix 3** show views of this shoreline.

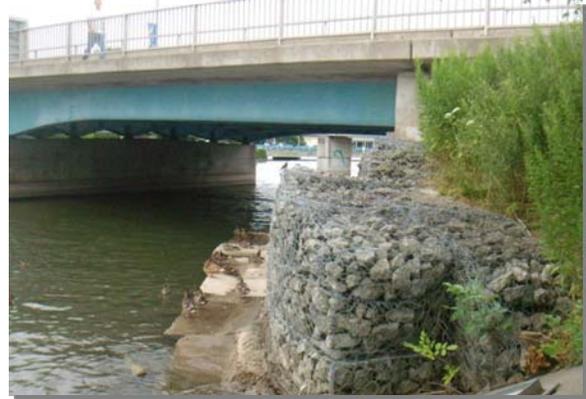
A14: Gabion Wall and Lakeshore Road Bridge

The connection between Port Credit Memorial Park (West) and Marina Park extends from the storm sewer outlet on the north side of the Lakeshore Road West bridge to the steel sheet pile wall on the north side of the pedestrian footbridge. The shoreline on the north side of the Lakeshore Road West bridge abutment is protected with gabion baskets and concrete slabs. There are two rows of concrete slabs along the shoreline with a top elevation of approximately 75.25 metres. The

The gabion baskets are positioned along the back of the concrete slabs. The top elevation of the gabion basket varies from 76.0 metres at the north end to 76.8 metres at the bridge abutment. The baskets are galvanized steel filled with 100 to 150-millimetre diameter stone. The gabion baskets appear to be in good condition. They have an uneven crest which is likely due to shifting of the concrete slabs on which they are founded. Photos A14 and A15 in **Appendix 3** show the gabion basket retaining wall.

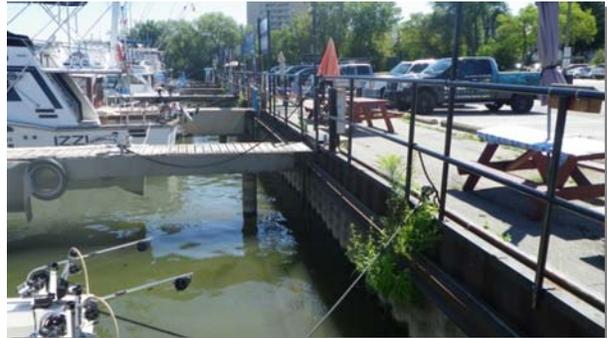
A20: Steel Sheet Pile Wall in Marina Park

The shoreline south of the pedestrian bridge along Marina Park is protected with a steel sheet pile wall. The steel sheet piles have an Algoma section similar to the walls on the east side of the river. The pile is approximately 10 millimetres thick. A square hollow section is welded to the front face of the wall approximately 0.5 metres below the top of the wall. Tie rods are not visible along the wall. The top elevation of the wall is 76.0 metres. The ground behind the wall is approximately 0.2 metres below the top of the wall. The river bottom along the toe of the wall at the time of the topographic survey was 73.75 metres. The steel sheet pile wall appears to be in good condition. The wall is not leaning and no areas of significant rust were noted during the above water review. Photos A20 to A22 in **Appendix 3** show views of the steel sheet pile wall.

Seven finger docks extend into the river from the steel sheet pile wall. These timber finger docks are supported on steel tube piles. The first pile is located approximately 1.5 metres from the face of the wall. The docks appear to be functional. Photo A20 in **Appendix 3** shows a view of the timber finger docks.

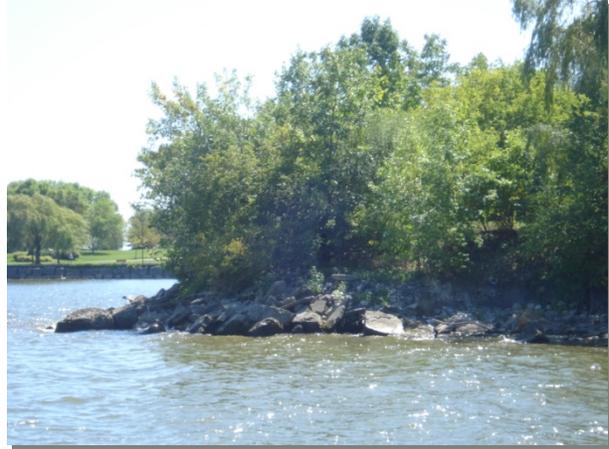
A28: Armour Stone/Rubble Revetment along Rivergate Easement

The shoreline along the Rivergate easement is approximately 200 metres long and extends from the south side of Marina Park to where it turns back towards Front Street south of the apartment building. The shoreline is protected with armour stone and concrete rubble. The armour stone ranges in size from 1 to 8 tonnes. Concrete rubble is mixed in with the armour stone. The crest elevation of the armour varies but is on average 77.0 metres. Rip rap sized material is present along the back of the structure and geotextile is visible in a section where the structure has failed. There are voids between the stones. The overall slope of the stone/rubble varies between 2H:1V and

3H:1V along the shoreline. The slope of the protection is flatter at the point where the shoreline turns back into Hacienda Bay. There is a 4-metre wide area behind the armour stone. The bank behind this area rises to an elevation of approximately 79.0 metres. Debris is mixed in with the stone and rubble and there is other evidence of overtopping along the structure. Photos A28 to A29 in **Appendix 3** show the shoreline along the Rivergate easement. Overall the shore protection along Rivergate easement appears functional at the current water level. During periods of high water and river flow, the structure may be unstable. There is a 15-metre long section of shoreline at the north end of the Rivergate apartment building property where it appears that the bank became unstable and slipped into the river. The steep soil bank is exposed with remnants of geotextile along the bank and riprap scattered at the waterline. There is some concrete rubble along the shoreline. Photo A29 in **Appendix 3** shows the section of shoreline that has failed.

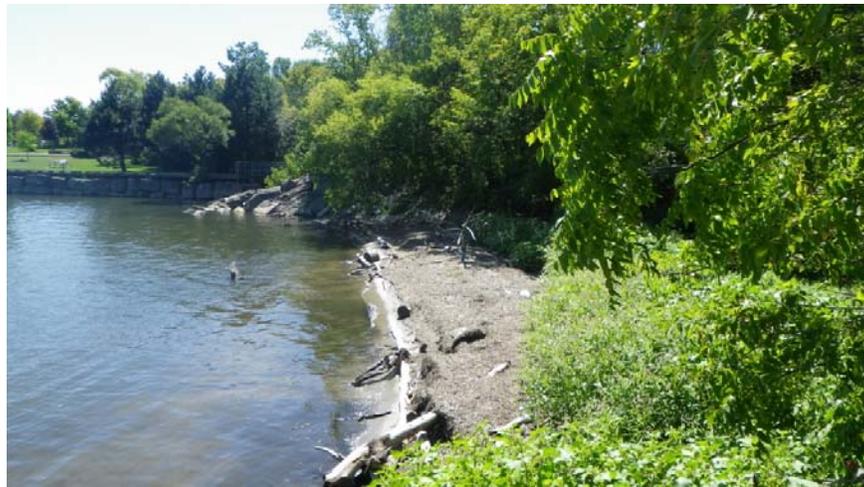
A30: Shore Along Rivergate Easement at J.C. Saddington Park

Hacienda Bay is the bay located south of Rivergate apartment building and north of the northernmost groyne in J.C. Saddington Park. A description of the north shore of Hacienda Bay is provided in Rivergate easement section above. A small fillet beach has formed where the shoreline orientation turns. The beach is approximately 35 metres long and 15 metres wide at its widest point with a crest elevation of 76.0 metres. There is silt/sand in the nearshore and organic material such as tree branches, wood chips and bark on the beach. The beach collects debris. Along the back of the beach the bank is protected with armour stone and concrete rubble. The bank has a crest elevation of 79.0 metres. There are mature trees and dense brush along the bank making the beach inaccessible. Photo A30 in **Appendix 3** shows a view of the beach.

A small armour stone groyne at the south end of the beach extends out. The elevation of the top of the groyne is approximately 77.0 metres. Photo A30 in **Appendix 3** shows the groyne at the south end of the beach. A creek on the south side of the groyne outlets into Hacienda Bay. The creek flows through J.C. Saddington Park. A timber pedestrian bridge crosses the creek into J.C. Saddington Park. The bridge is supported on two concrete abutments with armour stone on the river side.

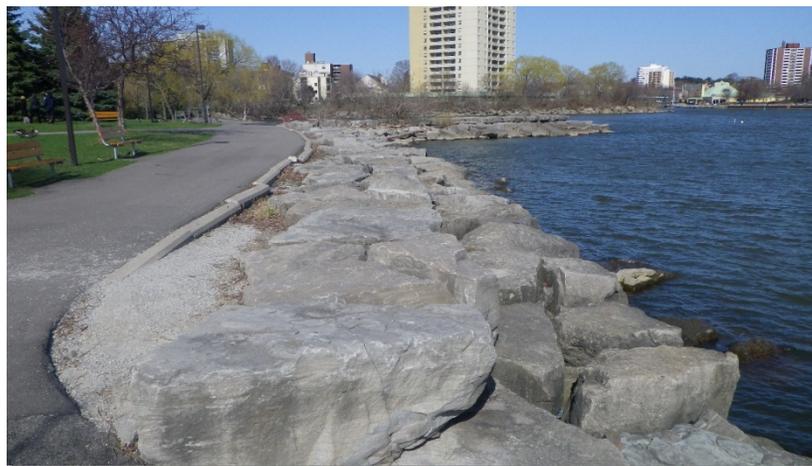
A34: Armour Stone Along J.C. Saddington Park, East Side

There are two sections of shoreline in the first reach, the west shore of the river and the east headland. The shoreline along the west shore of the river is 70 metres long and is protected with an armour stone revetment. The revetment is relatively flat at a slope of 3H:1V. The crest of the revetment is at elevation 76.5 metres. The stone ranges in size from 3 to 6 tonnes. There is a row of armour stone along the back of the revetment with a crest elevation of approximately 77.5 metres. There is a paved path behind the cap stone. The area between the paved path and armour stone has a row of parking curbs and is filled with gravel. The ground is uneven behind the armour stone. The paved path slopes toward the shore at the end of the revetment where the revetment transitions into the headland. There are some voids behind the armour stone at this location. Photo A34 shows a view of the revetment. Overall, the structure appears to be in good condition. There are gaps between the stones and evidence of waves overtopping the structure but the structure appears stable.
