**PRE-DESIGN REPORT / ENVIRONMENTAL STUDY REPORT
PORT CREDIT HARBOUR WEST PARKS**

**PORT CREDIT HARBOUR WEST PARKS
PRE-DESIGN REPORT / ENVIRONMENTAL STUDY REPORT**

Dillon Consulting Limited

Shoreplan Engineering Limited

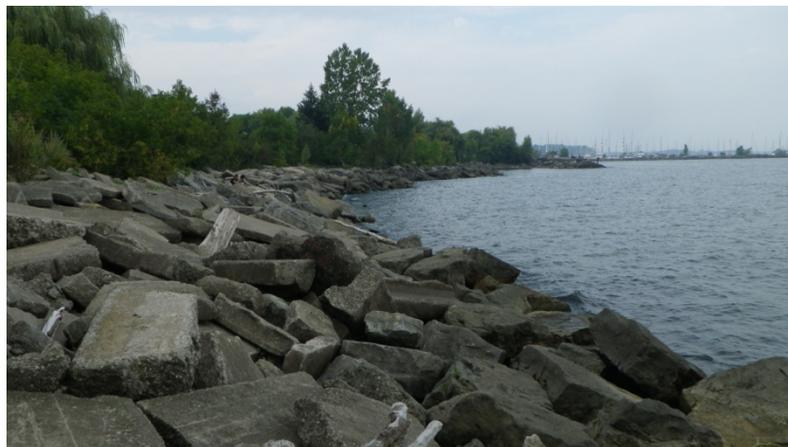
A37: Rubble Revetment Along J.C. Saddington Park, South Side

The shoreline in the second reach is protected with armour stone and concrete rubble revetment. The armour stone and concrete rubble appear to be randomly placed. The top elevation of the revetment is approximately 77.0 metres and the lake bottom varies between elevation 73.0 and 72.0. The slope of the revetment varies along the shore and on average is 3H:1V. Photo A37 in **Appendix 3** shows the revetment along this shoreline. There are areas behind the revetment where the ground is lower than the armour stone and riprap has been placed along the back of the revetment to stabilize the bank. It is likely this area has been eroded due to waves overtopping the shore protection. There are large gaps between the stones and debris such as tree branches and logs along the top of the revetment. The bank rises behind the revetment to an elevation of approximately 78.0 metres. There are signs of erosion along the bank.

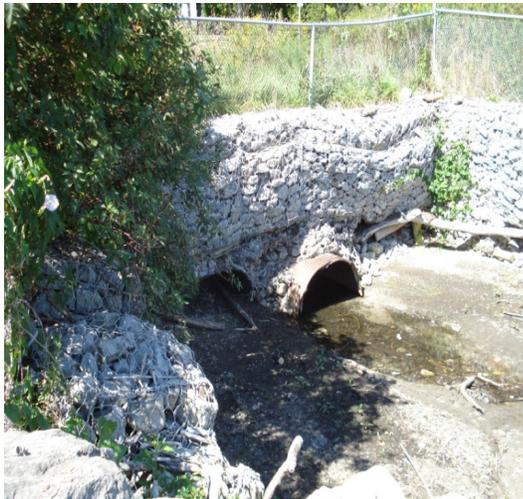
A40: Storm Sewer Outlets at West of J.C. Saddington Park

There are two storm sewer outlets at the west end of the reach. The outlets are 1.0-metre diameter corrugated steel pipe. The top elevation of the pipes is approximately 75.4 metres. The pipes were observed to be half full of debris during one of the site visits. There is a gabion basket retaining wall around the storm sewer outlet. The top elevation of the gabion basket retaining wall is 77.0 metres. Three rows of gabion baskets are visible around the pipes. The lower row is broken open and has lost some of its gabion stone. The second and third rows are still intact but have settled due to the collapse of the lower row of baskets. The gabion baskets extend around either side of the outlet to the shoreline where there is armour stone. Armour stone extends along the shoreline in front of the outlet. It has a top elevation of 76.0 metres and the lake bottom is at elevation 74.0 metres along the toe of the armour stone. The stones are randomly placed and there are gaps between the stones. Photo A40 in **Appendix 3** shows a view of the storm sewer outlet.

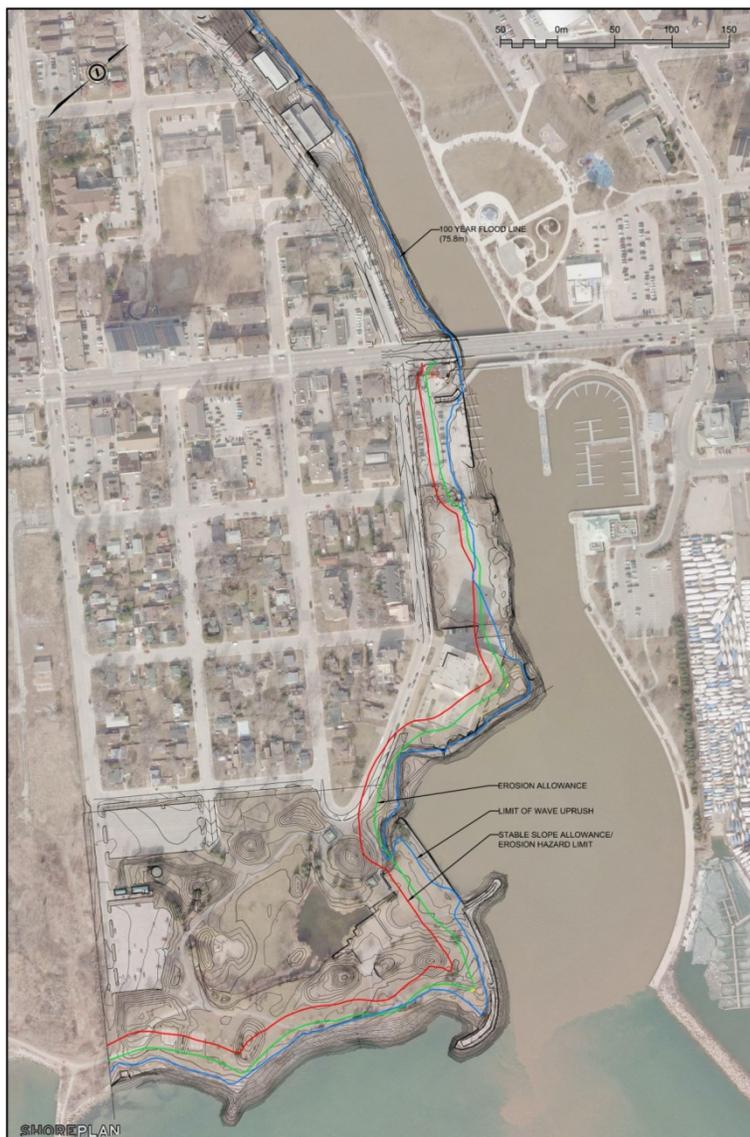
Figure 13: Updated Shoreline Hazard Limits

For this study we recalculated the erosion hazard limit using the stable slopes determined during the geotechnical investigation and more accurate estimates of the bank height and toe location. The erosion hazard limit is defined as the sum of an erosion allowance and a stable slope allowance. The erosion allowance is a 30-metre offset calculated as 100 years of erosion at the default average annual erosion rate of 0.3 metres per year. The provincial default value was used as no data exists to calculate a different rate for unprotected shores at this location. The stable slope allowance was calculated using the stable slopes provided from the geotechnical analysis (3H:1V) and the bank height determined from the OLS survey. The limit of the erosion allowance is indicated on **Figure 13**.

Figure 15 shows the location of the typical profiles and the calculated wave uprush limit. **Figure 13** also shows the calculated wave uprush limit together with the erosion hazard limit. That uprush limit corresponds to the flood hazard limit following MNR procedures.

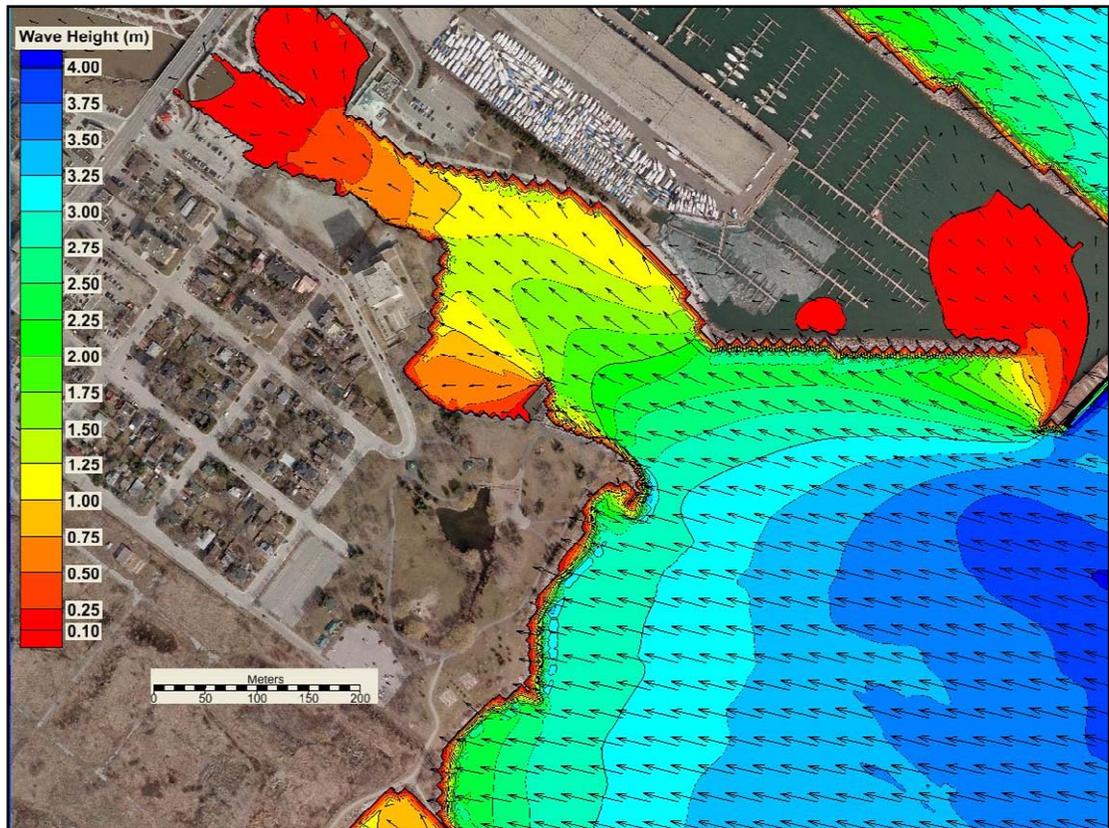
Figure 14: Design Nearshore Wave Conditions for Wave Uprush Analyses

Using a peak-over-threshold extreme value analysis of severe storm events, the 20-year return period deep water wave condition was determined to have a significant wave height of 5.2 metres and a peak wave period of 9.8 seconds. These values represent the upper limit of the 90% confidence interval from the statistical analysis.

This deep water wave condition was transferred in to the site by applying the two-dimensional, spectral, CMS-Wave numerical model, developed by the U.S. Army Corps of Engineers. The nearshore zero-moment wave heights that will cause run-up vary from approximately 3 metres fronting the more exposed portion of J. C. Saddington Park to less than 0.3 metres at the northern end of Marina Park. **Figure 14** is a combined wave height contour and vector plot showing the 20-year wave conditions along the project site.

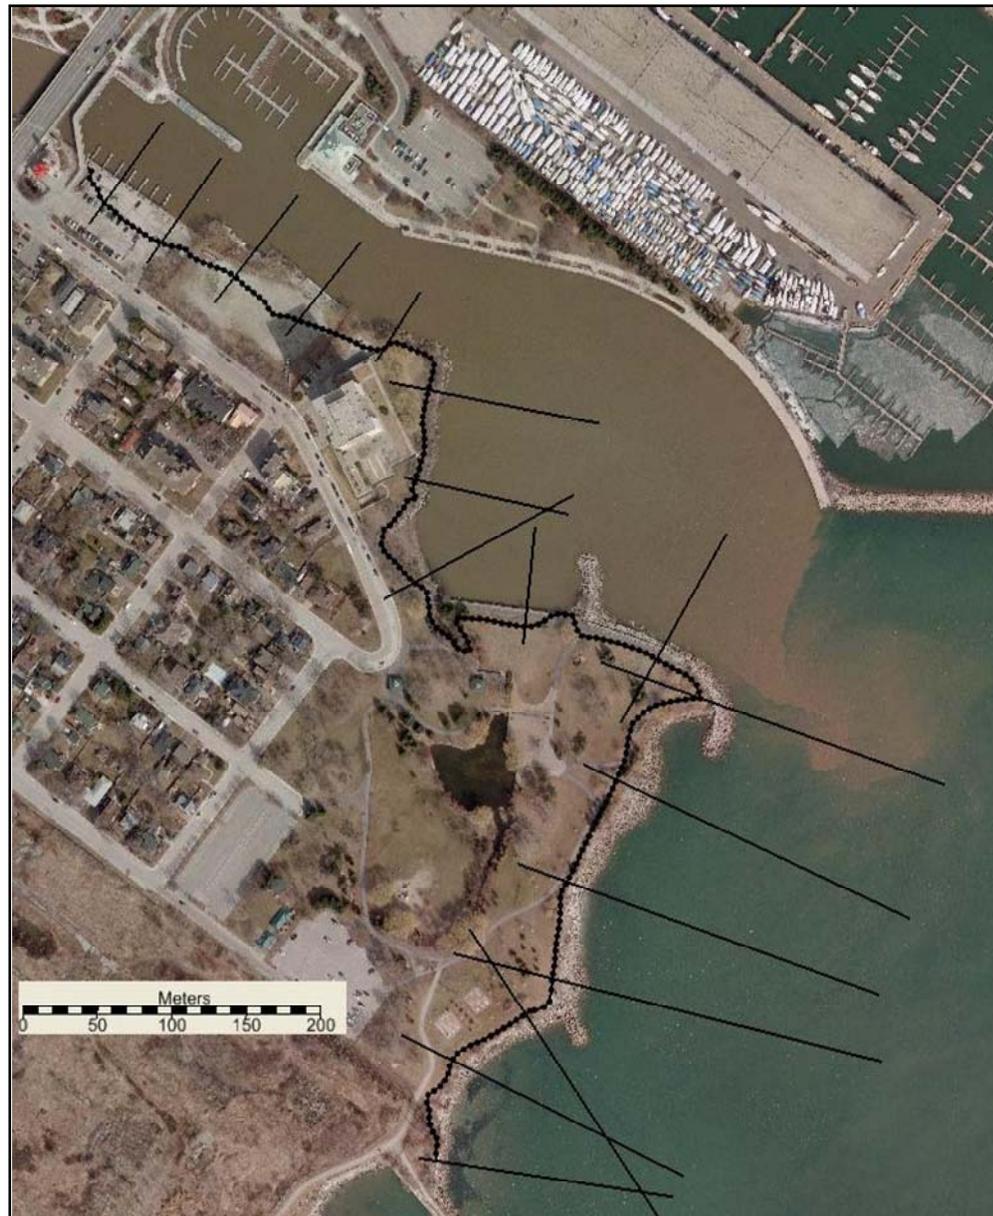
Figure 15: Location of Typical Profiles and Calculated Wave Uprush Limit

Typical cross-sections for each section of shoreline were derived from the detailed survey completed for this project (see **Appendix 5**). The 2% exceedance uprush elevation was calculated for all profiles but one, and the uprush limits between profiles were interpolated giving consideration to the topographic contours. For the section of shoreline with the concrete block wall, south of the launch ramp, we could not calculate an uprush elevation per se, due to the shape of the shoreline wall. Instead, mean overtopping rates were calculated using the plain wall overtopping equations from the Eurotop Overtopping Manual (Pullen et al, 2007). The Eurotop methods are the most recent and comprehensive methods for calculating overtopping on structures and are now frequently used in place of the overtopping methods described in the MNR (2001) technical guides. The predicted mean overtopping volumes were high enough (4 to 6 litres per second per metre length of wall) that it was concluded that the uprush limits behind the wall could be assumed to be in line with the uprush limits for the sections of shoreline on either side of the wall.

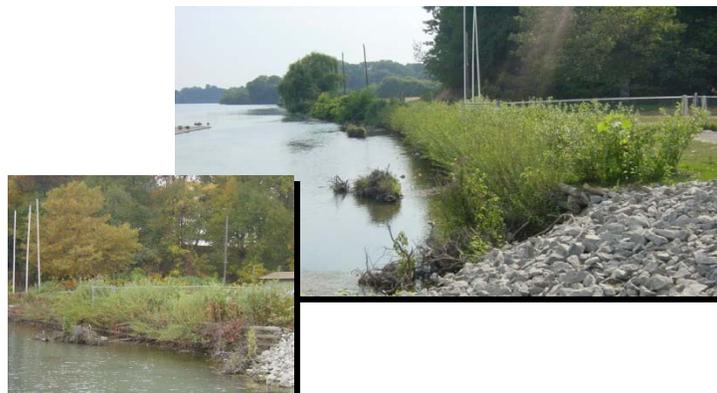
Natural Shore

The “natural shore” alternative involves the construction of live cribs and live stakes to create a natural shore. Stakes are live woody cuttings of a species that have the ability to root and grow, and over time can provide slope stabilization, improve aesthetics of a shoreline and provide habitat for wildlife. A live crib wall is a box-like, interlocking arrangement of log walls with live vegetation placed between the seams of each layer.

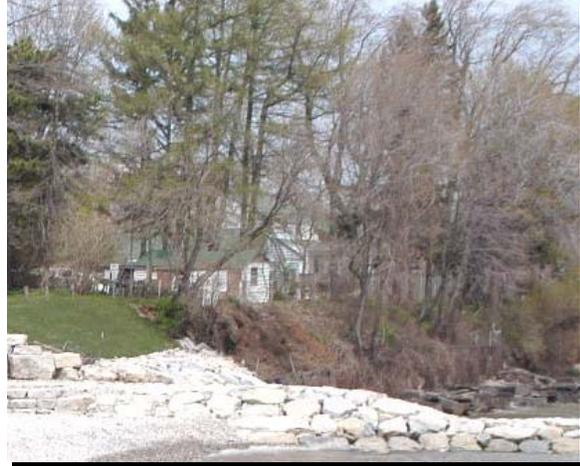
Hard Shore

This shoreline alternative involves the replacement of the current shoreline with a hard shore. There are a number of different types of hard shore including:

- stone revetments - sloping structures extend from the shore into the water to protect the shore from the action of waves
- seawall - a protective vertical or near vertical structure of stone, concrete or steel that protects the shore from the action of waves
- steel sheet piles - interlocking steel piles commonly used to construct a seawall with deep foundations providing protection from the action of waves

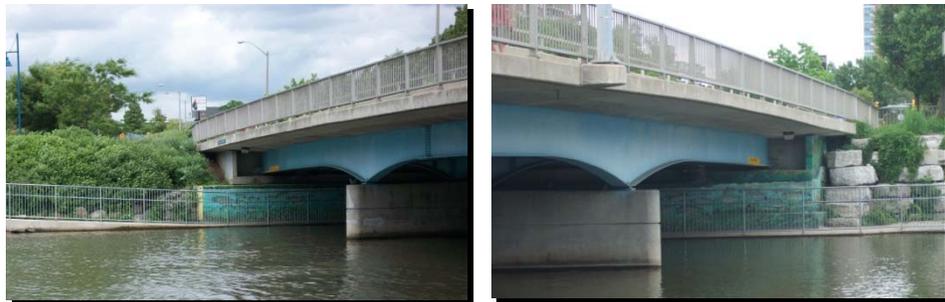
Underpass

The “underpass” alternative involves construction of an underpass passage below Lakeshore Bridge connecting Port Credit Memorial Park (West) and Marina Park with concrete access ramps. This underpass would be similar to the existing underpass on the east side of the Credit River.

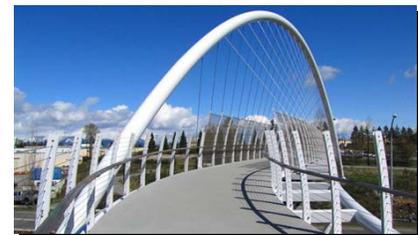
Overpass

The “overpass” alternative involves constructing an overpass with elevators to access the bridge above Lakeshore Road West, connecting Port Credit Memorial Park (West) and Marina Park.

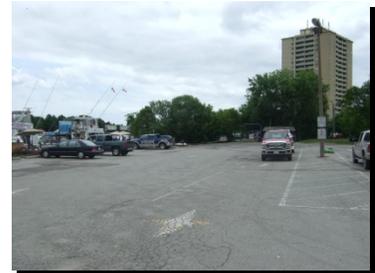
Do Nothing at North End and Flood Proof South End

This alternative leaves the current north end shoreline “as is”, but flood proofs and improves the shoreline at the south end by raising the backshore elevation of the existing topography and providing stone revetment and armour stone along the shore.

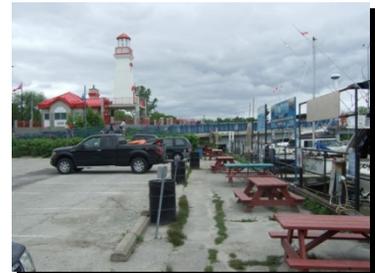
Flood Proof North and South Ends

This alternative involves flood proofing and improving the shoreline for both the north and south sections of Marina Park by raising the backshore elevation of the existing topography for both the north and south ends, reconstructing and repairing the existing steel sheet pile wall along the shoreline in the north section of the park, and providing stone revetment and armour stone along the south shoreline.

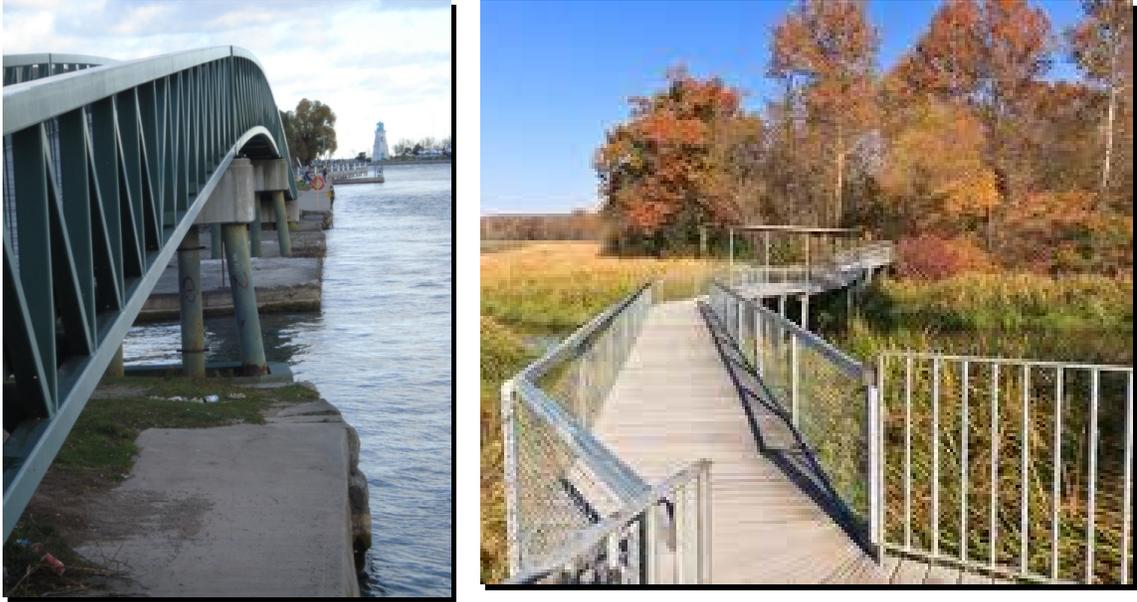
Shoreline Connection

The “shoreline connection” alternative involves creating a shoreline pedestrian connection between Marina Park and J.C. Saddington Park through the construction of an elevated fixed walkway.

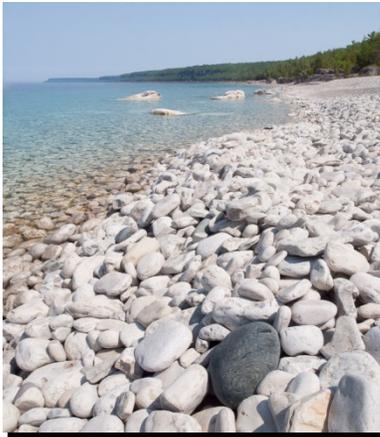
Improve Existing

The “improve existing” alternative involves additional placement of armour stone or riprap in the upper part of the revetment to provide a better level of protection.

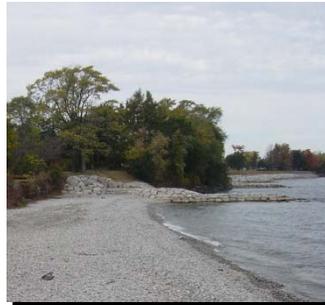
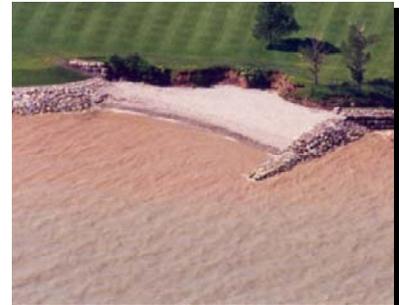
Cobble Beach

The “cobble beach” alternative involves the placement of cobble where suitable, and otherwise improving the existing conditions.

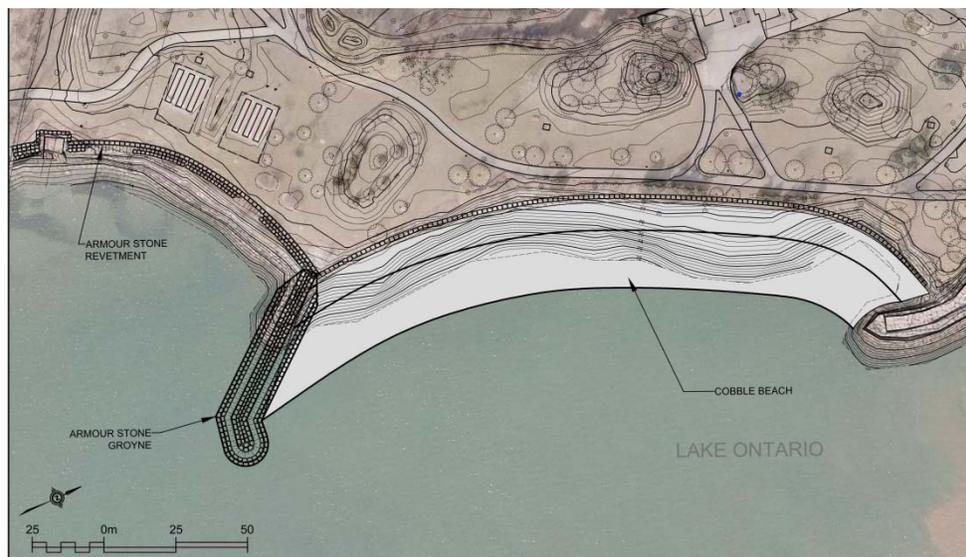
Figure 16: Groyne Option for Cobble Beach, J.C. Saddington Park

A review of these stabilization options clearly identified that there were no advantages to a detached headland over groyne extension. A detached headland would need to be more than double the length of the groyne extension. It would also be built in deeper water and thus result in over double the cost of the groyne extension. From the perspective of natural environment, a detached headland has a greater impact due to its footprint. Overall, it was determined that the groyne option is the only reasonable design for anchoring the proposed cobble beach.

For this project it is suggested that the end of the groyne be angled to the south east more directly into the direction of the large easterly waves to minimize wave reflection into the beach. The proposed cobble beach requires a 40-metre long extension to the existing groyne (see **Figure 16**)

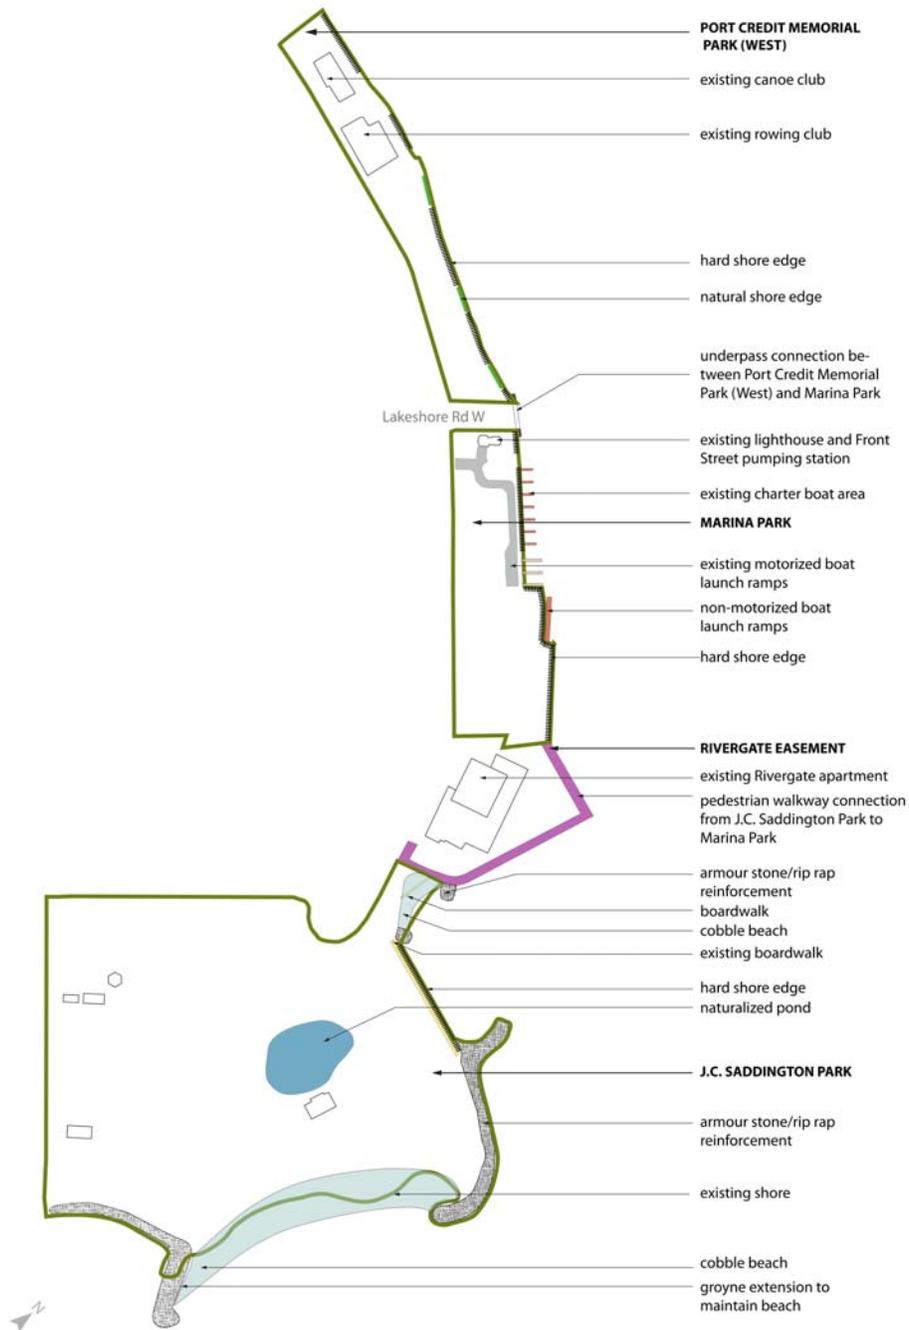
Figure 18: Port Credit Harbour West Parks Infrastructure Improvements

This section of the report provides a summary of all potential improvements that are needed to realize the redevelopment of the Port Credit Harbour West Parks as envisioned in the *Waterfront Parks Strategy (2008) (WPS)*, and as shown in **Figure 18** and the Large Block Concept Plan (see **Figure 17** in **Section 7**). The implementation, mitigation and capital budgets required for *Schedule B* and *Schedule C* Class EA Projects are also discussed.

The proposed shoreline improvement, including areas of naturalization, is shown in **Figure 18**, and is further illustrated in sample cross sections (refer to the key map, **Figure 19**, and the corresponding cross sections on **Figure 20**).

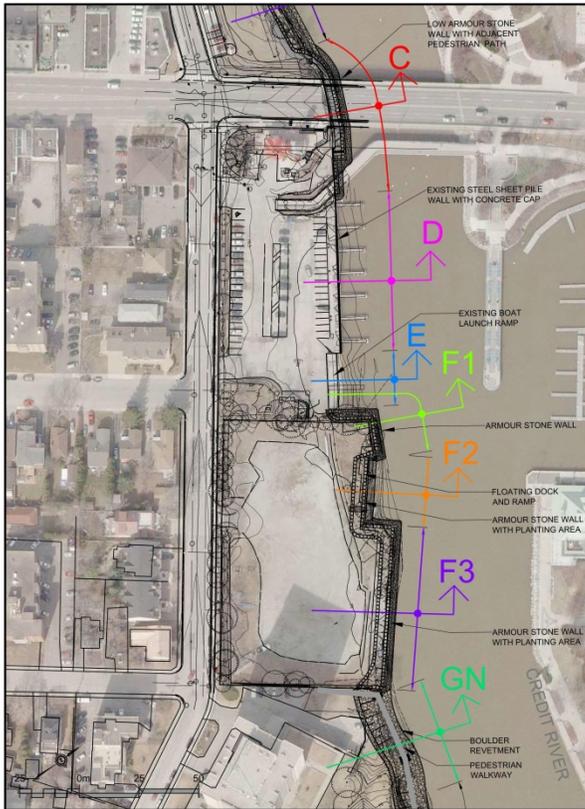
Figure 21: Underpass and Marina Park Cross Section Key Map

**Shoreline Reach Locations:
Underpass Connection**

The existing profile of the bank of the Credit River will be modified under Lakeshore Road West to accommodate pedestrians. To construct the pedestrian underpass the existing bank material will be excavated to a depth of approximately 72.5 metres GSC and replaced with riprap underlain by geotextile. An armour stone edge will be added to stabilize the infrastructure. No changes to the bridge abutment will be required. The pedestrian walkway will sit at an elevation of approximately 75.5 metres GSC. This is approximately 0.5 m above the average high summer water level of approximately 75.0 metres GSC. This is approximately 0.5 m above the average high summer water level and is at about the 1:100 year return period for still water level of Lake Ontario. It is anticipated that during high water levels the walkway may be temporarily flooded, similar to what occurs on the walkway on the east side of the Credit River. The underpass clearance will be approximately 2.5 metres. A cross section (refer to key map, **Figure 21**) of the pedestrian underpass is provided in

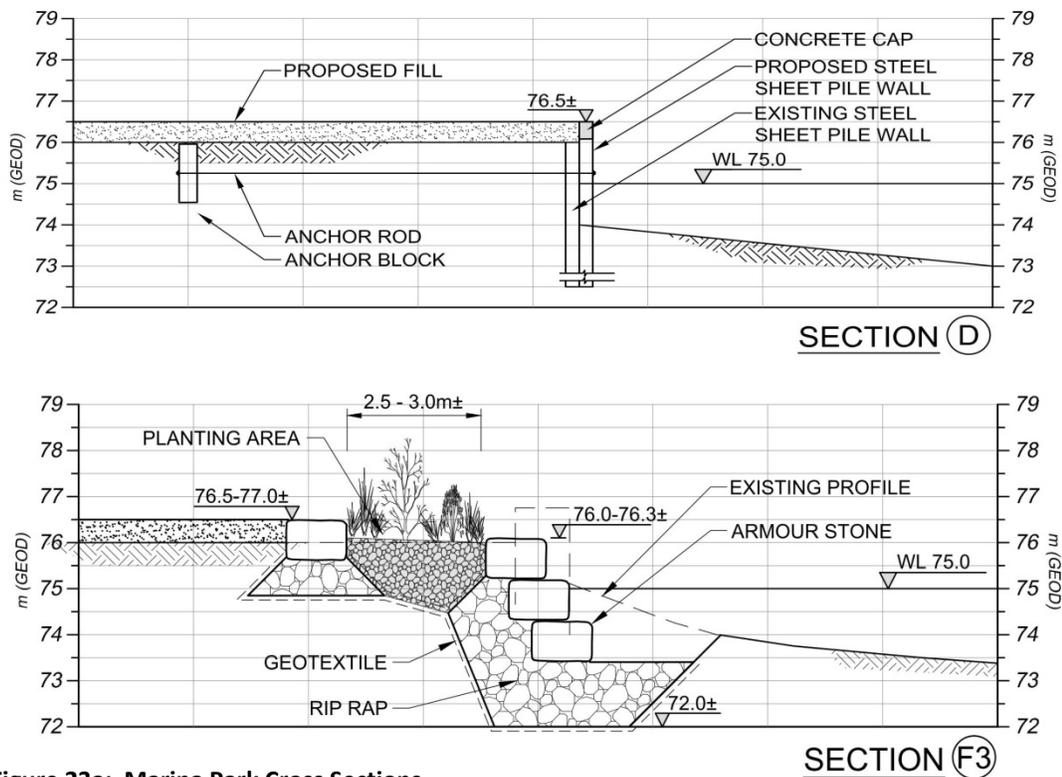
Figure 23a: Marina Park Cross Sections

It is anticipated that these park improvements will be staged such that fill and shore improvement at the south end of Marina Park (see **Figure 23a**) is undertaken first as the shoreline in this area is deteriorated. Improvements at the north section of Marina Park may be constructed at a later date as the shore infrastructure is still functioning. There is an existing stormwater outfall extending from Port Street South; this outfall will be accommodated in the shoreline improvements.

Marina Park is currently below the flood elevation and thus is at risk of flooding during design high water level (1:100 year water level). It is proposed that the elevation of the whole park will be raised to allow for year-round usability. It is prudent to accomplish this prior to investing in any other park enhancements. The elevation of Marina Park will be raised by approximately 0.4 to 0.5 metres (to an elevation 76.5 metres or higher) by adding clean fill as illustrated in **Figures 23a to 23b** (refer to **Figure 21** for cross-section locations). Stone revetment and armour stone will be placed along the shore to protect from erosion and the existing sheet pile wall in the area of the commercial charter boat moorings will be repaired.

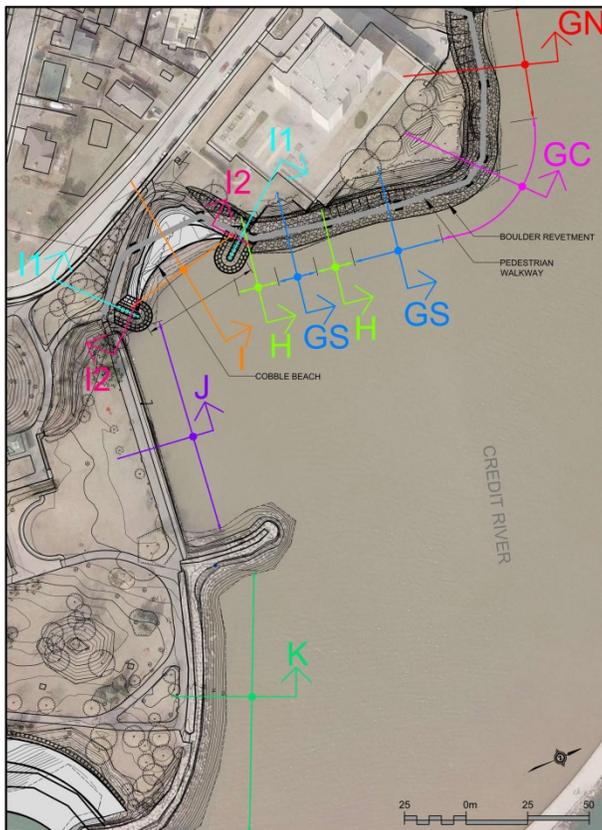
Figure 24: Rivergate Easement and J.C. Saddington Park Cross Sections Key Map

Shore along Credit River and Hacienda Bay, Elevated Pedestrian Walkway

An elevated walkway around the Rivergate easement property is proposed. The 3 metre wide walkway will connect to Marina Park at the north end. At the south end, the walkway will be directed along the back side of the proposed beach at Hacienda Bay, with direct access to the beach. This walkway would be constructed on piles driven to bedrock. Thus the walkway would be anchored to the bed of the Credit River and would not be directly connected to the shore, as shown in **Figure 25** (refer to **Figure 24** for cross-section key map).

Through the evaluation conducted as part of this Study, a cobble beach was identified as the preferred method to improve and stabilize Hacienda Bay. A proposed cross section for the shoreline is shown in **Figure 26** (refer to **Figure 24** for the *Section 1, 11 and 12* location). As noted in **Section 8.1.2**, it will be important to connect the Rivergate easement elevated walkway with the cobble beach. It is anticipated that cobble (approximately 20 to 40 mm in size) will be placed along the shore in the bay. The design and construction of the cobble beach will maintain the existing outlet for the J.C. Saddington Park pond. Periodic maintenance will be necessary as the cobble may shift in severe weather and this area will continue to collect waste and debris materials that travel down the river. The existing groyne which provides an anchor for the cobble beach will be reinforced with the addition of armour stone material.

The stepped revetment that extends from the groyne out to the southeast headland of the park is also functional (see **Figure 26** (*Section K*), and refer to **Figure 24** for cross section location). Although some settlement of armour stone appears to have also taken place, the structure shows no signs of failure or immediate maintenance requirements. As with the groyne described above, the type of maintenance that may be required in time includes the replacement of fractured stones or infilling of crevices found in the structure. In addition, the placement of additional riprap in the splash pad behind the cap stone may be required after a severe storm at high lake levels. Wave overtopping may displace some riprap and gravel material.

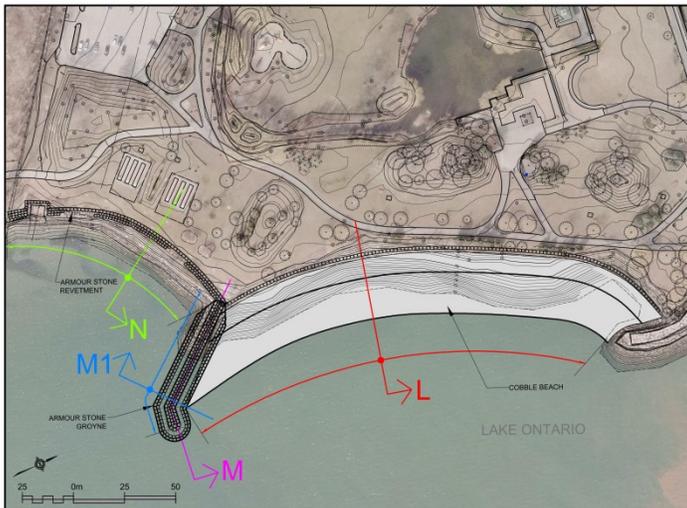
Figure 27: J.C. Saddington Park West Cross Sections Key Map

Southeast Headland to Central Headland, Central Headland to West Boundary

reconfiguration of the shoreline to extend the existing groyne by approximately 45 metres to provide the required protection to stabilize the beach. The shoreline in this area will also be brought back from its current location to allow for the formation of the beach. The cobble to be placed on the beach is expected to be approximately 50 to 150 millimetre in diameter, subject to detailed design. **Figures 26 and 28** (Sections L, M and M1) show the new shoreline in cross sections (refer to **Figure 27** for cross section locations).

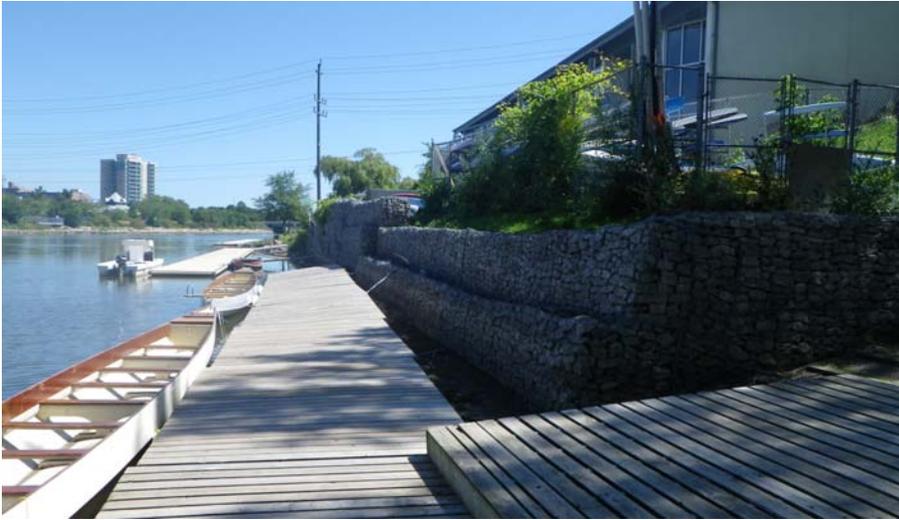
Photo A 1 – Docks and Gabion Wall in front of Mississauga Canoe Club

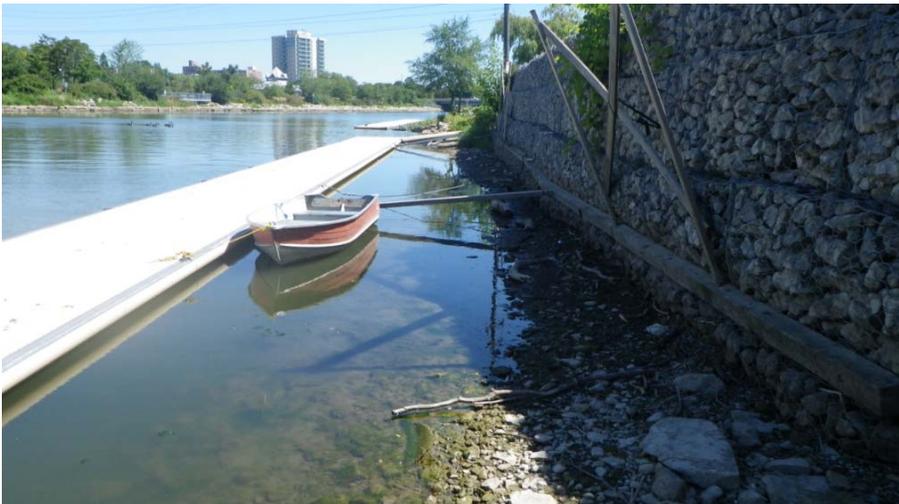
Photo A 2 - Docks and Gabion Wall in front of Mississauga Canoe Club

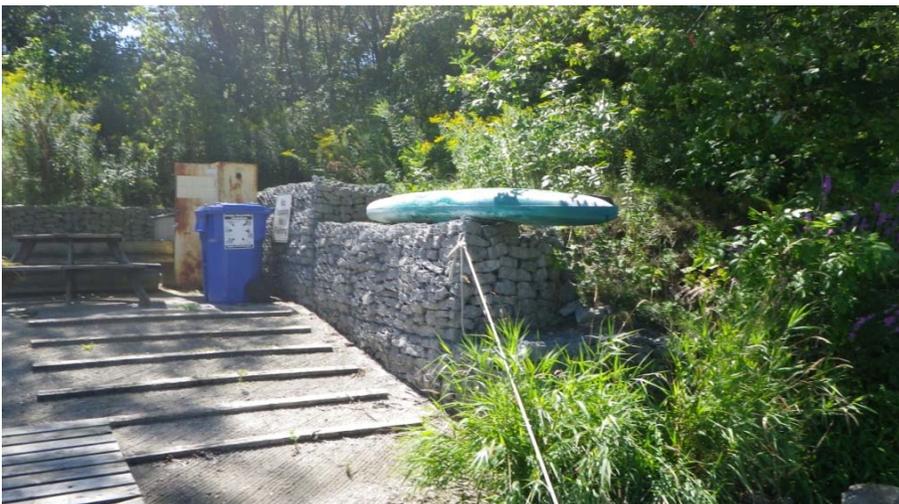
Photo A 3 – Access Ramp and Gabion Wall in front of Mississauga Canoe Club

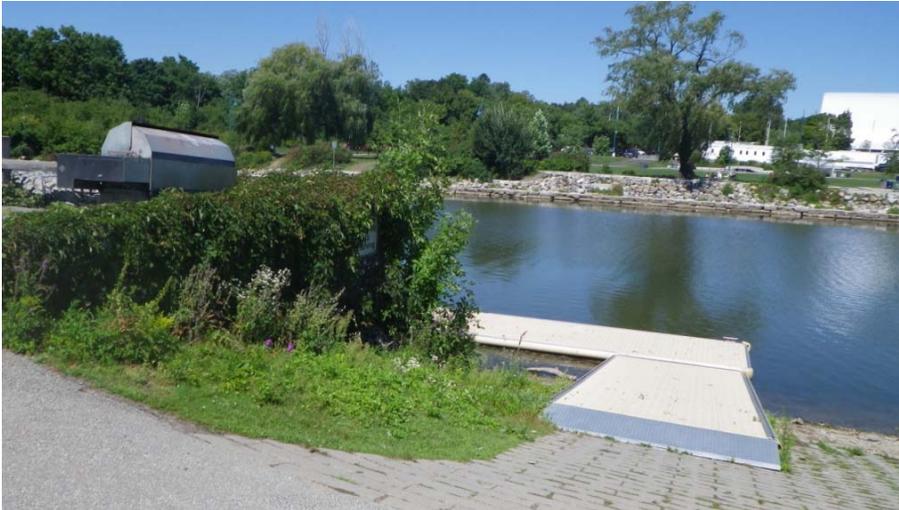
Photo A 4– Access Ramp on the south end of the Mississauga Canoe Club

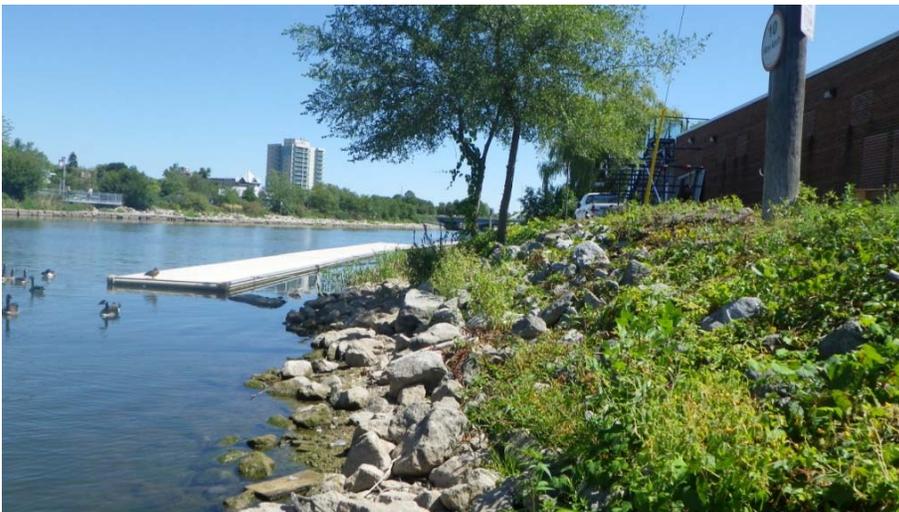
Photo A 5– Rip Rap Revetment and Docks in front of the Don Rowing Club

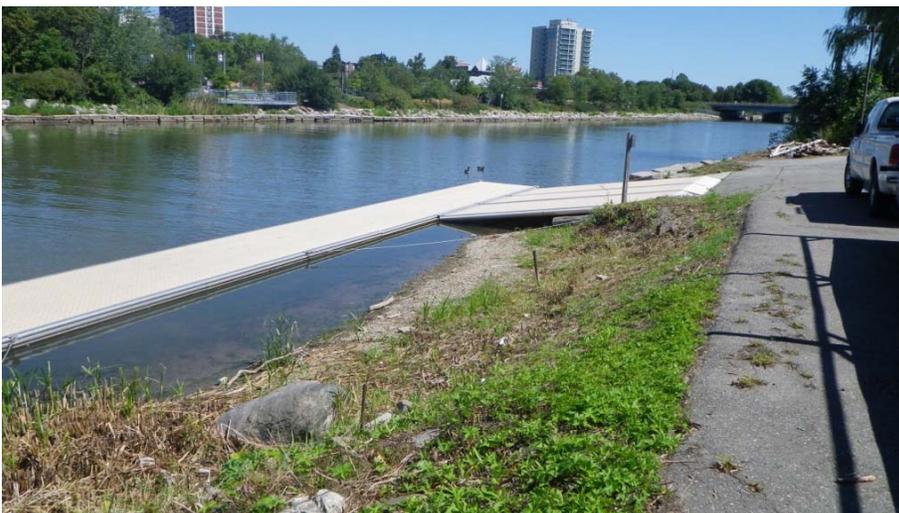
Photo A 6 – Access Ramp and Dock in front of Don Rowing Club

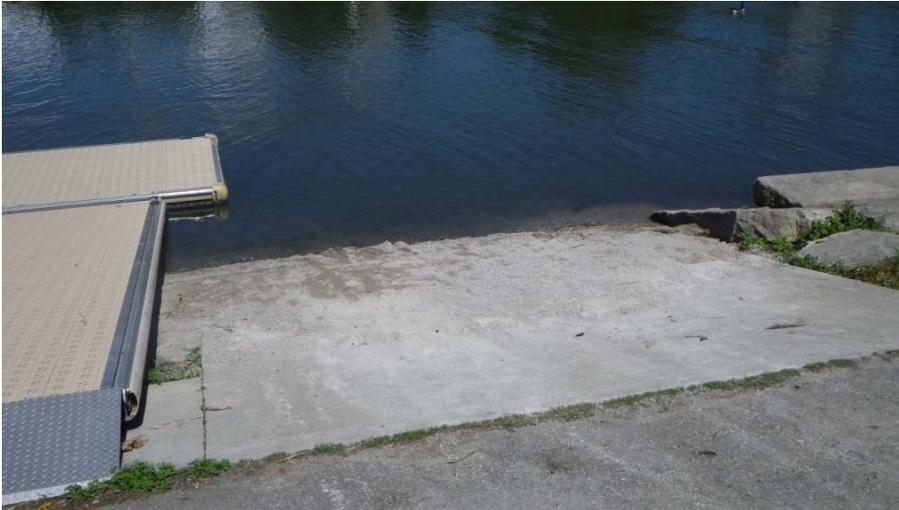
Photo A 7 – Access Ramp and Dock in front of the Don Rowing Club

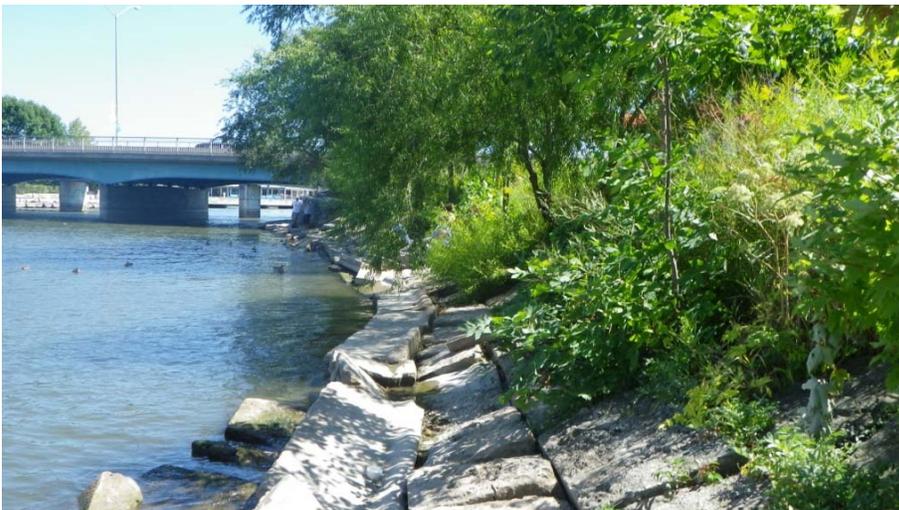
Photo A 8 – Concrete Slab Shore Treatment along Memorial Park (West)

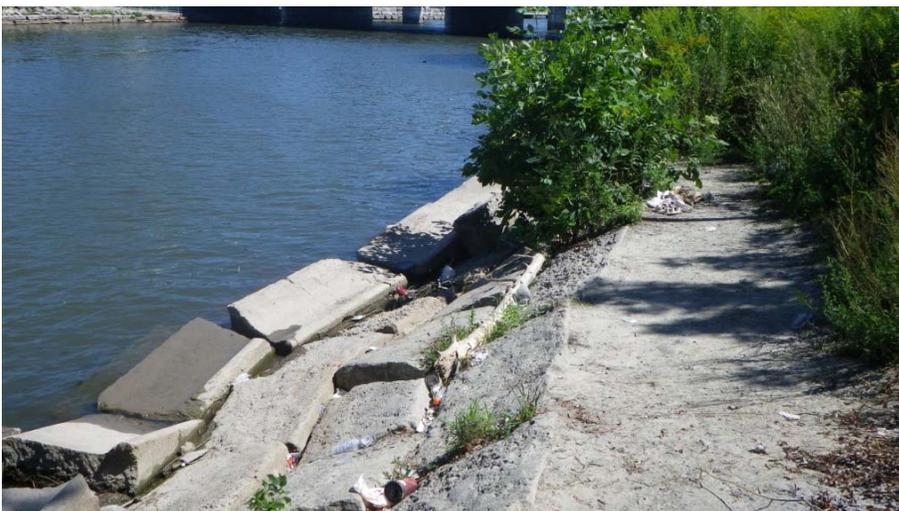
Photo A 9– Concrete Slab Shore Treatment along Memorial Park (West)

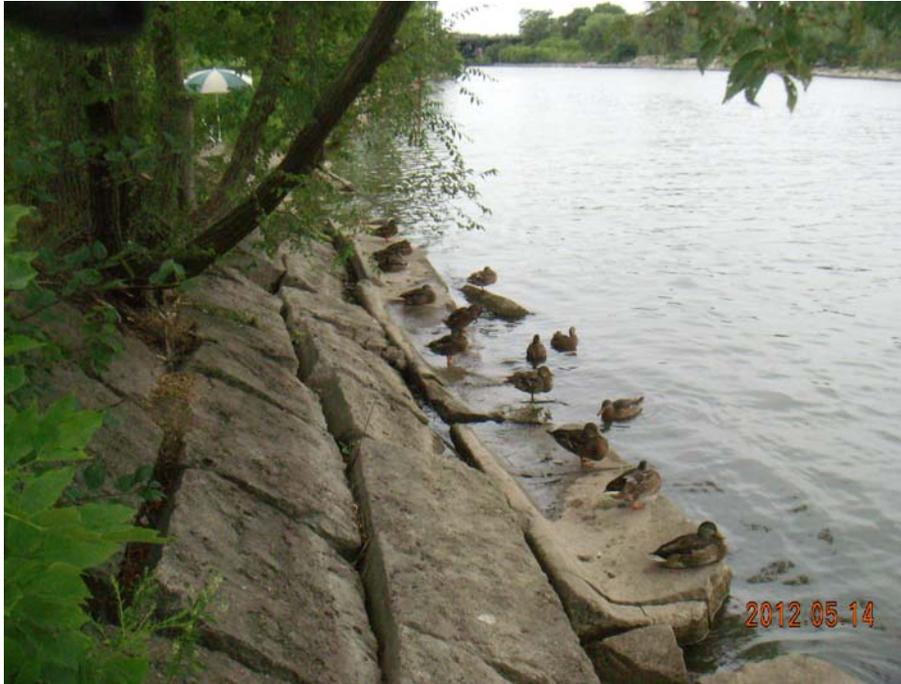
Photo A 10– Concrete Slab Shore Treatment along Memorial Park (West)

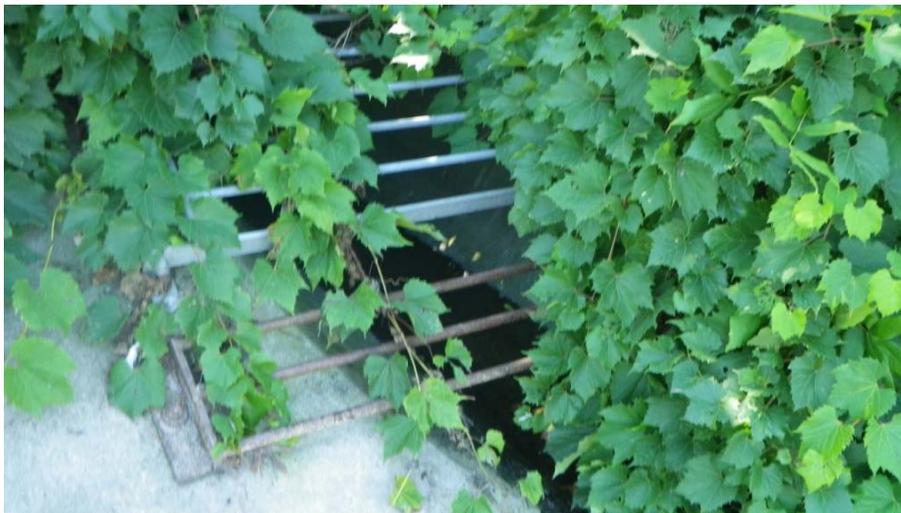
Photo A 11 – Storm Sewer Outlet North of Lakeshore Road Bridge

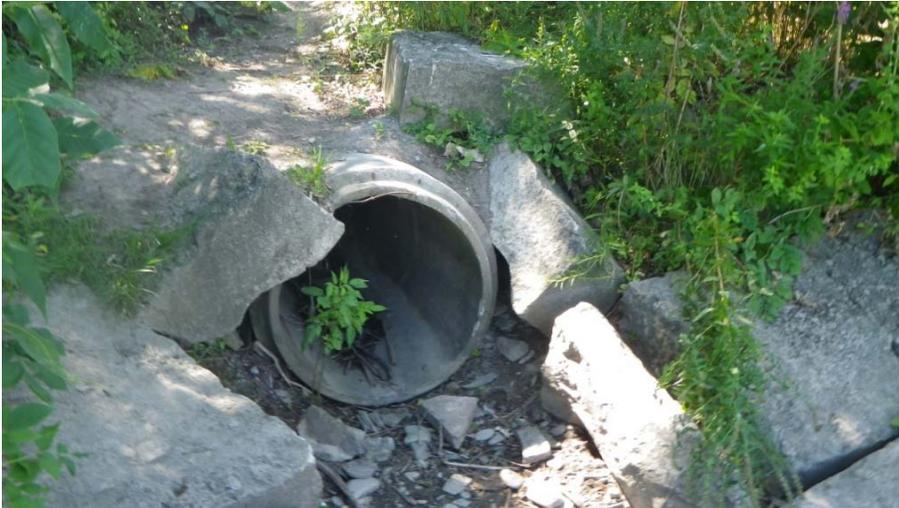
Photo A 12 – Storm Sewer Outlet along Memorial Park West Shore

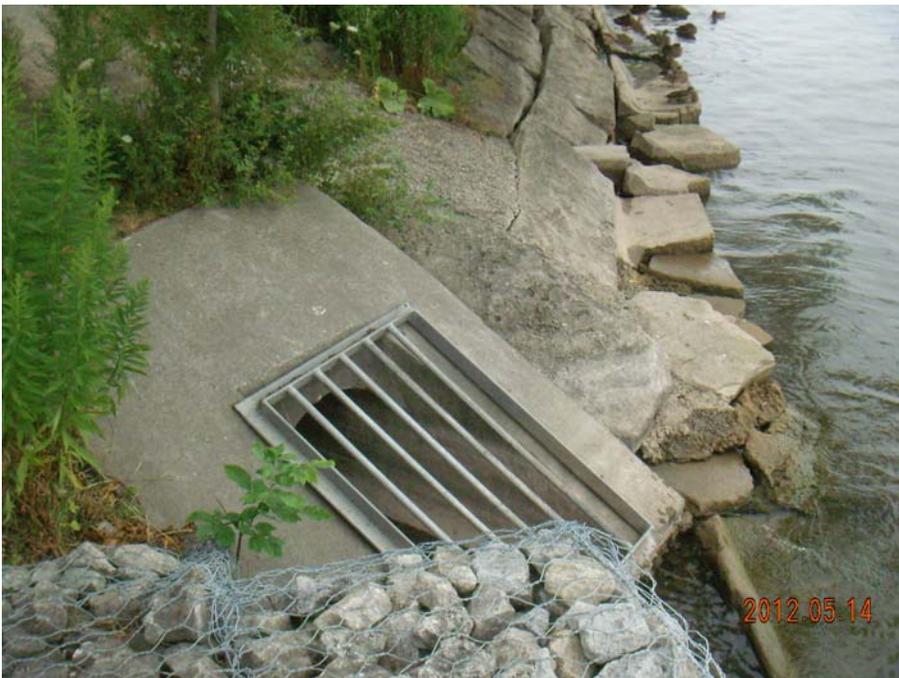
Photo A 13 – Storm Sewer Outlet North of Lakeshore Road Bridge

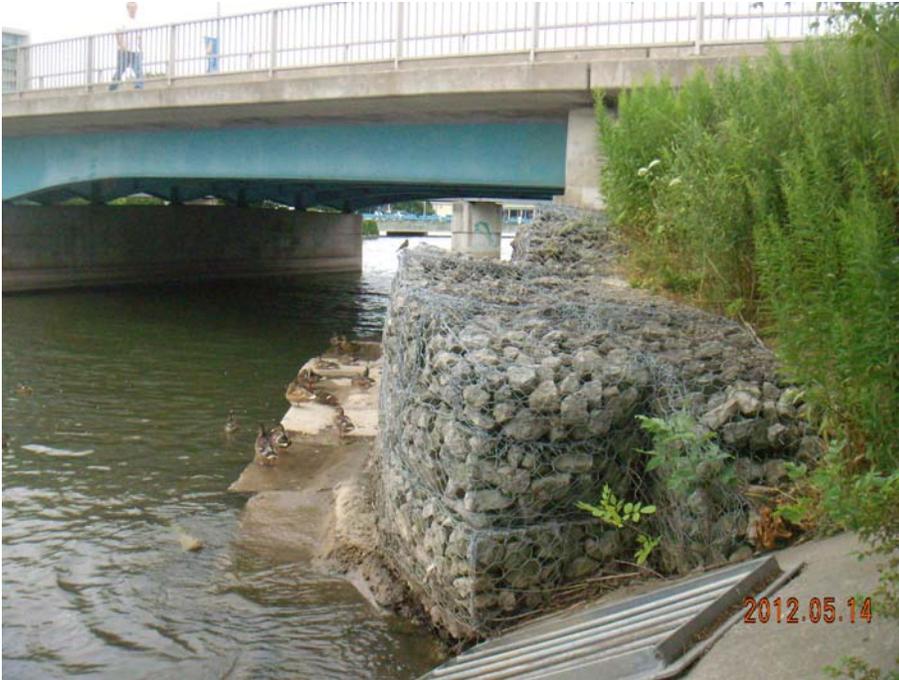
Photo A 14 - Storm Sewer Outlet, Gabion Wall and Lakeshore Road Bridge

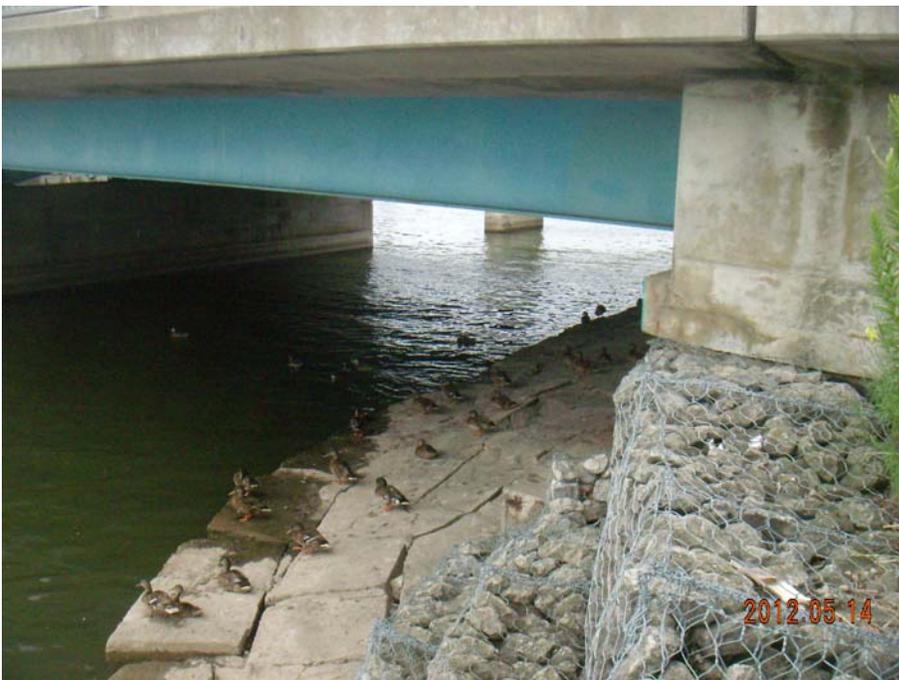
Photo A 15 - Gabion Wall and Lakeshore Road Bridge, North Side

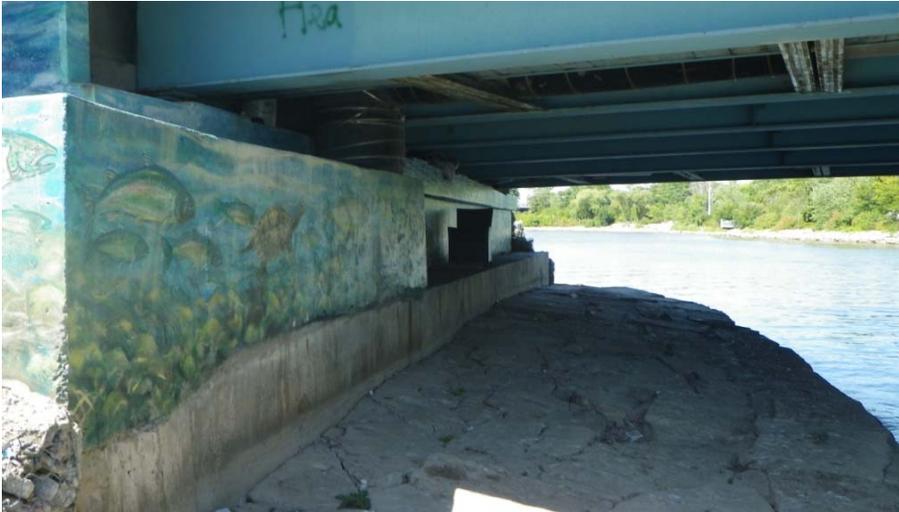
Photo A 16 – Shore Treatment and Abutment, Lakeshore Road Bridge

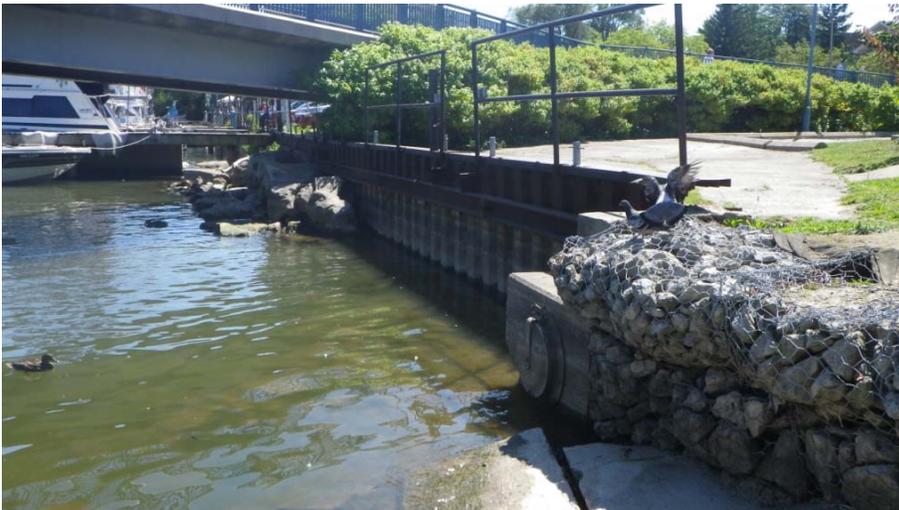
Photo A 17 – Gabion Basket and Steel Sheet Pile Walls South of Lakeshore Rd. Bridge
