**PRE-DESIGN REPORT / ENVIRONMENTAL STUDY REPORT
PORT CREDIT HARBOUR WEST PARKS**

**PORT CREDIT HARBOUR WEST PARKS
PRE-DESIGN REPORT / ENVIRONMENTAL STUDY REPORT**

Dillon Consulting Limited

Shoreplan Engineering Limited

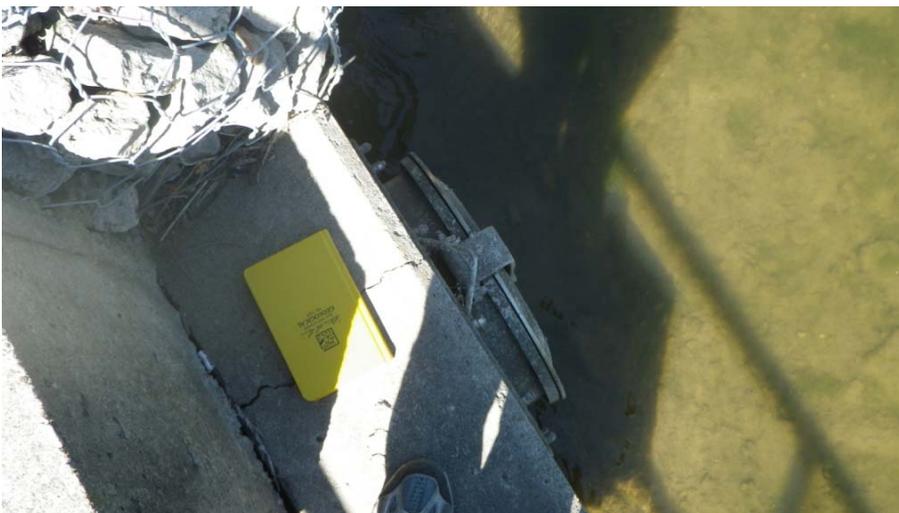
Photo A 18 – Sewer Outlet, South of Lakeshore Road Bridge

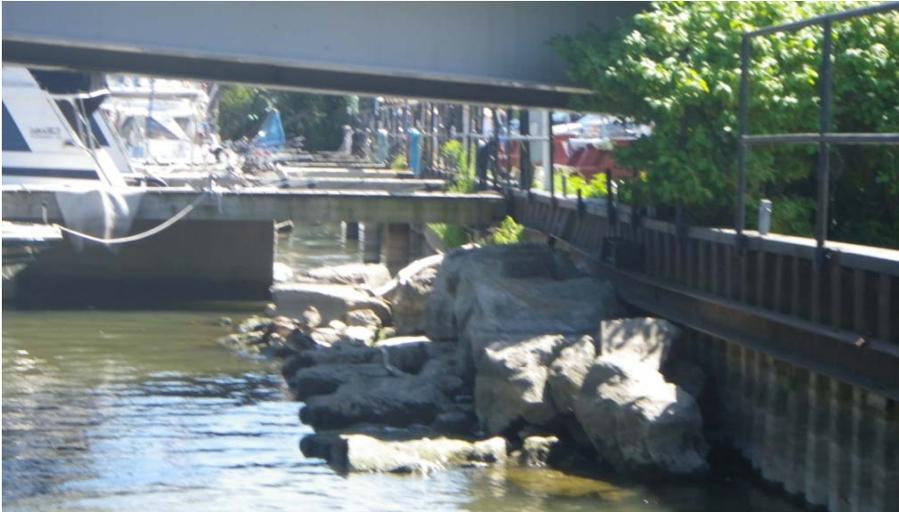
Photo A 19 – Armour Stone Revetment & Steel Sheet Pile Wall in Marina Park

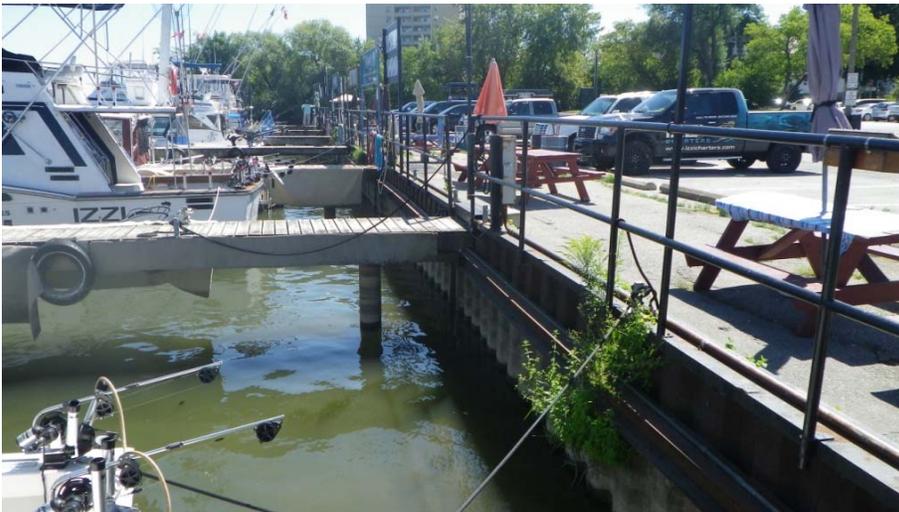
Photo A 20 – Steel Sheet Pile Wall in Marina Park

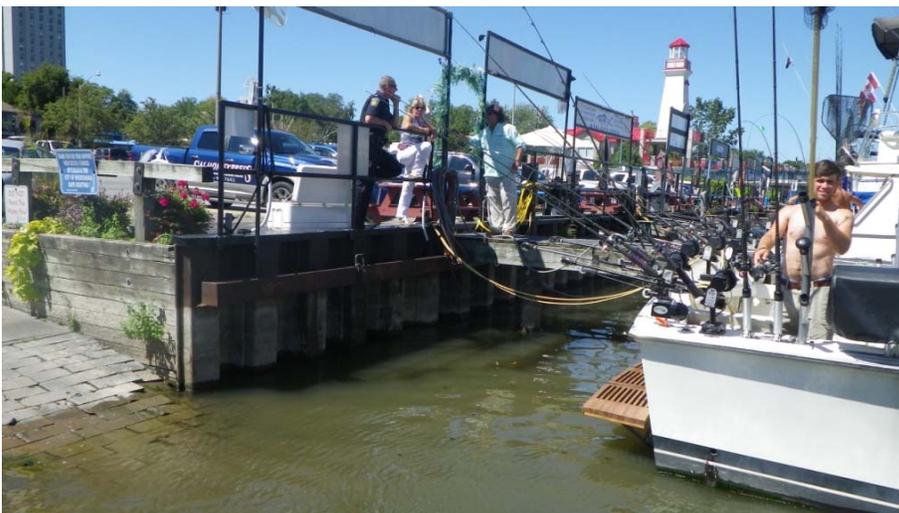
Photo A 21- Launch Ramp and Steel Sheet Pile Wall in Marina Park

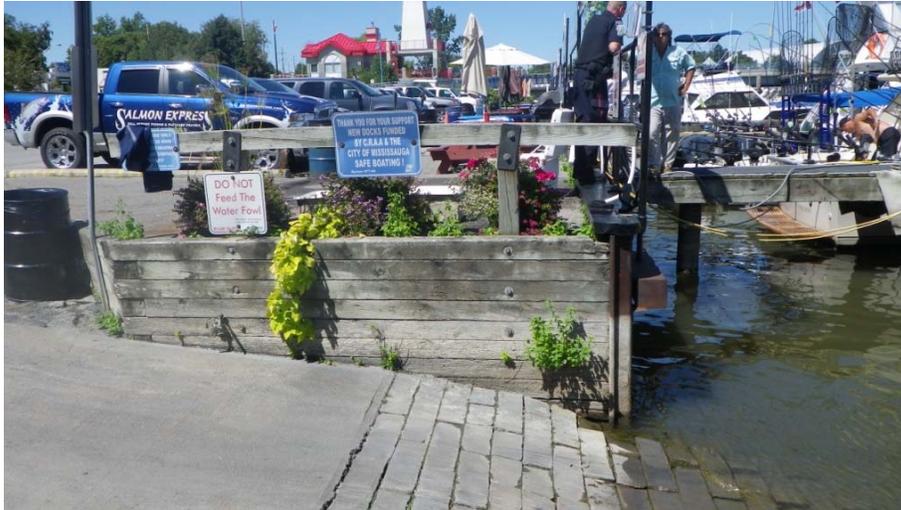
Photo A 22 - Launch Ramp, Timber and Steel Sheet Pile Walls in Marina Park

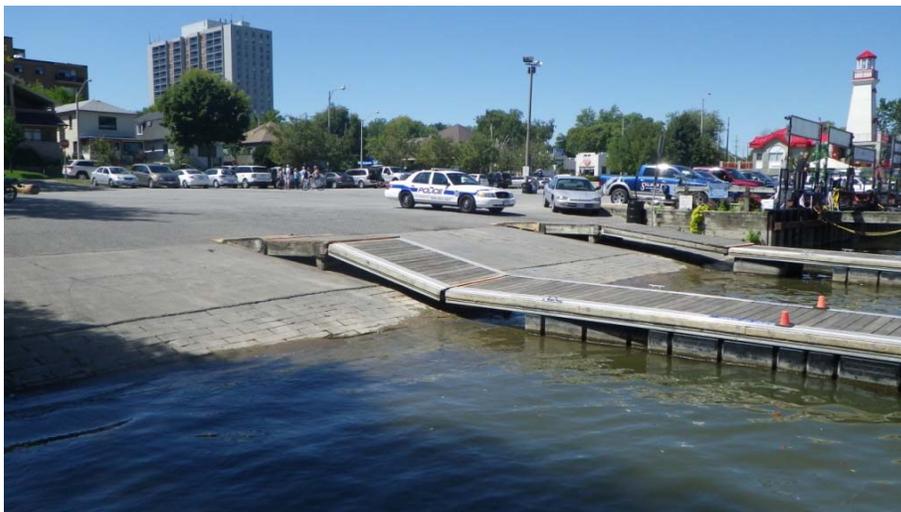
Photo A 23- Launch Ramp and Boarding Docks in Marina Park

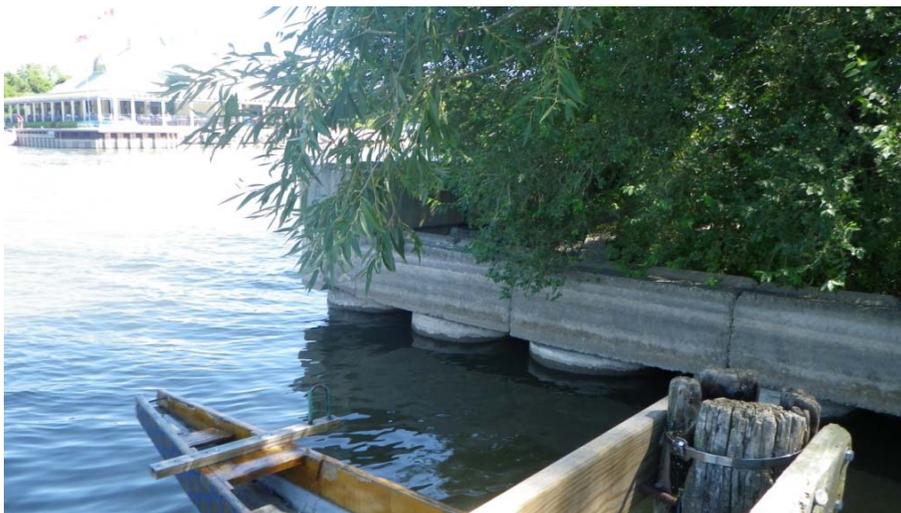
Photo A 24 – South Side of Launch Ramp Area in Marina Park

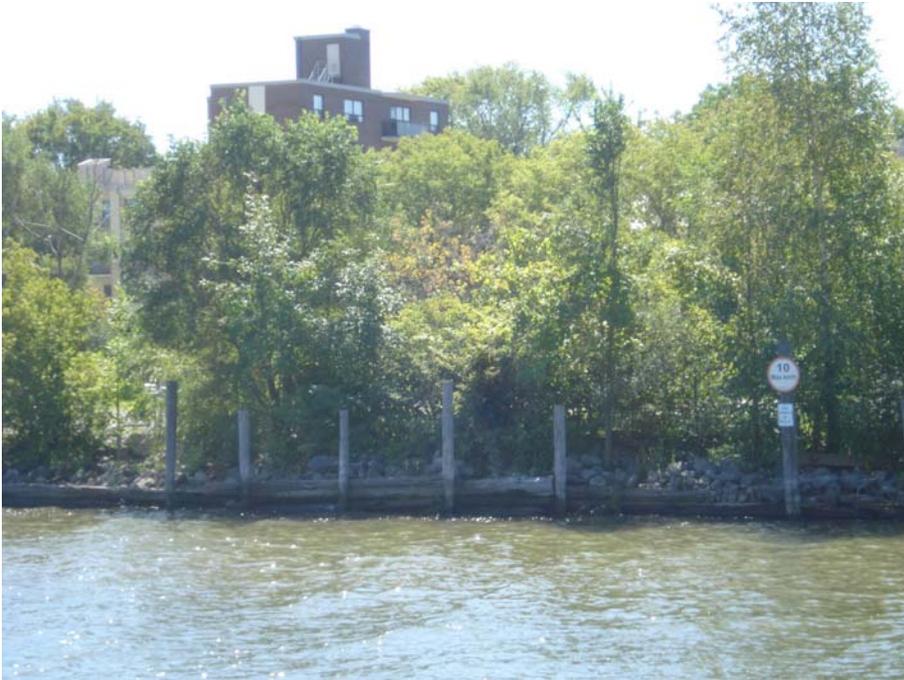
Photo A 25 – Shore along South Part of Marina Park

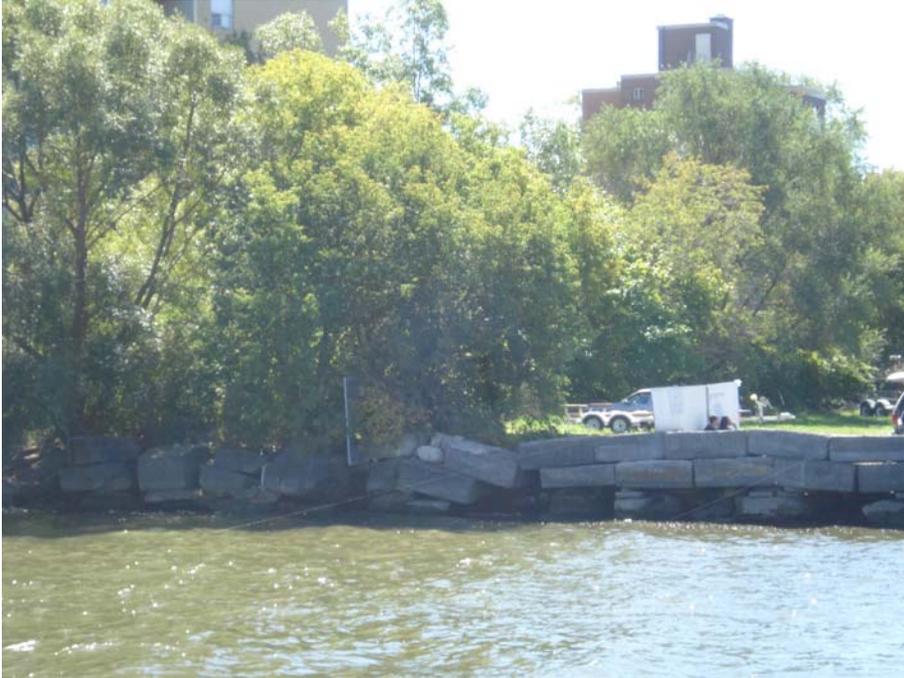
Photo A 26 – Shore along South Part of Marina Park

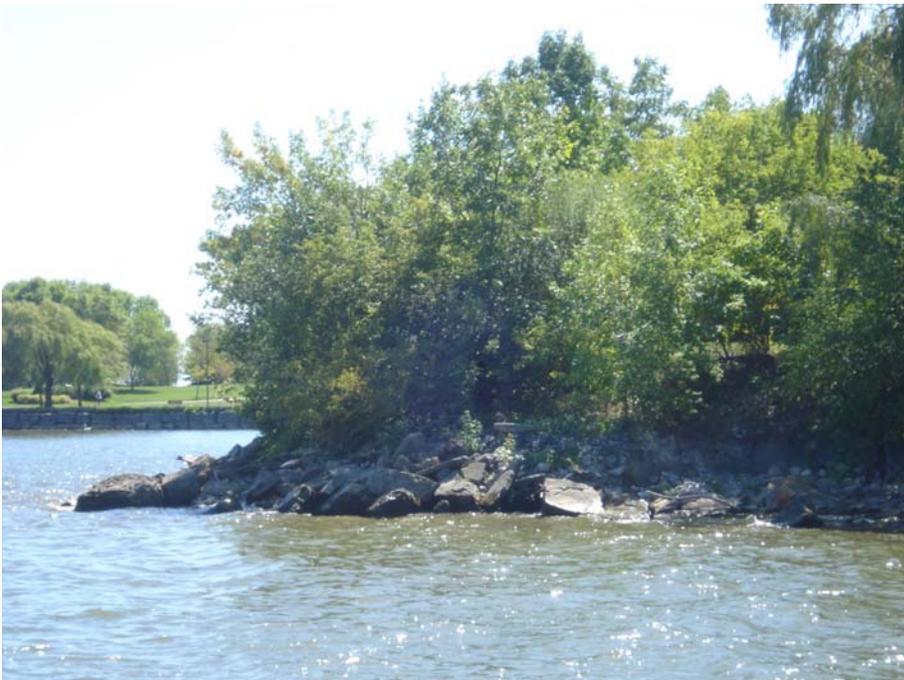
Photo A 27– Shore along South Part of Marina Park

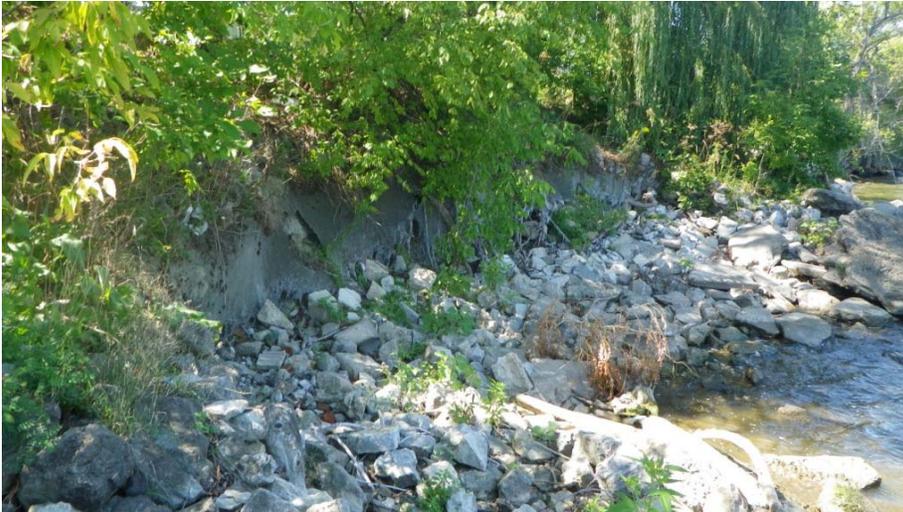
Photo A 28 – Armour Stone/Rubble Revetment along Rivergate Easement

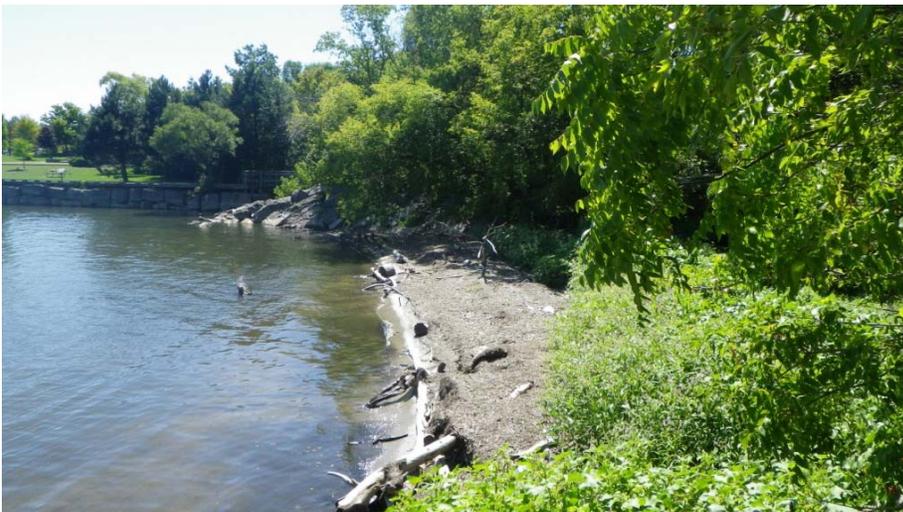
Photo A 29 – Failed Revetment along Rivergate Easement

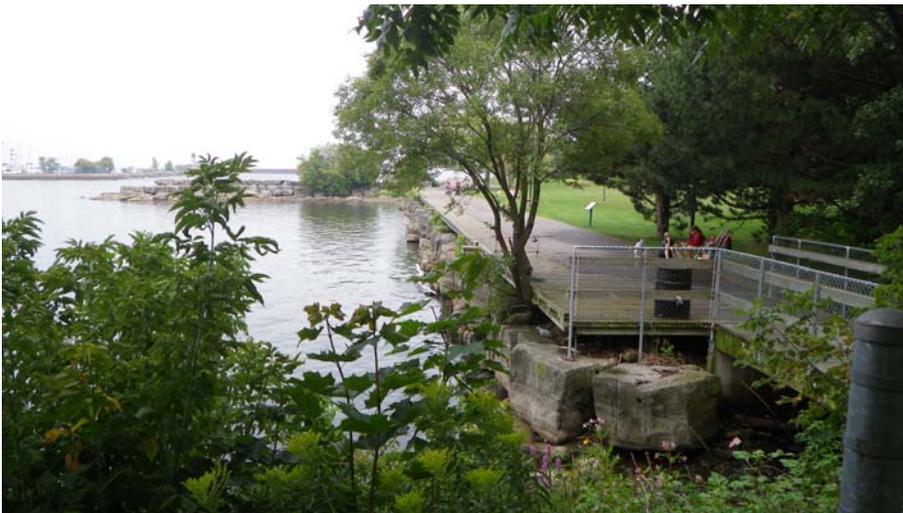
Photo A 30 – Shore along Rivergate Easement at J.C. Saddington Park

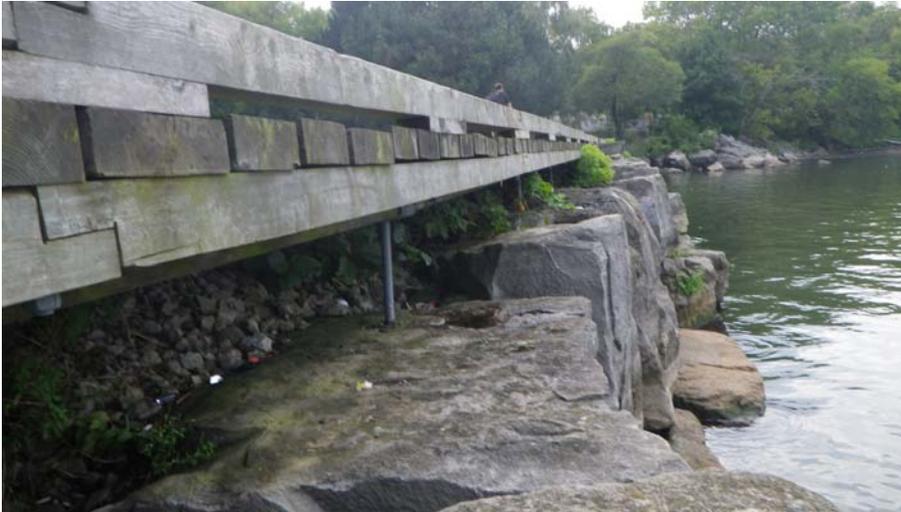
Photo A 31– Shore along J.C. Saddington Park, North- East Side

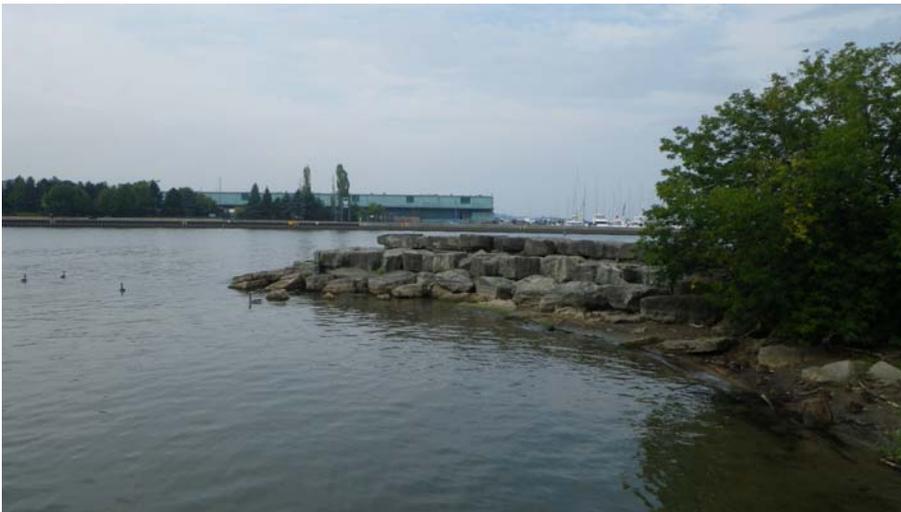
Photo A 32– Shore along J.C. Saddington Park, East Side

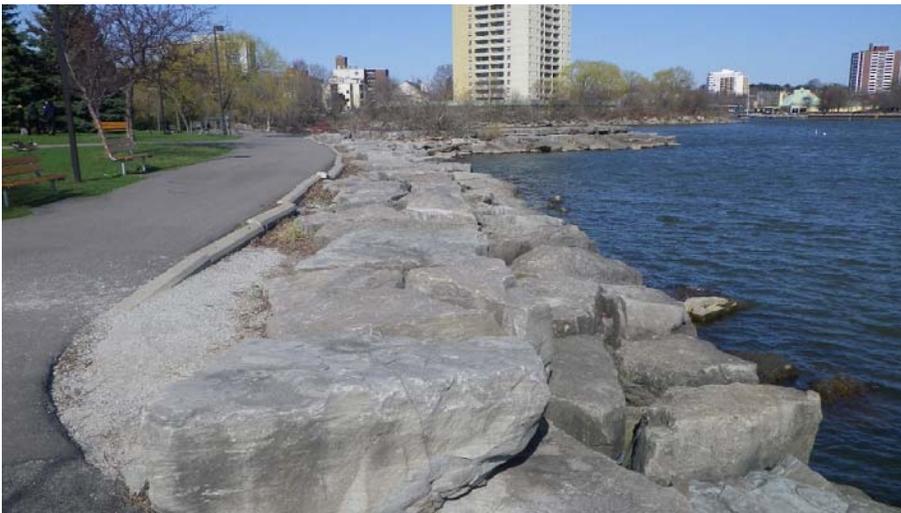
Photo A 33 - Shore along J.C. Saddington Park, Groyne on East Side

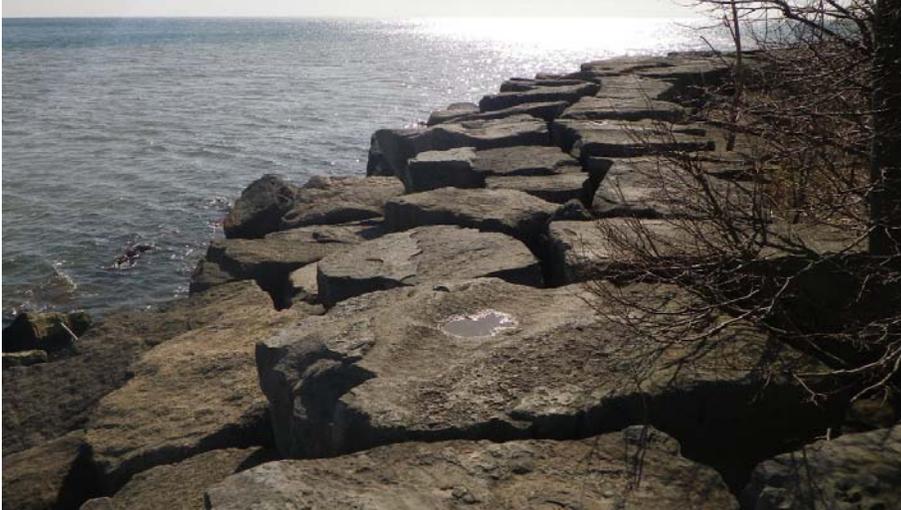
Photo A 34 – Armour Stone along J.C. Saddington Park, East Side

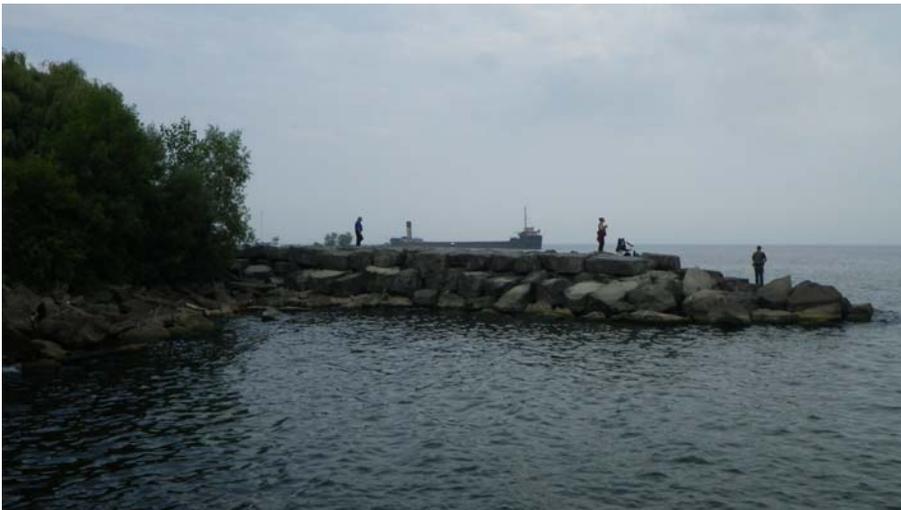
Photo A 35 – Armour Stone along J.C. Saddington Park, South East Side

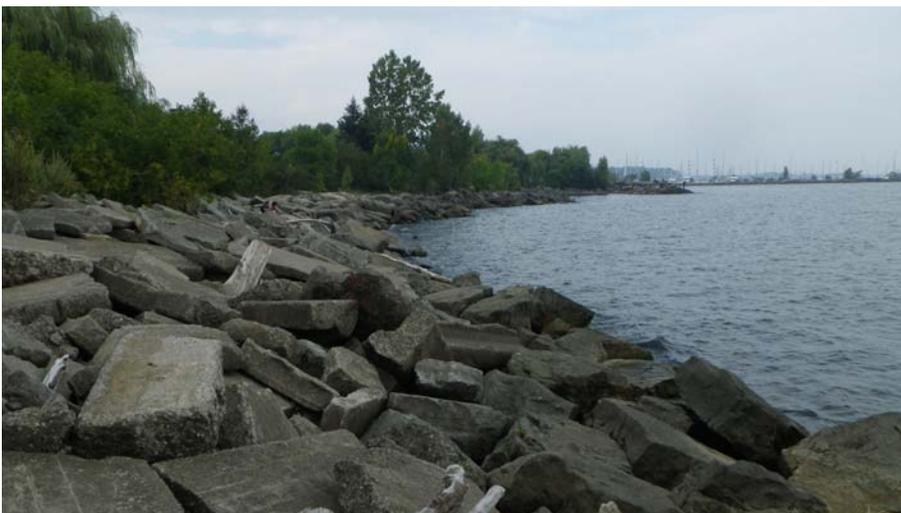
Photo A 36 – Armour Stone along J.C. Saddington Park, South East Headland

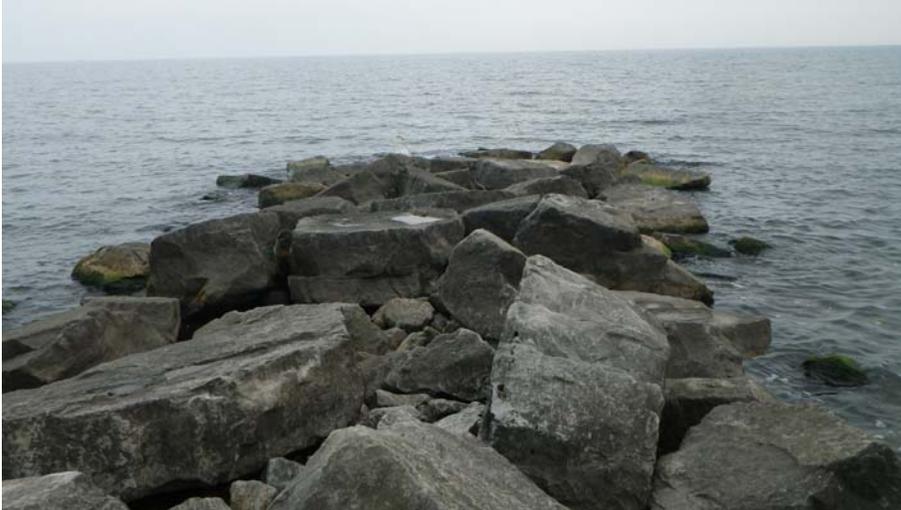
Photo A 37 – Rubble Revetment along J.C. Saddington Park, South Side

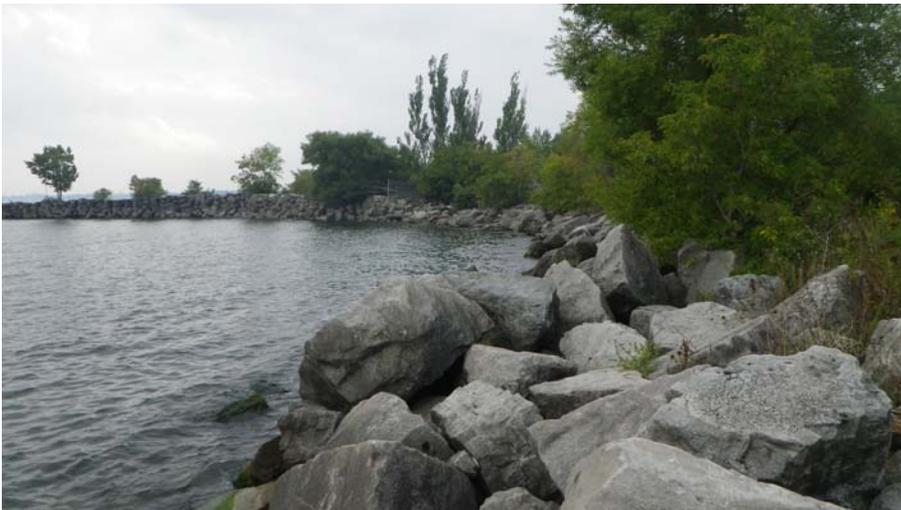
Photo A 38 – Armour Stone Groyne, Central J.C. Saddington Park

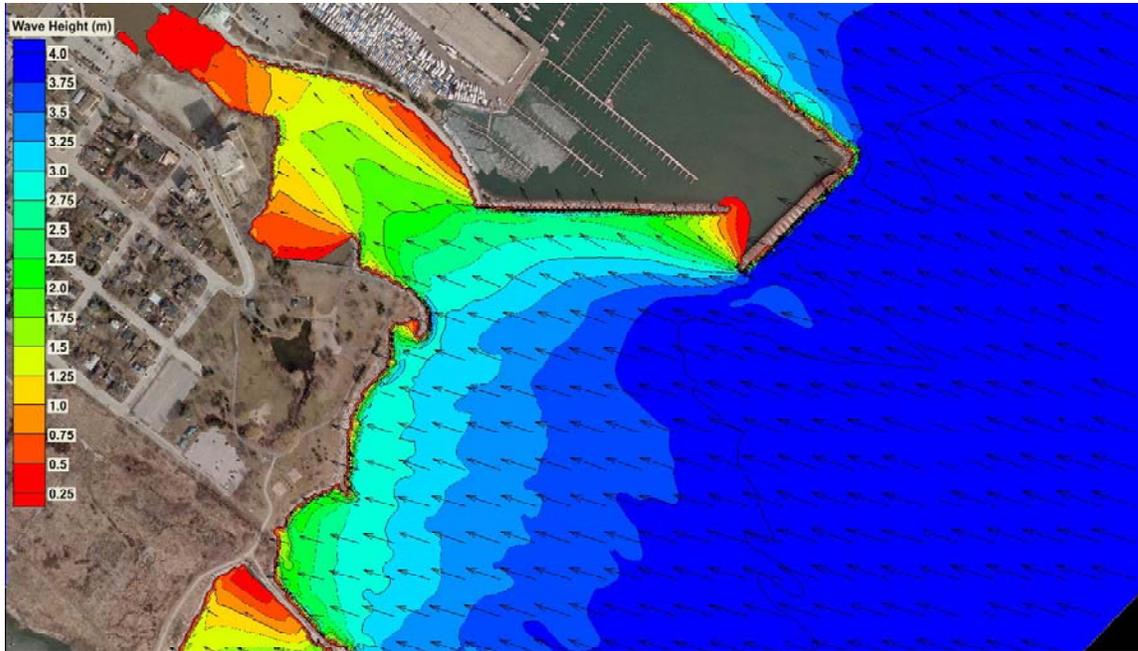
Nearshore Wave Energy Distribution

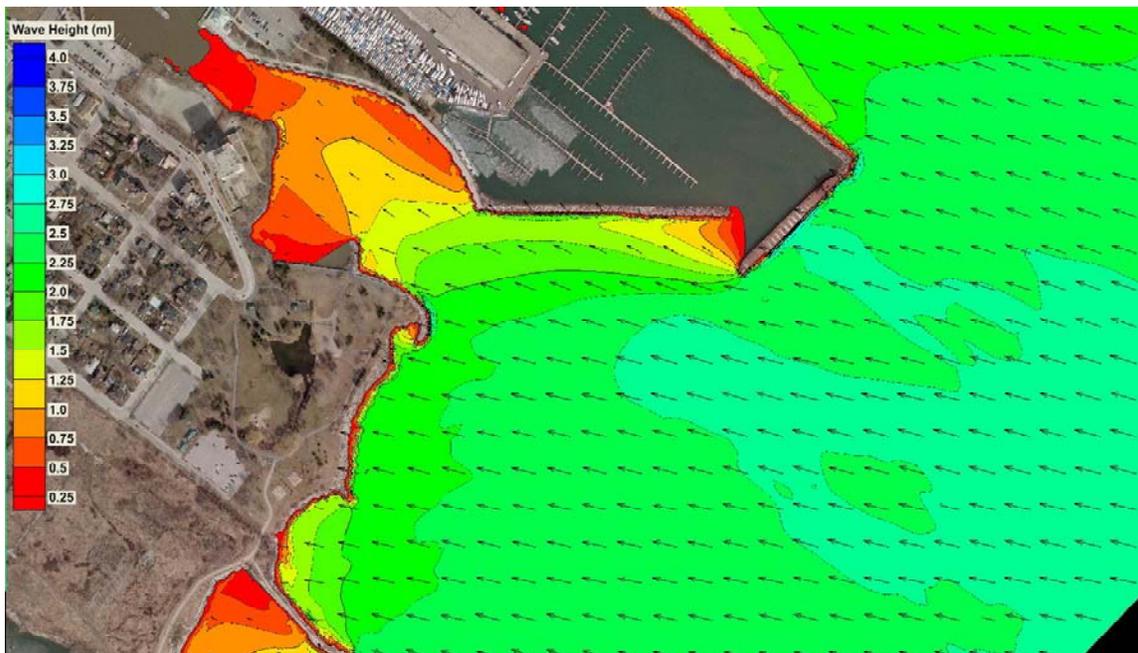
Design Wave (100-yr wave, 100-yr water level)

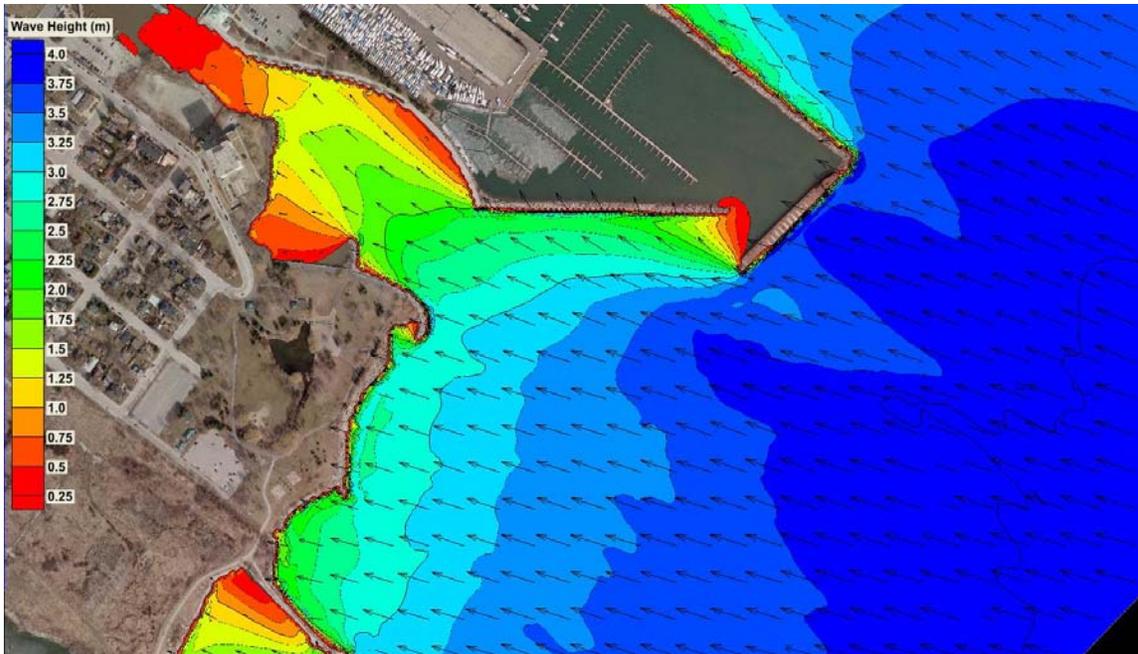
Annual Wave – Average of 36 Highest Annual Wave Heights
(3.4m 8s in deep water, analysis water level 75.0m)

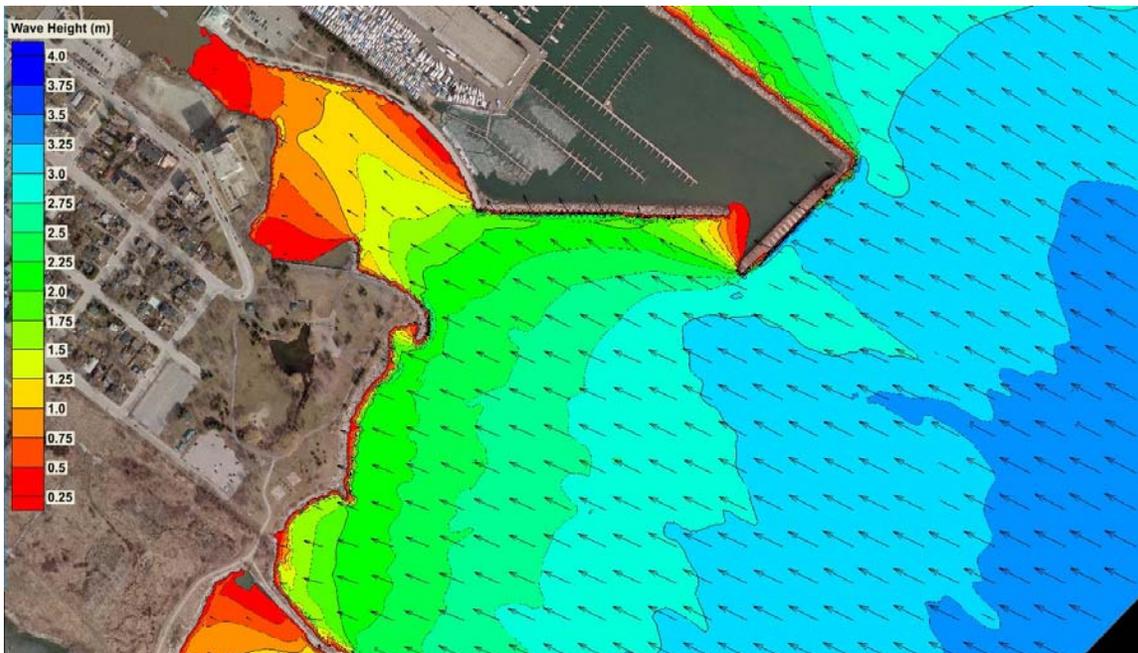
Highest Hindcast Waves – East Waves

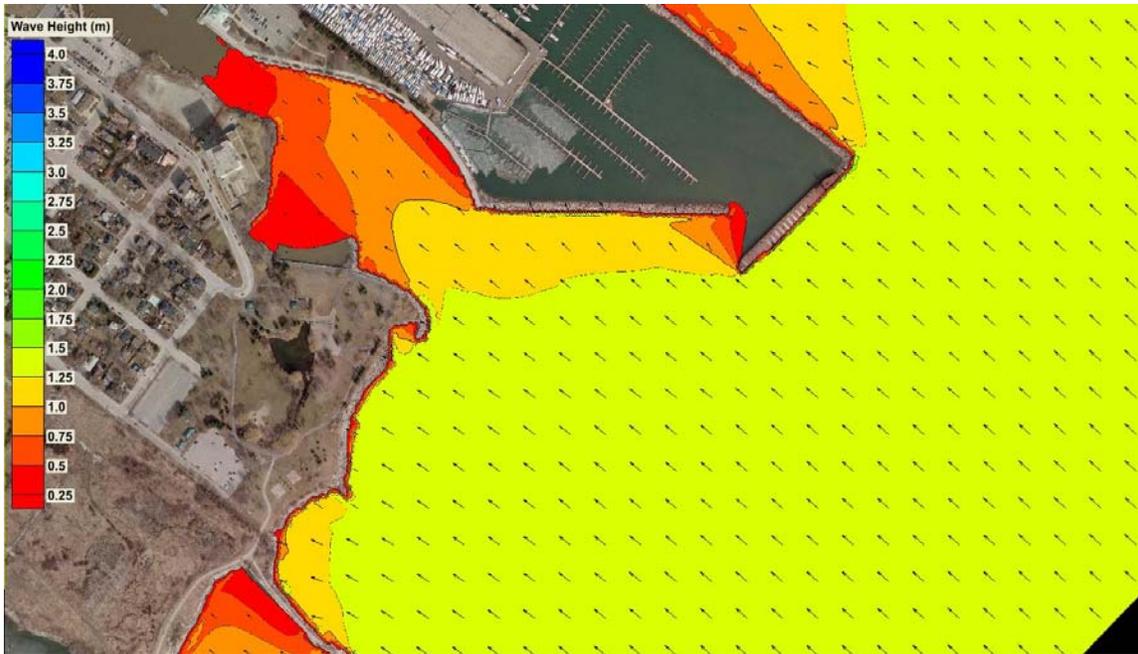
Highest Hindcast Waves – East-Southeast Waves

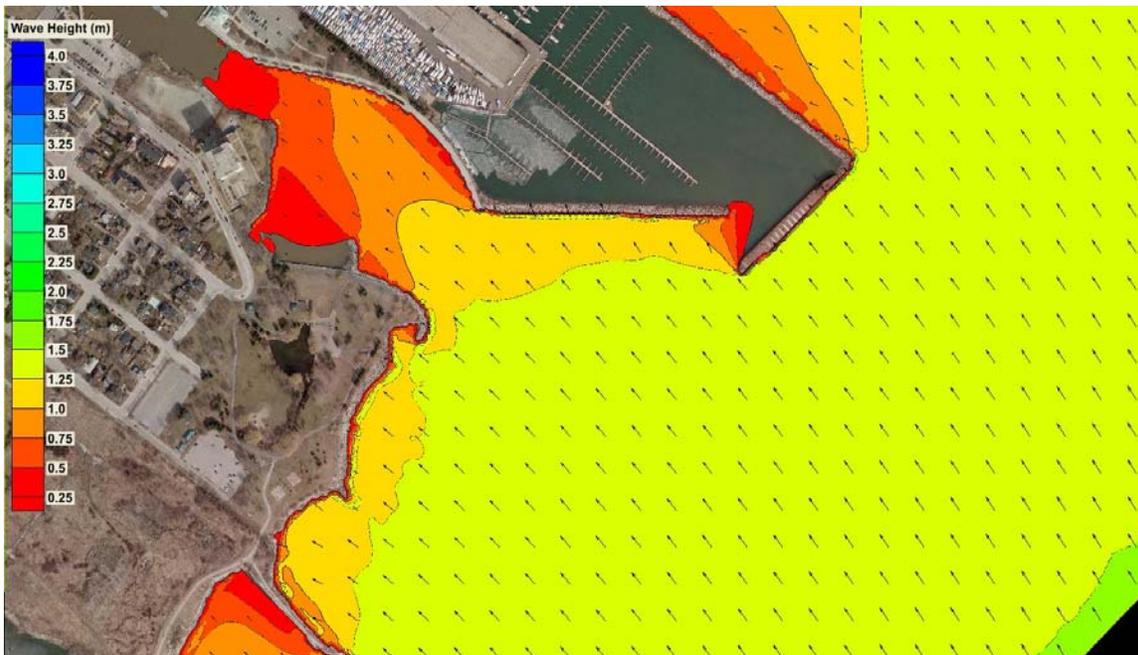
Highest Hindcast Waves – Southeast Waves

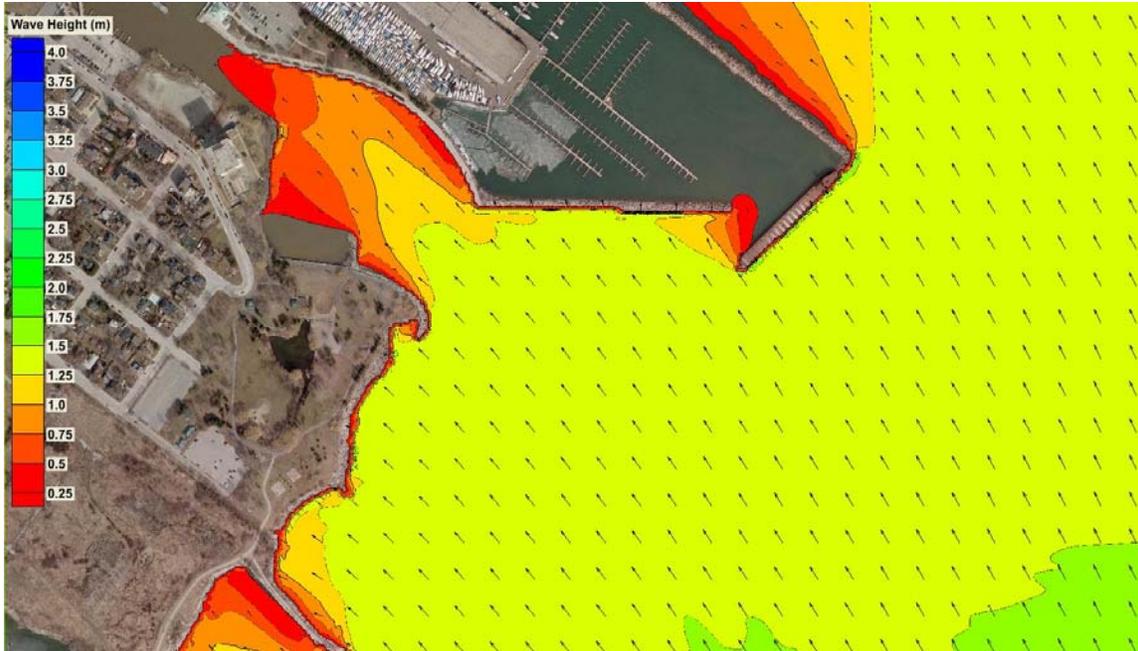
Highest Hindcast Waves – South-Southeast Waves

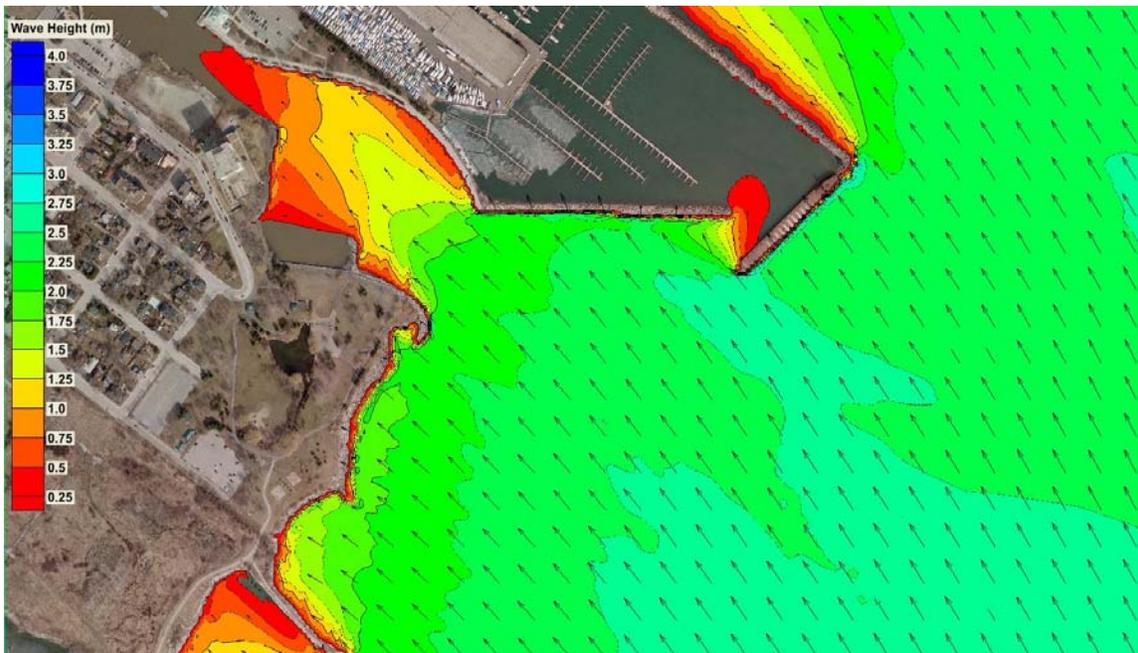
Highest Hindcast Waves – South Waves

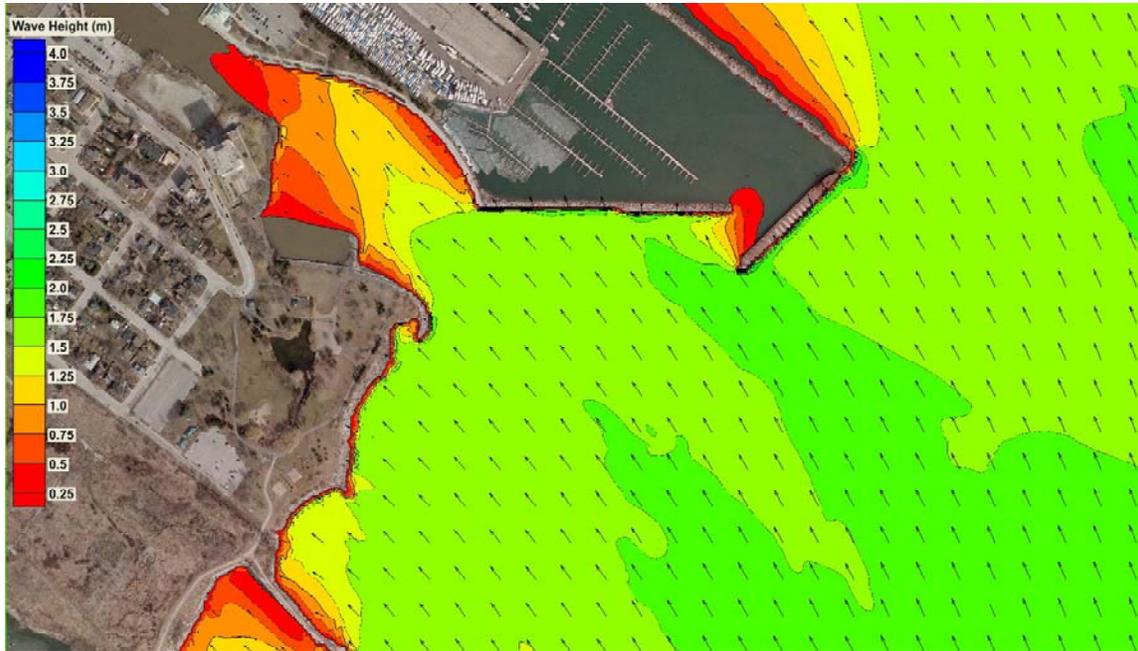
Highest Hindcast Waves – South-Southwest Waves

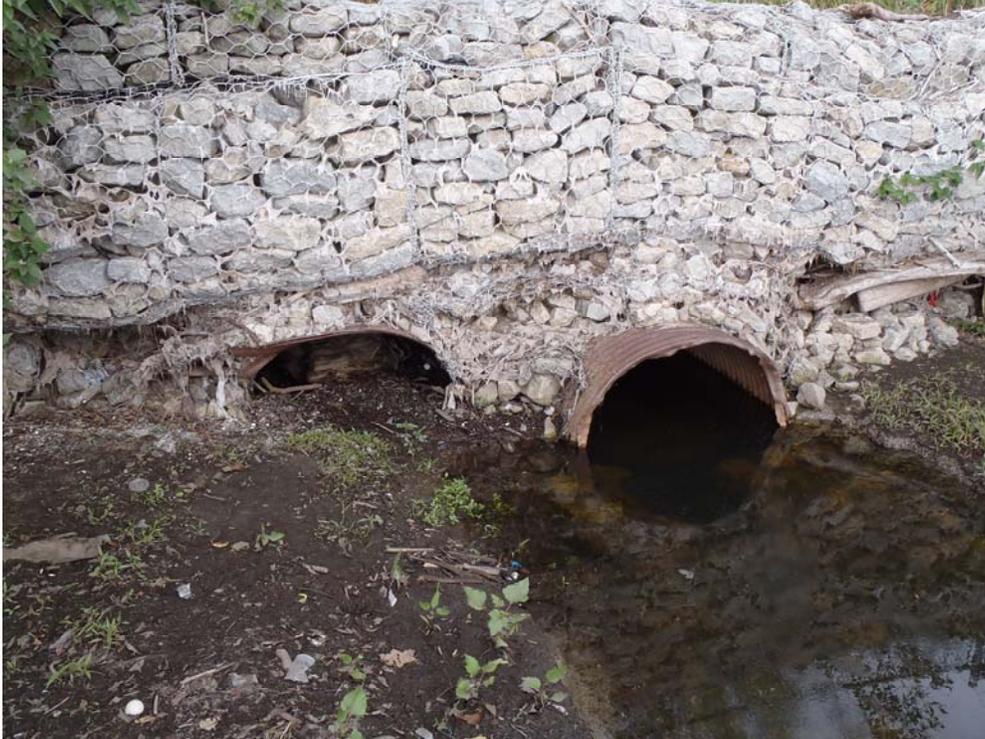
Photo 1 - Close up view of outlet structure at the extension of Mississauga Road

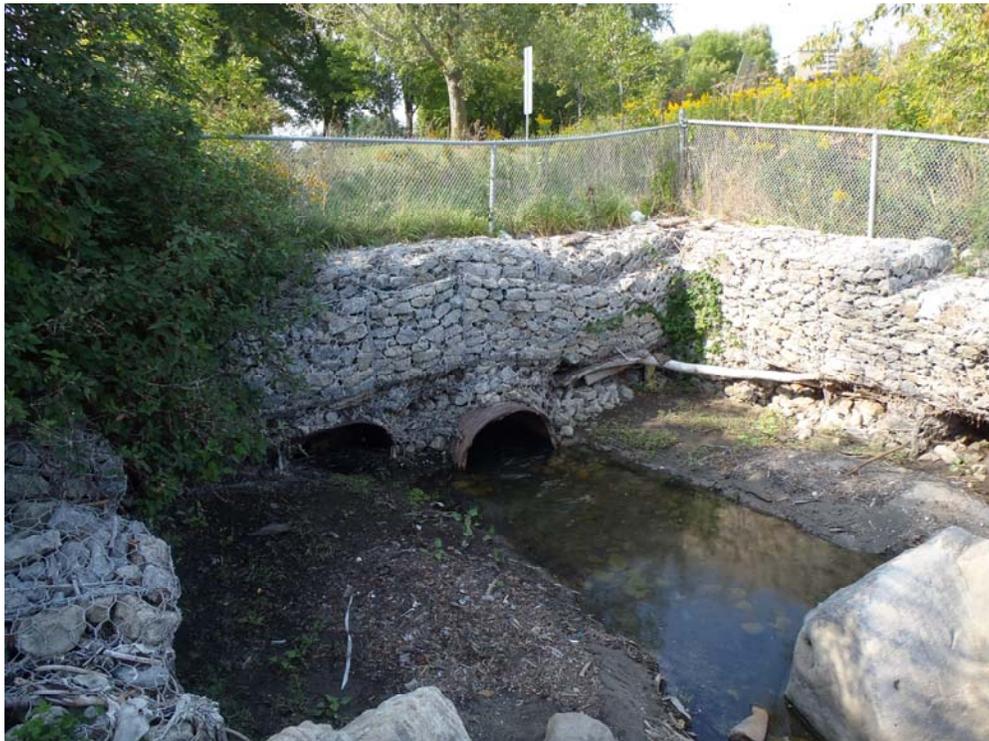
Photo 2 - Outlet structure at the extension of Mississauga Road

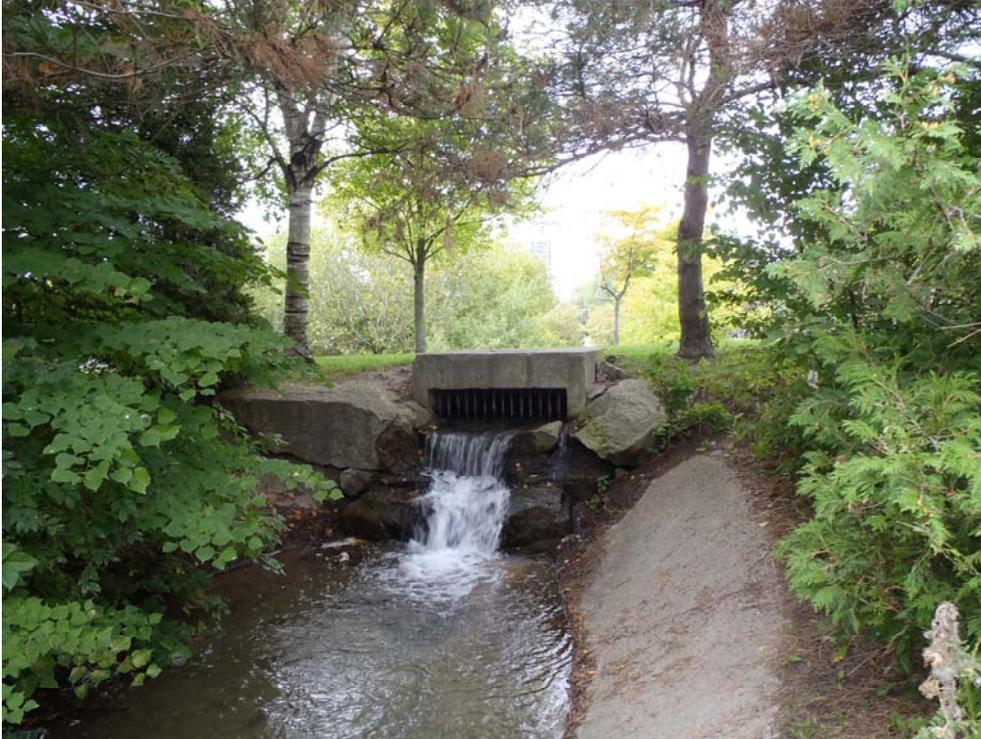
Photo 3 – Discharge structure into channel adjacent to former filtration building

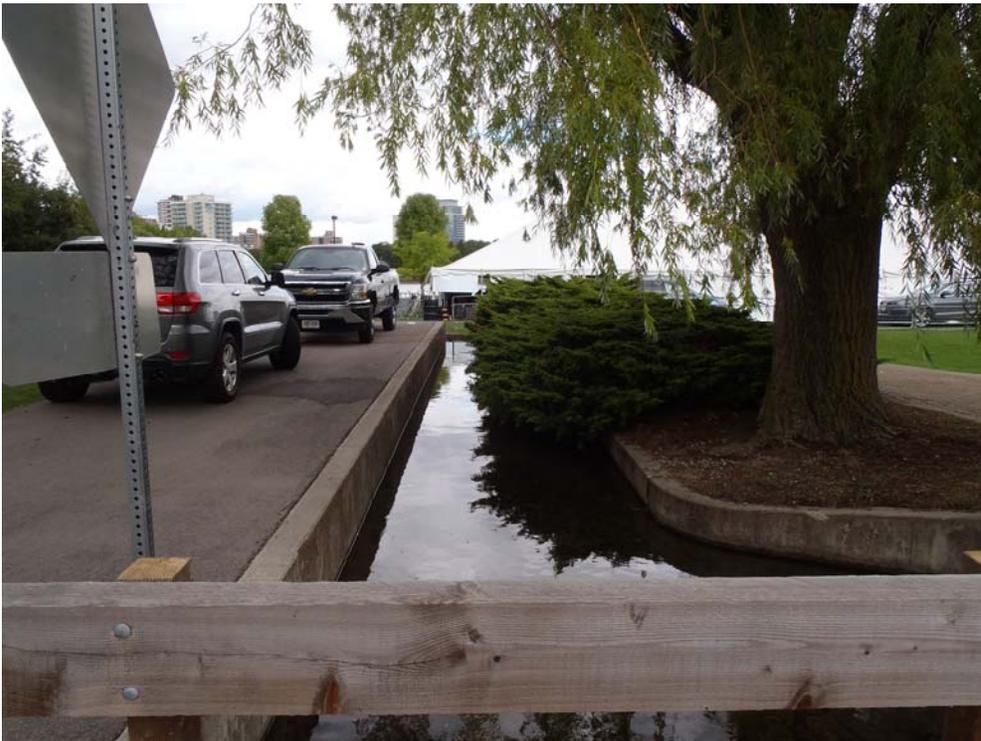
Photo 4 – Concrete outlet channel from pond flowing into naturalized outlet

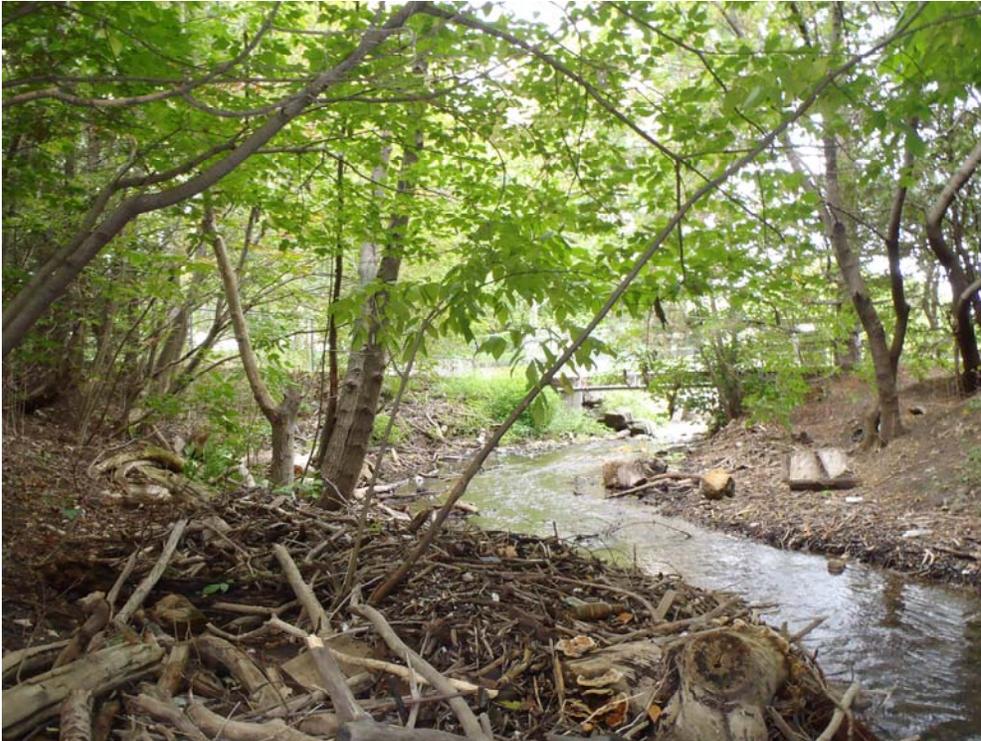
Photo 5 – Naturalized channel downstream of concrete outlet channel (Photo 4)

Photo 6 – Naturalized channel (Photo 5) discharge into Credit River

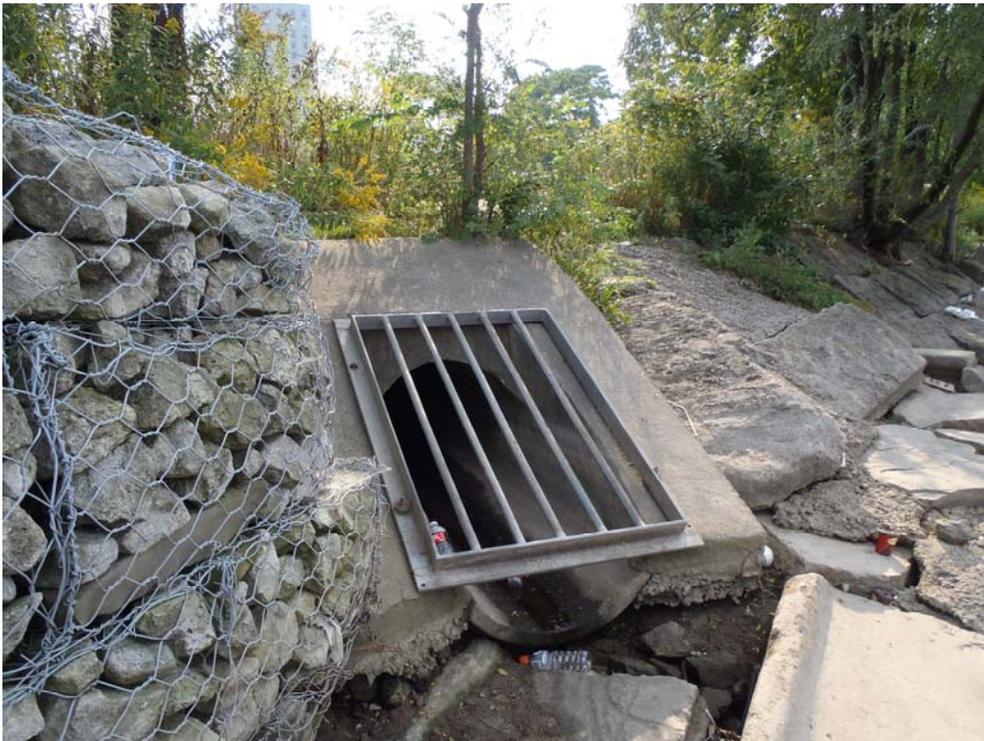
Photo 7 – Storm outfall at Marina Park

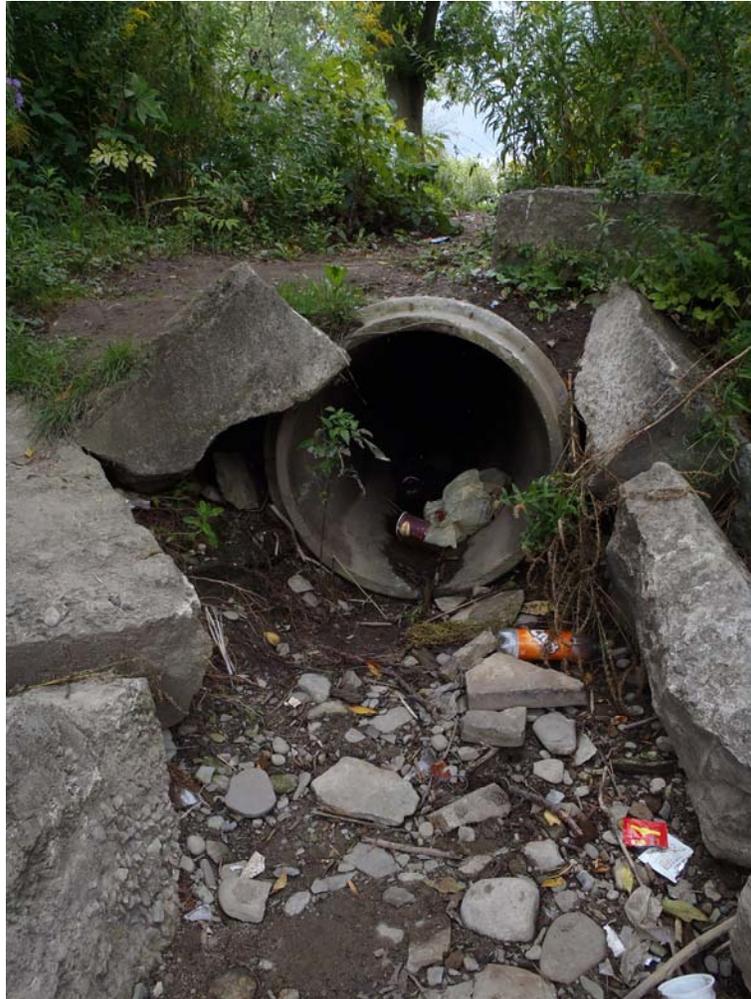
Photo 8 – Storm outfall at Memorial Park West at Lakeshore Road

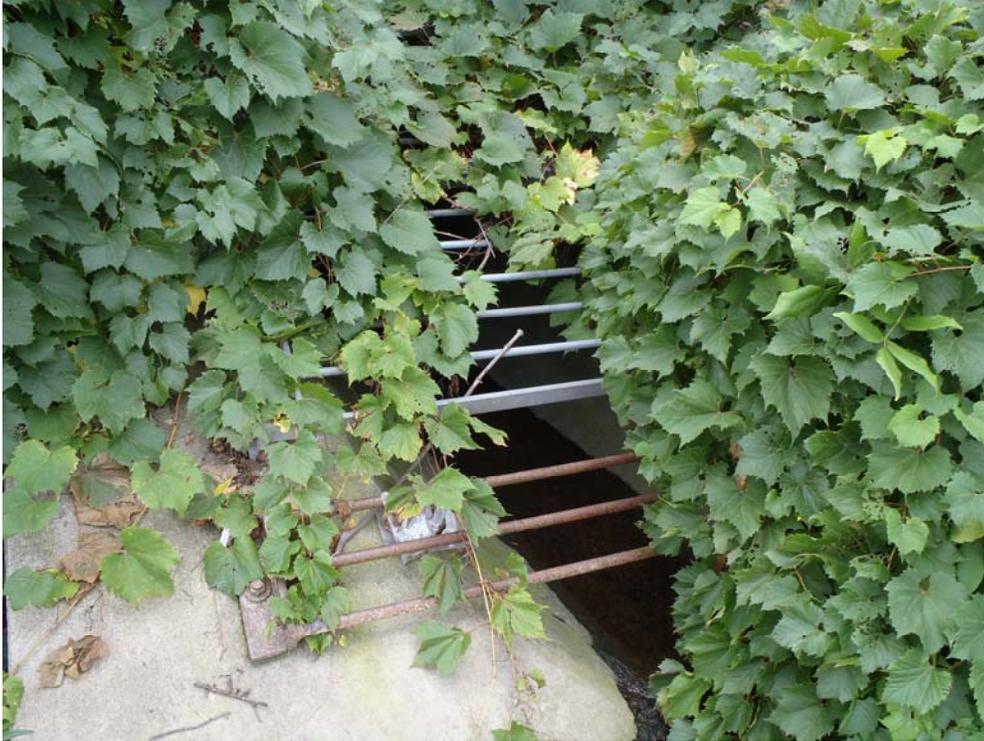
Photo 9 – Storm outfall (675mm) at Memorial Park West north of Lakeshore Road
